**ST AIDAN'S PARISH CHURCH
CHILTON**

QUINQUENNIAL INSPECTION 2017

DATE OF INSPECTION : 20 June 2017

**Malcolm R Cundick Dip.Arch.(Oxford) RIBA
ADG Architects
6 Pioneer Court
Morton Palms Business Park
DARLINGTON
DL1 4WD**

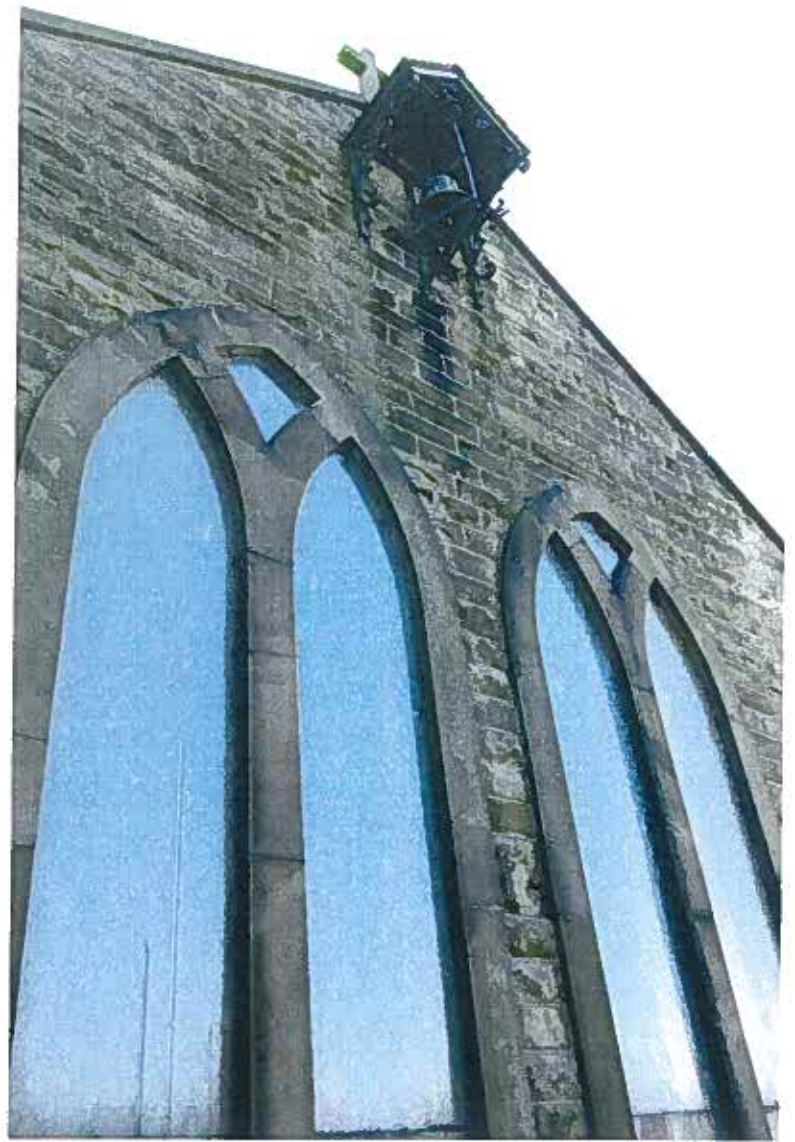
7

- 5.4a All windows are recorded as being fitted with temporary protective twin wall polycarbonate sheeting following vandalism in 1994/95. These were sealed with no ventilating air gap with potential consequent heat damage to leadwork etc. These are gradually being replaced with more robust single skin polycarbonate glazing with perimeter air gaps, particularly those incorporating stained glass. This replacement programme will progress as funding permits. Note in particular the sealed protective sheeting to the West gable windows above the Baptistry.

5. South West detail of West gable
6. Baptistry, South and North Porches from North West
7. West gable to Nave with sealed window protective sheeting
8. Mineral felt covering to Baptistry roof. Note defective mortar pointing to upstand.
Note staining from bellcote frame.

5. Renew threshold weather strip to Vestry door per 5.3a (B) £20
6. Continue programme of replacement protective sheeting to windows including boarded openings per 5.4a, 5.4b and 5.4c (C) £3000

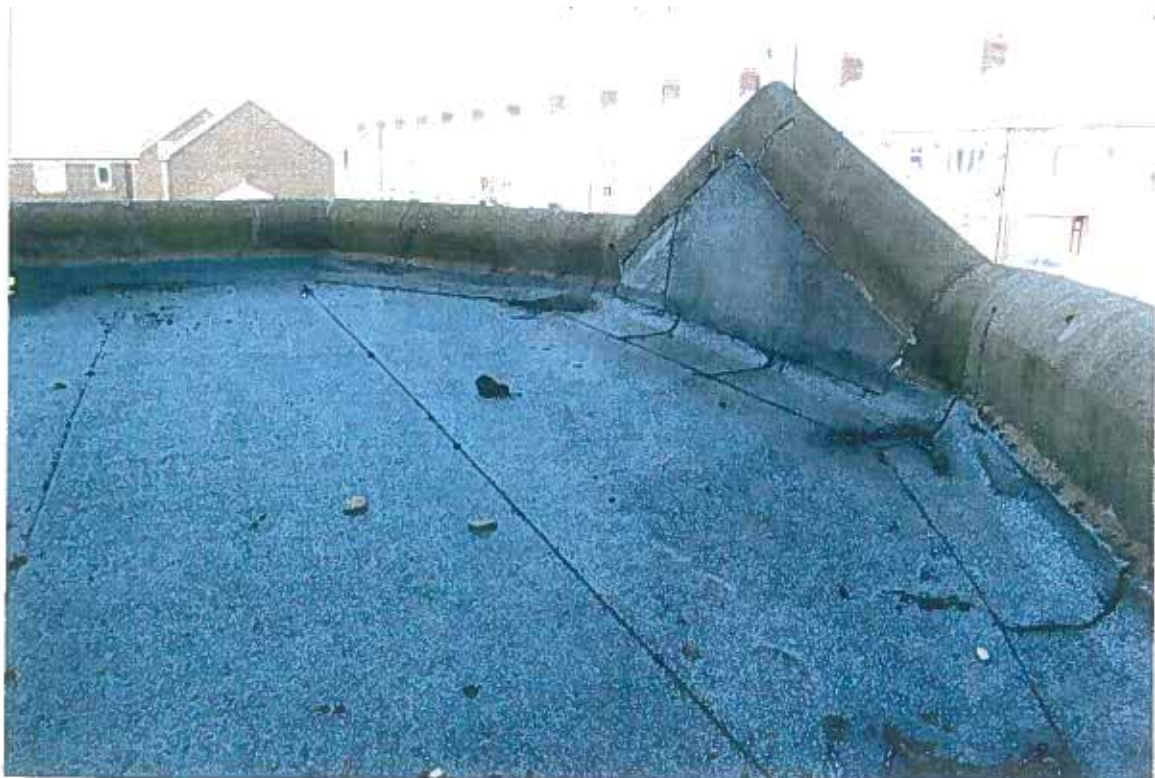
8

- 5.1d. The flat roof over the Baptistry has a replacement mineral felt covering with upstand flashings. It is in sound condition with no further reports of rainwater ingress which had impacted on the condition of internal ceiling and wall finishes. There is still evidence of small stones on the roof related to vandalism target practice on the bellcote which should be regularly monitored.

3. Monitor condition of flat roof covering to Baptistry and remove all stones from surface per 5.1d (B)
4. Carry out some localised remedial soft mix pointing to external stonework per 5.2a (B) £600

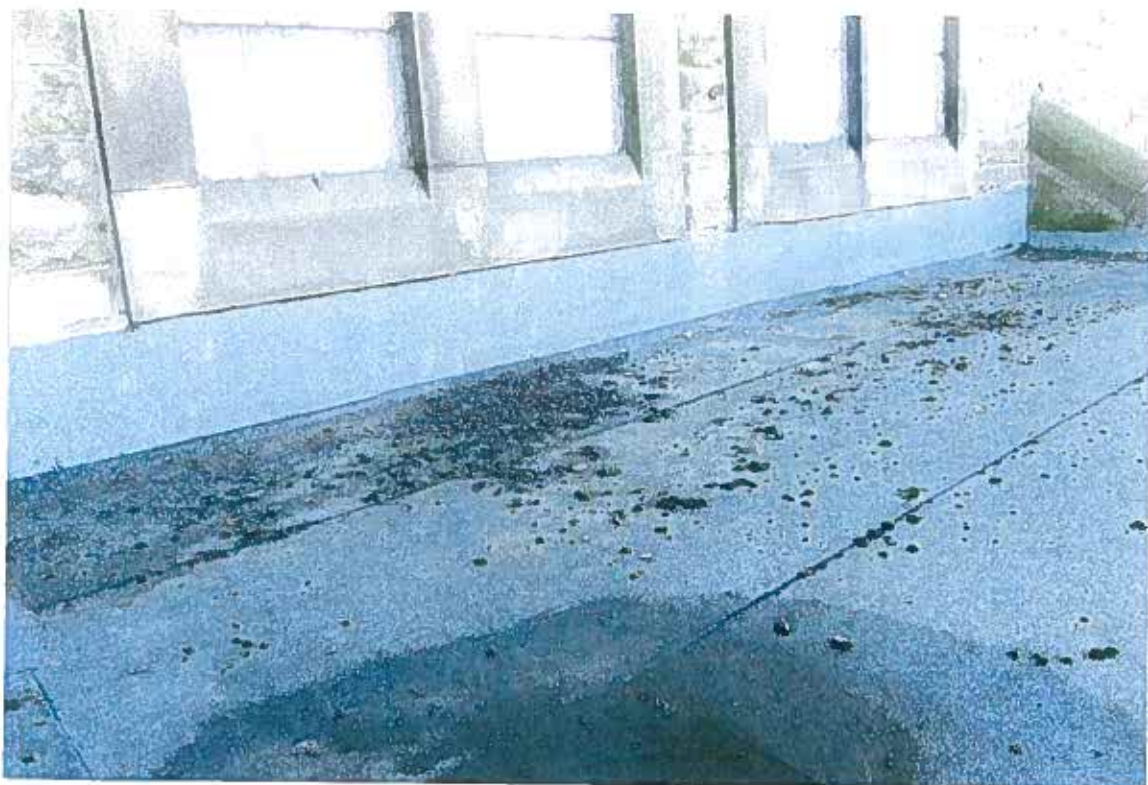
9

9. Bell target stones on surface of mineral felt roofing to Baptistry.
10. Ponding to Baptistry roof
11. North Porch
12. Open joints to North Porch parapet

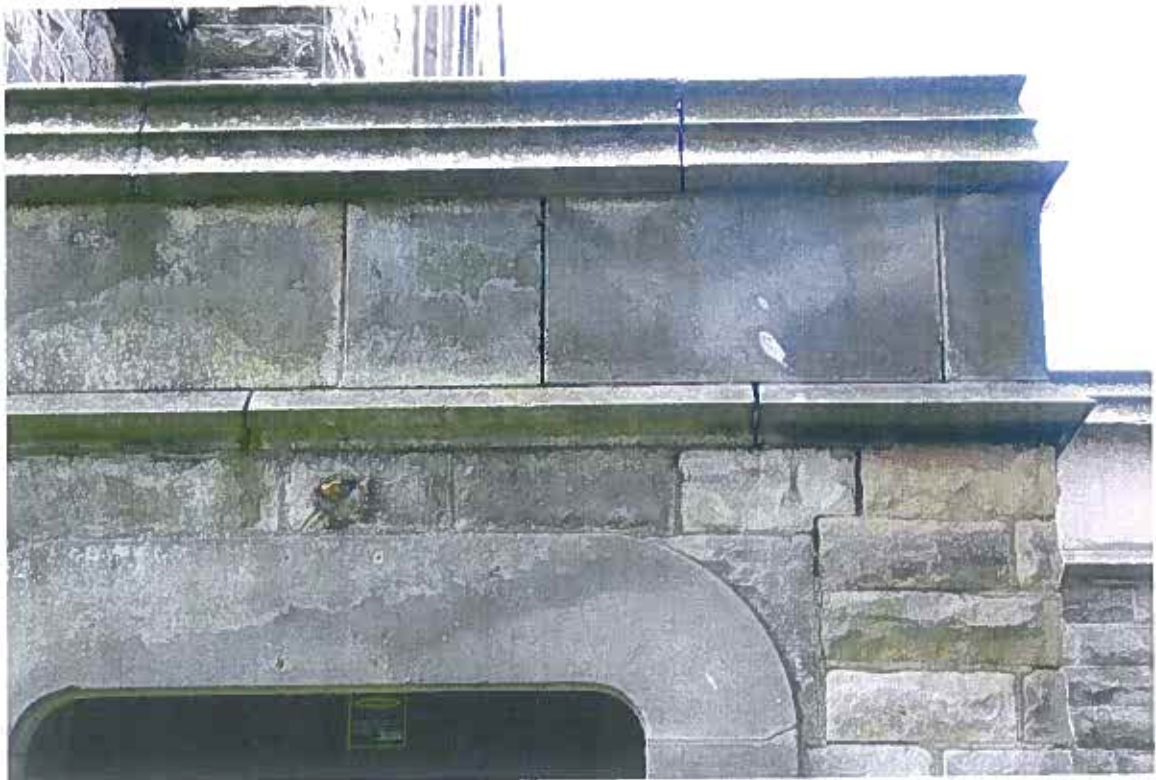
12

- 5.1 c. Roofs to the North and South entrances have parapet walls with lead lined gutters. Repairs carried out prior to the last inspection should be the subject of ongoing monitoring including elements of flashing in lead substitute materials.

1. Maintain a watching brief on the condition of roof slating and nail fixings ref 5.1a (D)
2. Maintain a watching brief on lead substitute flashings to the two Porch Entrance roofs per 5.1c (D)

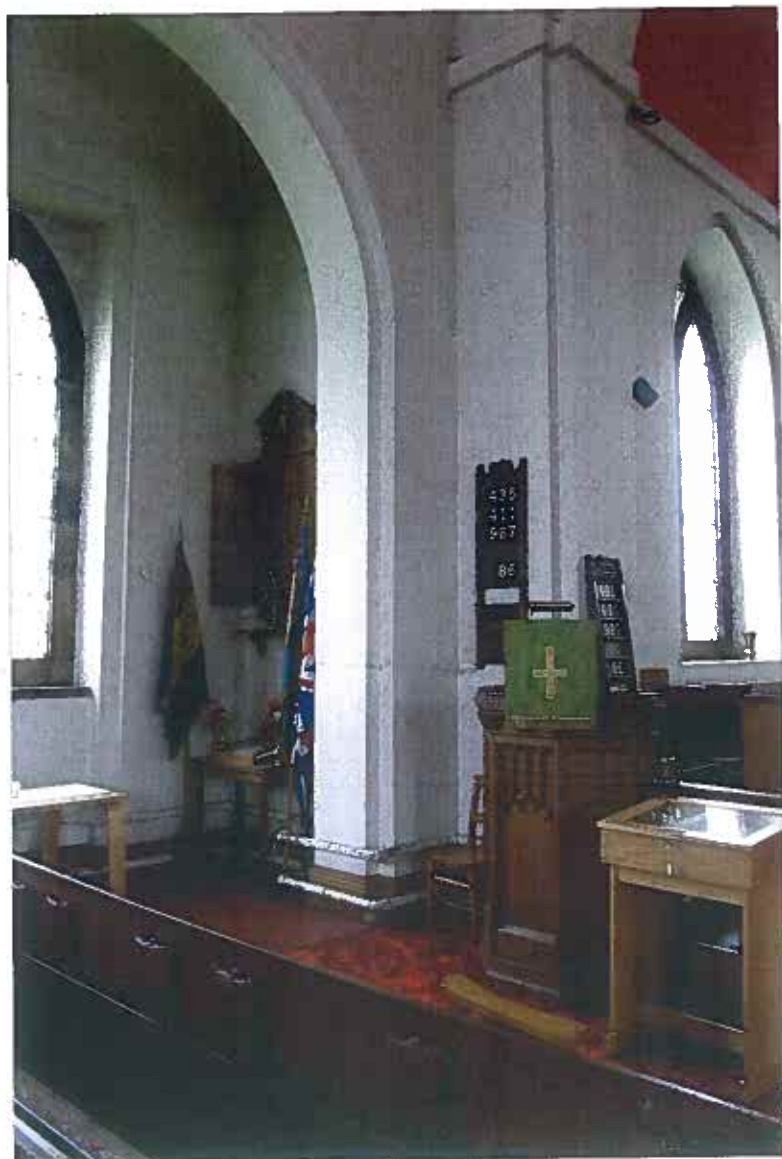
22

- 6.2 a Walls are plastered throughout and decoration is generally in fair condition except where past historic rising damp and rainwater ingress have required remedial measures. The projecting apse of the Baptistry and flank walls linking to the South and North Porches still identify remedial plaster render to a dado line above which is a demarcation line of efflorescence and degradation of plaster and decoration above. See photographs 27 to 30. A similar situation exists at the base of the North Aisle arcade column adjacent the pulpit. See photograph 22. Property Wardens have progressed initial scraping off of efflorescence in the Baptistry. Further cleaning off of defective plaster should be undertaken here and to the column adjacent the pulpit, followed by surface preparation, application of an antifungicidal wash and redecoration when walls are established as dry and free of moisture ingress.

20. Chancel.
21. Nave looking West
22. Pulpit and North Aisle/Chancel junction. Note render replastering to dado height
and efflorescence line at abutment with original plaster

7. Establish a programme for complete redecoration of internal walls in particular to remedy residual efflorescence defects and enhance ambience of interior. See 6.2a and 6.2b. (C) £4500

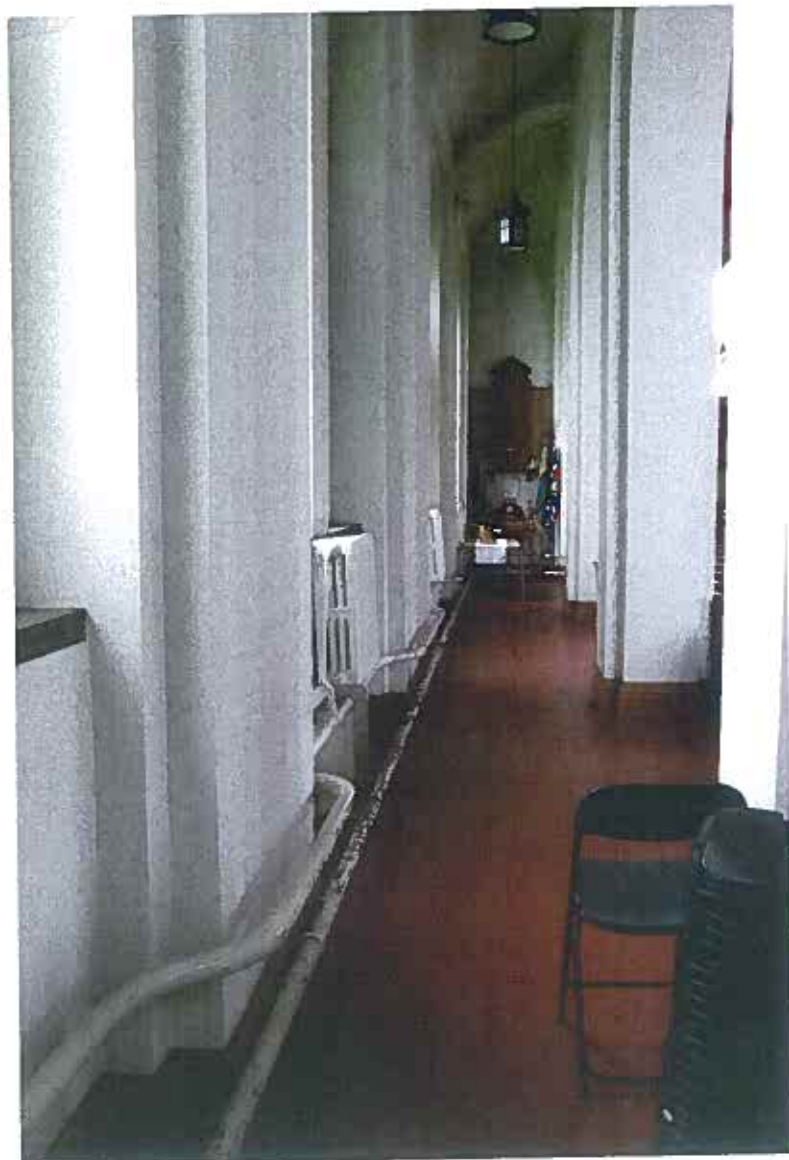
- 6.8a The heating installation is served by a oil fired boiler located in the Basement below the Choir Vestry feeding cast iron column radiators via low pressure circulating pipework. The latter is also cast iron and predominantly exposed particularly in the Nave where decoration is in poor condition suggesting incompatibility of the paintwork specification. This should be remedied in the next re-decoration process.
- 6.8b The heating system is shared with the Hall controlled by motorized valves which were repaired prior to the last Inspection. Heating is reported to be adequate with a two hour warm up period. All Boiler Room and underfloor pipework is insulated with appropriate levels of ventilation via external grilles.

24. North Aisle. Note spalling decoration to central heating pipework and painted concrete floor.
25. North aisle looking West
26. Aisle radiator and pipework detail
27. Baptistry looking North West
28. Baptistry gable wall
29. Baptistry/ South Porch wall with historic efflorescence plaster/decoration defect above new rendered dado.
30. Baptistry looking toward South Porch. Note plaster/decoration defects per 29.
31. Clergy Vestry
32. South Aisle. See notes per 24
33. Choir Vestry
34. Clergy Vestry

9. Explore opportunities to create an Accessible Toilet within the Church. See 6.7f and 6.11 a. (C) £8000
10. Thoroughly prepare and redecorate all internal cast iron radiators and circulation pipework. See 6.8a. (C) £1100
