## ST HELEN'S CHURCH, AUCKLAND

### REPORT ON QUINQUENNIAL INSPECTION March 2021

This report summarises the findings of an inspection of St Helen's Church, Auckland. Carried out on Tuesday 9<sup>th</sup> March 2021 by Inspecting Architect Ulrike Knox RIBA AABC and Stephen McConnell ARB.

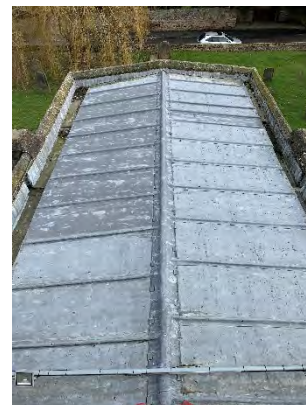
There do not appear to be any obvious cracks although there is an area of loose pointing above the flashing at the abutment to the Nave. There is an area of flashband to some flashing on the north wall.

The wall to the east end of the Nave is well pointed and in good condition.

- C • **Repair lead flashing to the north wall of the chancel roof and point flashing at abutment.**
- C • **Investigate ponding to the chancel roof south side.**

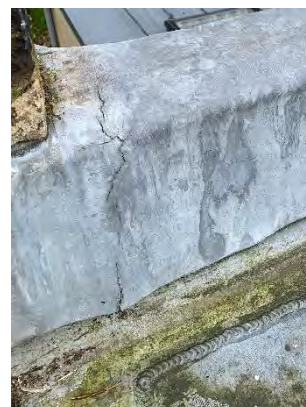
The condition of the lead roof covering and flashing is poor. There are significant flash band repairs to the flashings, and other cracks in the flashings which have not been given any temporary repair.

The main roof covering, which sits directly onto the ceiling boarding, has had many and frequent defects. Not only is there a problem with condensation in winter on the underside of the ceiling, there are cracks and splits, slumping and ponding. There have been attempts to stem the leaks using welded lead patches, but more recently the application of silicone mastic sealant. The sheets are over long and the hollow rolls have cracks at the ends where they terminate, as well as along their length.

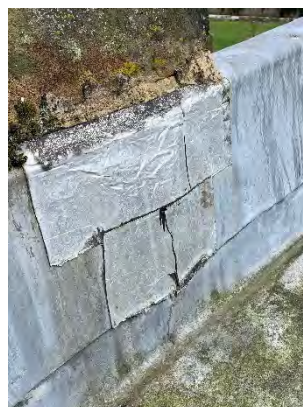
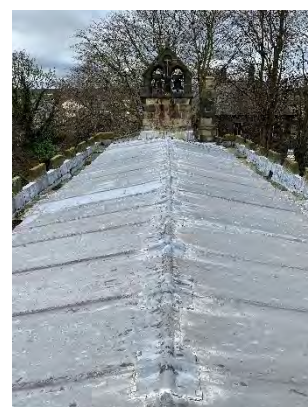
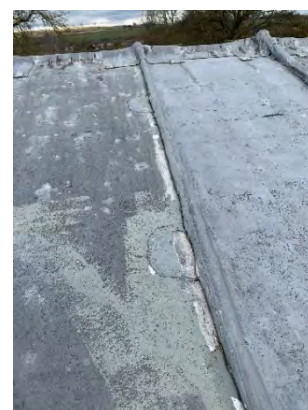
The stonework at this level also needs attention. The pointing and bedding of the coping stones is generally cracked and requires repointing. Some of the coping stones may be unstable, and the wall tops would benefit from the copings being bedded on a dpm.

The bellcote, housing the two sanctus bells, needs repointing. One stone has a visible vertical crack and requires repair.

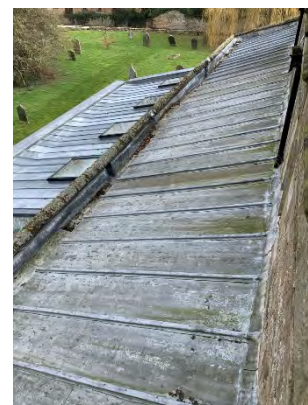
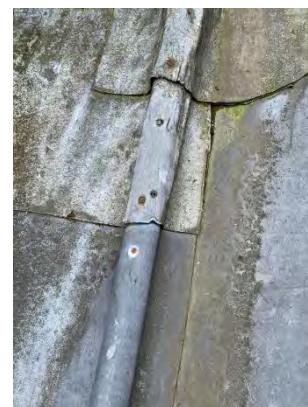
To the west end bays appear to have slipped towards the gutter indicating poor fixings. Many of the nails into the rolls have corroded. This is a poor detail. There are areas of flash band repair which should be properly repaired. There is a small area at the west end which requires pointing over the flashing.

To the back face of the parapet at the north, a silicone mastic has been used instead of mortar and this is in good condition.

The coping does not sit on a DPM and this is recommended.

- C**      • Properly repair flashing with lead.
- B**      • Reset coping on lead DPM and extend flashing to new extension roof.
- B**      • Refix slipped lead sheet. Patch nail holes with lead.

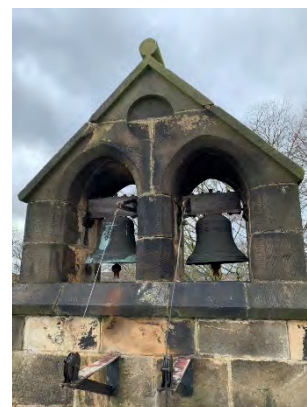
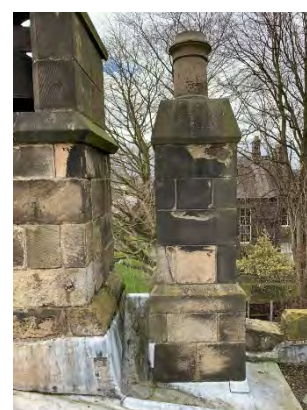
The central mullion between the openings to the Belcote and joints between the two stones which form the heads of the openings are cracked and there are open joints at this level. Whilst this is not urgent being a non-weathering element of the building, it would be advisable when high level work is anticipated to include this repointing. The copings also appear to be open.

- C • **The copings at the south of the Belcote, the joints appear open and require pointing within five years.**
- C • **Some repointing to the west elevation. Especially copings.**
- C • **Renew repairs around west window of north aisle.**

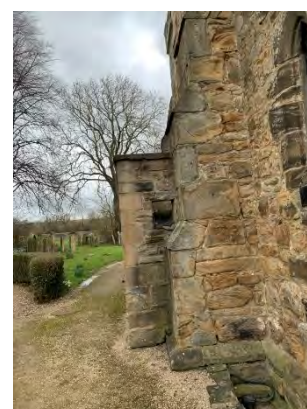
It would be advantageous to remove the Victorian boiler house construction since this is abutting the west wall and the felt roof is not in good condition. Water ingress is affecting the west wall.

To the quoins at the north-west corner, there are large cavities in the stonework due to weathering. To the south the pointing is now urgent. To the south aisle the pointing now requires urgent attention.

- B • Point upper levels of south aisle west end.
- E • Consider the removal of the boiler house.
- C • To the boiler house; carry out three large repairs using galetting and conservation mortar to fill the large cavities and also other adjacent cavities using armatures.

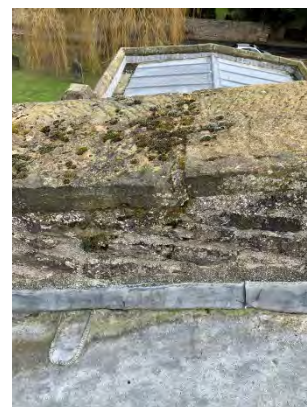
There is some dampness to the south side due to pointing loss at the copings. Generally pointing is good although there is some loss of pointing at lead chase.

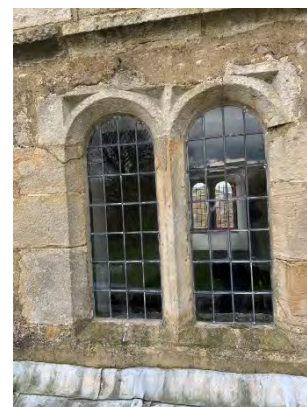
Satisfactory condition although there have been some previous repairs which require monitoring.

- 1.8.5. **Recommendations:**
- B • Lift copings and rebed on lead dpm (dampness is an issue below internally)
  - C • Point around north clerestory windows.
  - B • Repair casement and quarry to eastern north clerestory window.

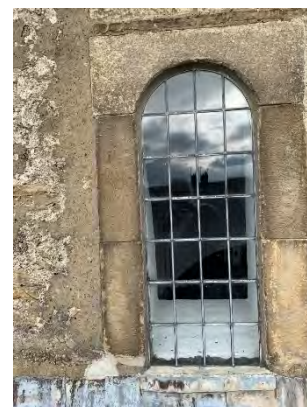
The second east window has central mullion and eastern jamb with vertical cracks. There are also a number of cracked quarries.

- 1.9.2. **Recommendations:**
- B • Repair quarries to the south clerestory.
  - B • Repair stone mullion and jamb to second east window of south clerestory.

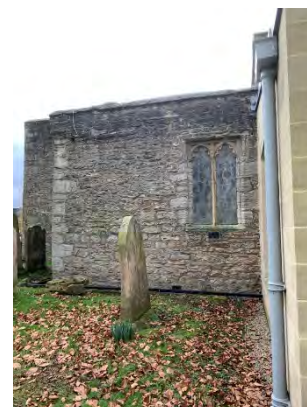
Grating is broken and requires replacement. The wall above the window bows out and can be holding water. It was noted that there is a damp problem above this window and there are a couple of areas of pointing which require repair soon. They are small but it may be the cause of the water ingress since there doesn't appear to be a problem with the roof and gutter.

- 1.10.2 **Recommendations:**
- C • Point open joints above window
  - C • Replace grating below window.

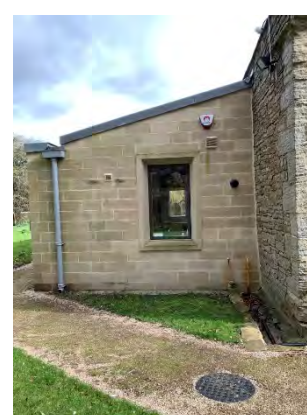
The condition is good but some maintenance is necessary to the oak door. It was noted that there was some staining around the extractor outlet.

- 1.11.2 **Recommendations:**
- C • Door requires some refinishing.

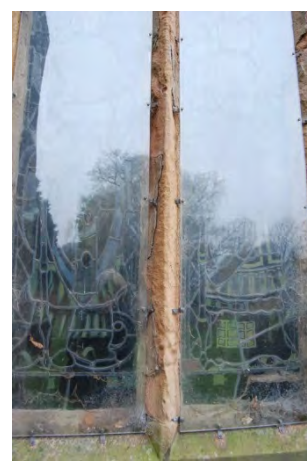
1.12.1 The east end of the North Aisle is in reasonable condition however there is significant weathering of the window surround.

The mullion has had some poor repairs in the past and these require re-doing. Depending upon the age of this window, the stonework should either be replaced or repaired within the next 2 years.

- 1.12.2 **Recommendations:**
- B • North aisle east end window surround stonework repairs required.

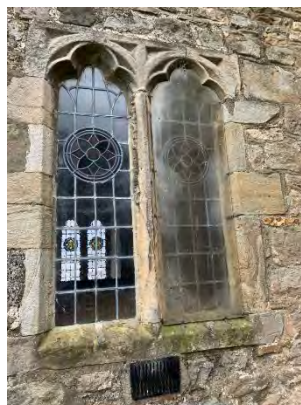
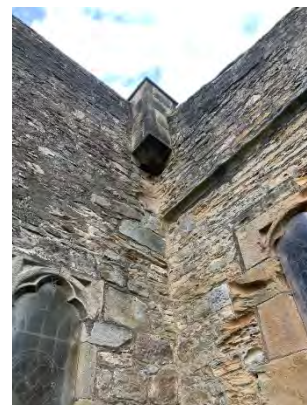
The window surround is in reasonable condition, although there is some loss of pointing at the head. Other than that, the wall is in reasonable condition.

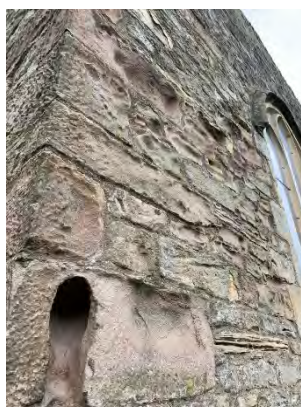
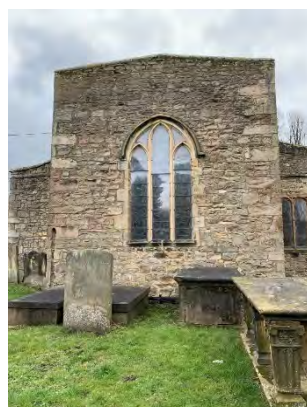
There are some significant voids to the south quoin stones which require repair. Similarly there are a number of other stones which have certainly been hollowed out and a stone repair program should be factored in within the next 6 years. However, the holes in the quoins here should be dealt with within the next 2 years.

- B • **Carry out stonework repairs to the south quoin of east elevation.**
- B • **Repair crack to east window sill.**
- B • **Point at window head and below parapet of east elevation.**
- B • **Plan further stonework replacement.**

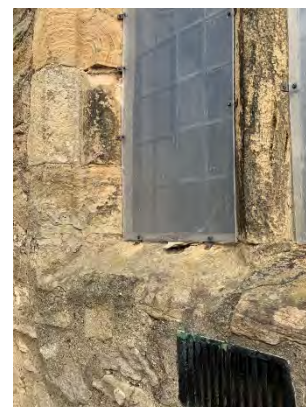
A repair should be undertaken to this sill. The left hand jamb is also requiring repair. The wall pointing is in reasonable condition at the moment.

- B**
- Repair sill and left jamb to south chancel window reveal.

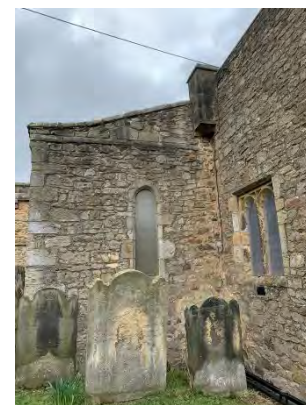
The pointing appears to be in reasonable condition however there is a corbeled out flue at the abutment with the Chancel which requires repointing. The window sill also requires repair.

- B**
- Repoint flue to chancel abutment to south.
- B**
- Repair stone to window sill to east south aisle.
- B**
- Point coping to east end of south aisle.

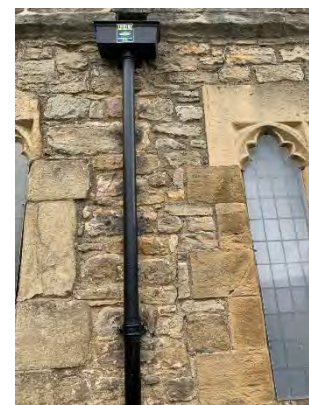
There is a small crack to the right hand side of the eastern most downpipe which should be pointed and monitored.

The west pipe may be blocked and there is green build up on the wall. This needs to be checked.

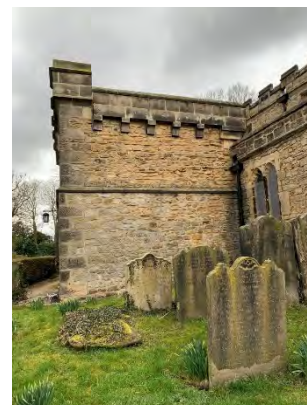
Below the string course the pointing has been carried out and it's in reasonable condition. Above the pointing is in poor condition.

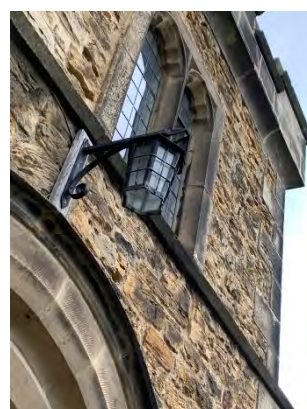
**1.18.2 South Face.**

Generally the windows are in good condition although some pointing to the west of the door will be required within about 5 years. Note opened up crack to the west of the door.

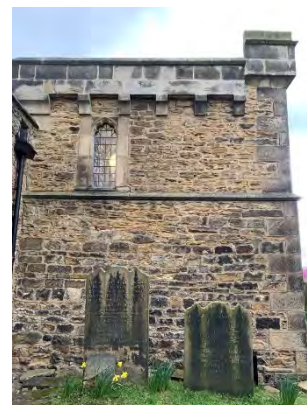
**1.18.3 West Face.**

This is in reasonable condition although the lower stones require pointing.

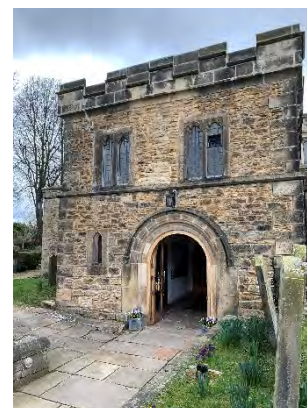
There are certain areas in the wall where vegetation has got in between the stones and this should be kept in check so that the stonework does not become unstable.

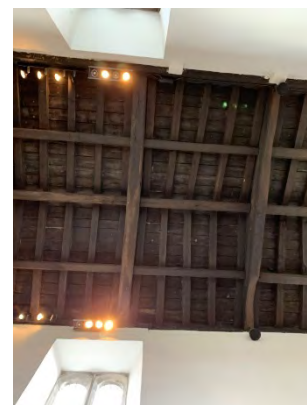
Apart from some flaking of the finish to the west end timbers, it appears to be in reasonable condition from the floor level. This is likely due to poor pointing of the bellcote, but there have been some recent leaks reported corresponding to defects in the lead.

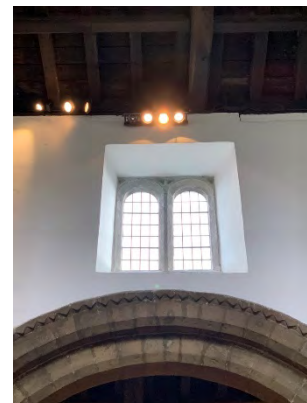
2.3.2. **South 2nd from the west:**

Has an opening hopper, although does not appear to be functioning. This should be repaired to aid ventilation. There are a number of cracked quarries and this may be due to iron fixings into the mullion. From the ground internally, it is not possible to see if the mullion itself is cracked. Closer inspection should be afforded.

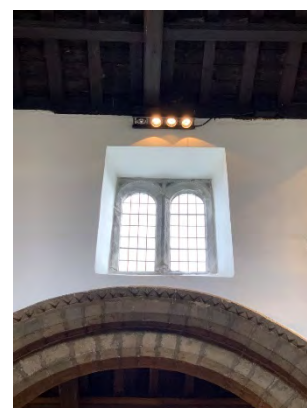
2.3.4. **South 4th from the west**

There are a number of cracked quarries and the mullion appears to be disturbed particularly at the bottom section and this should be given closer inspection.

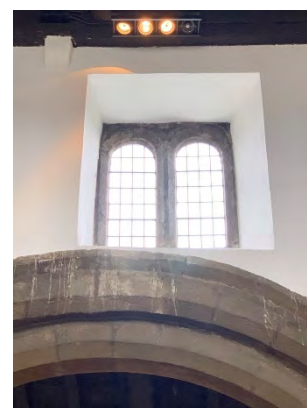
- 2.3.7. **North 3rd from west:**  
This has an opening hopper which does not appear to be functioning as mentioned elsewhere. There are a couple of broken cracked quarries. Above this window appears evidence of damp ingress from the Nave gutter.

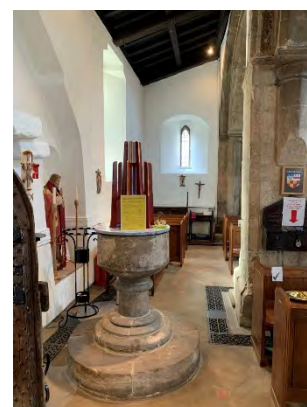
There has been some damp ingress above the window to the west of the porch which apparently has been repaired but the decorations need re-doing.

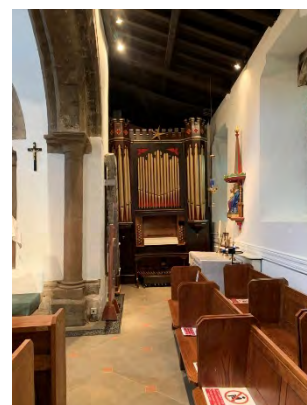
There was a small area of damp visible towards the east end of the Aisle Roof, where the timbers were slightly dis-coloured. This should be investigated and is likely to be due to a blocked gutter at some point.

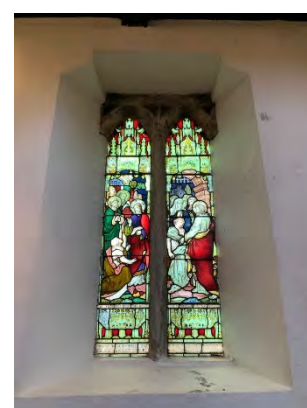
There is some deterioration of the stone work at the head of the window and this should be monitored.

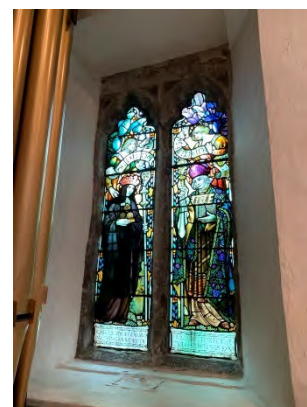
There is a small hole in the window of St Hilda. The text at the bottom is also being lost. There is some flaking of the paintwork to the head of the window. The stone mullion is somewhat decayed with thinning of the stone at the top of the mullion. At the moment this can be repaired and kept insitu although this isn't necessary within the next five years.

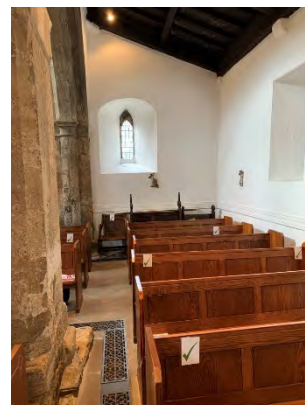
The dado and panelling appears to be in good condition generally. Above the dado to the left of the door there is some evidence of run off from the gutter level and indicates some problems with leaks. There is also a recurrent problem above the second window from the west and the third window from the west. Particularly the third window from the west which is of concern.

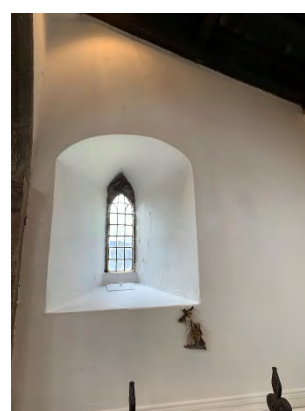
Stonework requires some conversation repair. There is also a broken quarry.

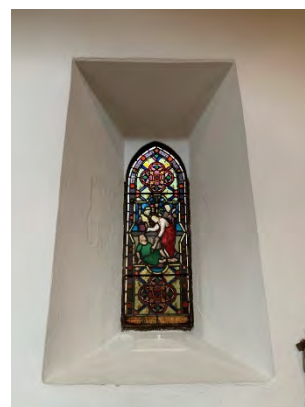
The stained glass itself is losing some of its detail. Other than that in good condition.

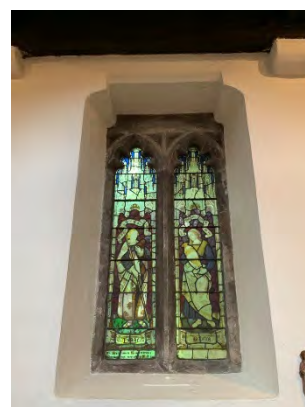
This is a memorial window, however much of the detail has been lost at low level and although there is a slight shadow of what was there, if this is not conserved very soon, then this will be lost entirely.

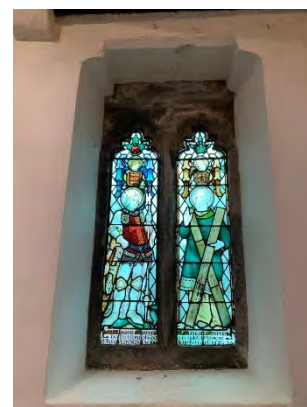
The stonework is generally dirty and crudely repaired at the head. This window is part of a two-part memorial to the First World War depicting the national saints of the UK. It is reported to be leaking and it would benefit from conservation and repair.

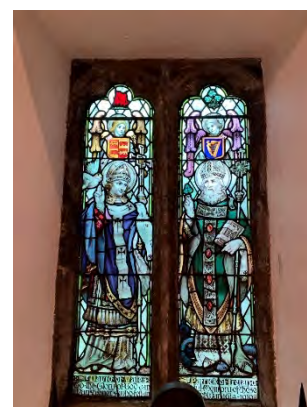
There is some loss of detail of the text at the base of the windows and some conservation is required before this is lost entirely.

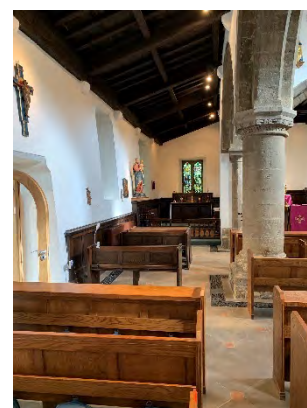
There have been reports of the gutter overflowing and therefore the timber work may be subject to decay. However, from the ground floor, it is not possible to tell although a sharp eye should be kept on evidence of wood boring insects.

2.5.9.	<b>Recommendations:</b>
M	<ul style="list-style-type: none"> <li>• The Church should continue to be vigilant for any evidence of sawdust which may be due to wood boring insects.</li> </ul>
B	<ul style="list-style-type: none"> <li>• Three memorial windows to the north aisle require conservation soon and stonework repair to the surrounds.</li> </ul>
C	<ul style="list-style-type: none"> <li>• Some decorations required where flaking paint due to damp.</li> </ul>
