## Church of St Cuthbert, Benfieldside

### **QUINQUENNIAL INSPECTION REPORT 2022**

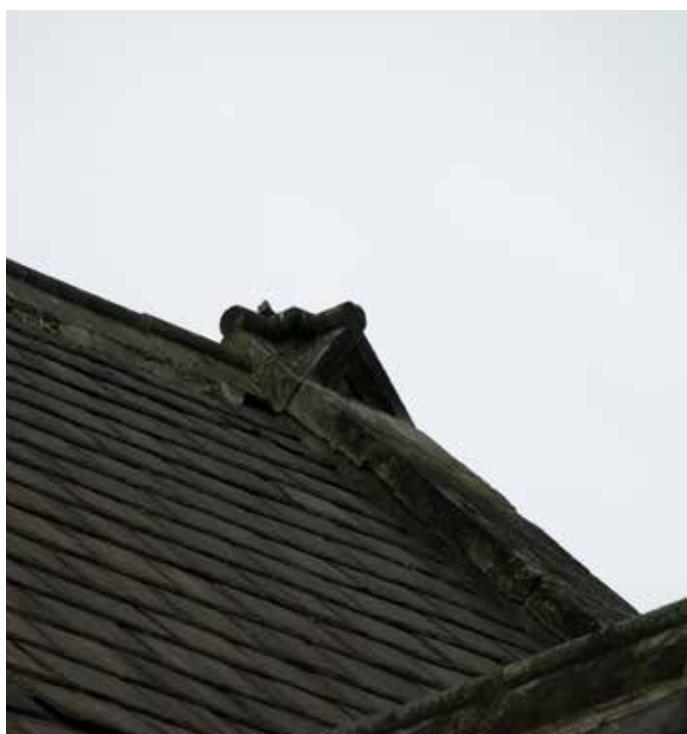
#### Misaligned copings to east end of Nave

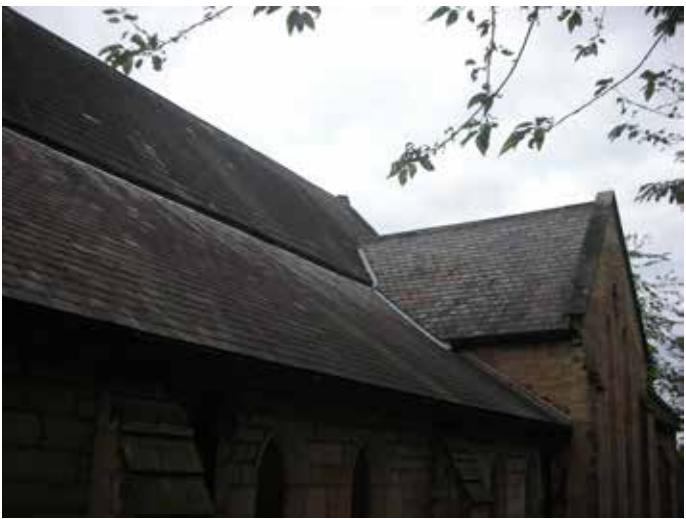
South roof pitches of nave, south aisle and south transept

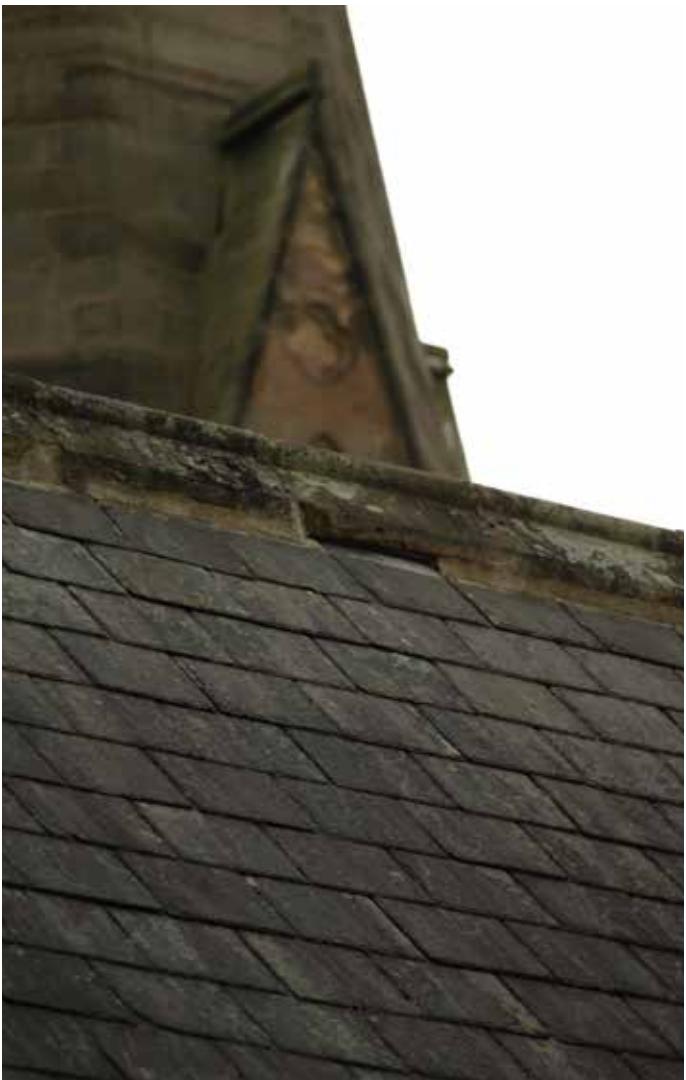
Lost pointing to south transept ridge

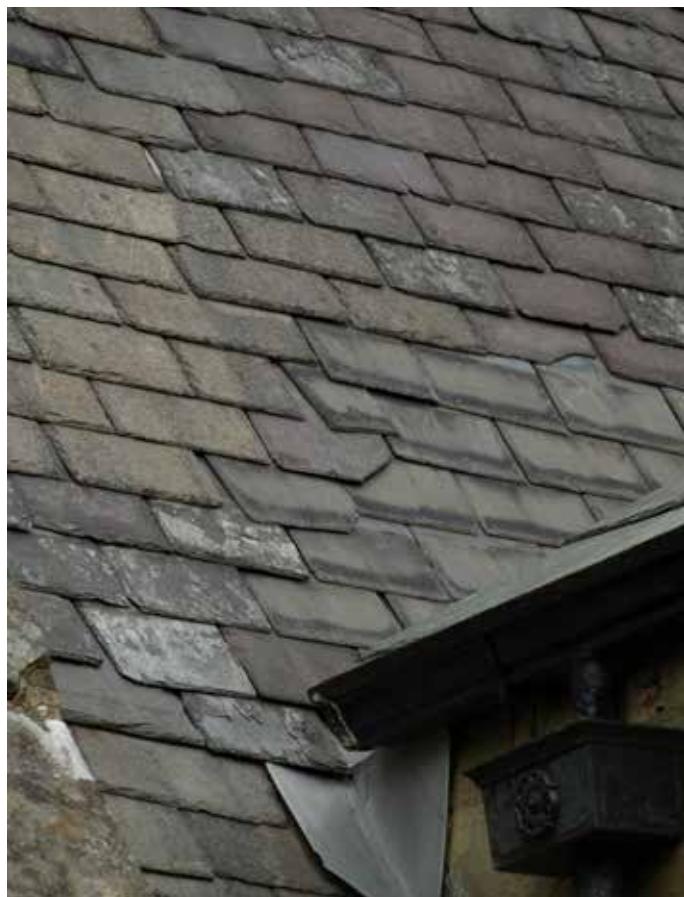
Displaced slates on Vestry roof - an inadequate repair

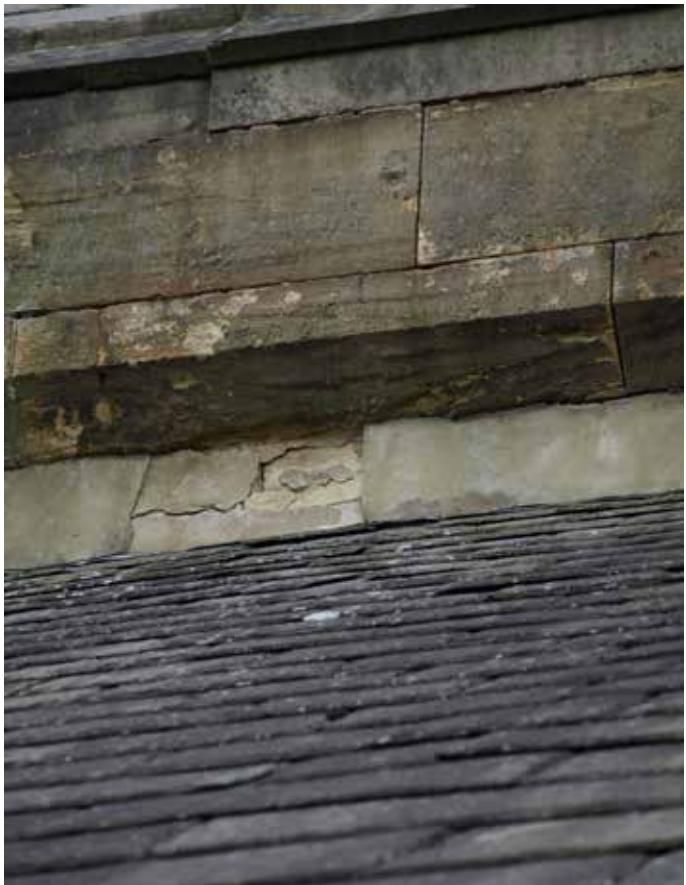
Parapet gutter of north pitch of nave, with cement mortar fillet/render, now deteriorating

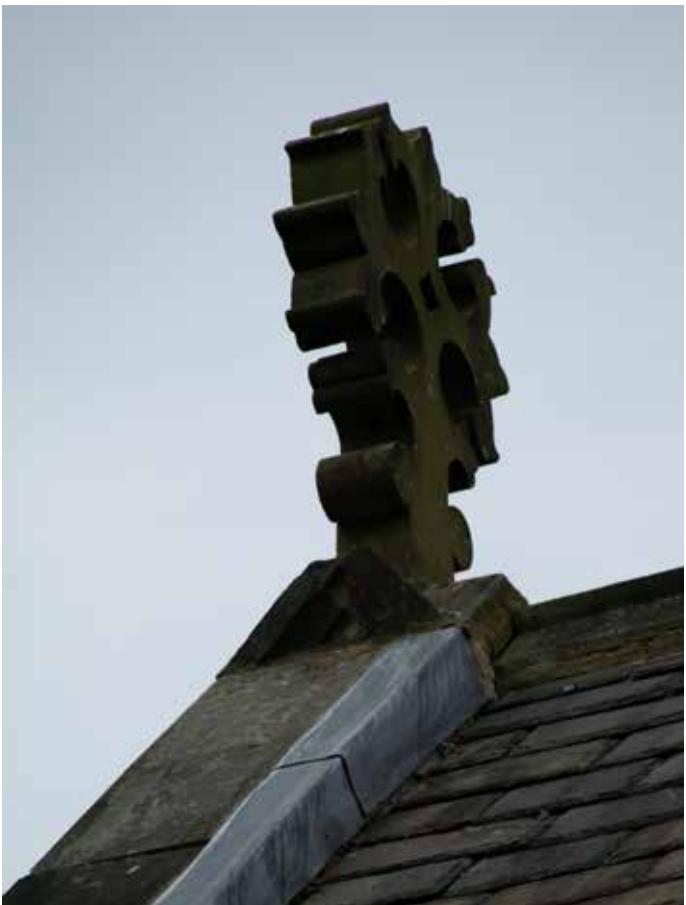
Mortar fillet to top of coping flashing cracked - a poor detail

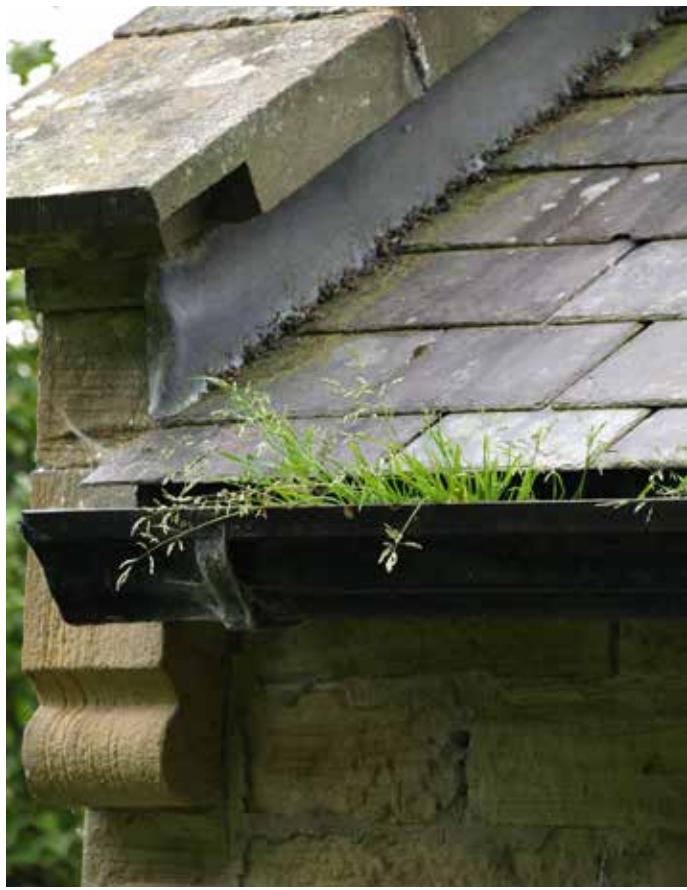
Gutters require frequent cleaning to prevent vegetation taking hold

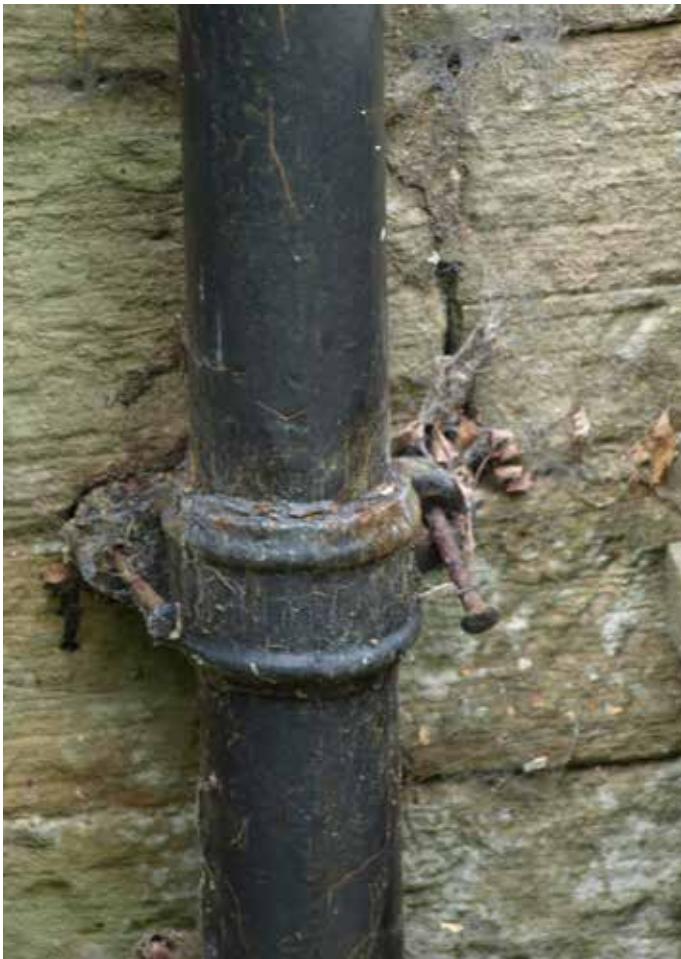
Some rainwater goods need re-fixing and re-painting

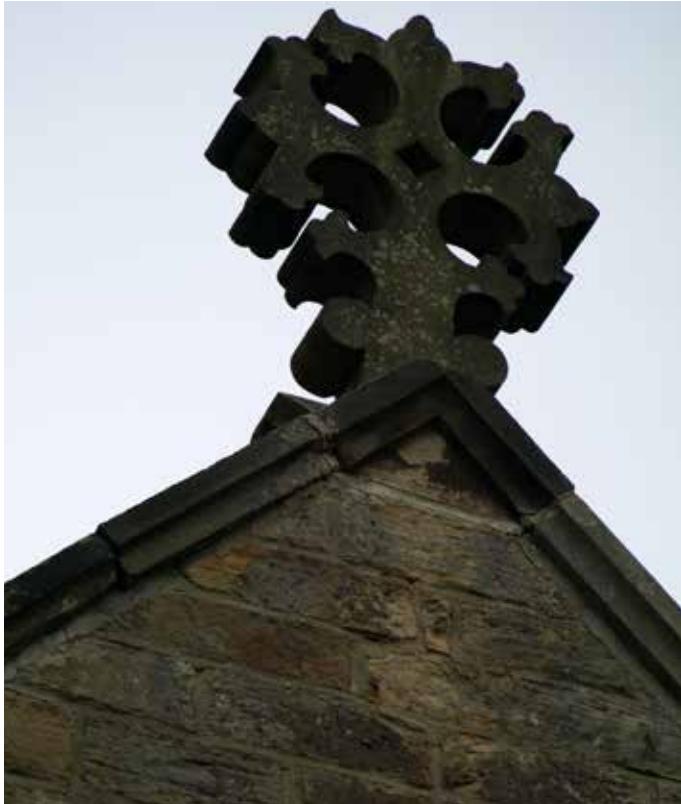
West end cross finial has bee re-bedded, but the mortar is cracking away in the joints again. Other open joints in coping.

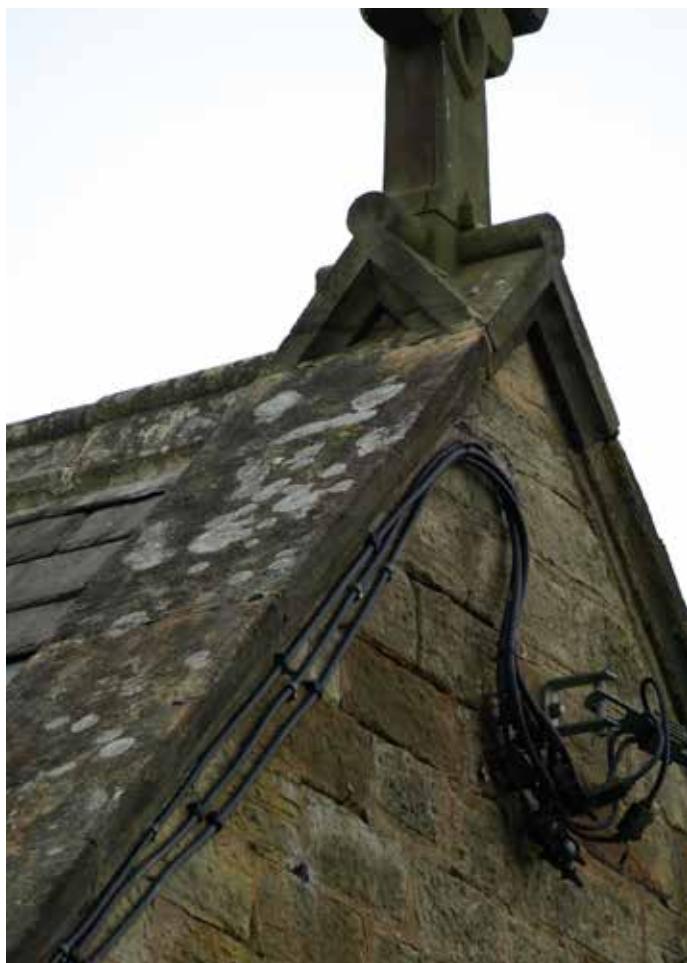
Split shaft to cross finial, and open joints in wall masonry

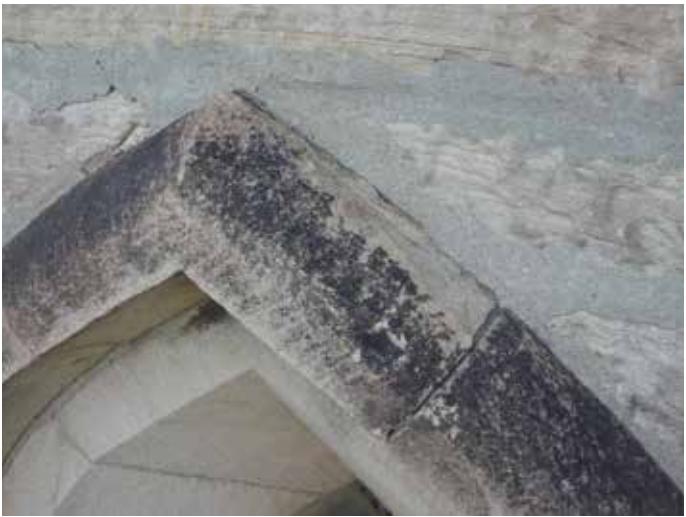
Spalling stonework on top of hood-moulding, cementitious pointing to the walling masonry adjacent

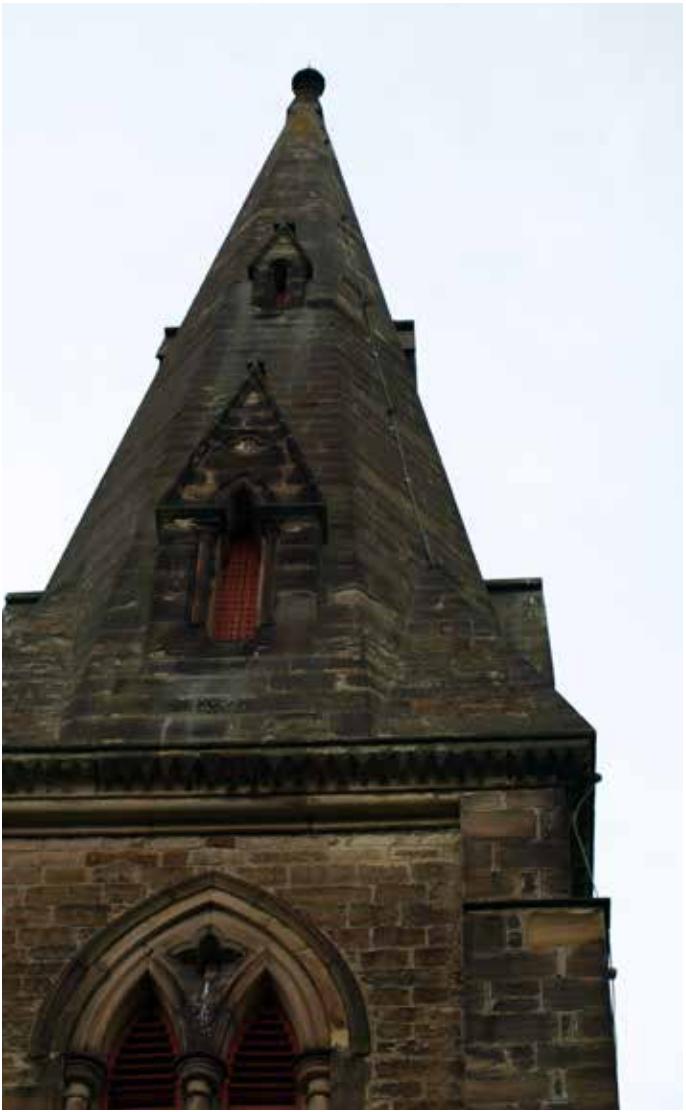
Tower masonry generally appears in good condition when inspected from ground level

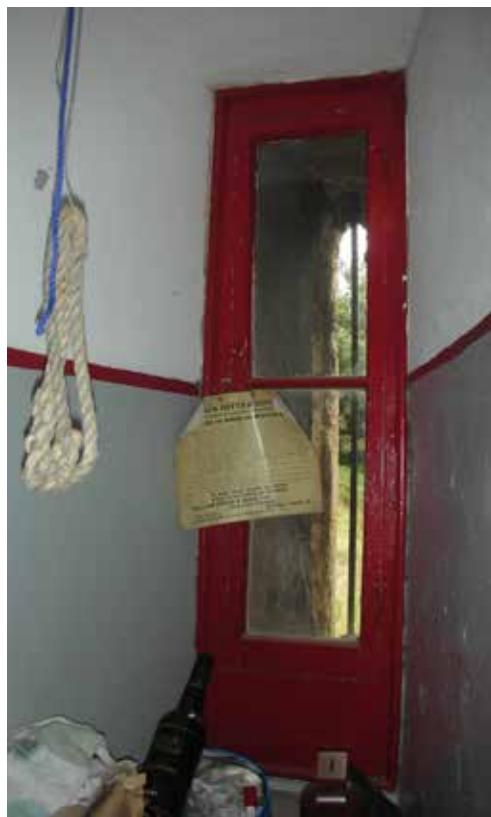
Right:  
Glazed internal windows in bell  
ringing chamber

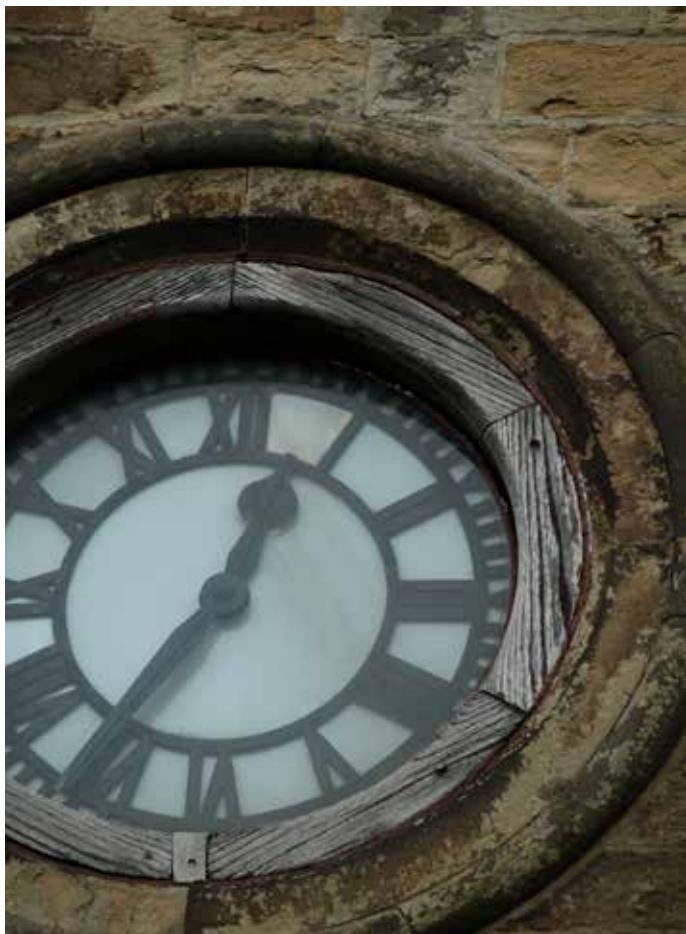
Glazing to clock face displaced, surround deteriorating

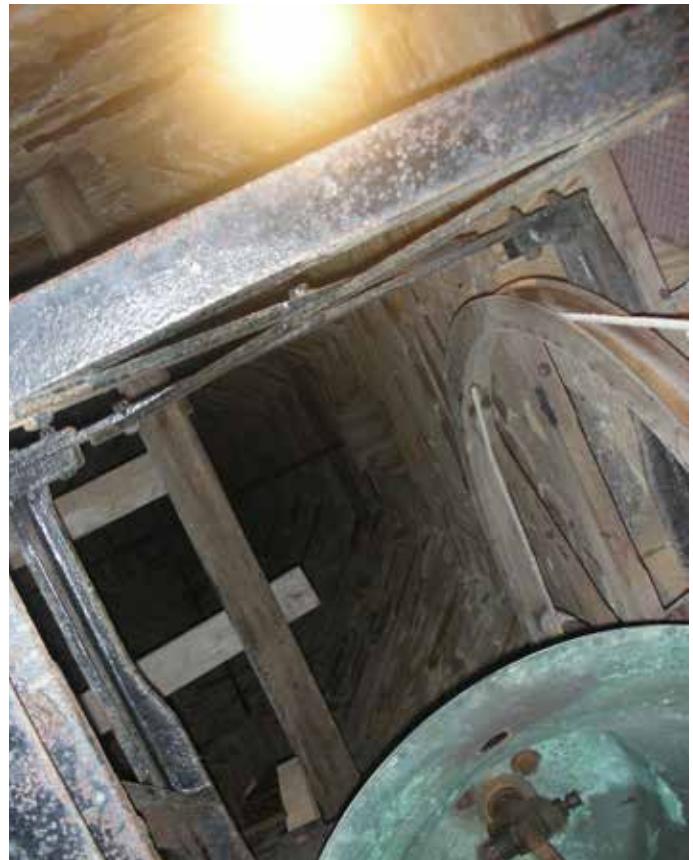
Stonework of spire seen through bell frame

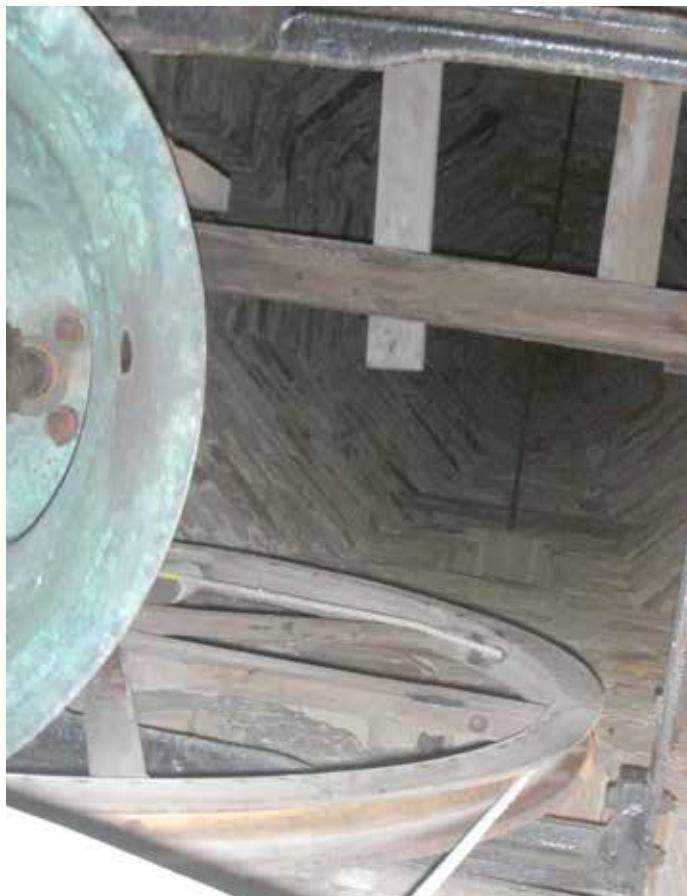
Spire beyond bell frame

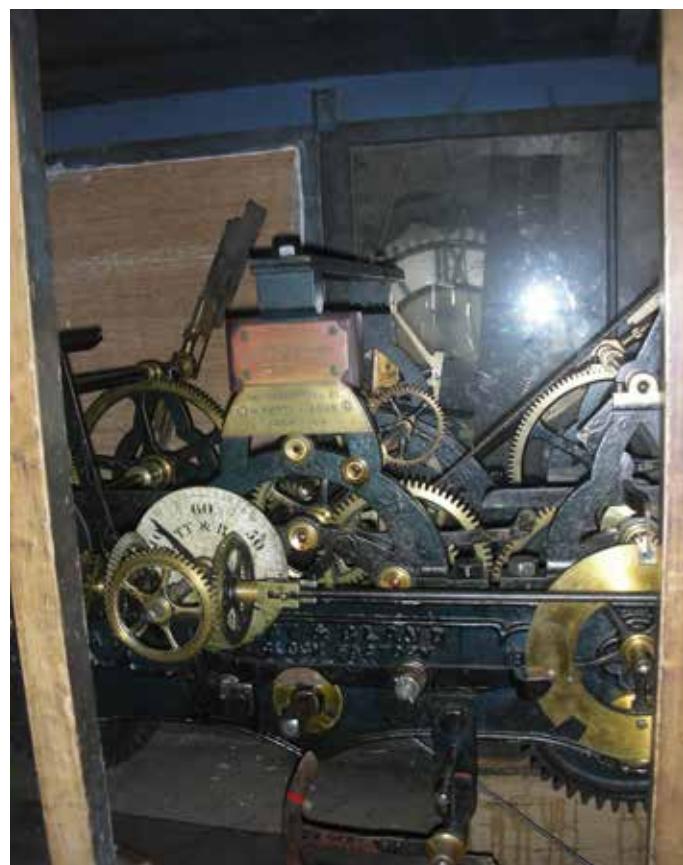
Clock mechanism generally in good condition

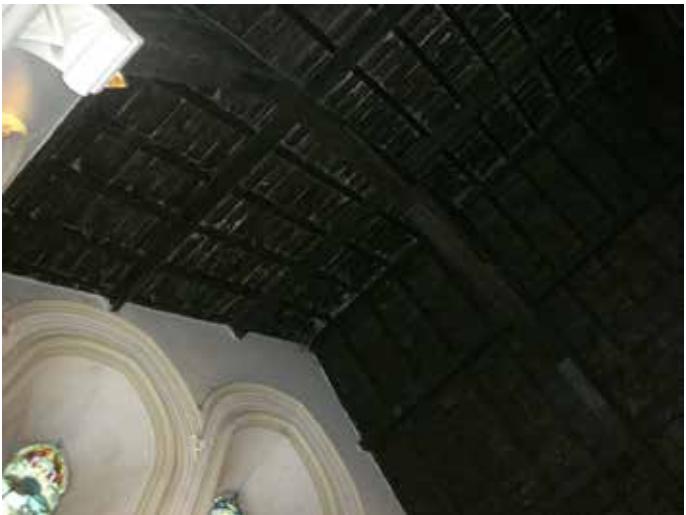
work is stained dark and structurally appears in reasonable condition from the ground. The timber trusses have been made in several sections with bolt fixings to secure.

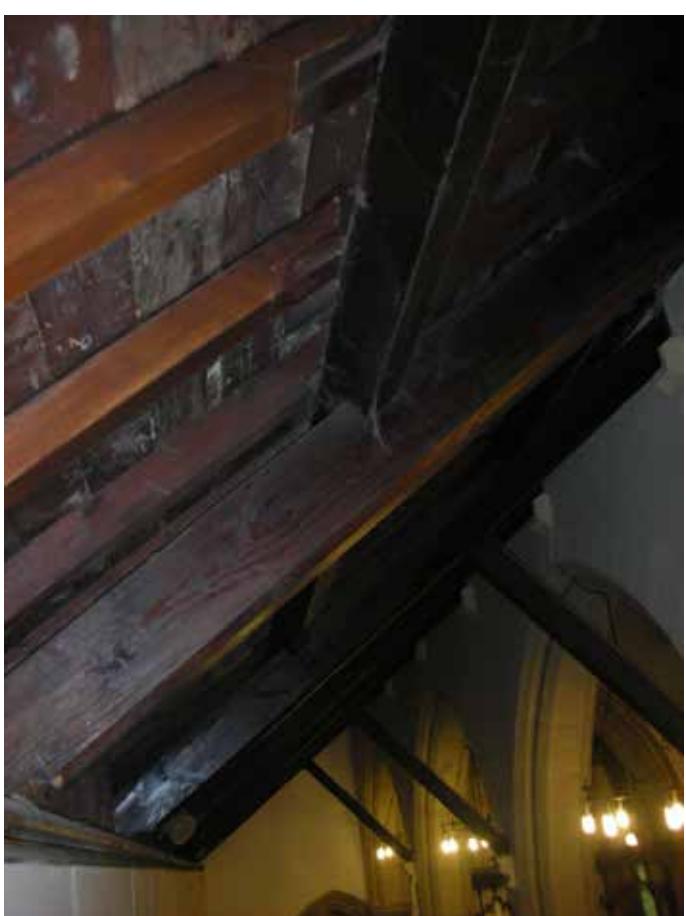
Former repairs to north aisle roof, west end

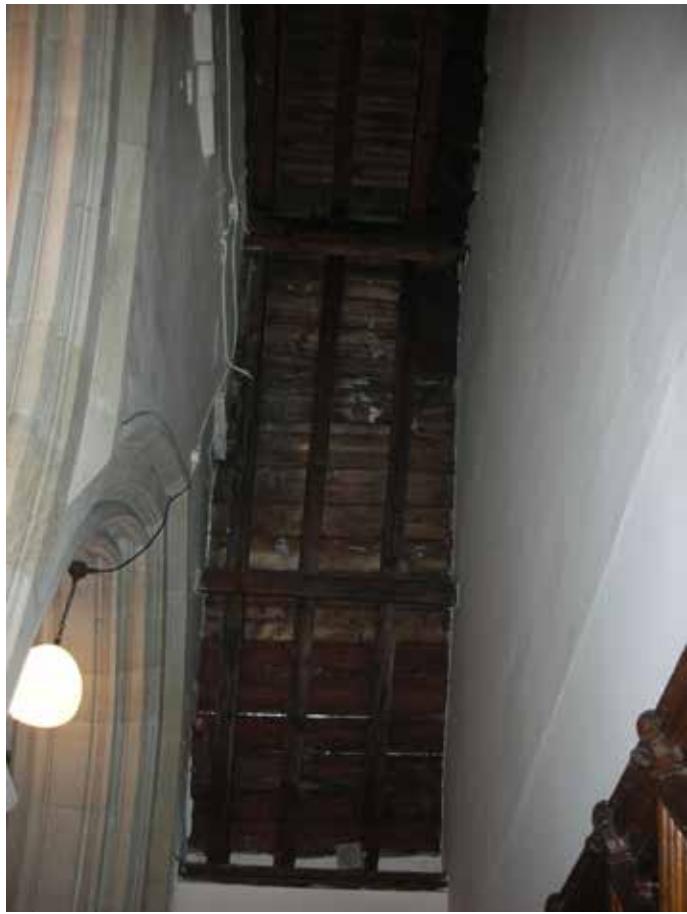
Roof over north stalls - lead theft caused major water ingress, now repaired

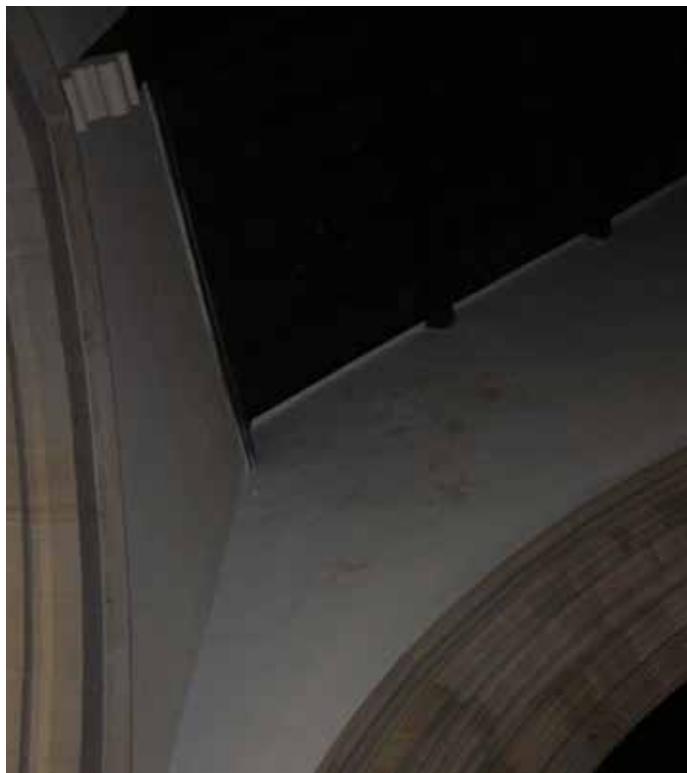
Damp staining over chancel arch, from nave

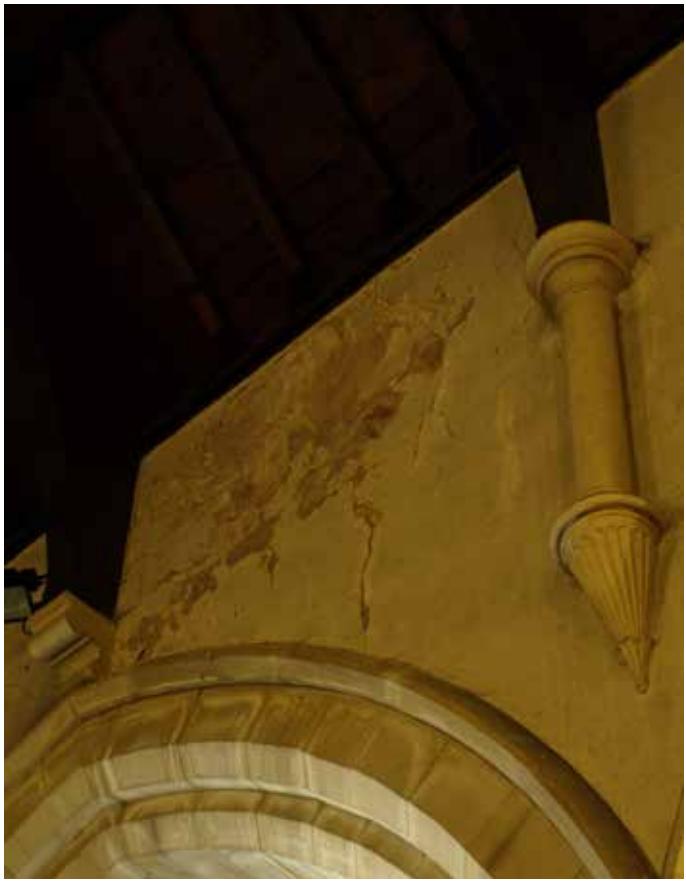
Damp staining to Nave walls at high level

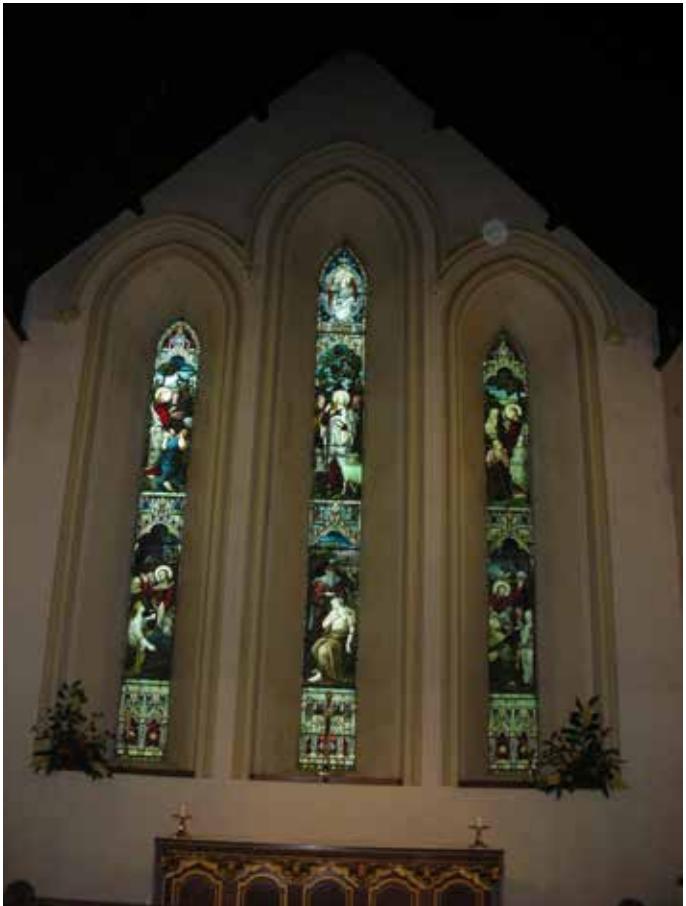
Main east window - all glazing in good condition

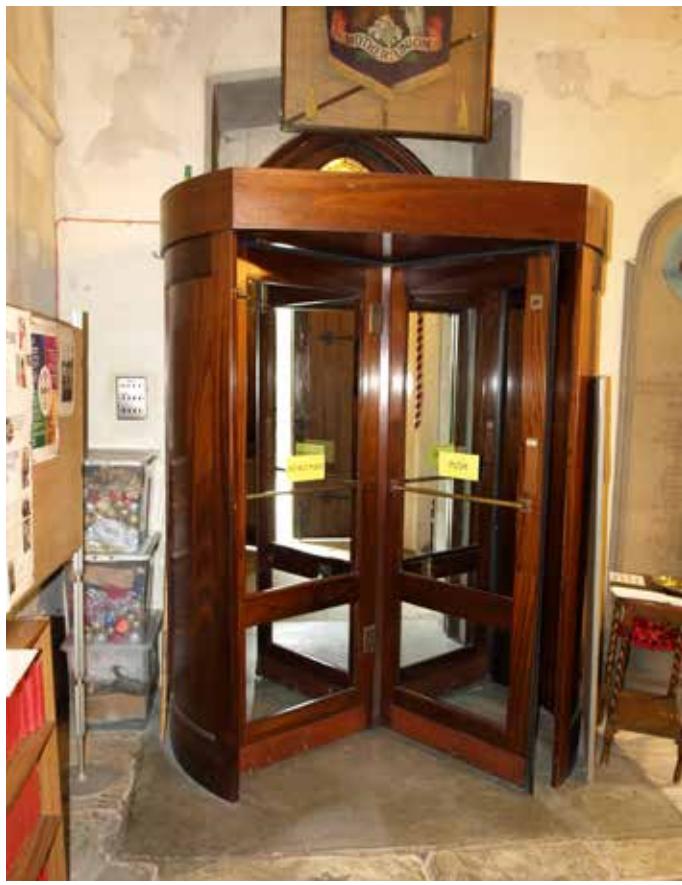
Revolving door is an unusual addition to a church, and presents difficulties for those with impaired mobility

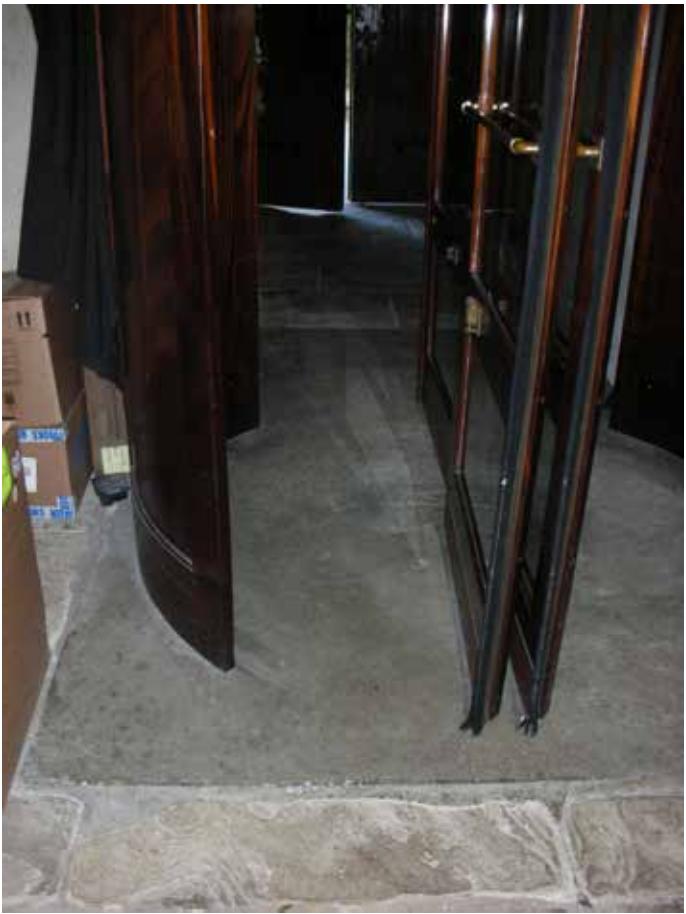
Screeed over stone flags to west revolving door

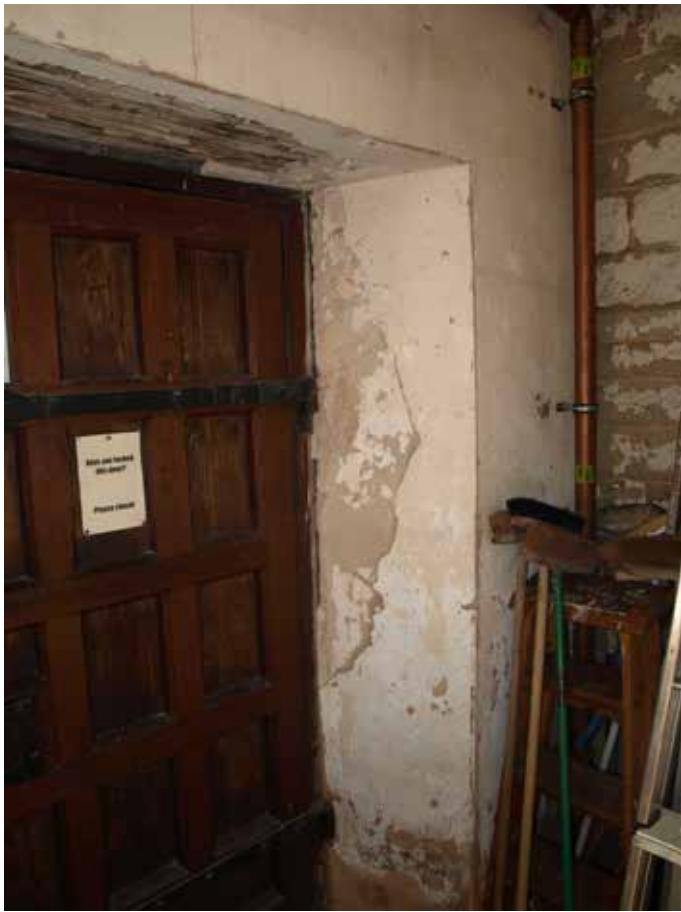
## Failure of plasterwork around external door to choir vestry

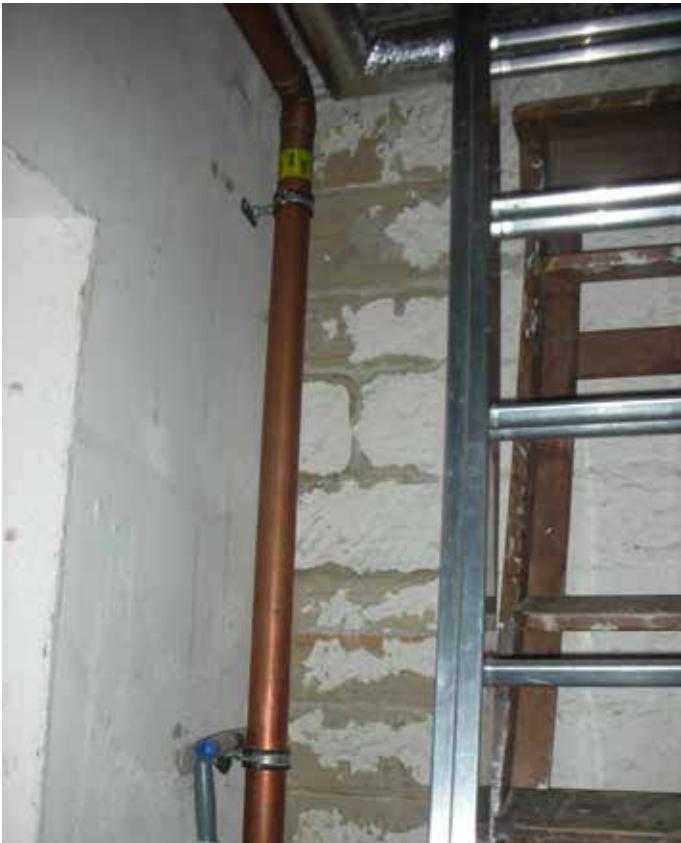
Paint directly onto stonework in choir vestry is peeling. This should be allowed to fall away and not over-painted.

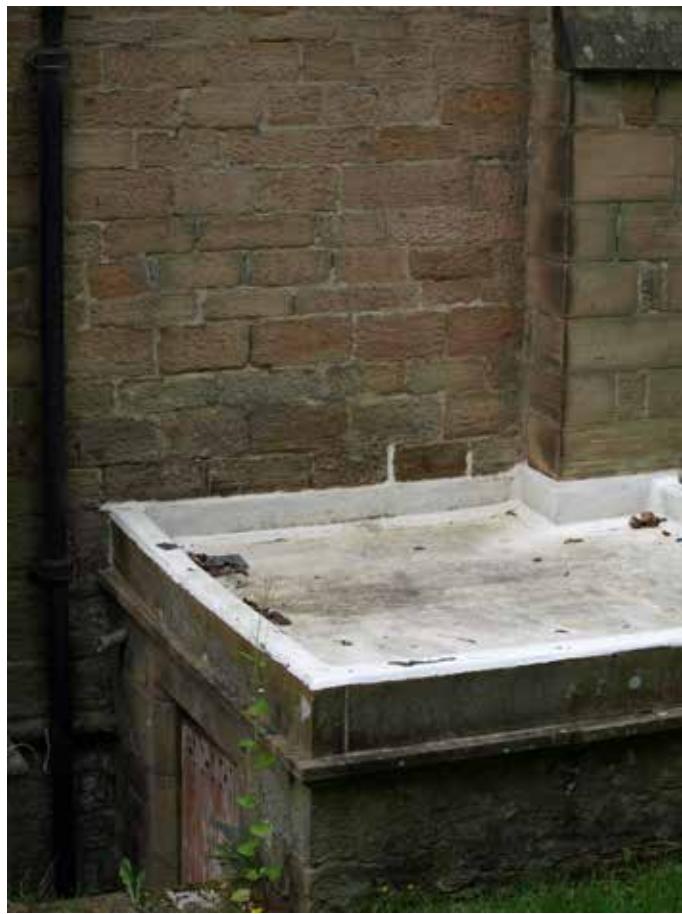
Recent new roof covering to redundant organ blower room
