**ST CHAD'S BENSHAM**  
**QUINQUENNIAL INSPECTION REPORT 2024**

An inspection for this report was carried out on 23 August 2024 by Amy Redman. The previous quinquennial inspection was carried out by Chloe Granger in 2019.

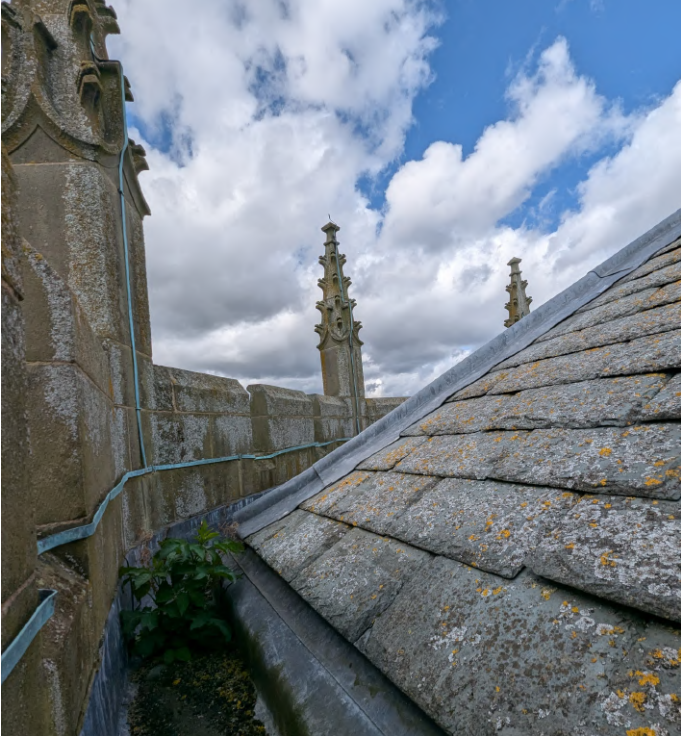
Tower re-roofed in 2015. Good condition. Some build-up of dirt and debris to gutters.

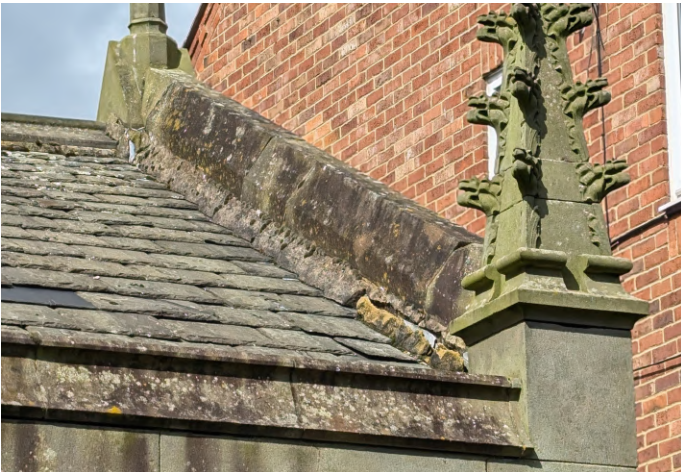
South roof pitch over retro-chapel. Cracking of mortar at verges.

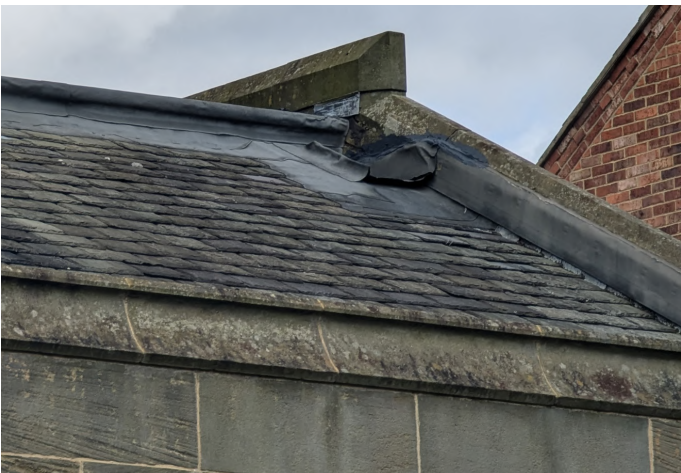
Areas on south chancel roof where flashings have been peeled back by thieves looking for lead

a)	*Replacement of slipped/broken or missing slates across all pitches. Replace missing flashings to the south chancel aisle and dress down felt and stainless steel coverings over lead to north pitch.	2,000

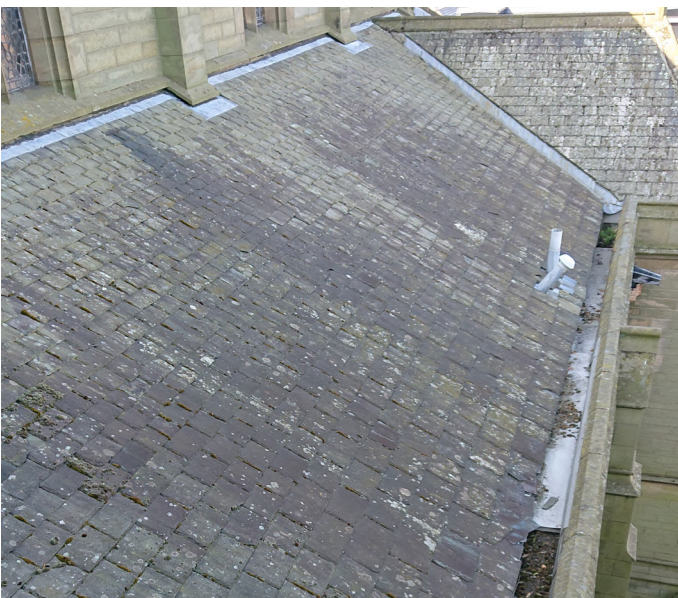
North aisle roof in poor condition. No cowl to vent pipe.

f)	*Add rain cowl to top of toilet extract pipe through roof of north aisle and fit extraction fan inside WC.	250
g)	*Fill cracks in concrete to front of west entrance and re-point steps to prevent weed growth in gaps.	500

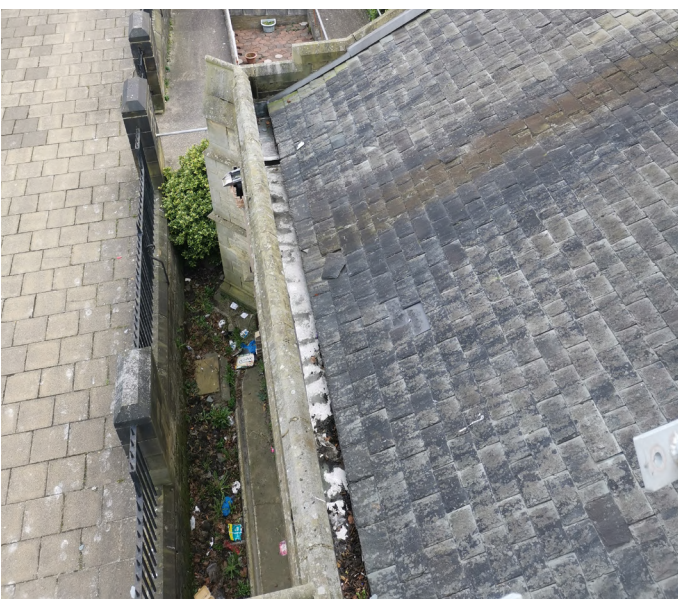
North chancel aisle roof in poor condition, slipped and broken states. Issue with gutters causing water ingress to the choir vestry below.

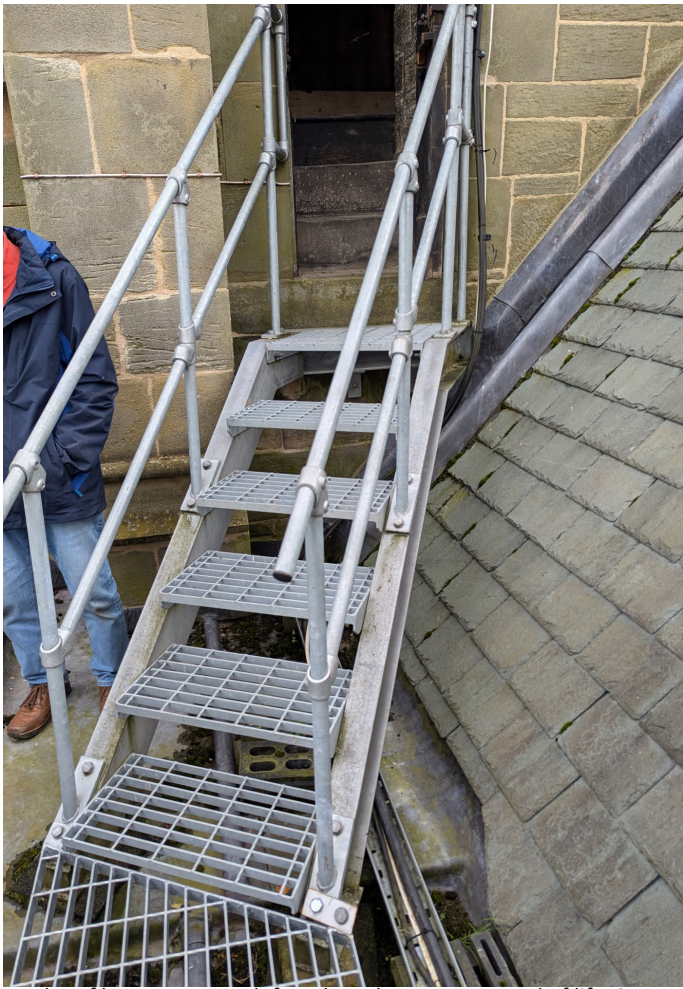
Lead roof between organ loft and north transept at end of life. Steps unsteady. Vegetation build up.

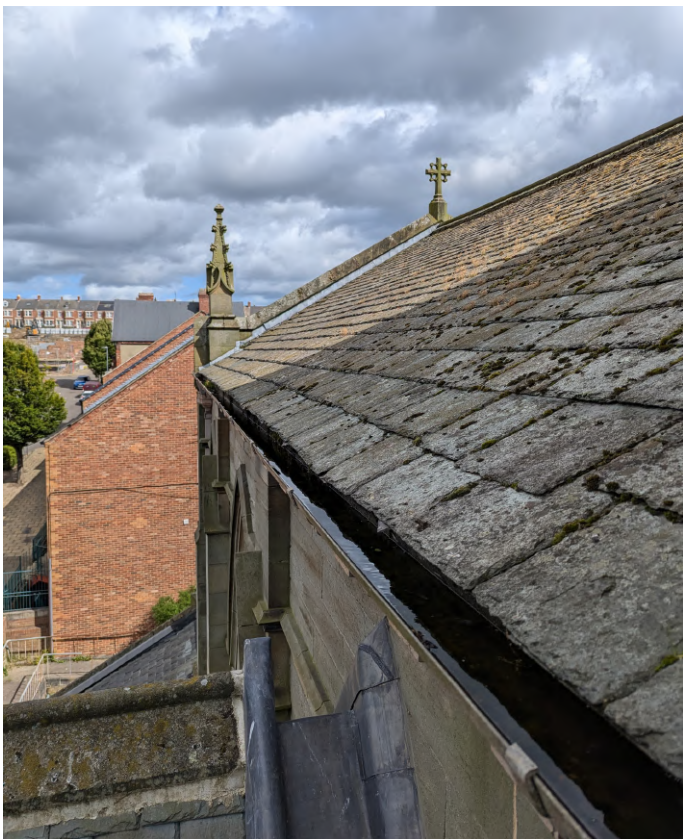
North Chancel Roof - gutter recently cleared, in fair condition

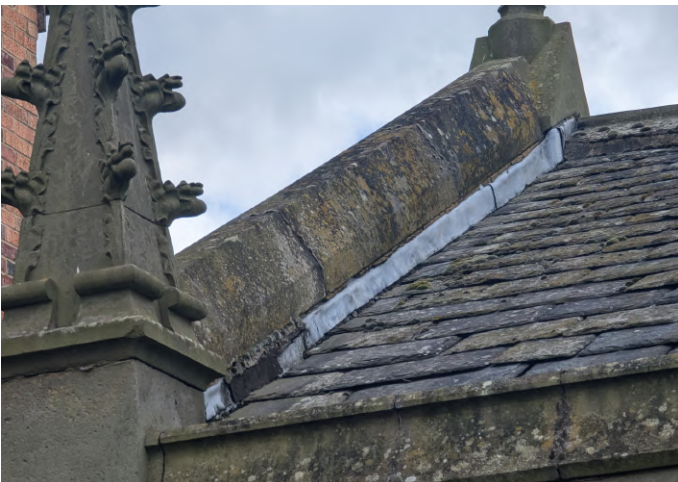
Gable verge of north roof pitch of retro-chapel. Flashings damaged.

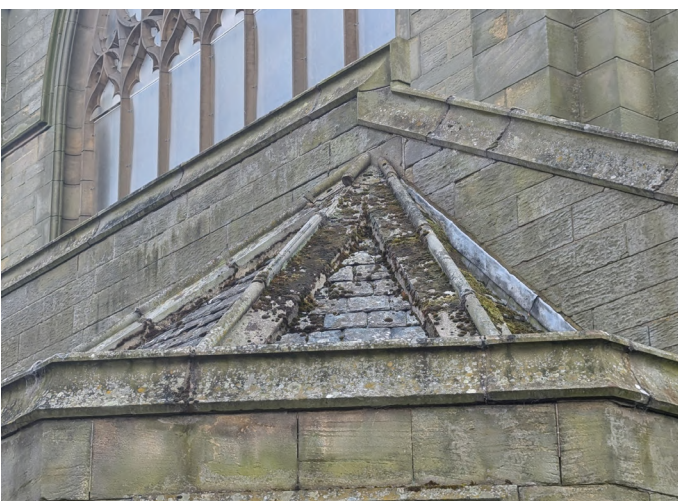
The roof of the small north-east porch, in this corner between chapel and north chancel aisle is in deteriorated condition. There are several broken slates over the four conical pitches, and the stone hips are deteriorated, with one roll completely missing and the other joints buttered across with mortar. The joints to the top apex stone are open. This stone is cut from a walling stone embedded within the wall of the north chancel aisle/ambulatory, where there is notable (historic) movement within the parapet. The lead flashings are worn and thin but serviceable. There is a stainless steel capping to the base of the flashing where thieves have ripped away the lead. This needs fully overhauling.

Roof of porch at north-east corner. Parapet over with movement to copings above.

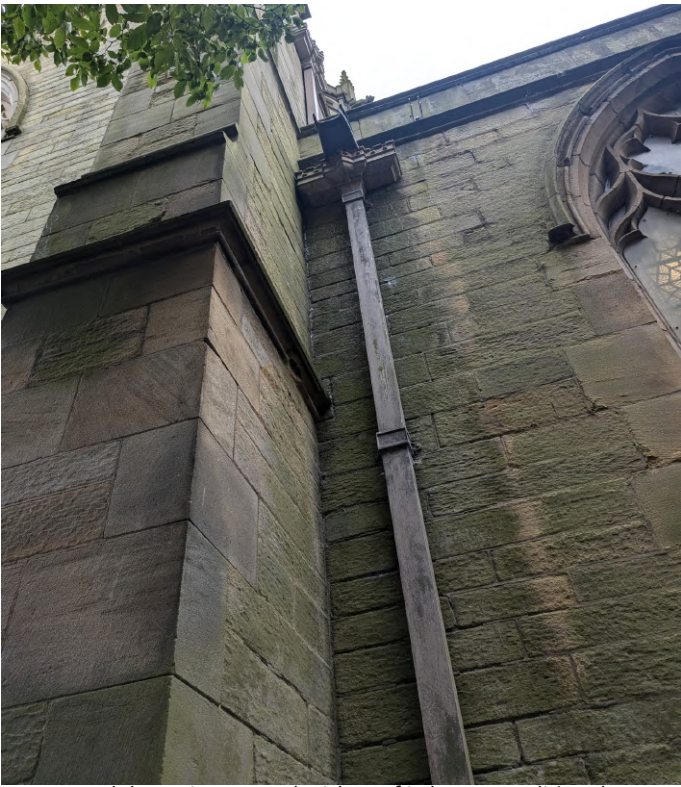
Hopper and downpipe to north aisle roof in better condition than before due to maintenance. Some refurbishment still needed.

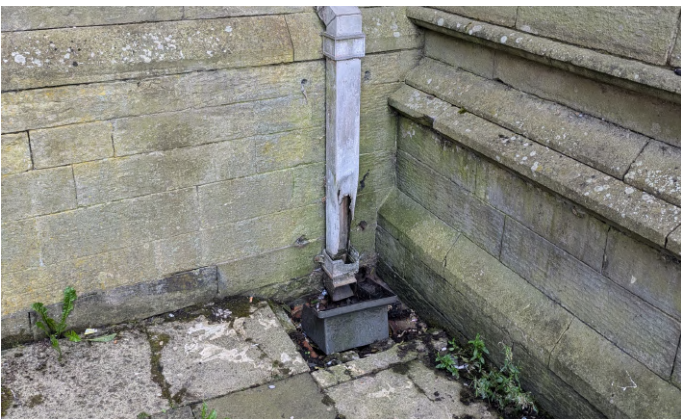
Damage to downpipe on north elevation.

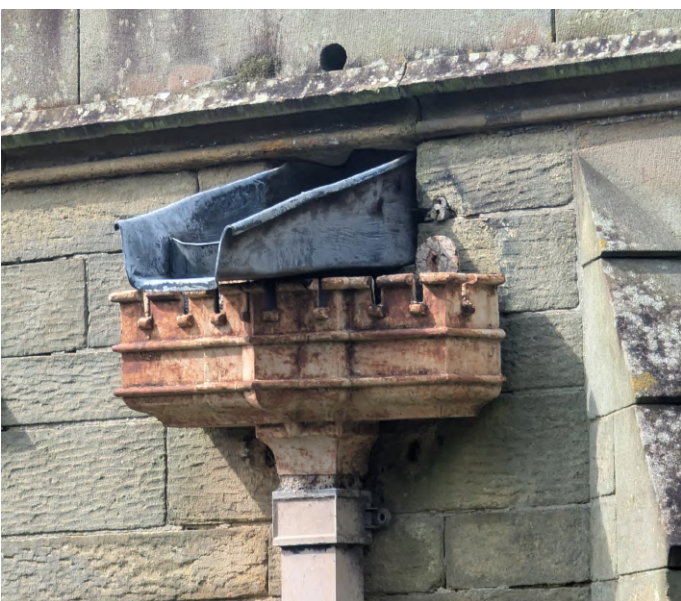
Hopper and downpipe to south retro-chancel elevation. Requires refurbishment.

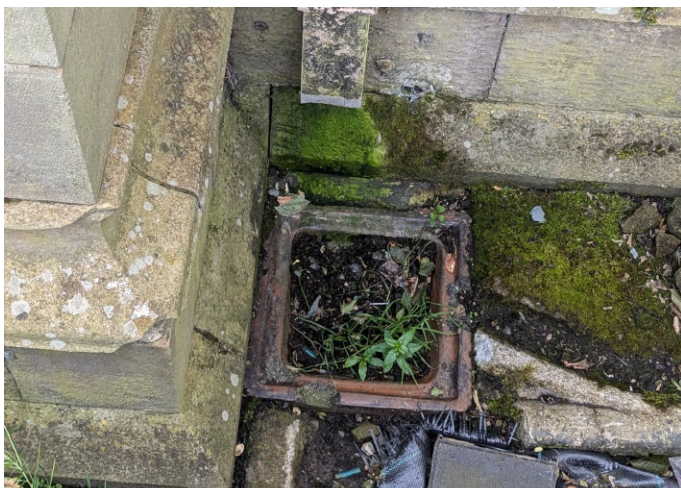
Blocked gully on south side of church. Shoe missing to hopper. Requires refurbishment.

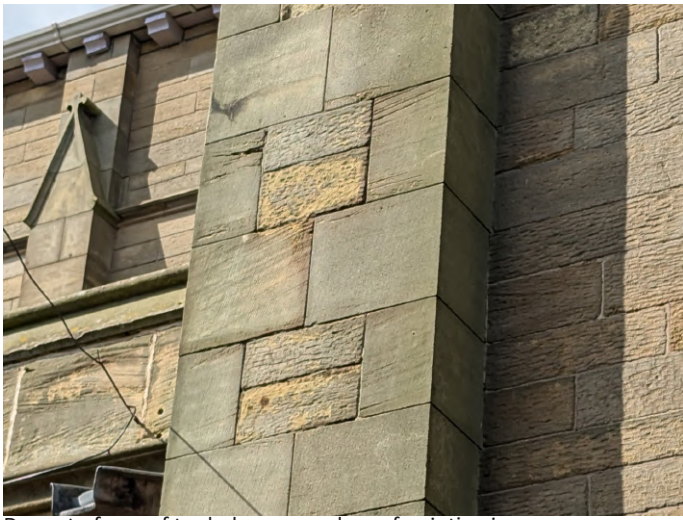
Decay to faces of tooled masonry, loss of pointing in some areas.

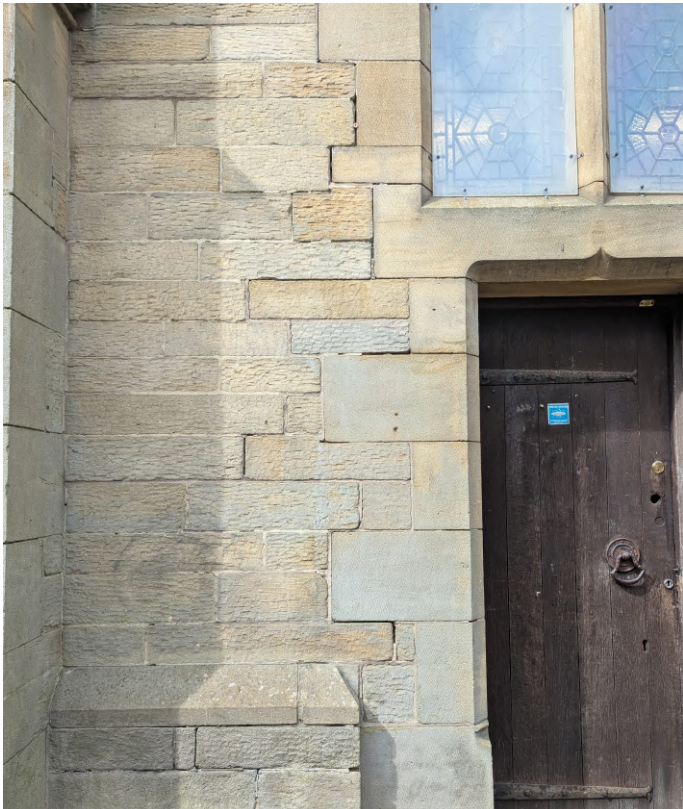
Movement to masonry on left side of south garden door. Now historic. Requires repointing.

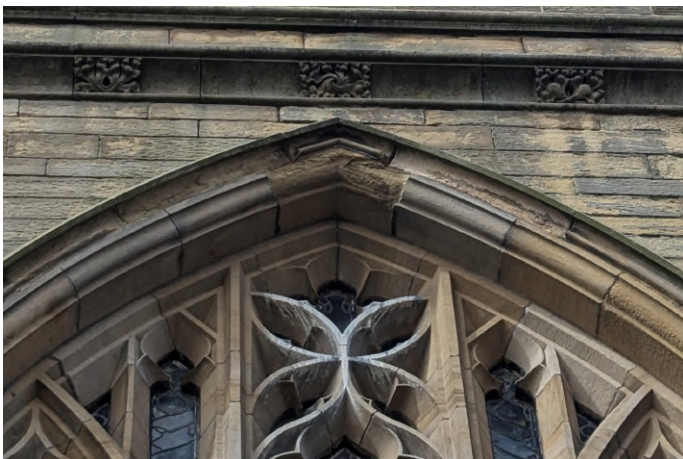
Decay to hood moulds of east window. Guano staining. Loss of pointing to fine joints and tracery.

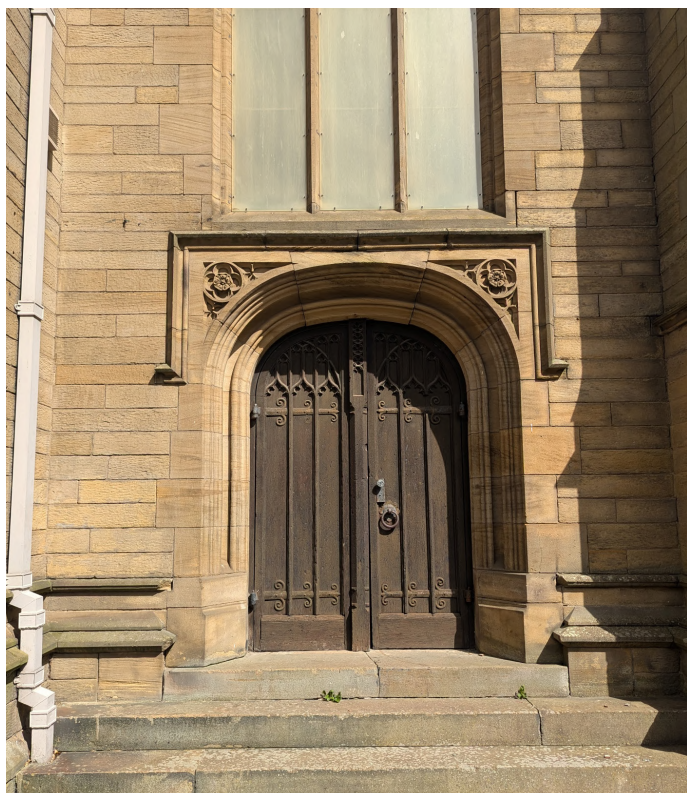
Key stone dropped over main west doorway - not progressed, as per previous QI.

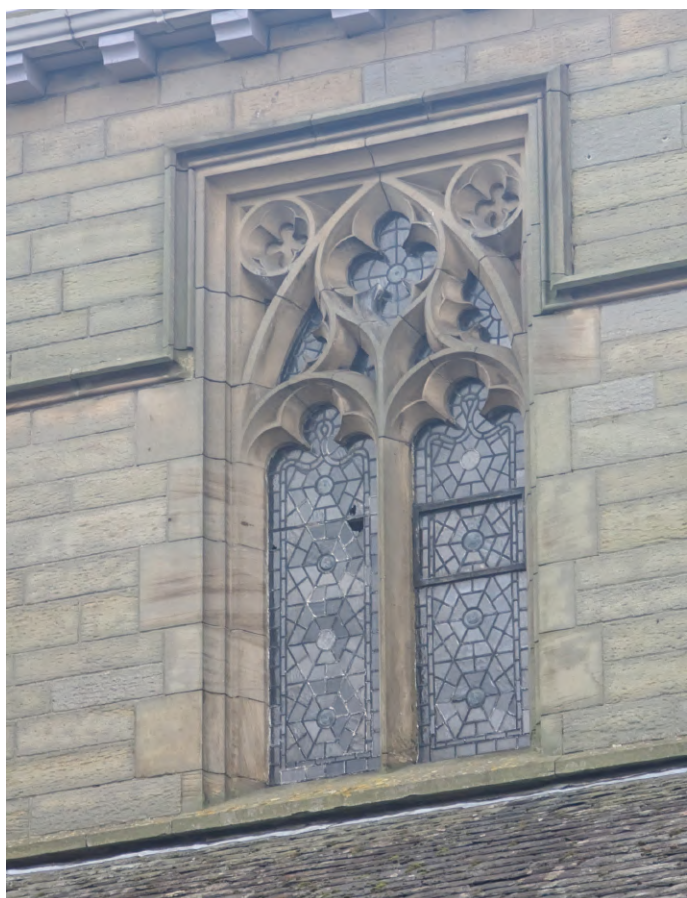
Vandalism to clerestory window on north side of church.

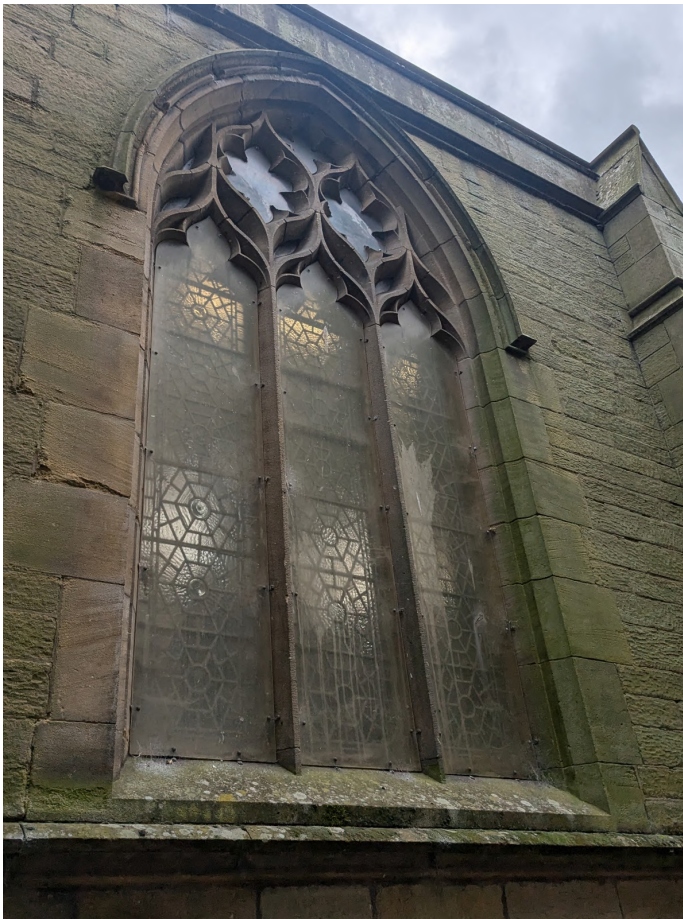
Some glazing within the re-ordered community area (west end) have been replaced with fibre glass. This is not appropriate and so should be replaced with clear glass.

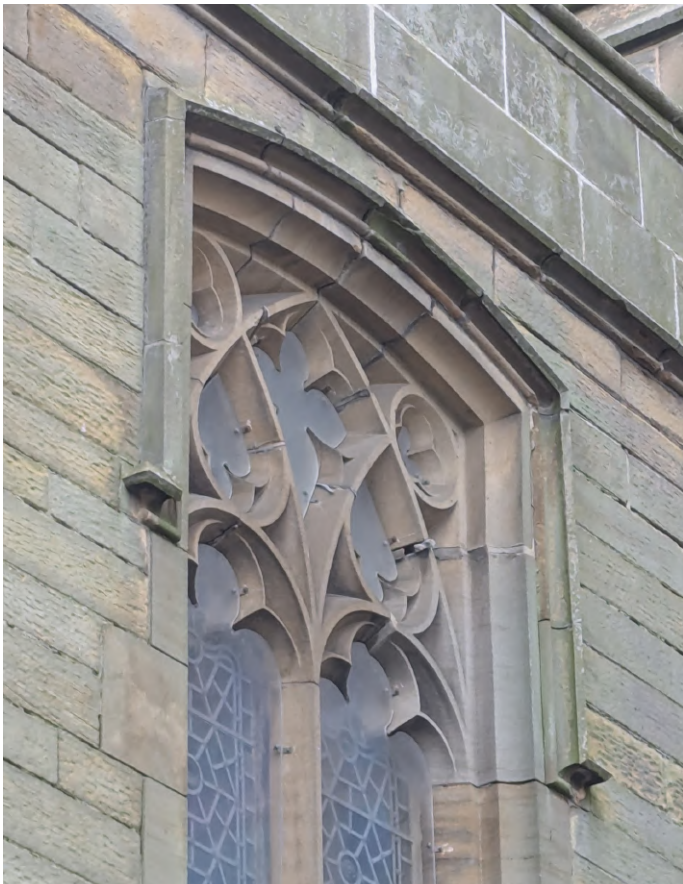
Loss of pointing to fine joints and tracery. Remove mastic and repoint in lime.

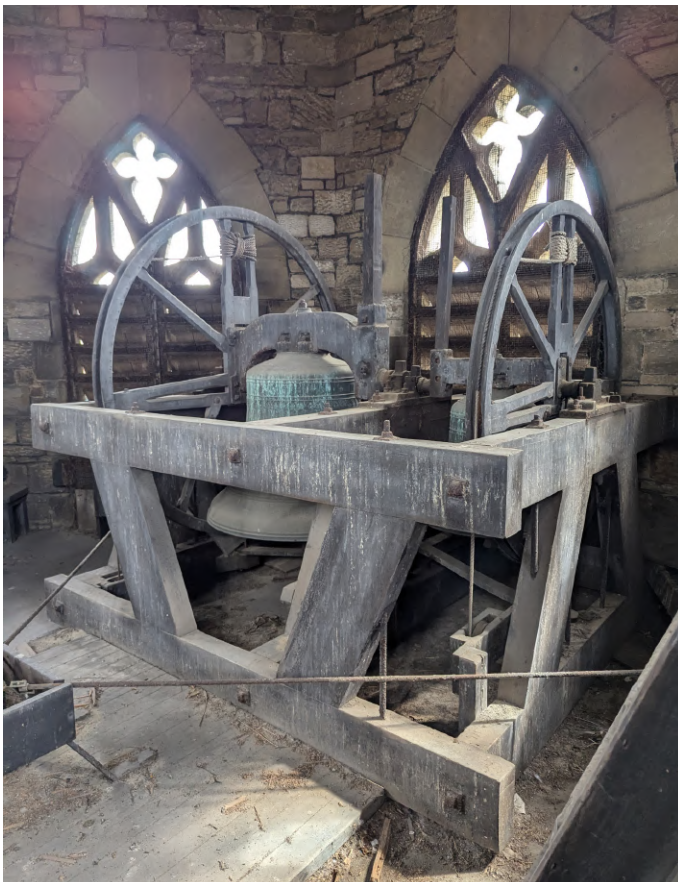
Timber bell frame on concrete floor - good condition though would benefit from a clean

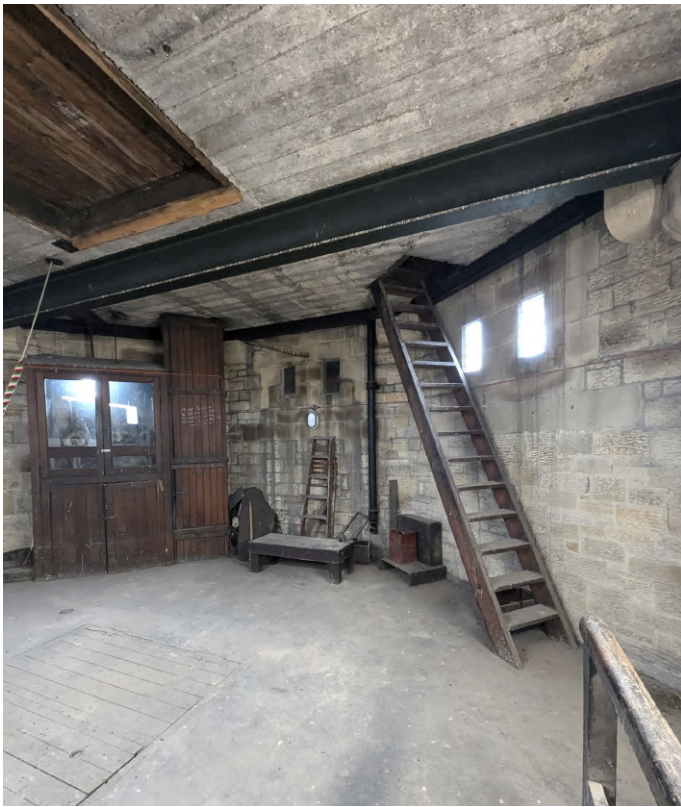
Access to tower roof. Add sign to warn users about the exit onto the parapet so they understand the risks. Clock mechanism behind.

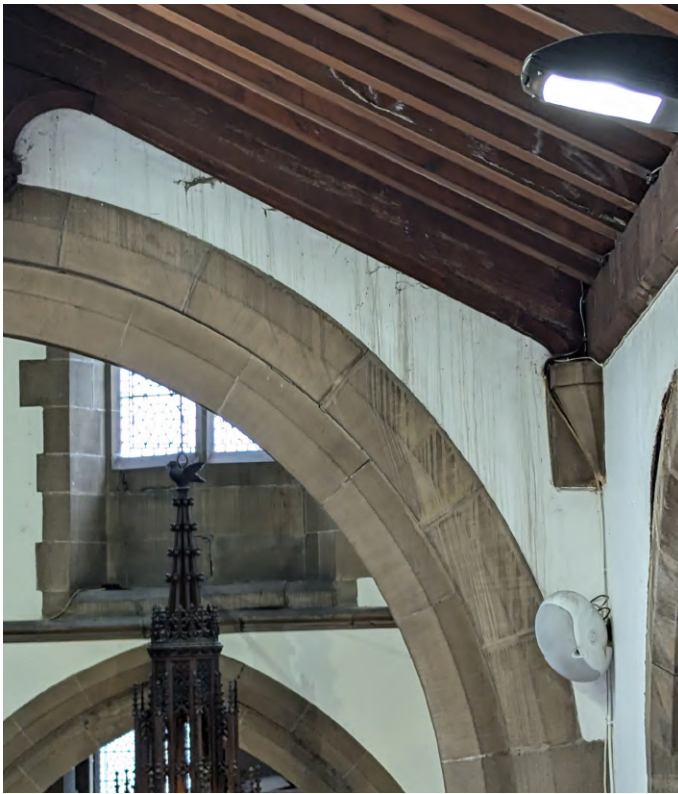
Water staining to wall below south aisle roof abutment with south transept. Now resolved. Monitor area and redecorate.

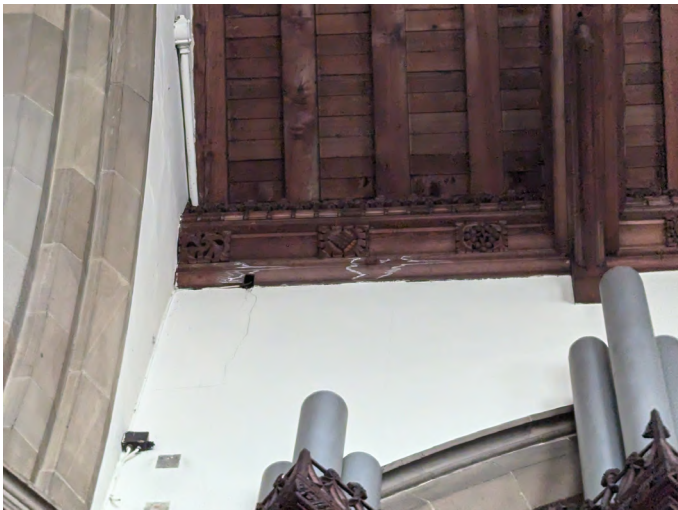
Staining to wallplate above organ. North chancel aisle requires reroofing.

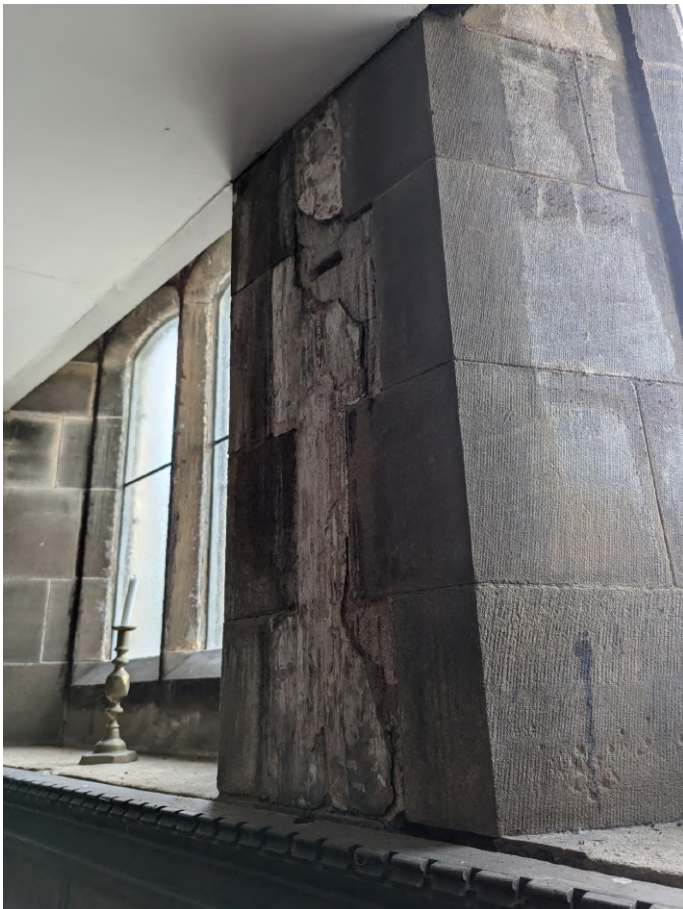
Issues with water ingress at choir vestry due to blocked gutters. Requires replastering after overhaul of rainwater goods.

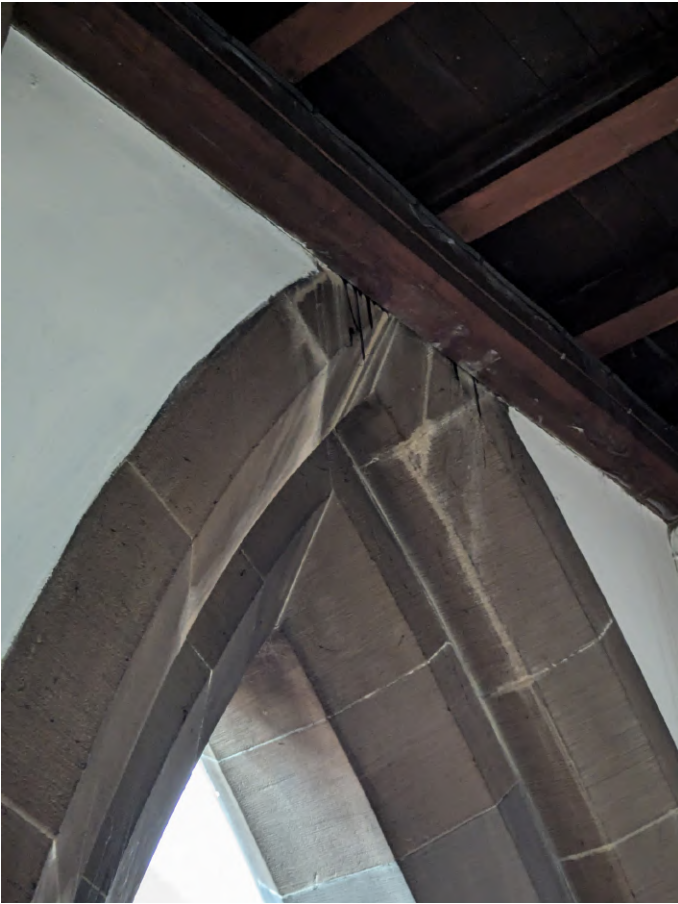
Water staining over window in Angel Loft/east ambulatory area.

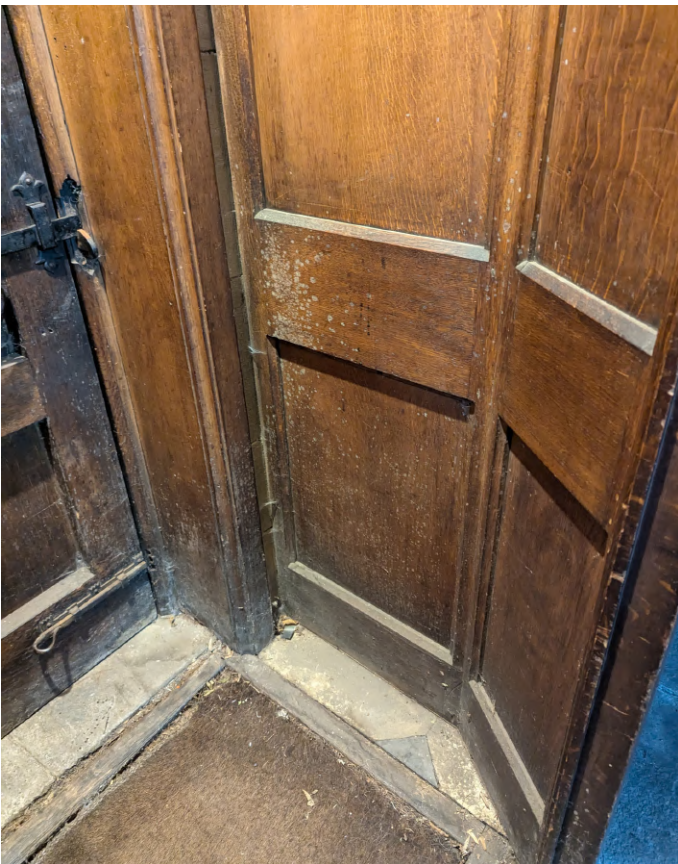
Mould to inside of north aisle draught porch, on both timber and mat. Poor ventilation still a problem.

d)	*Carefully remove timber panelling in choir vestry to inspect for rot. Ensure hopper/outlet externally is clear and sealed.	1,000
e)	*Drill holes in roof of north aisle porch and leave door ajar for ventilation.	DIY

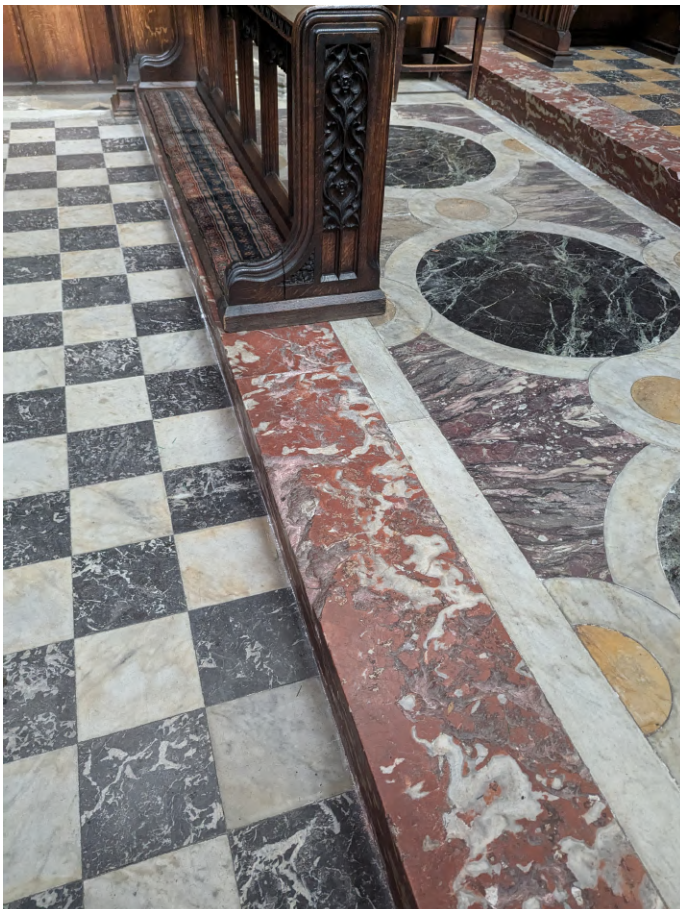
Marble floor to chancel - all interior of exceptional quality. Minor damage to steps.

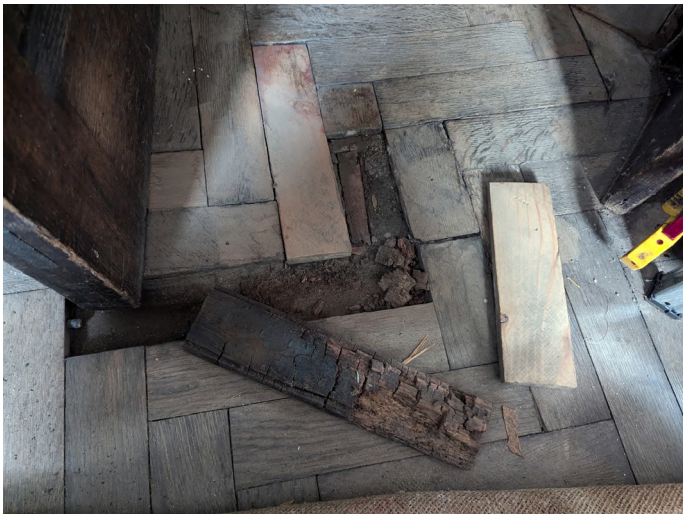
Rot to woodblock flooring at entrance to choir vestry.

h)	Sand-down and re-wax the flooring in the ground floor community room, entrance hall and other ground floor spaces.	£1,000
i)	Repair woodblock flooring to Choir Vestry. Issues with damp to be addressed first. Refix woodblock flooring and timber trim around font area.	£1,000

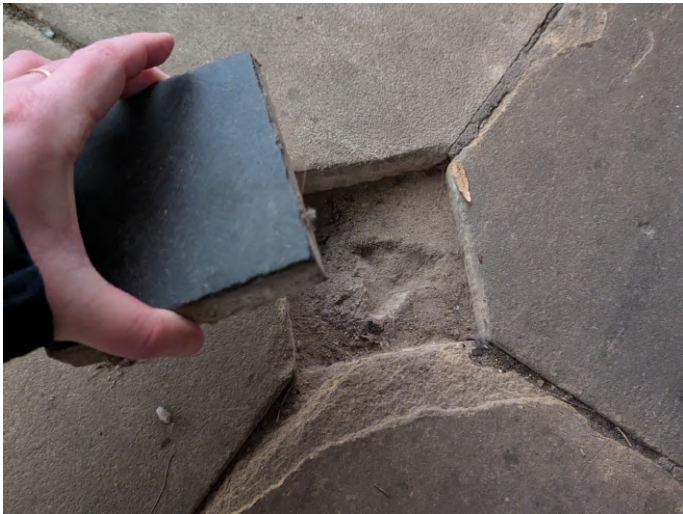
Loose tiles in ambulatory.

n)	Minor repairs to flooring in Ambulatory. Rebedding of tiles and repointing of fine joints.	£500

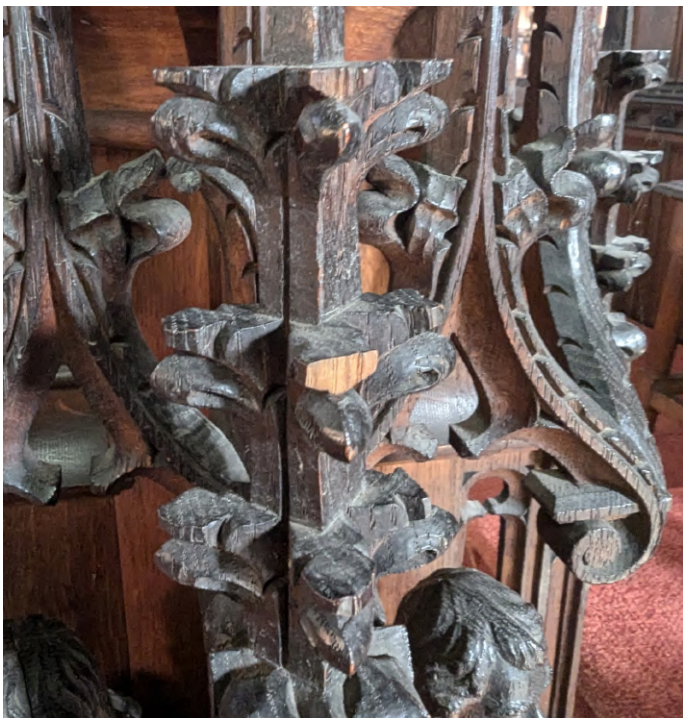
Minor mechanical damage to decorative timber.

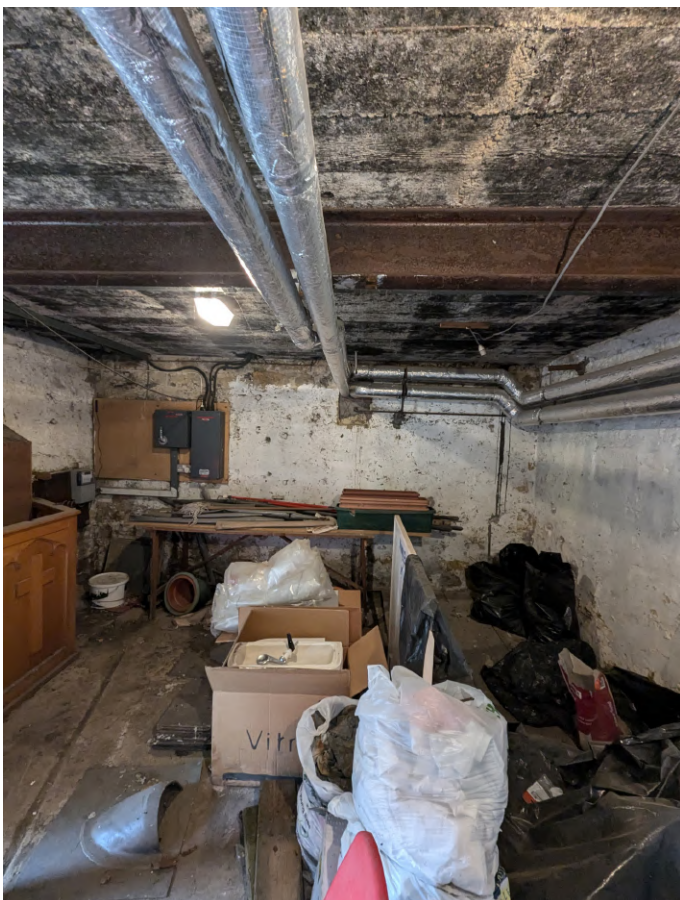
Boiler House - rusting to support beams.

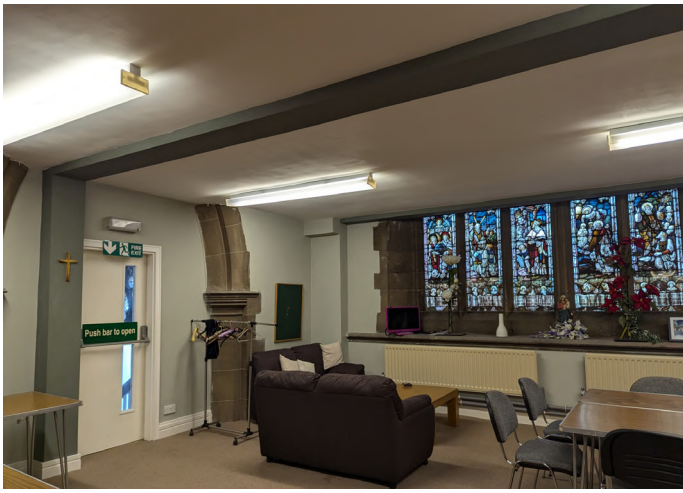
Meeting room on gallery level - ceiling cuts west window in half and creates a low-ceilinged, rather unpleasant space - consider removing the ceiling to allow appreciation of roof and west window (appreciate heating issues will have to be considered).

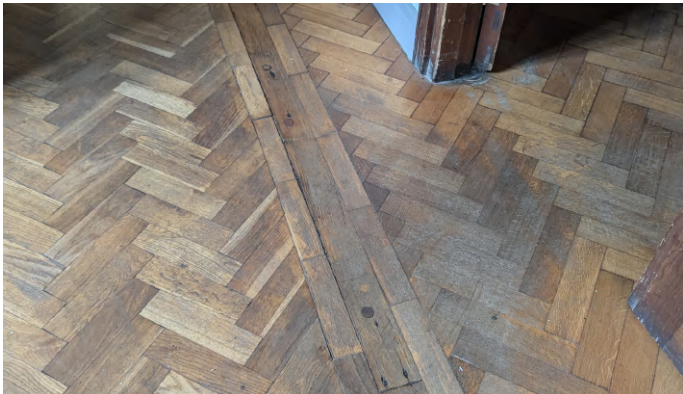
Wear and tear to flooring. Floor would benefit from sanding and re-finishing.

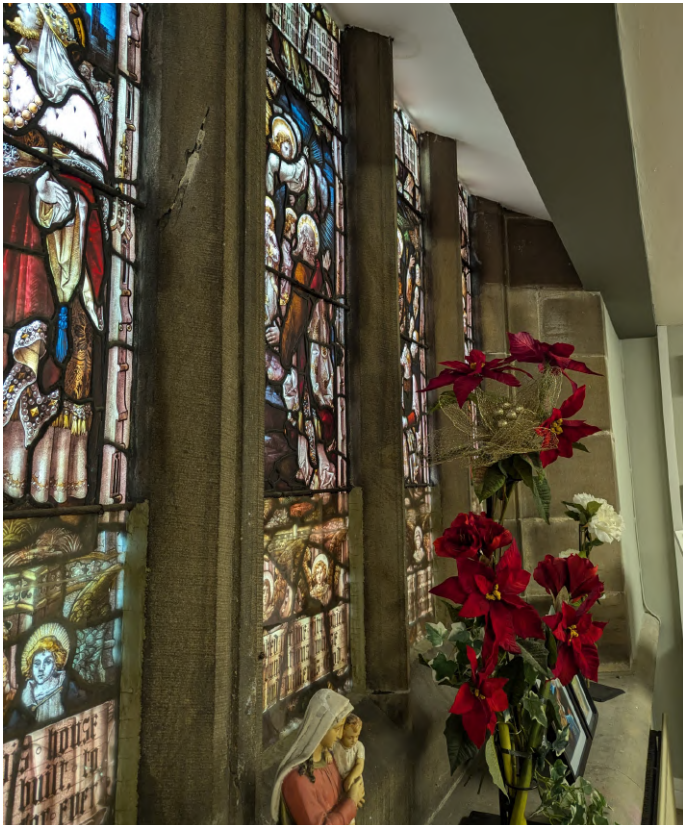
Re-pointing and minor repairs to glazing required to west window.

d)	Pointing of western window, both internally and externally, and minor glazing repairs and cleaning of stained glass panels.	15,000
e)	*Re-point low garden wall to south of retro-chapel and re-bed copings.	2,500

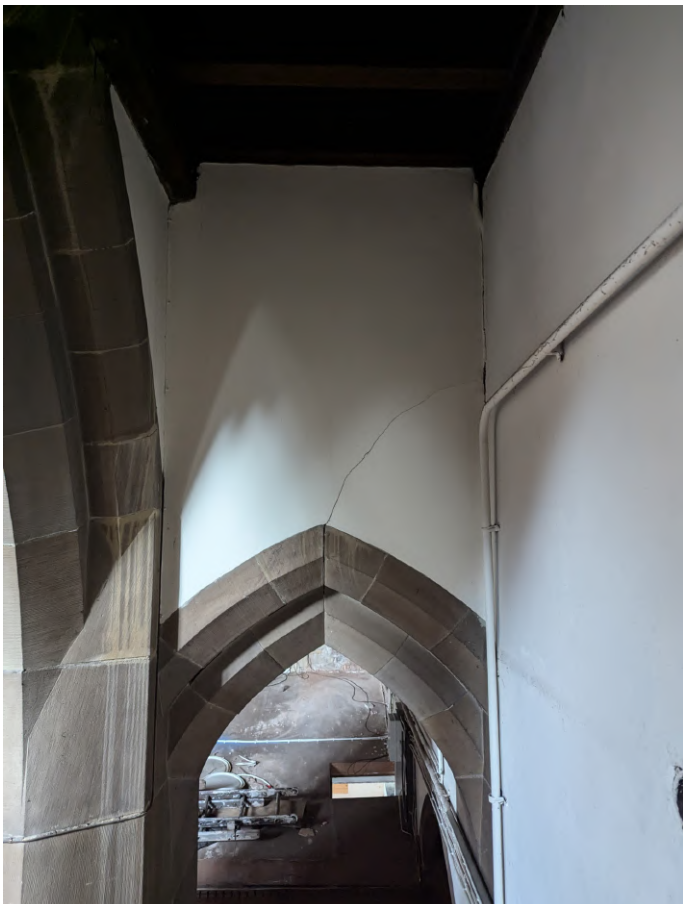
Crack at wall over Angel Loft. East ambulatory.

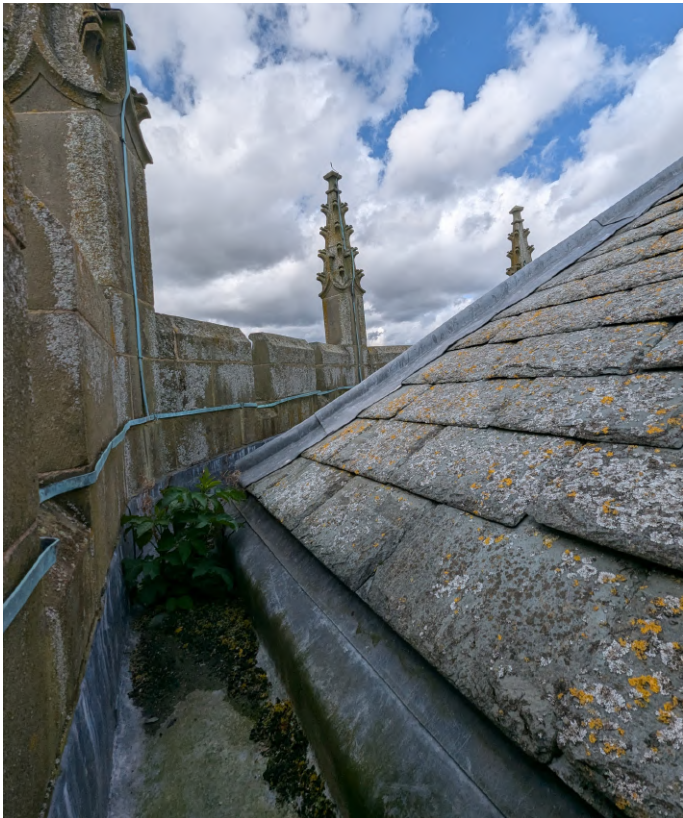
North pinnacle missing lightning rod (upper section)

b)	*Lightning conductor repair – rod to north-west pinnacle.	1,500
c)	*Close inspection of cracked apex stone to north-west porch to be carried out. Repair as necessary. (Inspect from cherry picker when carrying out roofing works above)	800

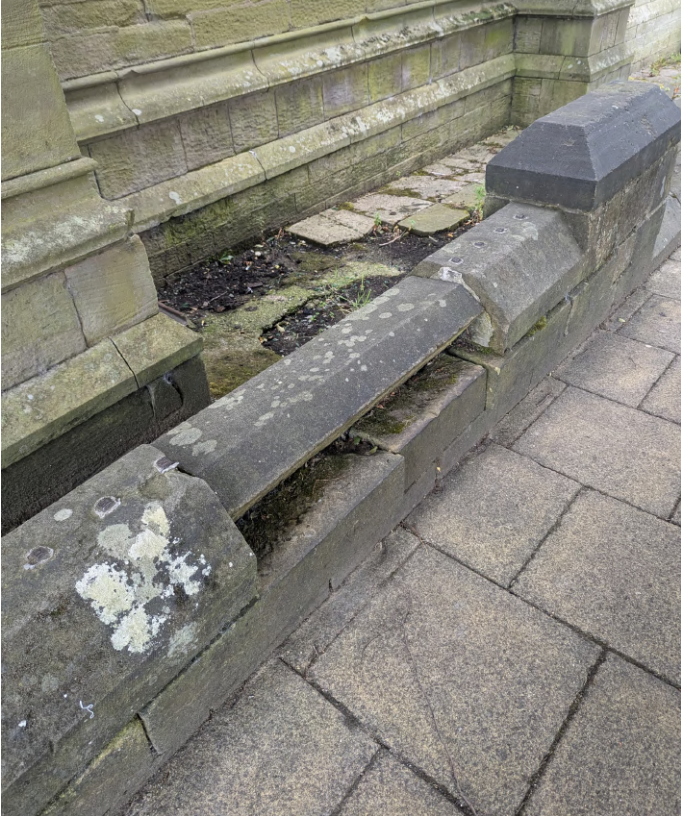
Railings missing from western end of north boundary wall. Areas behind boundary walls to be cleared regularly and kept tidy. Dislodged coping stone required re-bedding.

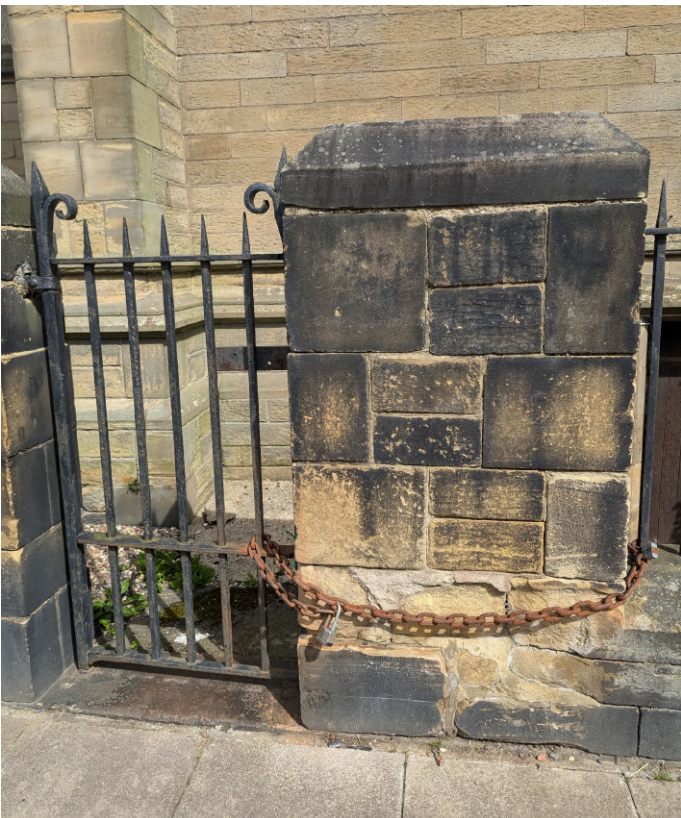
Damage to the stone pier at the west boundary wall due to the large heavy chain securing the west gate. General repointing required and minor indents to damaged stone.

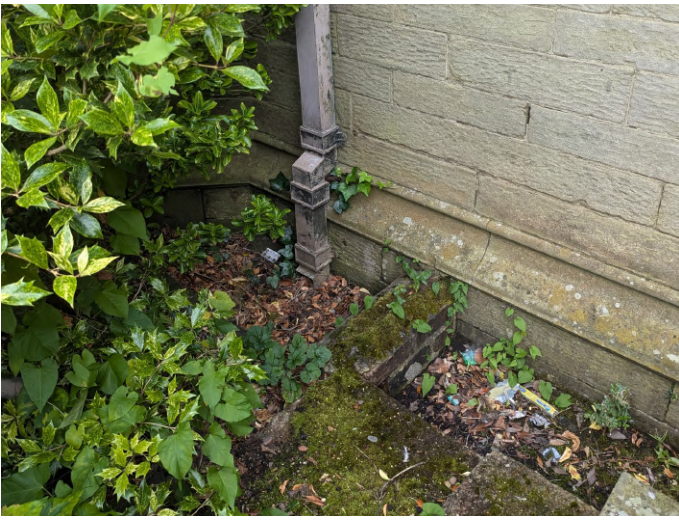
Ensure gulleys are clear and free-flowing.

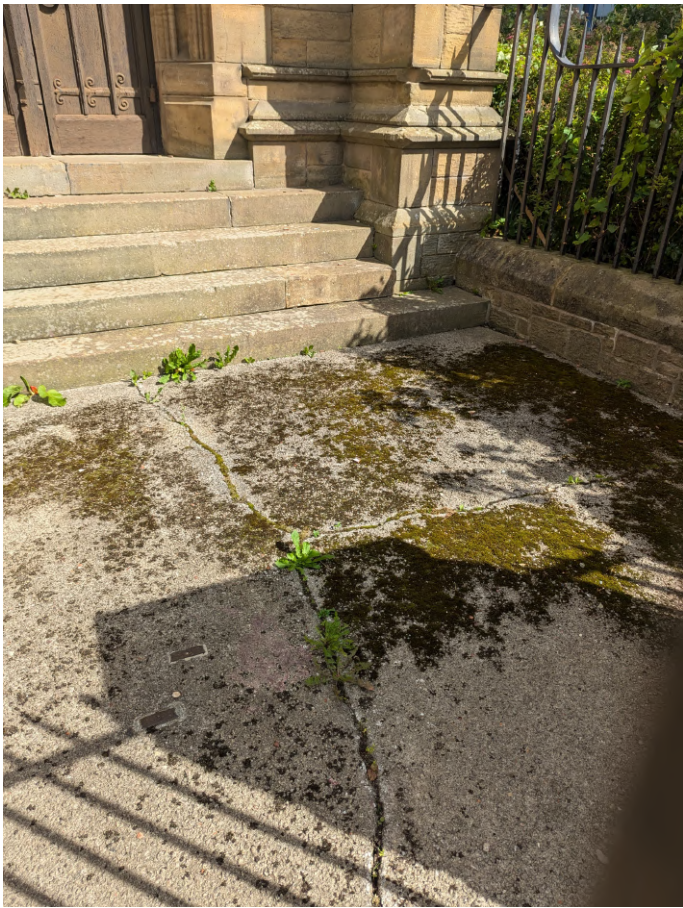
Cracked concrete to front of west door would benefit from repair and steps re-pointed to resist weed growth in gaps. External corners have been lost on some areas of the plinth course around the west door to both sides.
