# CHURCH OF ST. CUTHBERT, BILLINGHAM

Diocese of Durham

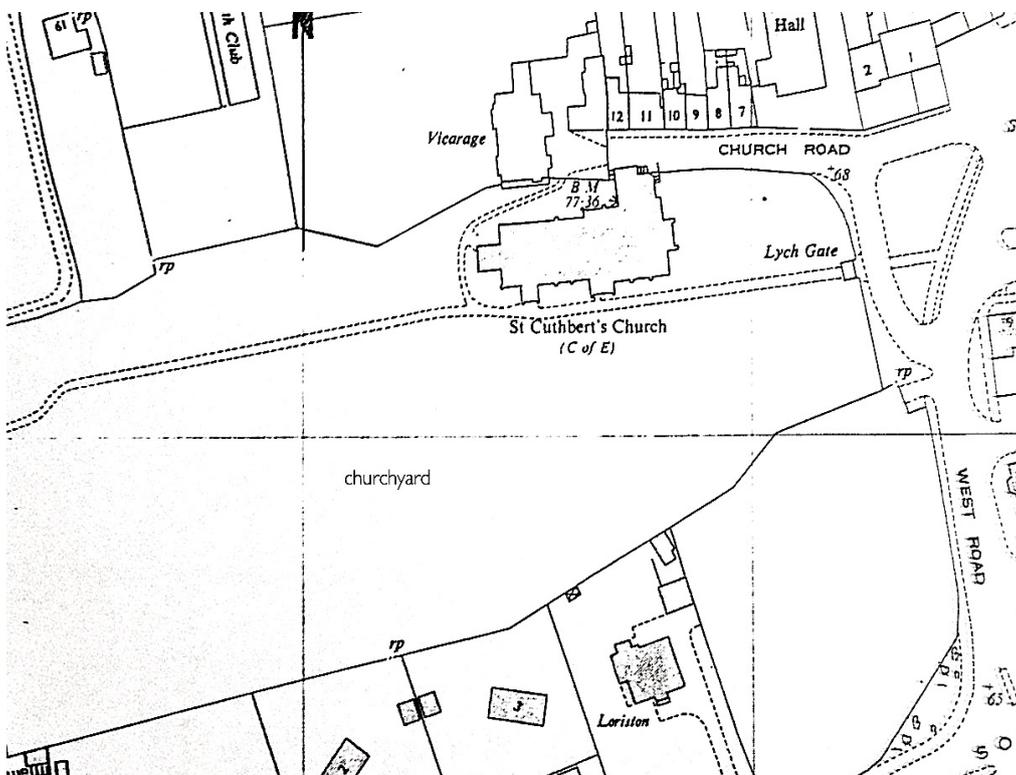
Site plan – not to scale

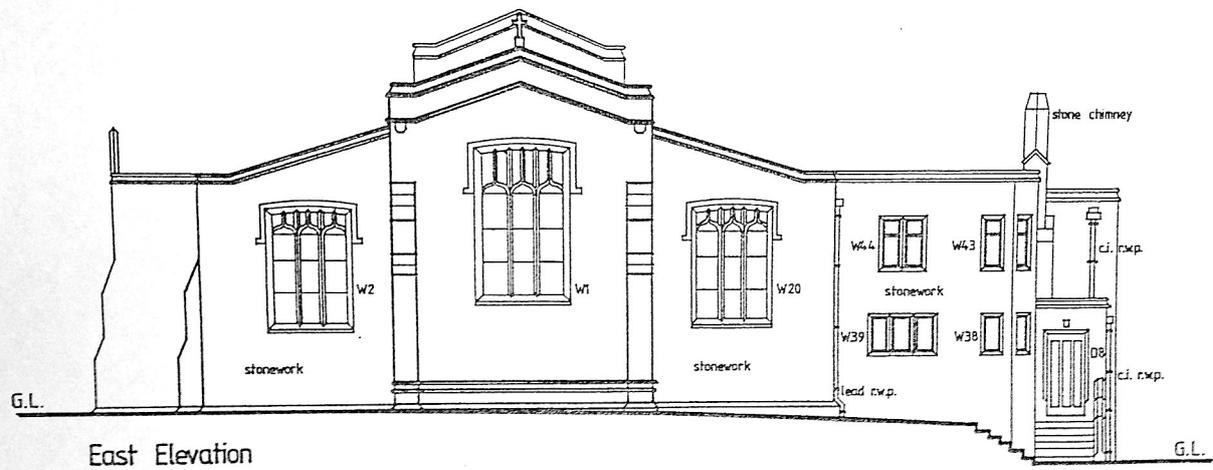
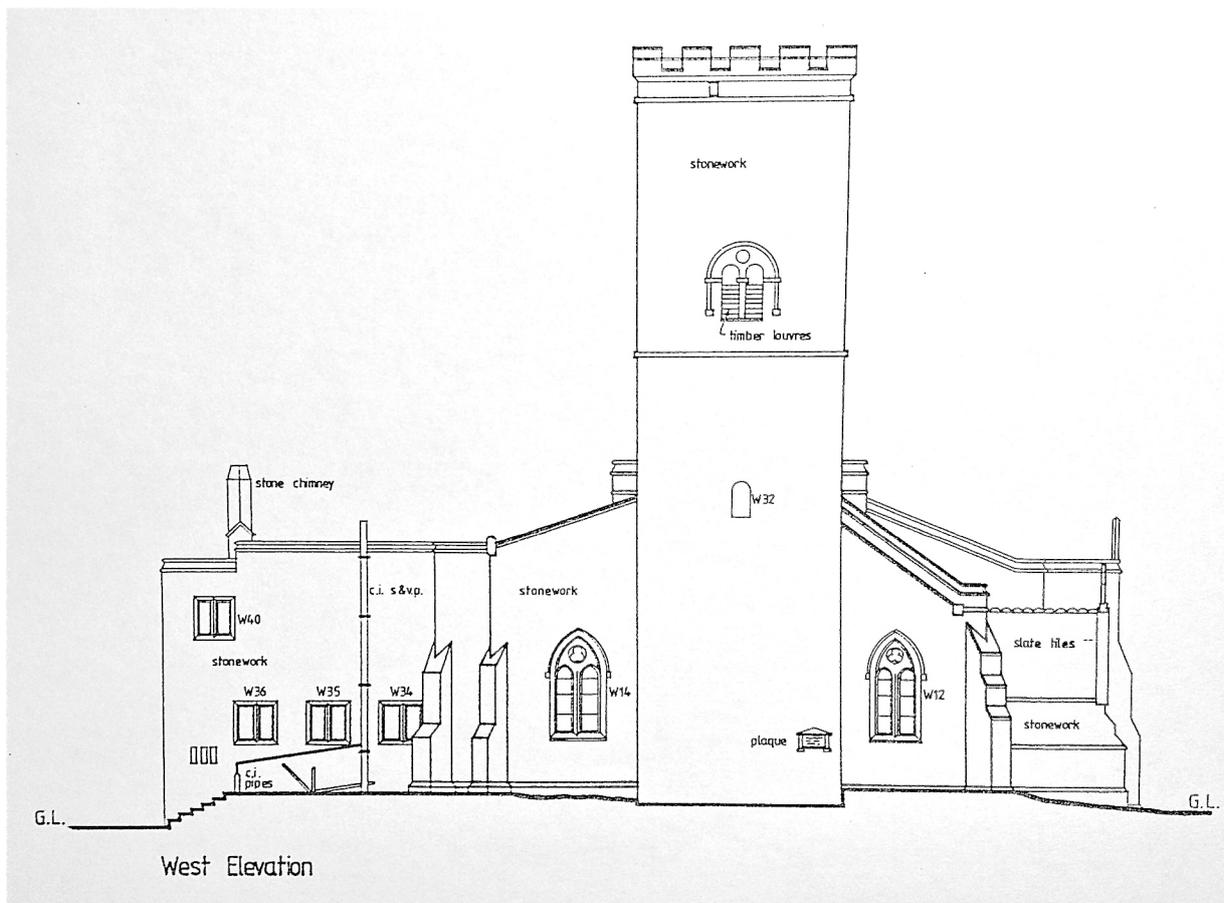
Appendix 2. Photographs of Principal Defects and Items to Note

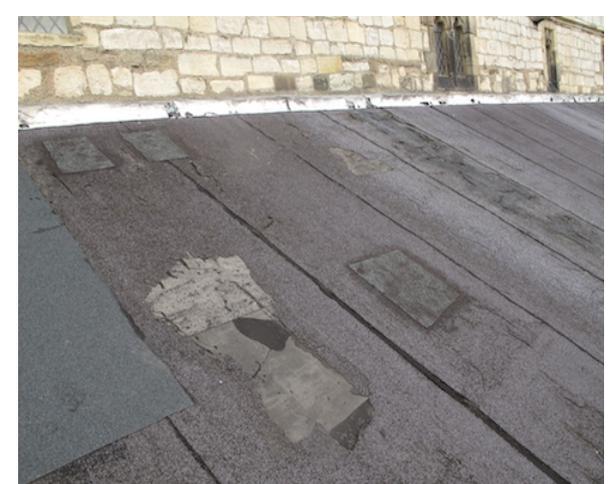
06 South Aisle roof – condition of felt coverings

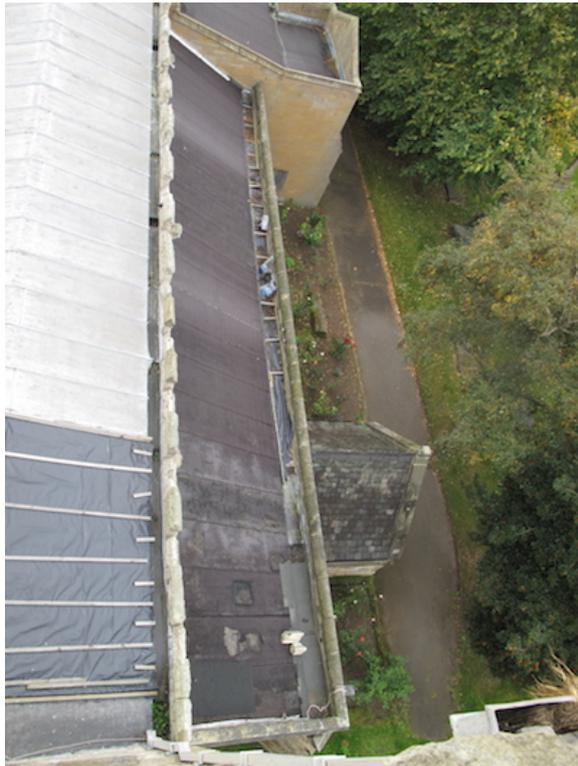
07 Nave Roof and South Nave Aisle Roof

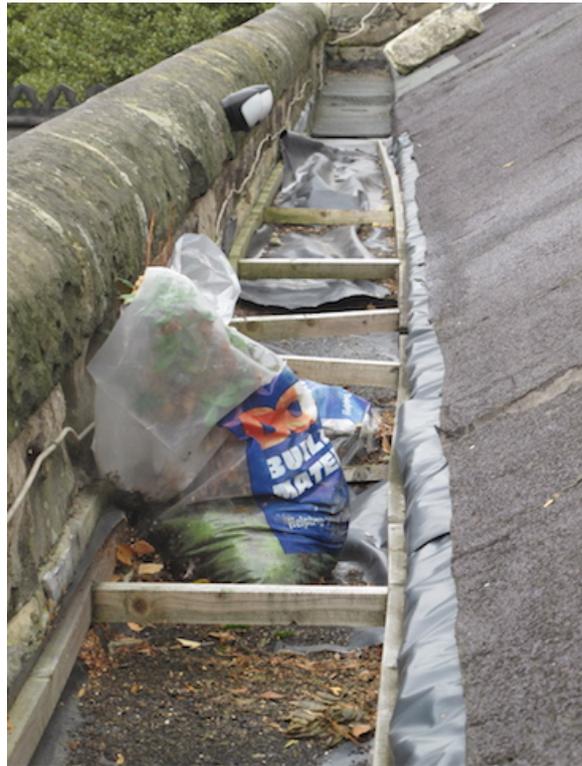
08 South Nave Aisle Roof – awaiting repairs

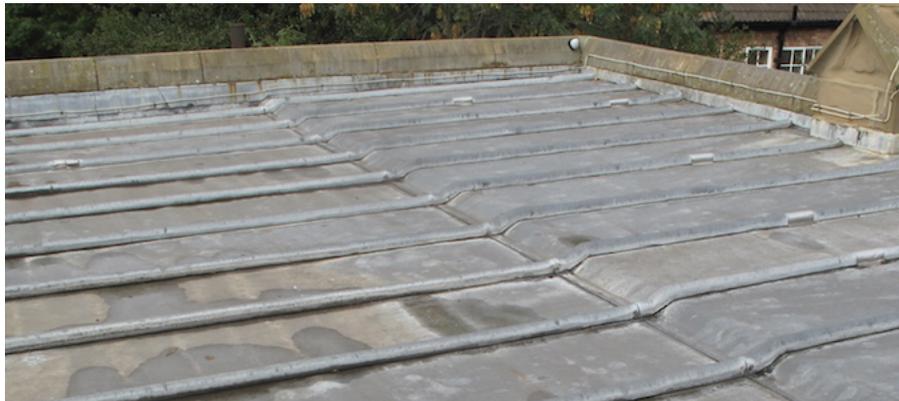
09 Meeting Room Roof – lead roll patches

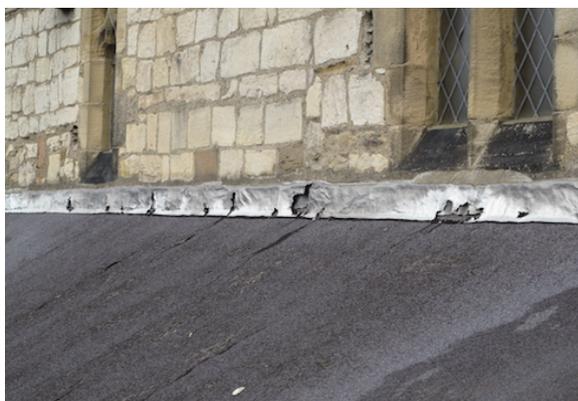
10 South nave Aisle Roof – defective flashings

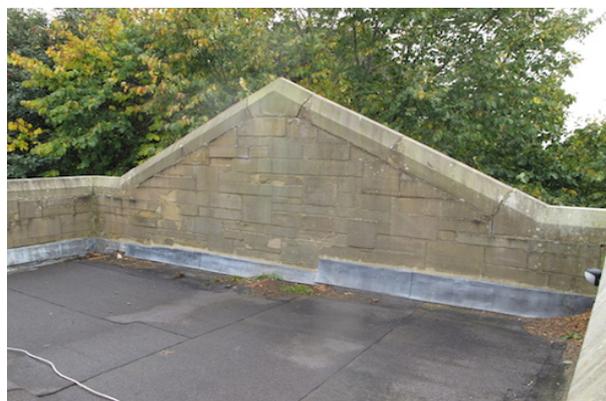
11 South Transept Roof – displaced stonework and open joints

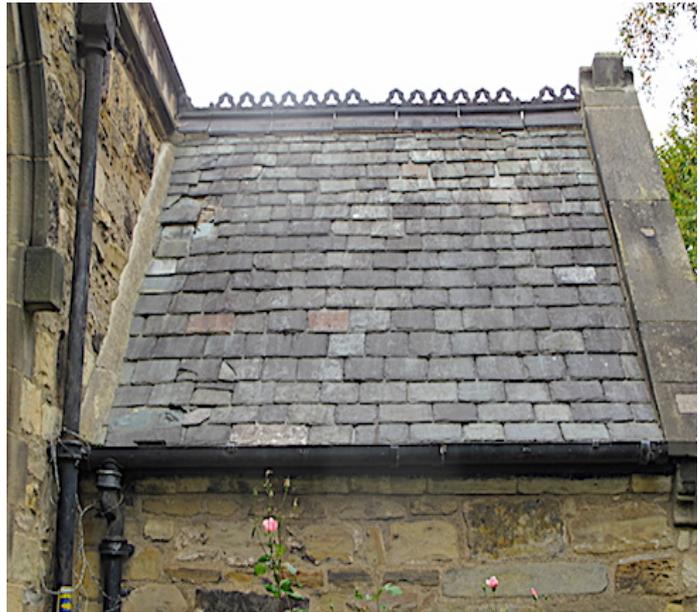
13 South Porch Roof – defective, slipped and missing slates

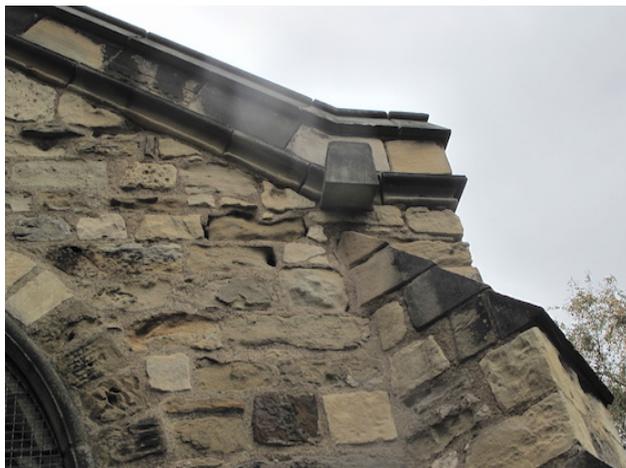
14 South Porch Roof – eroded stonework and open joints

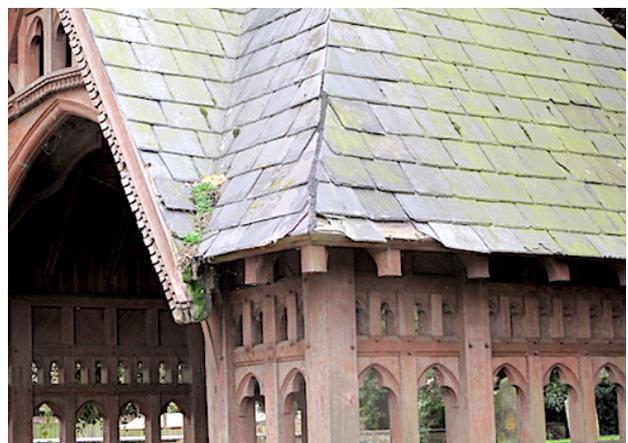
23 Lychgate – damaged roof at north east corner

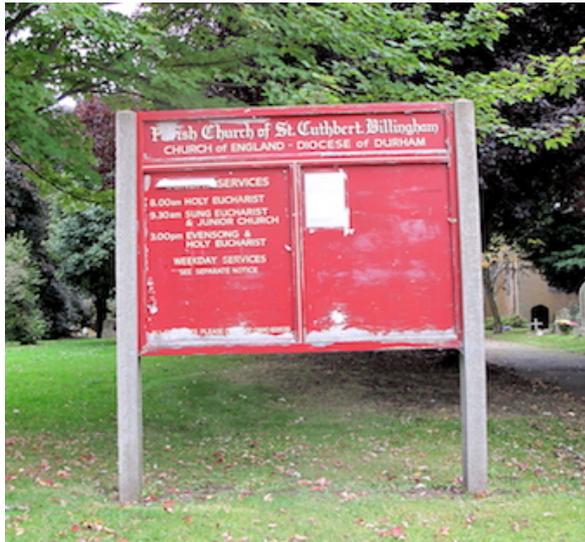
24 Notice board – some repainting needed

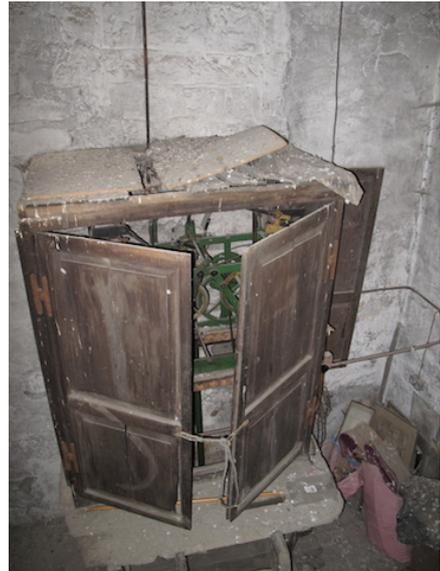
29 Clock Chamber – damaged clock casing

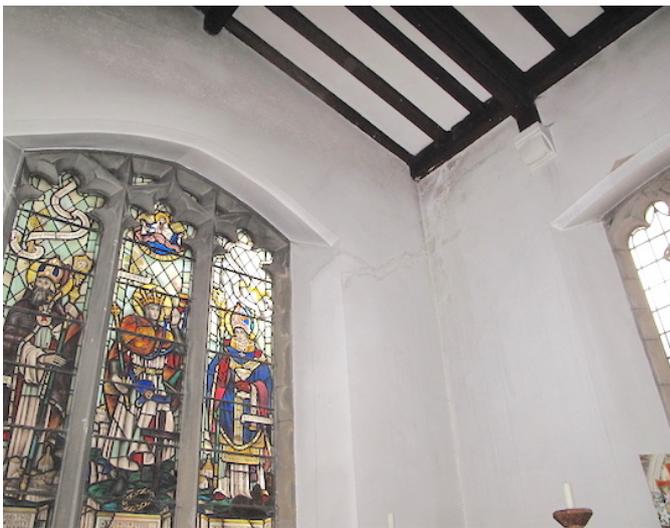
30 Lady Chapel – south east corner possible damp

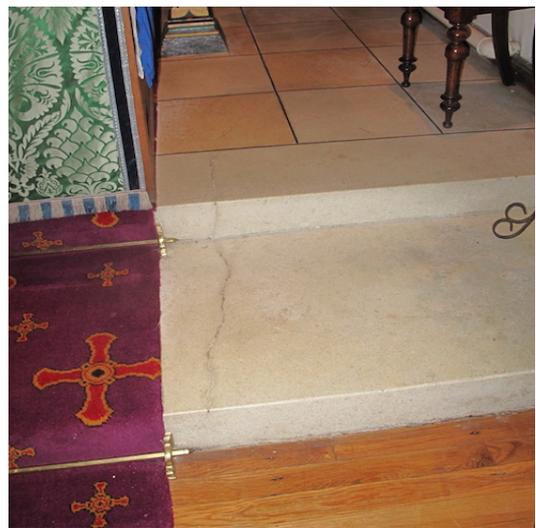
31 Sanctuary – crack in terrazzo floor

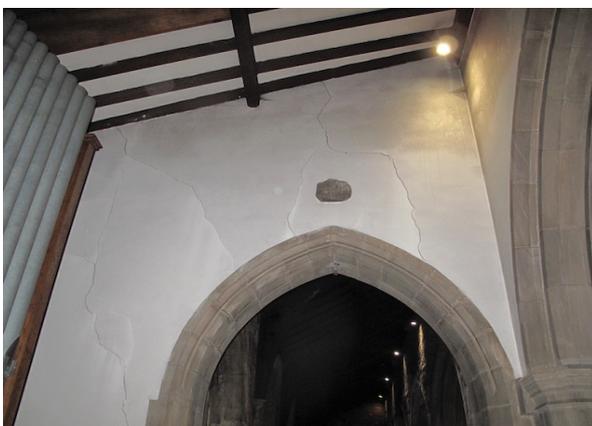
32 South nave Aisle west side – various cracks

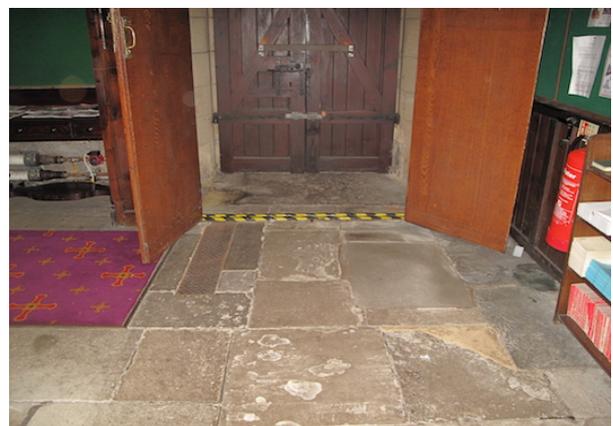
33 South Porch – damaged flags

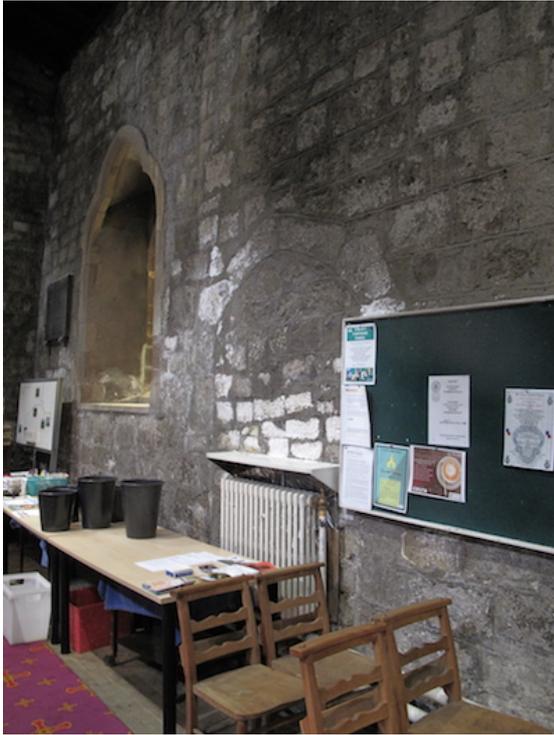
34 North Nave Aisle – salts above radiator

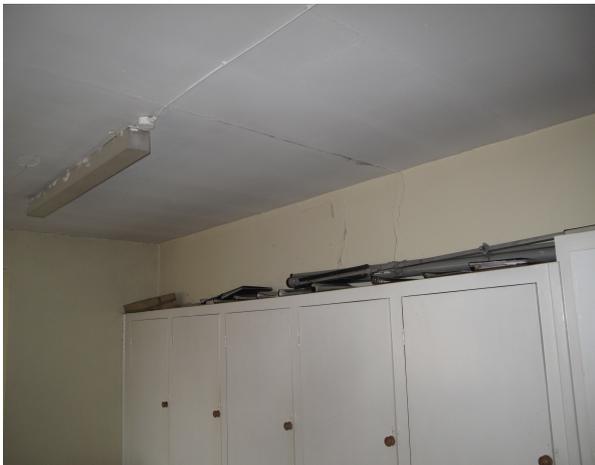
38 Meeting Room – cracks on east wall

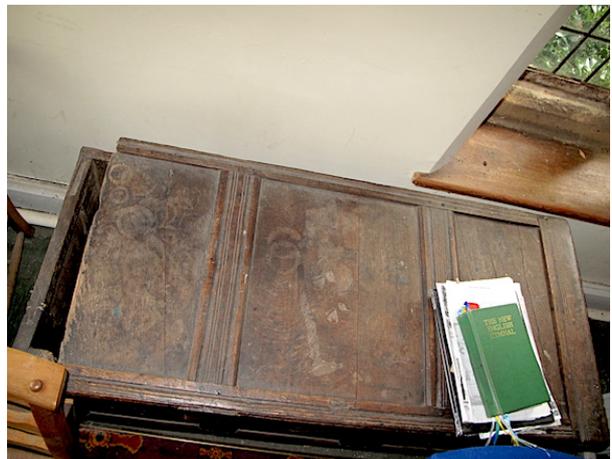
39 Meeting Room – oak chest on east wall
