CHURCH of ST. CUTHBERT, BILLINGHAM

REPORT ON QUINQUENNIAL INSPECTION OCTOBER 2023

Date of Inspection: 26th September 2023

GEOFFREY HOLLAND CHARTERED ARCHITECT

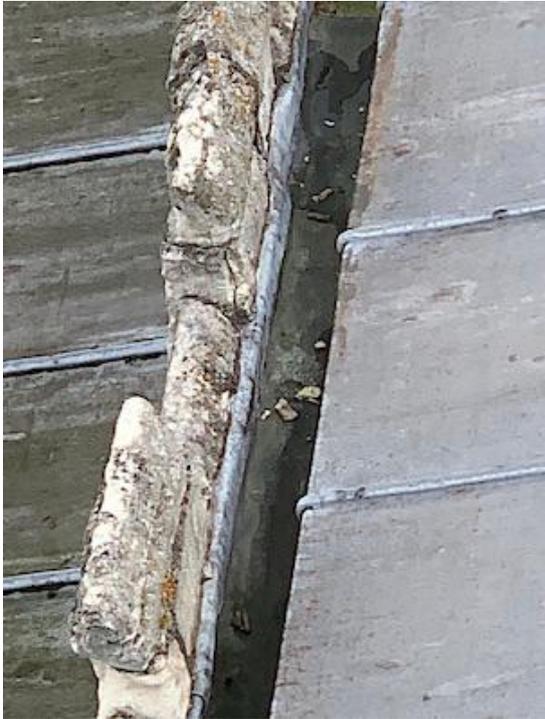
1. Nave roof south slope gutter – detached parapet stone.

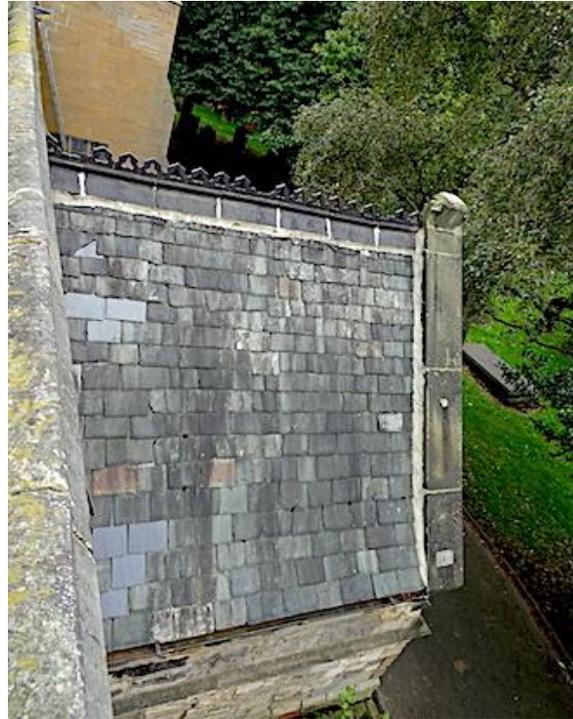
- 2.2.9 SOUTH PORCH ROOF**
- 2.2.9.1 Westmoreland green slate to both slopes in fair condition but one or two slates are mis-aligned and the roof present an overall 'tired' appearance. Some repairs were carried out in 2021 but in the future a complete re-roofing should be considered. M/D

2. South Porch roof showing condition of slates

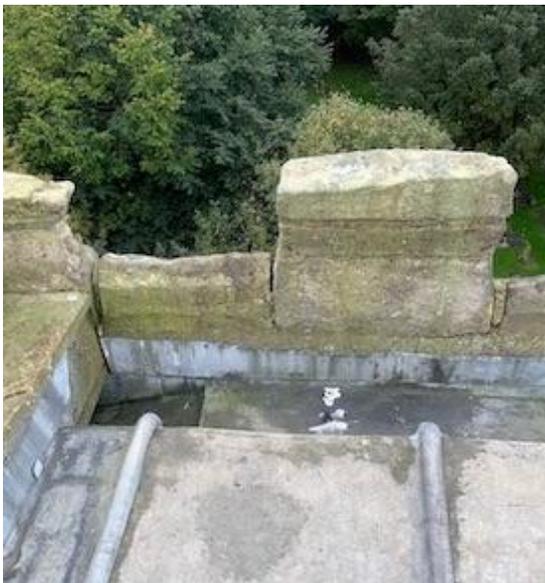
2.2.1.5 The low stone parapets and copings are in fair condition but there are open joints (11no.) to the north and south sides especially to the copings. Elsewhere on the parapets there are a few places where the mortar is either missing or defective and these defects ought to be corrected within the next few years. There are layered stone flags to the east and west walls in fair condition.

3. Tower roof showing open parapet joints

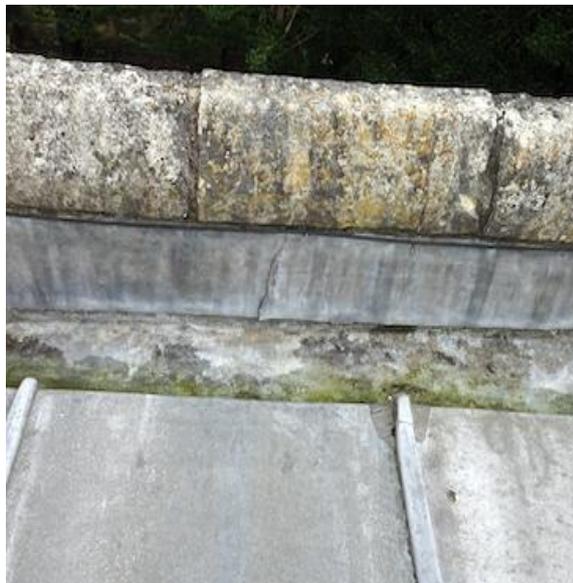
- 2.2.3 NORTH NAVE AISLE ROOF**
- 2.2.3.1 Lead sheet roof coverings with hollow rolls and lead lined parapet gutters. The 4no. sheets of lead stolen from the west end of this roof have now been replaced with lead sheet (May 2021). However, the flashings to the north parapet wall are torn in several places and will need to be replaced in due course. C

4. North Aisle roof showing open parapet joints & torn flashing

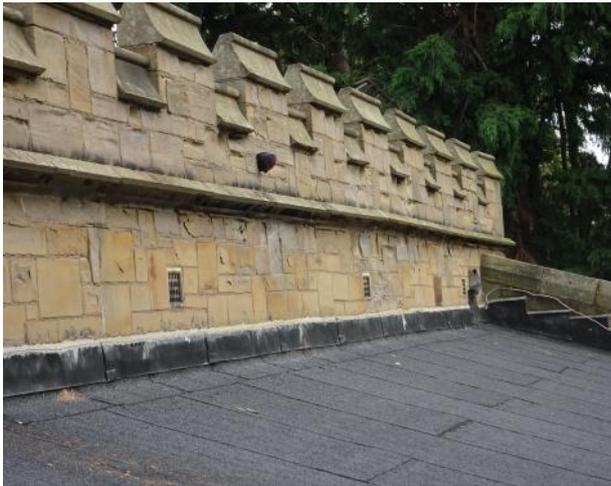
5. South Chancel Aisle roof and Chancel South wall stonework

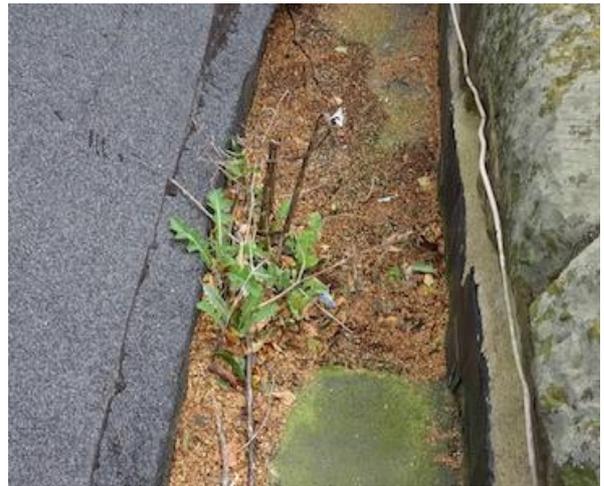
6. South Nave Aisle roof showing blocked gutter

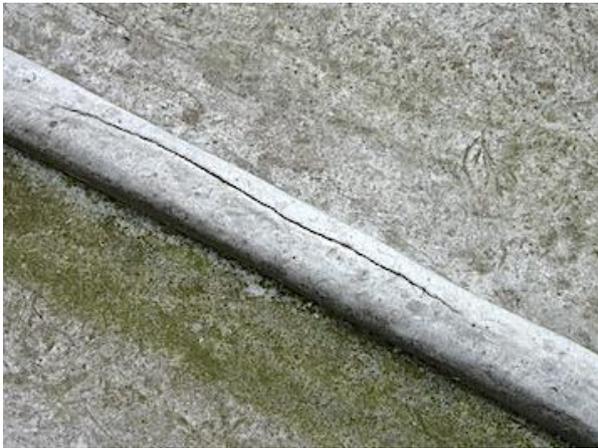
- 2.2.3.2 Several of the lead sheets towards the east end have ‘flashband’ repairs and these should be replaced in time as they are considered merely a temporary repair. In addition, some of the hollow rolls have splits in the top edges of the rolls and these will need to be properly repaired, with lead burned patches, at some time in the future. C

7. Typical split to top of lead rolls on North Aisle roof

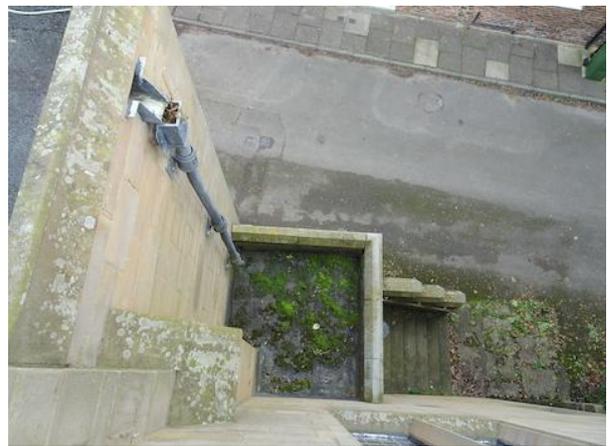
- 2.2.8 VESTRY STAIRCASE AND PORCH ROOF**
- 2.2.8.1 These staircase roof is covered with relatively recent grey mineral felt with similar flashings. It was reported five years ago that the felt had been re-laid relatively recently. It seems to be in good condition with only accumulated leaves and twigs to remove. In addition the lead rainwater hopper on the east side is blocked with twigs and leaves and needs clearing as soon as possible. M/A

8. View to vestry Porch roof showing blocked outlet from Stair roof

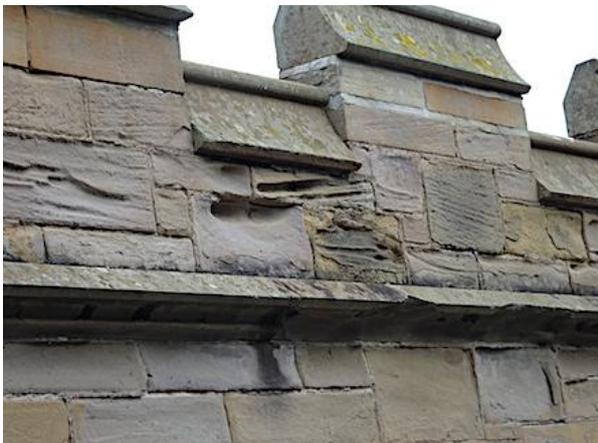
9. South parapet wall of Chancel showing eroded stonework.

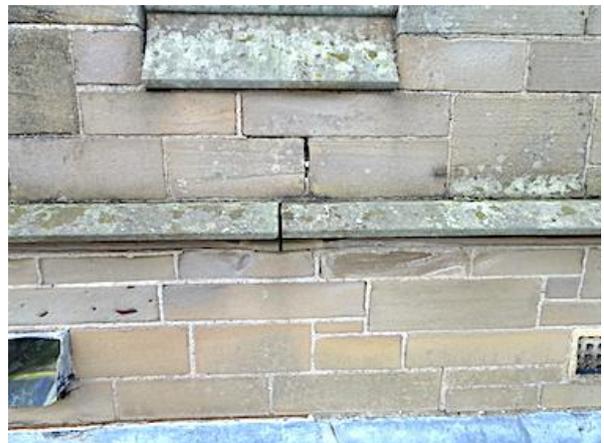
10. South parapet wall of Chancel showing movement in stonework.

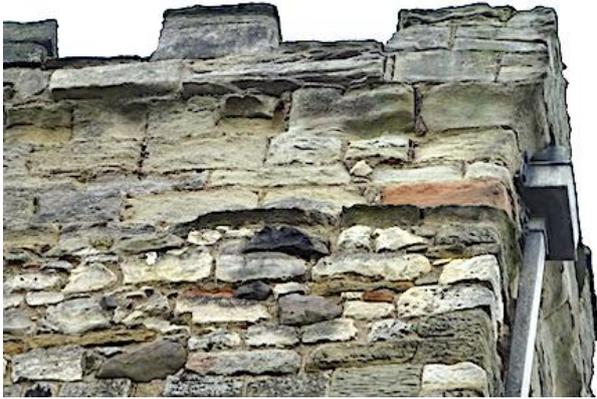
11. Tower parapet wall showing eroded stonework and open joints.

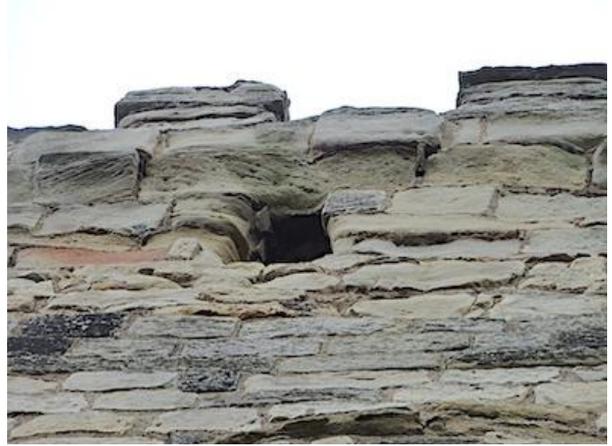
12. Tower parapet wall - deeply eroded stonework and open joints.

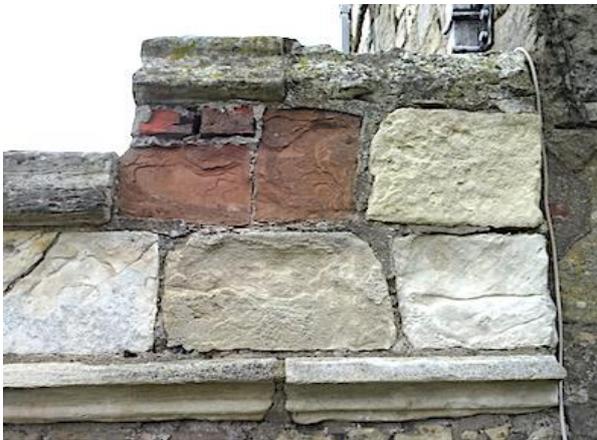
13. North Nave parapet wall next to Tower - open joints.

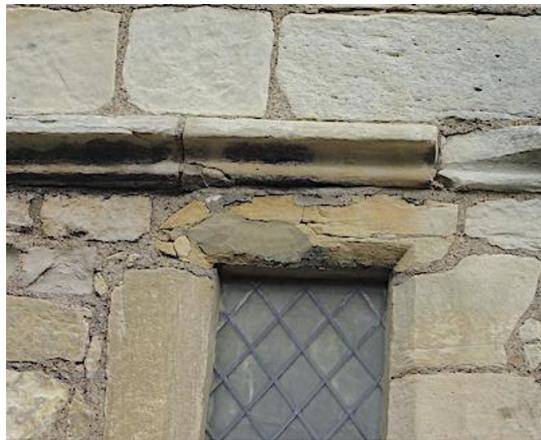
14. North Nave parapet wall next to Tower - open joints.

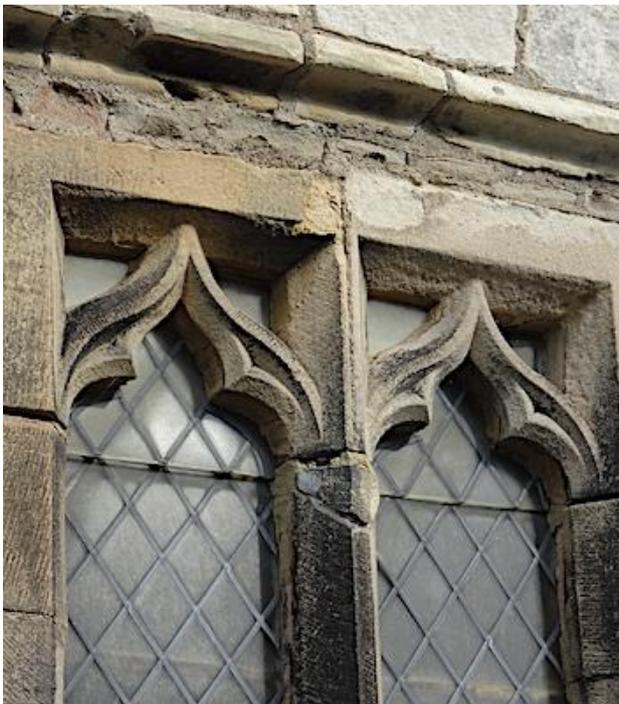
15. South Nave clerestory wall - open joints to window stonework.

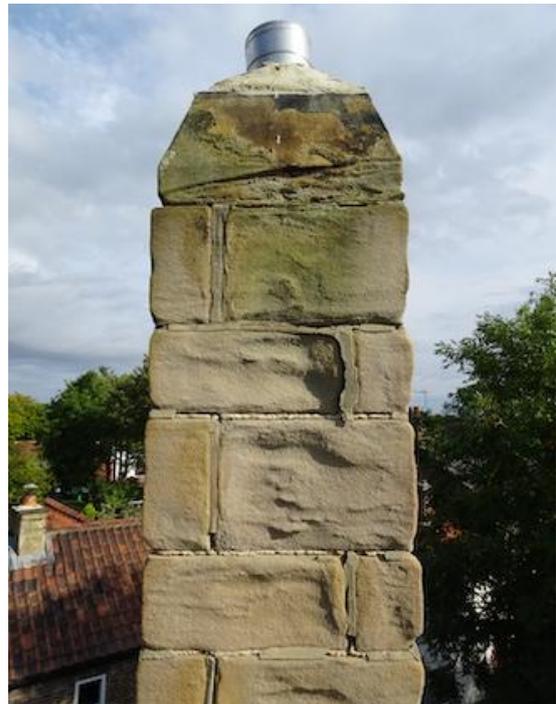
16. Boiler room chimney stack above Meeting Room - open joints

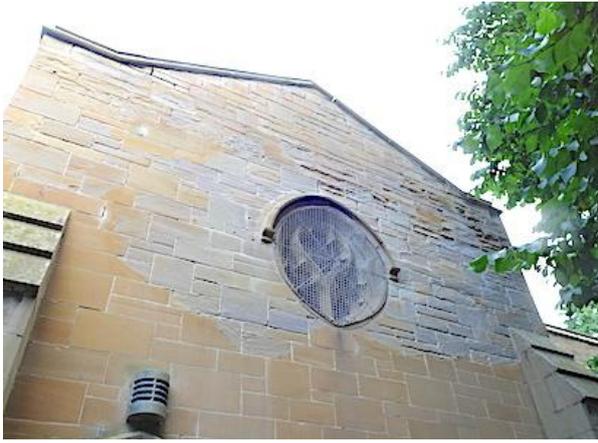
17. West gable of West Transept showing eroded stonework at top

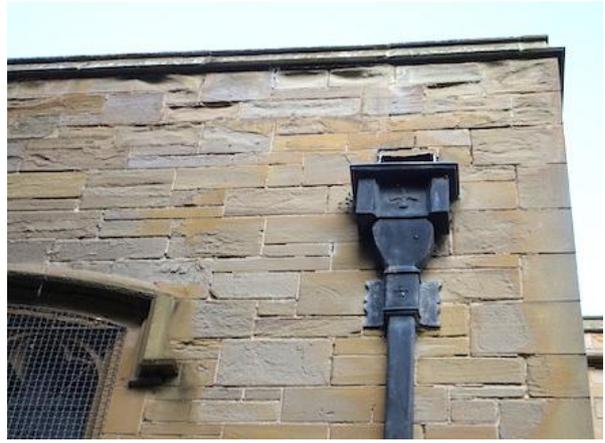
18. West end of south Chancel showing eroded stonework at top

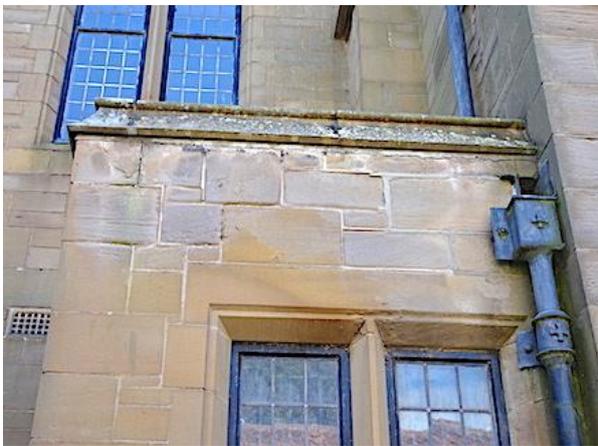
19. North face of North (Vestry) Entrance Lobby – poor pointing

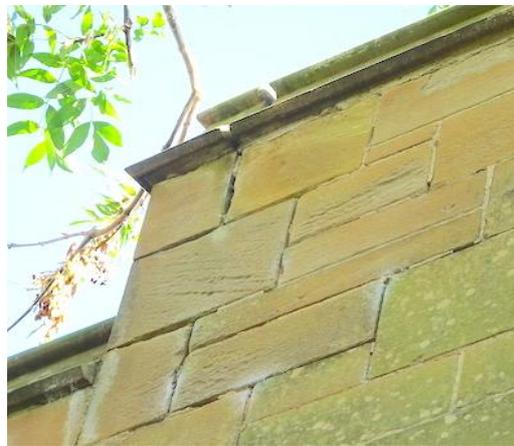
20. West wall coping of Meeting Room – open joints

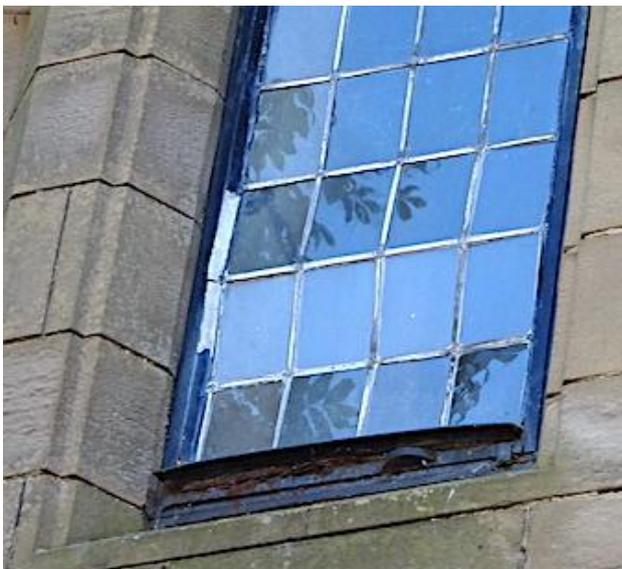
21. North corner window to Meeting Room – distorted lead panel

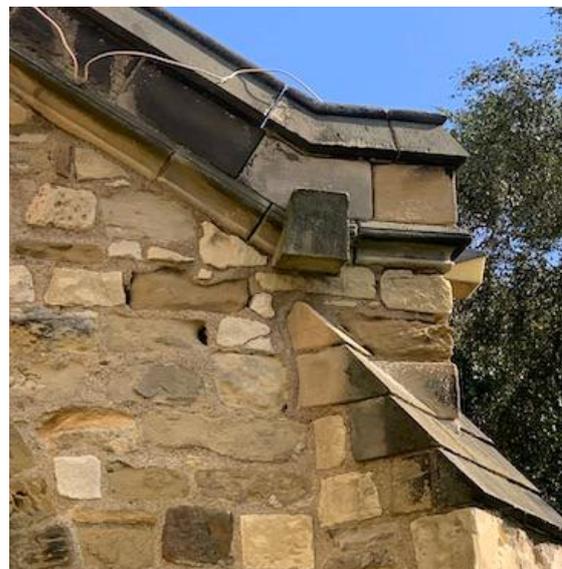
22. West face of South Aisle – open joints and eroded stones

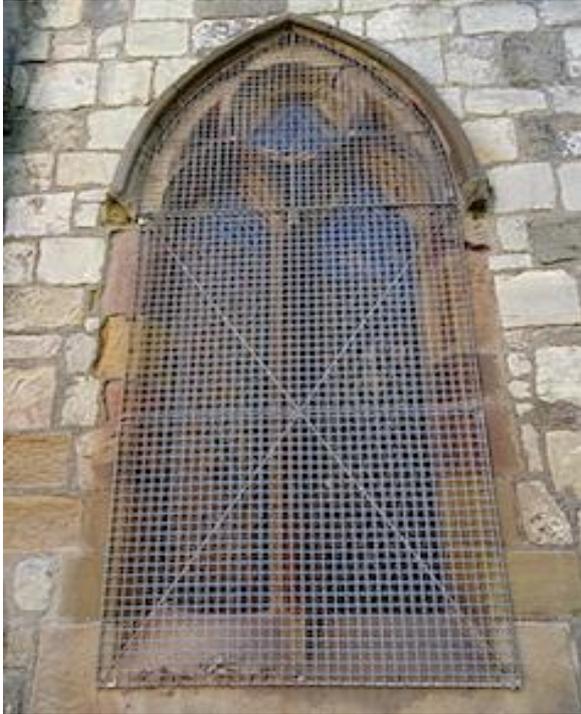
23. North Aisle window – eroded stone surrounds and tracery

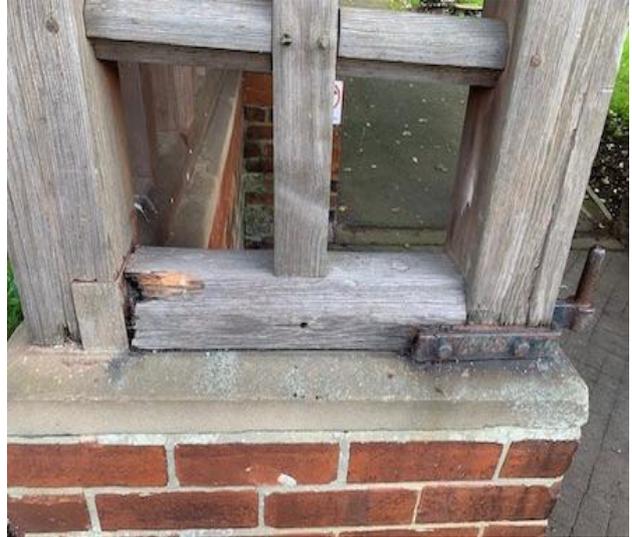
24. Lych Gate showing rotten soleplate timbers and rusty ironwork

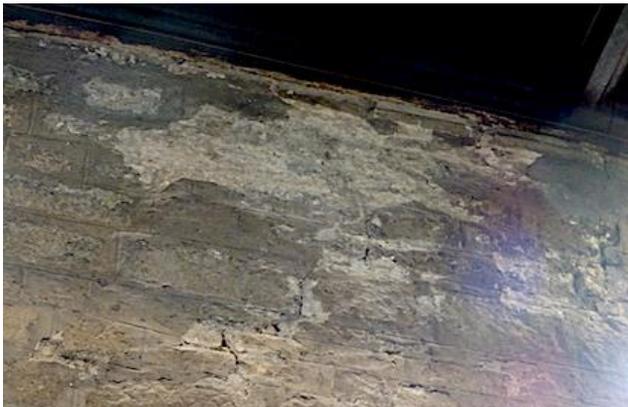
25. North Nave upper level – eroded stonework surfaces

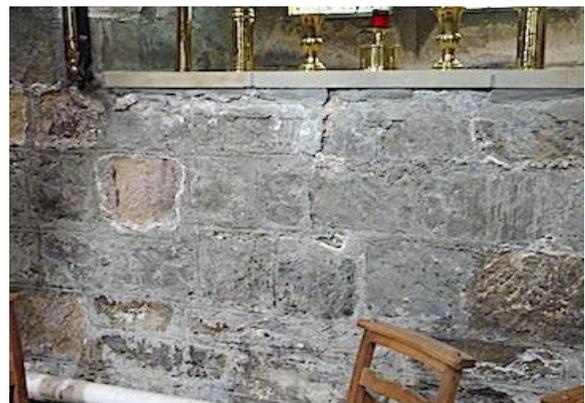
26. North Nave north wall – erosion and slats at low level

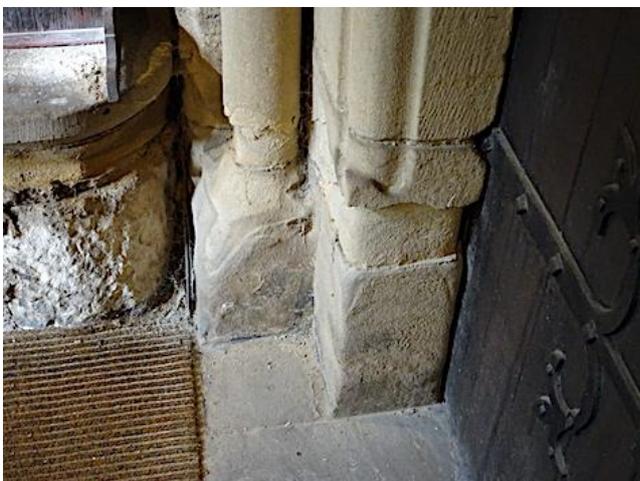
2.4.7.5	The apex cross was apparently removed for safety some time ago and is in the south aisle awaiting reinstatement.	
2.4.7.6	The ogee arch is in fair condition but there is considerable erosion to a depth of approximately 50mm to the east hoodmould. The angel head corbels either side of the arch are in fair condition but the eastern one is very worn.	N

27. South Porch – eroding stone base and shafts of entrance archway

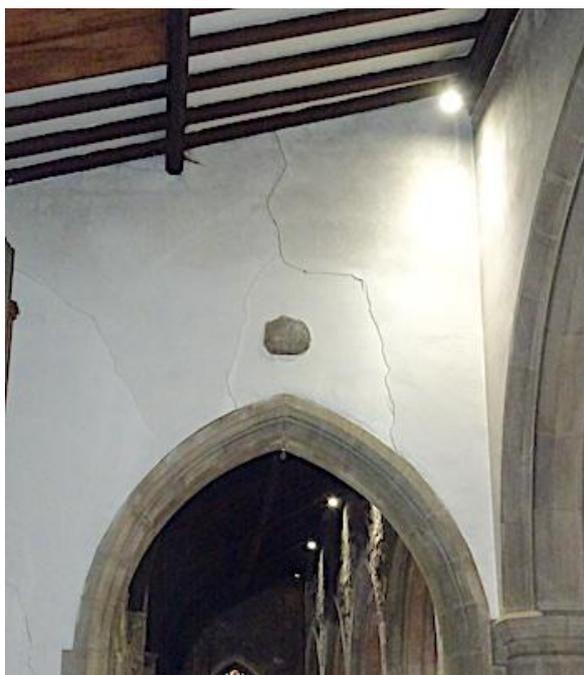
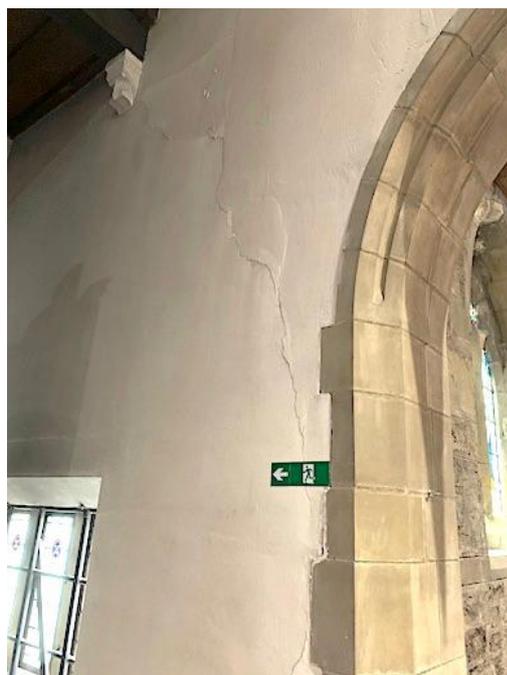
- 2.1.4 Probably associated with the above and showing itself internally there is movement in the wall dividing the South Chancel Aisle and South Nave Aisle where fractures are visible in the wall plaster even stretching over to the South Transept. N

28. and 29. North Chancel Aisle – fractures in South Transept wall above and to side of arch.

- 2.1.5 If not already actioned, a structural engineer ought to be commissioned to look at these matters mentioned above in closer detail to ascertain if the movement is live and to recommend any remedial action. A

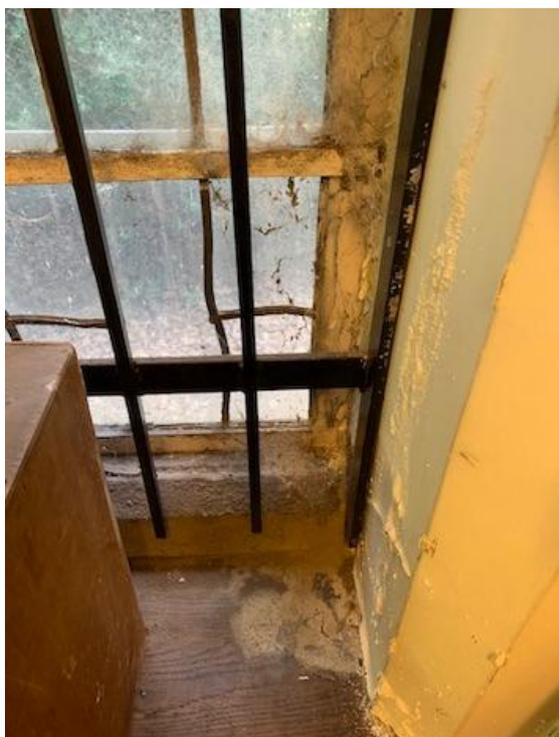
30. Vestry southeast window – buckled lead to panel

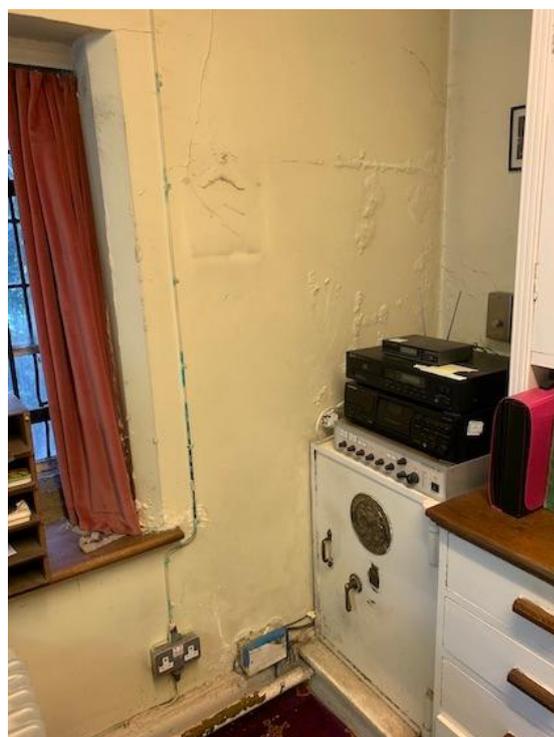
31. Vestry east wall south corner – numerous plaster defects
