**St JOHN the EVANGELIST
BIRTLEY
(2)**

QUINQUENNIAL REPORT
on the architect's inspection on

16 June 2023

IAN NESS
ARCHITECT
26 GROSVENOR PLACE NEWCASTLE upon TYNE NE2 2RE
tel & fax
0191 281 2559
i.ness@btinternet.com

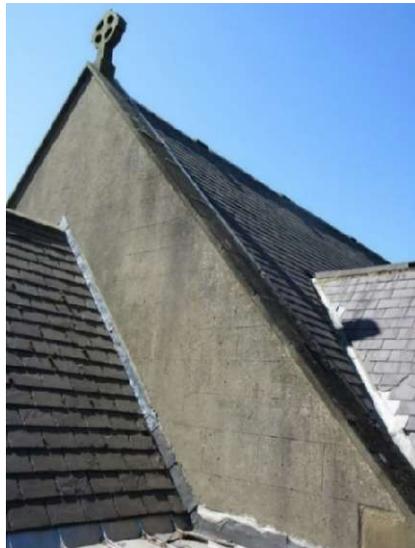
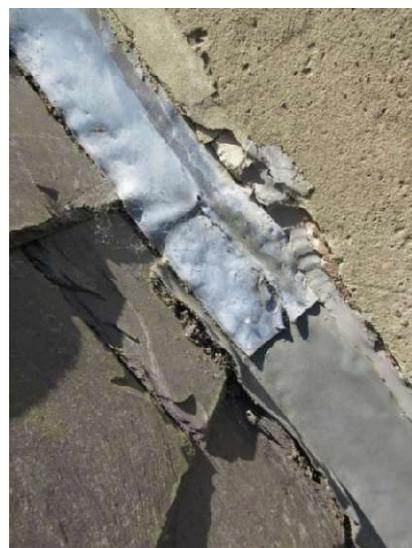
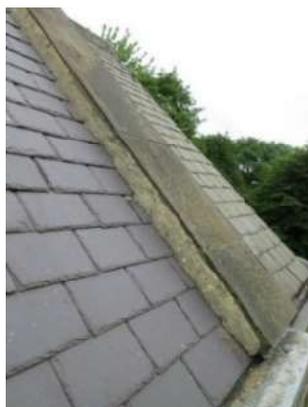
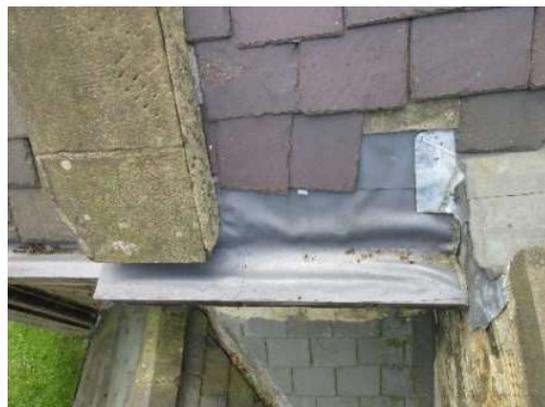
Choir S gutter and mortar fillet against upstand over arch

Choir N gutter – eave slate missing

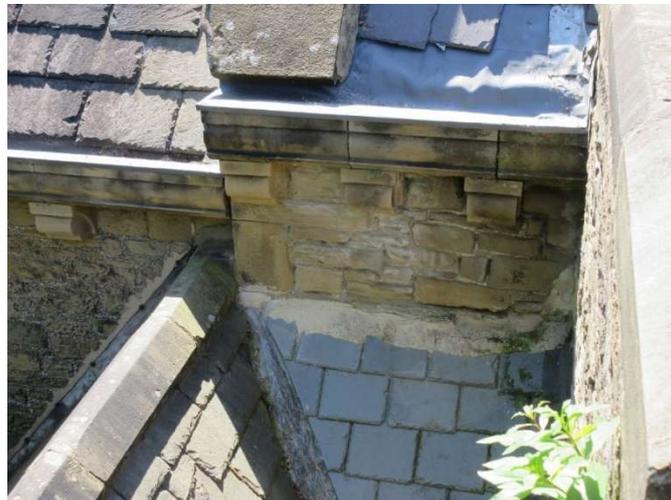
2008 – down pipe and (paint disguised) head flashing where Sacristy roof joins Choir

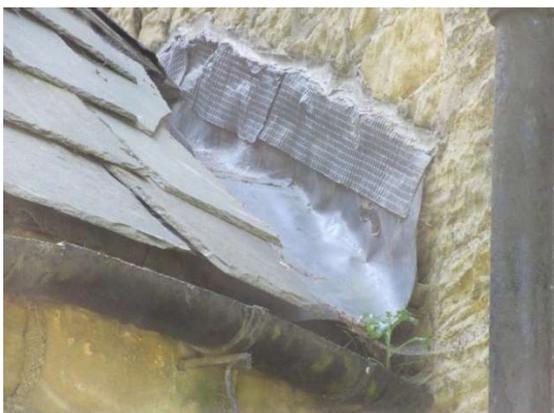
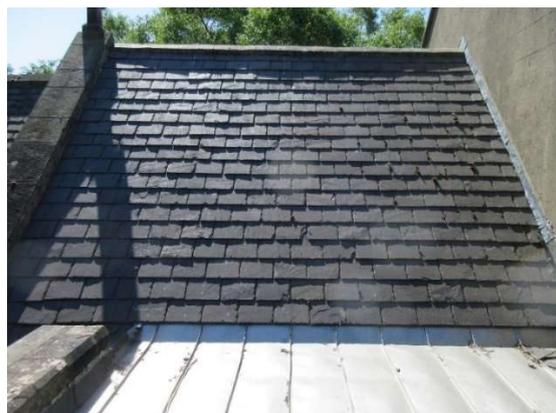
2023 – slate above Choir gutter, down pipe and Sacristy slate head flashing all missing

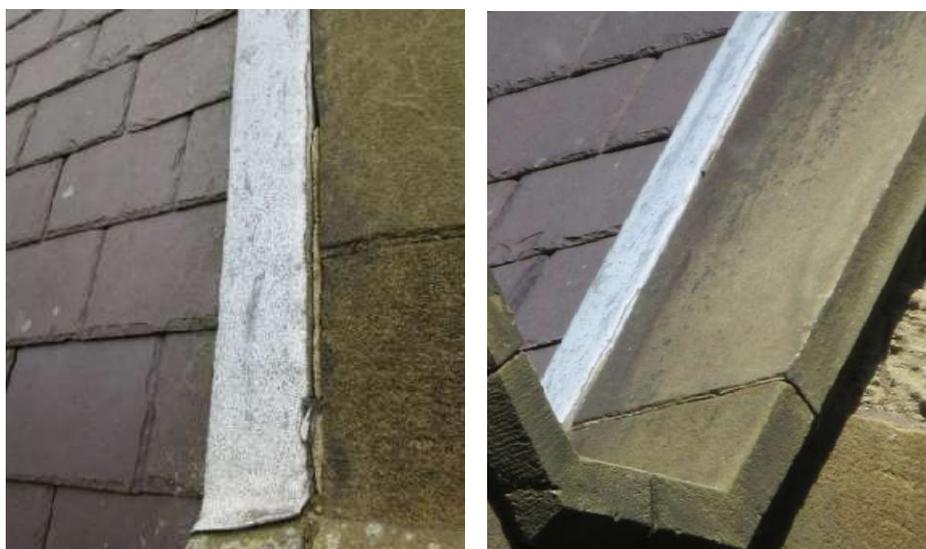
22. To accommodate the slightly raised Nave and Transept slates the flashings at their gables were changed to lead chased into the tops of the stone water tables. Some pointing in the chases remains missing and may be a cause of the damp in the plaster and paint inside.

Gaps in pointing at cover flashing in SE transept watertables

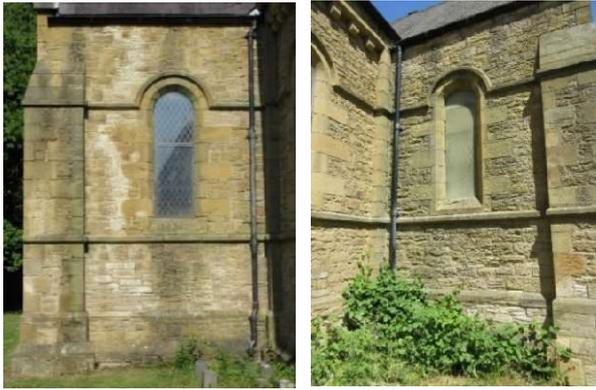
W of S Transept now fully overgrown by brambles

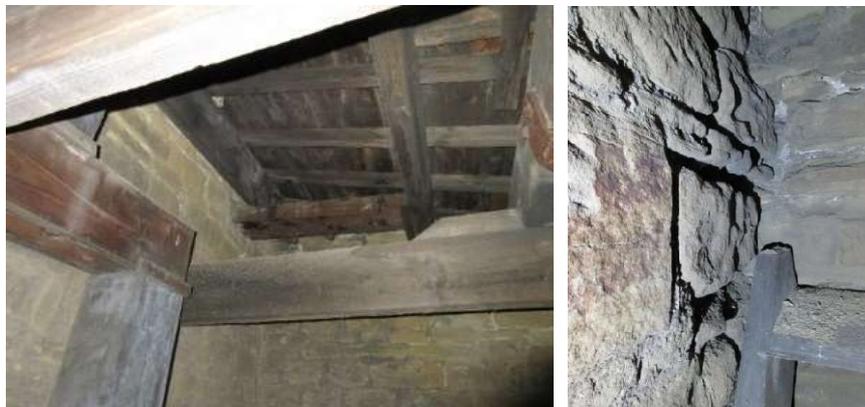
42. A low top stage with timber cross beams for a former centre flag pole base. Top of open wooden duct in SE corner. Weak floor boards. Eroded stone inside NE corner including a very deep void at the top corner.

Top stage – under the slipped roof lead and under the roof hatch

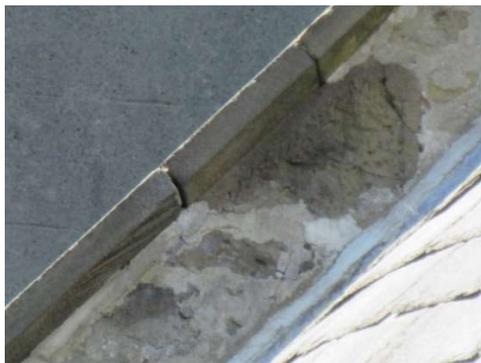
Choir E

51. **Choir** good except
- Some watertable joints appear open, perhaps causing the high level plaster decay inside
 - The low upstands over the Sanctuary have poor pointing and stone decay (plaster damage over arch)
 - Some open joints and stone decay below the SE window.

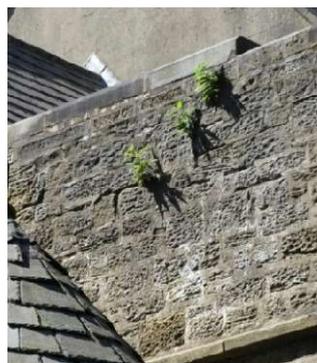
Organ E wall

52. Plants grow in open joints in the E wall of the **Organ Chamber**.
53. The E end of the **Nave** is rendered above window arch level, which may not keep out all driving rain.
 The mid height SE panel good, pointed in 1999. At the lower panel cement pointing spreads over the stones and there is minor stone decay.
54. **S Transept** fair after local stone replacements and pointing in 1999.
 All across the S side decay in a band of stone from plinth top to chest height suggests rising damp (perhaps concealed by dado inside). No apparent change.

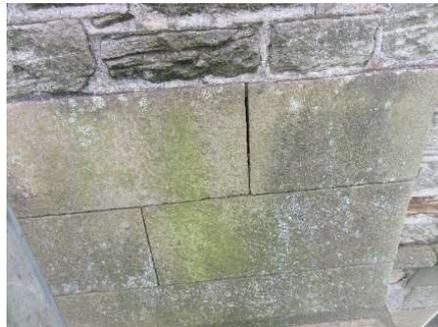
N Transept similar and open joints in top of buttress

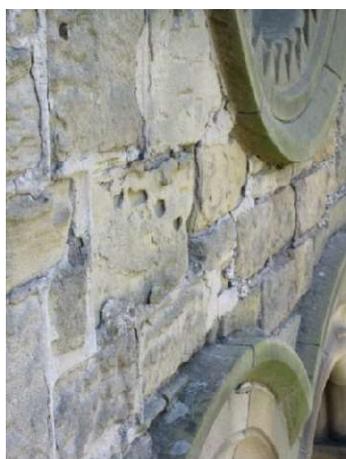
Gradual stone decay below the N Transept roundels

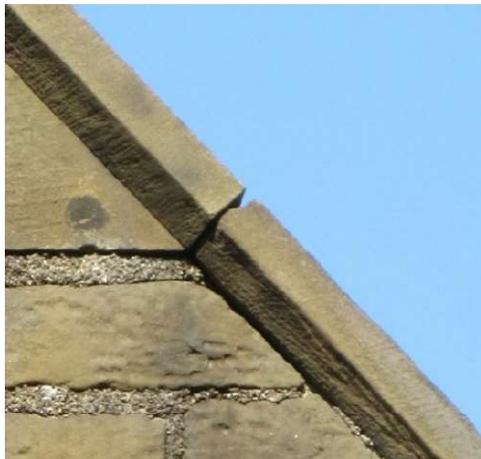
Open watertable joints at SW Nave – others similar

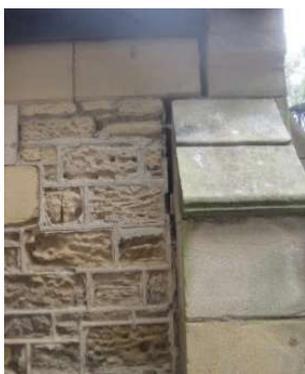
Crack at SW of Porch 2013

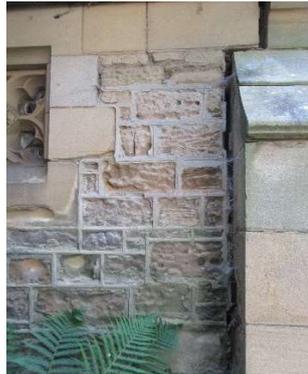
2023

58. The **Porch** buttressed ashlar gable with carved shields seems to have little or no bond to the side walls. The vertical corner joints have long been open, especially at W which is visibly slightly wider than at last inspection and also open inside. Mortar fillets on the roof are pulled out of the gable watertables. It is common for porches to have poor foundations and for their gables to lean out. This gable continues to rotate away from the side walls, especially at the W corner. A possible factor is poor drainage of water from the Office roof close to the Porch W side softening the ground under its founds. Closer examination would show whether simple straps can be fixed between roof timbers and gable to resist further leaning. Other narrow joints in the ashlar are open. Some decay in rubble side walls.

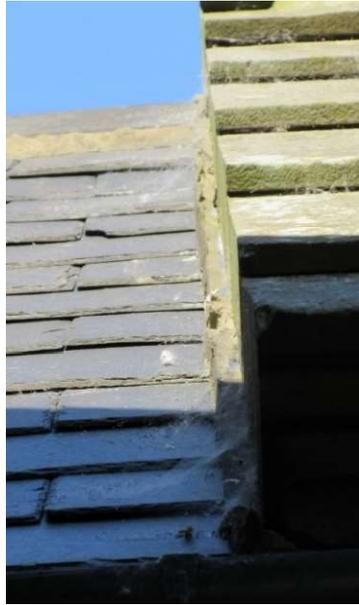
Porch SW roof fillet pulled out of Gable copings

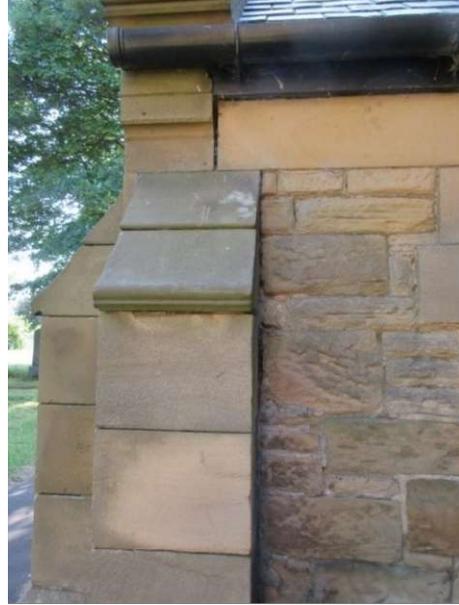
Porch SE – minor crack

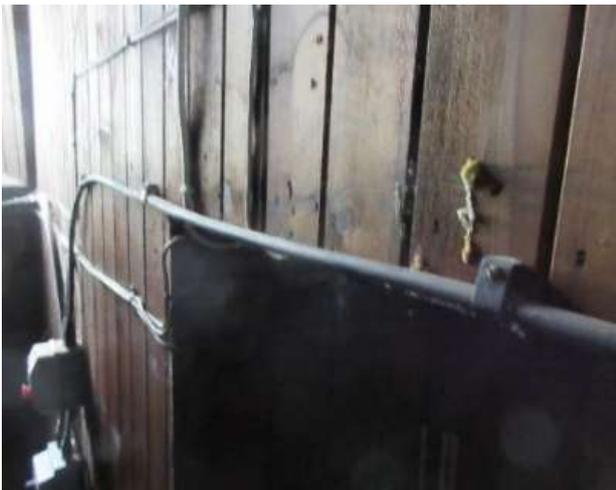
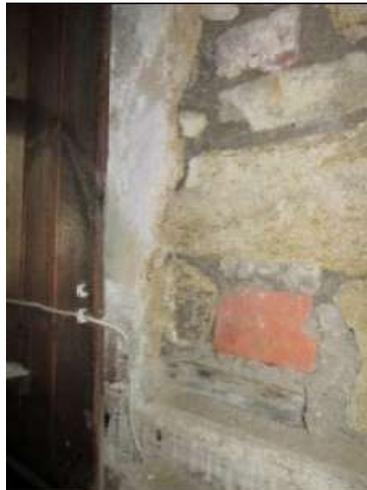
E wall of Organ chamber

95. Organ chamber N and E boarded full height except the S end of the E wall (around the opening into the Sacristy) which is brick with part plaster. Thick salts show the wall has been very wet. The salts and dirt should be vacuumed away to keep them out of the organ although difficult in confined space.

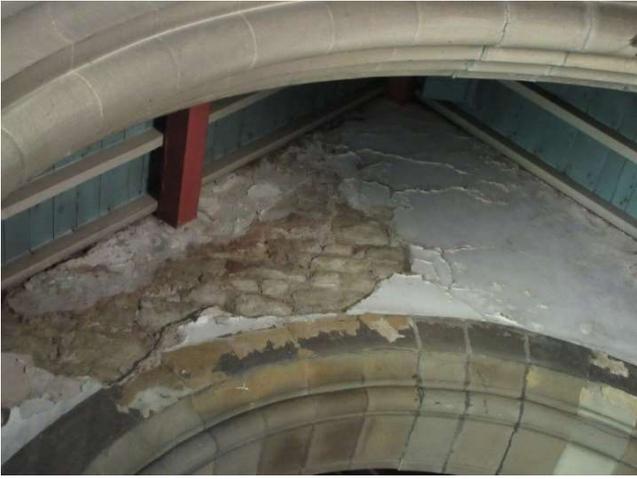
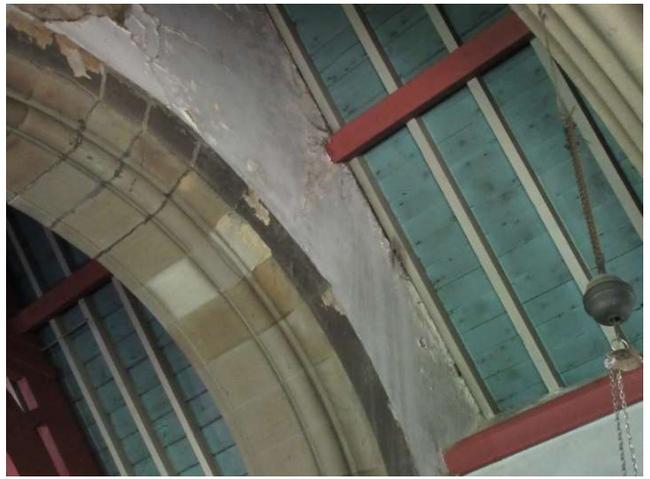
- at SW corner of **Choir** plaster damp and damage at six adjacent arch stones (rainwater pipe and gully para 31)
- at top NE corner of **Choir** a large patch of plaster damage and at both faces over the arch between Choir and Sanctuary large patches of plaster damage and loss, all much worse than previously (para 15)

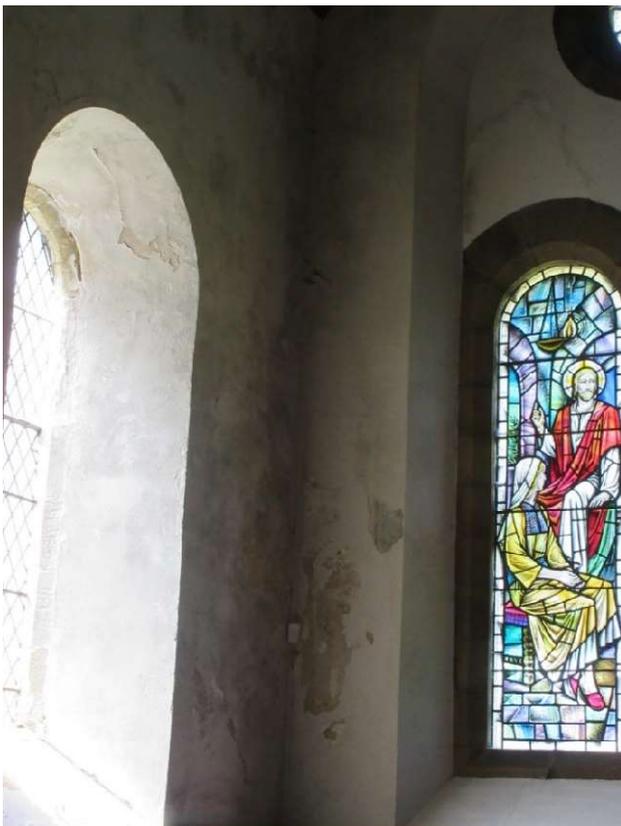
N Transept W corner

- at top of **S Transept SE corner**
- at **N Transept NW corner** and over and under the **W window** efflorescence of salts and paint poor (salts outside)
- at **N Transept NE corner** some mould on the paint (winter condensation on the coldest masonry)

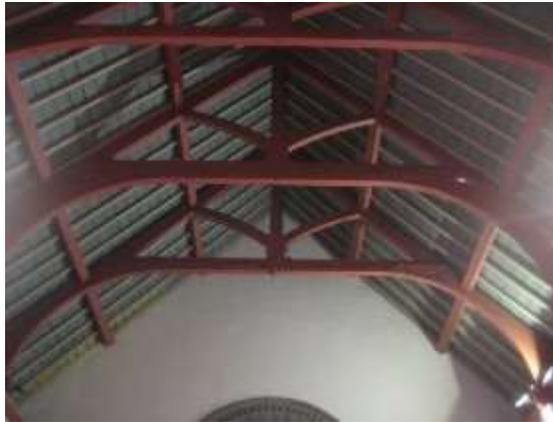
former Uplight trial

A past experimental LED uplight showed uplit roof timbers could be attractive.

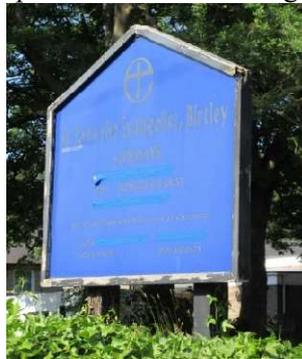
150. Sign at the middle of the W side, now poor condition and illegible.
