CHURCH OF ST. ANNE BISHOP AUCKLAND

DIOCESE OF DURHAM

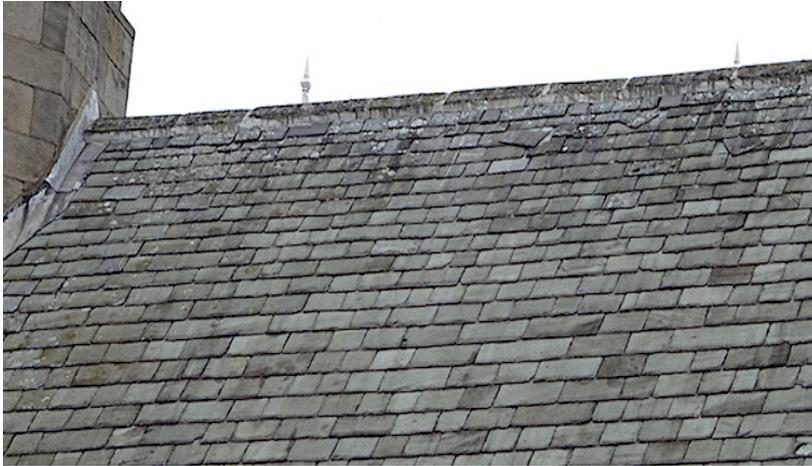
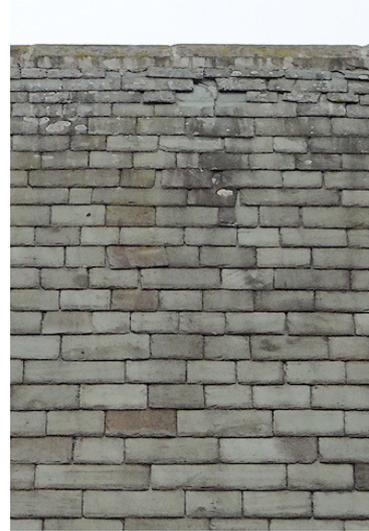
Nave south slope showing slipped slates at ridge

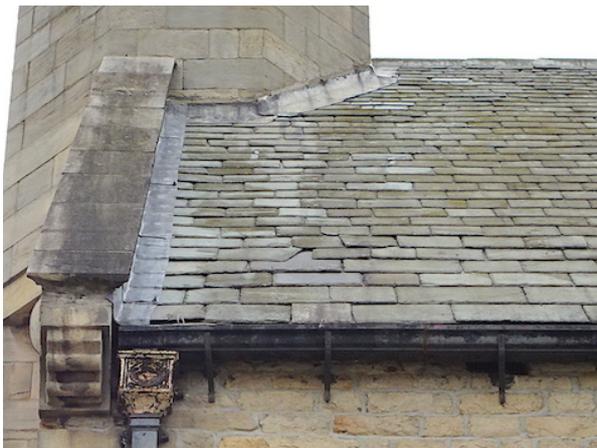
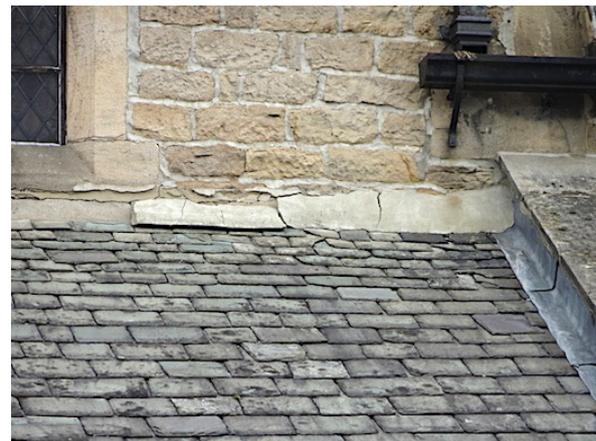
Nave South slope west end - defective areas of slate; rusty rw goods. South Aisle east end – defective mortar flashing

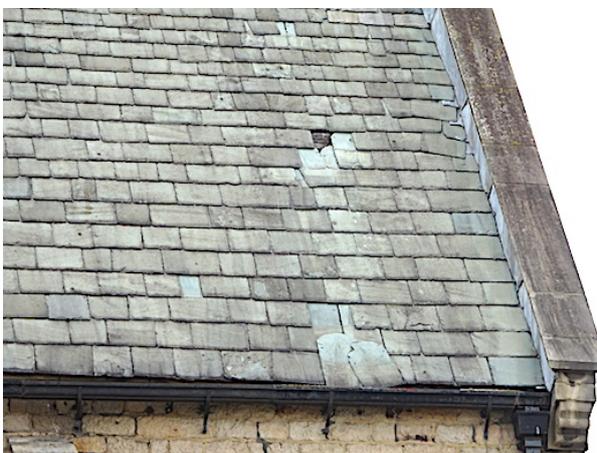
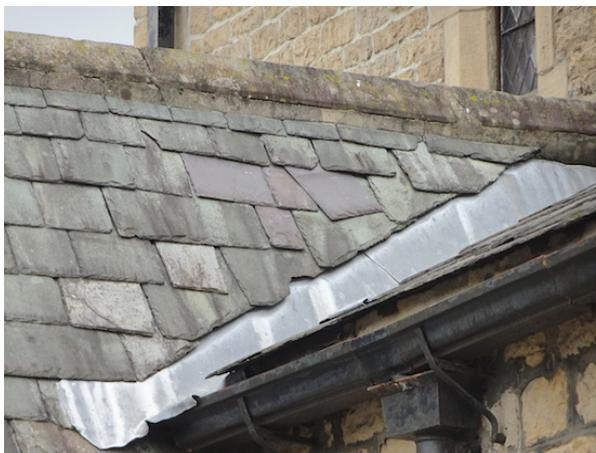
Chancel south slope showing slipped slates at east end and at eaves South Porch roof east slope – defective slates and rusty rw goods

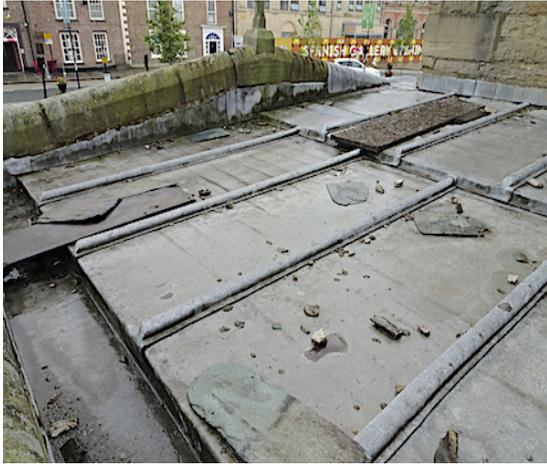
South East Vestry roof – poor condition and defective gable.

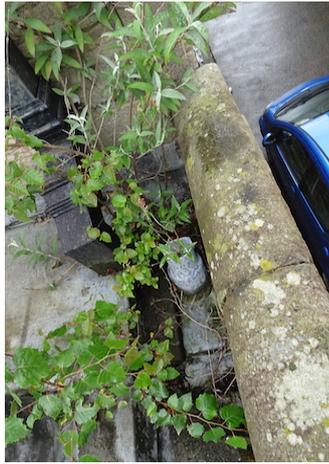
Sump at north end of east gutter

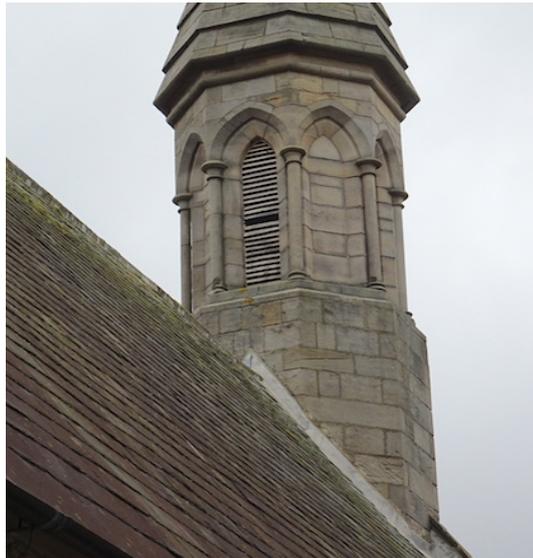
Bell Turret east side – missing timber louvre. (South side also).

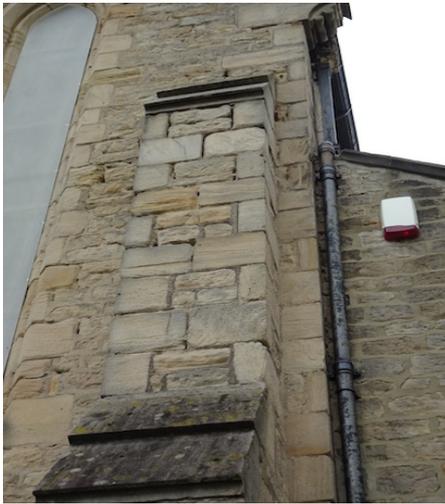
West end Nave wall – south buttress open joints

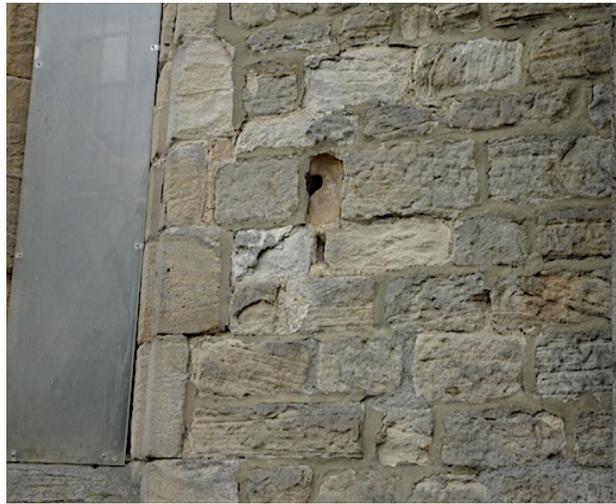
West end South Aisle wall – defective and eroded stonework

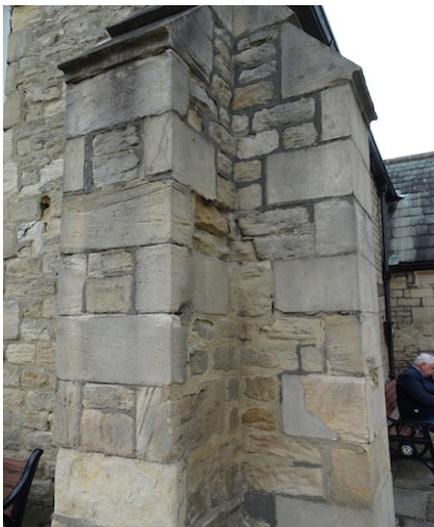
South west end of South Aisle –buttress stonework

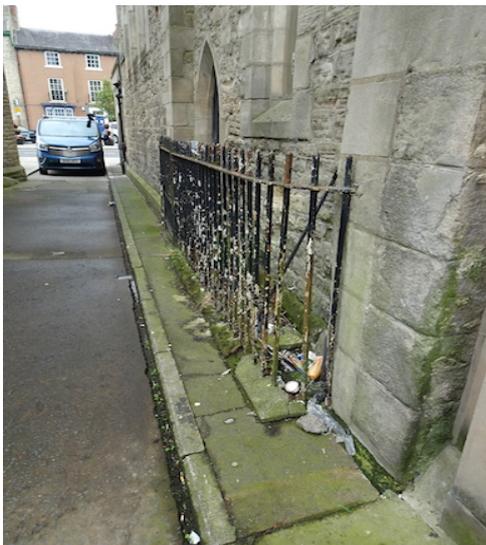
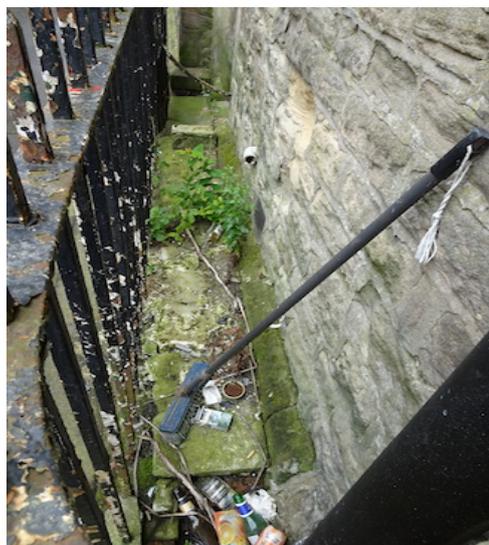
Vicars Vestry east wall - railings in poor condition Vicars Vestry east wall – gap requiring clearing and repair

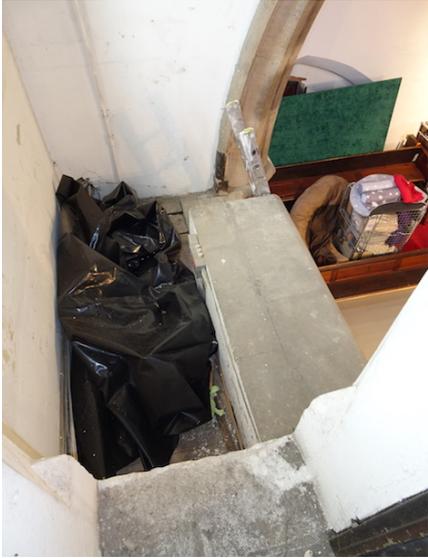
Access landing for Bell Turret at west end

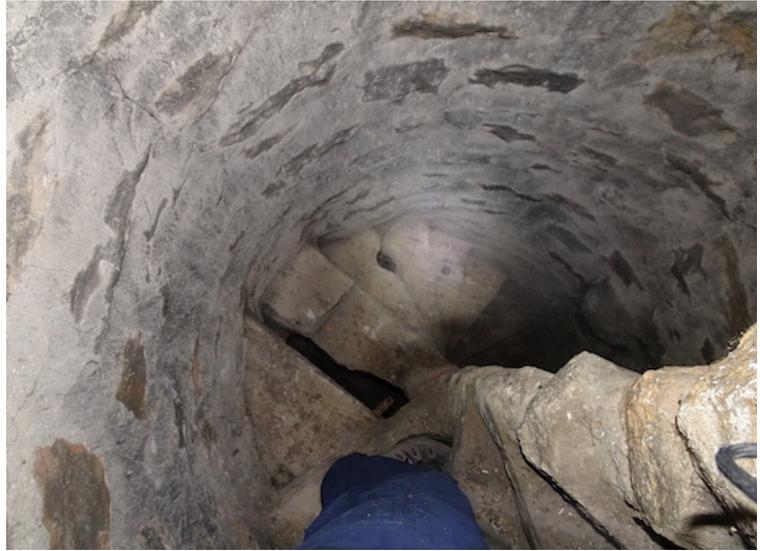
Bell Turret staircase showing missing and defective steps

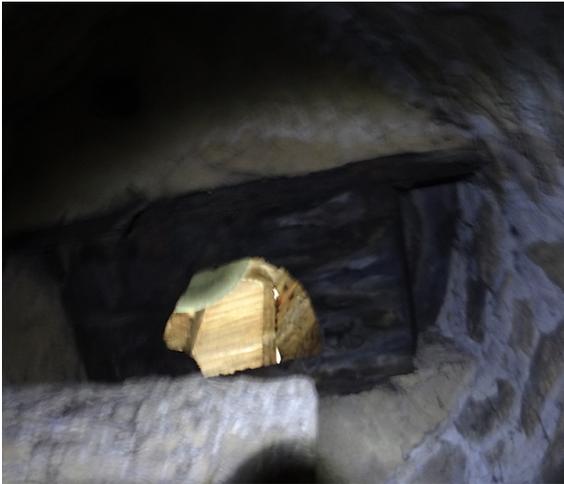
Bell Turret top of staircase showing defective hatch

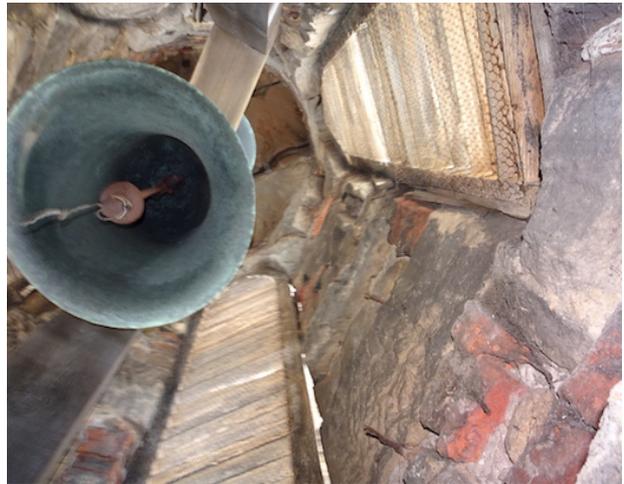
Bell Turret – interior of belfry showing gaps in masonry to louvre panels

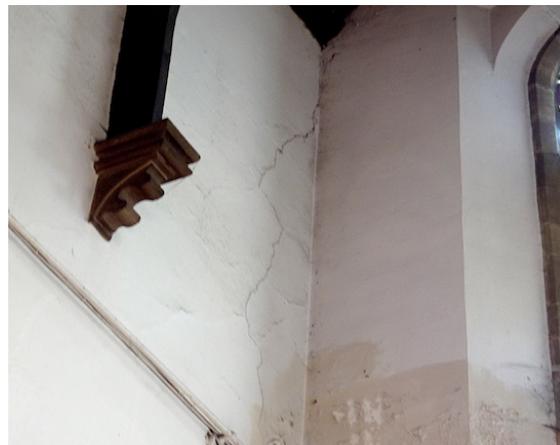
South west corner of Nave showing vertical crack in wall

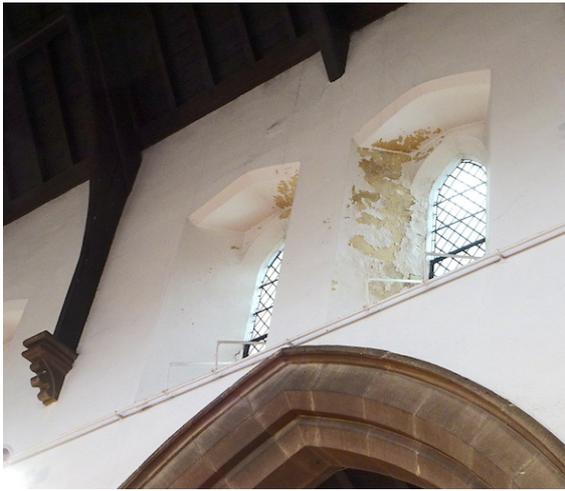
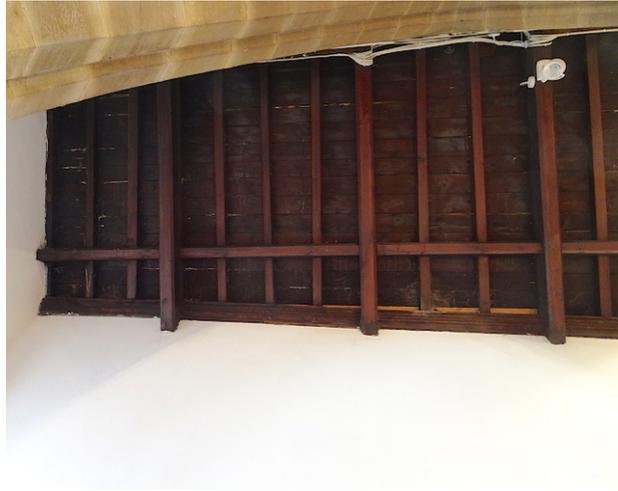
Nave north wall clerestory window – damp penetration to reveals. North Aisle roof – white staining on underside of painted boards

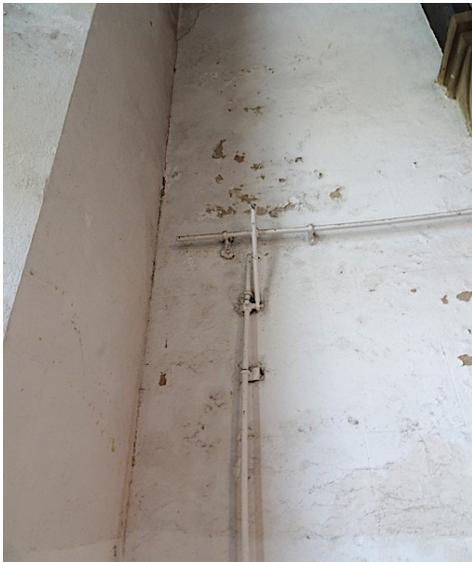
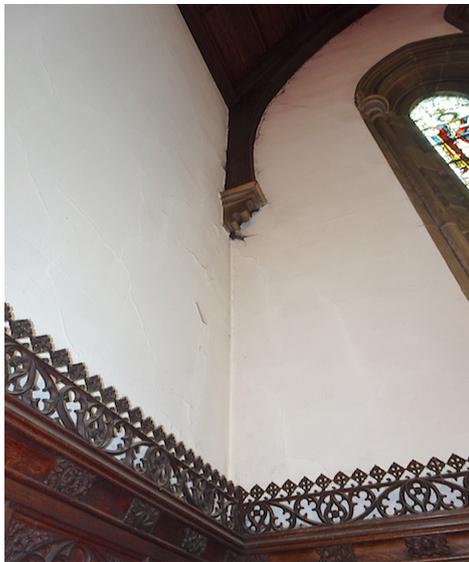
Nave north wall – unused window opening mechanism. Chancel north wall – stretch marks on plaster surfaces
