QUINQUENNIAL INSPECTION REPORT

BISHOP MIDDLEHAM, ST MICHAEL

**DIOCESE OF DURHAM
ARCHDEACONRY OF DURHAM
DEANERY OF SEDGFIELD
PARISH OF UPPER SKERNE**

**QUINQUENNIAL INSPECTION AND REPORT
January 2025**

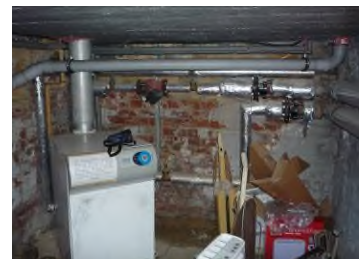
- D** **Boiler Room:**
- Ceiling – shuttered concrete, good condition.
 - Walls – brickwork, some spalling of bricks at the east side and west, which has then been cemented over and this looks to be as a consequence of damp coming off the stairs. They have also been overpainted and that decoration is coming away now.
 - Floor – concrete, good condition.

Recommendation: clear stair gully, clean down steps, repoint steps, repair door, decorate door

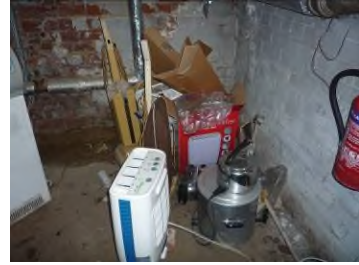
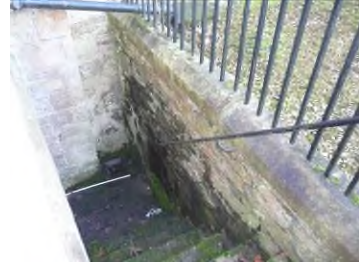
- Timber louvered door, one missing.
- Decoration required on the outside and a general clean down. Lumber in the room needs removing.
- Room has had boiler removed but contains some circulation pipework.
- the external gully at the bottom of the steps looks blocked.
- The stairs are rather damp and have a lot of moss on them and some open joints at the risers that have sunk a little bit. The return wall with the balustrade above very wet Because it is acting as a soakaway) for the chancel and boiler roof rainwater) Handrail is rusting significantly at the bottom of the slope. The balustrade above is in fair condition.

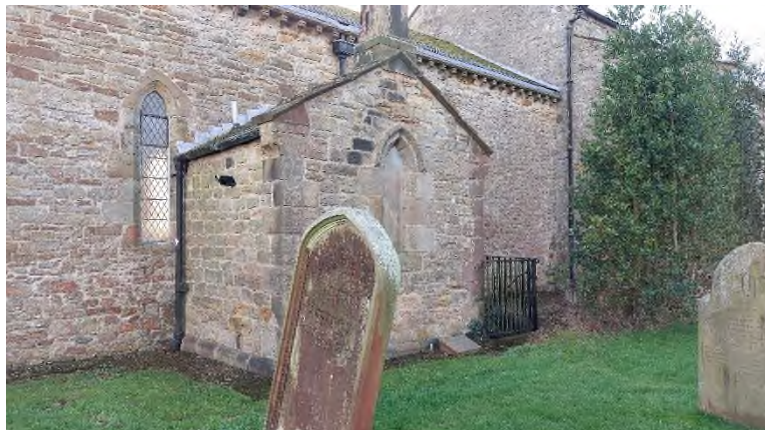
North Vestry:

- West slope:
 - Ridge – angled stone slate, bedding okay. North abutment flashing and soakers to rebated water table.
 - South abutment - step flashing to chancel in leadwork that is okay. It has a back gutter by the buttress and this needs checking.
 - General – Westmoreland slating has had some repair with tingles, looks okay.
- East slope:
 - Ridge – as west.
 - South abutment – as west.
 - North abutment – as west but the pointing is holding up here. Slight lift of the flashing to the chimney stack.
 - General – a lot of moss on the slating could do with being removed.

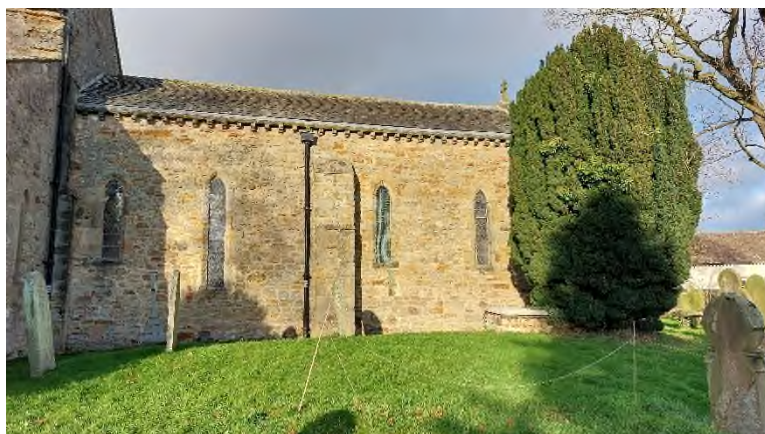
- South slope:
 - Ridge – as north.
 - West abutment – lead flashing, the pointing is holding up. There is a back gutter at the buttress and this has some vegetation in it.
 - East abutment – as north slope but small area of pointing missing up at the ridge and also midway along where the water table

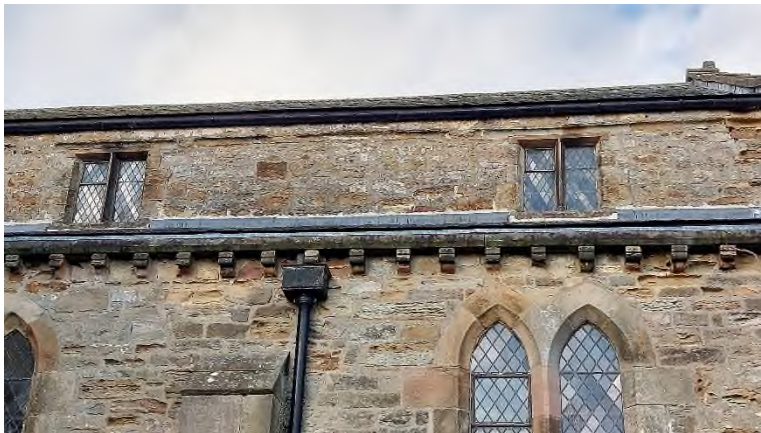
South aisle:

- Ridge – horizontal, flat lead flashing to the nave clerestory. Its abutment pointing to the clerestory windowsills is ok but heavy handed.
- West abutment - partially obscured by trees. Its raking flashing tucked into the water table okay. East abutment – ok
- General – the slating is all in good condition.

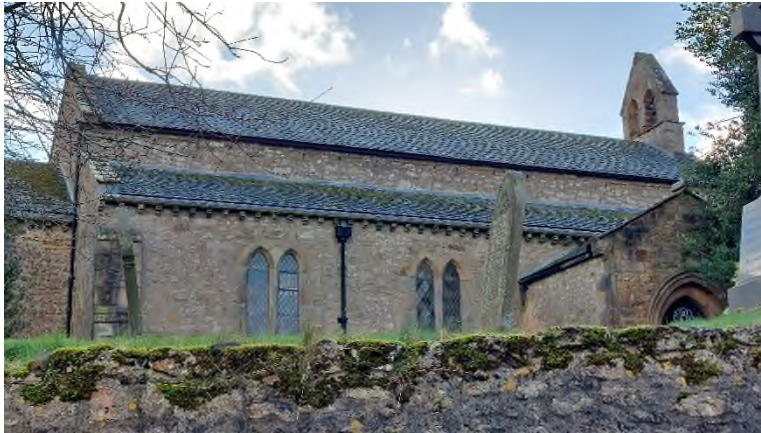
North aisle:

- Ridge – lead flashing to nave is sound, though it is slightly uneven at the eastern end – the lead hasn't been cut well horizontally but it is sound.
- East abutment – raking flashing tucked into the water table okay. Slight cracking at the joint of the lengths but no need to change.
- West abutment – raking flashing into water table okay.

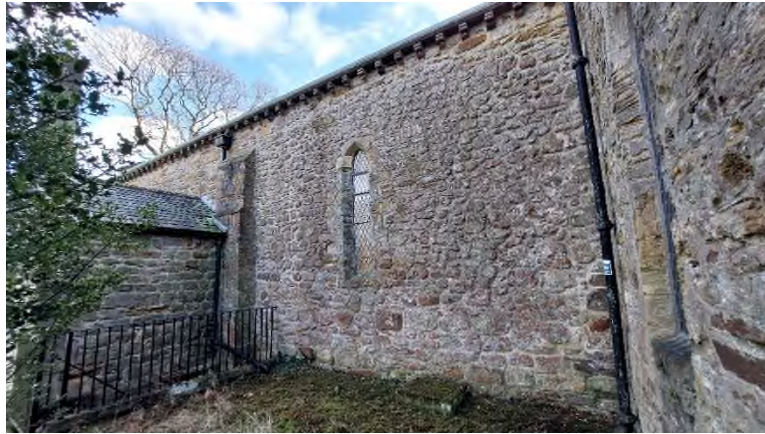
- North Vestry:

- West – Half round gutter leading to rusting downpipe which takes the chancel and discharges to open ground hasn't been repositioned as per the last QI recommendation. This is wetting the retaining wall to the boiler steps and really needs a better way of discharging – perhaps to bring the pipes out on the northern or eastern side?
- East – half round rusting gutter, possible leak midway along, planting at the top end. Cast iron circular downpipe to salt glazed gulley looks okay. Decoration breaking down.

General: address vestry discharge to ground wetting boiler room, check parapet gutter lead joints are functioning, unblock gulleys, dig out porch gully, replace missing grids, fix loose collars.

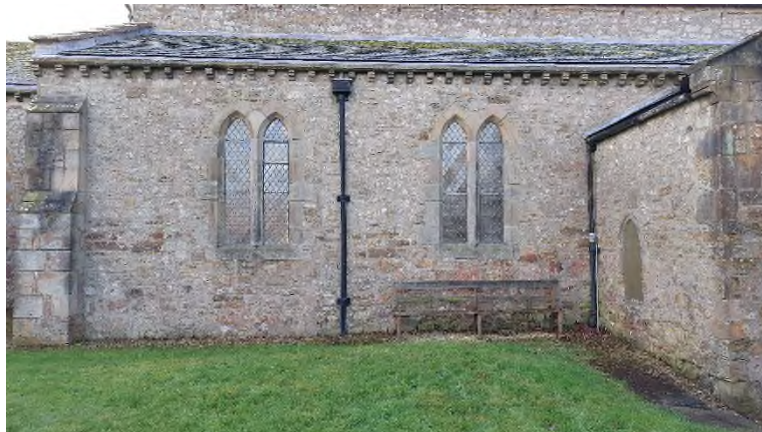
Chancel:

- North – parapet gutter. The gutter lining might have lead expansion joints. There is a covering of a joint in a lead piece, all of which it seems have cracked the weld on them and this then questions whether we actually have a water tight parapet? It leads to an outlet midway to square hopper with a lead cap for leaves probably. The western pipe comes to discharge on the vestry roof. The eastern is down to a cracked top gully.
- South – same detail as the north but can see the cover flashing over the parapet joint isn't cracked – it is designed that way. Square head hopper to

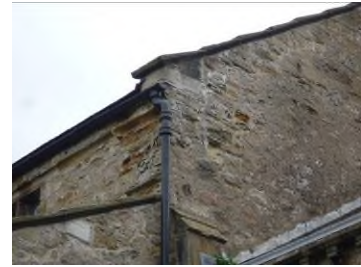
- South – long run of gutter, half round. Looks okay but is a long way away from the roofing felt and the felt isn't dressed fully into the gutter suggesting there may be rainwater washing down the wall. To single downpipe at the east end which is okay. Leads into a cracked salt glazed gulley silted/leaves as it is to all gullies.

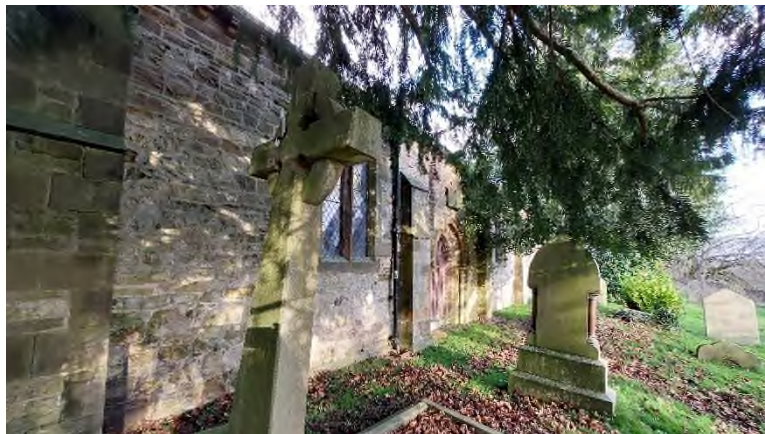
South aisle:

- Parapet gutter, same detail as chancel, to single hopper head with a rusty top to it. No lead protection to keep the leaves off here to circular downpipe, to salt glazed gulley in good condition.
- Further downpipe at the western end, rusting hopper head suggesting overflow. There is also a plant within it, leads to downpipe to blocked salt glazed gulley. The tree is branching out onto the roof here.

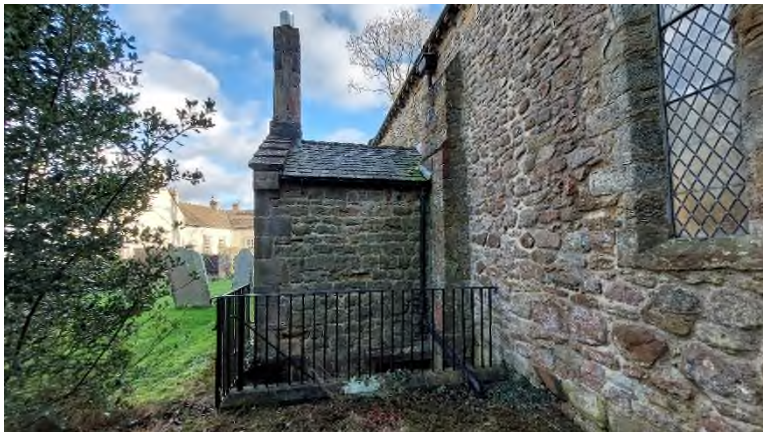
C North vestry:

- West – couple of eroded stones but no real need for work yet. Some erosion to the pointing above the boiler house that does need doing. Below the stonework is brickwork to the boiler house steps. The plinth has open joints and the brickwork is sound but not pretty.
- North – water tables look okay. Large chimney at the apex has open joints to the stonework and broken stonework at the terminal (caused at the time of the new boiler installation?). Walling below this is in good condition. Single lancet in good condition. This has dirty polycarbonate with obscure diamond pattern glazing behind that has plenty of cobwebs in it.
- East- coursed wall, has been patched with different mortar mixes over time and there has been some remedial repointing since the last QI. There is also cement here which is spoiling it rather.

Recommendation: repoint open joints to walling and chimney stack and repair top

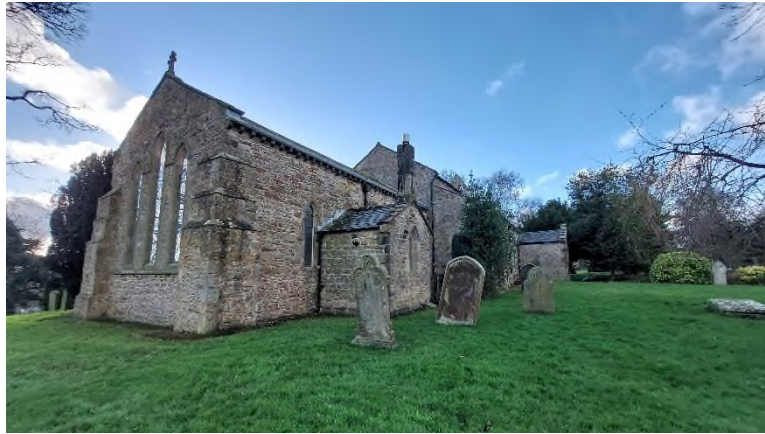
C Chancel:

- North – random coursed rubble in the older western part and brought to course a little more on the newer eastern part. Single lancets with diamond leaded obscure glass. Parapet formed from over sailing gutter table supported by stone corbels – all looks okay. Walling is generally sound though there are a couple of open joints at lower level.
- East buttress – angled, open joints to the sloping copings at the stages. Mid buttress ok and has been re-pointed. Open joint in walling at the elbow of the gutter and a bit damp at the bottom of the basement steps. Slight erosion to the stonework closer to the gully on the west side.

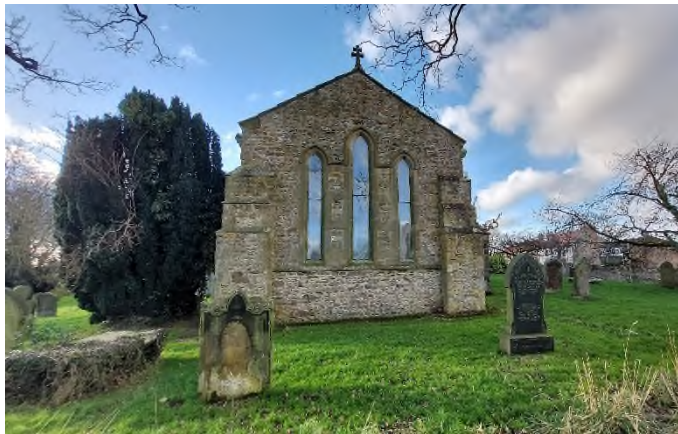
- East – cross and water table okay. Slight crack to the kneeler on the south side- as before and no change. Walling generally in good condition. There are open joints on the string course below the lancets. Triple lancet window, the stonework is in good condition and there are just some slight open joints in the very narrow jointing of the arch stones and jambs which can wait. Spot on polycarbonate guarding over pictorial glass with many cobwebs behind.
- Wall has two buttresses: south – open joint to the

sloping stage caps. North – some erosion to the south facing stonework and the west but okay for the present. Some open joints to the raking capping.

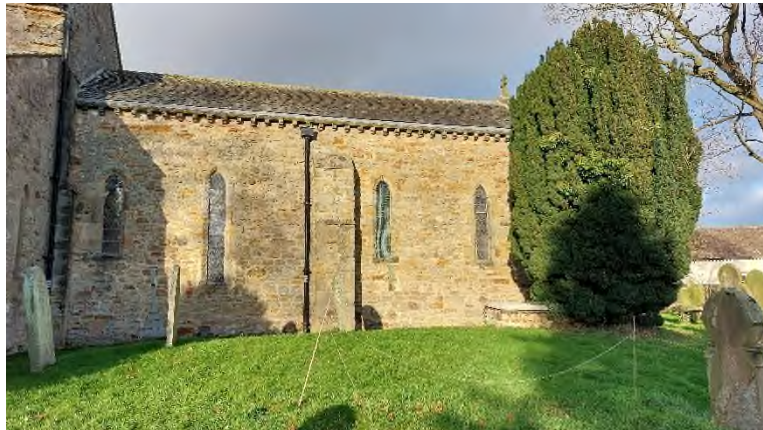
- South – random walling, generally okay. A couple of eroded areas above the second lancet and beneath that open joints at the foot of the wall. The wall has a mid-buttress with open joints at the top stage and as it adjoins the wall by the downpipe. Four windows reading from left to right:

Recommendation: repoint open joints to walling, deshale and inspect south W1 and be prepared for repair, inspect all the other windows at the same time.

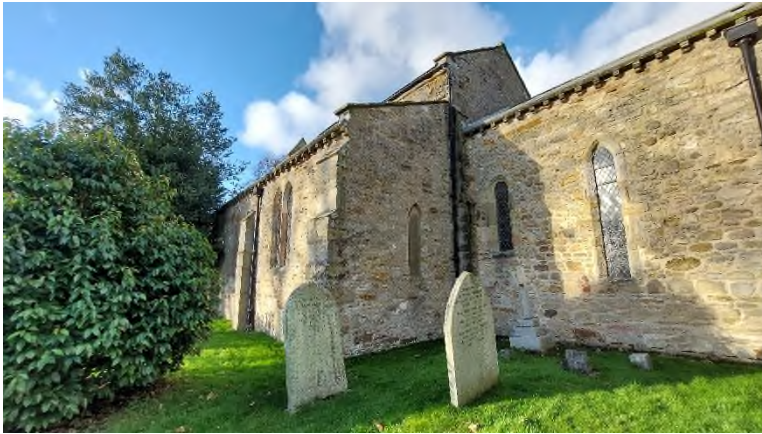
- East – water table okay. The walling has been over restored with cement, there are a couple of stones that require deshaling. Crack showing on the area close to the water table kneeler and there looks to have been some work in this area in the past but it is not structural. Some open joints at the foot by the wall. Single lancet window with laminating stonework and open joint to cracked cill. Pictorial glass in diamond pattern with darkened polycarbonate.
- South – open joints to the gutter table. Corbels look okay. Wall has four bays:
 - Bay 1 – open joints to the buttress. Walling generally sound with some open joints to the plinth and a couple of stones. Twin light lancet, slight open joints to the dressings. Has obscure diamond pattern, unprotected glazing.

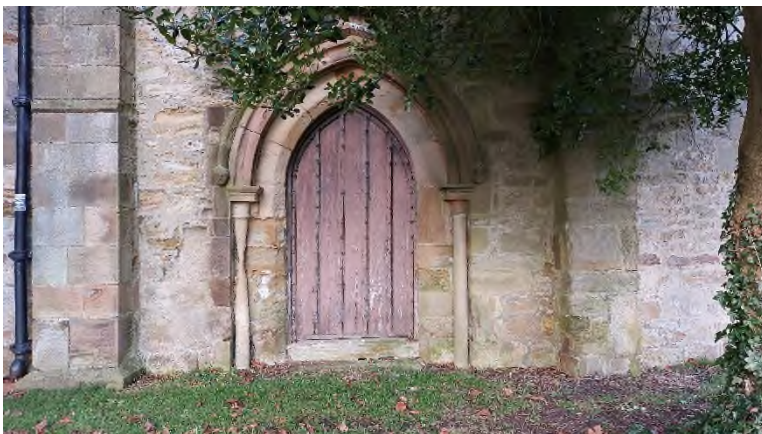
- Bay 2 – buttress as Bay 1. Marking from heating system overflow. Eroding stonework above the doorway. Lancet arch to doorway, hood mould okay. Inner order jambs are breaking down. Western nook shaft is wasting away and may snap soon.

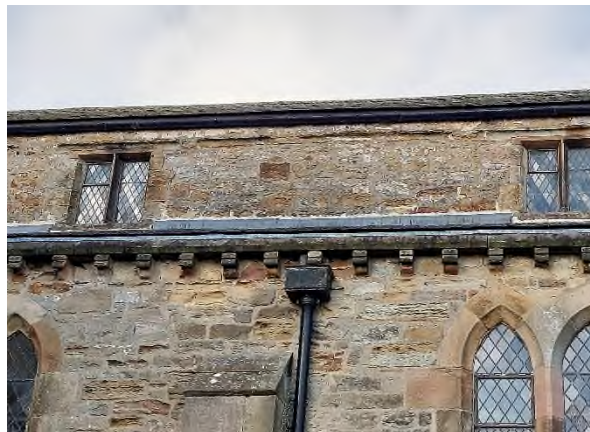
- South – moulded string course to former parapet now heavily eroded though it is no longer performing a water throw function. Walling has been over cemented in the past. There are some open joints. The flashing to the aisle has been cemented in heavily.

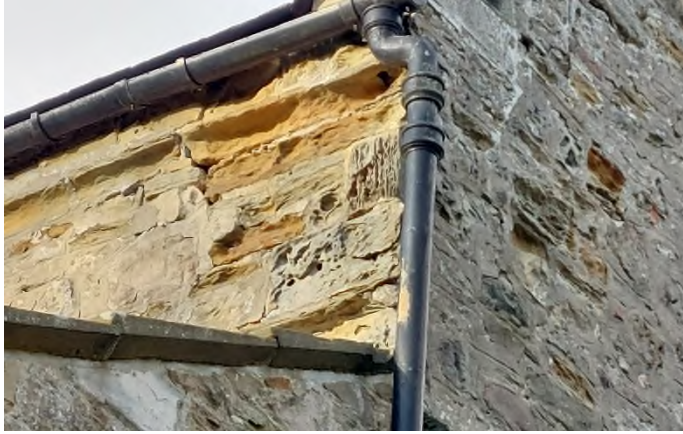
There is little change from the last Inspection. The PCC have carried out routine and timely maintenance. The fabric is in good order as it is of good appearance and fresh condition internally. The SE corner nave clerestory wall corner is looking to be eroding more and there is a question over the truss bearing here and possible cracking mullions, all which suggests the need to have a mason look at it and repair as required.

- Area of major erosion at the south-east corner of poor quality stone and you can see into the core in some places there. There looks like three or four stones need to be replaced and this needs an inspection by a stone mason. Wall has three windows, square heads with ashlar dressings. They are in good condition but there are some open joints to the stonework
- Clerestory windows, the mullions appear to be cracking, particularly the two eastern most and they could do with a high-level inspection. Inside, they also have chicken wire either inboard or outboard and its purpose is a little unclear and the decoration hasn't extended to the edge of the window reveal.

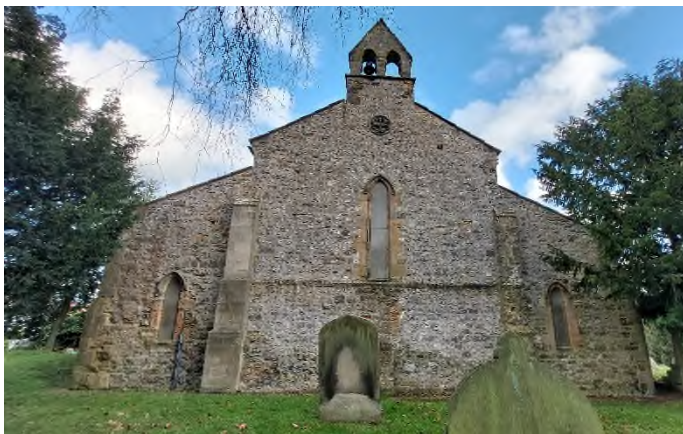
- West Gable – heavily restored stonework (explains presence of tie plate at high level?) and there are multiple areas of stone erosion to individual stones. Water table okay, open joints to the stub buttress and the plinth course. The string course is shaling and has open joints. Single lancet window

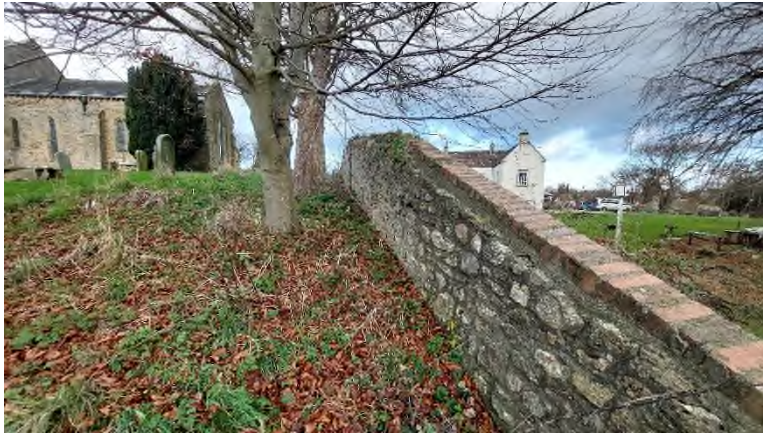
- **East Boundary:**

Magnesium limestone random rubble boundary wall. Has had a new doorway installed in 2020. Some erosion to the base of the buttress on the right-hand side and it seems to be drifting away slightly. The pier caps to the entrance are somewhat eroded now. Ivy growing on the walls in places. Has a brick capping that is generally sound with much cement pointing over it. Probably had a better capping than this that may have been robbed in the past? Quite mature trees on this boundary – a mixture of sycamore and chestnut. At the southern end, the wall slopes down as the ground runs away and it is not possible to see.

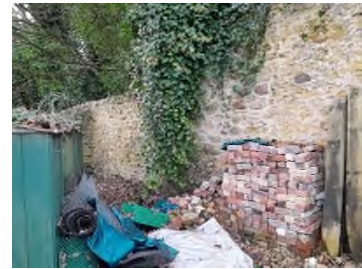
patch repairs in the past and some limited pointing is required. The boundary to the east retains the churchyard and the ground level is significantly high compared to the to the other lower side. It has had a repair due to collapse in 2022. It needs an annual check from the neighbour side and grounds management on the church side to reduce any additional loading by raising ground level or tree root influence.

There had been a collapse at the change of height on the neighbour side (of just the facing?) repaired 2021. The southern boundary runs down to a dene type area, likely chance of a wall right at the very bottom of the land, somewhat obscured by ivy and shrubs.

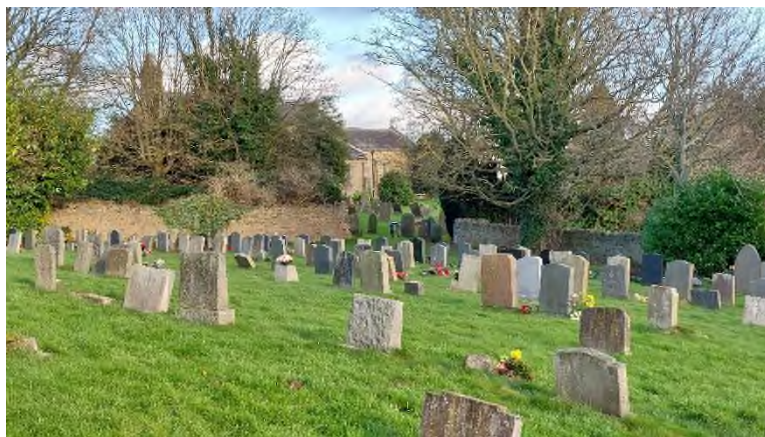
There is an extension to the churchyard on the north western side (1909). It is surrounded by field walls in limestone, some coping missing on the southern side (against farm). The western side has a significant amount of laurel against it which is hiding the farm buildings. The wall is not able to be inspected. The same applies to the majority of the northern side and where the wall is visible, the wall tops require some consolidation.

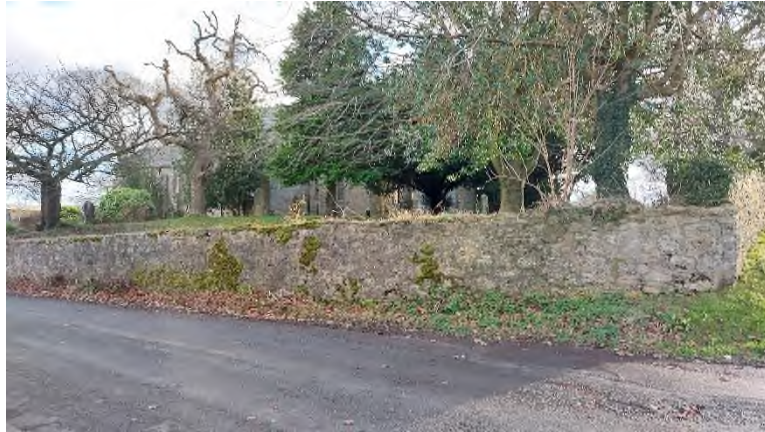
Northern Boundary:

The northern boundary wall retains the high-level churchyard. Has been patch pointed in the past. Some of the copings need re-bedding. Large holly tree at the corner threatening it. Pathway made in the centre of the wall leading to the entrance gate, the return stone wall is okay.

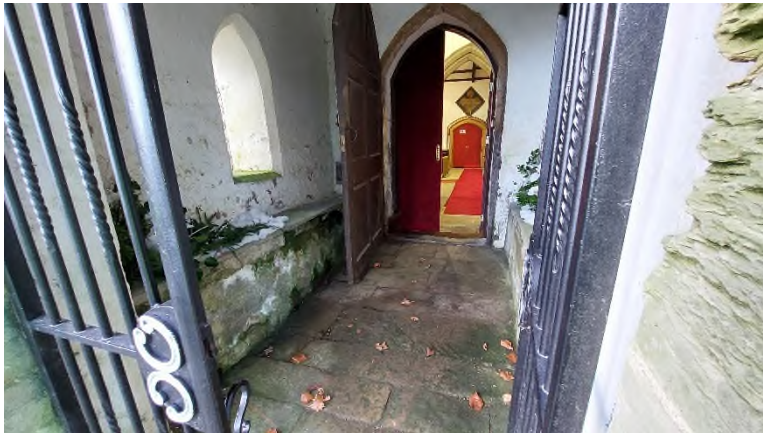
D North porch:

- Ceiling – sloping boarded, fair condition with cobwebs.
- Walls – painted plaster, fair with cobwebs. Crosshead tablets mounted on the walls, slightly green. Corbel decoration breaking down. Walls are green on the west where the ground level is fractionally higher – perhaps six inches? Benches formed from cement topped stone walls suffering from damp.
- Floor – slightly uneven paving flags, but fair. Pair of coir matting doormats at the doorway. Slightly raised threshold and step down to the nave floor via a pair of double doors which really does give you the sensation of a trip hazard. Baize cupboard doors just about closing – the latch has been repaired in the past and just about catches.

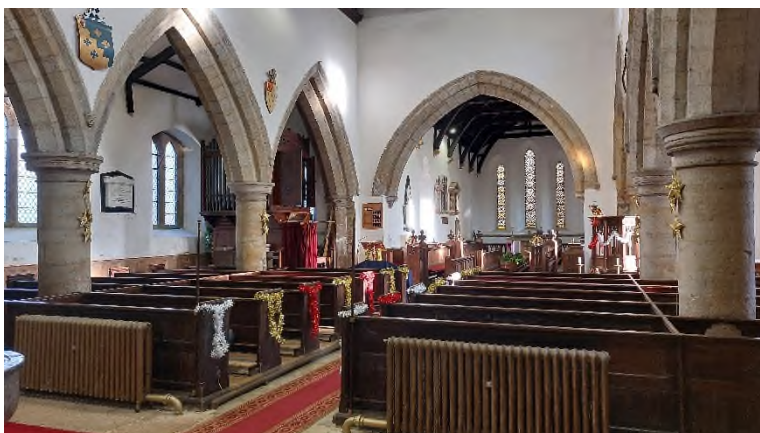
C North aisle:

- Ceiling – sloping with exposed truss rafters and purlins. Plastered and painted panels in fair condition.
- Walls – painted plaster with exposed timber dado below (reused panelling from removed box pews in 1906). Some evidence of discolouration at window sills and plaster blowing a bit above the dado. Damp in the organ corner.
- Floor- see following section

Recommendation: remove lumber from organ area to encourage air movement

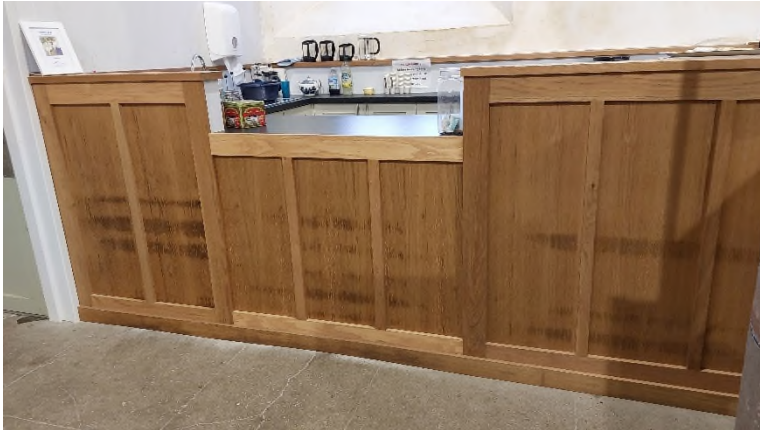
kitchen sink and fitments all in good order. Banding staining on the oak fronts and knots beginning to show on painted woodwork. Gate door doesn't latch.

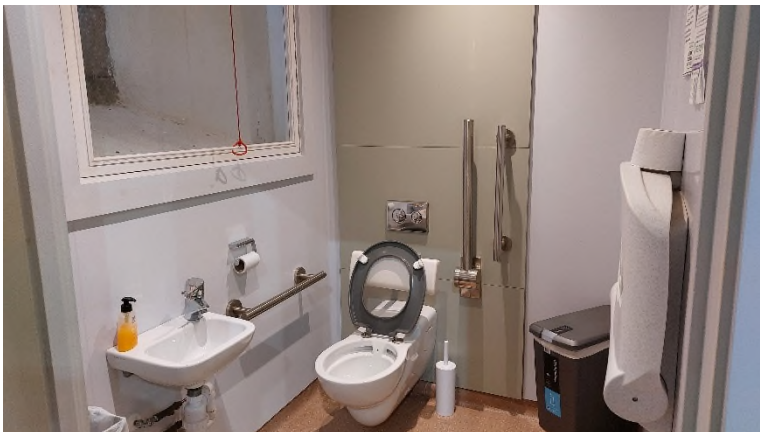
wc and basin in good condition. Door locking has been changed and latching lost. Door is catching in frame.

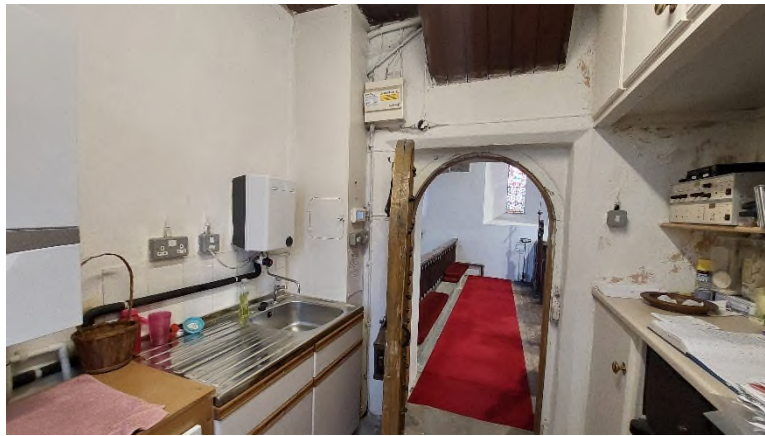
- Ceiling – low boarded ceiling, painted and in fair condition.
- Walls -painted. Has had water penetrating the south west corner of the room – probably from the flashing above. Cupboarding on the west wall, no evidence of damp. Contains an elementary sink unit with hot water and looks like the walls have been re-plastered in the past as there is no skirting.
- Floor – Concrete
- Door – catches at the lock and on the floor.
- Now houses the combi boiler

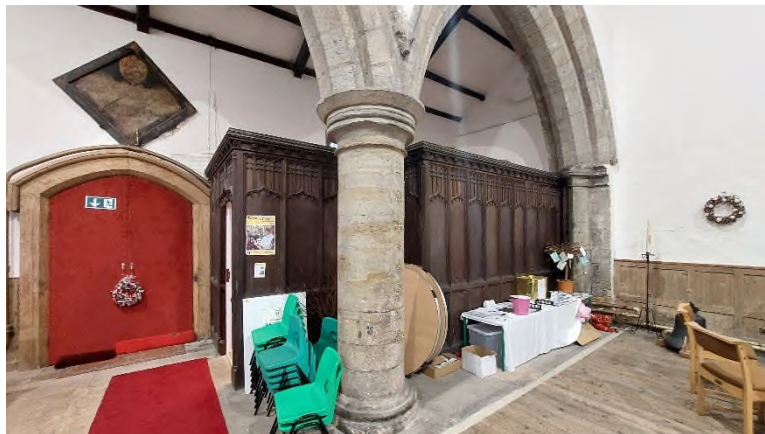
Victorian screened vestry converted in the 2014 works to provide a quiet space with new ceiling and secondary glazing to the windows. Door catches in frame, dust build up at secondary glazing. Does it smell of cat in here?
