# Quinquennial Inspection Report

**Parish Church of St Nicholas  
Bishopwearmouth, Sunderland  
Diocese - Durham  
Archdeaconry – Sunderland**

**Date of report:** 13 August 2021

**Ref:** 21026

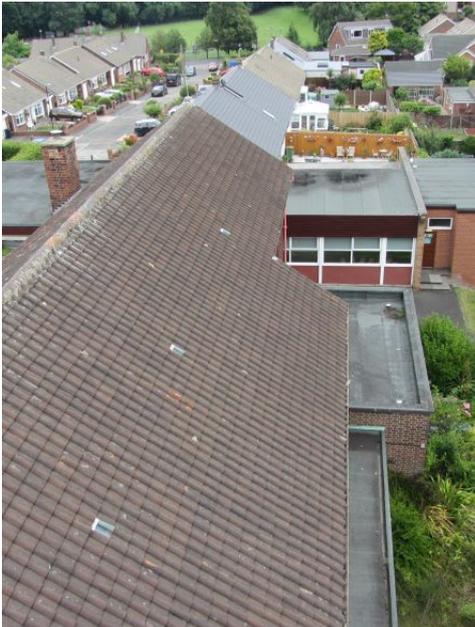
<p>Nave &amp; Chancel south slope</p>	<p><u>Nave and Chancel:</u> Generally, the roof tiles are in fair condition. However, there is some missing bedding to some of the ridge tiles.</p> <p><u>Chancel verge:</u> The verge pointing is in poor condition to the east gable of the Chancel (especially the north slope).</p> <p><u>Chancel apse:</u> There is a gap between the gutter and the tiles on the east slope – an eaves tile appears to be missing.</p> <p><u>Flat roofs:</u> Mineral felt - inspection limited to view from the Tower (South Aisle and Lady Chapel only). Some ponding to Lady Chapel roof.</p> <p><i>NB The Baptistry, North Aisle and Vestry block flat roofs were not inspected and the writer cannot state they are free from defect.</i></p> <p><u>Tower/Nave valley gutters:</u> These are blocked with vegetation and debris.</p>

<p>Repair needs</p>	<p><u>Nave/ Chancel ridge:</u> Localised re-bedding of ridge tiles.</p> <p><u>Chancel verge:</u> Removal of unsound pointing; repointing.</p> <p><u>Chancel apse:</u> Replace missing eaves tile.</p> <p><u>Lady Chapel roof:</u> Monitor ponding.</p> <p><u>Tower/Nave valley gutter:</u> Clear vegetation and debris.</p>	<p>B</p> <p>B</p> <p>B</p> <p>D</p> <p>B</p>

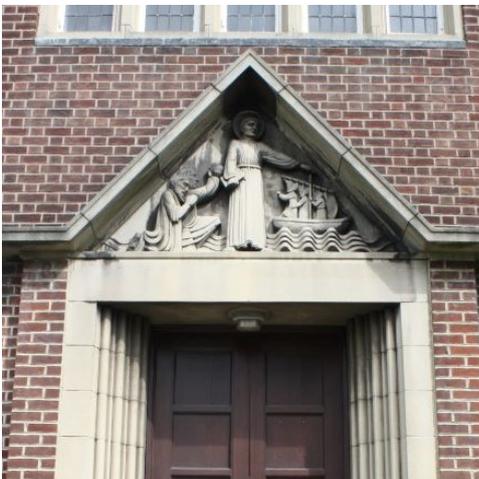
<p>Tympanum over main entrance</p>	<p><u>External walls:</u> The facing brickwork to the upper section of the Tower is understood to have been re-pointed in circa 1998. The lower section of the Tower was re-pointed in 2014. The brickwork and pointing is generally in good condition.</p> <p>The decorative stone tympanum (bearing a carving of St Nicholas aiding sailors in distress above the main entrance) is showing signs of weathering and grime. (See photo). Consideration could be given to its cleaning. The copings to the tympanum have open joints.</p> <p>The timber louvres are in fair condition though there is a missing blade on the west elevation.</p> <p><u>Roof:</u> <u>Parapets:</u> concrete coping stone with felted joints; upstand walls finished with fibreglass to inner faces. The fibreglass is breaking down. Externally a small shrub is growing out of the north parapet.</p>

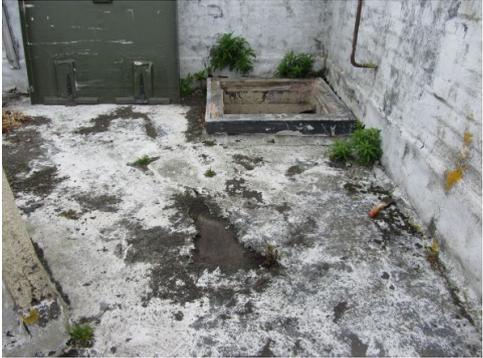
<p>Defective fibreglass roof finish</p>	<p><u>Roof finish:</u> the fibreglass finish is breaking down in a few places leaving the mastic asphalt below exposed (see photo opposite).</p> <p><u>Flagpole:</u> the sides of the concrete support are spalling.</p> <p><u>Roof hatch:</u> has been replaced and is in good condition.</p> <p><u>Internal metal ladders:</u> in fair condition.</p> <p><u>Hopper and downpipe:</u> There is some vegetation growing adjacent to the hopper though the hopper itself appears to be clear. Past leaks associated with the hopper and downpipe are evident.</p>	
<p>Repair needs</p>

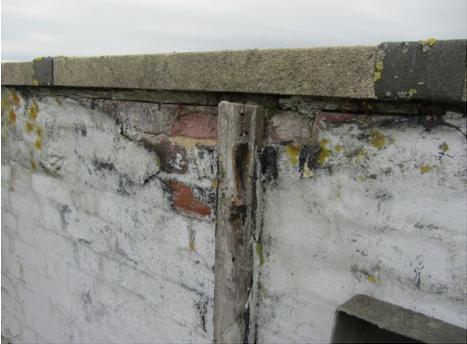
<p>Defective fibreglass to parapet</p>	<p><u>Tympanum:</u> repointing open joints in coping; consider specialist cleaning of carved frontal.</p> <p><u>Louvres:</u> replacing missing louvre blade to west elevation.</p> <p><u>Parapets:</u> removal of fibreglass followed by raking out and repointing of inner faces of parapet walls; removal of shrub from outer face.</p> <p><u>Roof finish:</u> removal of fibreglass finish to roof. Replacing with an alternative roof finish or upgrading the original mastic asphalt.</p> <p><u>Flagpole:</u> repair or replace concrete support to flagpole.</p> <p><u>Hopper and downpipe:</u> removal of vegetation; checking hopper &amp; downpipe joints for leaks.</p>	<p>C E</p> <p>C</p> <p>B B</p> <p>B</p> <p>B</p> <p>B</p>

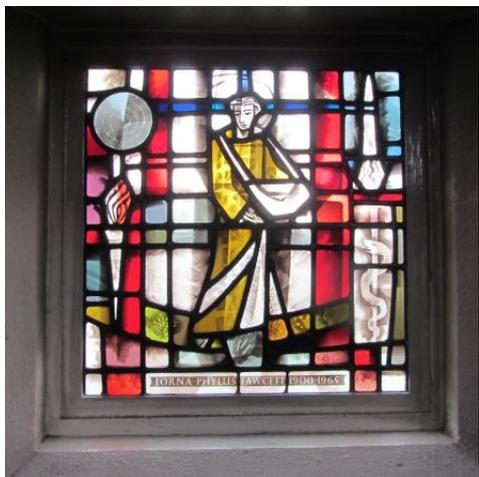
<p>The polycarbonate over-glazing to the many of the windows is looking discoloured due to UV light and dirt. Ideally these would best be replaced in new UV-resistant polycarbonate.</p> <p>There is some rusting of the metal framed casement windows in the Tower first stage. Removal of rust and localised redecoration is recommended.</p> <p>A glass hopper wing to one of the Choir Vestry staircase windows is cracked. Replacement is recommended.</p> <p>Generally the stained glass to the windows is in good condition with the exception of one of the low level windows (Fawcett memorial – see photo) in the South Aisle where there is some bowing. It is recommended that a glazing conservator be engaged to give advice.</p>	<p>E</p> <p>D</p> <p>D</p> <p>C</p>

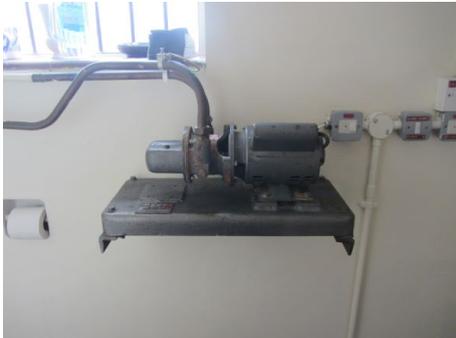
<p>Boiler sump pump located in toilet</p>	<p><u>Sacristy and adjacent Toilet:</u> Evidence of blistering paint to external walls – consider improving ventilation and redecoration. Some staining to carpet tiles.</p> <p>WC pan and new hand-basin in toilet in good condition. The sump pump takes up space and could be hazardous. (See photo). Consideration should be given to re-siting it.</p> <p><u>Choir Vestry and adjacent Toilet:</u> There is flaking paint and cracks in the plaster to walls and some flaking paint to ceilings. Removal of unsound paint, plaster repairs and redecoration is recommended. The vestry carpet is worn and should ideally be replaced.</p> <p><u>Kitchen:</u> There is no kitchen or servery in the church. Consideration should be given to installing a servery (possibly at the rear of the Nave) to serve hot drinks etc after services.</p>	<p>D</p> <p>E</p> <p>D</p> <p>E</p> <p>E</p>

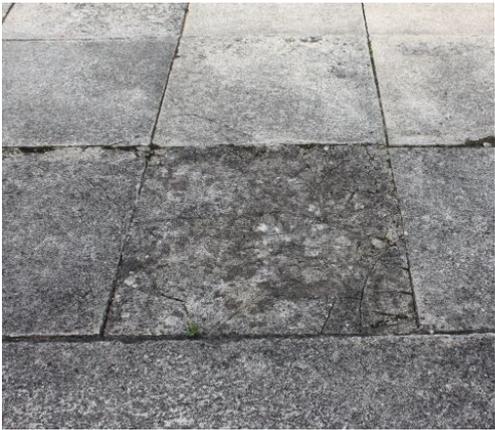
<p><u>Paths:</u> There are some minor cracks in the tarmac pavings on the south side of the church which should be monitored.</p> <p>20% of the concrete paving flags (between the two flights of steps) by the main entrance are cracked. The pavings are also uneven and pose a tripping hazard. It is recommended that the paving is re-laid incorporating new flags for safety reasons.</p> <p><u>Steps:</u> Some of the mortar has fallen out of the joints to the risers and raking out and re-pointing is recommended.</p> <p><u>Drive:</u> The tarmac drive and car park are in good condition.</p> <p><u>Access:</u> see para 2.7 for comments.</p>	<p>B</p> <p>B</p>

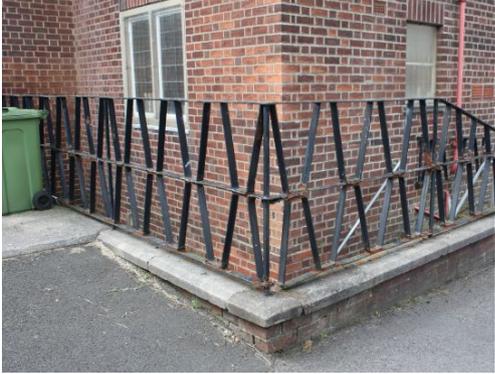
<p>Rusting fencing by boiler room</p>	<p><u>Side gate on west boundary:</u> Gate posts split and decayed at top and bottom.</p> <p><u>Fencing to north of access drive &amp; car park:</u> 1.2m high open boarded fence – in fair condition.</p> <p><u>Metal gates to play area:</u> Wrought iron – evidence of rust.</p> <p><u>Metal railings to dwarf walls by main entrance:</u> Wrought iron – evidence of rust.</p> <p><u>Metal fencing on boiler room retaining wall:</u> The railings are in poor condition with considerable rusting.</p>	
<p>Repair needs</p>	<p>Staining of the timber fences and gate every 5 years is recommended to prolong their life.</p> <p>The gate posts require monitoring for further deterioration and subsequent replacement.</p> <p>It is recommended that the rust is wire brushed off the metal gates and main entrance railings followed by re-decoration.</p> <p>Replacement of the railings by the boiler room steps is recommended.</p>	<p>D</p> <p>D</p> <p>C</p> <p>C</p>

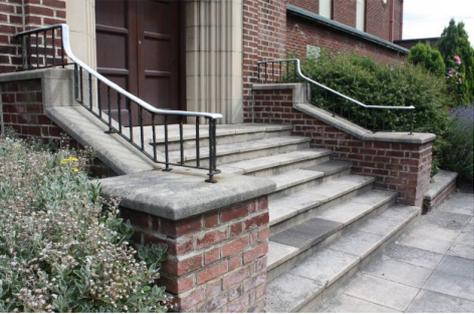
<p>Steps and dwarf walls at entrance</p>	<p><u>Shrubs and flowers:</u> The shrub beds adjacent the entrance path and the flower bed by the South Aisle are well-stocked, attractive and well maintained. Pruning is recommended especially on the public footpath side where it encroaches.</p> <p><u>Grassed areas:</u> These are cut regularly in the growing season.</p> <p><u>Hedging:</u> The hedging is healthy and well maintained.</p> <p><u>Dwarf walls by main entrance:</u> There are a number of open joints in the brickwork and the concrete copings which require re-pointing. Some of the copings are loose and require re-bedding. The dwarf wall on the east side of the entrance is damaged and localised reconstruction is needed. (See photo opposite).</p>	<p>M</p> <p>C</p>
<p><b>3.4 Trees</b></p>		
	<p>A mature silver birch tree is located on the south side of the church but is far enough away from the building not to pose any problems of roots or overhanging branches currently.</p> <p>A younger silver birch tree on the west boundary has shallow roots and is close to a drain run. It is recommended that the drain is checked for encroaching roots which could cause blockages.</p> <p>A flowering cherry and other smaller trees are located on the west boundary. These appear in healthy condition but pruning is recommended.</p>	<p>M</p> <p>M</p>
