Church of the Good Shepherd
Bishopwearmouth

Quinquennial Inspection Report
September 2018

Inspecting Architect: H P Massey BA, BArch. (Hons)
Hugh Massey Architects
designhaus
205 Park Road
South Moor
Stanley
Co. Durham
DH9 7QE
Tel: 01207 280095
Email: hugh.massey@hughmasseyarchitects.co.uk

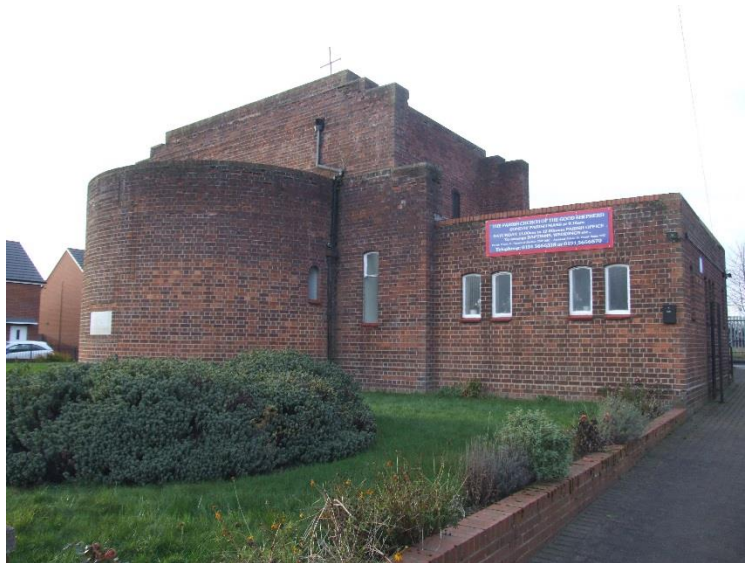
3.0	General Structure
3.1	<p>The building is fundamentally stable however the principal issue appears to be the breakdown of brick faces, particularly at the east (sea facing) end, coupled with missing concrete capping pieces.</p> <p>Moisture is penetrating the wall head and affecting both internal and external surfaces dramatically. The previous inspector suggested that the mortar mix strength being greater than the brickwork is likely to have accelerated the degradation of brick faces. My own contention is that without a competent capping, a double weather parapet wall is prone to freeze/thaw brick face degradation.</p>

View from northern access route,
showing high level brick spalling

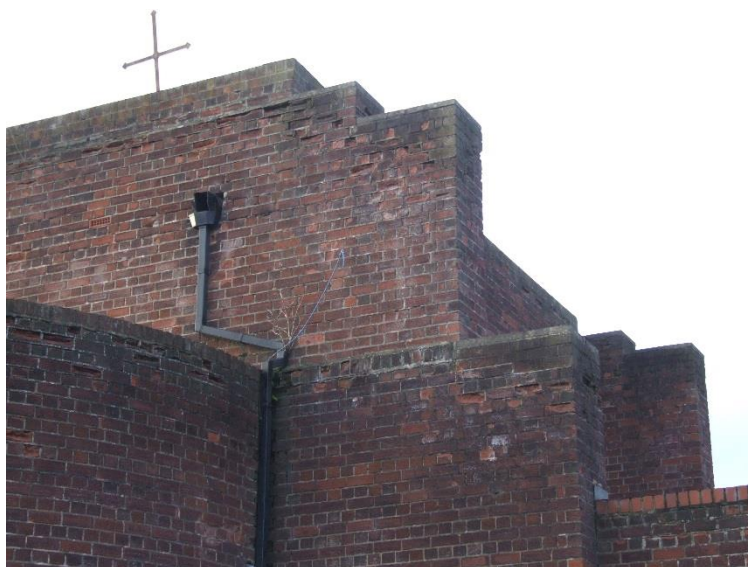
4.1	<p><i>Apsidal east end (sanctuary):</i></p> <p>It appears the capping course of brickwork has been replaced at some point, however there is significant loss of brick faces to the east end and north parts for at least 3 courses below the capping course, and cracking at around 7 down, suggesting the depth of the upstand wall. The short armed cross feature formed with headers is barely distinguishable.</p>

Detail of brick spalling,
north east corner

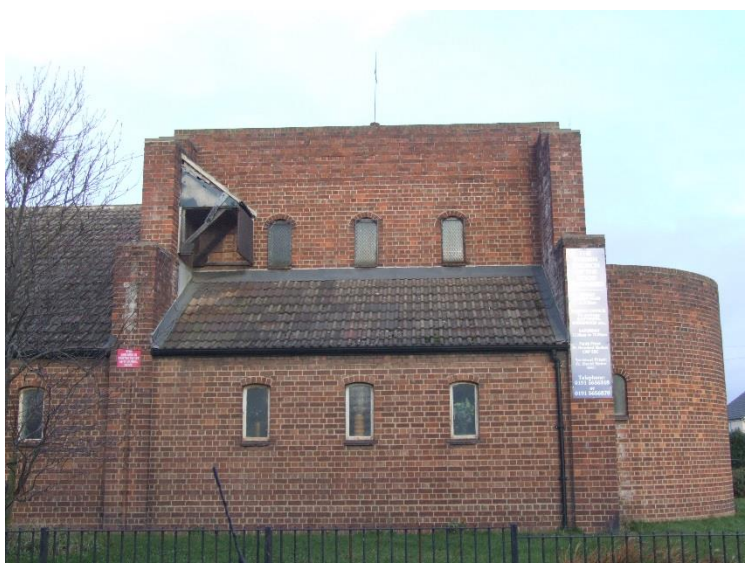
8.2	Fixity of the cross to the chancel roof should be checked.
8.3	There is a small bellcote on the south side of the chancel, but there appears to be no bell. The structure, though probably part of the original design, is in poor condition, with metal grillage. Restoration should be considered.
INTERNAL INSPECTION

South elevation, chancel area
Redundant bellcote

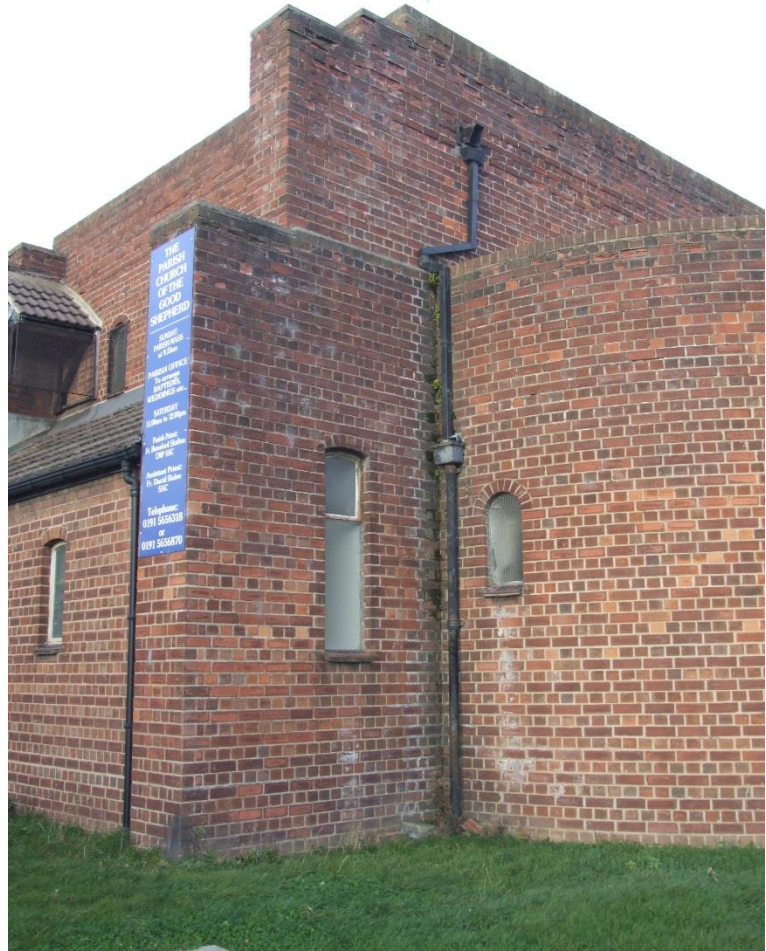
Southeast corner,
damage from downpipe leakage

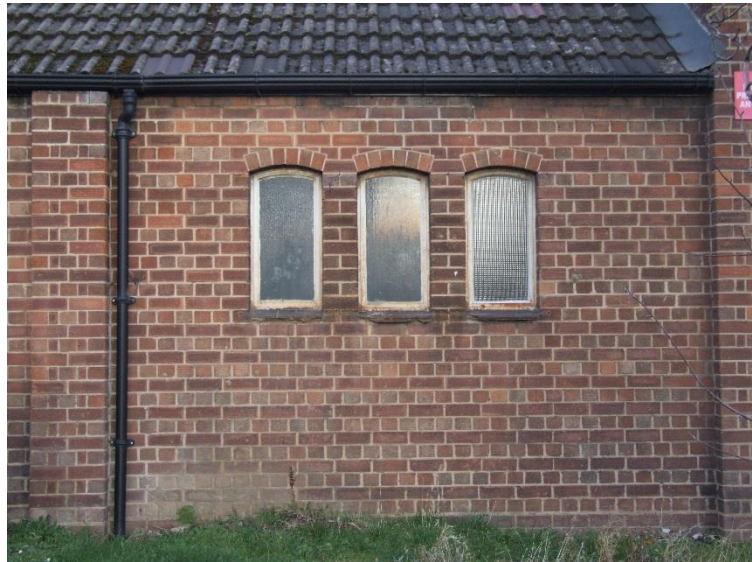
4.6	Tile slip sills are complete to the northern rooms but on the west and south sides have suffered what would appear to be mechanical damage.
4.7	Brickwork window openings at lower level, to windows and doorways, are generally flat arches, whereas window heads to the apsidal end and at higher chancel level are semi-circular.

7.2	All windows are rusty and have suffered particularly in contact with damp walls.
7.3	Upper level windows to the chancel are protected with rectangular expanded metal grilles.

South elevation, damaged plain tile sills; corroded steel windows

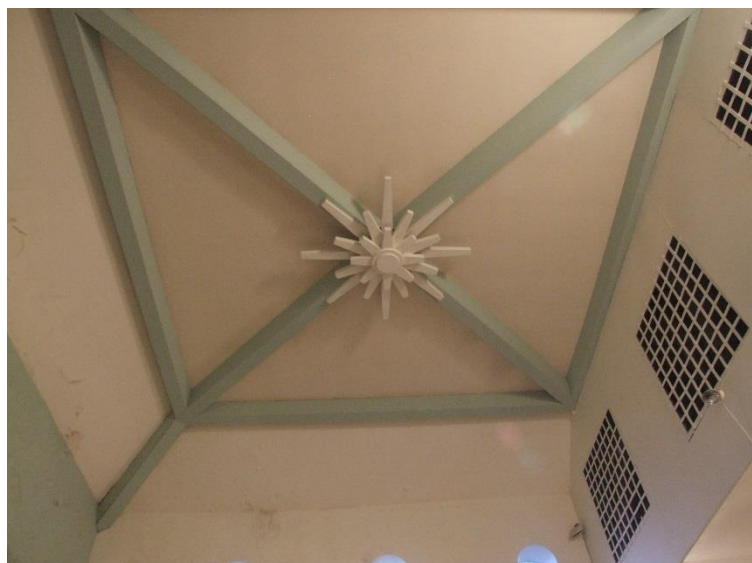
Ceiling detail (chancel), with evidence of damp penetration

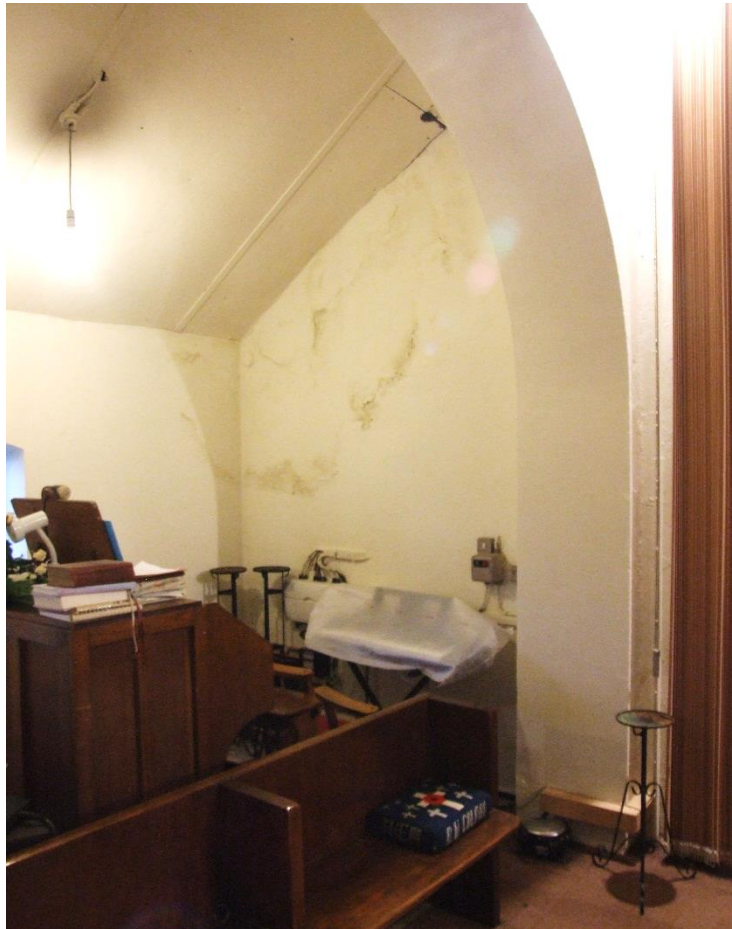
Damp penetration,
south aisle, west end of chancel

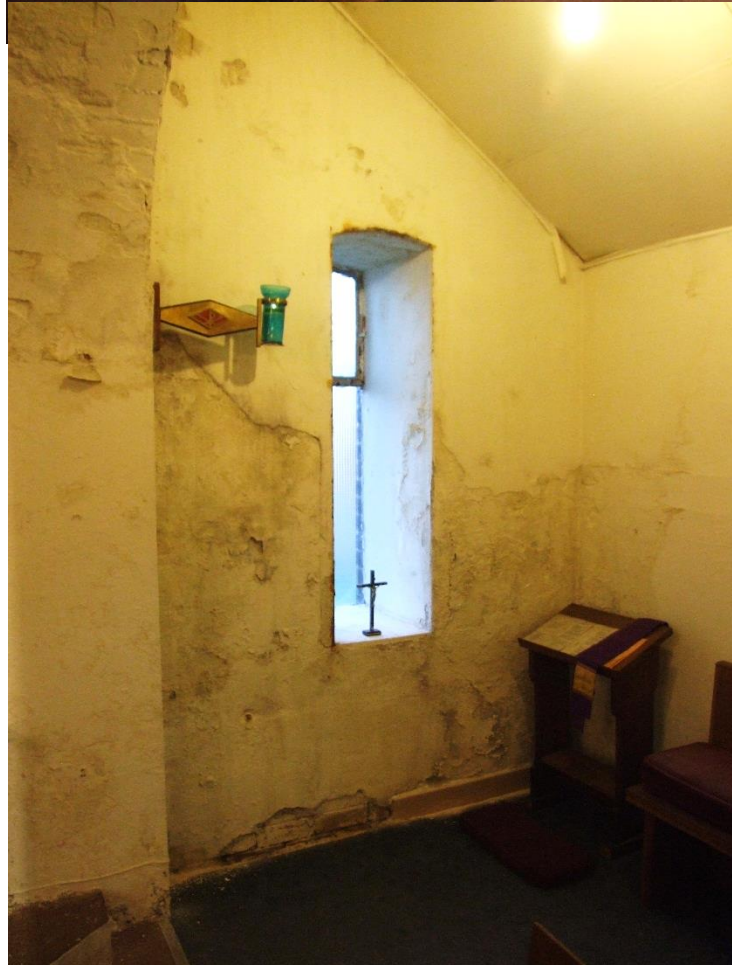
Damp penetration,
south aisle, east end of chancel

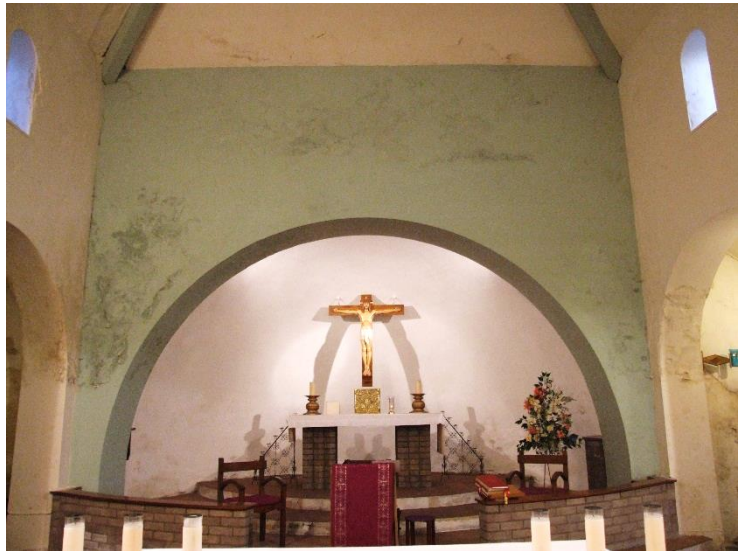
10.2	Substantial, consistent water penetration has produced significant damage to plaster surfaces, some of which are spalling, particularly large areas at the eastern chancel end.

View from chancel to sanctuary
showing damp penetration

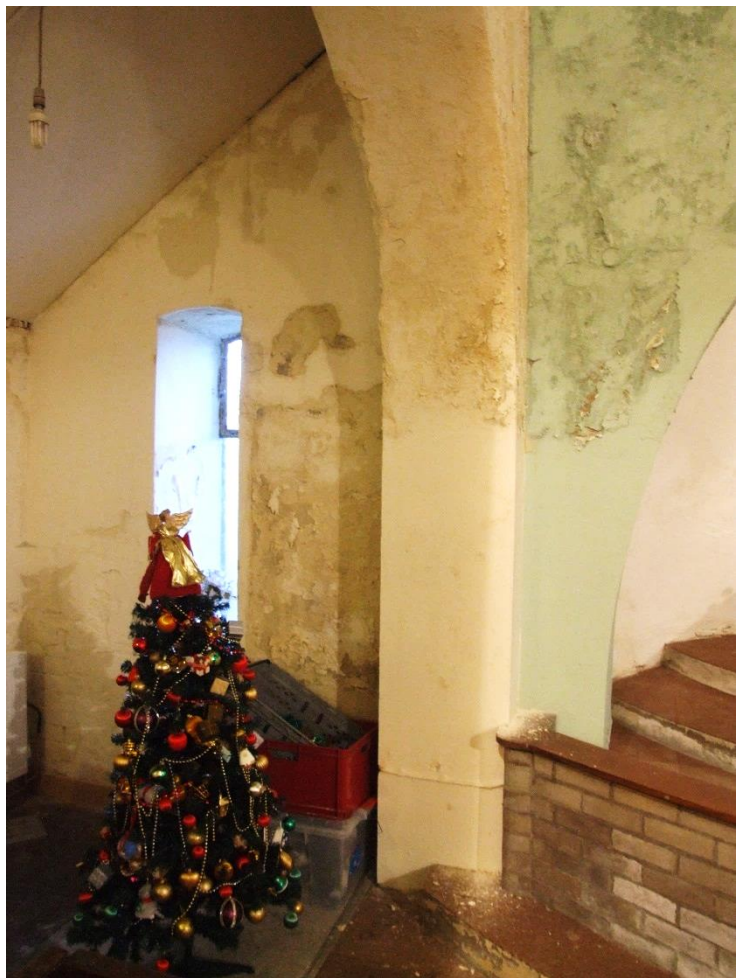
Damp penetration,
north aisle, east end

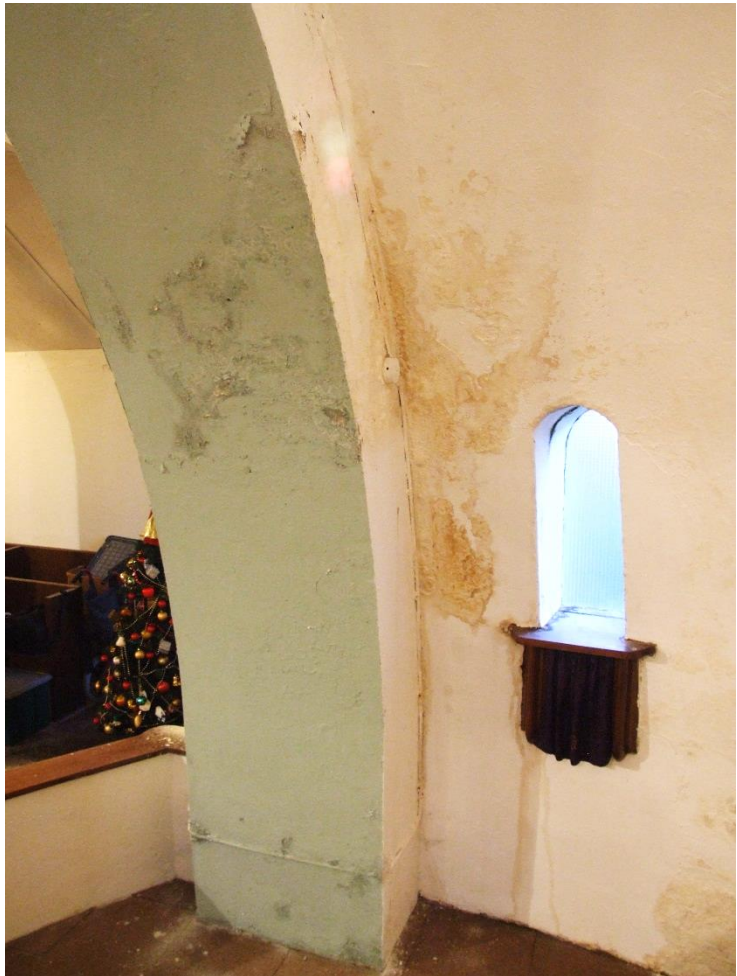
Damp penetration,
sanctuary arch, north side detail

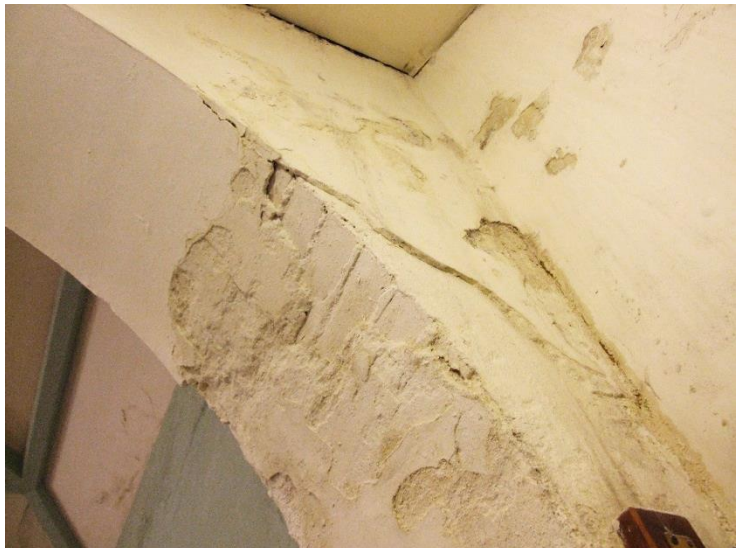
Damp penetration and plaster loss,
sanctuary south aisle

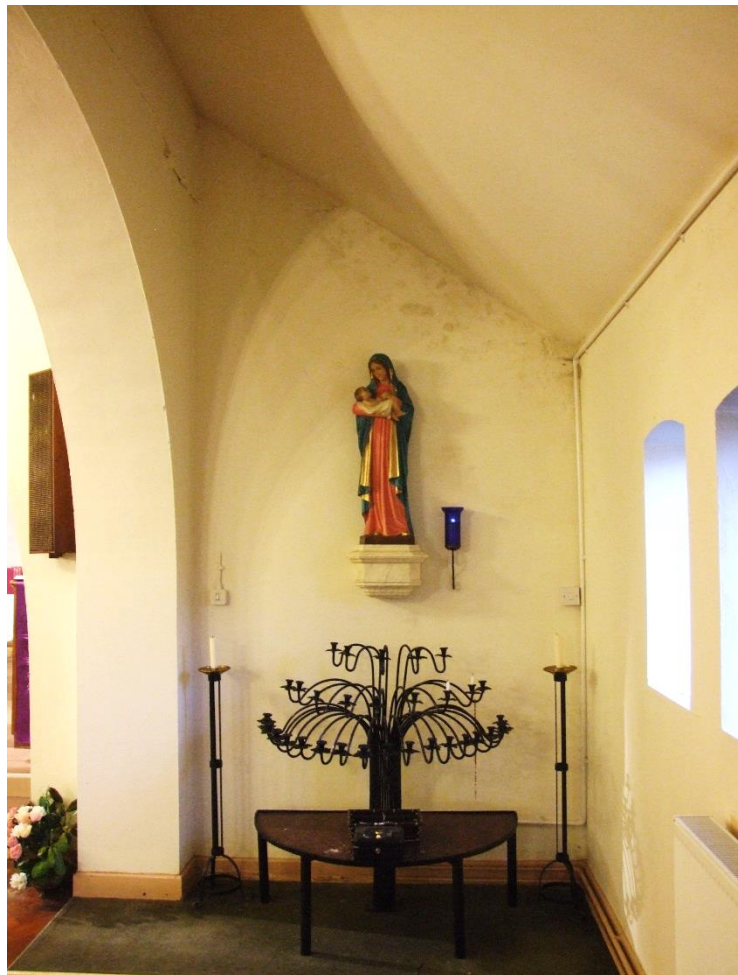
Alcove, south aisle showing
high level damp penetration

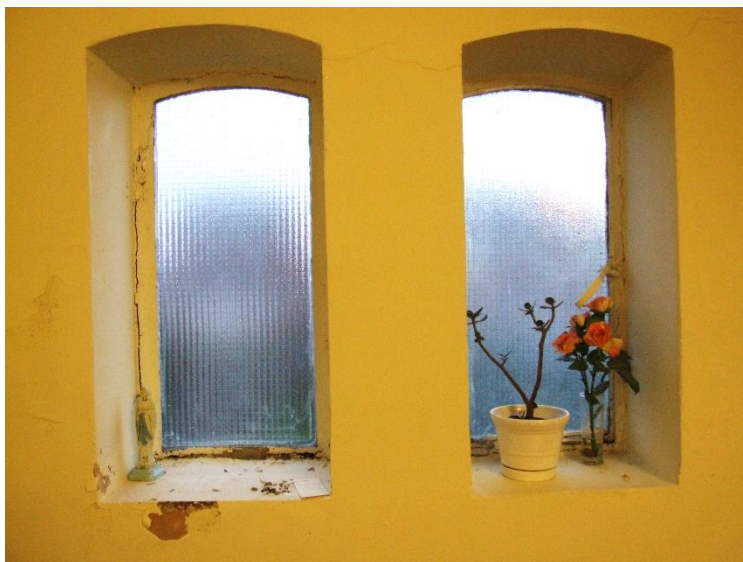
Rusting steel windows
in meeting room

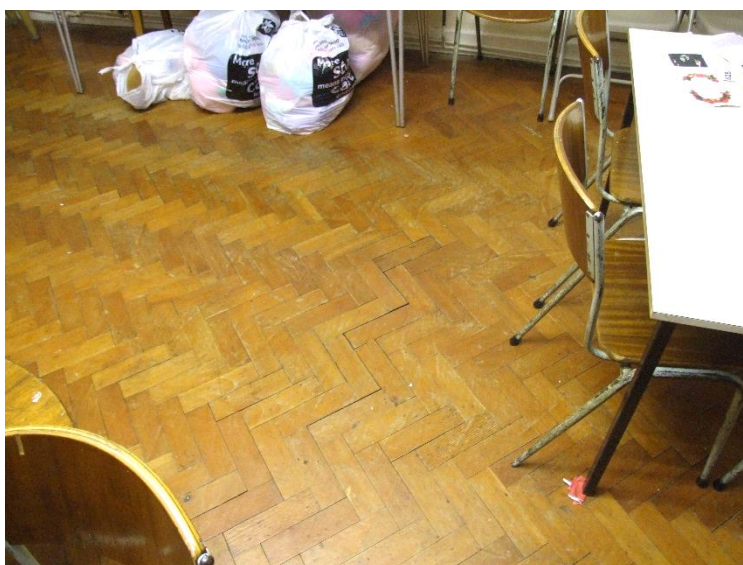
15.2	The meeting room has timber herringbone parquet flooring with a line of loose elements, suggestive of slight slab movement and consequent de-adhesion.

Meeting room, loose parquet blocks

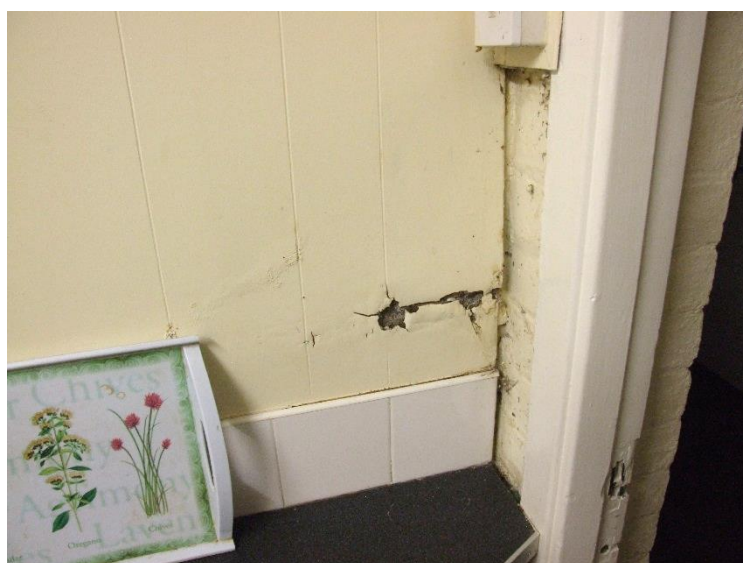
Kitchen damp penetration causing
timber lining breakdown
