**Diocese of Durham**  
**St Cuthbert, Blaydon**

**Quinquennial Report**  
On the architect's inspection of

**17<sup>th</sup> April 2023**

**Sarah Harrison RIBA**

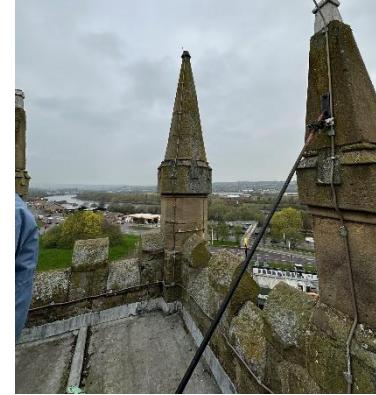
Figure 1- Metal stays to mid pinnacle

6.1.2 There are metal stays with a single bolt to the back of each intermediate pinnacle, the southern support is moveable, the easternmost is completely loose and the bolt has sheered.

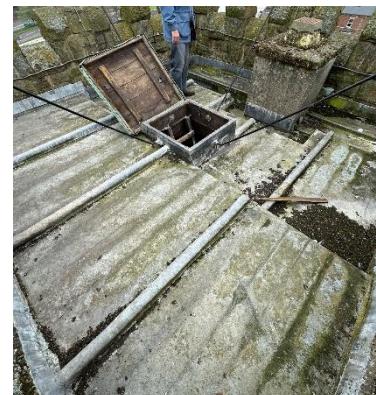
Figure 2- Tower roof and hatch

6.1.3 The hatch to the roof is copper covered. It remains awkward to lift and would benefit from being hinged. One of the stay rails has rotten and is loose.

6.1.4 To the southeast bay there is a welded seam, the welding looks to have a hairline crack but this could just be to the surface as there is no sign of water penetration below currently.

6.1.5 The rendered, probably brick flue has an air brick to the top, this might be a redundant flue but the air brick is vertical so rain can enter and the mortar pointing around it is coming away. The chimney appears to be open beneath.

6.1.6 There is a loose wire which formerly served as a net fixing to prevent bird ingress, this should be completely removed if no longer in use.

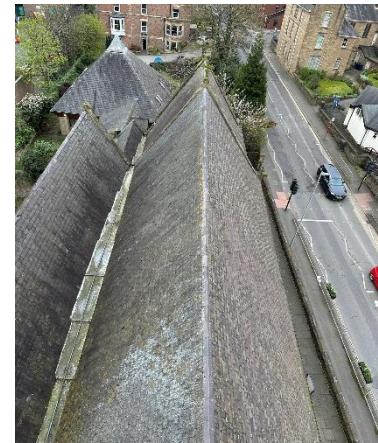
Figure 3- North Face of Nave Roof

6.3 **Nave** As chancel, steeply pitched slate with valley to the north. The blue clay saddle type ridges are spoiling and cracking in some places. However, to avoid breaking more slates when replacing, save these repairs up for when condition worsens.

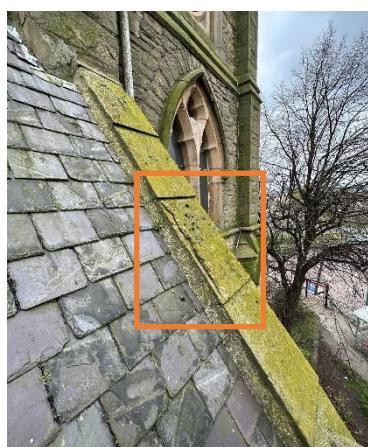
Figure 4- Coping stone delamination

- Ridge – Looks ok apart from some slight delamination of ridges, bedding seems ok.
- General roofing – A few slates slipped or broken across the slope, some moss clusters.
- West abutment to tower has vegetation build-up in the small valley, as per the south elevation.
- The water table to the west has two coping stones which are delaminating, one of which has a large top section loose and liable to falling which could be dangerous.
- East abutment appears ok.
- The lead box gutter between the north aisle and nave looks in good condition though there is some leaf and moss build up.

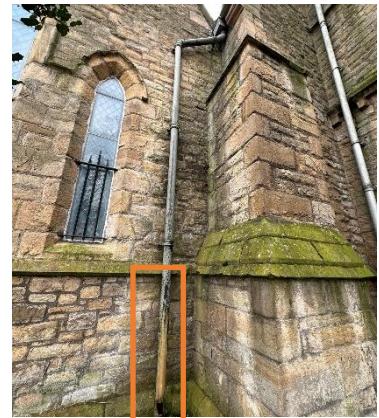
Figure 6 - RWP to north aisle from valley

7.2.1 North Aisle – This has a downpipe connected to the hopper that takes the discharge from one end of the valley gutter between the nave and aisle. The wall is a little less green than at the last inspection from photographs, suggesting that the water cascading over the top of the hopper was a former issue. The decoration is coming away from the pipe and there is a hole in the lower section of the pipe, there is also no grid on the gulley. This links to damp at item 15.2.

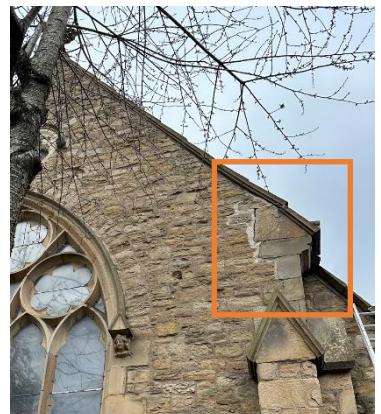
Figure 8 - crack to kneeler at 8.4.1

8.4.1 The view is slightly interrupted by trees. The north side has a crack at the foot of the kneeler and it is rotating outwards slightly, looks like there has been repair to this in the past in lime mortar. You can see that the line of the water table isn't true and this is quite a big stone, you can also see that the bed joint to the kneeler support stone is triangular so the kneeler needs picking up and putting back in again. The kneeler on the other side has a slight crack to it but can be re-pointed and doesn't need re-set at this time.

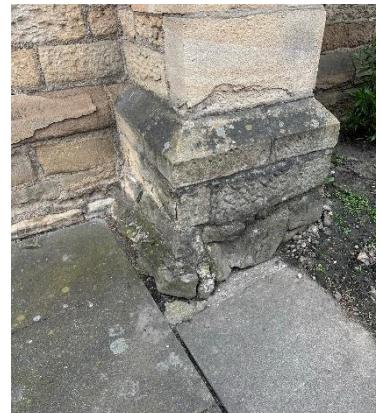
Figure 9 - erosion to base of buttress

8.6.2 **Bay two** – Open joint to the gutter corbel, masonry ok, windows ok, slight cracking to the putty. Stone erosion to base of buttress.

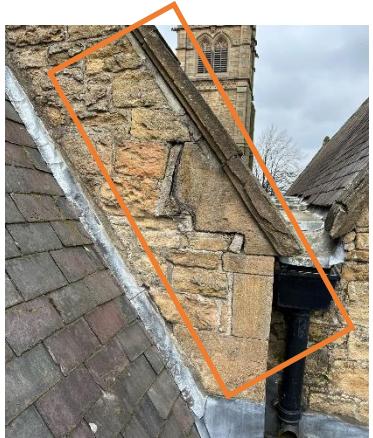
Figure 10 - crack to kneeler at 8.9

8.9 **Nave east** – high level above adjoining chancel there is a large crack that runs from mid gable to the kneeler at the eaves. The kneeler itself looks to have moved outwards by 30mm. This area looks to have been filled many times, could be due to eaves spread.

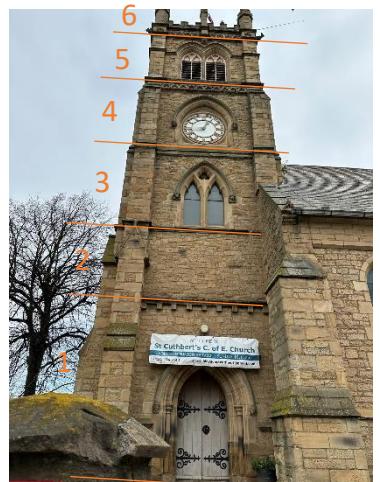
Figure 11 – south tower

Stage 6 – Pinnacles and battlement ok. Upper quatrefoil ok.

- Stage 5 – Paint coming away from the louvres, slight erosion to string course to the east, delamination stone to the bottom west side.
- Stage 4 - Heavy erosion to the string course above quatrefoils. Quatrefoil eroded. Clock dial lost its decoration, slight delamination of stone to clock reveals.

- Stage 3 – Looks to have had mortar repairs at spring point of arch. Slight erosion above window apex.
- Stage 2 – Open joints at the string course.
- Stage 1 South entrance – Walling partially covered by sign, slight erosion to the nook shafts, base and the plinth, some damp showing at the bottom of the door.

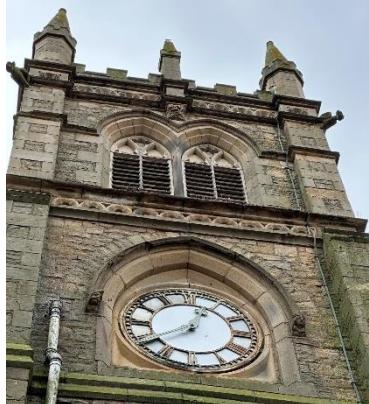
Figure 12 - north tower and clock

- 10.2.5 The room contains the clock mechanism and three dials on all elevations apart from the west, there is no obvious makers' mark of the clock. The central clock mechanism within the timber frame was reported redundant by the last inspector and the clock now has individual mechanisms on each of the dials and looks to be an installation of Smith of Derby. The clock is reportedly maintained by the local authority yearly. There is a crack in the glass to the northern clock face.

9.1.5 The louvre timberwork needs repair and painting. Netting the face would discourage perching birds.

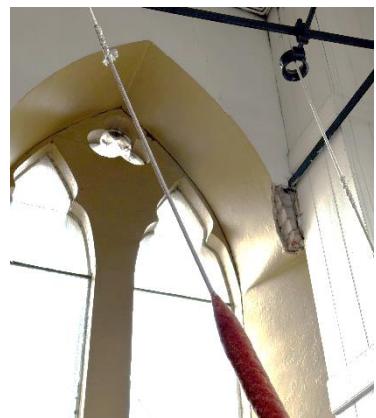
Figure 14 - crack to south at 10.3.2

- 10.3.1 Ceiling – Painted timber boards, some pigeon muck coming through the gaps, one board missing.
- 10.3.2 Walls: South face – slight hairline crack in the plaster above the window, this leads down to the western springing point where the plaster has broken away from the face.

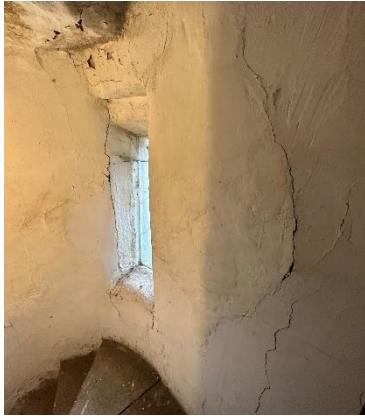
Figure 15 - crack to stair

- 10.4.1 Walls – Are plastered and painted, generally fair, cracking at the top of the step by the window looks similar to the photo included in the previous report, decoration has deteriorated slightly. Some additional cracks to the underside of the stairs, not mentioned in the previous report but appear historic- monitor.
- 10.4.2 Windows – obscured glass badly pointed in but currently secure.

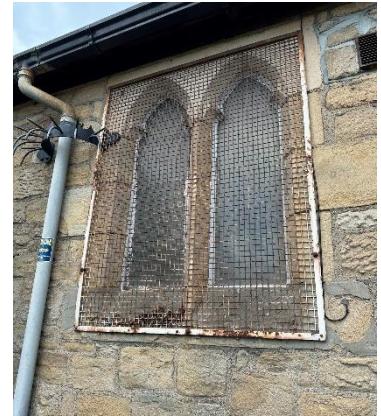
Figure 16 – north vestry mesh

- 11.6 North Aisle north - Same defect to window security mesh and glass as the vestry.

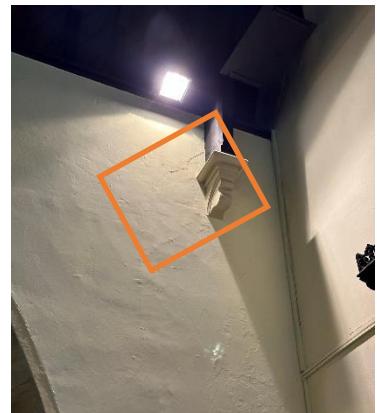
Figure 19 – crack discussed at 14.1.3

14.1.3 **North arcade** – Features four arches with painted columns and the bases, all appear ok, they have had the occasional decorative knock. There is one crack to the walling at the base of the truss nearest the chancel, this was not reported in the last inspection but doesn't appear new – monitor.

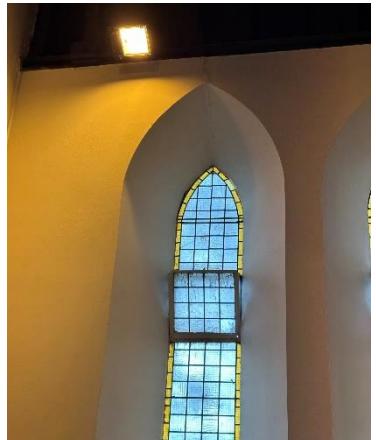
Figure 24 – window with hopper and cracked pane

- 18.1.1 Window one – Pictorial glazing cracked to LH lancet, external Georgian wired.
- 18.1.2 Window two – Plane obscure quarries different patterns backing to Georgian wired glass, ventilator in the open position doesn't appear to be able to be closed. RH lancet glazing cracked.
- 18.1.3 Window three – Both pictorial and obscure the pictorial has two panes of clear glass within it, which is cracked to the top LHS.
- 18.1.4 Window four – This is pictorial and all ok.
