CHURCH OF SAINT BRANDON

BRANCEPETH

REPORT ON QUINQUENNIAL INSPECTION

Inspection Date: 17th August 2023

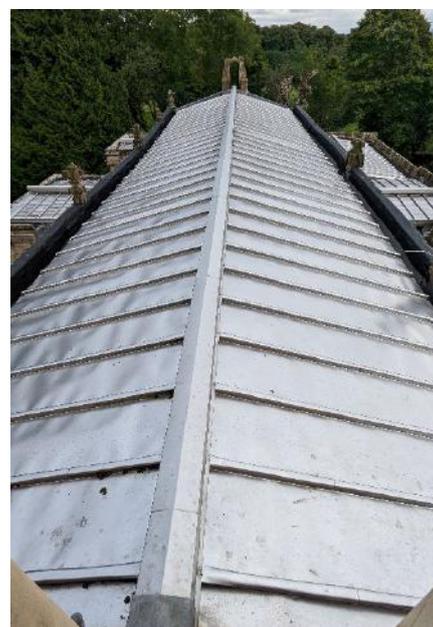
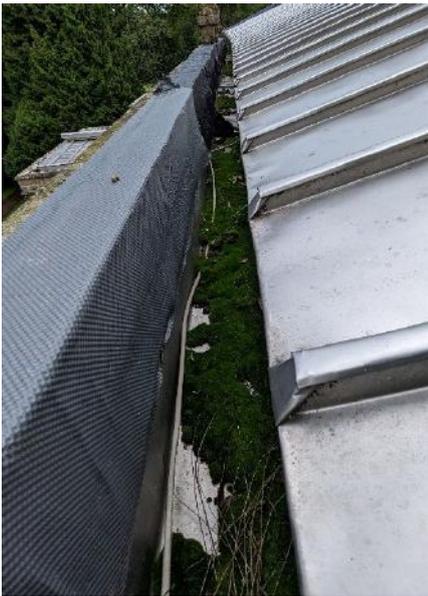
2.1.2.	<p>Nave Roof This is in stainless steel on a steel frame, all rebuilt post fire. The nave originally had lead flashings into stainless steel parapet gutters.</p> <p>The lead flashings have been replaced with black Ubiflex (or similar) which caps the copings. The quality of the installation is generally poor as elsewhere. The full length of the gutters could not be checked due to low parapets/access restrictions, however, there is a split section of flashing to the south west corner that needs urgent repair / replacement. There also appeared to be split sections over the westernmost outlets to both the north and south gutters. Replacement of the whole length of flashings in a different material should be undertaken.</p> <p>There is a build-up of moss in the gutters, particularly to the north side that needs clearing.</p>

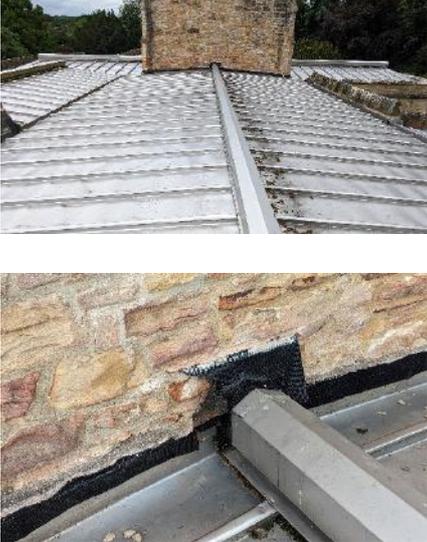
<p>2.1.6.</p>	<p>Chancel Roof</p> <p>This is stainless steel however the lead flashings were stolen. As set out earlier the roof was renewed in 2004 and the flashings poorly replaced.</p> <p>The flashings at the junction of the ridge and Nave walling are black ubiflex (or similar) and have split and require replacement. The flashings to the east are in felt and are in a better state of repair.</p> <p>The copings were repointed in 2022 and the parapets are in good order.</p>

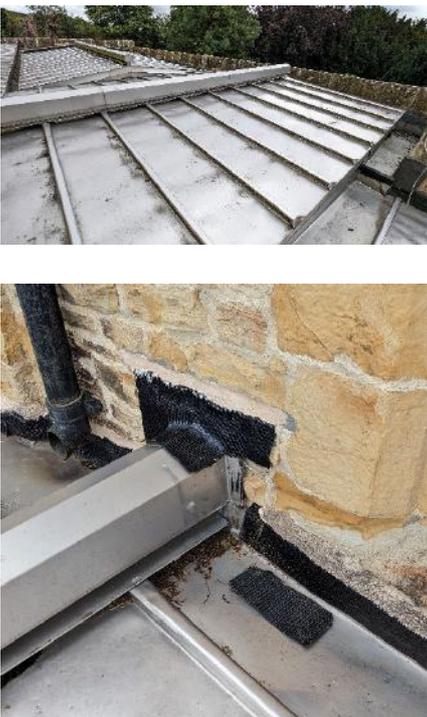
<p>2.1.8.</p>	<p>South Transept Roof Stainless steel as before and parapet in good order. Lead flashings have been stolen and poorly replaced in felt to the south and black ubiflex (or similar) to the north. Replacement of the whole length of flashings in a different material should be undertaken. The flashing to the north at the junction of the ridge with the Nave should be urgently repaired as it has split.</p> <p>Some scratches are present to the stainless steel roofing – access for maintenance should be assessed to avoid scratching roofing.</p>

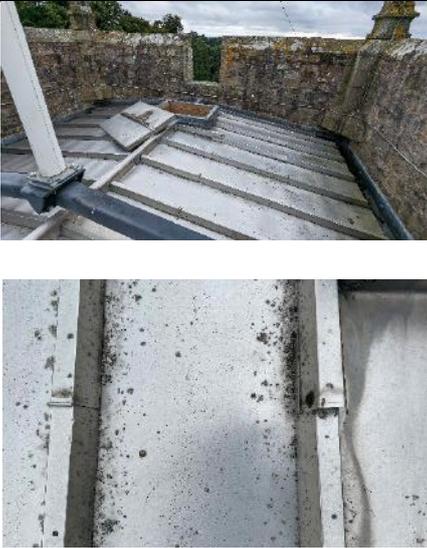
<p>2.1.10.</p>	<p>Tower Roof All of the stainless-steel roof is in good order other than one batten roll which requires a new clip.</p> <p>The stonework is shaling in places however the parapet and pinnacles appear to be sound. There are a few open joints in exposed locations that should be pointed to avoid water ingress and exacerbated weathering of the masonry.</p> <p>The end of one of the cables supporting the flagpole is frayed and it was reported that this damages the flags. This is past the fixing and could be taped or capped to avoid this in the future.</p>

<p>Access to the tower is difficult and could be improved. The access hatch could be hinged (the damage to the clip could be due to the current hatch) and bars added to crenels (where this will not hinder access for the flagpole).</p>

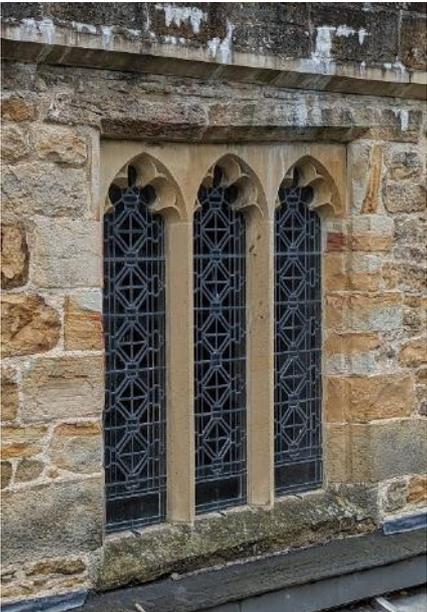
2.2.4.	<p>North Nave Clerestory Bay Three Second window from the West</p> <p>As previously the window head and mullions are replaced and the window reveals and cill are original. Much of the stonework has been re-pointed since the rebuilding in 2004. There is some lime staining where mortar was washed out during construction. The cill and reveals are friable and well weathered. Note that the string course under the parapet is new along the whole of the north elevation.</p> <p>There is no flashing beneath the cill and the mortar has come loose. The open joint should be pointed with flexible jointing compound (to allow expansion and contraction of the felt beneath).</p>

<table><tr> <td style="width: 5%; text-align: center;">B</td> <td>• North Nave Clerestory Bay Three – Second window from the West: Replace the failed pointing below the cill</td> </tr></table>

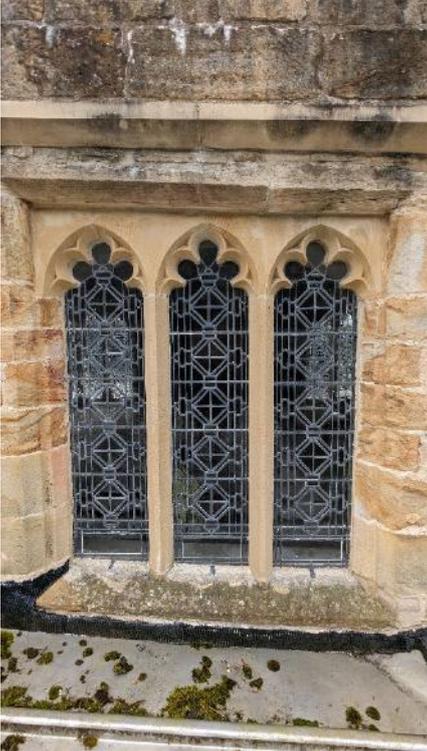
<p>2.2.5.</p>	<p>North Nave Clerestory Bay Four Third window from the West</p> <p>As before the heads and mullions are new, as is the glazing and lead work. The reveals and cill although weathered are in reasonable order. The adjacent buttress has had new stone replacements.</p> <p>To the head, lamination has been pinned back but requires further conservation repair (see photo). Also some failed pointing around central light.</p>

<table><tr> <td style="width: 5%; text-align: center;">B</td> <td>• North Nave Clerestory Bay Three – Second window from the West: Replace the failed pointing below the cill</td> </tr><tr> <td style="text-align: center;">B</td> <td>• North Nave Clerestory Bay Four - Third window from the West: Carry out conservation repair to head and reveal. Point open joints around central light.</td> </tr></table>

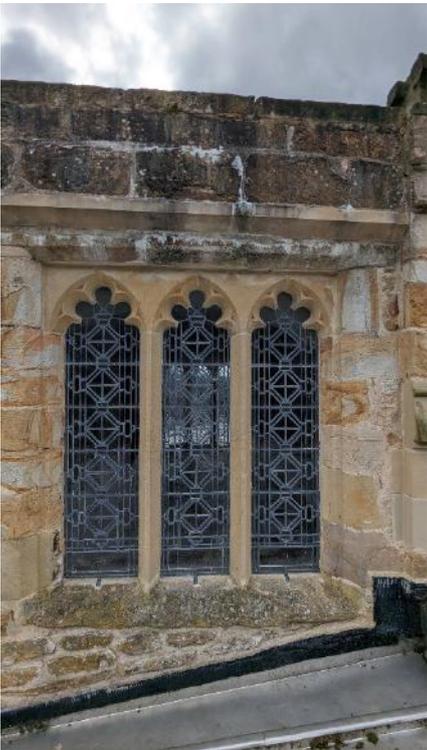
<p>2.2.6.</p>	<p>North Nave Clerestory Bay Five Fourth window from the West</p> <p>This also has new heads and mullions. The reveals and cills although weathered are in reasonable condition. Above the windows there are lime stains. On the east reveal of this window there is a stone which has got its face blown and another with a crack in it. This stone is particularly friable and some pointing may be necessary around the stones.</p>

<table><tr> <td style="width: 5%; text-align: center;">B</td> <td>• North Nave Clerestory Bay Three – Second window from the West: Replace the failed pointing below the cill</td> </tr><tr> <td style="text-align: center;">B</td> <td>• North Nave Clerestory Bay Bay 5 - Fourth window from West: repair failed pointing.</td> </tr></table>

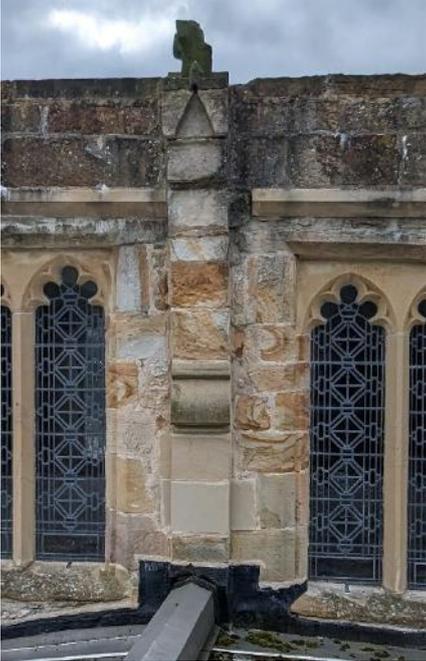
<p>2.2.7.</p>	<p>North Nave Clerestory Wall Generally The small buttresses between the window bays have pinnacles with crockets and poppy heads. One pinnacle has lost its top and requires pointing. Generally, the pinnacles appear to be well bedded and secure but were not physically tested. A number of stones on the small buttresses between the windows are weathered and require replacement.</p> <p>The flashing is universally of poor quality and should be replaced – refer to roof section for recommendations.</p>

<table><tr> <td style="width: 5%; text-align: center;">B</td> <td>• North Nave Clerestory Bay Three – Second window from the West: Replace the failed pointing below the cill</td> </tr><tr> <td style="text-align: center;">B</td> <td>• North Nave Clerestory Generally - Point base of pinnacle (third from the west) and replace weathered stone to buttresses.</td> </tr></table>

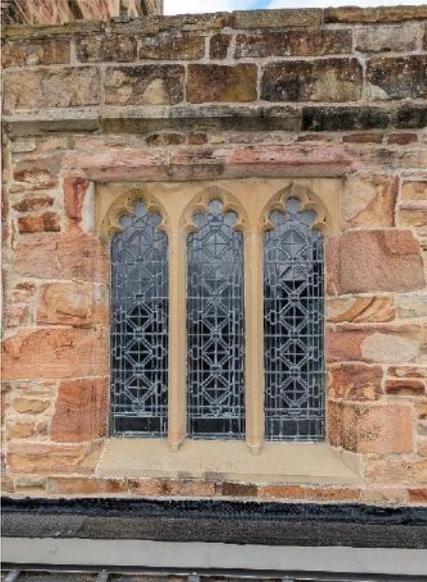
<p>2.3.4.</p>	<p>Between Bay Two and Bay Three is a small buttress. There is a crack to the buttress capping and the moulded section at the base is severely eroded and a new carved section should be inserted. There are a couple of open joints that require repointing.</p>

<table><tr> <td data-bbox="272 949 323 1070">B</td> <td data-bbox="323 949 1525 1070"> <ul style="list-style-type: none"> • South Nave Clerestory Bay Two – First window from the West: Repoint open joints and conduct conservation mortar repair to western reveal, considering application of burnt sand mastic along the window line. </td> </tr><tr> <td data-bbox="272 1070 323 1115">C</td> <td data-bbox="323 1070 1525 1115"> <ul style="list-style-type: none"> • South Nave Clerestory – Replace moulded stone to buttress and repoint open joints. </td> </tr></table>

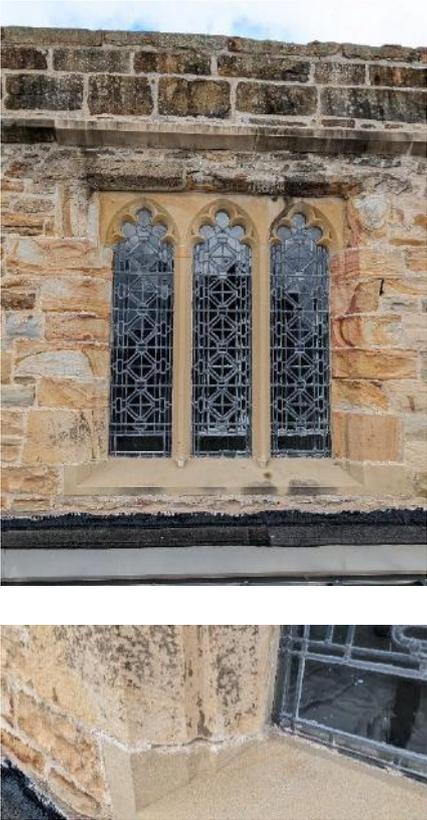
<p>2.3.6.</p>	<p>South Nave Clerestory Bay Four 3rd window from the West As previously, post fire heads, mullions, cill and glazing. The reveals are eroded but have undergone repair. There is some lime staining where mortar was washed out during construction. Some pointing has failed. Buttress between 3 & 4 has been recently replaced. As before the string course is almost all replaced although there is one original stone. The parapet looks sturdy.</p>

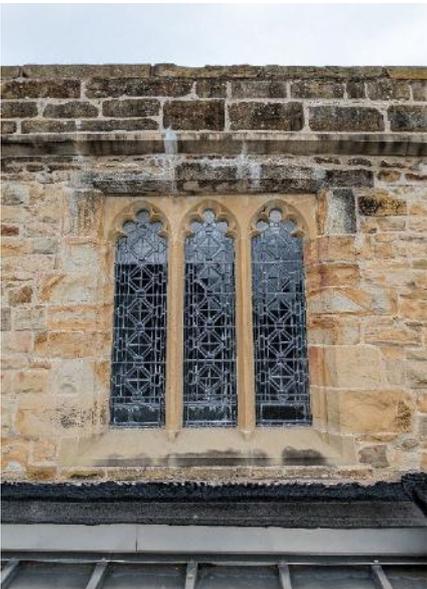
2.3.7.	<p>South Nave Clerestory Bay Five 4th window from the West</p> <p>Some conservation repairs are failing where they have been used to fill cavities in the stone.</p> <p>As before, post fire heads and mullions however the cill is older. The mortar fillet at the base of the window has failed in a couple of places.</p>

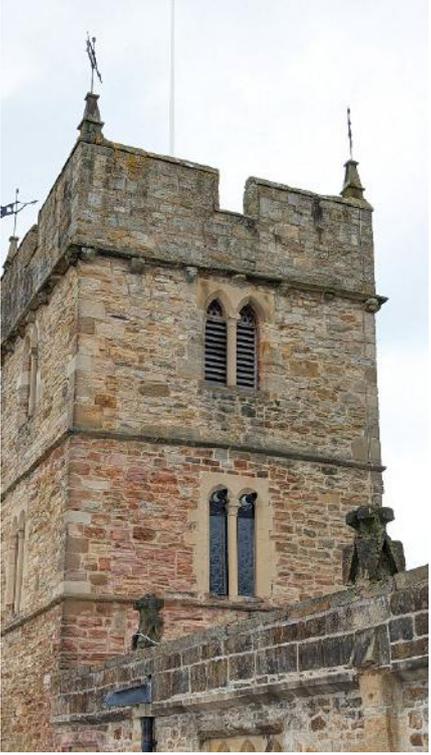
<p>2.4.5.</p>	<p>Upper Section of Tower East Side</p> <p>The upper section has an opening with timber louvres. The head, cill and mullion has been renewed post-fire. It was difficult to see the junction with the stone but the seal could probably be improved (e.g. with oakum and burnt sand mastic). The corbelled string course above has some open joints that should be repointed and one of the corbels has lost a corner but is otherwise appears to be in a reasonable condition.</p>

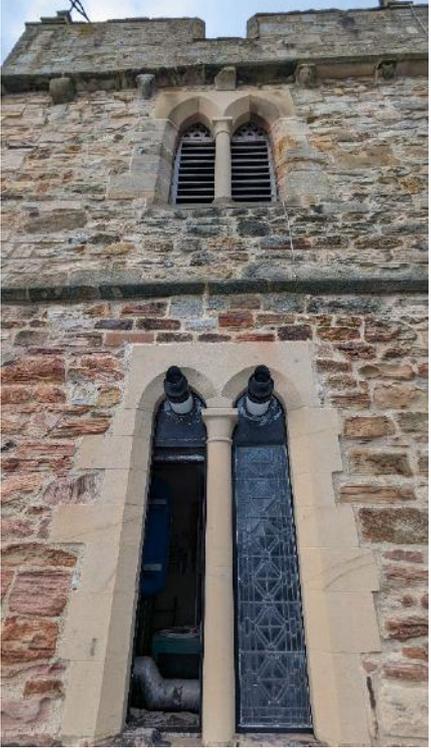
<p>2.4.6.</p>	<p>Base of Tower North Side – From Roof Level</p> <p>There is a small round headed window stone, the bottom of the east and west reveal is severely eroded and cracked and requires renewal.</p> <p>The middle section of the tower has a double headed Venetian style window with a central circular column. The glazing has been renewed. The heads and some of the reveals have been renewed along with the central column. The stonework has been re-pointed and is in good order.</p>

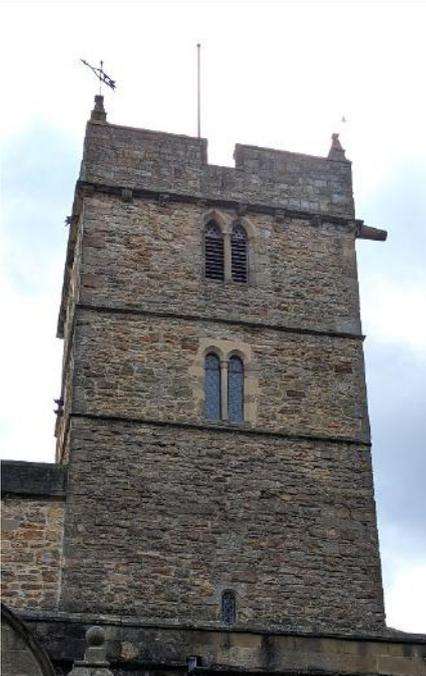
<p>2.4.7.</p>	<p>Upper Section of Tower North Side</p> <p>This also has a double headed Venetian style window with a central column behind which are timber louvers to the Bell Chamber. Most of the stonework at the heads of the window and the central column are new. This section appears to be in good order. Some of the moulding detail on the corbels under the string course is beginning to be lost however they appear reasonably sound. The parapet level appears to be in reasonable condition.</p>

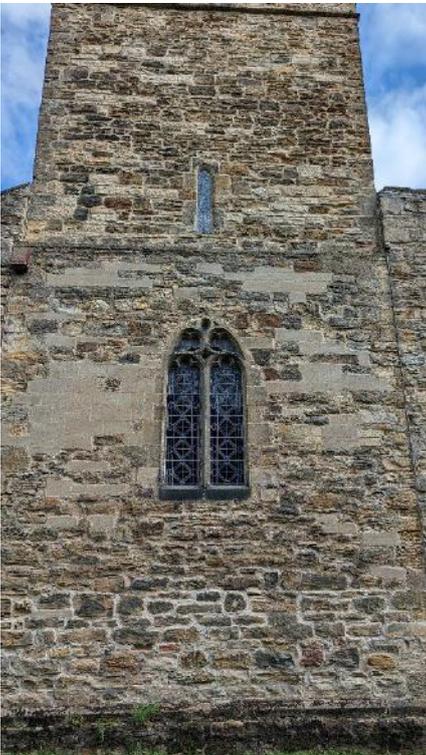
2.4.9.	<p>Middle Section of Tower West Side</p> <p>This section has been re-pointed post-fire. There has been some replacement of stones (over twenty years ago) and this is much more successful than in the lower section. This stone has been pitched and is laid to random coursing. Below the string course there is a rusty box fixed to the wall. This should be removed.</p> <p>There is an arched headed window – the glazing has been renewed and appears in good order. Some sealing required from the interior (refer to interior).</p>

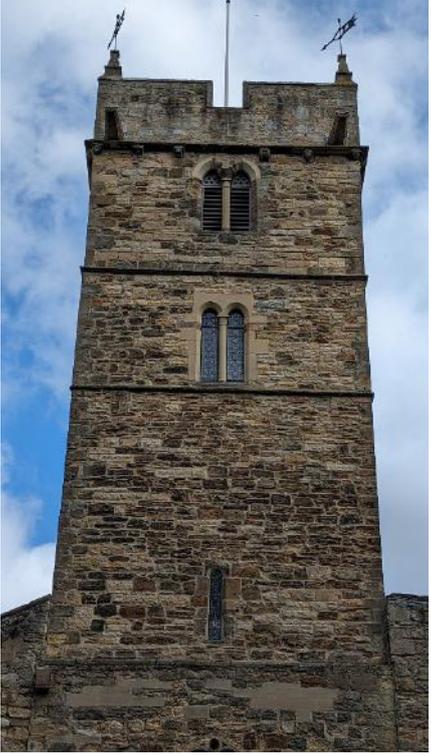
2.4.10.	<p>Upper Middle Section of Tower West Side</p> <p>This has double lancet windows in Venetian style with a central column. Most of the stonework around these windows has been replaced and the stonework on this section is well pointed and in good order.</p>

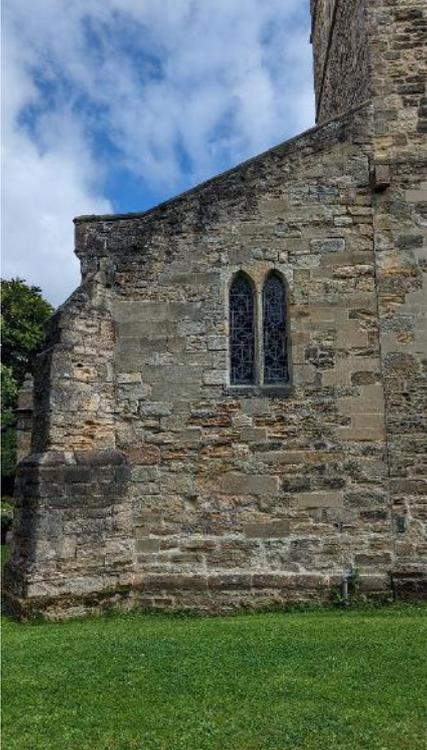
2.5.2.	<p>West End - Gable of South Aisle</p> <p>This has a two lancet window which has been replaced as elsewhere. The stonework around the window appears to be in reasonable order although some localised repointing is required to the bottom right of the window. Otherwise pointing is in reasonable condition – the lowest 1m was repointed in 2022. There is streaking below the parapet and the copings should be pointed and vegetation removed (refer to South Aisle roof). There is damp internally so this should be addressed as soon as is practicable.</p> <p>There are various very eroded stones in this elevation some of which will need replacement in the not too distant future. At the base of the plinth there are two cast iron access points to services beneath.</p>

2.5.3.	<p>Recommendations:</p>	
	B	<ul style="list-style-type: none"> West end generally: Stone work replacement needed (except upper tower)
	B	<ul style="list-style-type: none"> West elevation, north aisle: repoint stonework to window and localised areas to the bottom left and top right.
	B	<ul style="list-style-type: none"> West elevation, north aisle: remove vegetation and repoint open joints on completion.
	B	<ul style="list-style-type: none"> West elevation, south aisle: conduct localised repointing.
	E	<ul style="list-style-type: none"> Ground levels around the west end should be improved if damp becomes a problem internally.

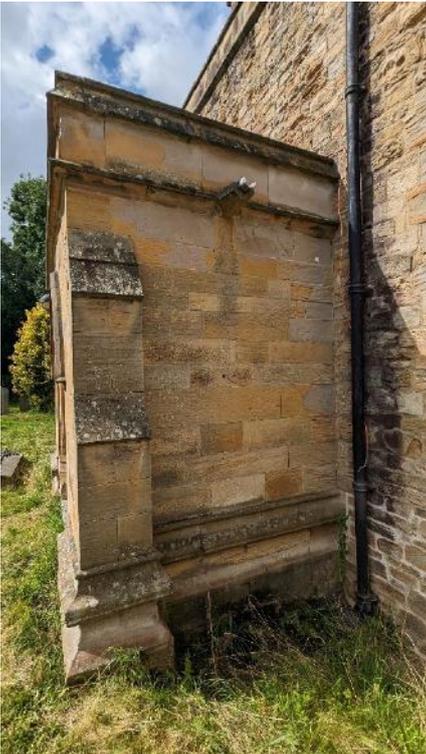
<p>2.6.3.</p>	<p>South Elevation: Wall above South Porch There are areas of severe erosion at this level and some replacement and pointing should be considered. There are a couple of open joints to the parapet (below the copings) that should be repointed.</p>

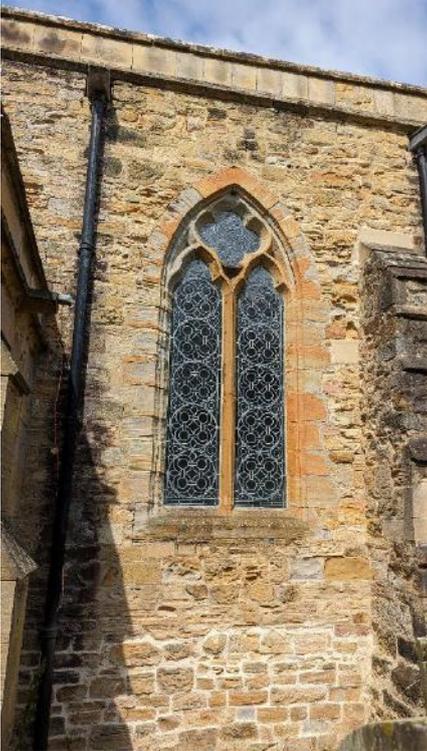
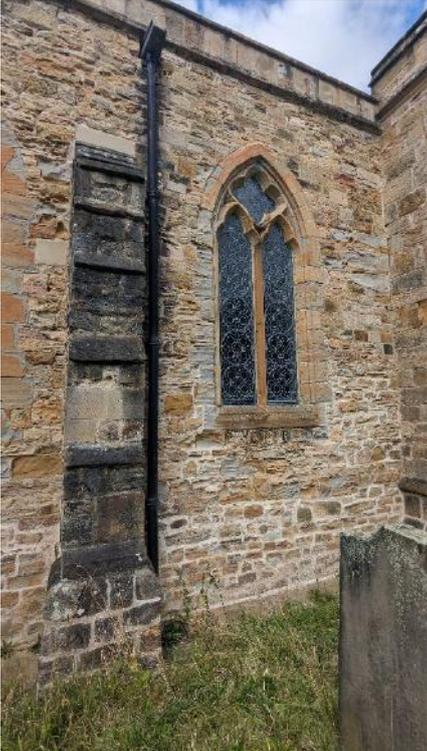
<p>2.6.5.</p>	<p>South Elevation: Bay Three From the West</p> <p>The buttress between Bay Two and Three is in reasonable condition however some of the coping stones are shaling somewhat. This should be noted.</p> <p>Bay 3 has a two lancet window as before with a quatrefoil above. The reveals and cill are original as previously apart from the inner section of the west reveal which may have been inserted post fire. The cill directly below the mullion has shaled and the flaunching at the base of the windows has cracked somewhat. A repair should be incorporated. The stonework to the entire reveal and head of the window has open joints and should be pointed in lime mortar.</p> <p>There are areas of severe erosion on this elevation and replacements should be considered along with localised repointing. The bottom metre of stonework</p>

<p>was repointed in 2022, along with an area to the bottom right of the window.</p> <p>The downpipe in this bay feeds into a gulley blocked with vegetation. This should be cleared and the downpipe checked for blockages generally as there is staining to the masonry behind the downpipe.</p>

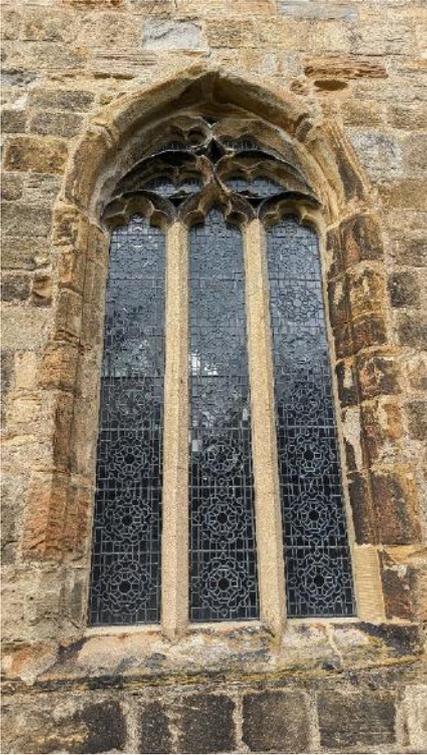
2.6.8.	<p>Lady Chapel: South Elevation Bay One from the West</p> <p>This has a three lancet window with decorated tracery above. The eastern reveal is well weathered and little of the moulding remains, but, the window tracery, parapet and plinth were pointed in 2022 and therefore the effects of weathering should reduce.</p>

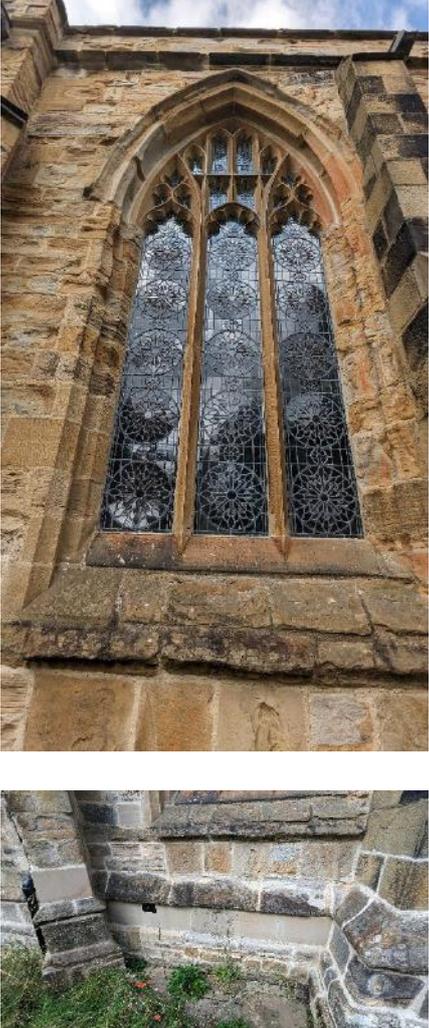
<p>2.6.9.</p>	<p>Lady Chapel: South Elevation Bay Two from the West</p> <p>This has a similar window to the one adjacent. The west reveal is very eroded, however, repointing in lime mortar and conservation mortar repairs were undertaken in 2022 across the bay (except the western buttress) to slow down weathering to the masonry and address the worst affected stones. New stones were inserted below the string course and to the base of the buttress. Further stone replacements may need to be considered in the future but this is not anticipated in this quinquennium. The elevation is currently in good condition.</p> <p>The downpipe has been connected to a new soakaway. The gully had a build up of vegetation – the gully and rodding points should be routinely cleared.</p>

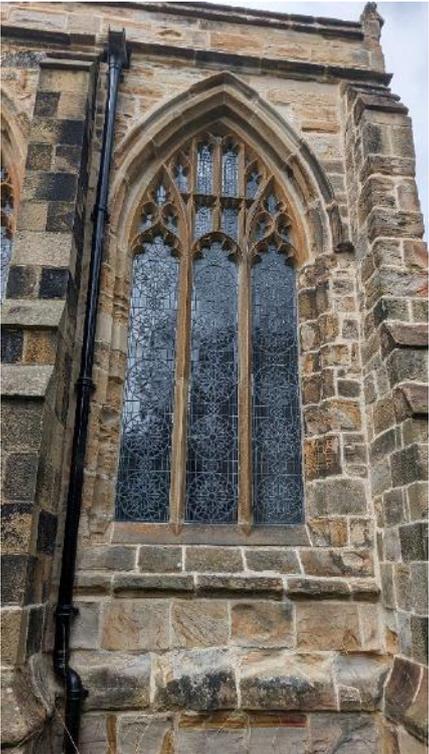
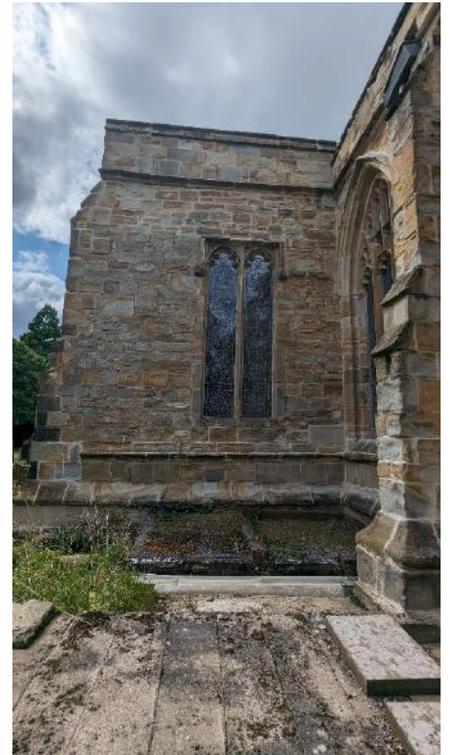
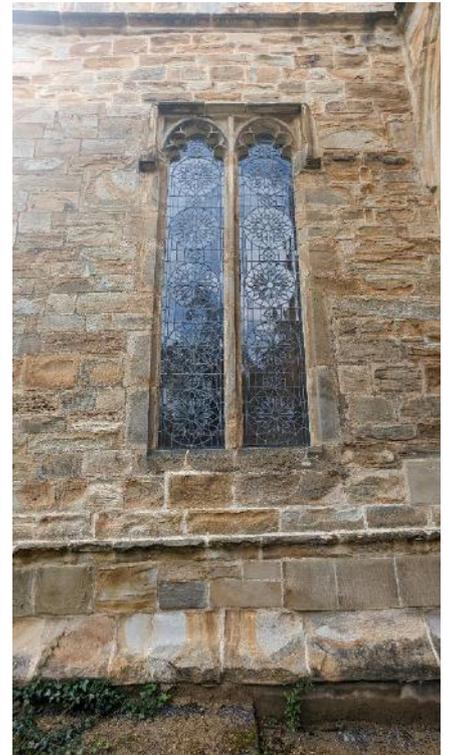
Lady Chapel: East Elevation Gable

There is a loose power cable pulled off the wall – requires removal if redundant.

2.6.11.		Recommendations:
	M	<ul style="list-style-type: none"> • Clear blocked gullies and downpipes throughout.
	B	<ul style="list-style-type: none"> • South elevations, Bays One to Three: replace eroded stone and repoint open joints and areas of hard mortar.
	B	<ul style="list-style-type: none"> • South elevation, Bay One: Repoint open joints to copings at west end.
	M	<ul style="list-style-type: none"> • South elevation, Bay One: Clear vegetation to overflow chute
	C	<ul style="list-style-type: none"> • South Porch: Repoint fine open joints to plinth, string course, hood mould and parapet.
	C	<ul style="list-style-type: none"> • South Porch: secure cables at high level.
	B	<ul style="list-style-type: none"> • South Porch: replace rusted gulley grate.
	D	<ul style="list-style-type: none"> • South Porch: refinish door.
	C	<ul style="list-style-type: none"> • South elevation, Bay Two: To the east of the South Porch; eroded stones require replacement below the window. Remove fixings.

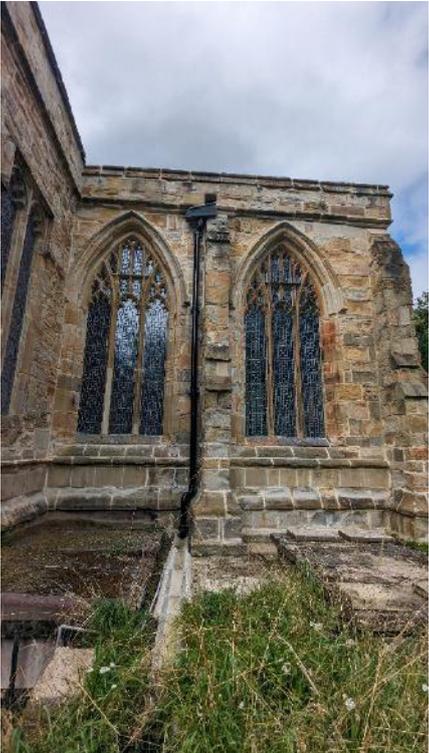
2.7.2.	<p>Chancel: South Elevation Bay Two from the West</p> <p>As adjacent this has a three light window with decorated tracery above.</p> <p>Pointing of the copings, window tracery and stonework beneath the window were undertaken in 2022 to address ongoing erosion. Stone replacement was conducted along and beneath the string course to address undermining of the parapet. Further stone replacements may need to be considered in the future due to previous erosion (eg window reveals and plinth) but this is not anticipated in this quinquennium. The elevation is currently in good condition.</p> <p>Note that there is an outlet from the roof over the first bay of the east end of the elevation and the overflow is working effectively, though it is evident that water is splashing up from the flat roof of the boiler house onto the plinth courses. Removal of the boiler house and an improved detail to be considered (refer to previous section).</p>

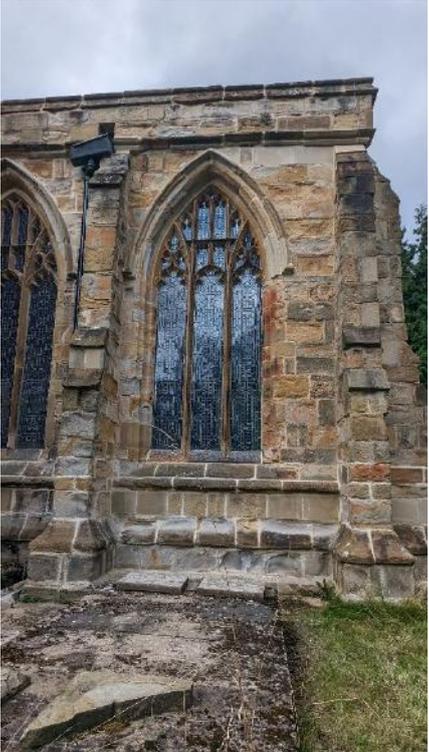
<p>2.7.3.</p>	<p>Buttress to the East of Bay Two from the West The weathered stone to the top of the buttress and a few other stones were replaced in 2022 and mortar repairs and repointing undertaken at low level. Replacement stone was also made to the adjacent buttress at low level. It is now in good condition.</p>

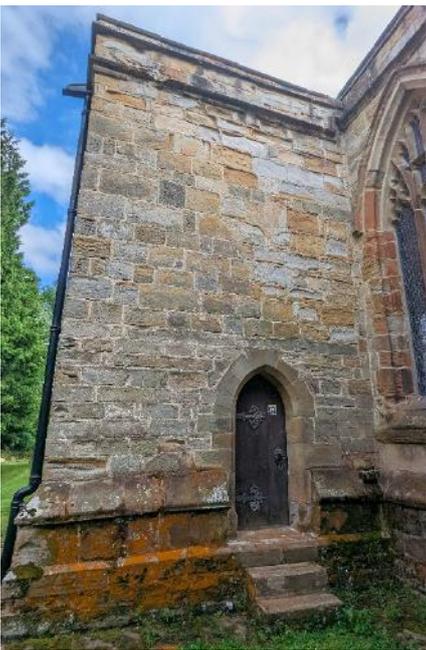
There is some orange algae at plinth level and moss to the flagged area. The moss to the flags should be removed as this is a slip hazard.	
2.7.9.		<p>Chancel: North Elevation This short elevation is split into two bays. There is a build up of moss to the flagged walkway which should be cleared as this is a slip hazard.</p> <p>Bay one from the East The easternmost bay has a three lancet window with decorated tracery above. Mullions and tracery appear to be in good order. The reveals are well eroded and there are some fixings which need removing from them. Open joints at the head require pointing. The elevation is well pointed however there is a small amount of stonework just above the overflow which requires repair. The new lead overflow does not follow the line of the original stone overflow.</p> <p>The plinth has a build up of moss and lichen and may be damp. Re-pointing in lime mortar is advised.</p>

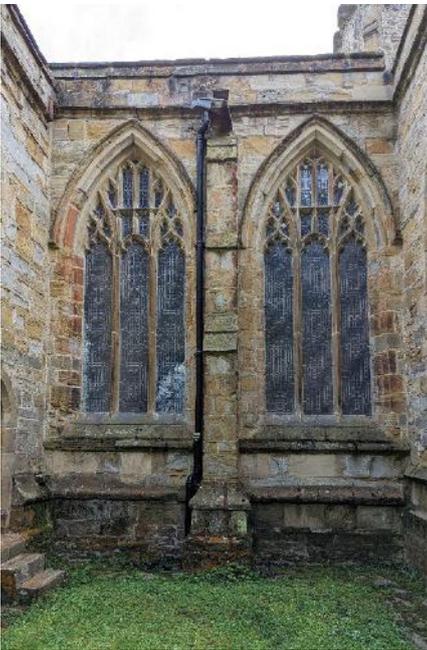
2.7.10.		<p>Bay two from the East This also has a three lancet window with tracery above. Mullions and tracery appear to be in good order and the reveals somewhat less eroded than the window adjacent. The pointing is in good order. The buttress appears to be sound.</p> <p>The plinth has a build up of moss and lichen and may be damp. Re-pointing in lime mortar is advised.</p>

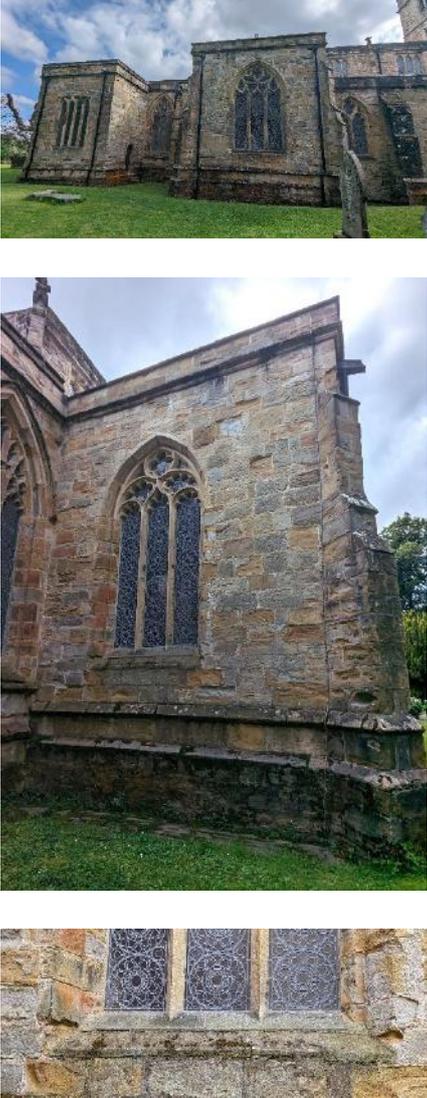
2.8.2.	<p>North Transept: North Elevation</p> <p>This has a three light window with tracery above. There are small fixings around the window stonework which require removal. However, the stonework around the window appears to be in reasonable order.</p> <p>The wall stones are suffering from erosion as elsewhere. Some areas of pointing are required:</p> <ul style="list-style-type: none"> • at the joint with the flagged walkway • below the lower string course • at higher level to the bottom left of the window hood mould <p>The downpipes and overflows appear to be working well and are free flowing.</p>

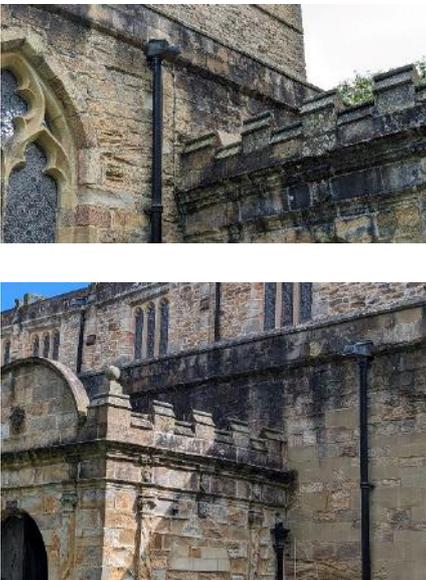
2.9.4.	<p>North Aisle: North Elevation, Bay Four</p> <p>This is a blind bay with a considerable amount of replaced stone which is in dressed and tooled ashlar which appears rather unsympathetic. The pointing appears to be in reasonable condition. This elevation also has a vent constructed in stone as on the South side.</p>

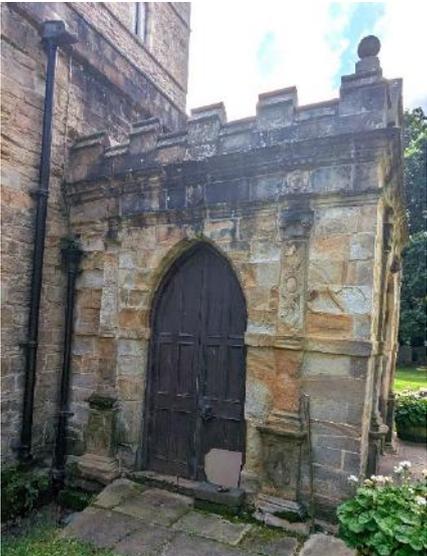
carved decoration depicting ionic columns with rusticated stonework and carved stonework. The details of these pieces of stone are being at risk of being lost by erosion. Above the pilasters are faces carved in stone and above those small set forwards with dental moulding. There is a downpipe in the corner – the outlet is blocked and requires clearing.

2.10.4.	<p>M</p> <p>C</p>	<p>Recommendations:</p> <ul style="list-style-type: none"> • Vigilant maintenance is required to ensure the good order of the porch. The outlets are blocked and require clearing. • Carry out 3D recording of the carved details for archive purposes.

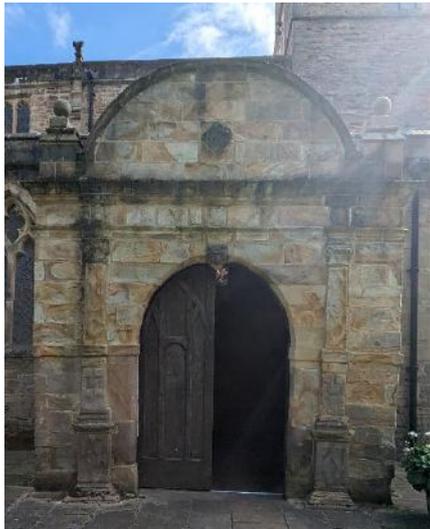
2.10.3.		<p>North Porch: West Elevation</p> <p>This elevation has an opening which has been blocked up with stone. One is severely eroded. There is a carved keystone as before and two flanking pilasters. At higher level there is a daylight sensor for the lights.</p>

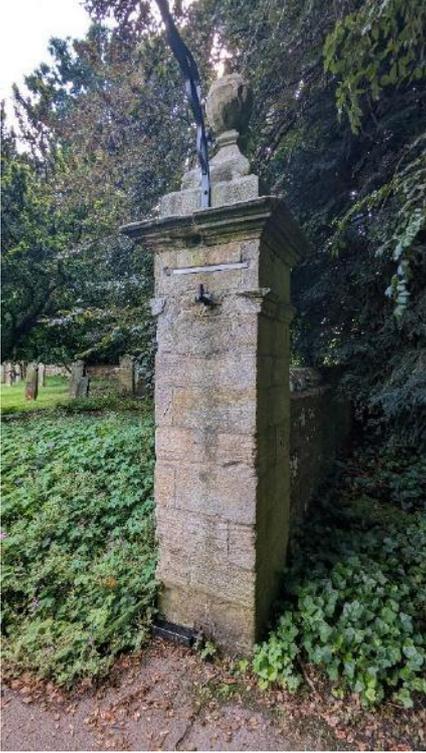
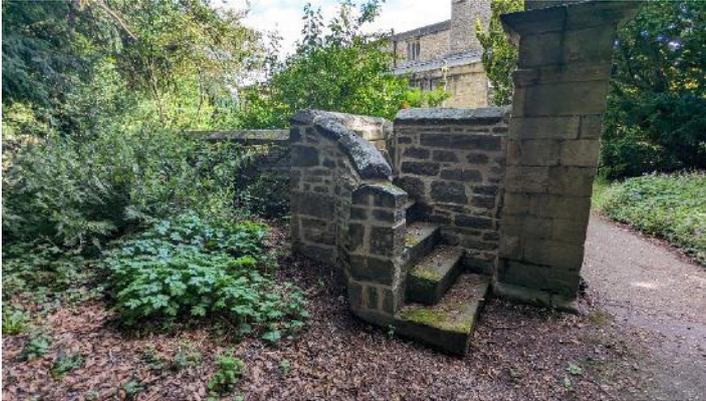
<p>2.12.3.</p>	<p>Most of the boundary walls are obscured by foliage however where they are visible, joints are open in places and re-pointing and consolidation should be considered. There are a few locations where coping stones have been lost – these should be replaced to avoid further damage to the wall.</p>

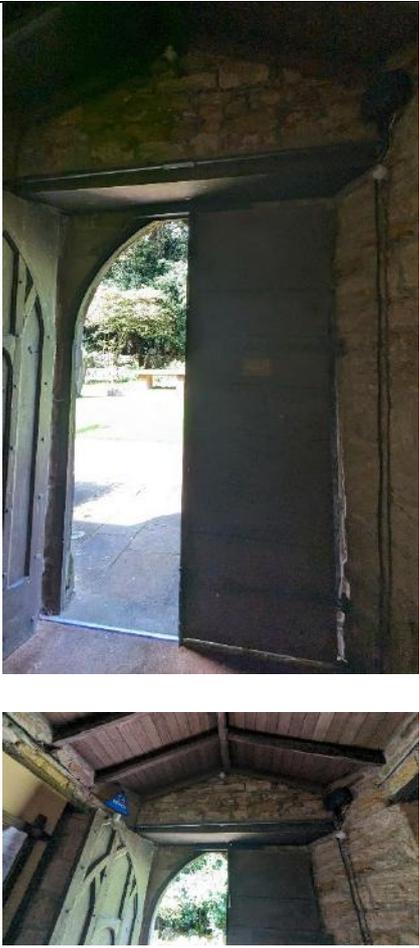
<p>3.1.2.</p>	<p>North Porch: West wall</p> <p>The blocked up doorway has a seat built into it. Below that the stonework is in poor order and should be re-pointed and a couple should be replaced.</p> <p>Within this space there is an ADT fire and security panel. A notice board has been introduced since the last QI to hide these services. The wiring on timber listed in the last QI is still visible and could be improved if possible.</p> <p>To the east and west walls, there are large cross slabs, displayed vertically.</p>

3.1.6.	<p>Recommendations:</p>	
	<p>D • North Porch: West wall, improve unsightly wiring.</p>	
	<p>B • North Porch: internal stonework repairs are generally required (below seat to west wall and above door to north wall).</p>	
	<p>C • North Porch: East wall, replace lost strap hinge to door.</p>

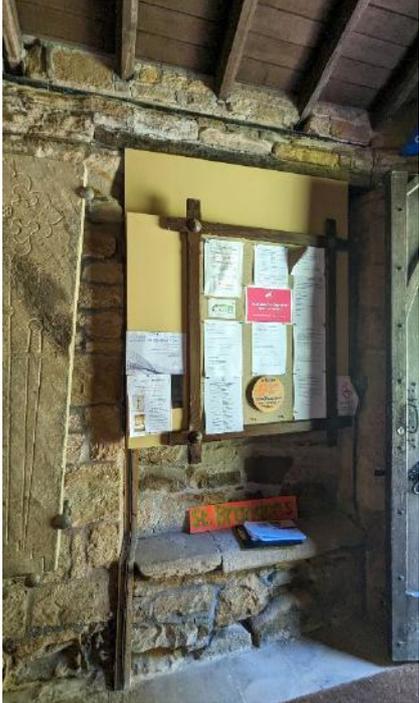
<p>3.1.3.</p>	<p>North Porch: South wall</p> <p>On the south wall of the North Porch there is a fire break glass box and an ADT punch pad. The lantern has been put in above the doorway.</p> <p>The oak door was installed post fire and has hand forged nails and handmade ring latch.</p>

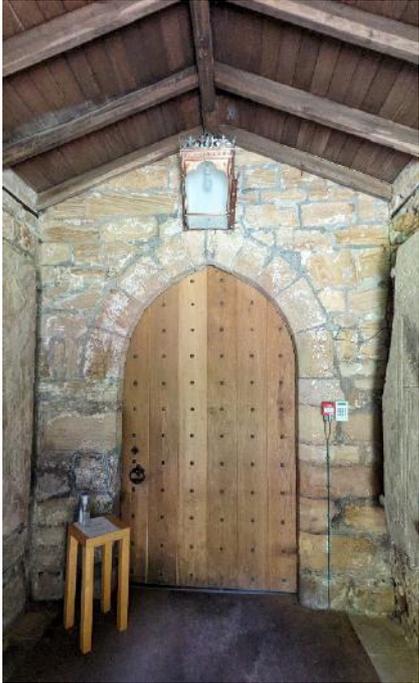
<p>3.1.4.</p>	<p>North Porch: East wall</p> <p>To the east elevation of the porch there is a stained oak door which is bolted and has a timber bar across it and it isn't used normally. One strap hinge is missing. The ferrementa should be redecorated.</p>
