INSPECTION AND REPAIR OF CHURCHES

CARE OF CHURCHES MEASURE 1991

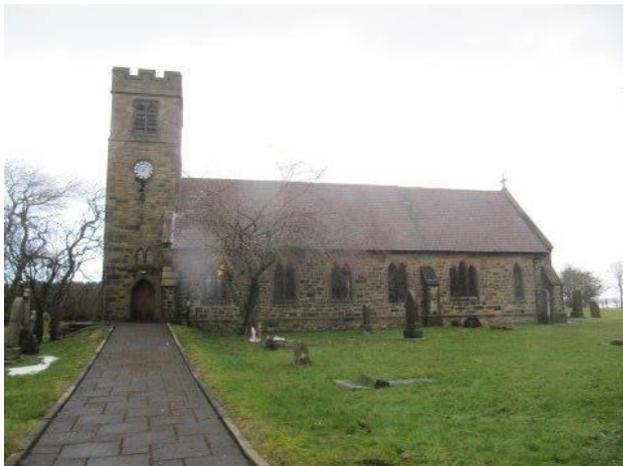
**QUINQUENNIAL REPORT on the
THE CHURCH OF ST JOHN the EVANGELIST
BURNHOPE**

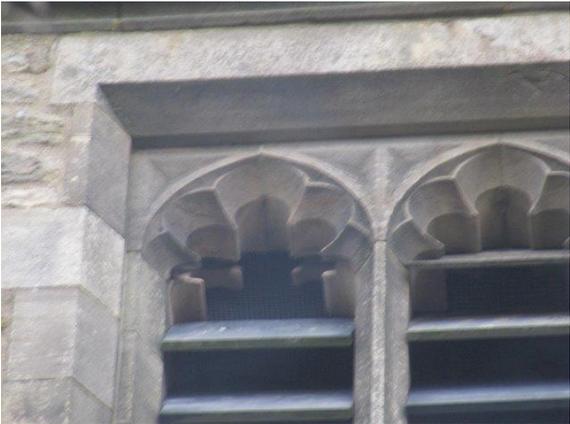
Missing louvre to South Elevation of tower

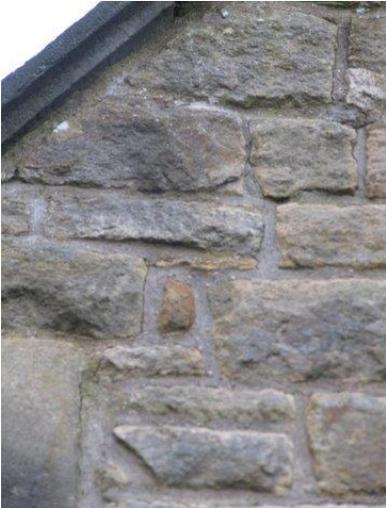
Cracking to East gable of Chancel

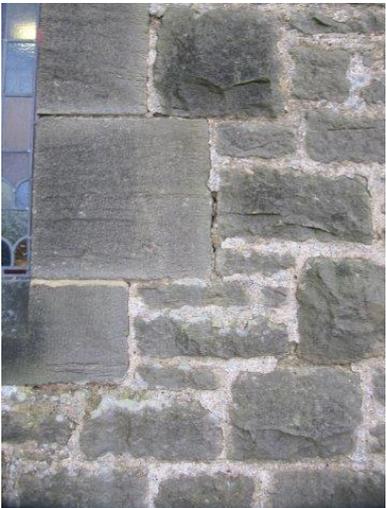
Missing mortar to North Elevation of Vestry

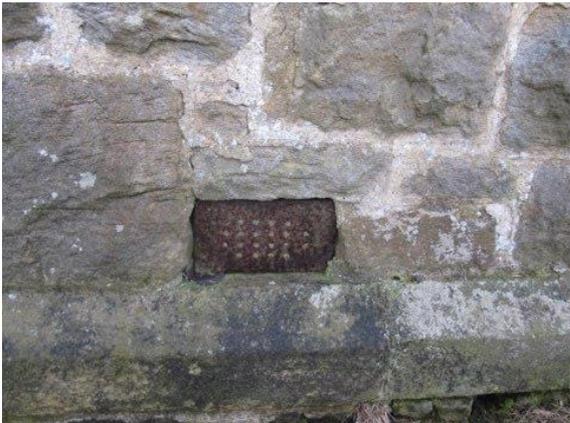
Rusting and filled vents to Vestry

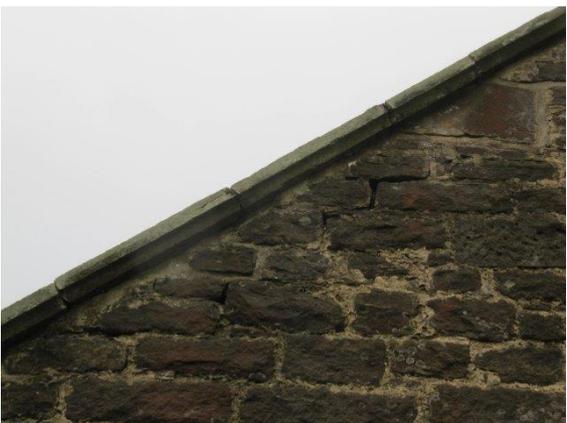
Open joints to North Elevation of Vestry

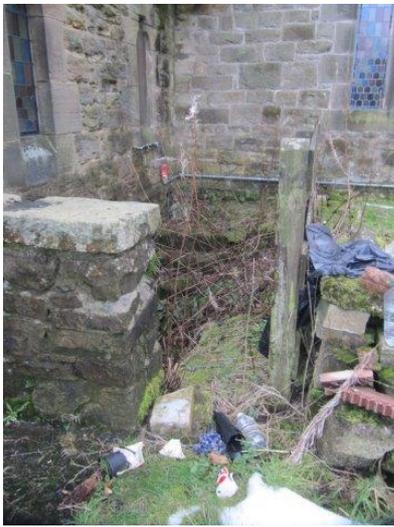
Gap in barrier to side of stairs and collection Of discarded and broken objects

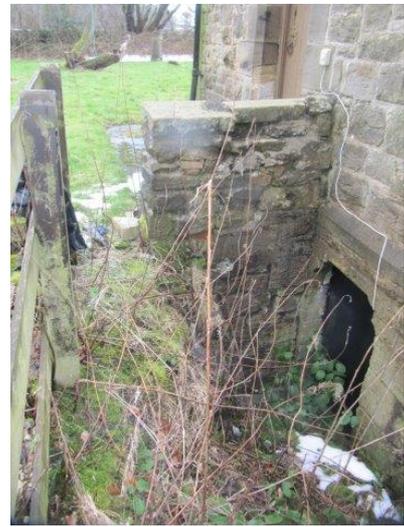
Vegetation ad debris to boiler room steps

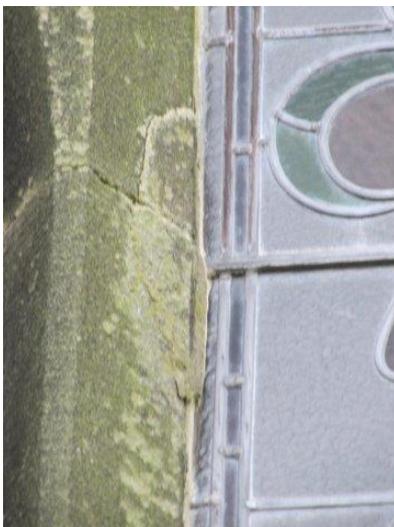
Crack to mullion East window of Chancel

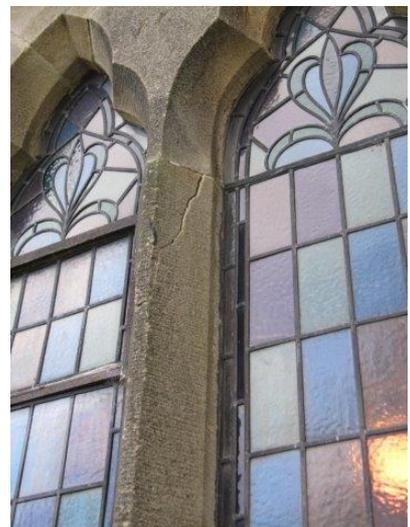
Crack to mullion North Nave window

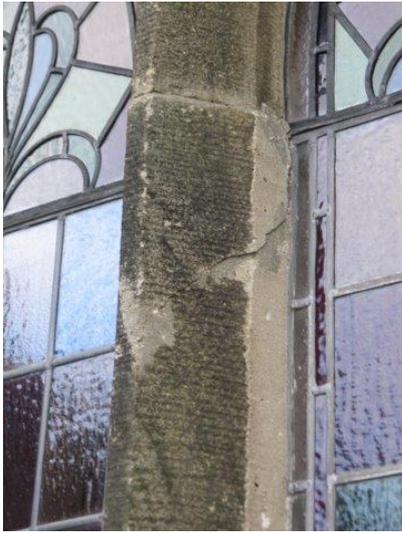
Crack to mullion North Nave window

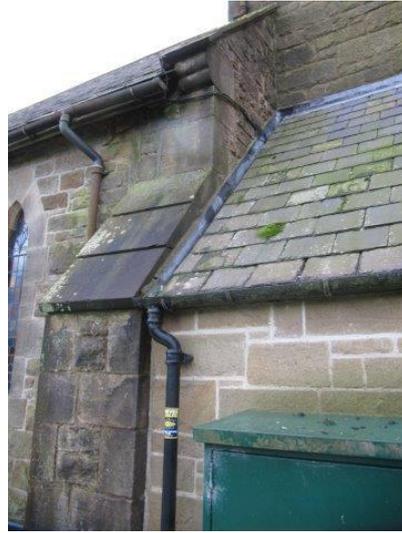
Buttress to West of Nave

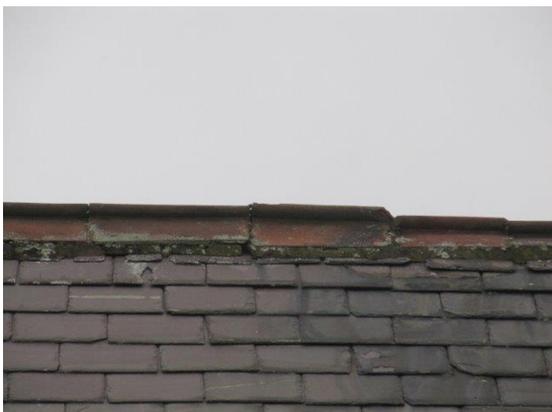
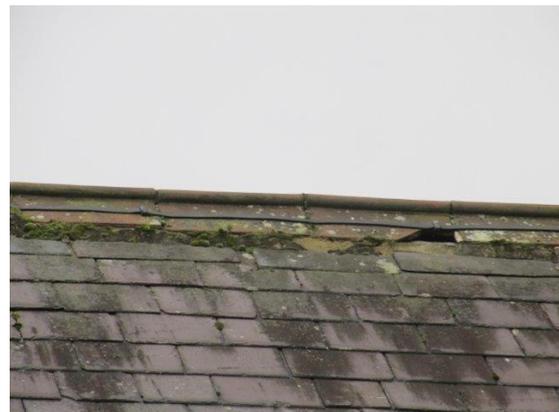
Missing mortar to South Nave/Chancel roof and cracked ridge to North Nave roof

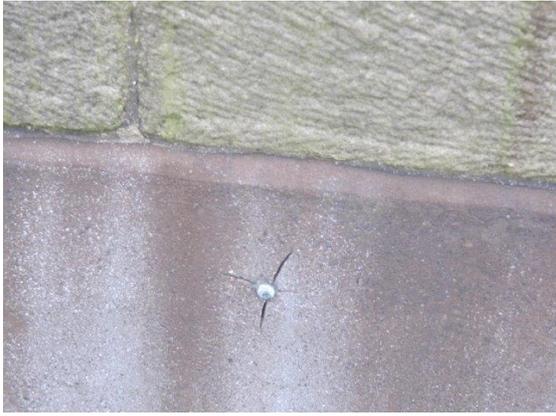
Splits in Tower asphalt around metal pin

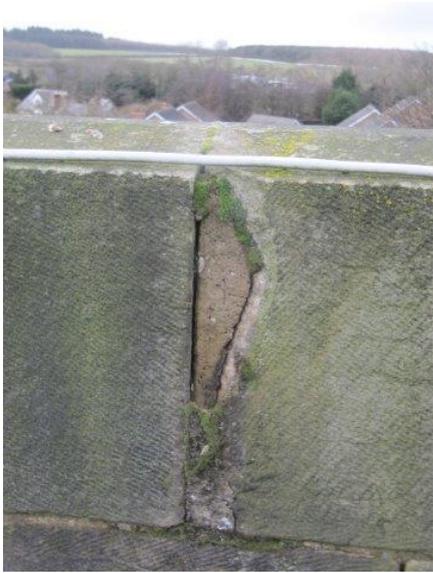
Failing mortar repair to tower parapet

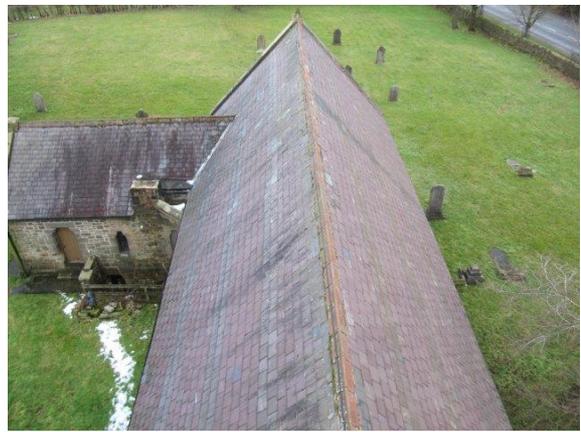
General view of main roof looking East

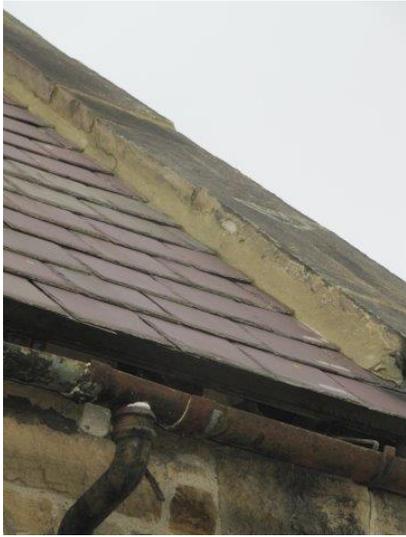
Rusting gutter and slightly sloping section of gutter to North Nave

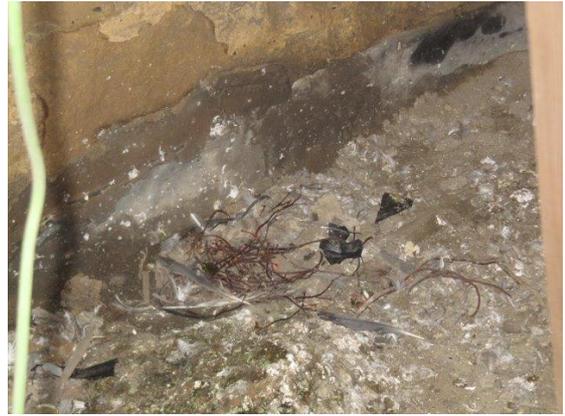
Pigeon droppings to tower

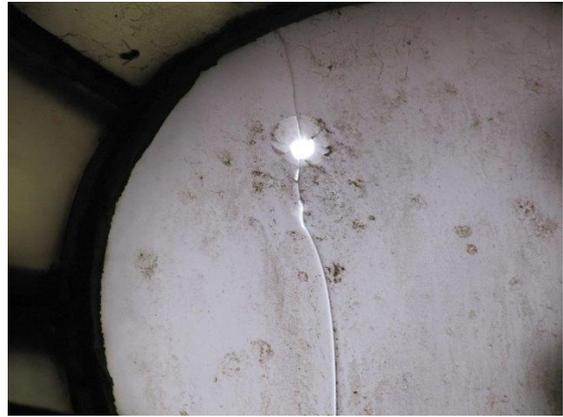
Crack and shot hole to clock face

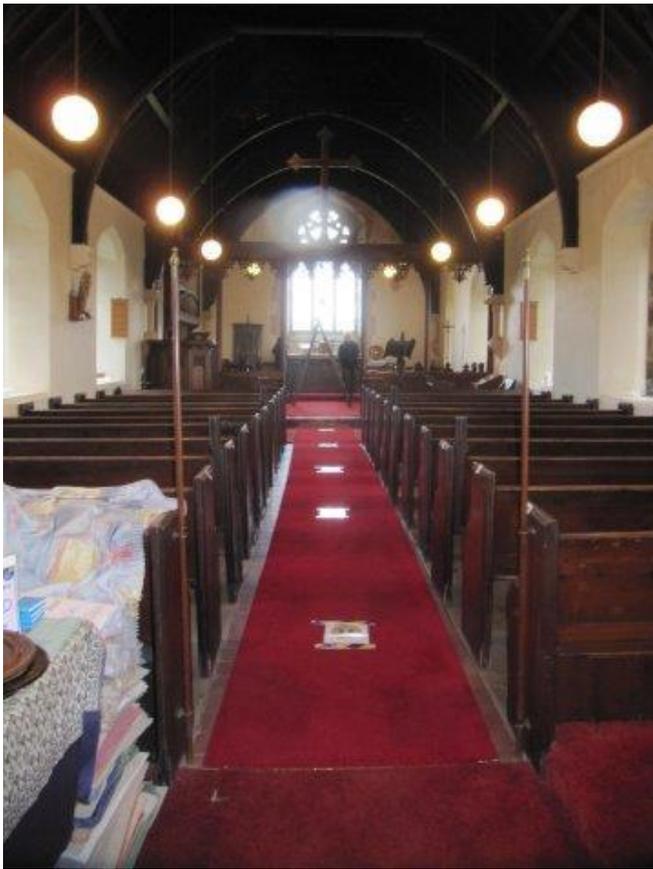
General view of Nave and Cancel looking East

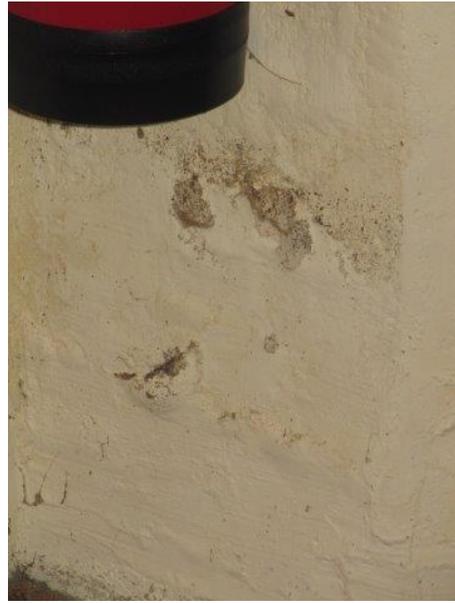
Failing plaster to base of porch wall

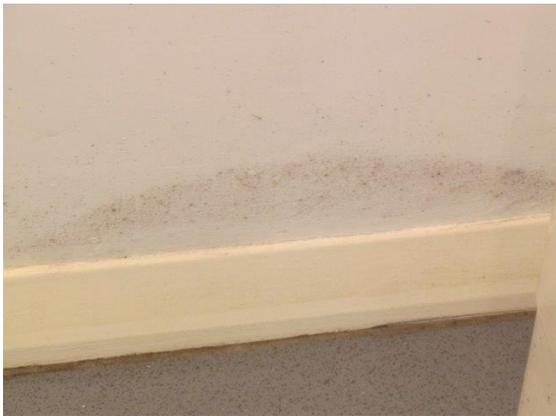
Damp/mould to base of WC wall

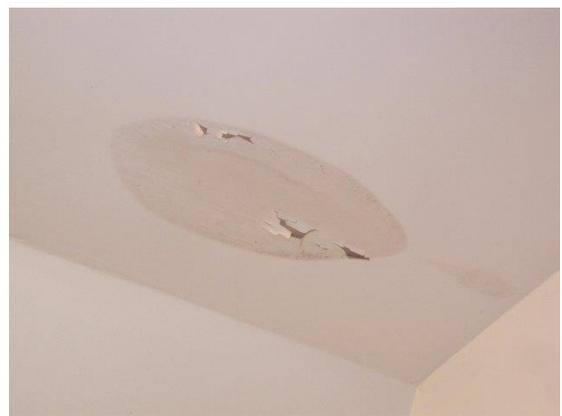
Damp staining and flaking paint to WC ceiling

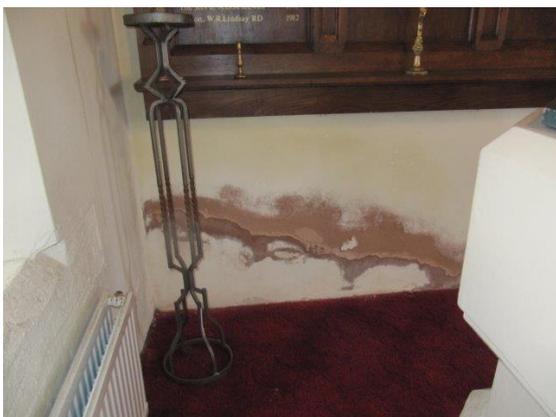
Failing plaster to West wall of Nave

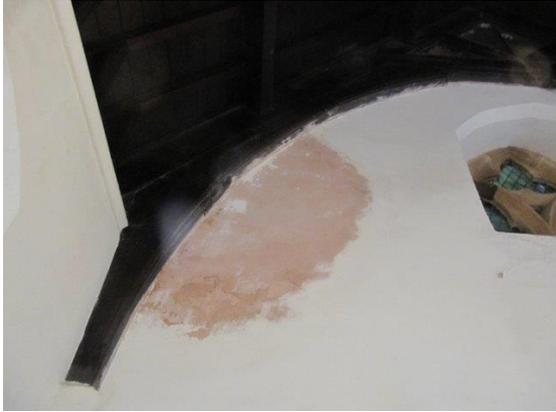
Exposed plaster at high level to West wall of Nave Failing mortar to North Nave window

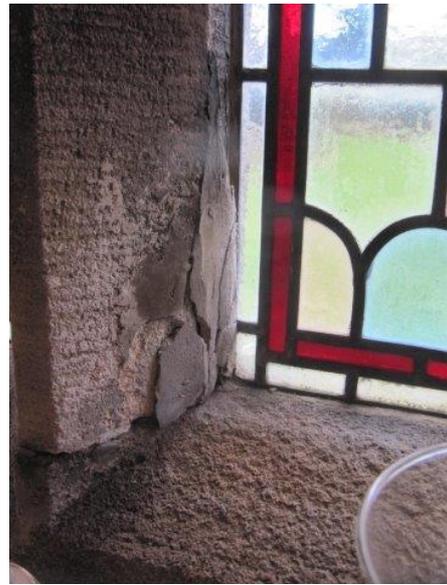
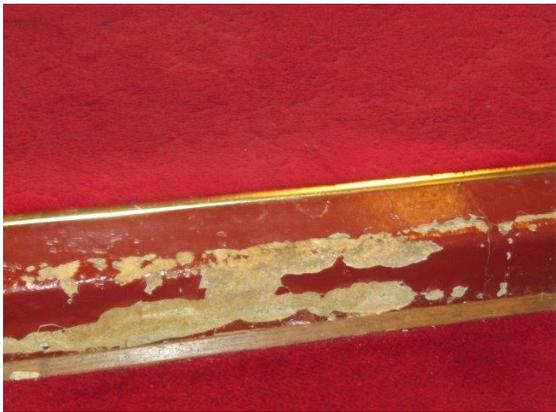
Failing paint to Chancel step revealing sanding stone behind

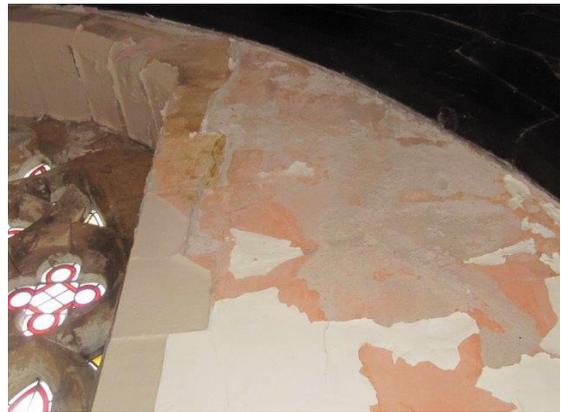
Exposed and potentially damaged plaster to East wall of Chancel

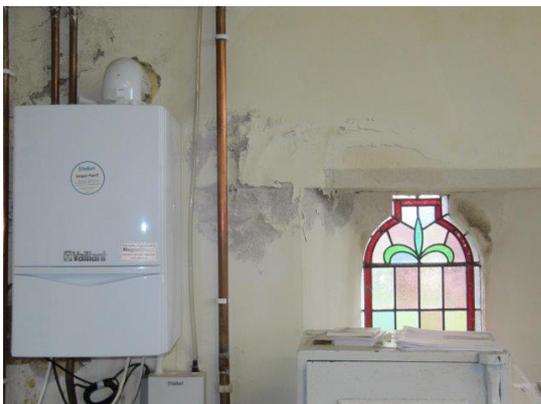
Damaged plaster behind boiler

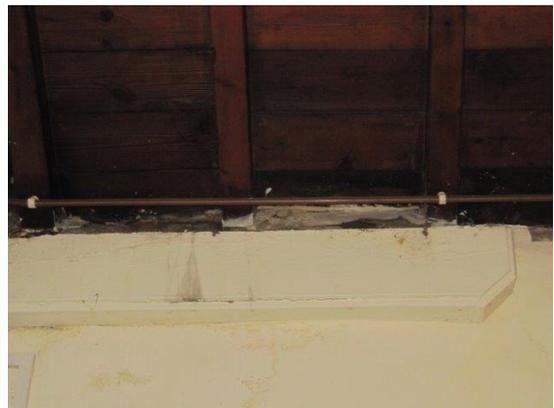
Damaged wall plate in vestry

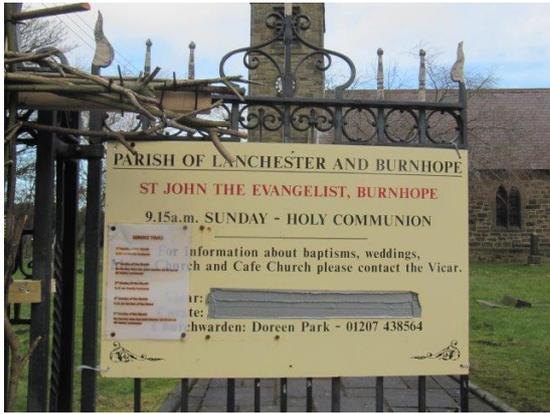
Noticeboard with taped corrections

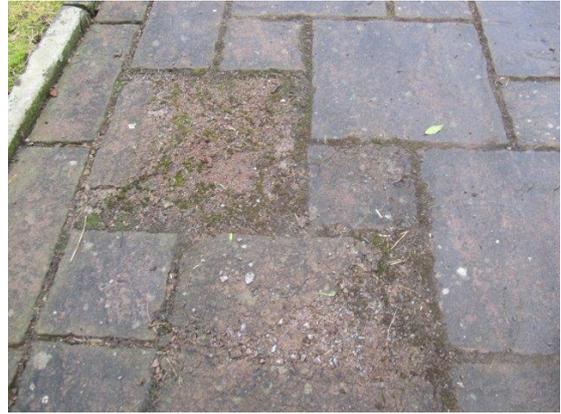
Damaged paving slabs to main path

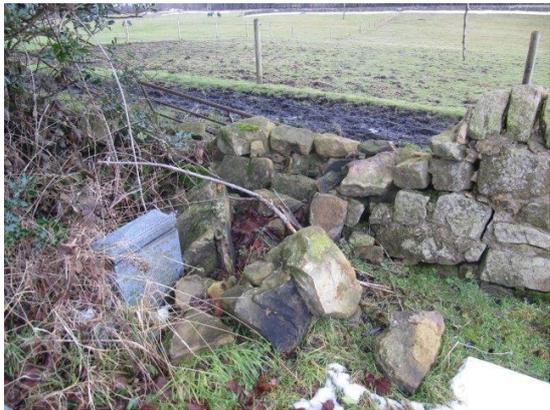
Fallen section of wall to North side of newer graveyard

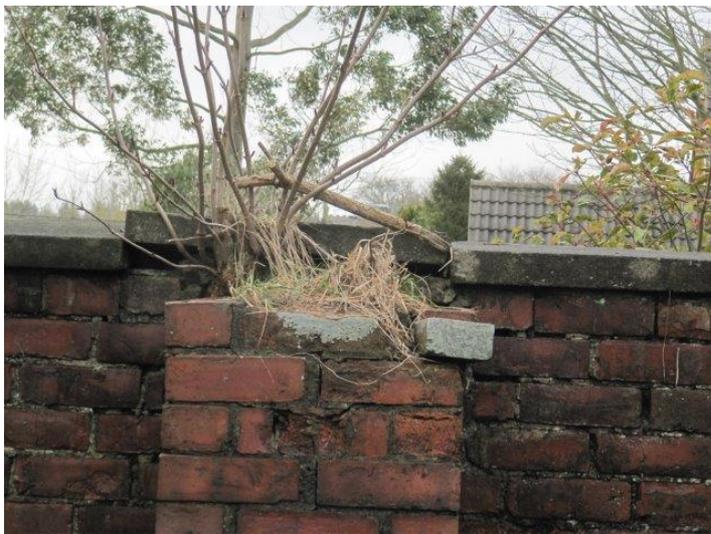
Damaged section of Western boundary with sapling, vegetation growth, open joints and lifted copings
