INSPECTION AND REPAIR OF CHURCHES

CARE OF CHURCHES MEASURE 1991

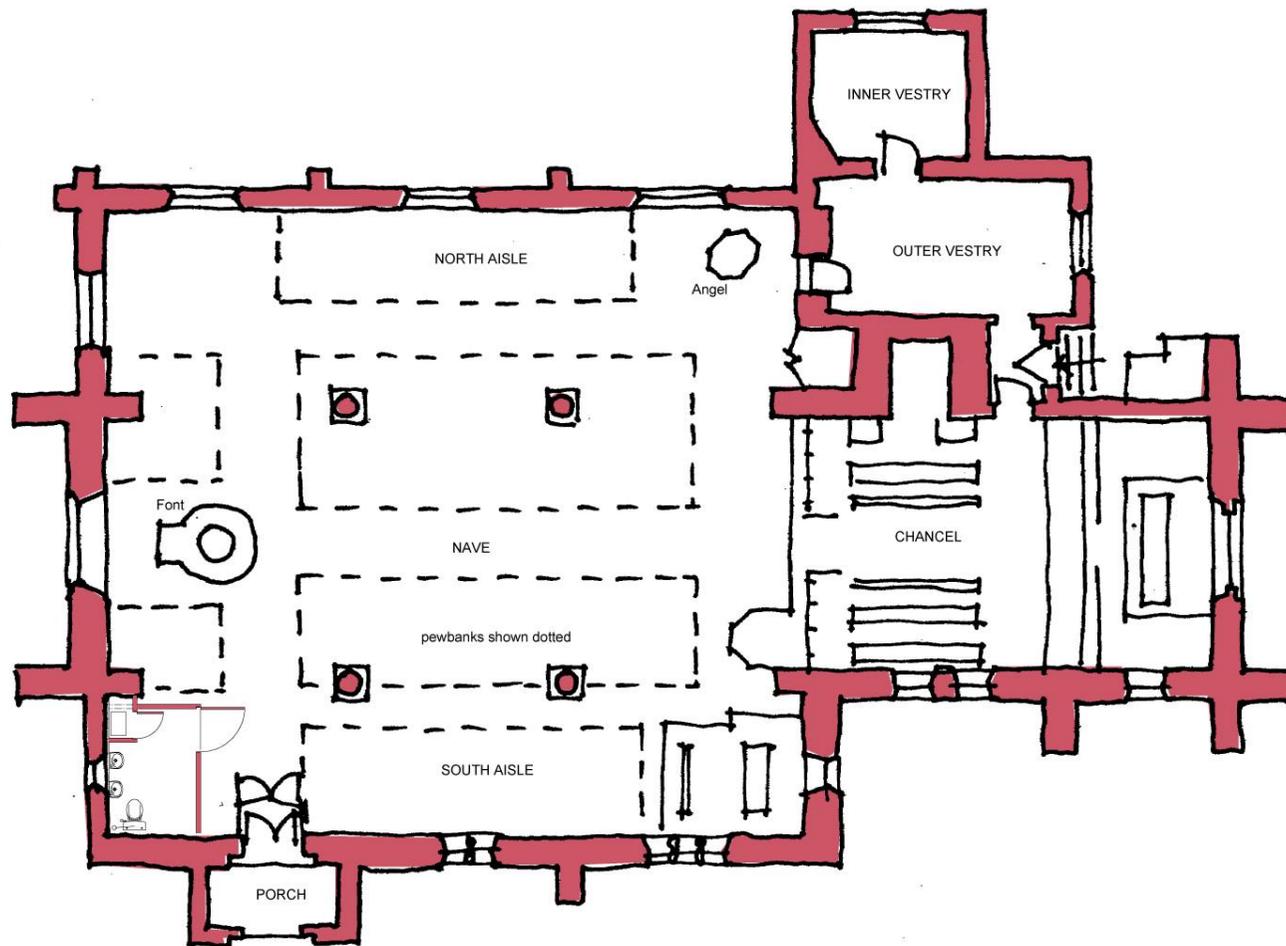
ST BARNABAS BURNMOOR 2014 QI
SKETCH PLAN AS EXISTING DO NOT SCALE

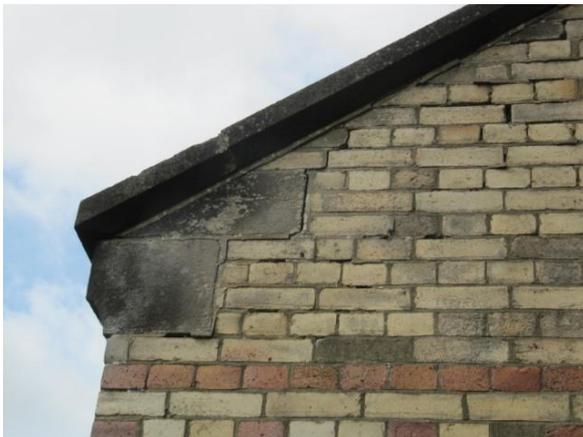
Crack to East elevation of the South Aisle

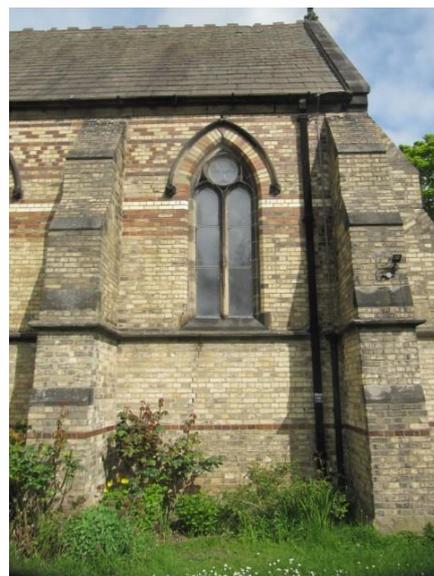
South Elevation of the Chancel currently being monitored due to movement

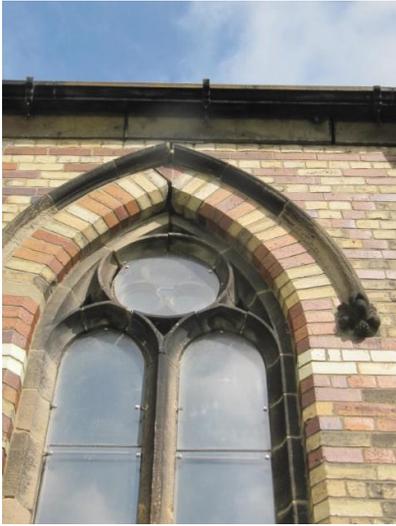
Cracking through the tracery and below the cill of the south Elevation of the Chancel

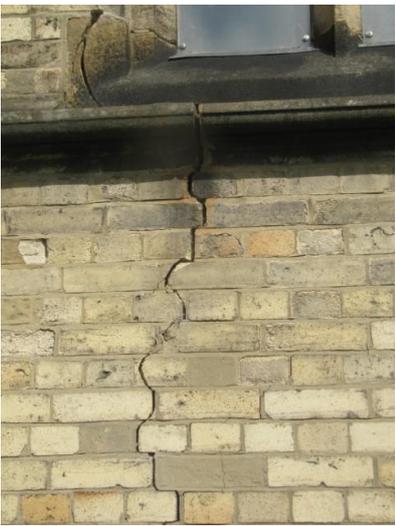
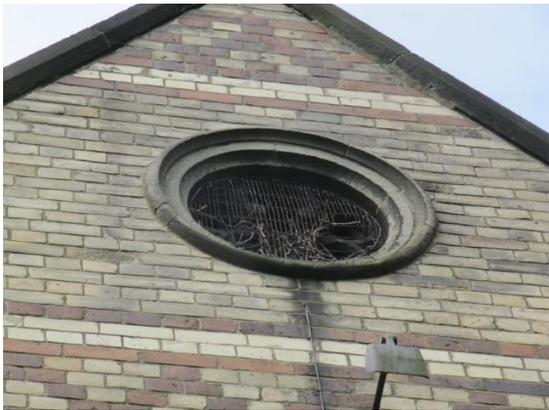
Damaged mesh to opening on the East Elevation Of the Chancel

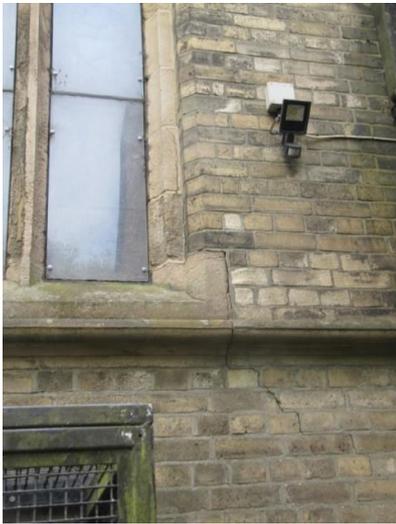
Cracking to North Elevation of the Chancel

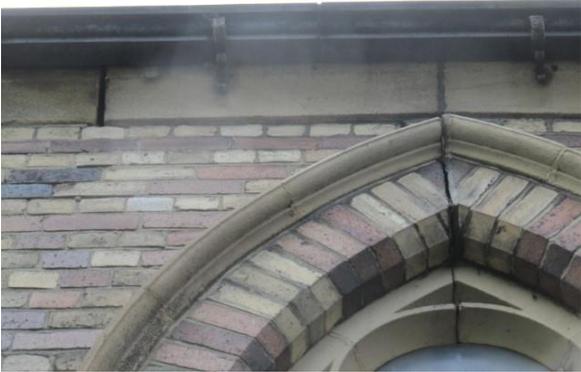
Cracking to North Elevation of the Chancel Of the Chancel

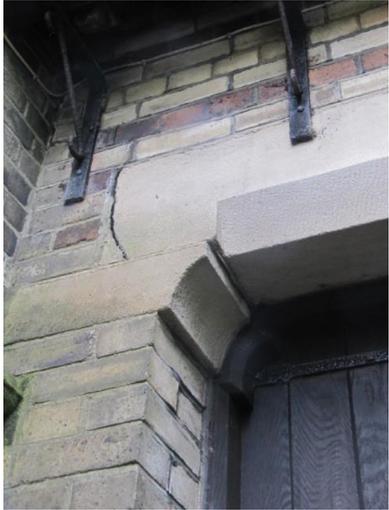
Cracked Lintel to rear entrance door

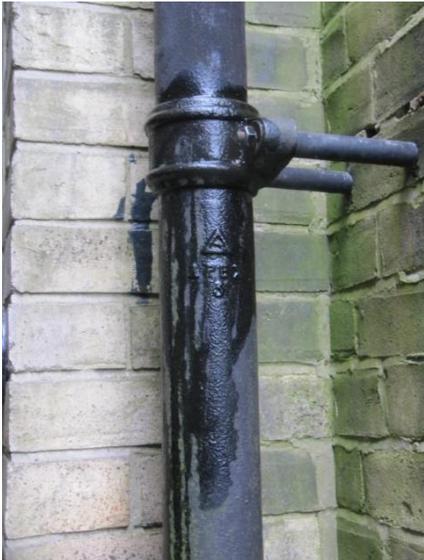
Leak to Downpipe by rear entrance door

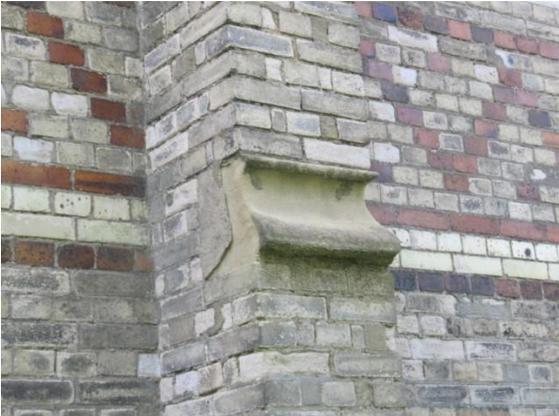
Weathered stone to North Aisle buttress

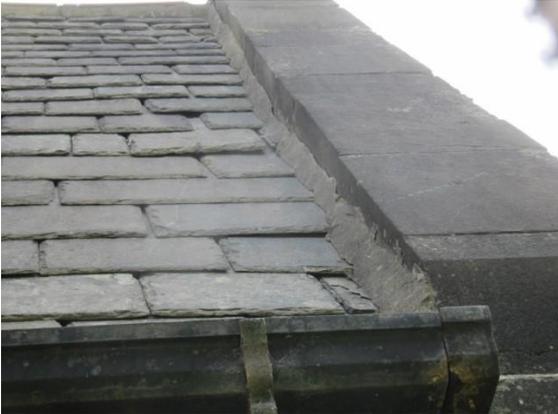
Cracked mortar fillet to porch roof

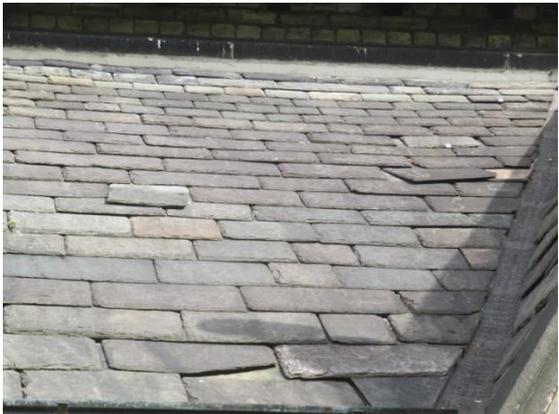
Slipped slates to South Aisle roof

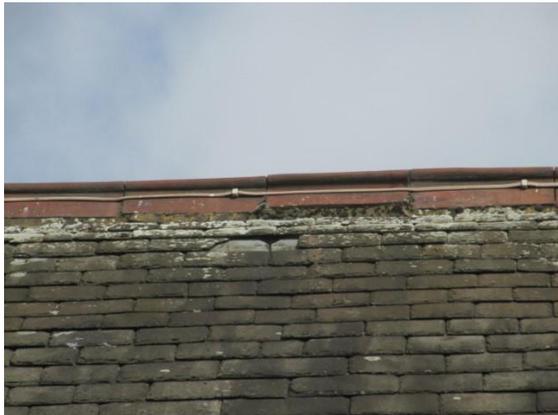
Slipped slate and missing mortar to ridge to Nave

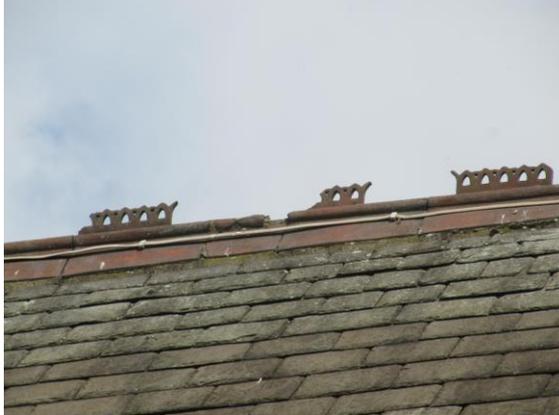
Weathered ridge tiles to the Chancel roof

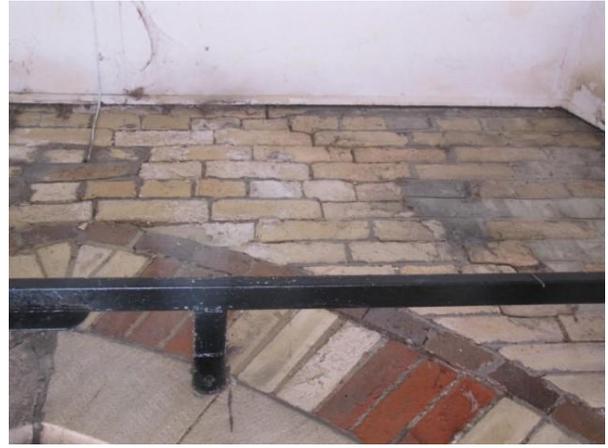
Salts and damaged bricks to porch over main door

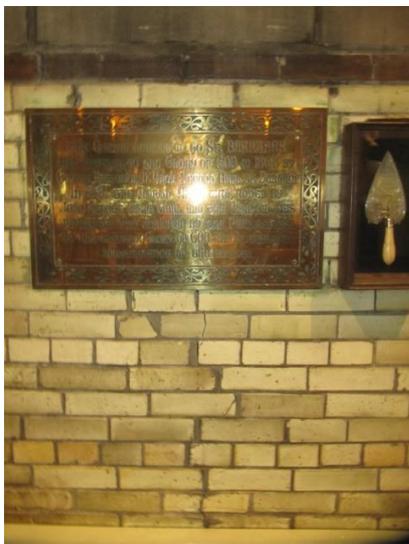
Cracking to West wall of the Nave

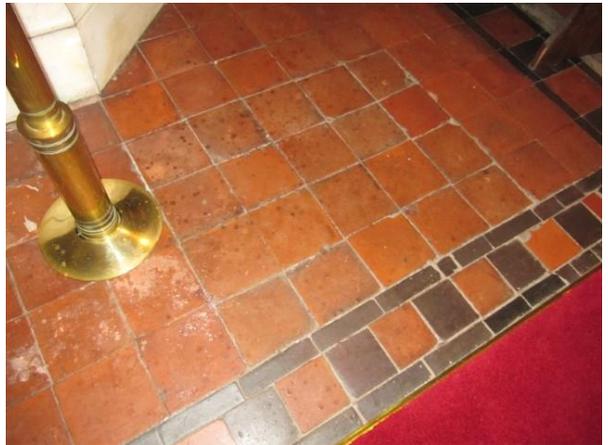
Slightly sunken area of floor to the East of the Nave

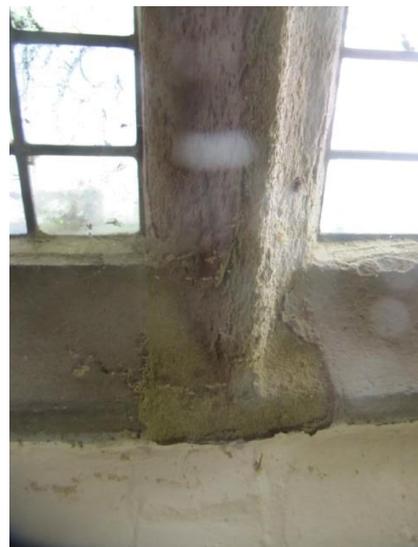
Failed coating and stonework behind in the Vestry.
