INSPECTION AND REPAIR OF CHURCHES

CARE OF CHURCHES MEASURE 1991

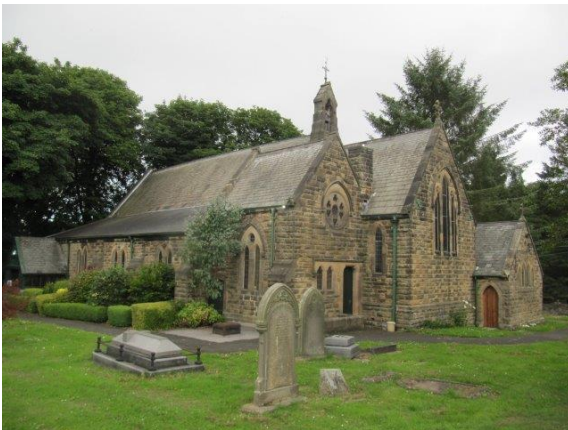
**ST JAMES CHURCH
BURNOPFIELD
Co. DURHAM**

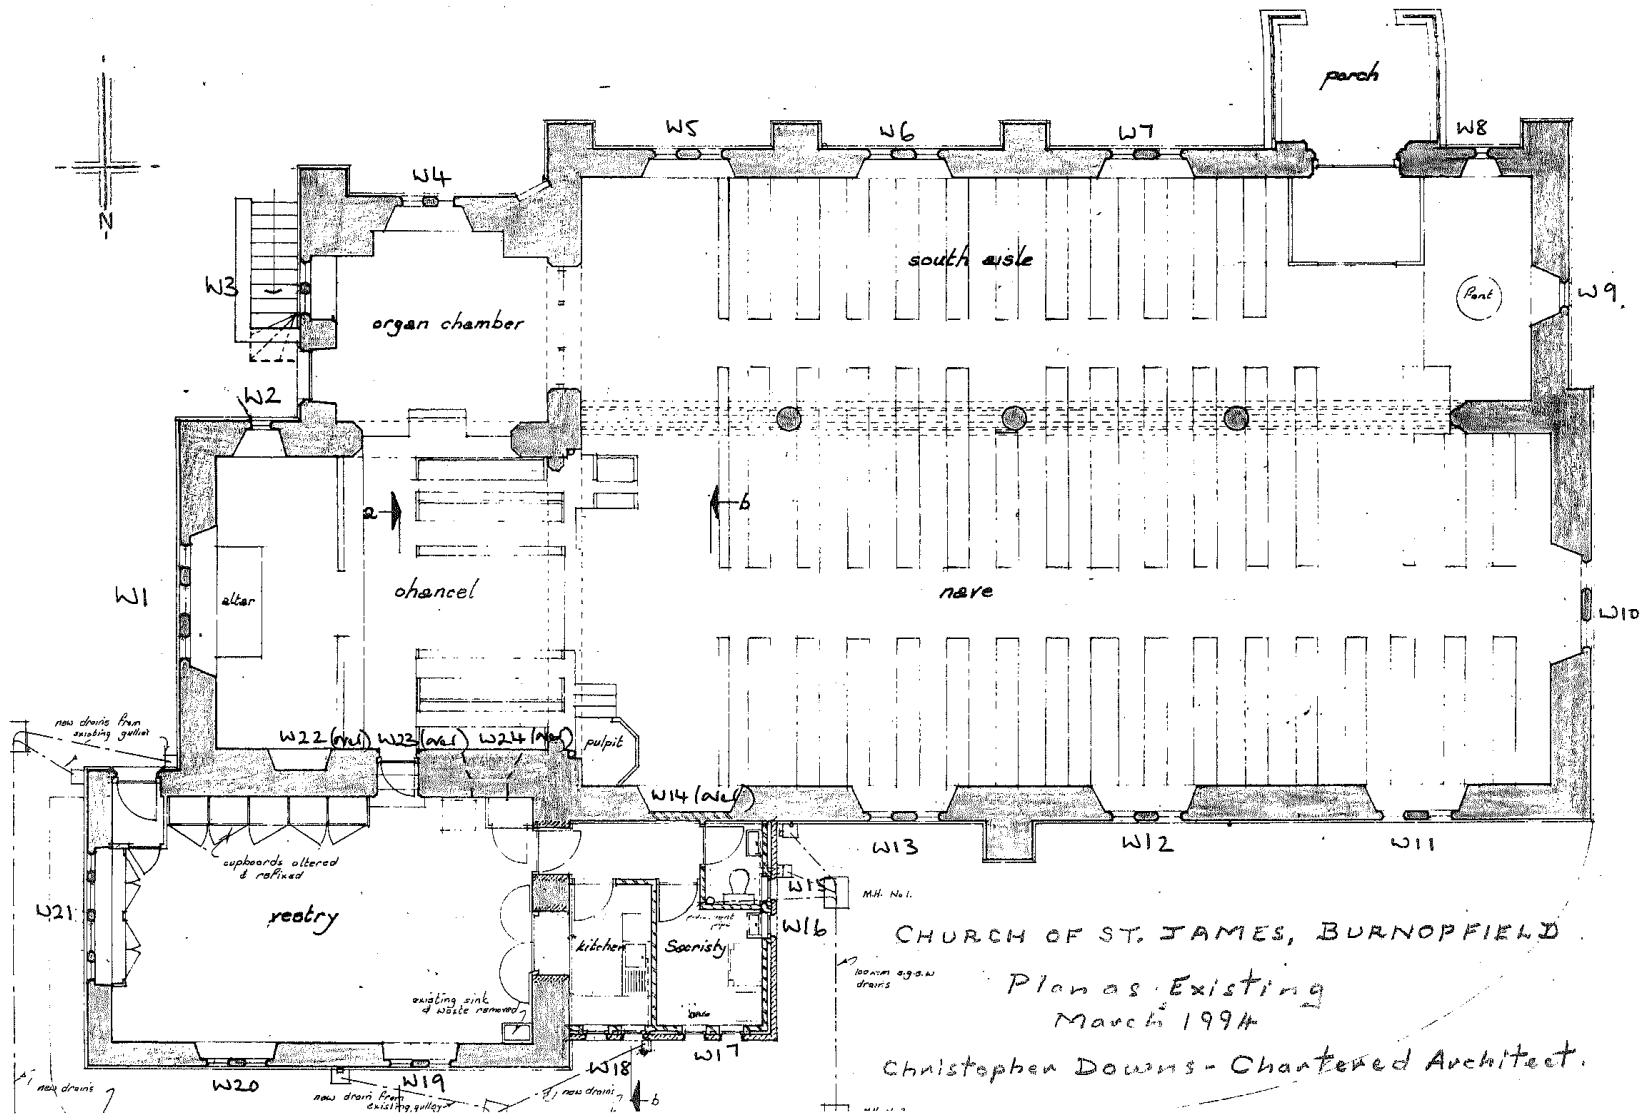
CHURCH OF ST. JAMES, BURNOPFIELD
Plan as Existing
March 1994
Christopher Downs - Chartered Architect.

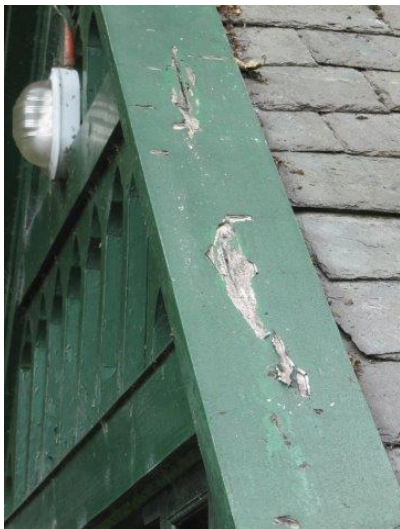
Bare wood and peeling paintwork to porch

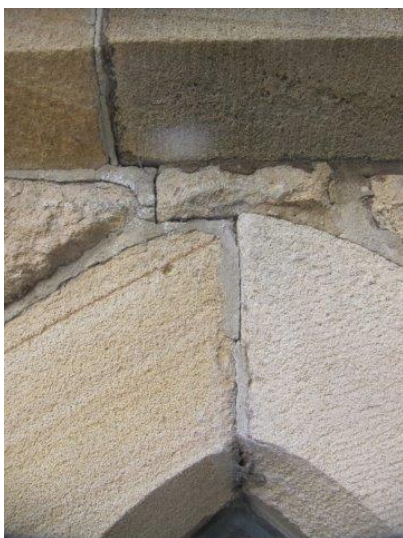
Cracking above windows on North elevation of Chancel and damage to quoin in the same area

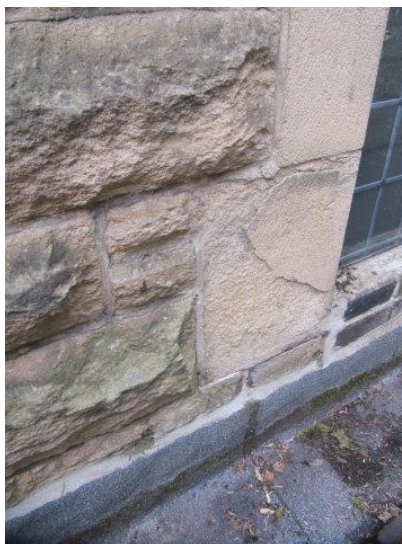
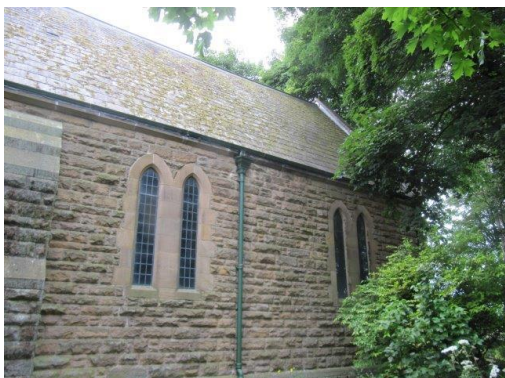
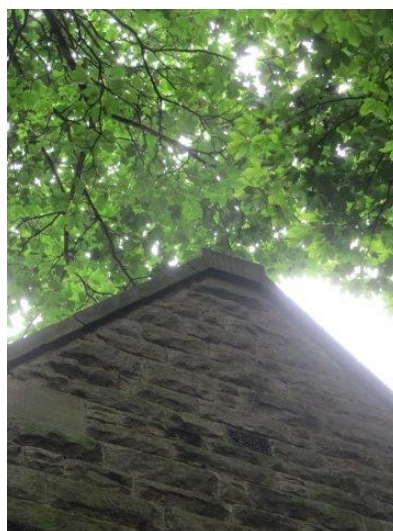
Overhanging branches from mature trees at the West end of the church need trimming where these are too close to the building fabric

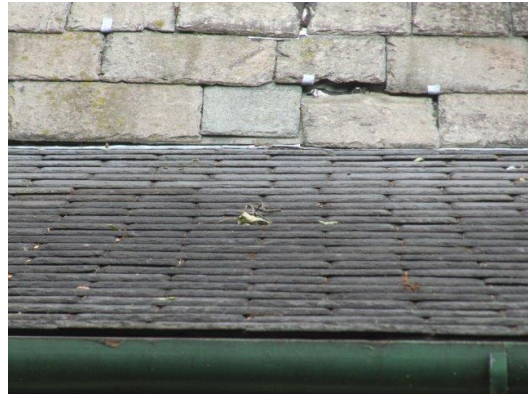
Cracked slate to South slope of the Nave roof (this was noted in the previous report)

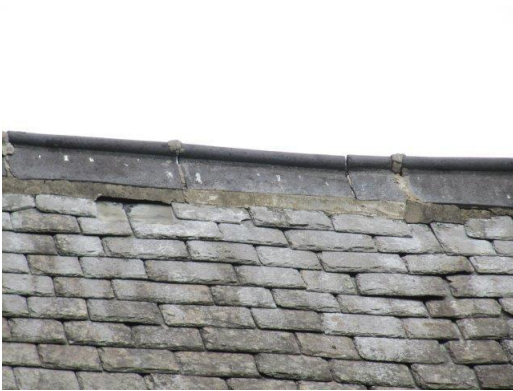
Failing mortar bedding and failing mortar fillet to roof over organ chamber

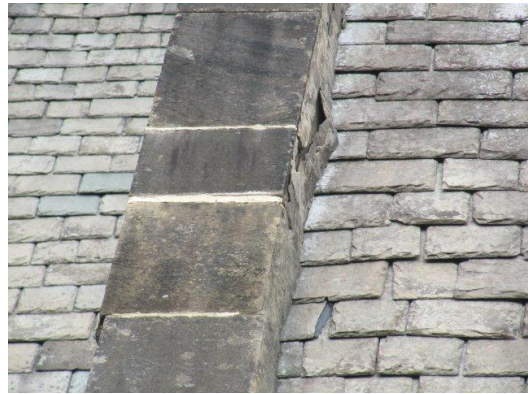
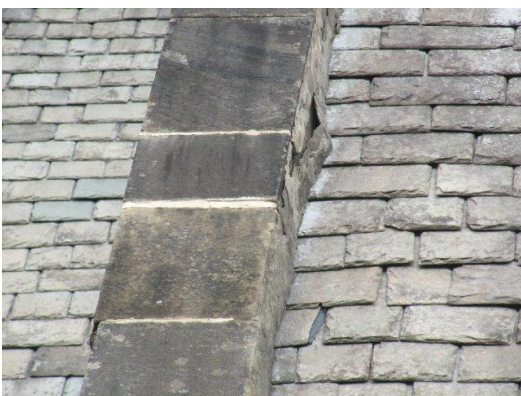
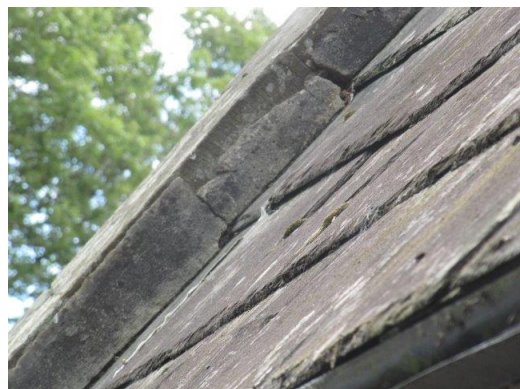
Cracking or mortar fillet to North slope of Chancel roof

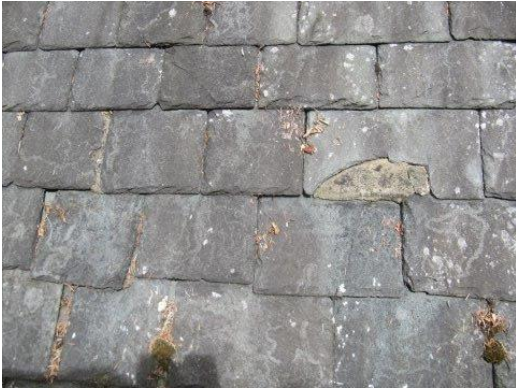
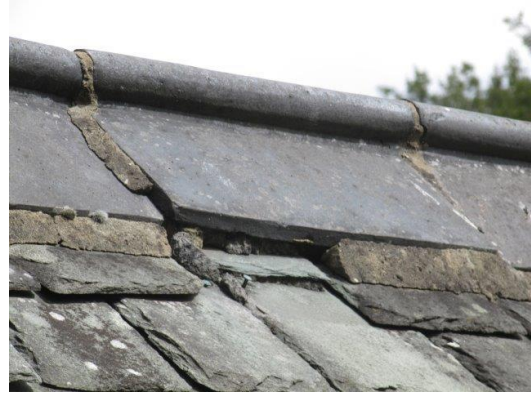
Failed mortar repair to slate over choir vestry/meeting room and missing mortar bedding to the same roof

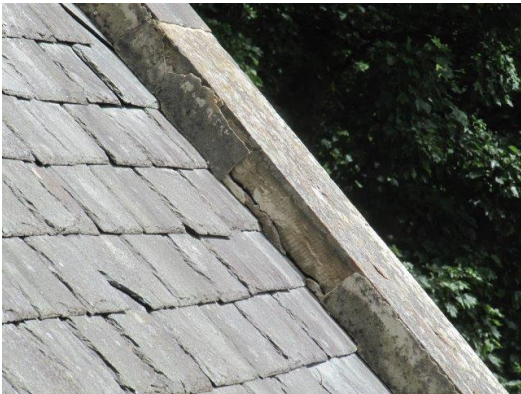
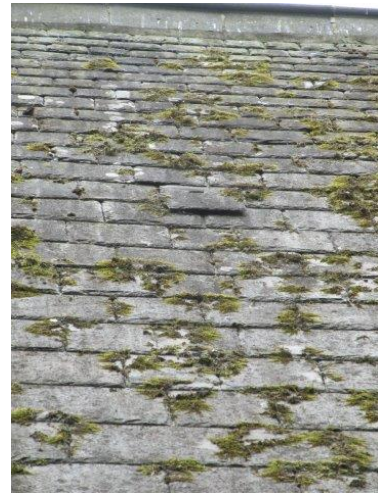
Loss of mortar fillet to roof over choir vestry/meeting room of the Nave

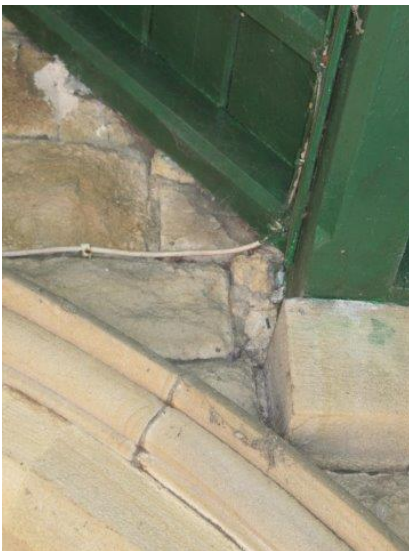
Cracking to North wall of porch over door surround

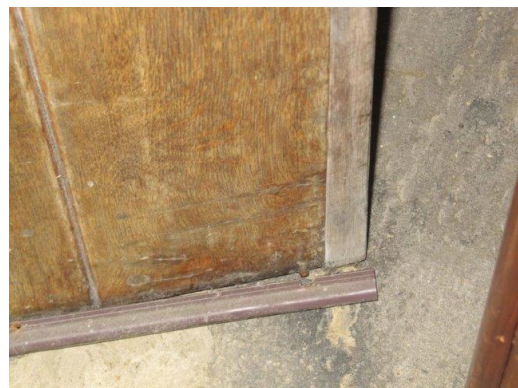
Failing weather / draught strip to base of lobby door

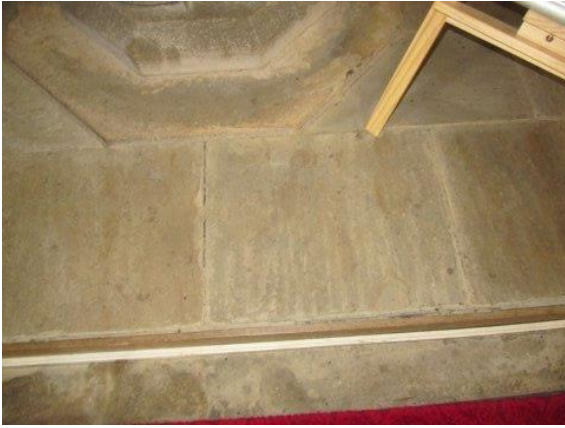
Poor demarcation to change of level near the font

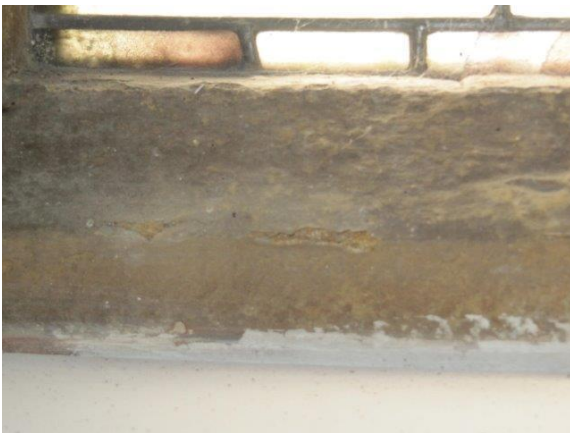
Typical damage to coating to the window surrounds

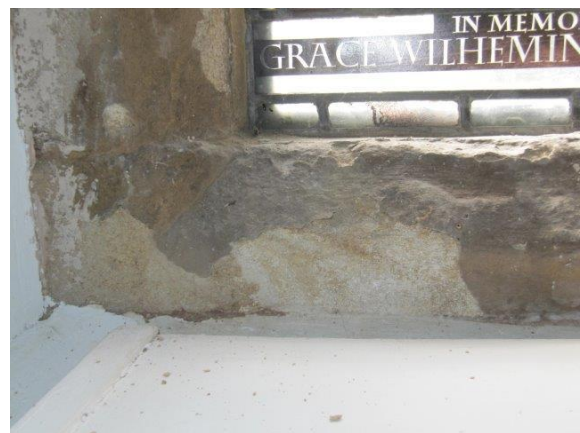
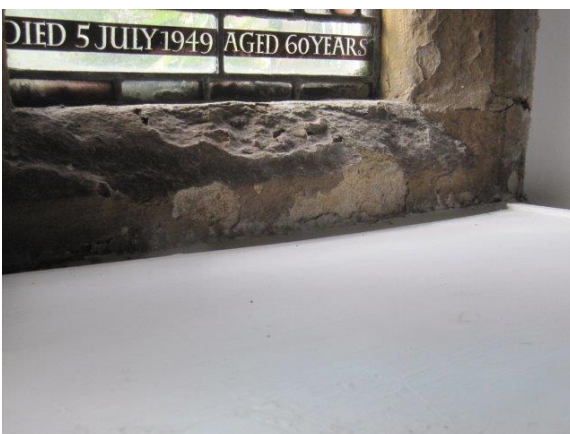
Typical damage to coating to the window surrounds

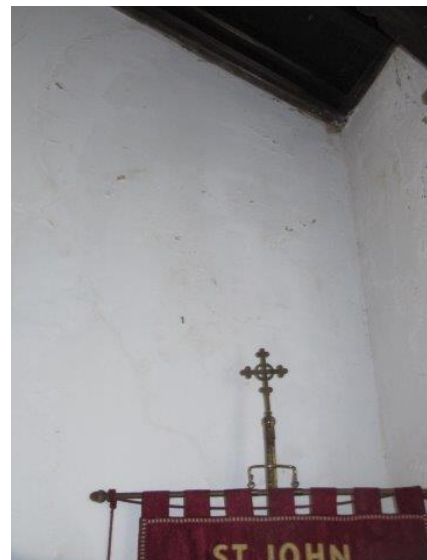
Damage to plaster in the South East corner of the South Aisle

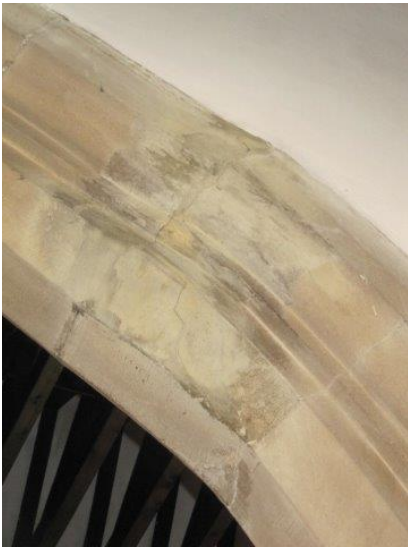
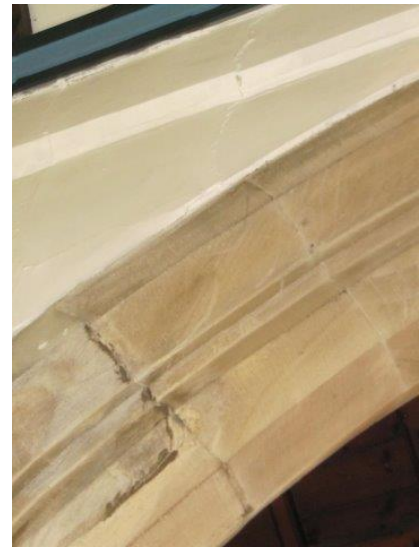
Cracking to mortar repair to Western arch of South Aisle and cracking to the same area in the Nave

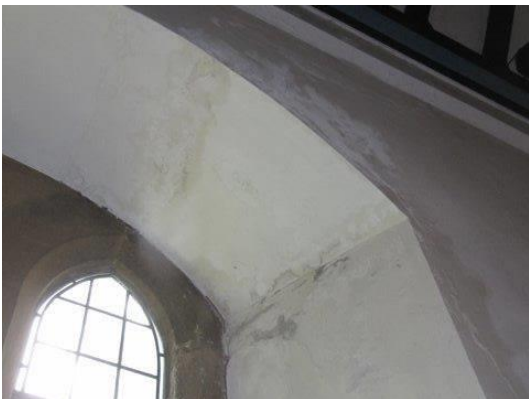
Damage to plaster to the North wall of the Nave by window W13

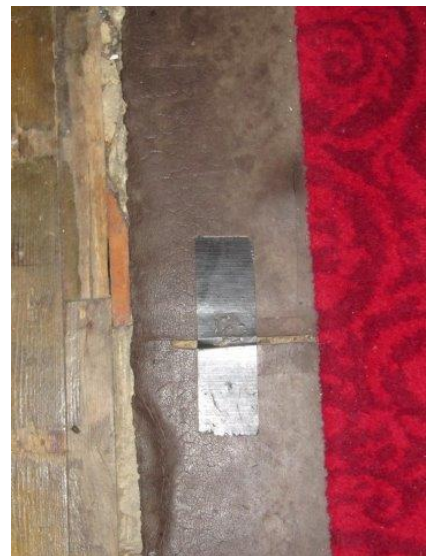
Repaired split to underlay of Nave carpet

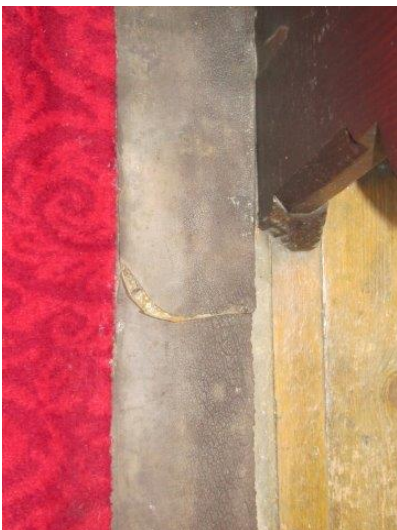
Further splits visible to underlay of Nave Aisle carpet
