Diocese of Durham  
Quinquennial Inspection  
St Peter's Church, Byers Green

Architects Report

inspected March 2024

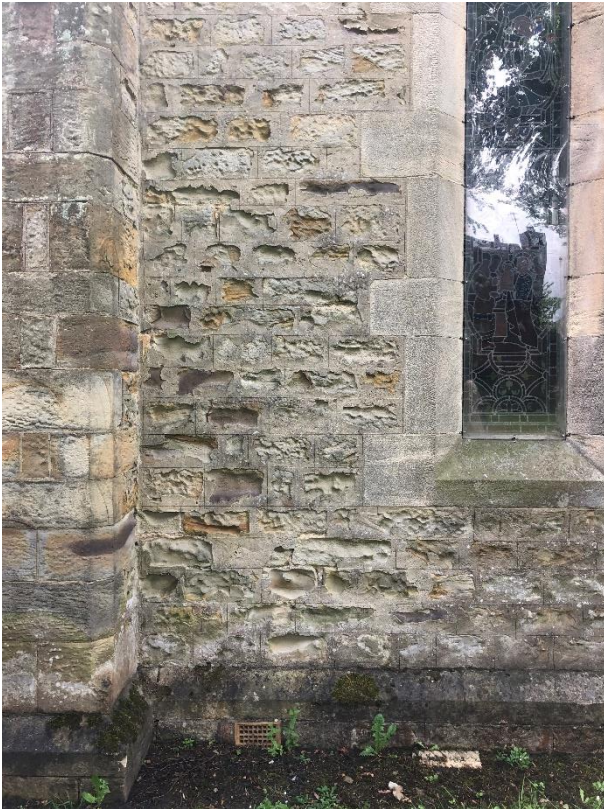
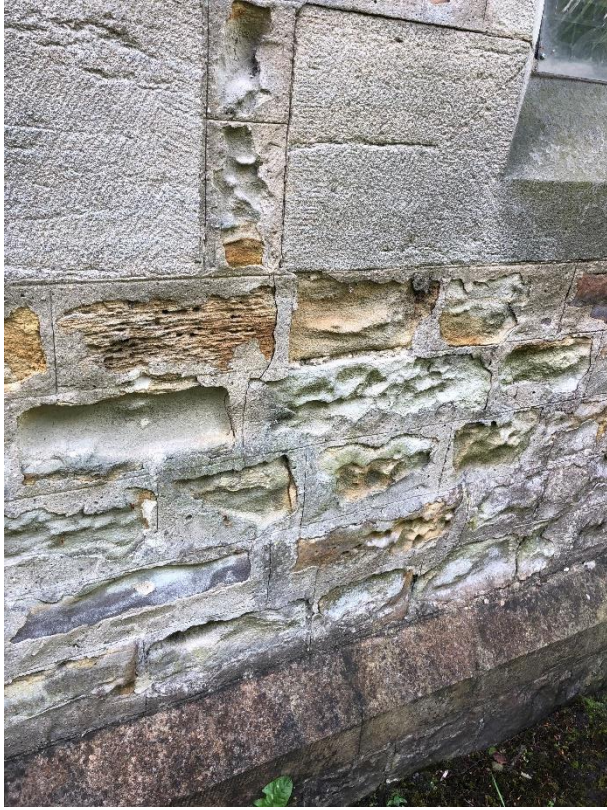
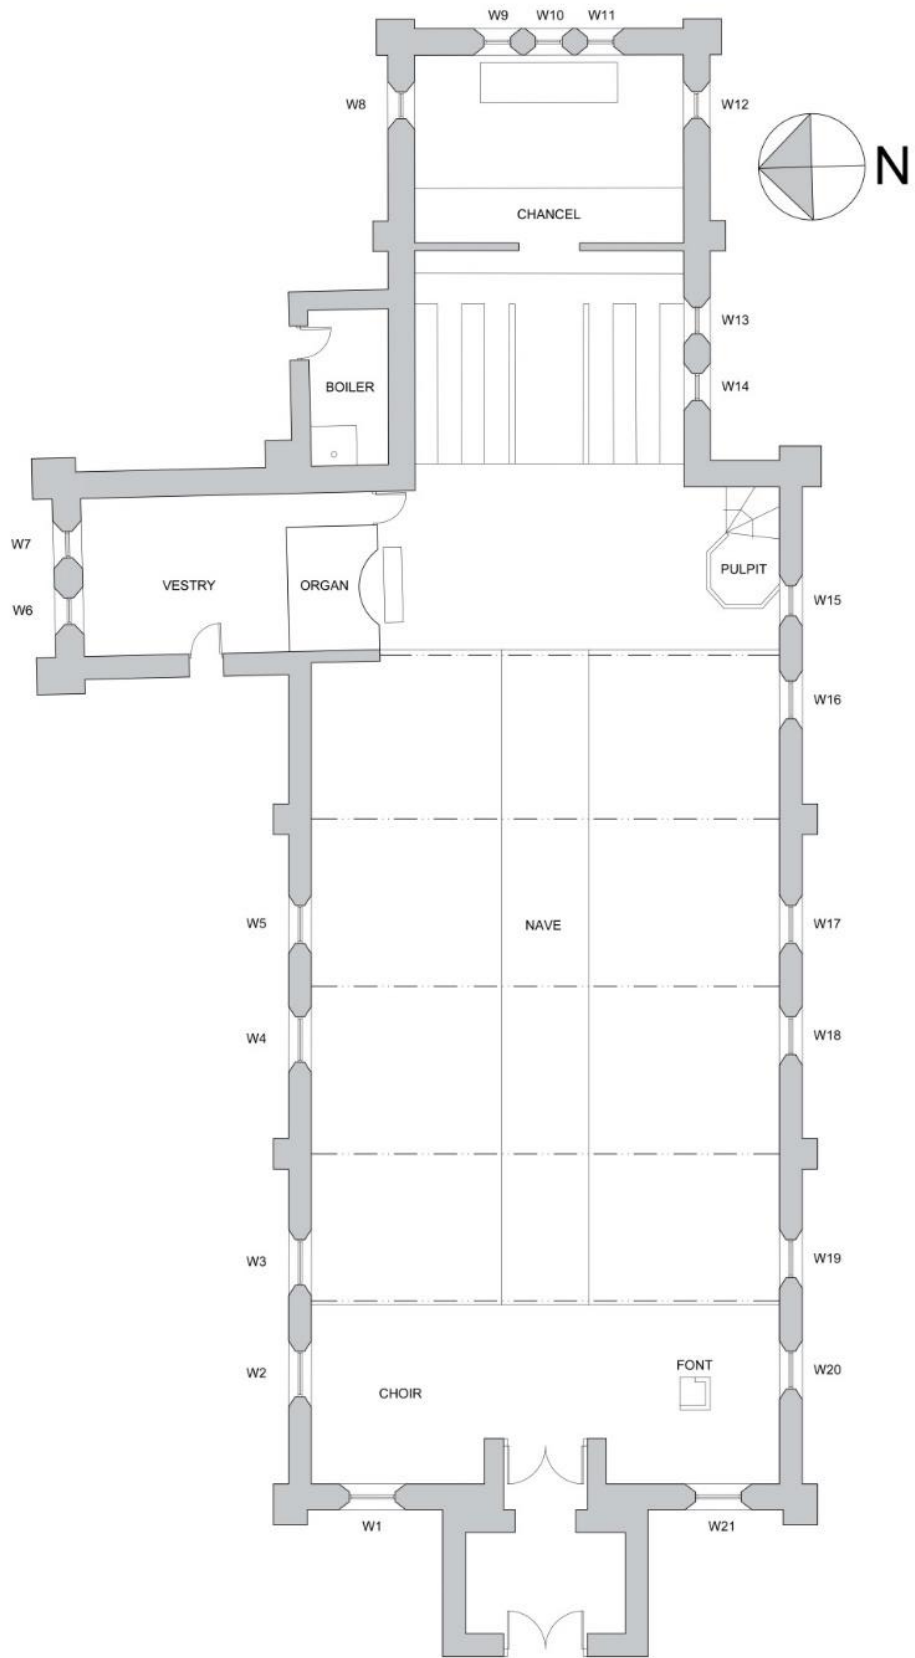
4.2 The exterior of the Church is generally sound but there is a problem, referred to in the 3no. previous QI reports, with some earlier repointing that needs to be addressed, urgently. Gutters and downpipes should be inspected annually and cleaned or maintained as necessary as well as an inspection of the fabric generally with particular reference to the cracks or structural movement identified in the report. If any change is noticed it should be reported to the inspecting Architect. This will help to prevent minor maintenance items develop into serious defects.

Images to show mortar defects.

Re-pointing, the hard cement-sand mortar shall be carefully removed, so as not to damage the stonework further. Any loose stone should be carefully brushed back to a sound face. The wall should then be re-pointed using a basic regular Naturally Hydraulic Lime mortar; NHL 3.5 with a local sand. Samples of and mixtures of sand should be tested to ensure a match in colour and texture to the original mortar. Sample mortar to be approved by Architect.

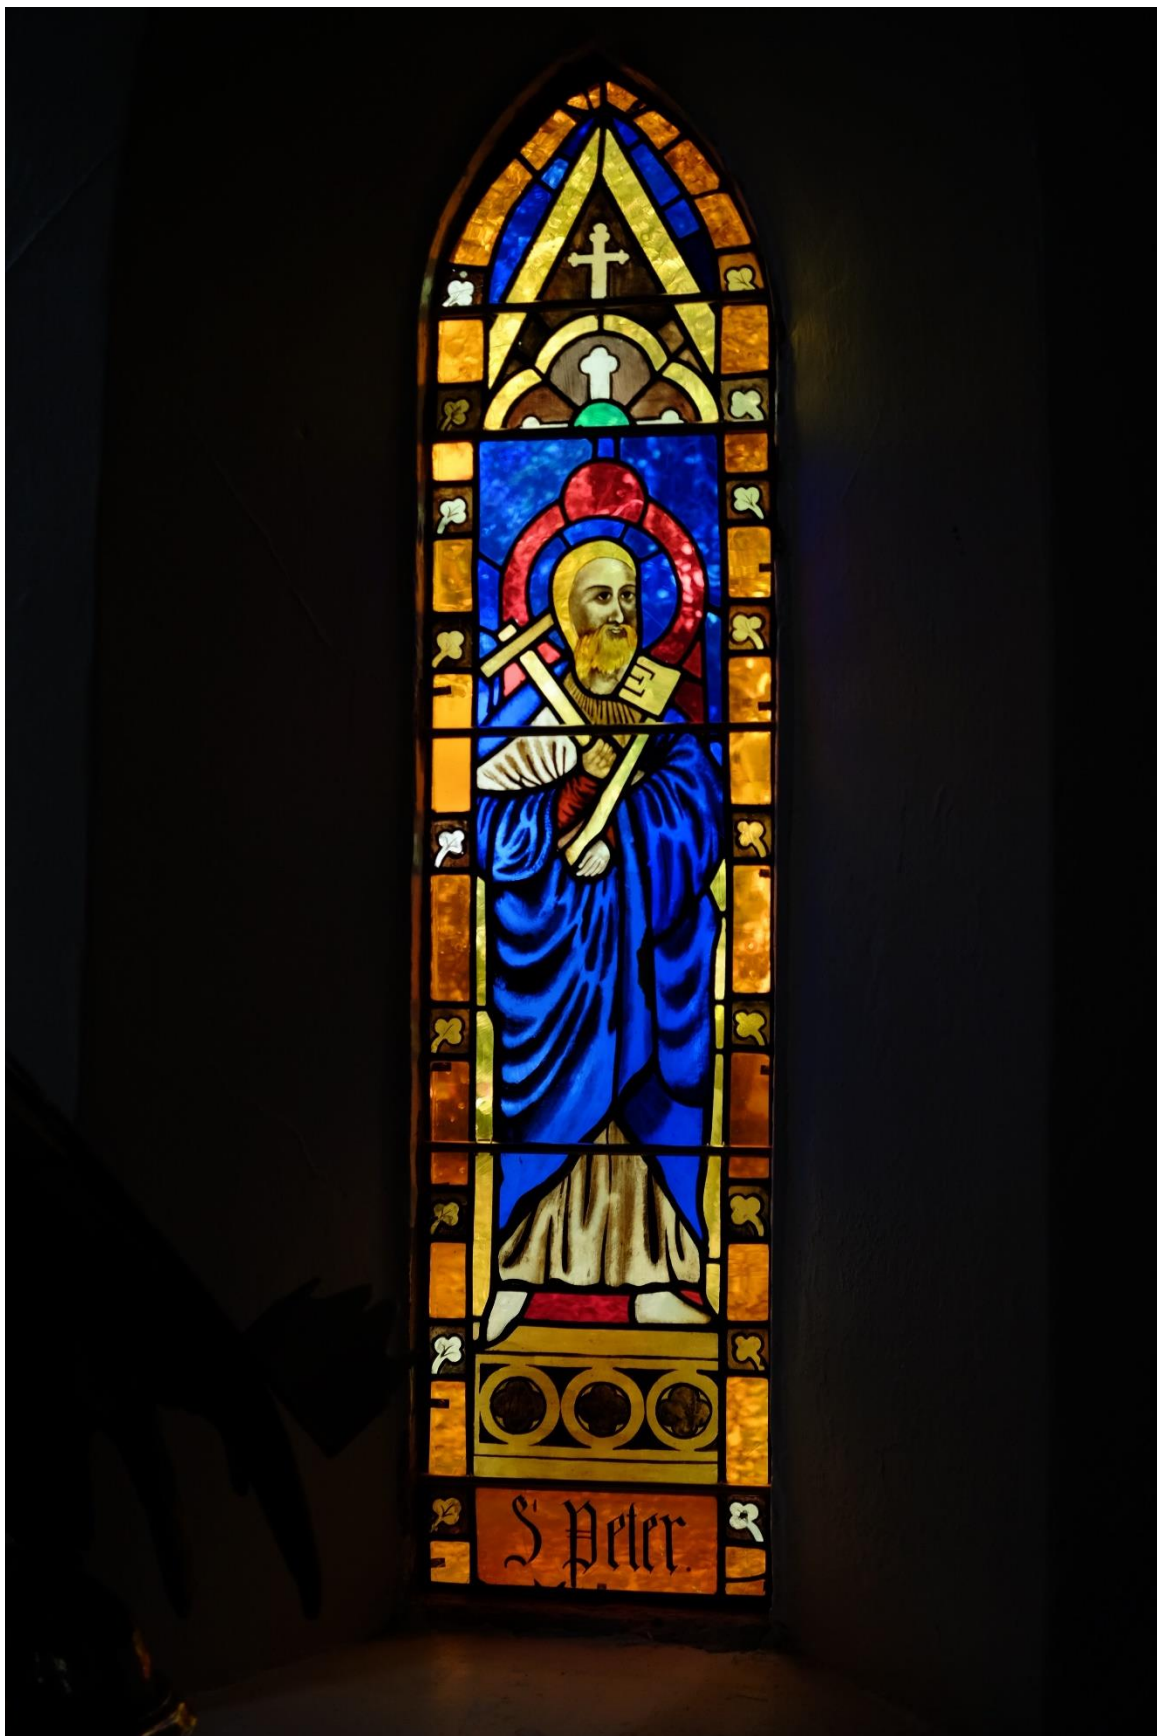
nii) Window W8

Window W8 was restored by Jonathan and Ruth Cooke between September and November 2017 see appendix B for the detailed description of the repair and post repair image. Further detailed information of the repair/conservation work undertaken is detailed in their report. However, the making good of plaster finishes and internal decoration work undertaken post conservation work has left deposits of plaster / paint on the surface of the window. Specialist advice should be sought regarding the removal of the deposits such to minimise the potential for damage.

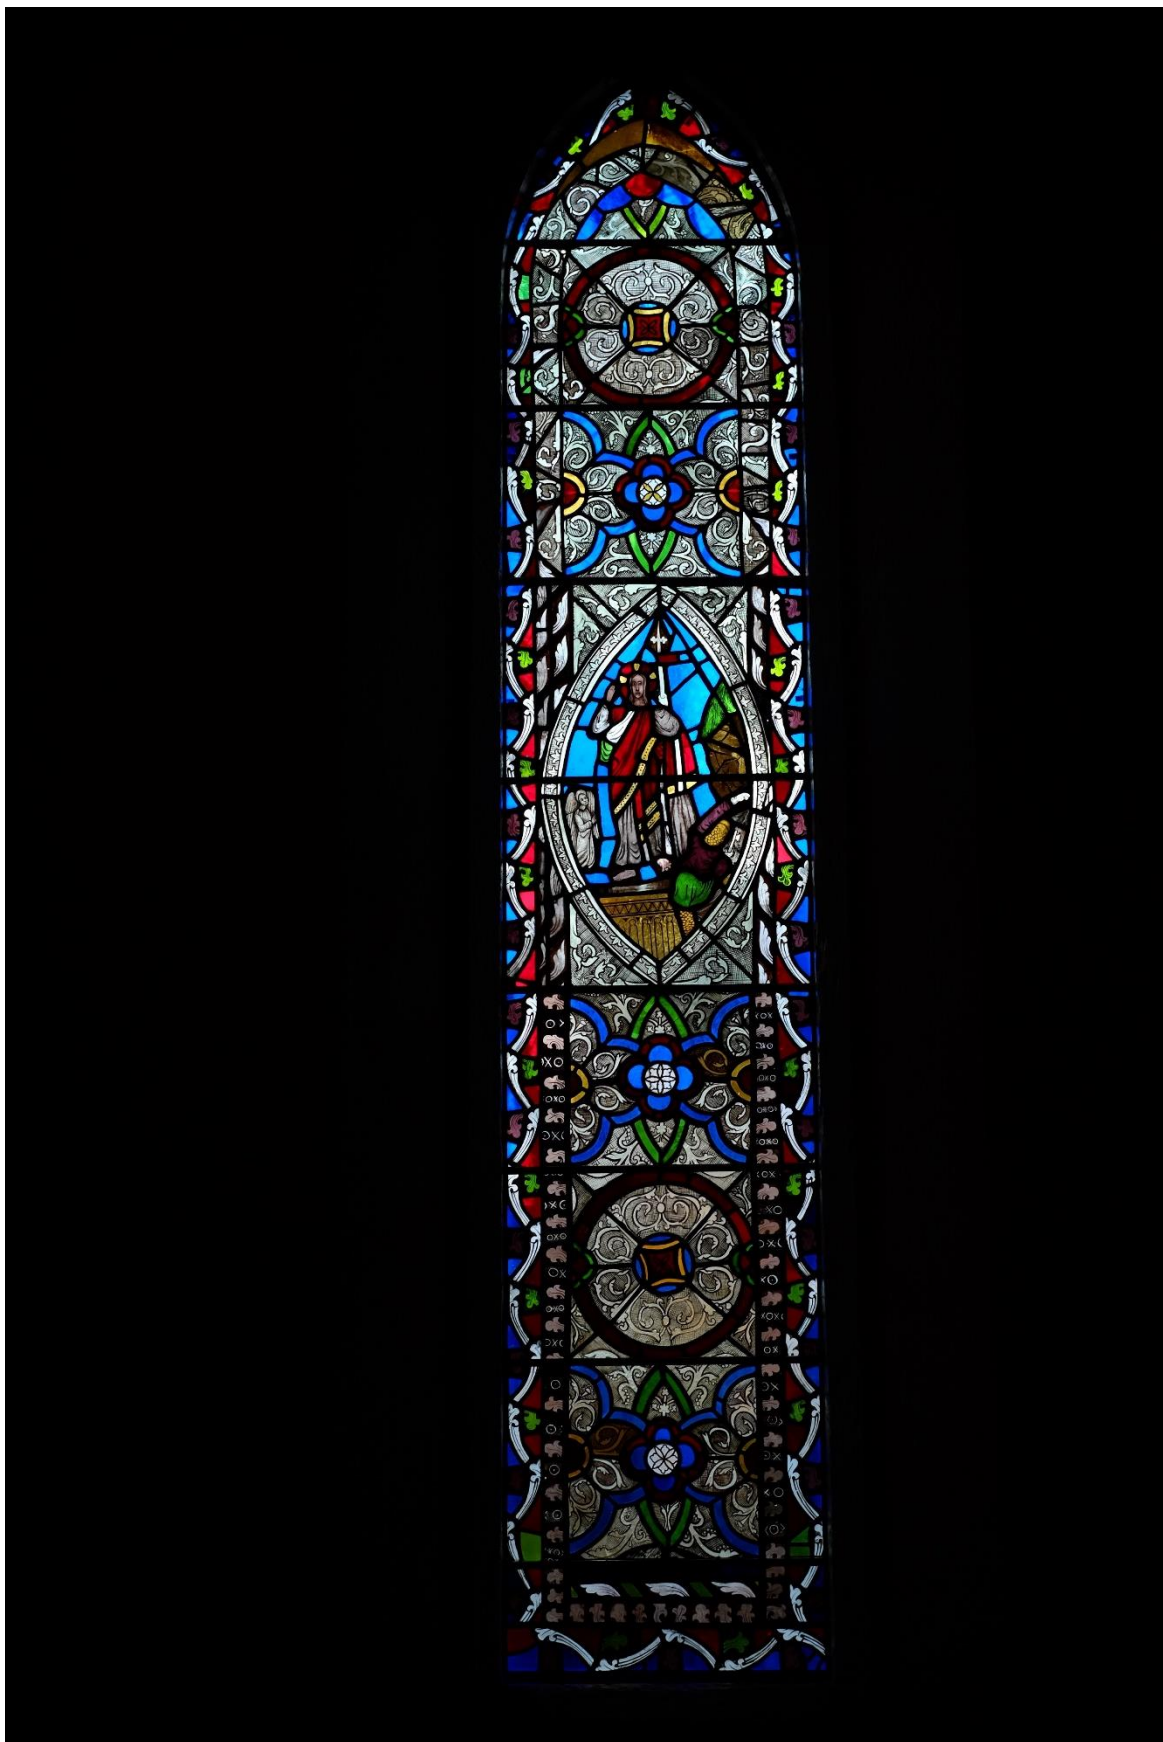
nvii) – Window W2

- a) The leaded light is bowing between the glazing bars. 3
- b) There is movement between the glass and the lead comes in places sufficient to allow daylight between them restoration is required. N.B. This window previously had a thin metal plate set into the splayed cill stone with an inscription which was partially illegible. The metal was corroded around the edges and near the centre, it has been confirmed that the plate was zinc. This has now been replaced with a replica zinc plate with matching paint finish and lettering.

Window W2 was restored by Jonathan and Ruth Cooke between October and December 2016 see appendix B for the detailed description of the repair and post repair image. Further detailed information of the repair/conservation work undertaken is detailed in their report.

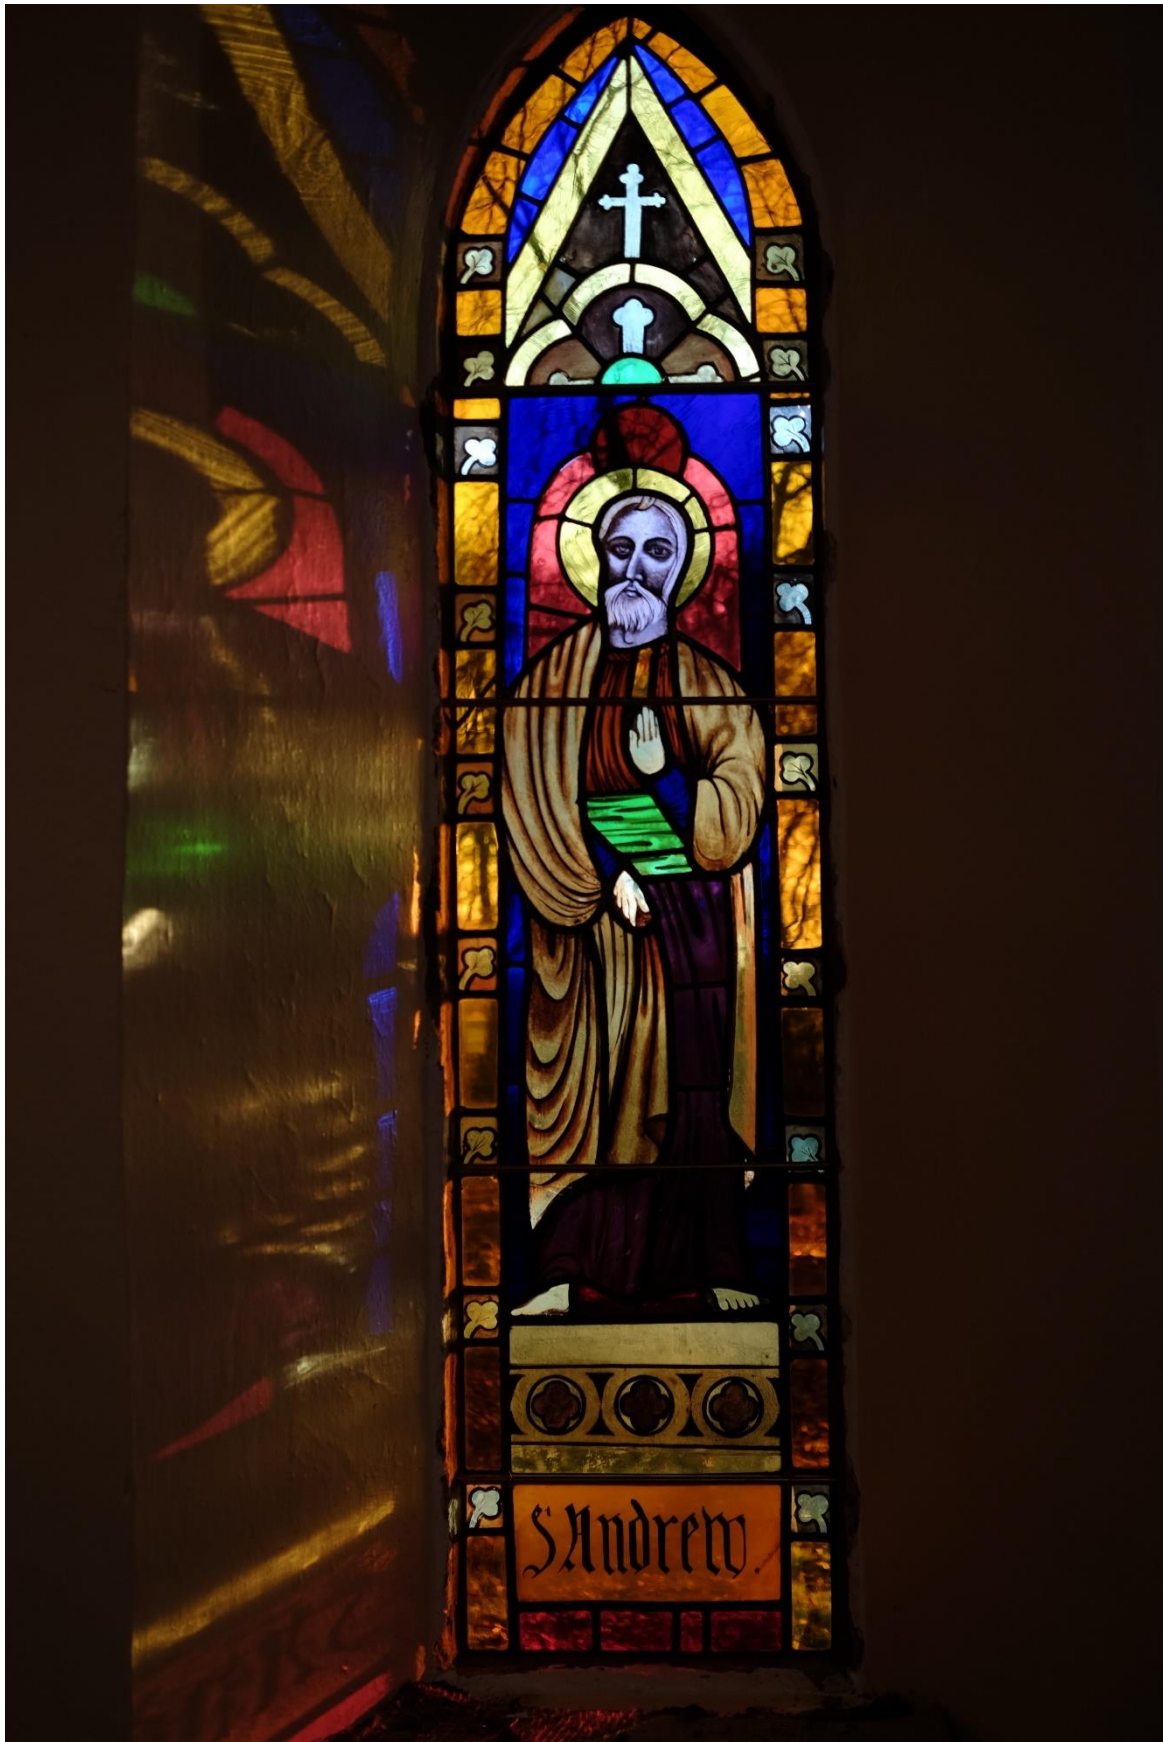
sii) – Window W12

Window W12 was restored by Jonathan and Ruth Cooke between September and November 2017 see appendix B for the detailed description of the repair and post repair image. Further detailed information of the repair/conservation work undertaken is detailed in their report. However, the making good of plaster finishes and internal decoration work undertaken post conservation work has left deposits of plaster / paint on the surface of the window. Specialist advice should be sought regarding the removal of the deposits such to minimise the potential for damage.

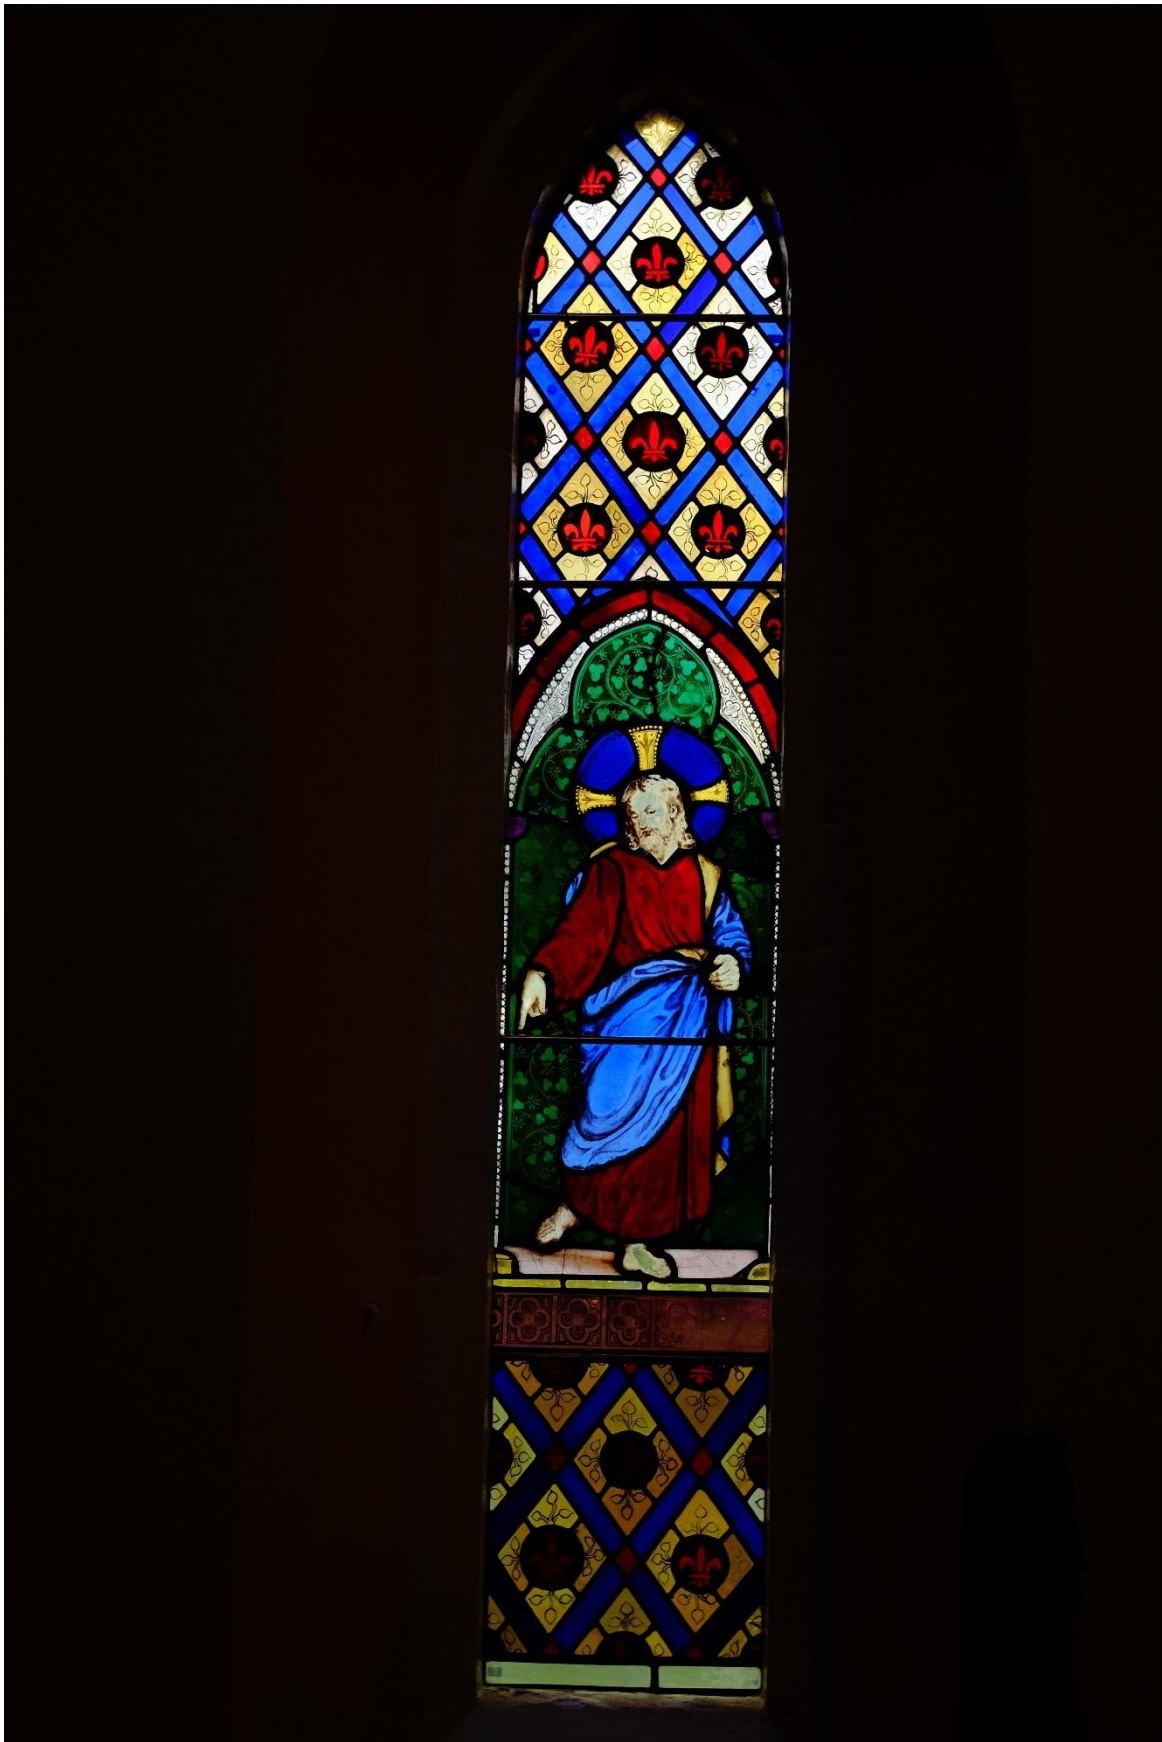
siii) – Window W13

Window W13 was restored by Jonathan and Ruth Cooke between December 2016 and January 2017 see appendix B for the detailed description of the repair and post repair image. Further detailed information of the repair/conservation work undertaken is detailed in their report. However, the making good of plaster finishes and internal decoration work undertaken post conservation work has left deposits of plaster / paint on the surface of the window. Specialist advice should be sought regarding the removal of the deposits such to minimise the potential for damage.

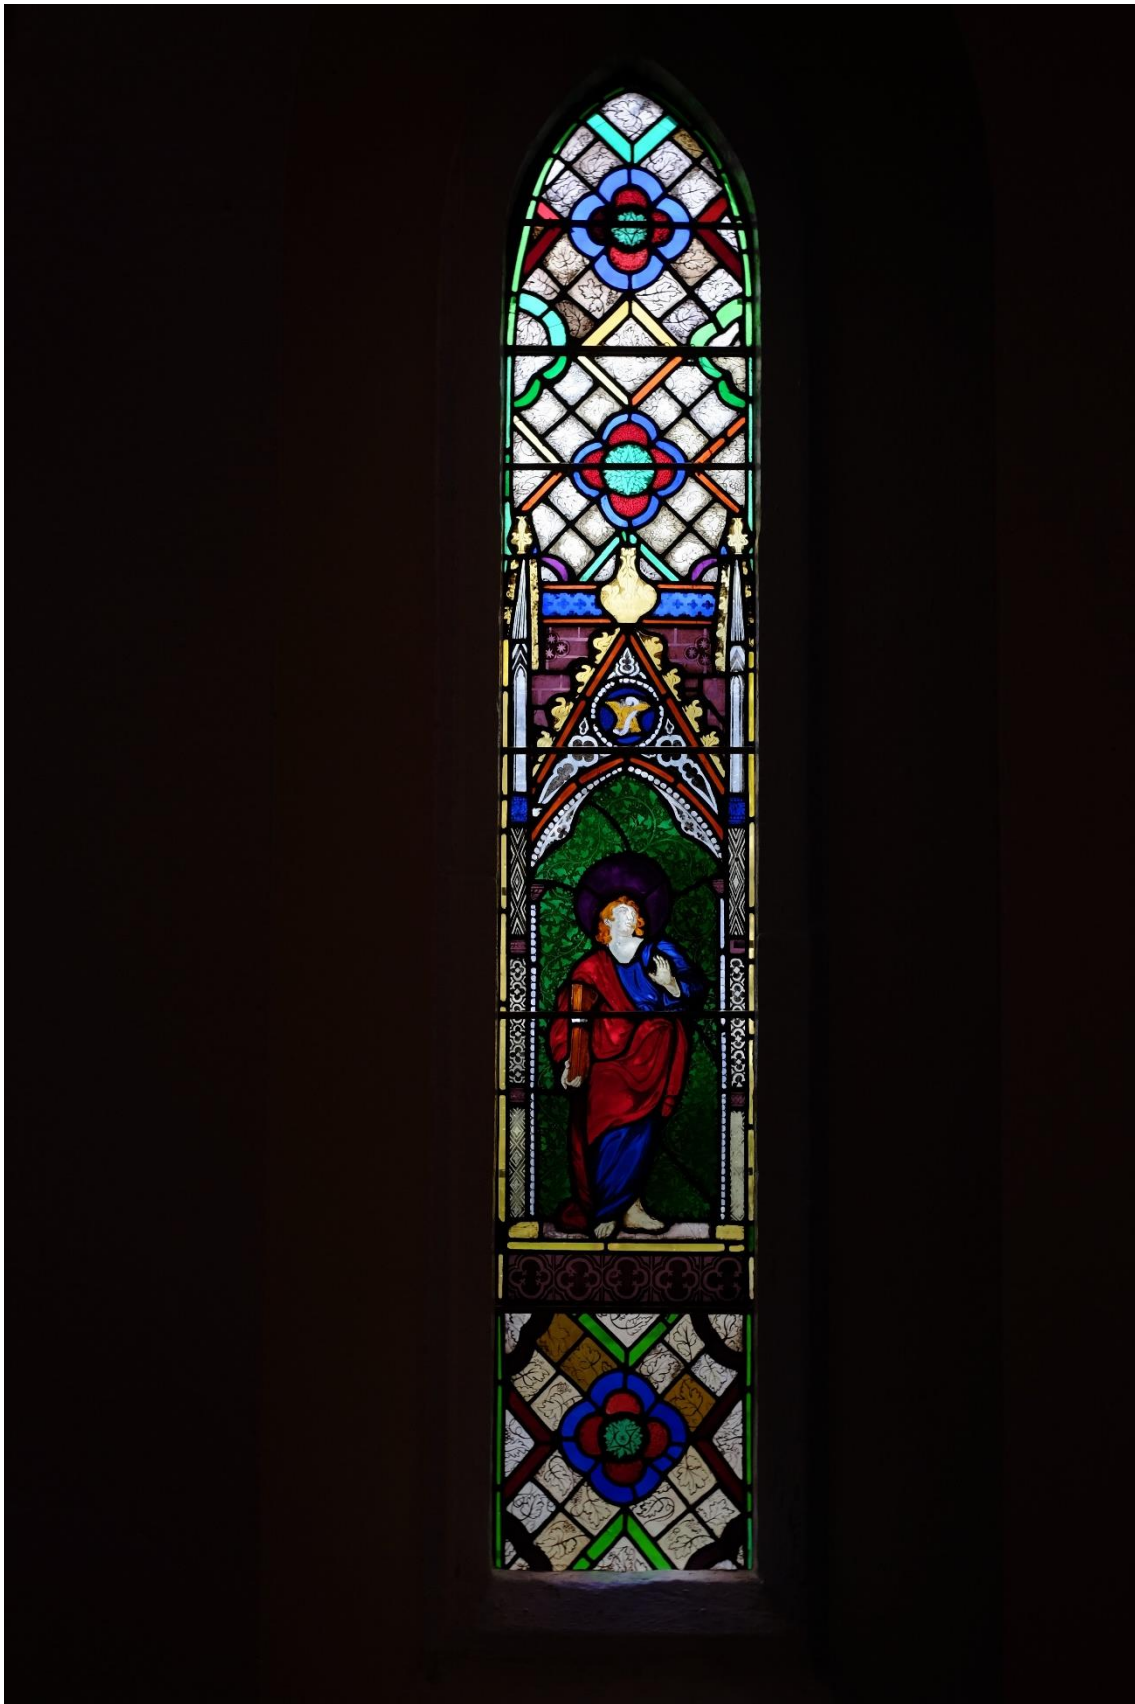
siv) – Window W14

description of the repair and post repair image. Further detailed information of the repair/conservation work undertaken is detailed in their report. However, the making good of plaster finishes and internal decoration work undertaken post conservation work has left deposits of plaster / paint on the surface of the window. Specialist advice should be sought regarding the removal of the deposits such to minimise the potential for damage.
