**St MARY and St CUTHBERT**  
**CHESTER LE STREET**  
(4)

**QUINQUENNIAL REPORT**  
on the architect's inspection on

**26 April 2023**

a grade I listed building

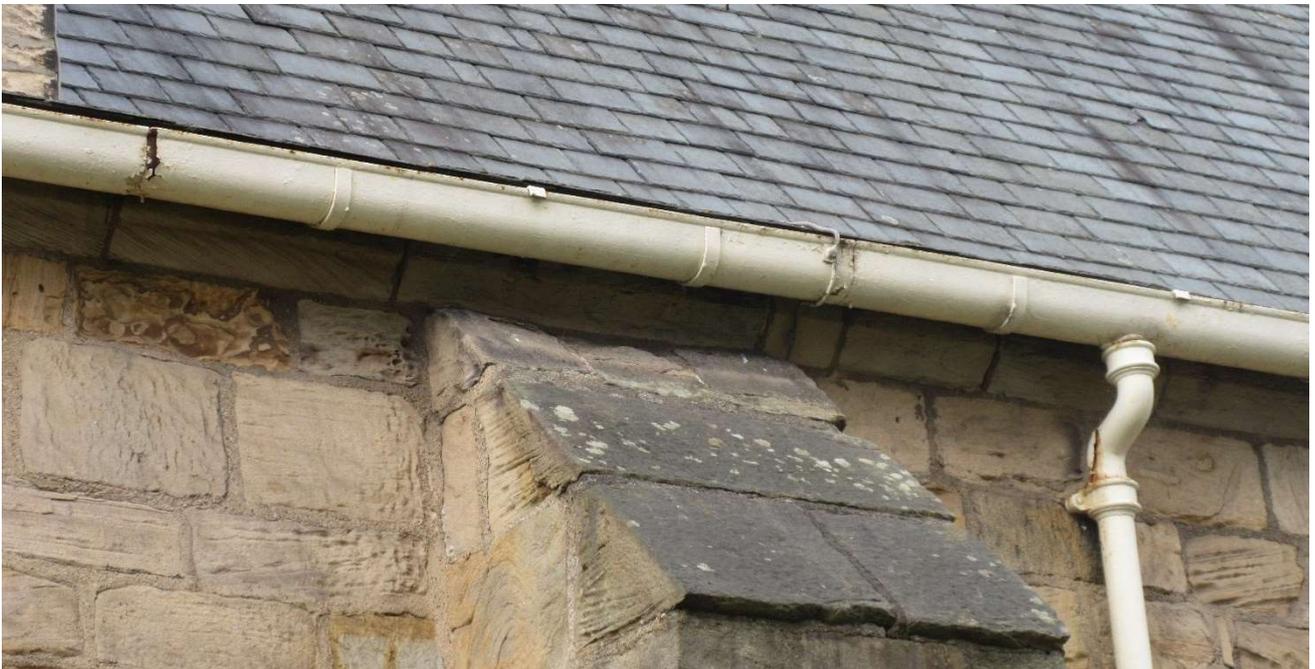
17. Painted cast iron half round gutters (deep flow at Chancel and Aisles) and pipes well spaced off the walls with shoes over gullies. Mainly sound except:  
Some pipe backs not well painted  
S Aisle gutter joint is rusting over 2<sup>nd</sup> window from E. Under the Tower the gutter is cracked and rusting. Its W pipe top swan neck is broken and rusting. Its bottom joint has opened and the section is loose from the wall.  
Ankerage gutter and pipe beginning to rust. The N Aisle gutter paint is poor.  
Gutters W of the Lambton Pew and at Organ (which is part on a corbel course) paint poor. Their shared pipe bottom fixing is loose, so the bottom length can move.  
Vestry small gutter rusting and may spill R of the door. Pipe sound but paint poor at back (hard to reach)  
N Chancel gutter, some rusting joints, paint poor.

S Aisle W end – gutter and pipe breaks

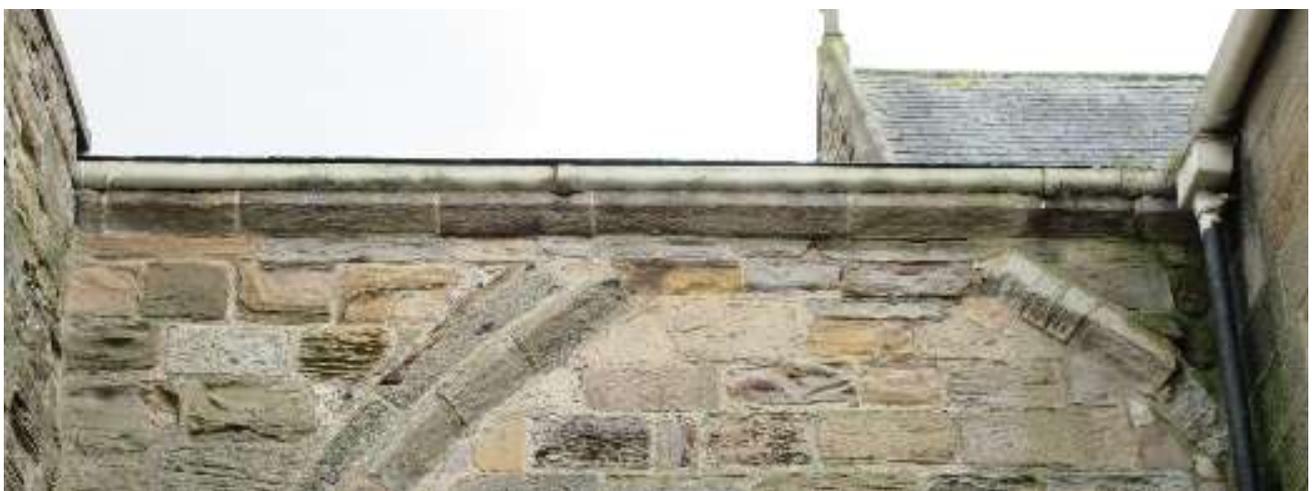
Organ gutter – paint poor

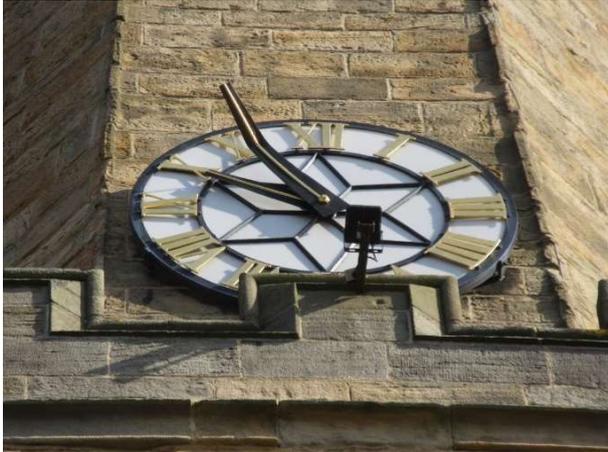
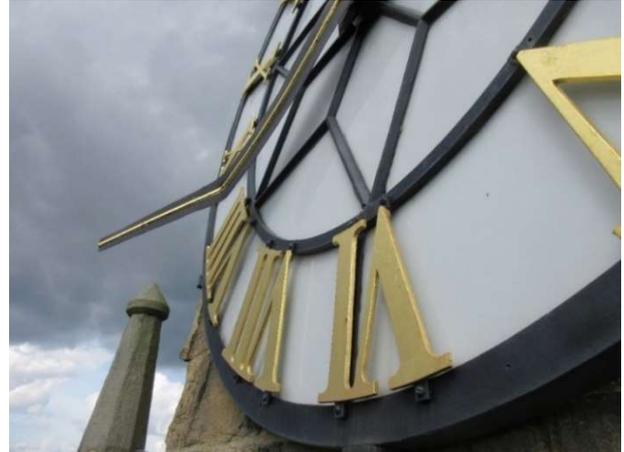
Bent hand at South clock dial

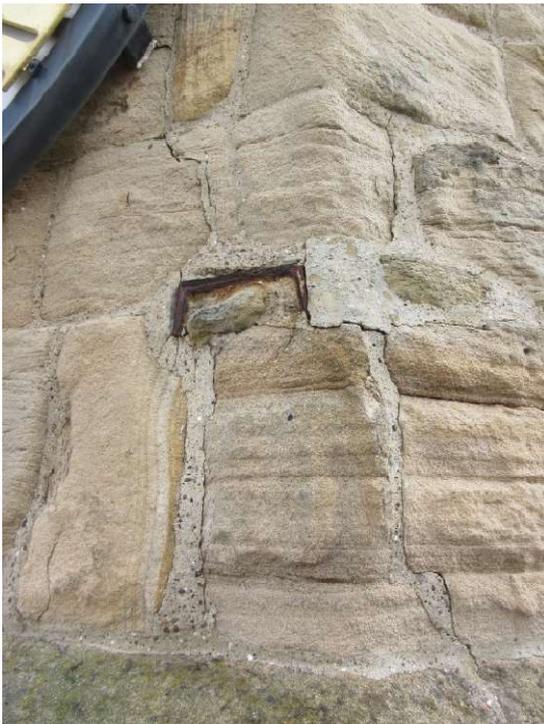
22. The clock stands on two painted steel channels and an I beam. The painted steel ends show some rust. One channel passes all through the stone Spire shell. Its exposed outer end is rusting close to a Spire corner (S of the W face). Slight vertical cracks in mortar joints above and below the exposed steel may show the rust is expanding enough to push the stones apart. However there is similar cracking at two other corners without exposed steel (N of the W face, W of the S face) so the cause is not certain. There embedded steels do not appear on the outer face but may be rusting in the spire thickness.

Corner S of the W face – joints cracked above and below rusting channel end

23. Whether or not the present cracks result from rust expansion it can be expected that any ungalvanized steel built into or through such thin masonry will rust and expand eventually, damaging the Spire. So replacement of these steels with galvanized or stainless steel (by clock maker because the clock will be disturbed?) in say the next three years appears necessary. Responsibility (Local authority?) should be checked.

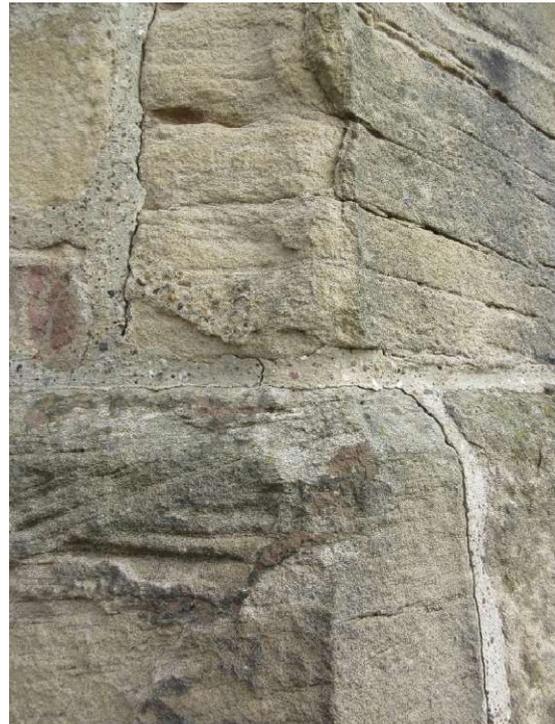
Cracks at another W corner with no exposed steel

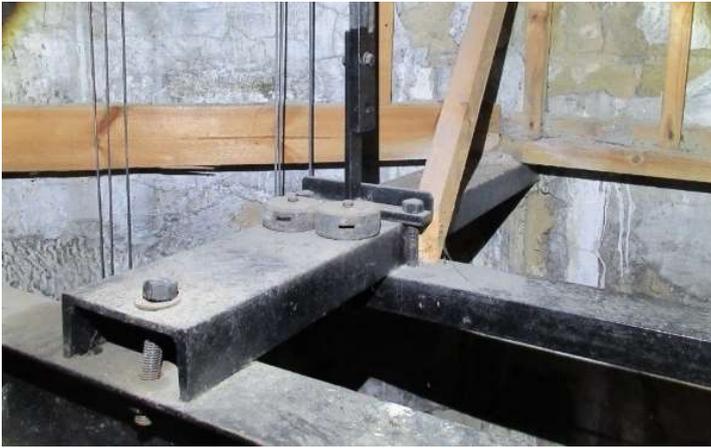
Same channel internally

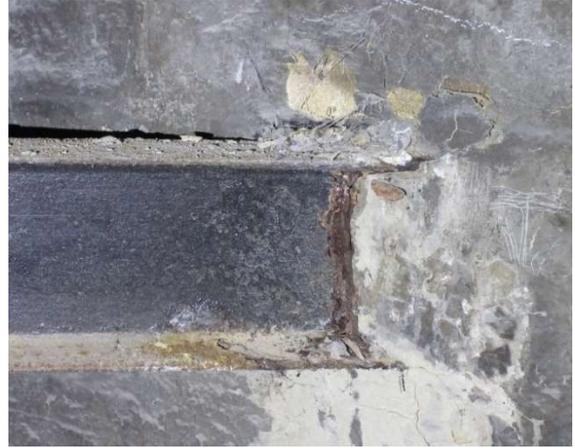
Rust begun at a clock steel embedded in the spire shell

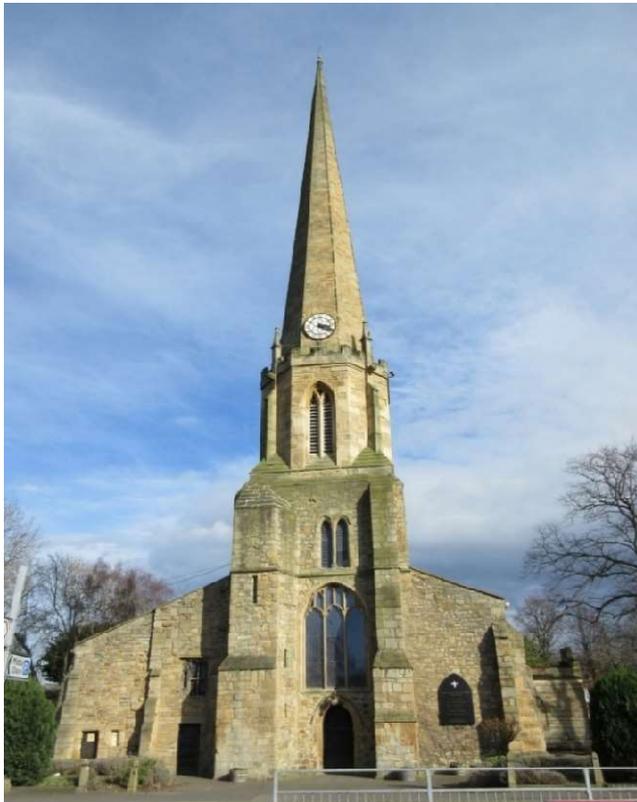
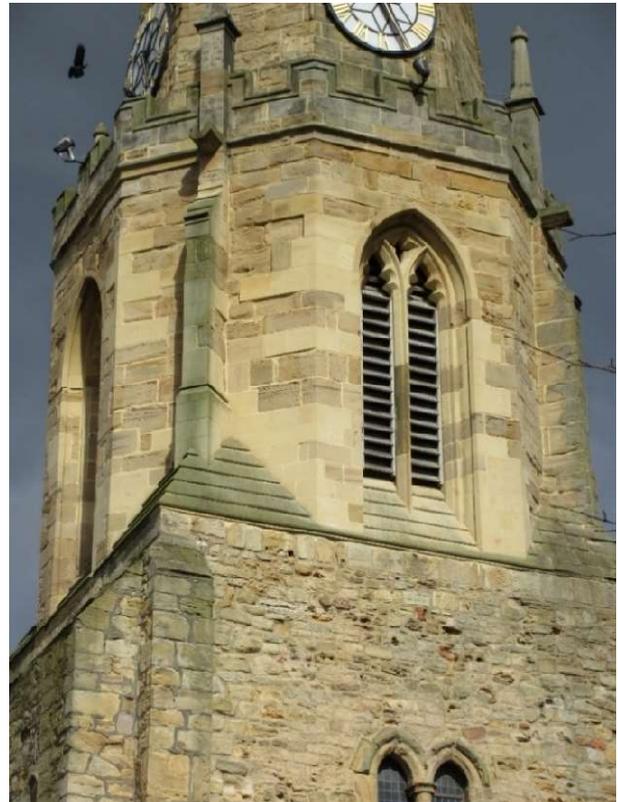
S side of Belfry and Tower

S pointing and stone good except scattered stones have deep decay pockets which would be better part mortar filled to slow decay.

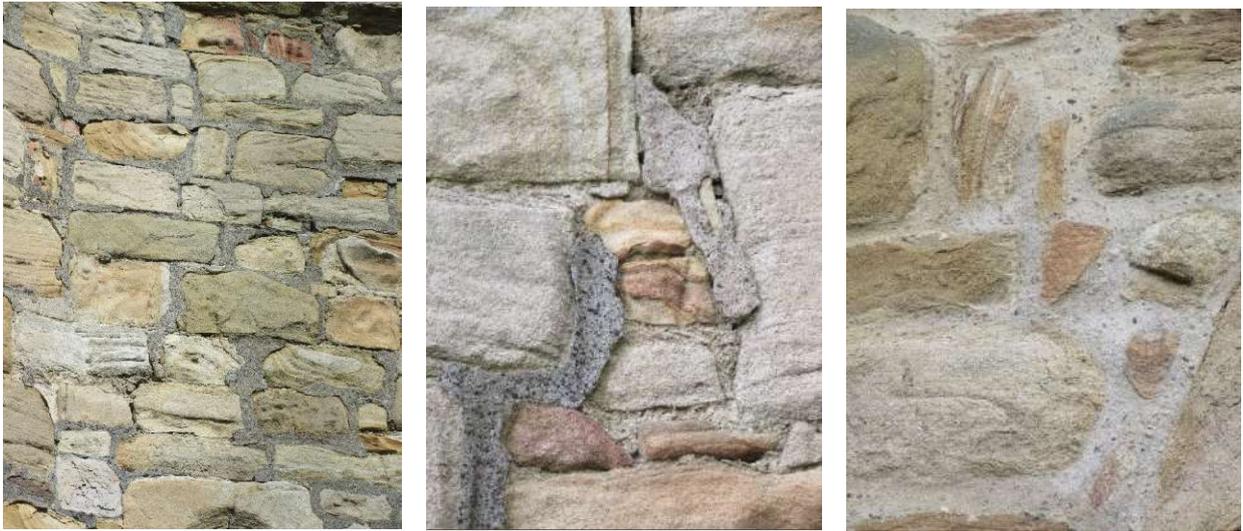
W wall mainly good but some surface decay behind hard dark pointing which is spread over many stones especially at the top stage and spiral stair turret where the stone and pointing types are mixed with some open joints.

Mixed stone and pointing types W side of Tower – including recent lime pointing over the W door

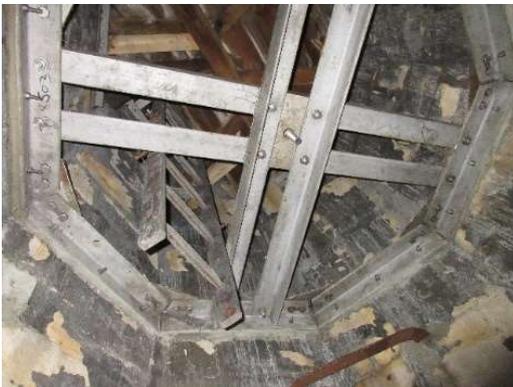
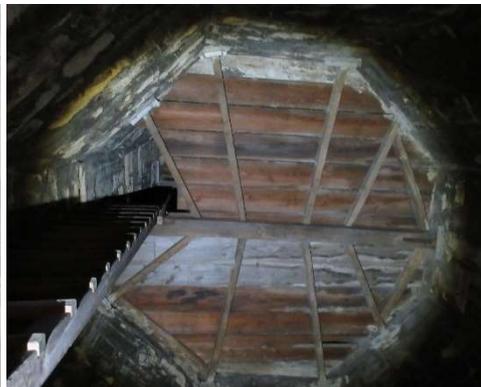
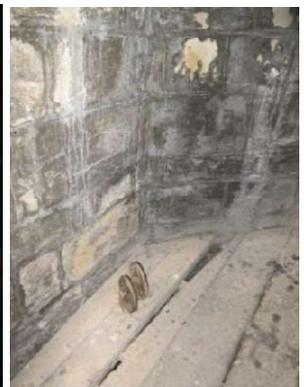
Stainless or galvanised top lattice typical timber platform of mixed boards and beams with sand debris & loose boards

30. Woodworm damage at the top of the upper ladder and in the bearers under the top wooden platform. Not known whether it has been treated and the sand debris makes it impossible to see any active wood dust caused by worm.

29. The other platforms stand on modern stainless angles. The timbers are of mixed ages and conditions with many gaps in the boards. No apparent structural function. Stone debris sand covers the boards. Vacuuming all platforms would

- limit sand falling onto the bells below
- at future inspections show whether decay of the masonry and woodworm continues

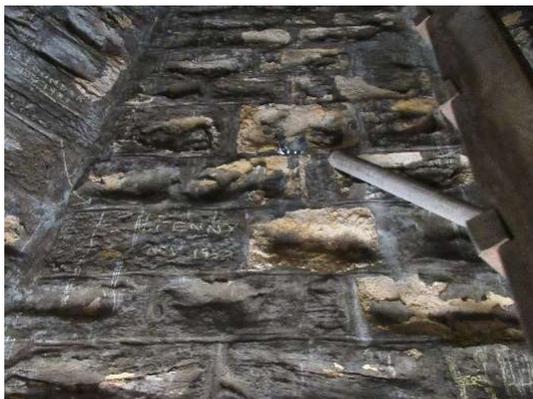
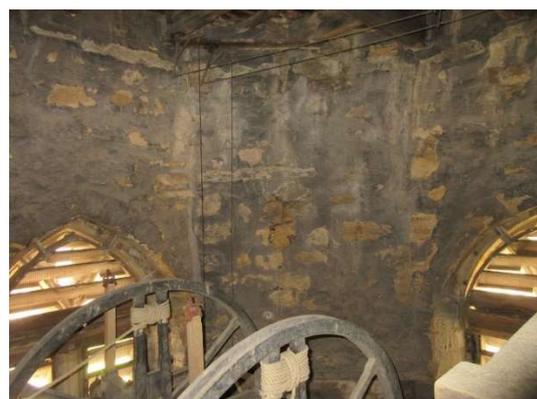
Typical Spire wall condition. Some old decay has been whitewashed over, some more recent.

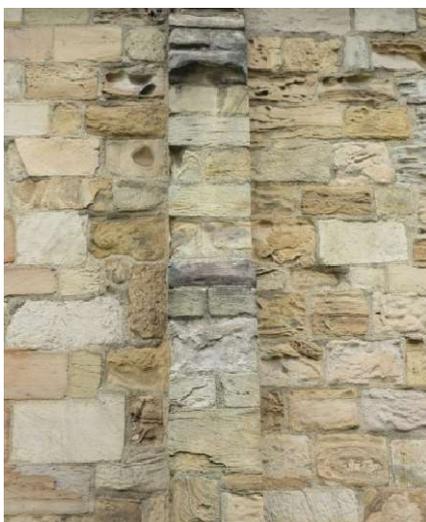
S Aisle – decay at buttress E of the Porch

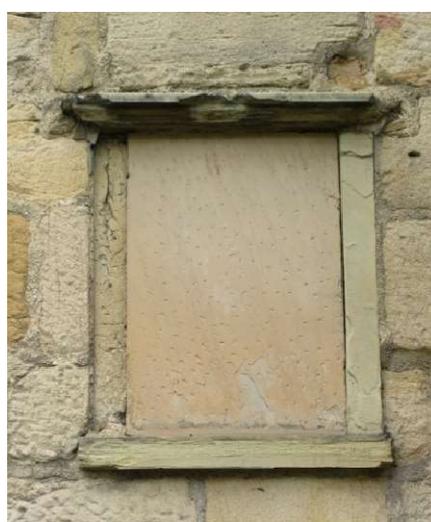
40. At SE a curious small rectangular frame with decayed moulded head and sill and one missing side around a blank panel. May be best removed and infilled to match wall.

S Aisle – blank frame at SE

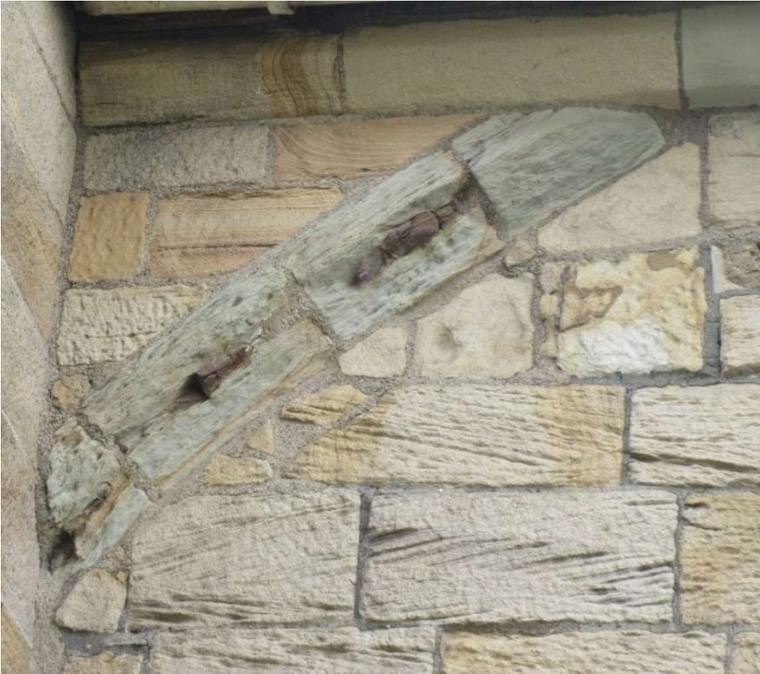
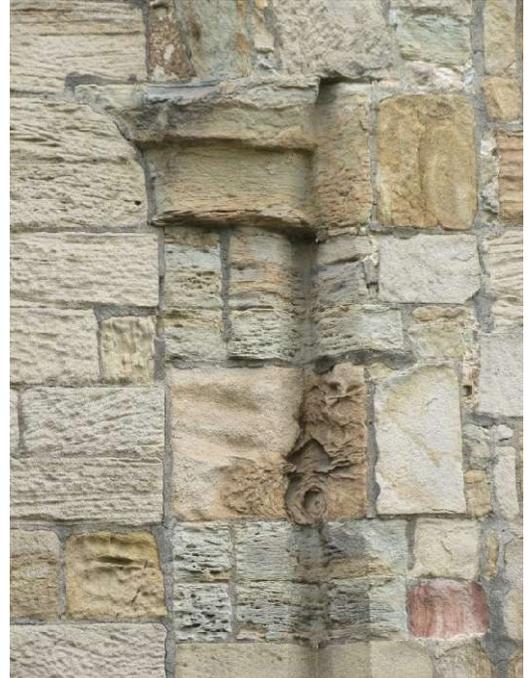
Blocked arch at E end of N Aisle by the Lambton stair – decayed but no visible change

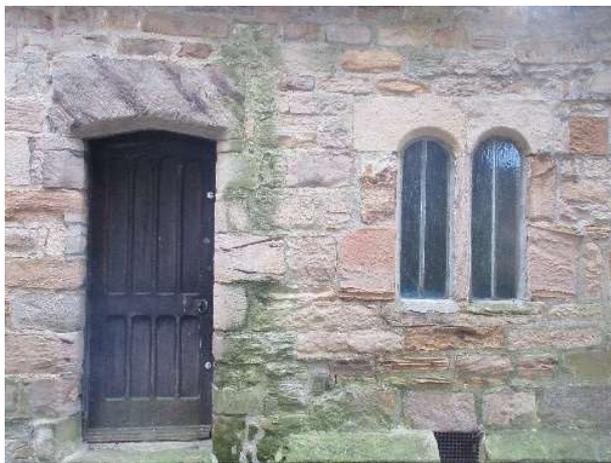
Vestry door and E window

77. Vestry door – Cranked chamfered lintel. Face bedding on a slight skew makes an interesting pattern of decay like tree rings. Decay in most reveals, three with mortar skim part missing.

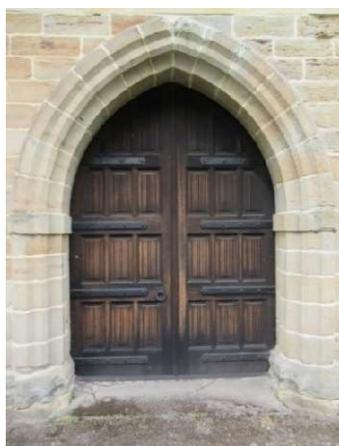
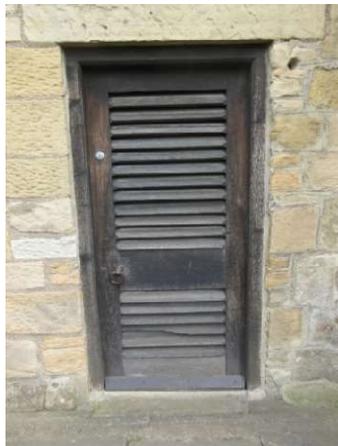
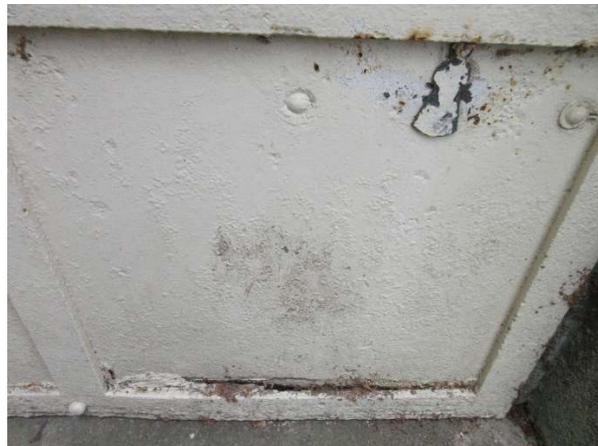
Bottom of Lambton Crypt door

79. Lambton Pew door – oak frame and boarded door with cover laths. Repaired since last report with added weathermould. Painted railings will need paint soon.  
Crypt – Very wide painted iron door on pintles in a stone rebate. Bottom distorted. Fair but rust begun.  
Needs regular paint including filling at bottom.

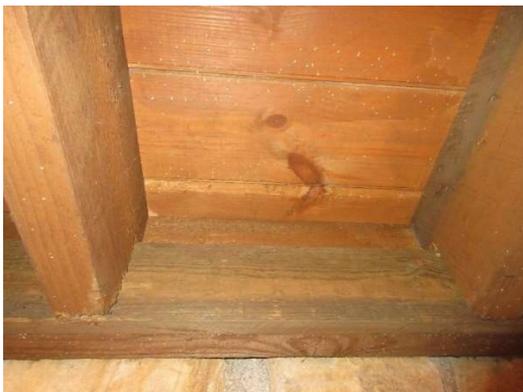
Ankerage

The first floor over the entry is modern softwood joists and boards on one painted steel beam, all exposed. Appear sound except some light woodworm damage to joists and boards along its S edge.

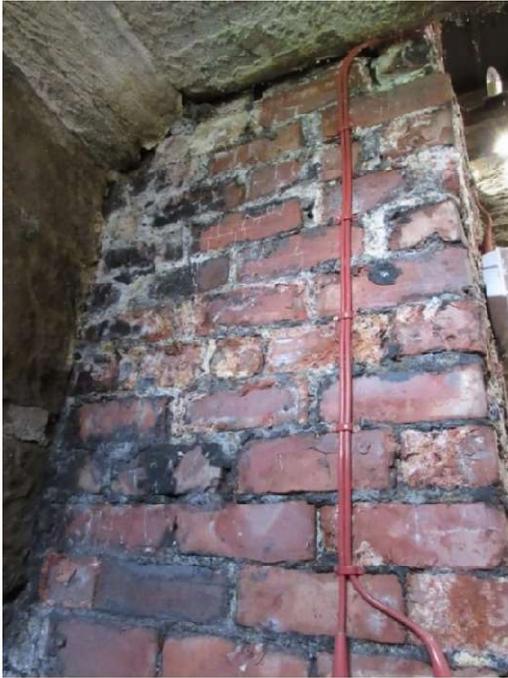
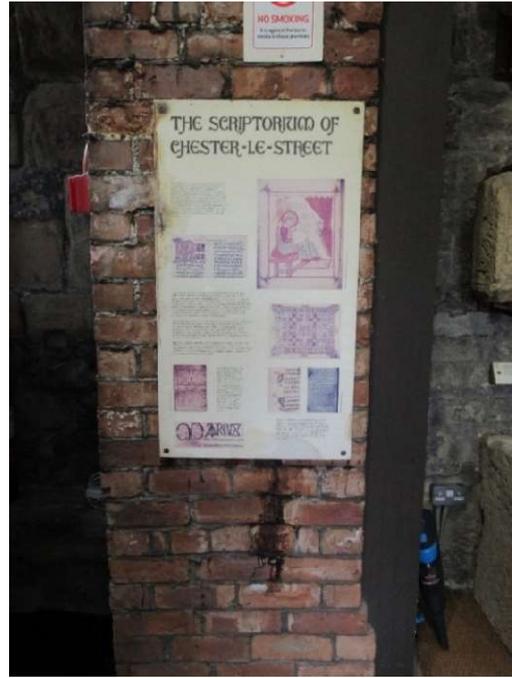
Brick Chimney where it passes through the Ankerage salts continue to effloresce full height especially at top and now tarry water seeps out at head height

127. In the Anker House the brick flue or casing around a flue liner continues to deteriorate with brick spalling, widespread efflorescence of salts and now apparent leakage of tarry water at head height. Brick fragments and salts are being vacuumed from the carpet and flue indicating damp continues. This suggests either serious leakage of water from above or of flue gas from below not escaping to atmosphere but condensing. In either case heating engineer's advice is needed. The brickwork may need to be opened up to investigate. If a flue liner is complete the terminal on the chimney may need renewal. See item 2.  
The heating engineer may advise whether the boiler failure was caused by or was a cause of flue damage.
