St Mary the Virgin, Cockfield

Quinquennial Inspection

CONDITION SURVEY 2021

THE DIOCESE OF DURHAM
The Care of Churches Measure 2018: Quinquennial Inspection Report Form

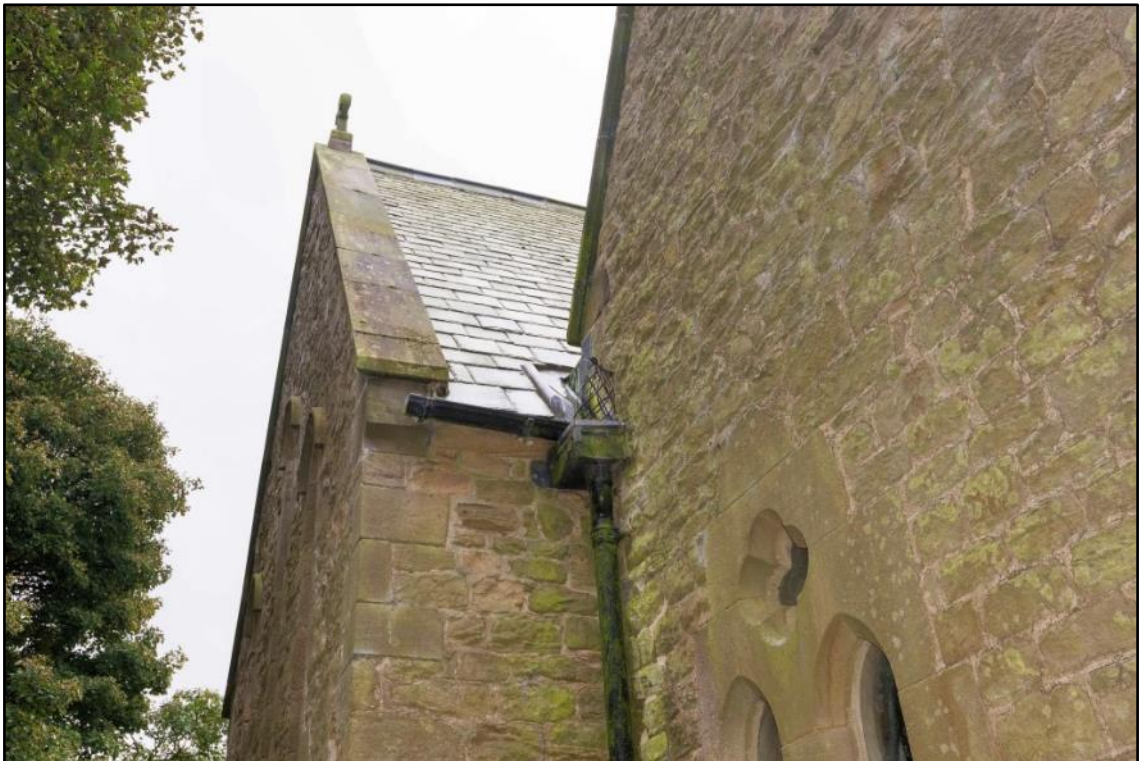
Junction of the Chancel and the Vestry

1.07	General condition of the building	The church is in good condition and well maintained by the congregation. There is no sign of any subsidence or settlement. There is no damp penetration apart from that emanating from valley gutter between the chancel and vestry.

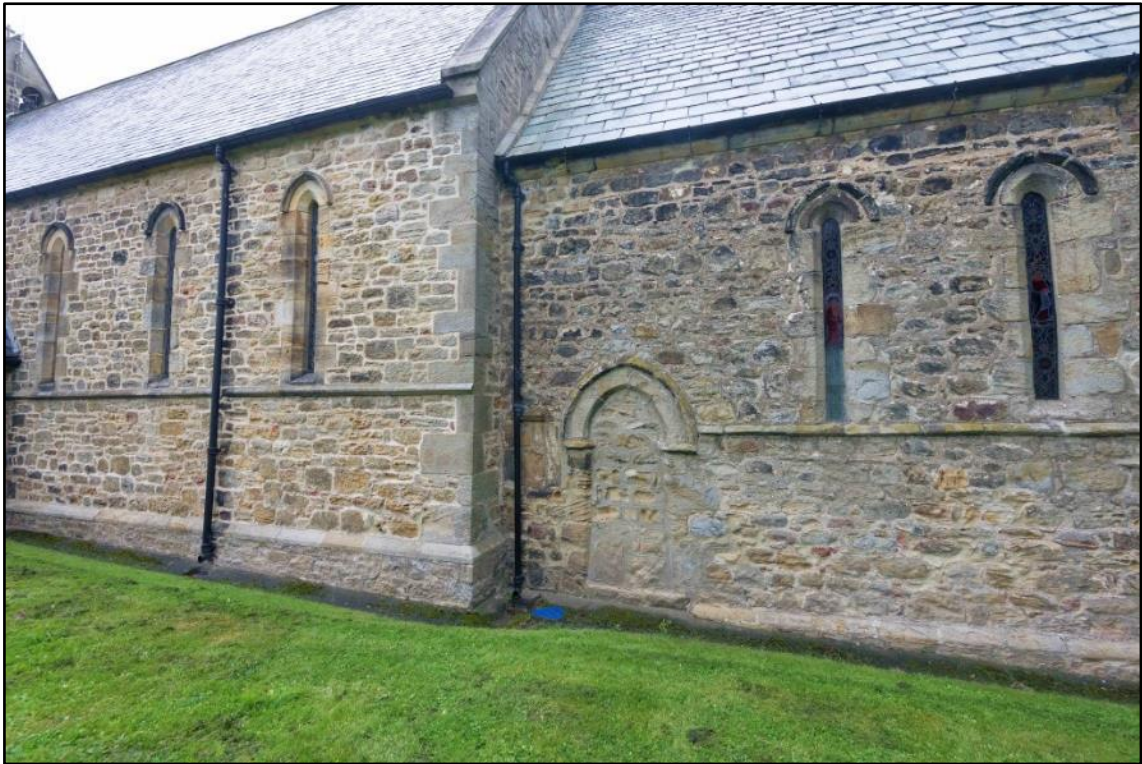
South Elevation: junction of nave and chancel, showing an infilled very early doorway

3.05	Walling	<p>Buff Local Sandstone</p> <p>Dressed and regularised to all corners, plinth strings, openings, buttresses, water tables, parapets and the eaves projection with reasonably fine joints. All the infill stone face is built with varying heights of regularised stone blocks.</p> <p>A mixture of repointing has occurred over time giving something of a patchy appearance. I assume that most of the repointing was carried out in mortar which incorporates cement binders. More recently applied pointing is hopefully bound with lime.</p> <p>Ideally 3.5 Naturally Hydraulic Lime bound mortar should be used mixed 1:3 with sand.</p> <p>The worst stone erosion has occurred to the old doorway in the south elevation off the chancel and is probably associated with the use of cement based mortars.</p>

This erosion should be monitored and a programme of repointing the worst affected areas should be established.
3.06	Timber porches, doors and canopies	Doors to Both Porches and the Vestry Heavy timber ledge frame and board construction stained black. All in acceptable condition but would benefit from cleaning down and re-staining. Boiler Room Door Timber door which requires decoration.
3.07	Windows

2.02	Works recommended to be carried out during the next 12 months	<p>3.05 External Wall Repointing A phased programme of repointing should be established. The first priority would be the south wall of the chancel. The infilled priest's door is particularly in need.</p> <p>4.08 Repair Lime Plaster to east gable of Nave Once the external wall face has been pointed. Repair the water damaged internal plaster.</p> <p>6.04 Cast Iron Railings, Walls and Gates A phased programme of repair and redecoration should be established.</p>	<p>Unknown</p> <p>£3,000</p> <p>Unknown</p>

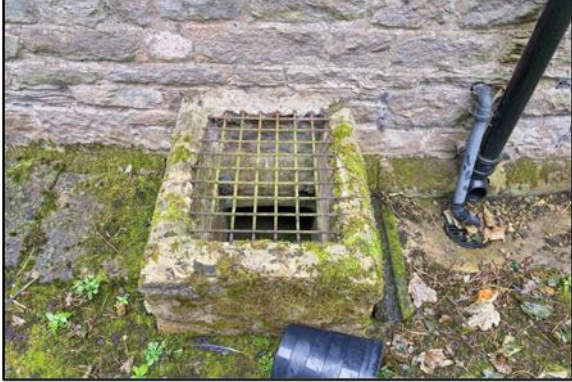
<p>Foul Water Drainage</p> <p>The kitchen tea point appears to not have foul drainage and connects to the rainwater system.</p>

<p style="text-align: center;"><i>Centre: boiler room vent. Right: Sink waste connection to a rainwater gully.</i></p>

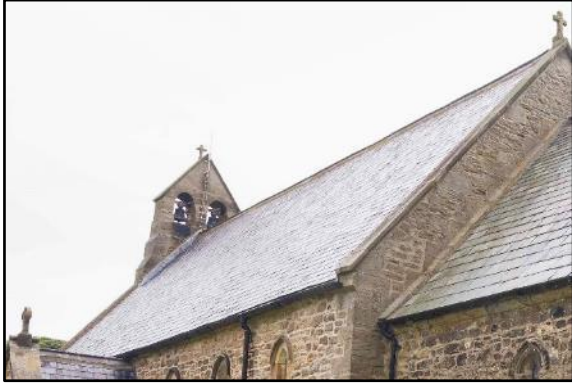
3.04	Bellcotes, Parapets, Chimneys, Verge upstands.	<p>Bellcote and Bells</p> <p>A modest double bellcote sits at the apex of the west nave gable. The stonework was probably repointed when the reroofing was done and appears to be in good condition. A lightning conductor projects above the bellcote ridge and the stone cross. There are recent lead flashings around the base of the bellcote.</p>

<p style="text-align: center;"><i>The belfry and water tables.</i></p> <p>Gable Water Tables</p> <p>Large sandstone flags supported on kneeler stones in acceptable condition. Most of the pointing looks in acceptable condition. That associated with the chancel arch gable have recently been redone.</p>

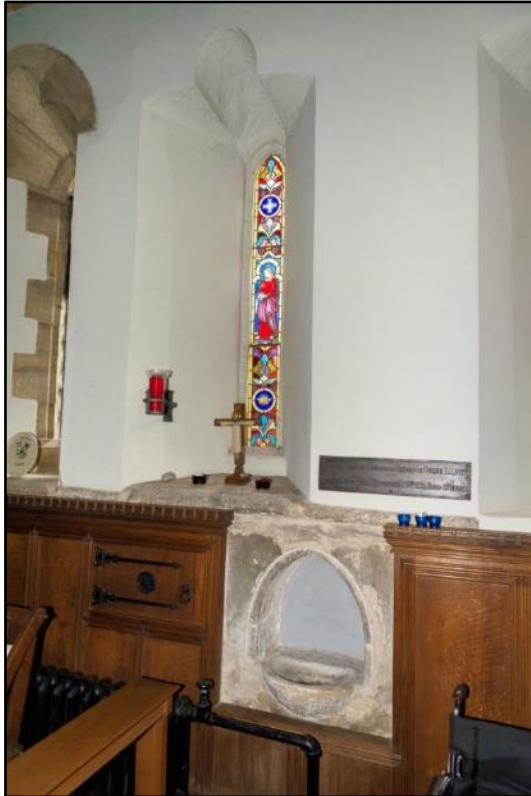
W15 Stained Glass

Stained Glass Windows
		W10 – W12 and W15 – W16 in chancel. All in acceptable condition no damage observed.
		Plain Leaded Lights
		W2, W4, W6, W8, W13, W18-W20, W21, W23, W26, W27 and W29. Diamond quarry leaded glass fixed lights. W1, W3, W5, W7, W14, W22, W24, W25 and W28. Diamond quarry leaded glass with hopper ventilators. Ideally all the vent hoppers would be overhauled. Some could be made operable and the remainder fixed shut.

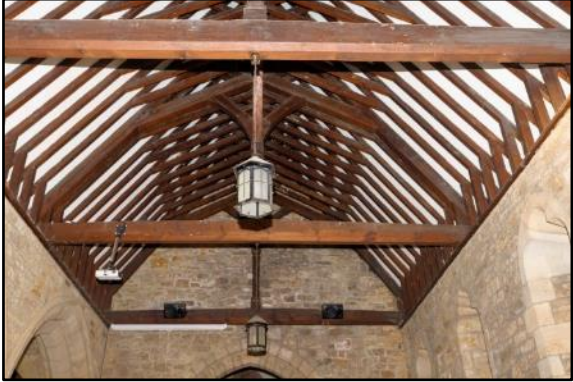
<p>Timber principal trusses and timber rafter trusses with painted plaster sloping soffits. All in acceptable condition.</p>
		<p>North Aisle</p>

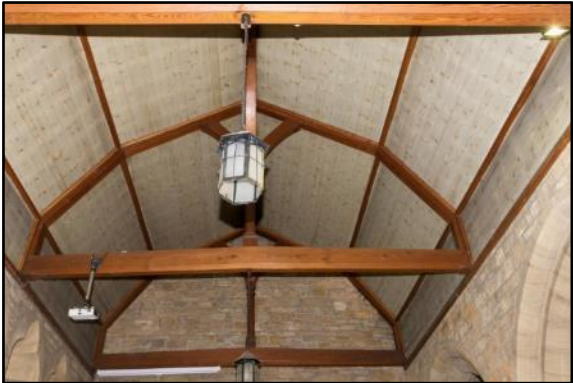
<p>The design of the roof structure appears to be modelled on the earlier nave. The lining has been carried out with timber boarding which makes quite a different visual effect. This appears to be in acceptable condition but would possibly benefit from redecoration.</p>

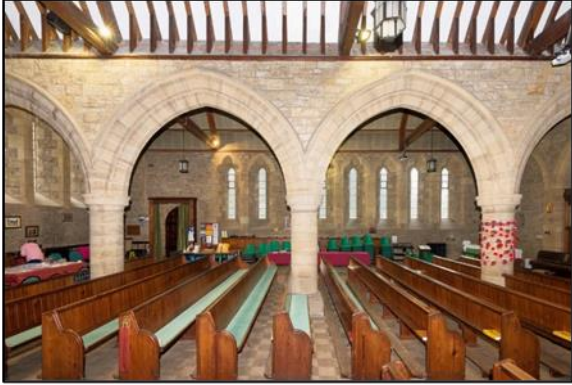
<p>Arcade between nave and north aisle</p>

<p>Dressed sandstone inserted into the north wall of the Nave when the Aisle was added. No signs of decay or rising moisture in the column bases. All in acceptable condition.</p>

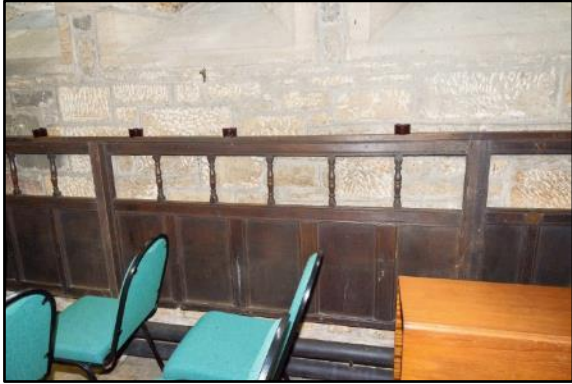
<p>Timber panelling, without skirting and surmounted by a rail supported on turned columns. This appears to be earlier than the current pews and is perhaps a feature of the original nave. All in acceptable condition.</p> <p>Dado Panelling: To the north wall of the aisle. See general pictures at front of this chapter. Timber vertical boarding detailed to match the current pews. In acceptable condition.</p>

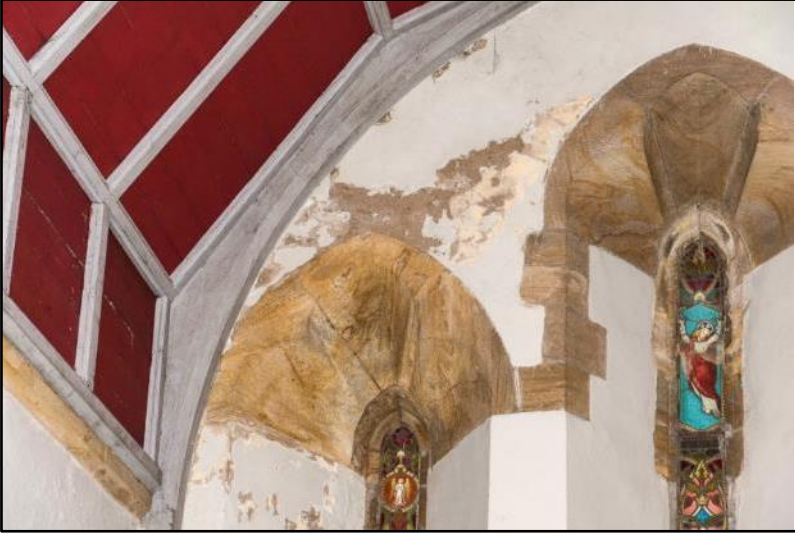
4.08	<p>Internal finishes Comment on materials and condition of wall and ceiling finishes noting any dampness, areas of decayed plaster and other defects.</p>	<p>Chancel Walls: plaster with paint finish. Some exposed stone to east wall. Some damage caused by water penetration to the east gable caused by blocked central valley gutter.</p>

<p>Once the wall has dried out, patch repair the lime plaster as required, and redecorate whole wall.</p> <p>Nave and Aisle Skirting level: Exposed stonework often supporting heating pipework. Dry and in acceptable condition. Dado: see 4.06 Upper walls: Exposed, mortar pointed stonework. In acceptable condition.</p> <p>Organ Chamber Lime plaster, decorated,</p> <p>Vestry Walls: plaster with paint finish. Some exposed stone to east wall.</p>

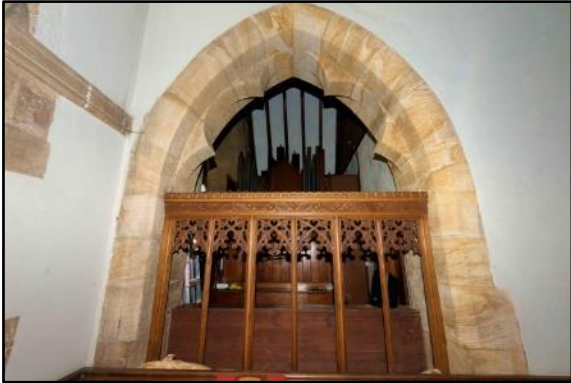
4.11	Organs, and other instruments	<p>Organ The organ itself appears to be in reasonable condition and its regular maintenance is recorded in the log book.</p> <p>Organ Chamber This is a small space and the organ is tightly fitted into it.</p>

<p>In the short term a thorough clean of the space around the organ should be carried out. The condition of the plaster needs to be monitored over a few months and repair and redecoration of the plaster considered.</p>
4.12	Monuments, tombs, plaques etc	<p>Stone Grave Markers: East Wall of Aisle</p>

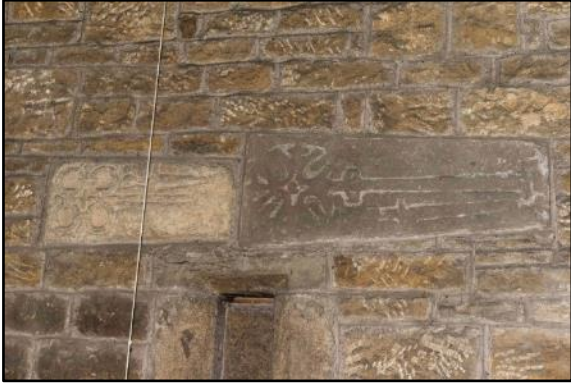
<p style="text-align: center;">In acceptable condition.</p> <p>Memorial Plaque in Stone: East Wall of Nave</p>

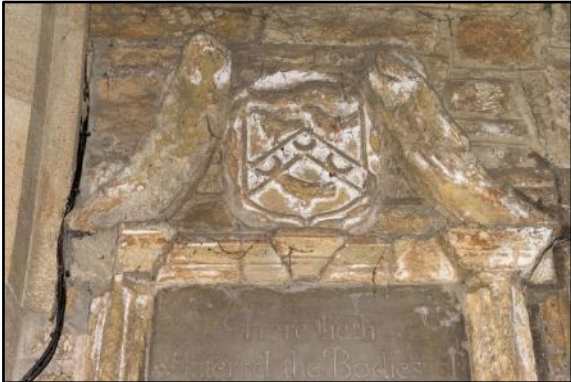
<p>The white bloom appears to be the remains of lime wash decoration and is having no detrimental effect on the stonework.</p>

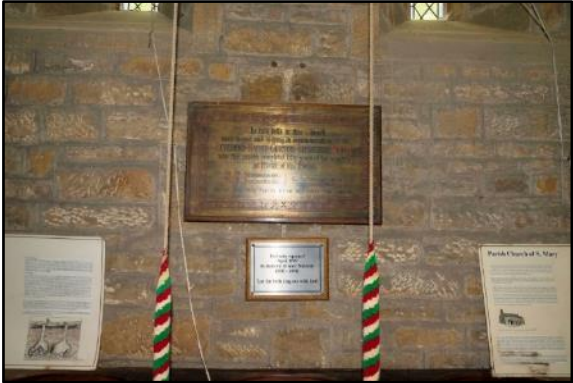
<p>Brass Plaque: East wall of Aisle.</p>

<p>In acceptable condition.</p>
--	--	--

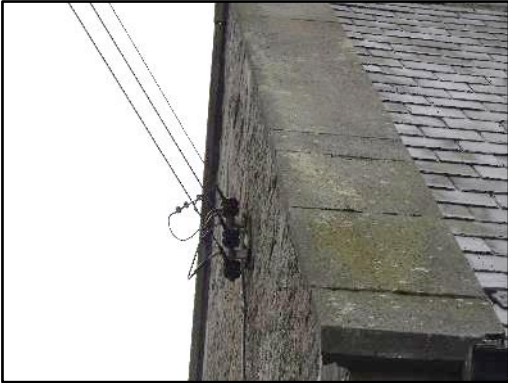
<p>The supply cable runs down the gable and enters the church in the northwest corner of the vestry.</p>

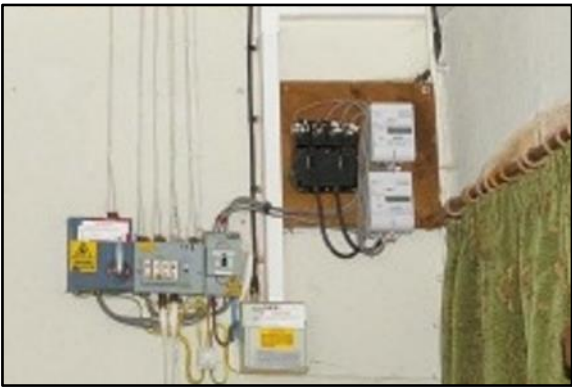
<div data-bbox="683 212 1257 593" data-label="Image"> </div> <p data-bbox="475 607 1465 636">A distribution board mainly, controlling the lighting, is located next to the north door.</p> <div data-bbox="715 647 1225 1028" data-label="Image"> </div> <p data-bbox="523 1041 1417 1070">The boiler house has an elderly electrical panel which needs to be reviewed.</p> <p data-bbox="464 1122 1481 1182">Each of the distribution boards includes fuses. The replacement of these with more modern trips should be reviewed.</p> <p data-bbox="464 1193 1481 1254">The lighting was mainly by halogen spot lighting and these are being replaced low energy LED equivalents in stages</p> <p data-bbox="464 1265 1002 1294">There doesn't appear to be an intruder alarm.</p>

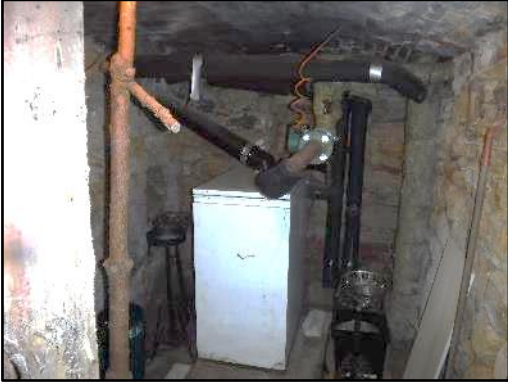
<p style="text-align: center;">The oil boiler in the basement.</p> <p>The oil boiler appears to be quite elderly, and well maintained. Its replacement should be considered during the next Quinquennium.</p>
5.07	Sound system	All appears to be reasonably modern equipment and fit for purpose. AV projectors are neatly installed to the nave and north aisle.
5.08	Lightning conductor	A modern lightning conductor protects the bellcote and is regularly serviced.
5.09	Fire precautions	A 6kg foam extinguisher next to the entrance door and a 2.5 litre CO ² extinguisher in the vestry.
5.10	Asbestos	There are no visual signs of asbestos. Basement boiler houses are often places where asbestos is left. Prior to work being carried out an asbestos inspection must be carried out.

2.06	Works required to improve the energy efficiency of the structure and services	<p>5.06 Boiler The existing boiler is more than 25 years old. Consider replacing with a more efficient condensing boiler.</p> <p>2.06 Insulation Consider installing insulation, the roof would have the highest priority.</p>	<p>£3,000</p> <p>Unknown</p>
2.07	Works required to improve disabled access	<p>Consider adjusting floor and ground levels at the south porch to provide permanent ramped access to the nave.</p> <p>Consider the provision of a Part M WC facility within the grounds of the church.</p>	<p>£3,000</p> <p>Unknown</p>

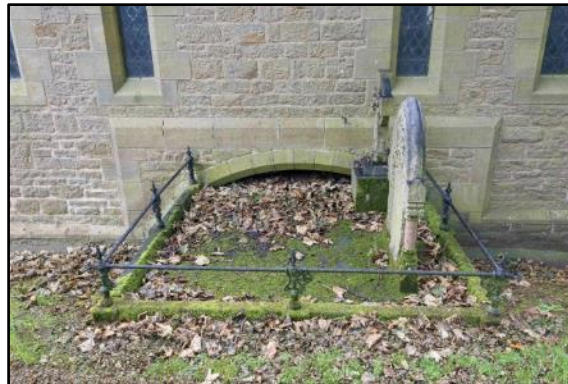
A vault like tomb is in very close proximity to the north elevation. It appears to have been in place prior to the construction of the north aisle. The external wall of the aisle has been built to bridge over the tomb. All in acceptable condition.

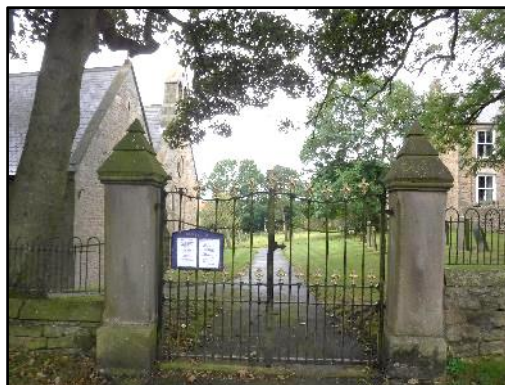
Gates

The Iron gates to the north site entrance require minor repair and redecoration. One finial is missing.

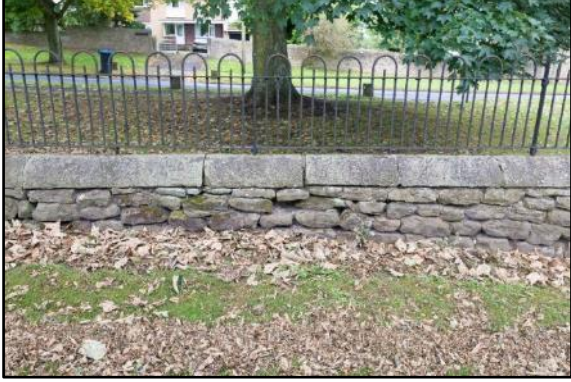
<p style="text-align: center;"><i>North Boundary Wall</i></p> <p>North Boundary The stonework of the low wall would benefit from consolidation and repointing in lime mortar. The iron railings all require minor overhauls and redecoration.</p>
