**MAYA POLENZ** ARB AABC

Accredited Conservation Architect

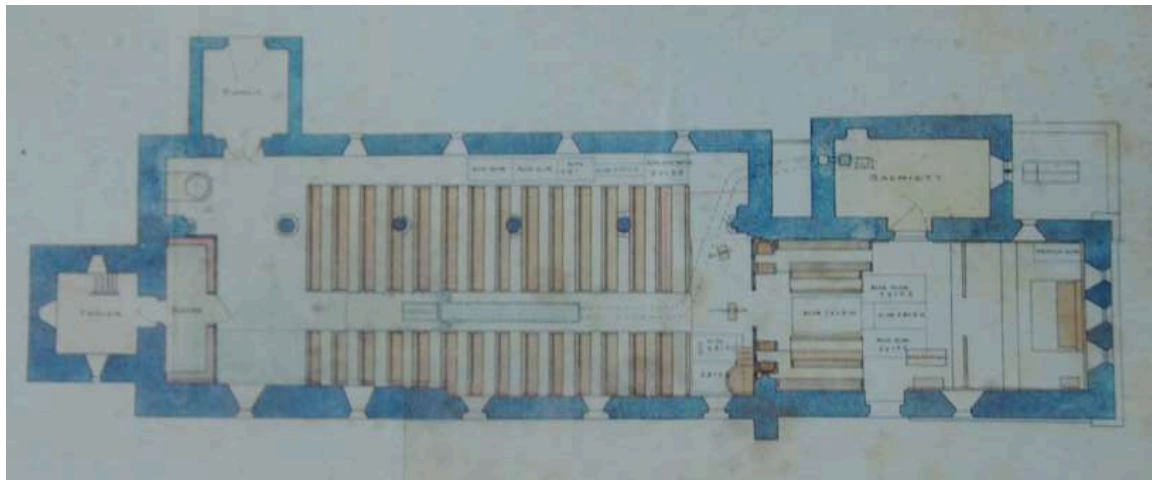
*Church plan post 1870, a copy hangs in the Porch. Font & tower vestry since moved, kitchen & organ added.*

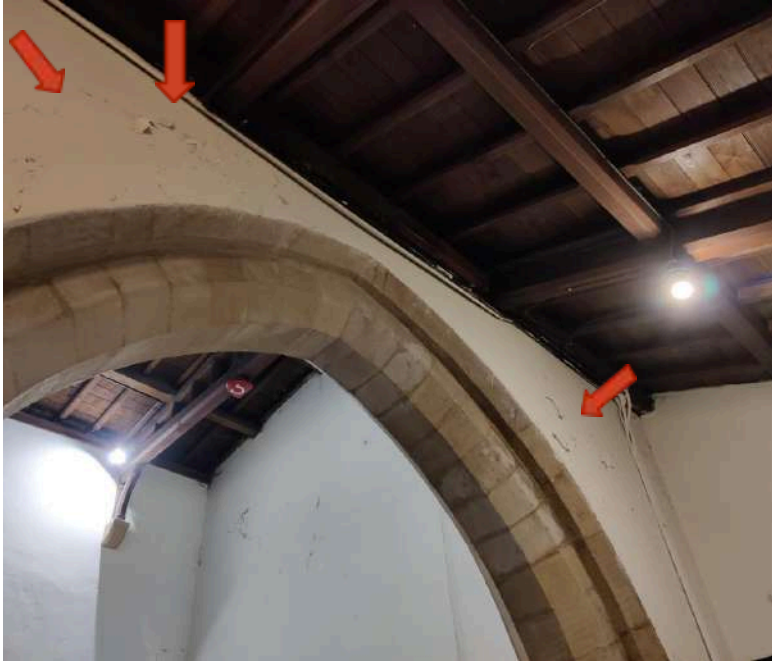
11. Large area of failing plaster at Southwest abutment of North Aisle to Nave (arrows)

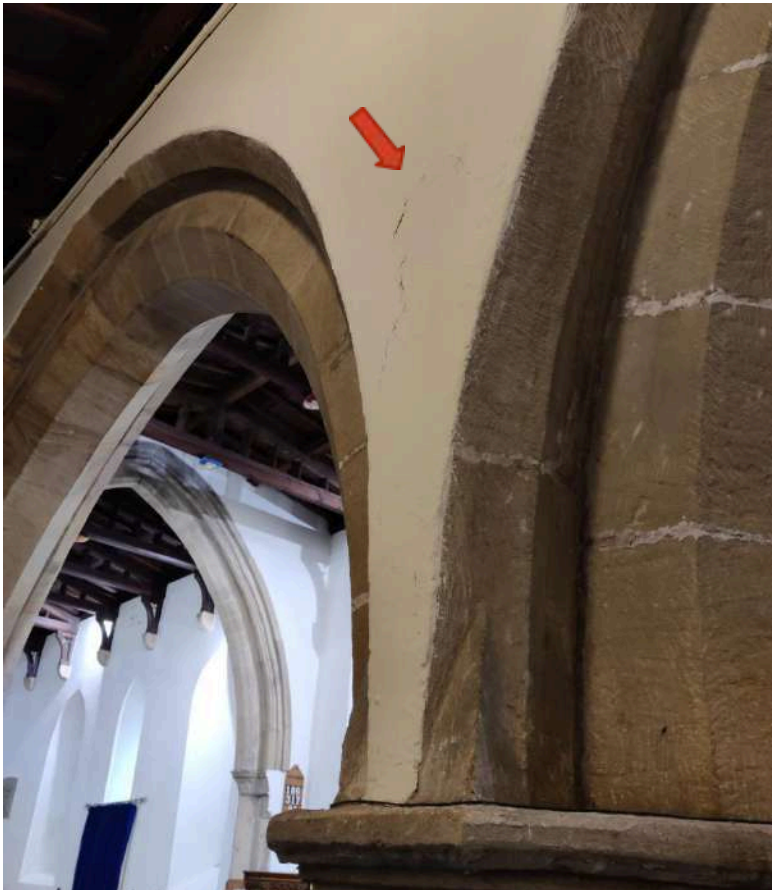
12. Failing plaster at base of arch between North Aisle and Nave (arrow)

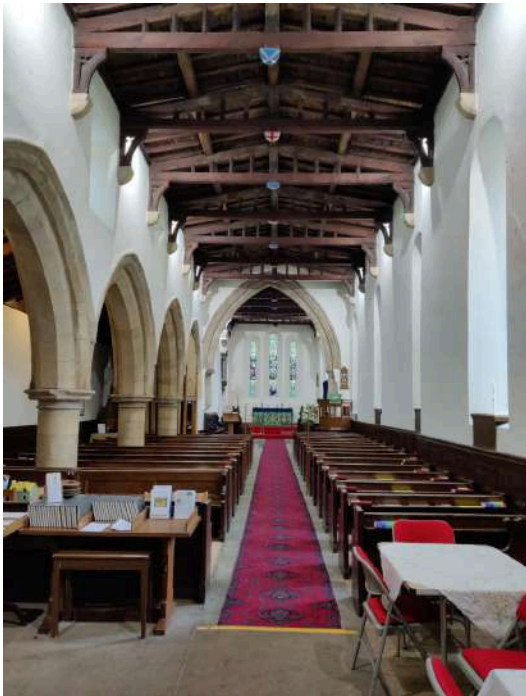
13. Nave looking East

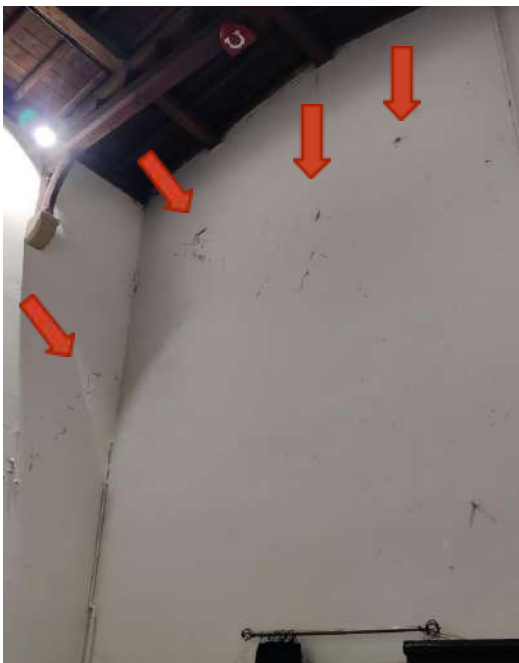
15. Wide-spread failing plaster at high-level at the West end of the Nave (arrows)

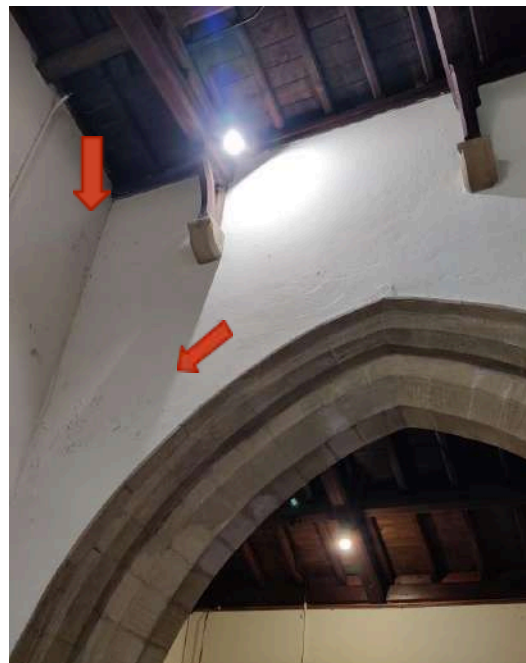
16. Failing plaster at the Northwest abutment of the Nave to the North Aisle (arrows)

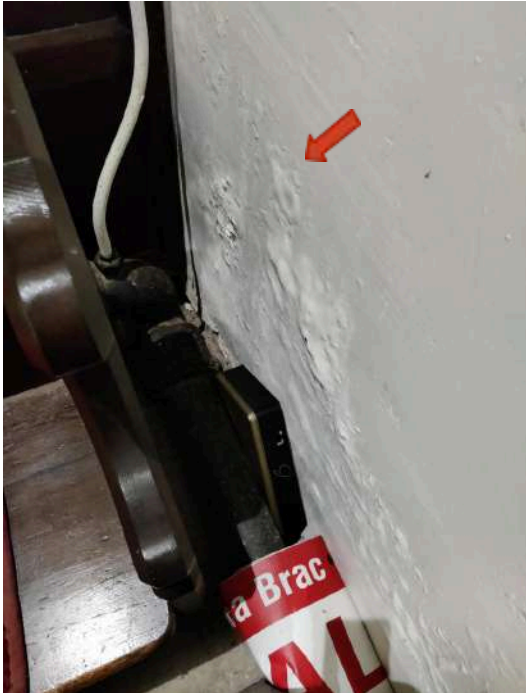
17. Localised blistering plaster at low level at the West end of the Nave

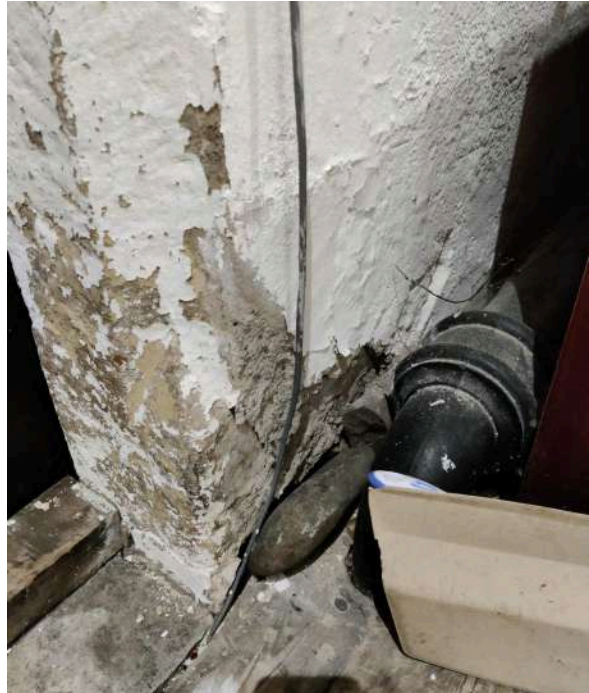
18. Localised failing plaster at low level at the West end between Nave and North Aisle

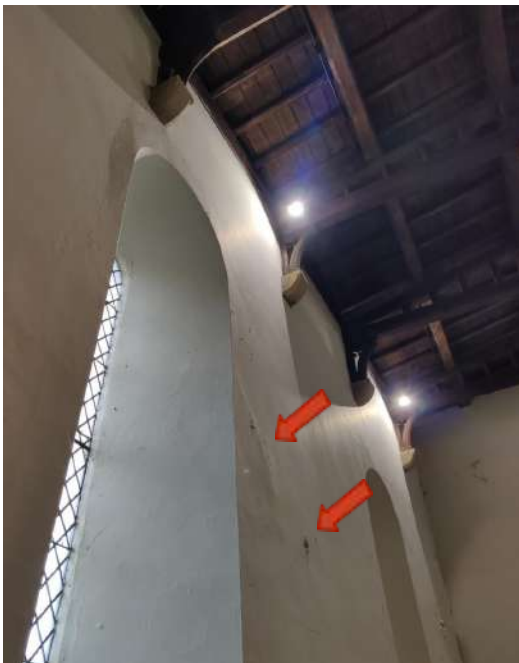
19. Blistering of paint on South wall of Nave

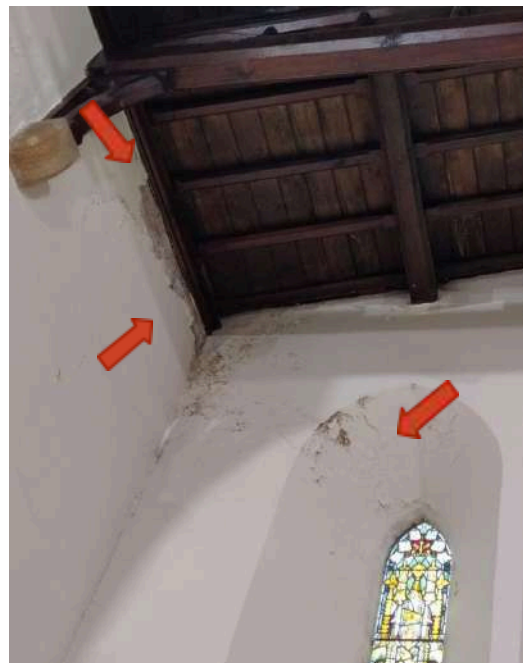
24. Past water damage to E ceiling abutment of Chancel, reported as repaired

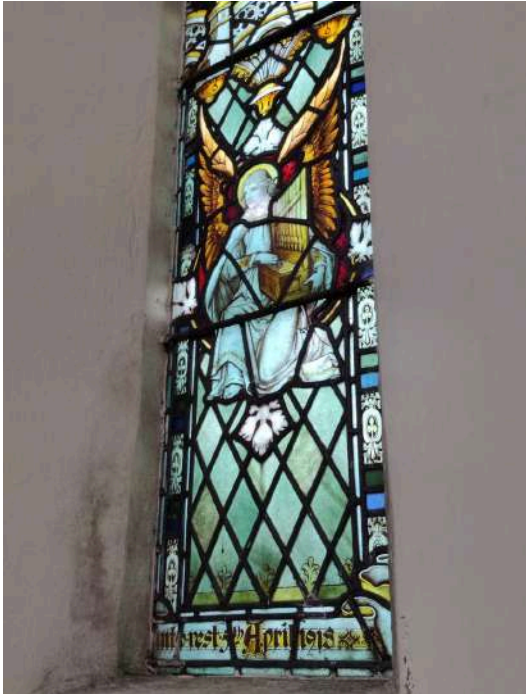
25. Bowing stained glass should be monitored

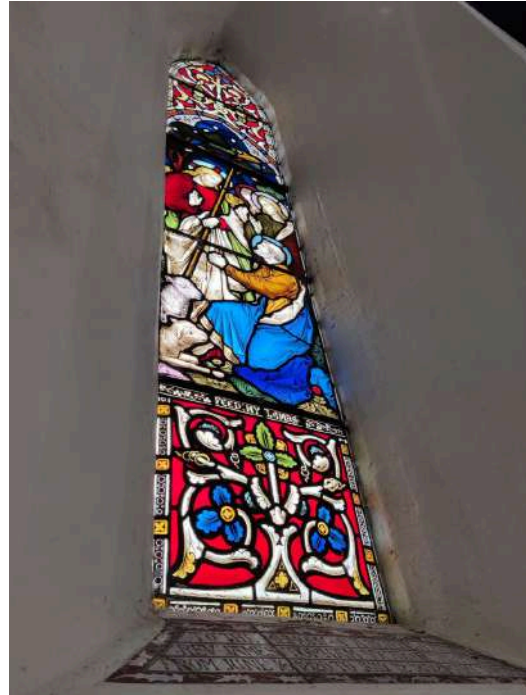
26. Stained glass in S wall of Chancel

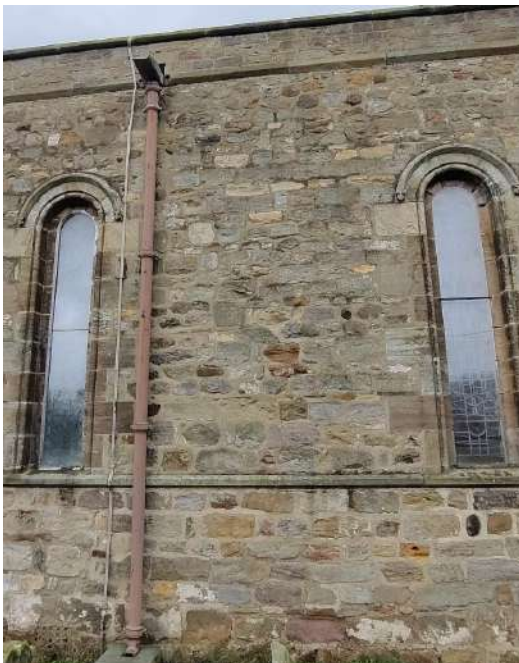
42. S elevation of Nave showing blistering paint internally near location of downpipe. No external defect is visible. Roof outlet should be looked at.

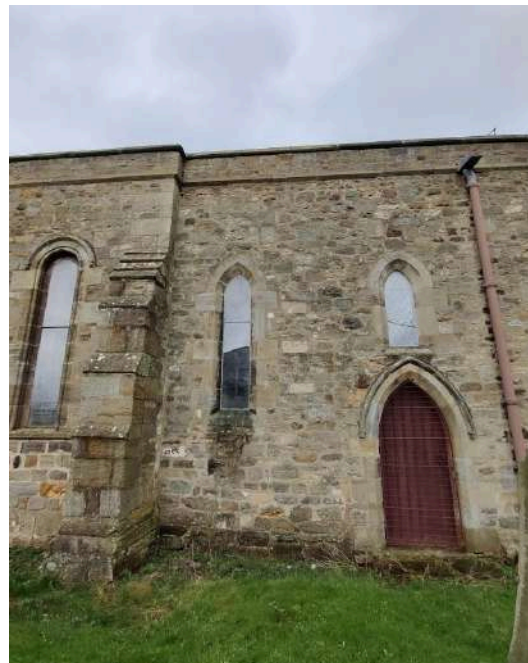
43. Nave/ Chancel S wall. Chancel door and grille would benefit from cleaning & redecorating.

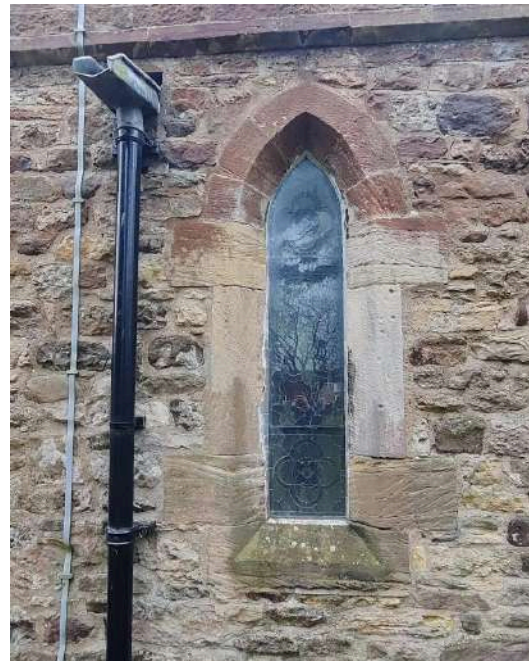
50. North Aisle window. Internal plaster is cracking. The external stonework is generally wet but there is no visible external defect.

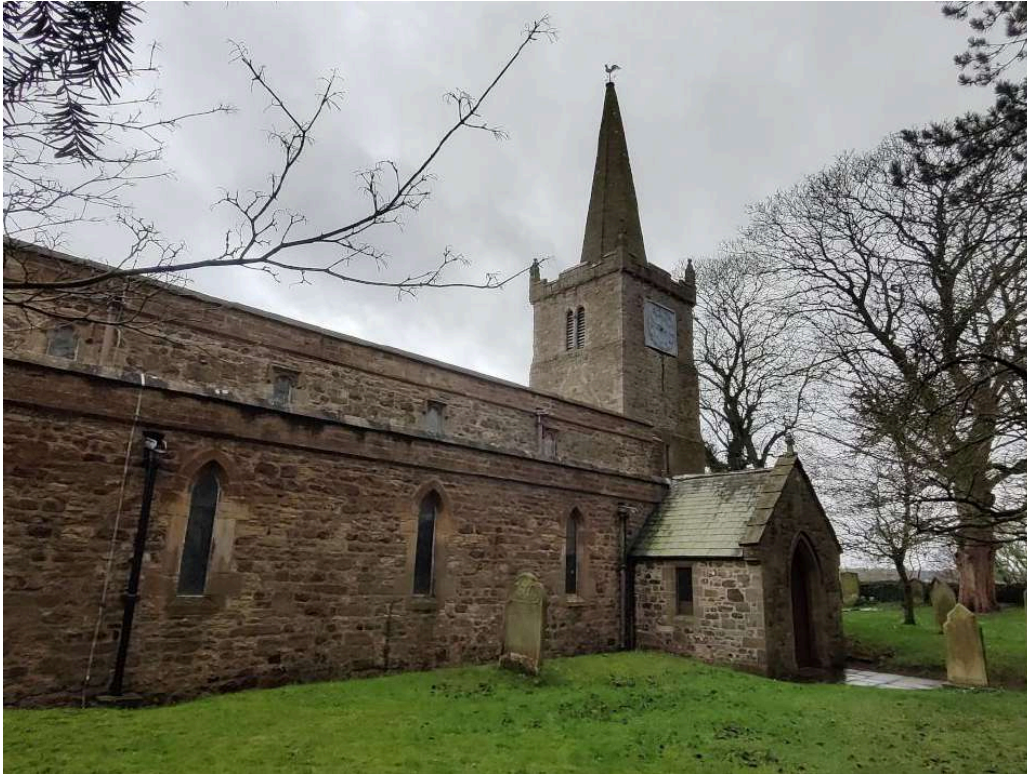
51 (above). View from NE    52 (below). View from N towards Vestry and Boiler House

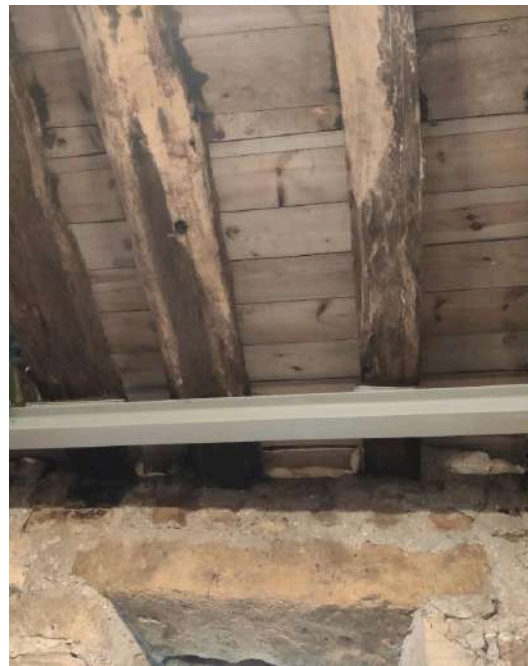
60. Tower first floor - new steel beam supporting decayed beam ends

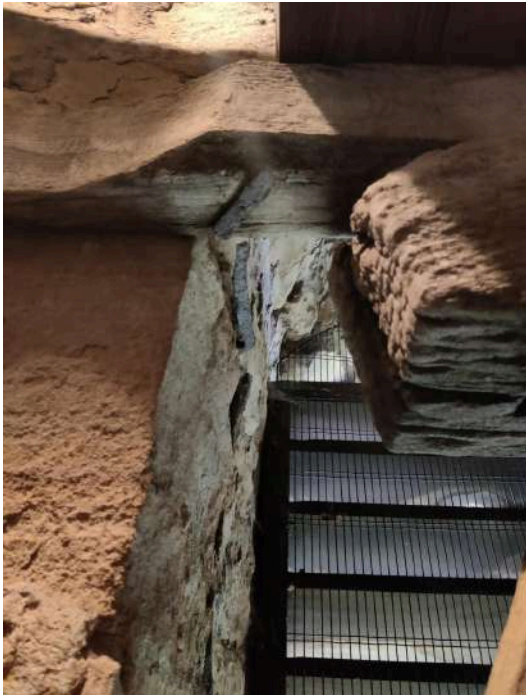
61. Tower top floor, netted louvred openings and redundant timber bell frame, which is wet to the touch and decaying at its base.

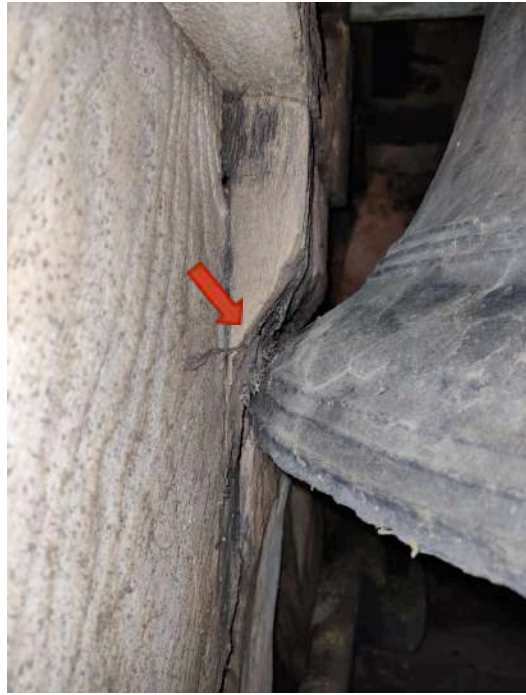
62. Redundant headstock dropped due to decayed base and is leaning on bell. The headstock needs to be fixed clear of the bell.

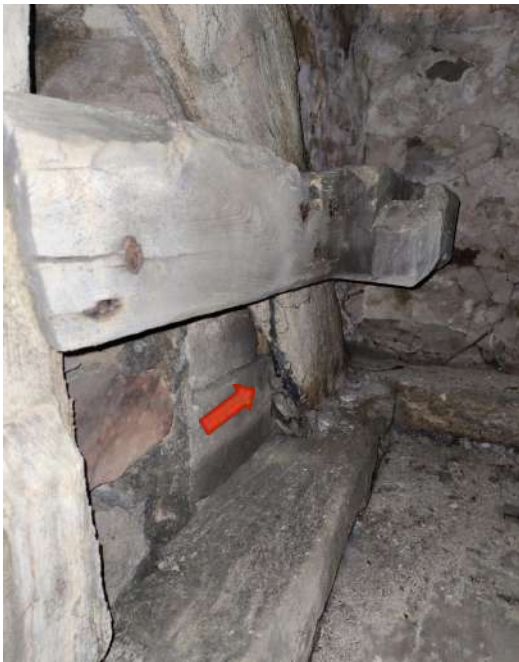
63. Wetness & decay to historic bellframe (arrow)

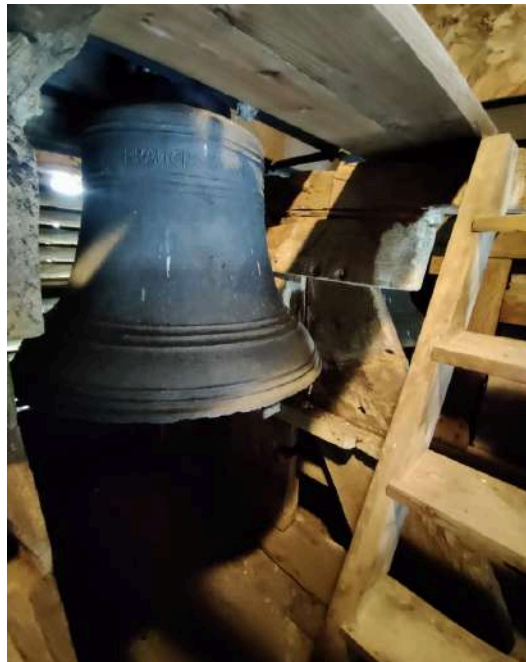
64. View from SE onto bells

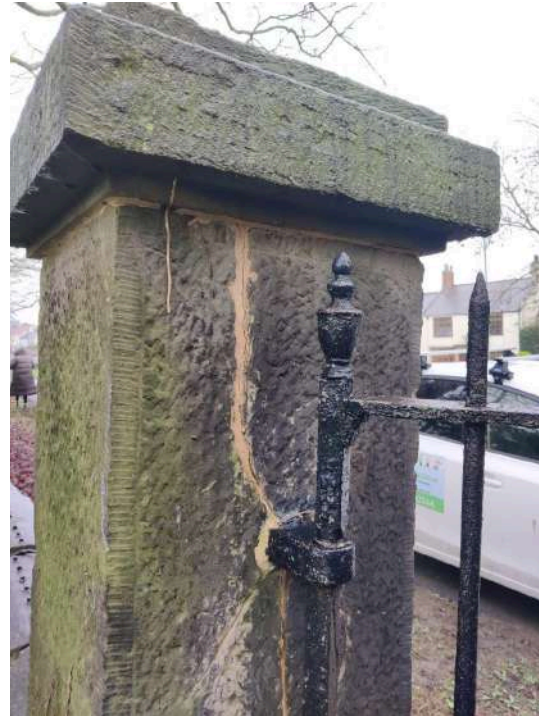
69. Crack requires repointing or complete treatment of rusting hinge end.

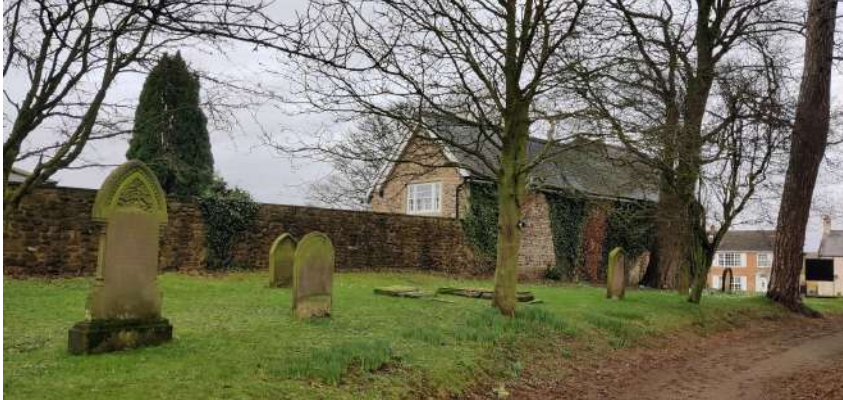
70. W boundary wall seen from main path

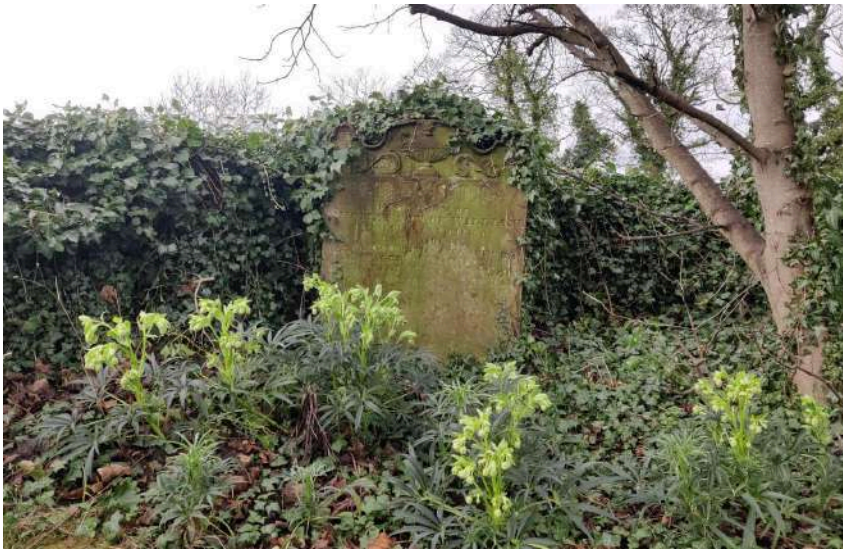
73. Corner of W and S boundary wall is overgrown

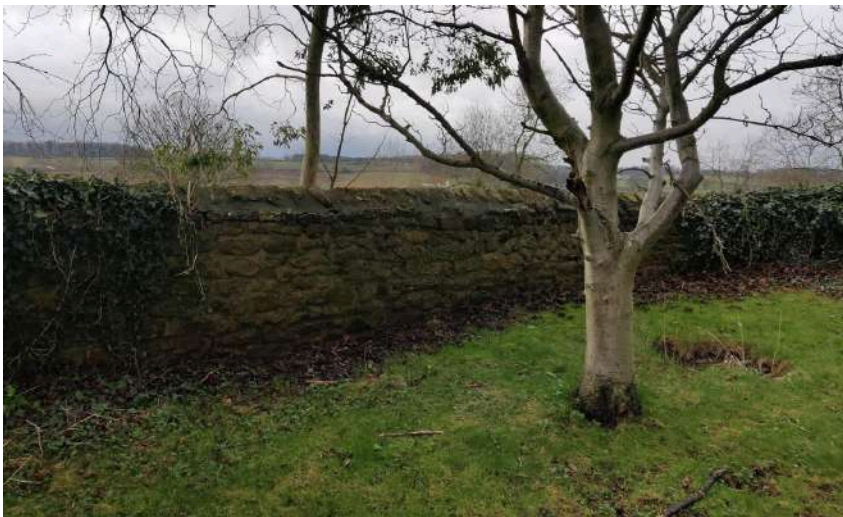
This is a taller retaining wall on the other side and its condition should be checked, with agreement for access from the adjacent owner.

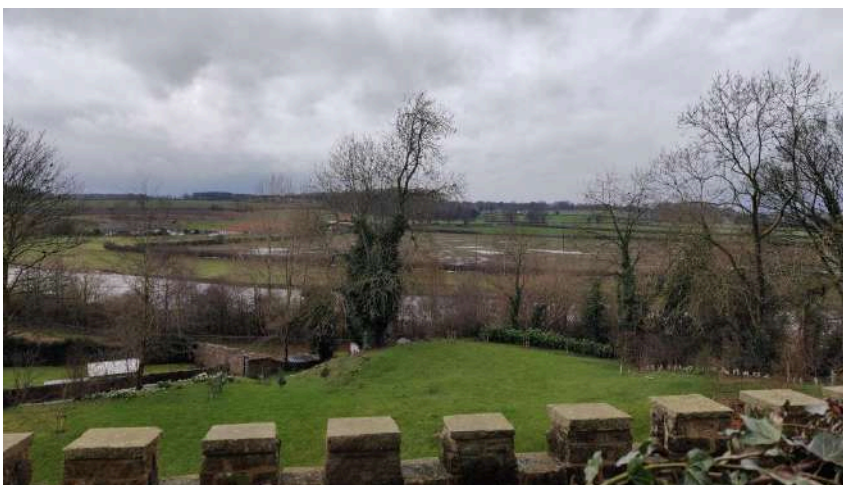
75. View over S boundary wall. The crenellated wall at the bottom of the photo is a separate retaining wall beyond the boundary wall.

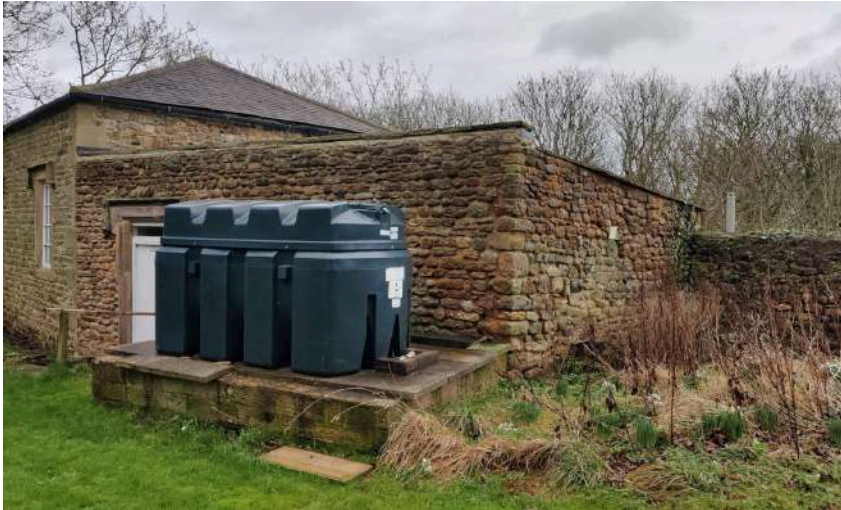
76. W boundary wall and oil storage, with the Church Hall in the background

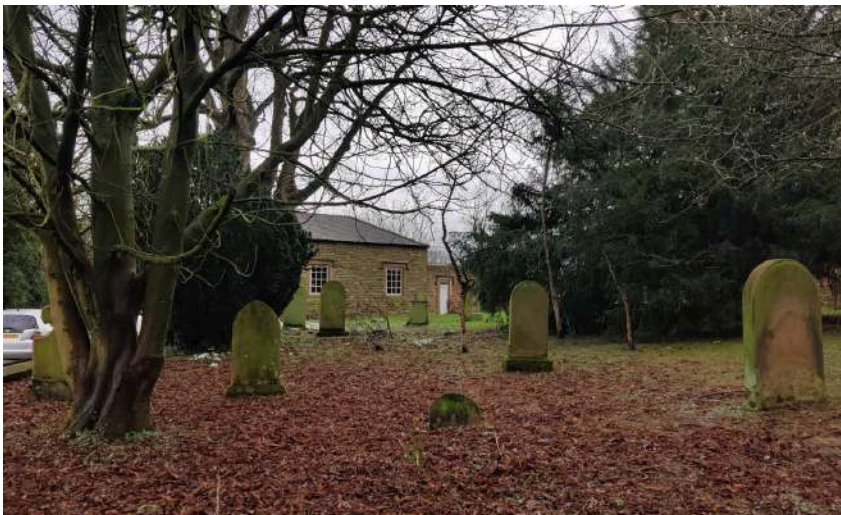
77. View across the churchyard to Church Hall
