QUINQUENNIAL INSPECTION REPORT

CONSETT, CHRIST CHURCH

QUINQUENNIAL INSPECTION AND REPORT
April 2022

David Beaumont BA (Hons) Grad Dip, RIBA, AABC

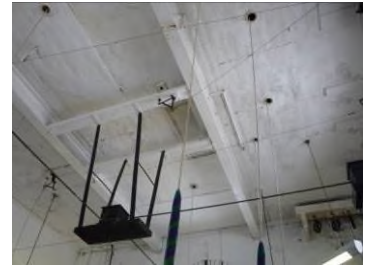
- **Ceiling** – Warped fibre board panelling looks damp (but I don't think it's 'wet' and the ceiling is beginning to break up on the N side just above the foot of the stairs. Two steel beams have rust coming through the paint work- they just need redecoration.

- **Floor** – Is solid and contains the bell ringers' fly collection.
- **Miscellaneous** - Small cupboard to one side full of maintenance equipment. Within the clock cupboard the small window on the W Rooks are nesting, glass is broken and there is also an exposed lintel that looks a bit run down and the plaster is coming away a bit and there is quite a bit on the floor which won't be helping the clock mechanism.

Recommendation: Remove rust to beams, clean up the dial vent holes and shutters. repair rook glass, eradicate flies, redecorate

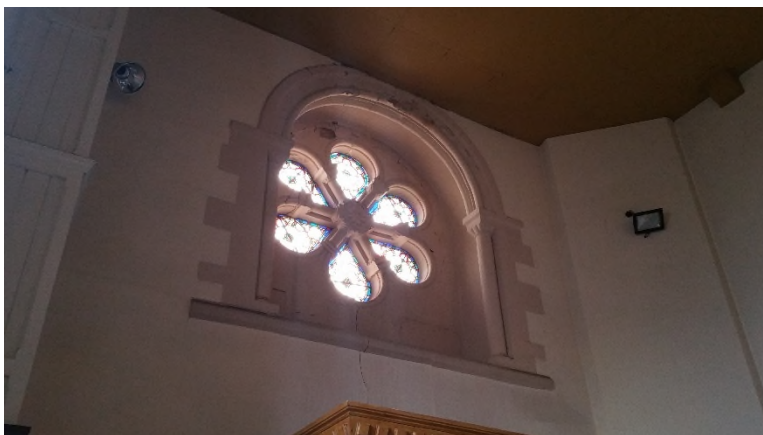
D Base of Tower:

- **Ceiling** – Flat ceiling of boarding like elsewhere.
- **Walls** – Are much the same as last time, horizontal crack to the N side just below the corbels. W wall has crack coming down from the rose window, I think the decoration to the arch is just a little worse than it was before. Slight crack at the angle of the two walls to the left of the Parish clock plaque and a crack to the arch head of the doorway at the bottom of that doorway the wall has been patched up with some gypsum plaster. Slight crack to the arch into the nave on the N side.

- **Floor** – Is nice granolithic tiles they are ok.
- **Miscellaneous** – There is a timber lobby, door is catching slightly and the carpet is kept down by tape and could do with updating to avoid becoming a trip hazard. The entrance doors are ok, they just fit but there is a draught coming through them of course, hence the lobby, the former curtain has gone now.

Recommendation: update carpet, consider draught stripping entrance doors

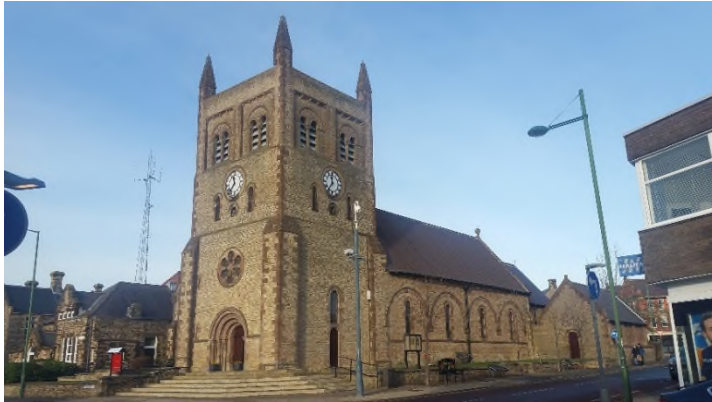
Tower: There is significant vertical cracking to the tower on the south-west corner, probably due to ground conditions. The tower has been the subject of an engineer's report in 2004 and a quick comparison between the pictures of the cracking then and now shows little change, however the underlying problems remain and joints remain open. Because of dropping out of mortar and one stone (causing the west doorway to be closed temporarily) in 2014, a high level inspection was carried out by Taylor Hastwell (see report in appendix). They reported multiple pointing failure, cracked stones, rusting metal ties, crushing to the west wheel window, mesh to the windows beginning to fail etc. Their estimate was £27,000 ex vat however this does not include the engineer recommendations of 2004, when an estimate was produced for £60,700 ex vat. The engineer report recommends full scaffold and Cintec anchors installed along with a complete repoint and stone repairs. It is probable that this engineering figure can be revised up to c. £100,000 ex vat. The whole repair of the tower is probably in the region of £150- 175,000 ex vat and professional fees.

Recommendation: The recommendations of the engineer report in 2004 are still valid and with recent mortar failings and close inspection when carrying out roof repairs, the combined results mean that the church should address the tower defects in the next five years.

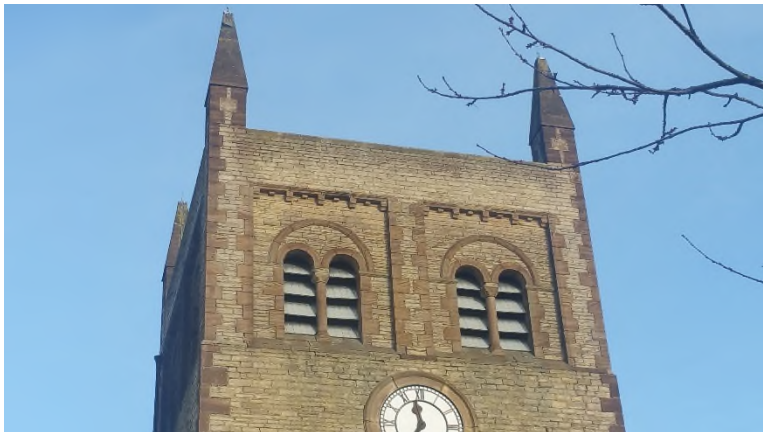
West face- Bird nesting in the small window under the dial, crack running through the rose window and head of the doorway, multiple erosion and open joints. Separation to the south buttress.

West Elevation – Chip out to the pinnacle top of the NW corner. Quite a bit of erosion to the parapet. Belfry openings look ok. There are cracks/open joints to the cills (same as the other sides)

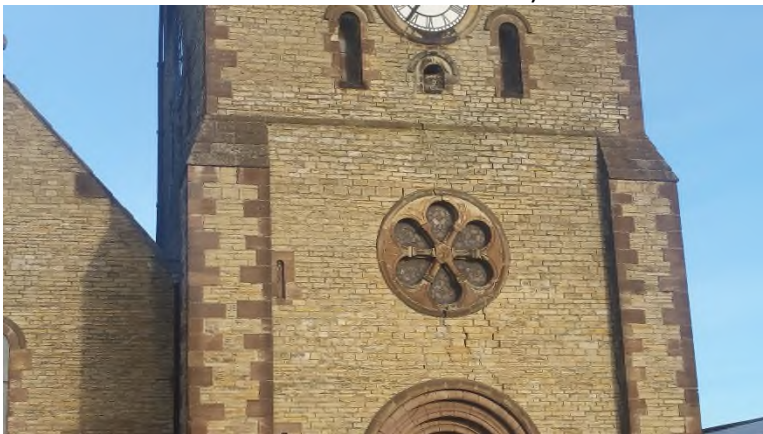
Above the clock dial are open joints and slight suggestion of movement and you can start to see it wriggling down from roundabout six o'clock past the Rooks nest right through to twelve o'clock on the rose window, coming out at six o'clock and also at five o'clock wriggling down to the arch, I don't think it has progressed since the last inspection from a casual look at the old images. The rose window spokes look to be coming apart as they lose their compression as the tower widens and that is a worry. There's a lot of wide joints with cement pointing falling out. A lump came out of the rose window c. 2018 causing the entrance to be barriered off. The steeplejack returned and removed some of the loose cement.)

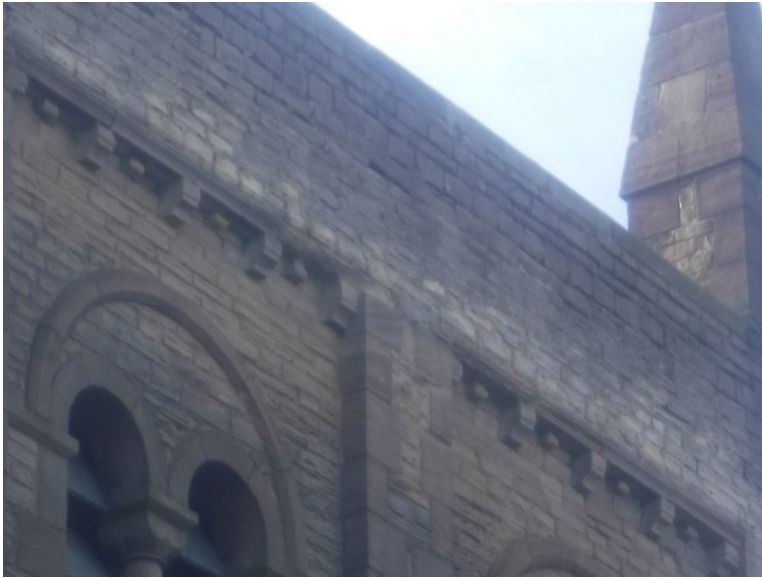
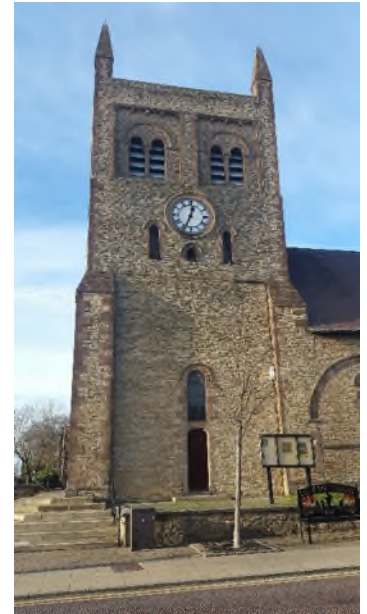
South Elevation –

Better condition than the E, you can see the cracked pinnacle top here, open joints mostly at the parapet, there is a crack to the W quoin of the window and I think that is from last time. The buttress shear cracking looks the same.

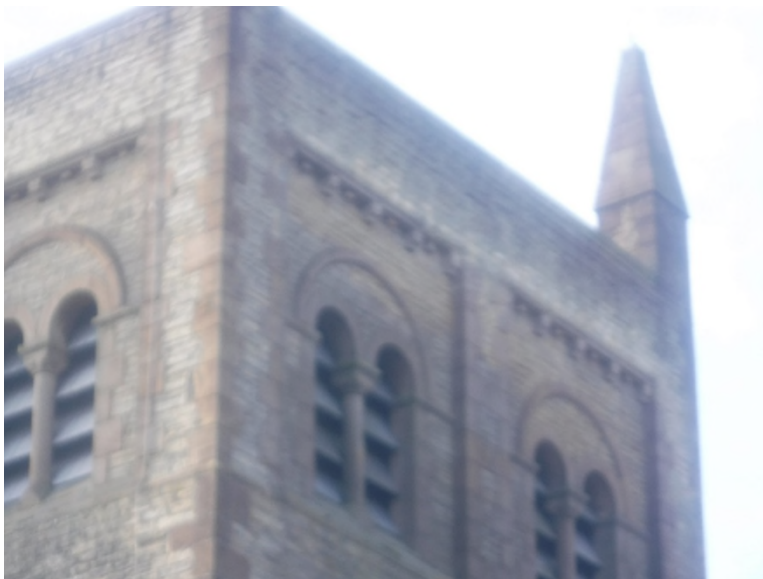
East Elevation –

Loss of pointing to the parapet, below that the general walling has quite a lot of loss on the stonework. The belfry openings look ok but the S one has a bit of a chip out of the face of the transom column and it may have a shear crack below the capital.

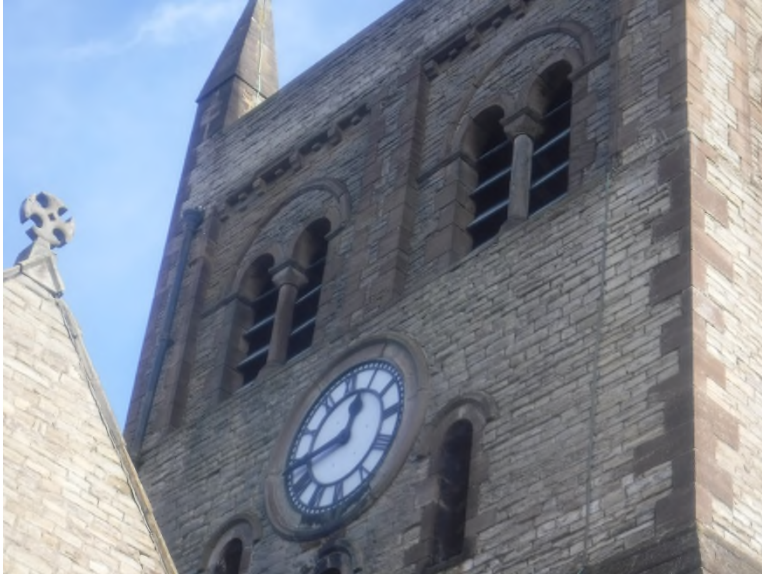
North Elevation – This looks really poor. Joint gaps at the belfry cills, bit of a crack below half past six on the clock, also that discoloured stone band line seen on the W is also there on the N.

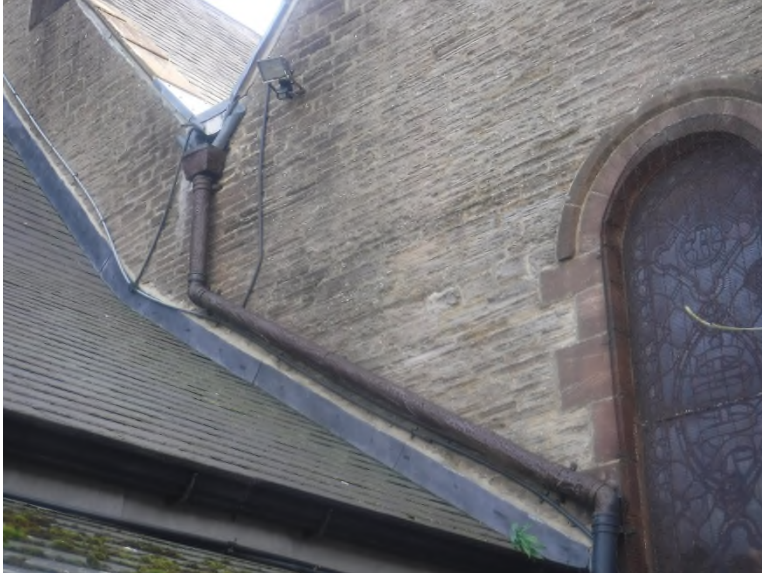
- **East End:**

Nave outlet downpipe is ok, repaired in 2013, it comes from the valley gutter. Watermark is from earlier failure- now corrected.

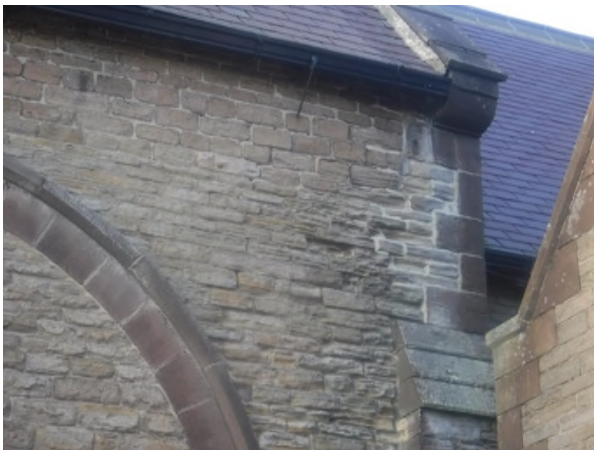
- **Nave:**

South side – Gutter ok but grass up at the tower end, downpipe in dire need of decoration but is ok, leaves in the salt glazed gully. Is the central downpipe hopper blocked?

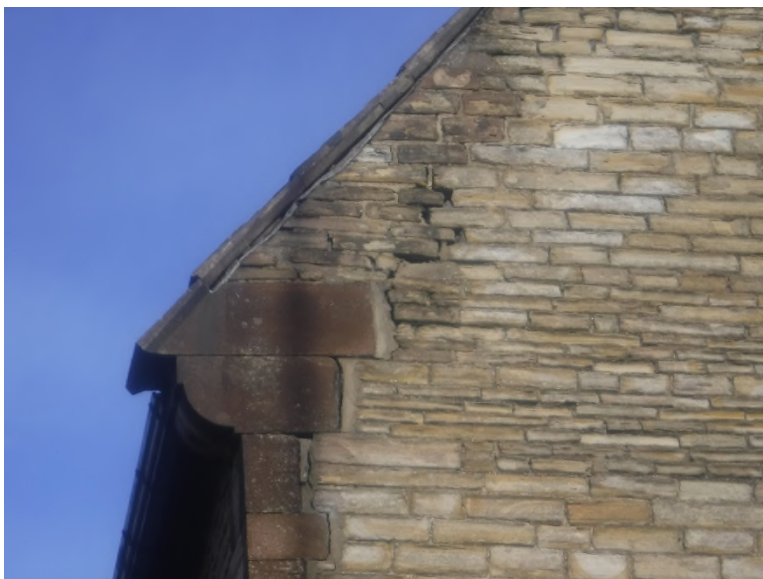
C **North Aisle:**

The watertable is laminating badly, the cross also laminating, walling is eroded badly below the apex above the window, also to the left of the window and to the right of it too,.

The kneeler is losing its bond and this needs some diligent repairs. It hasn't changed much in the last 5 years but it shouldn't be ignored.

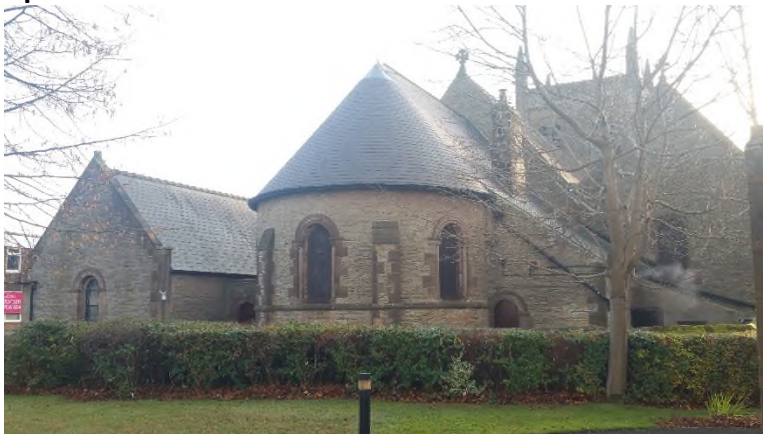
Apse

East end – This is semi-circular masonry rather damp looking at the bottom of the wall, is that because of the tarmac up against it? Buttresses are ok, some of the cement pointing is rock hard and it should all be replaced in lime. The bottoms of the window shafts continue to splinter on the rusting dowels.

Recommendation: repair shafts.

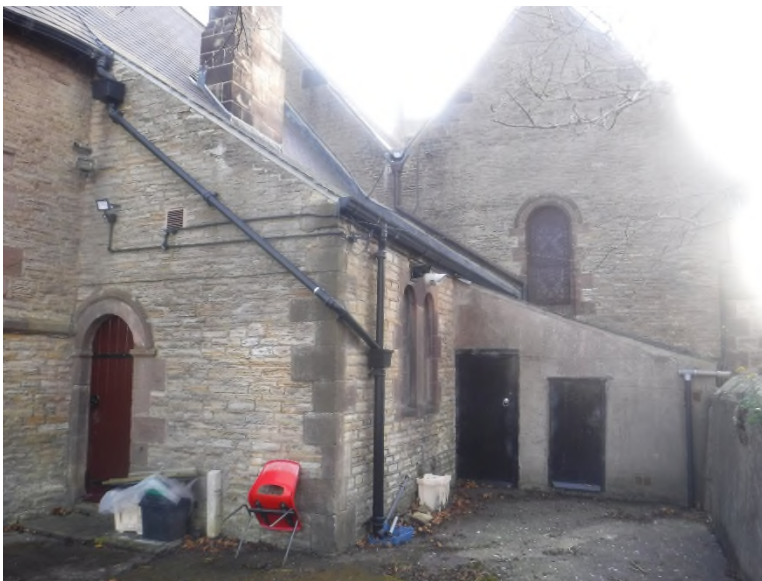
Boiler Room:

The original boiler room, now used for storage.

Boiler room and store have been reroofed and guttering repaired since last QI. Masonry is ok, redecorated door.

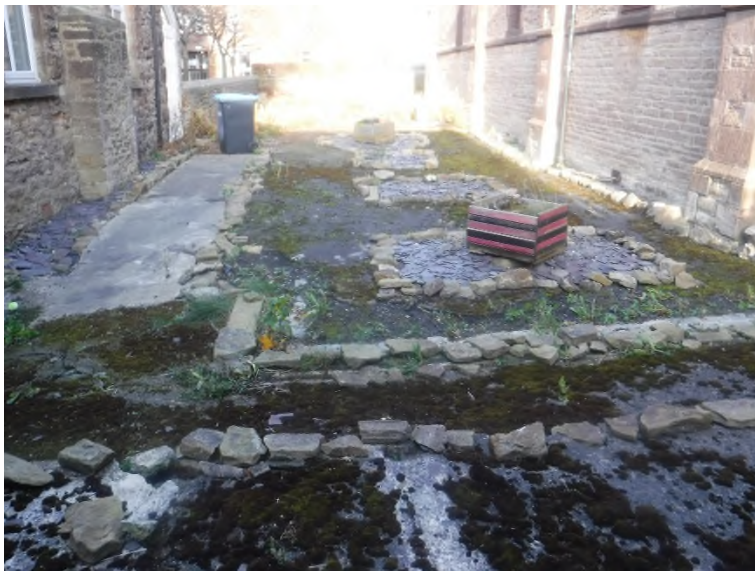
North Side:

The yard at the rear is part of the Parish Hall and is their rear means of escape. It is in poor condition (though has been tidied up since the last inspection) and because of undulating ground surfaces of the demolished former outside wc block whose drainage connections are still visible in the ground makes it a health and safety trip hazard.

The boundary wall to the E side is cement rendered and is looking much worse than it was before, there are some trees in the neighbouring properties in the NE corner and they have been dropping a bit of leaf littering into the church and hall gutters and they choke it a bit. They need to know who owns this wall to understand repair obligations. it is pretty poor certainly on the inside of it, on the opposite side the neighbours side it is impossible to see as there is vegetation growing up against it.

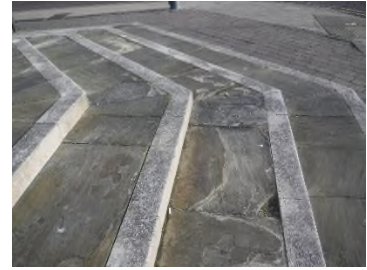
Timber gate between the aisle and parish hall coming apart.

Recommendation, repoint open joints to ramp retaining wall, repair steps (trip hazard).

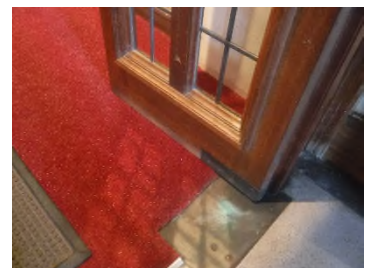
D Entrance lobby: Timber draught enclosure formed of glazed screens. The entrance door is slightly warped and the catch just about holds the lever in place. The hinges have had various types of washers added to them over the years however it is generally serviceable. A former curtain rail remains to keep the draught out in the past. The curtain is now gone. The side door doesn't latch properly.

Recommendation: Ease doors

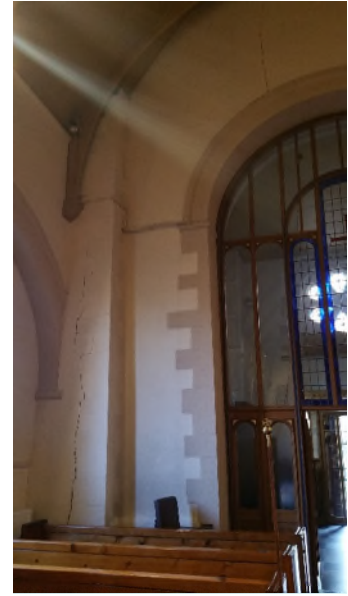
- **West wall** – 5mm crack reported in last QI on the southern side of the semi-circular arch boarding and the wall might now be 6mm. Also historic hairline crack to the arch which is also decorated in

Artex. The southern side of the wall has a long vertical crack of approximately 6mm at the base tapering to 2mm at the top as the last inspection. This looks like a shear crack resulting from ground movement or tower loading. The base of the wall is showing some damp and some poor cement infill.

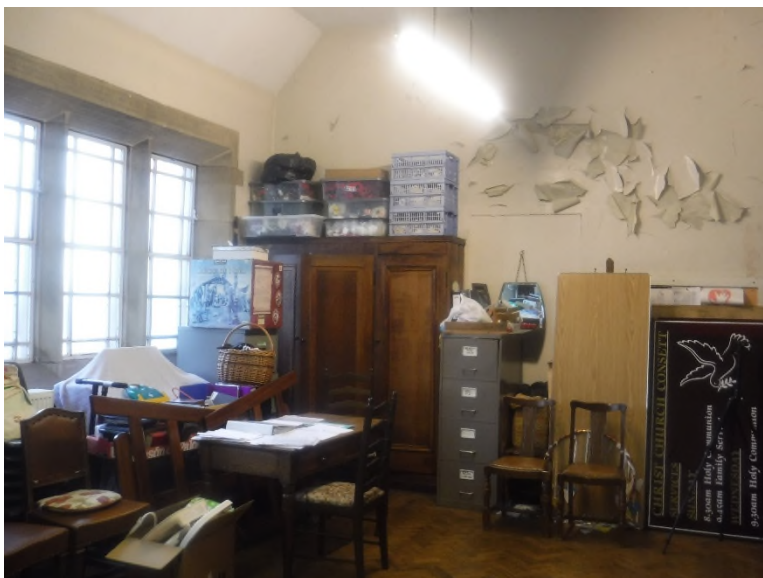
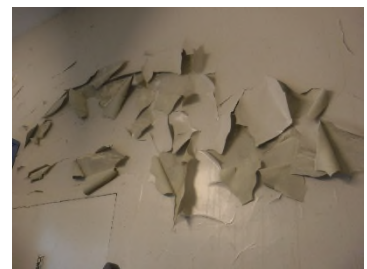
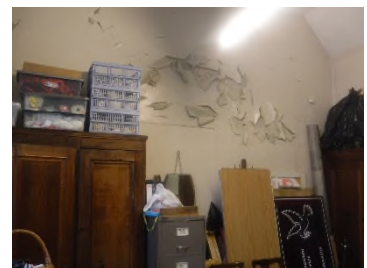
D Choir vestry:

- **Door** – catching.
- **Ceiling** – Flat ceiling with sloping margins showing slight historical cracking and in need of decoration.
- **Walls** – Plaster with flaking decoration. South wall has large three light windows, displayed reveals that are in good condition containing metal framed

windows with timber glazing beads. Some of the glass has been broken in the past and the glazing beads are loose. Some have been replaced with putty rather than glazing beads. Looking shabby now. Perhaps security ought to be considered in this room.

Recommendation: Decorate ceiling and walls, refix glazing beads and remake poor putty pointing with new glazing beads. Ease cpd doors and remove lumber. Consider security.

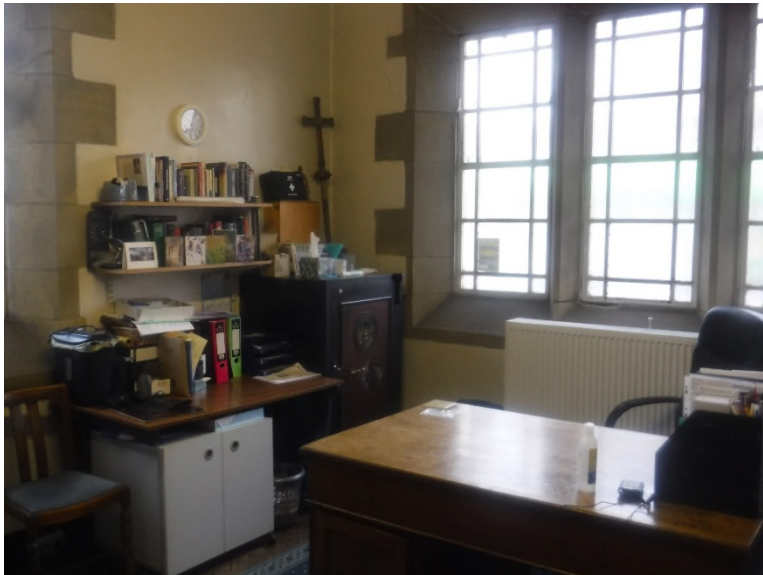
Office:

- **Ceiling** – As choir vestry.
- **Walls** – As choir vestry. The wall between this room and the choir vestry has 1mm diagonal cracking due to ground settlement. The south window, three light, has seen repairs in the past, slightly butchered on the glazing beads and there

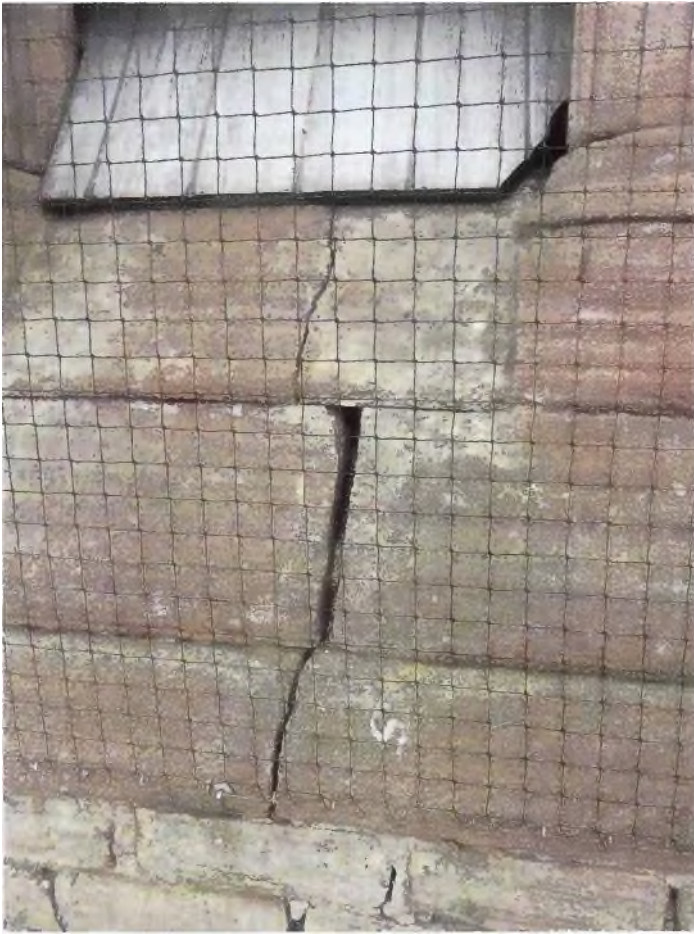
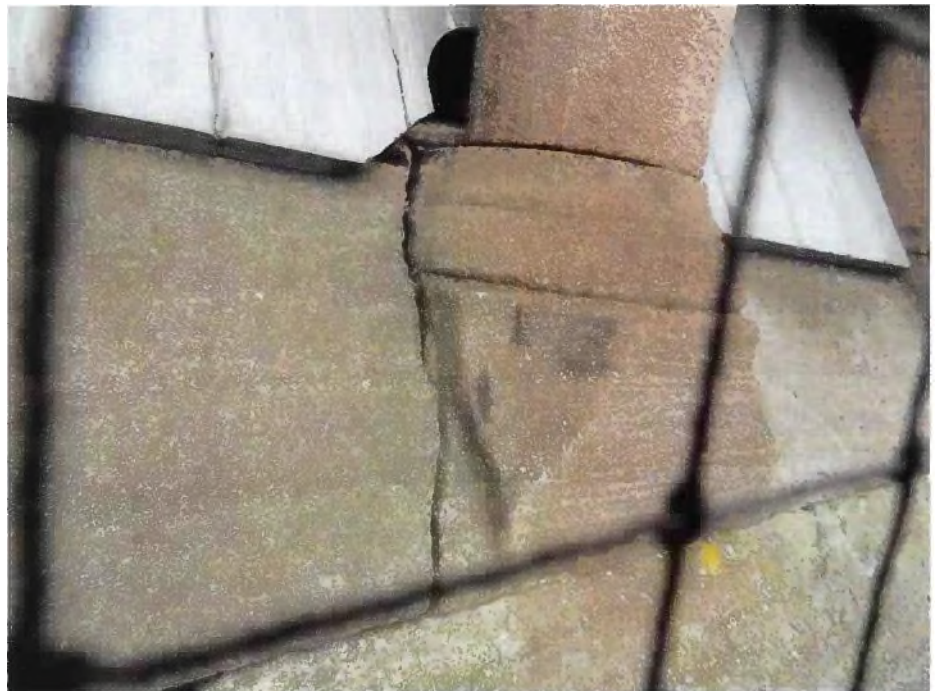
Examples of cracks to sill stones.

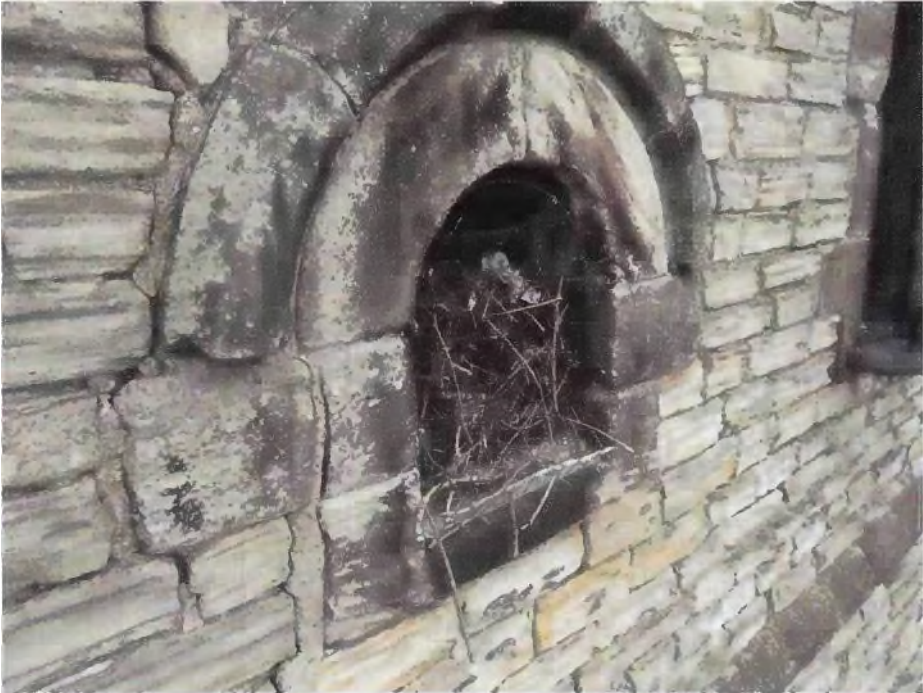
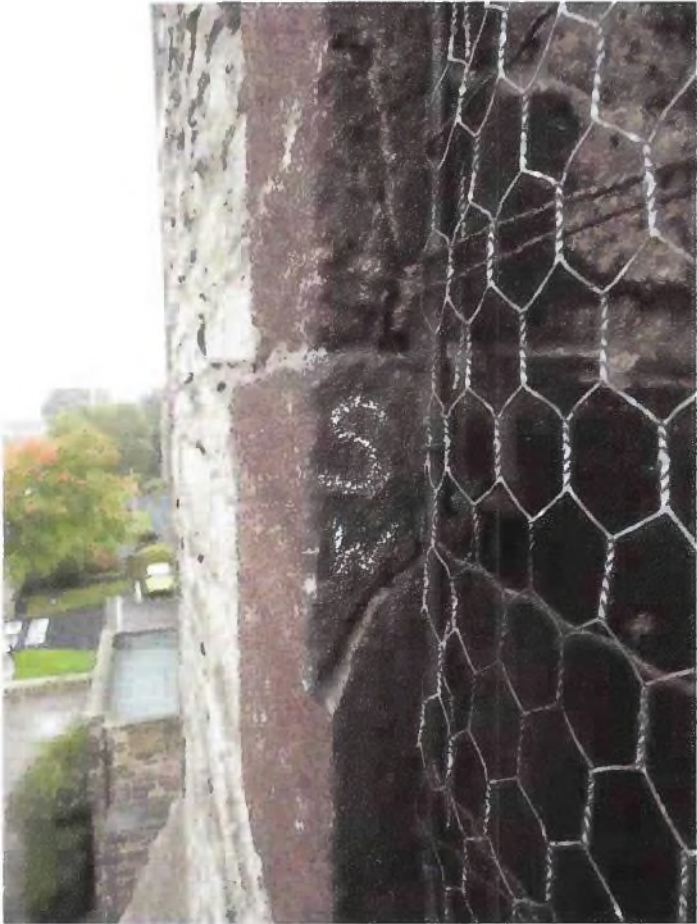
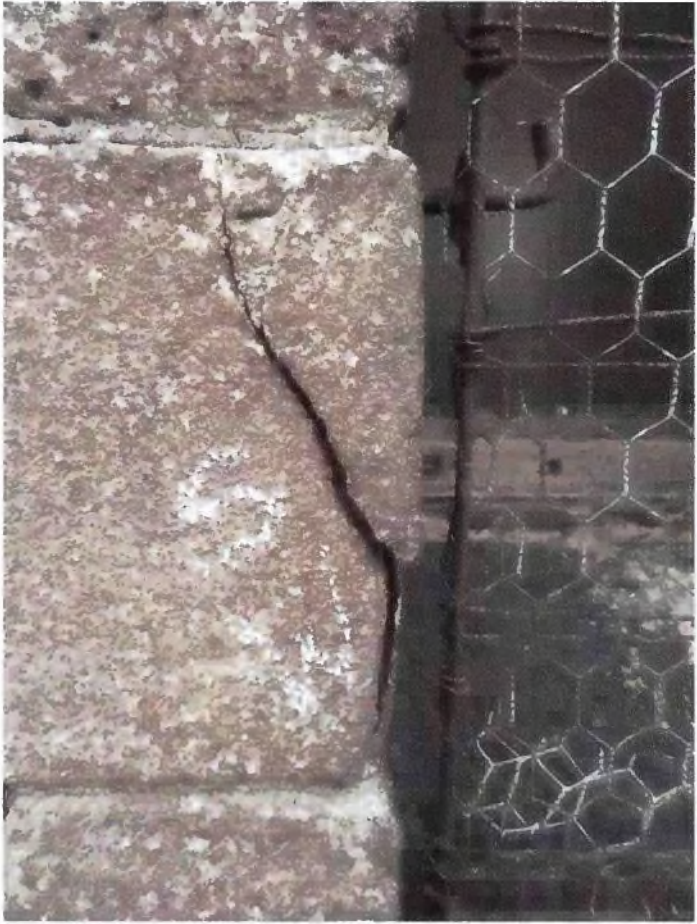
Examples of failed mesh and cracks in stonework caused by supporting frames.

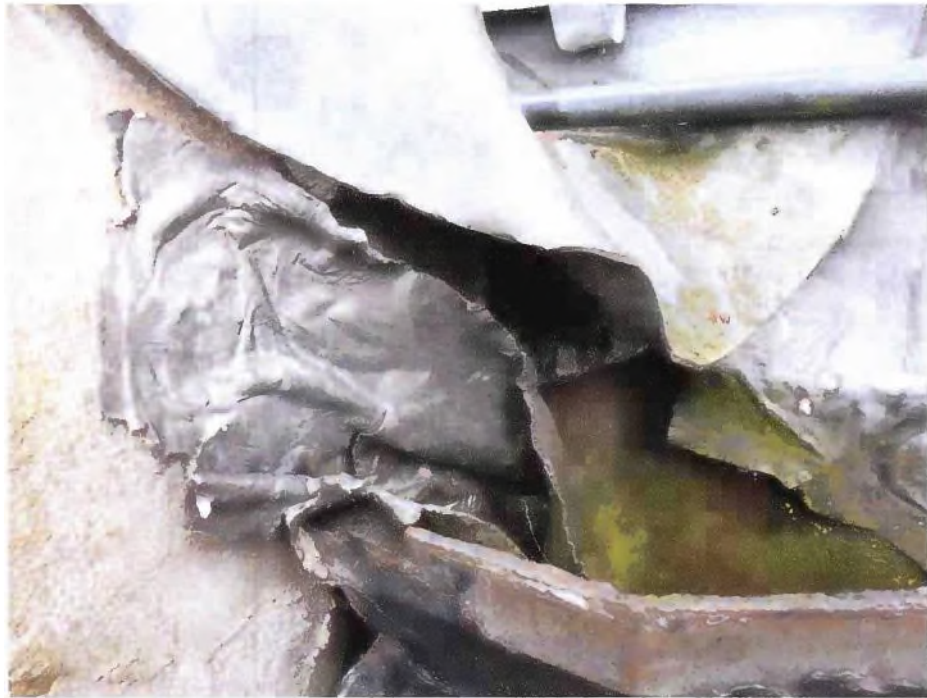
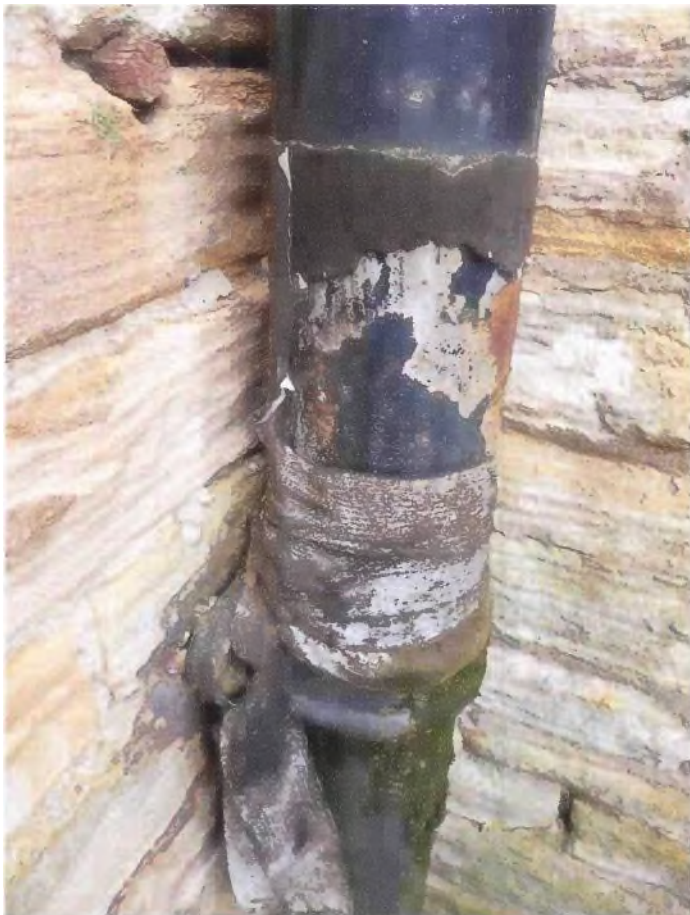
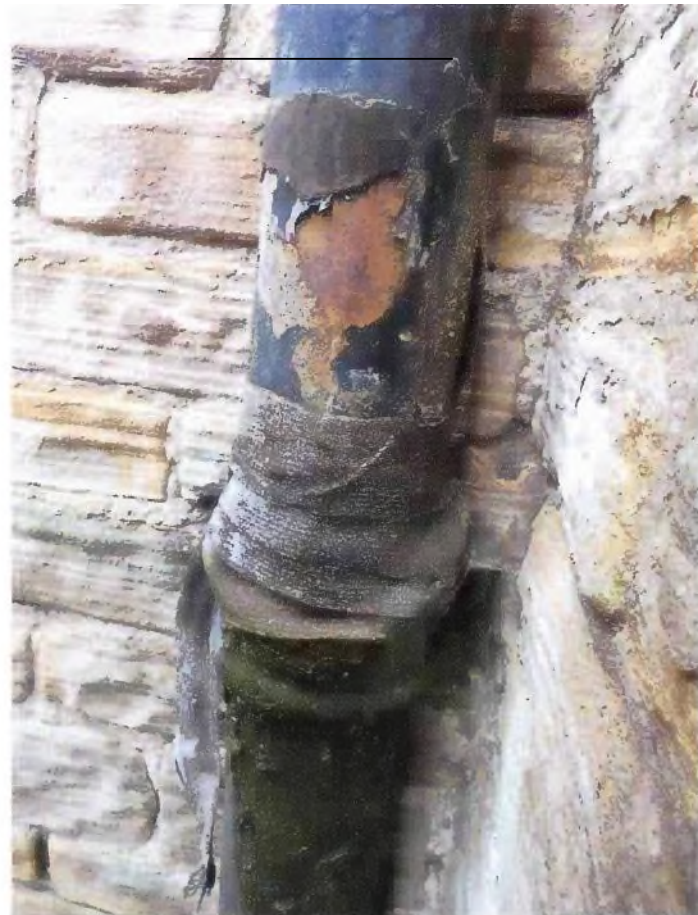
Examples of failed downpipe repairs.
