**CONTINUATION FROM CONSETT, CHRIST CHURCH QUINQUENNIAL
INSPECTION REPORT
For
CHURCH HALL**

David Beaumont BA (Hons) Grad Dip, RIBA, AABC

Observations made from a walk around the building during the QI inspection on 25th Nov 2021

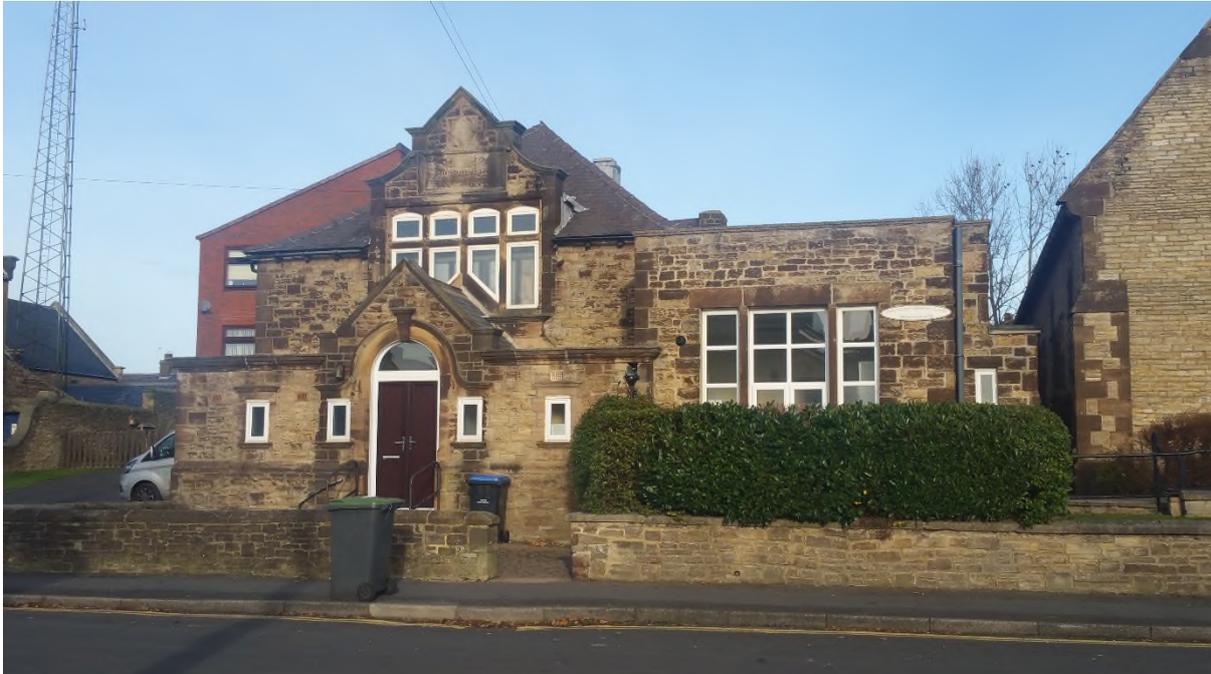
Roof slating looks generally ok a bit laminating at the vestry N side. The land is picked up in the NW corner where the Victoria Court development paving has come up. It used to have a ventilator boxed off now in the centre of the roof, also got a stub chimney that I think is capped off probably alright. The gutter to the yard looks a little adrift from the edge of the slating maybe the water overshoots there. The pointing to the wall here is poor though the masonry itself is reasonably sound. There are a few pockets of stonework that are eroded but they will be alright.

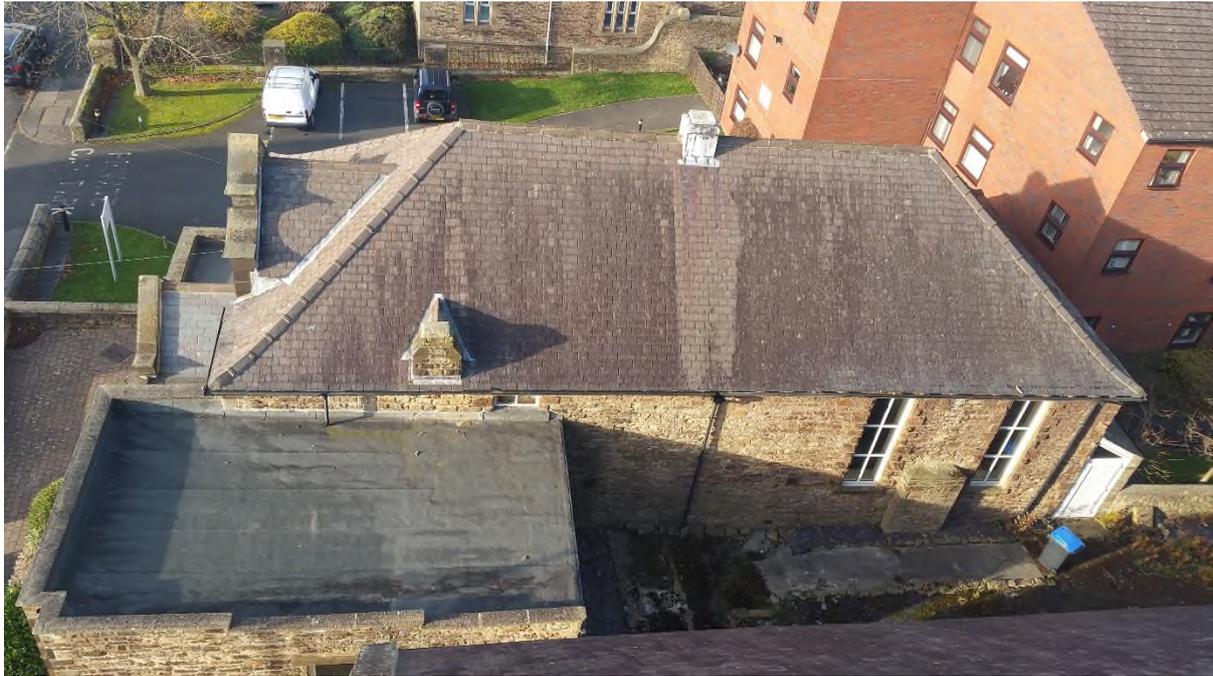
Walls have got cement ribbon pointing and there is an area of walling that is poor. Walling is coursed but generally ok on the road side elevations, there has been some cement repairs that is not very good.

The copings are concrete they hide little flat roofs that need looking at.
