**QUINQUENNIAL INSPECTION REPORT
OF
DALTON-LE-DALE, ST. ANDREW**

**DIOCESE OF DURHAM
ARCHDEACONRY OF DURHAM
DEANERY OF EASINGTON**

QUINQUENNIAL INSPECTION AND REPORT

DATE August 2021

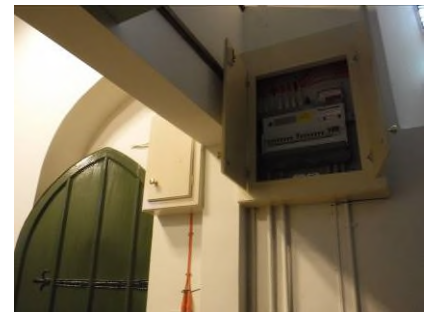
- **Lighting:** The lighting installation was installed perhaps twenty years ago and is all LED lamps now and whilst the light is not generous it has a suitability that fits the church.

Recommendation: Carry out a five yearly test and the recommendations of the test report.

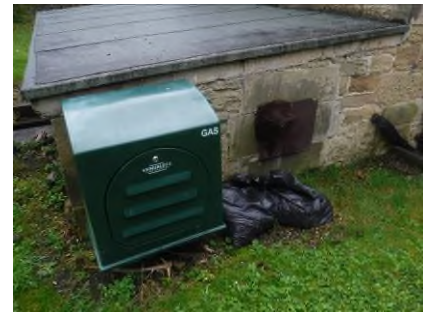
- **Gas meter:** A new gas meter housed in a green cabinet has been placed on the side of the boiler room.

Recommendation: None.

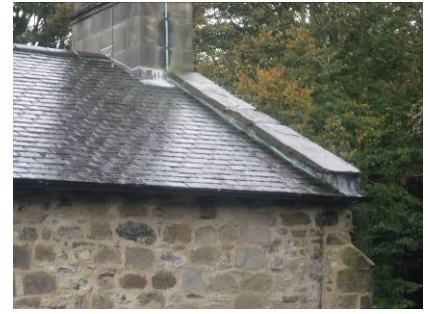
N side – Ridge as the nave and there are some loose pieces of bedding that are showing on the roof.

General – The slating is generally ok, as is the nave.

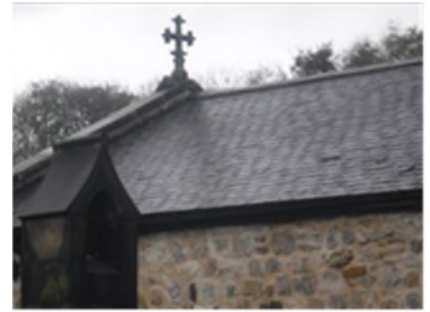
S side – Ridge two of the tiles are laminating and there is some bedding showing on the roof.

W abutment – Same as opposite side and ok.

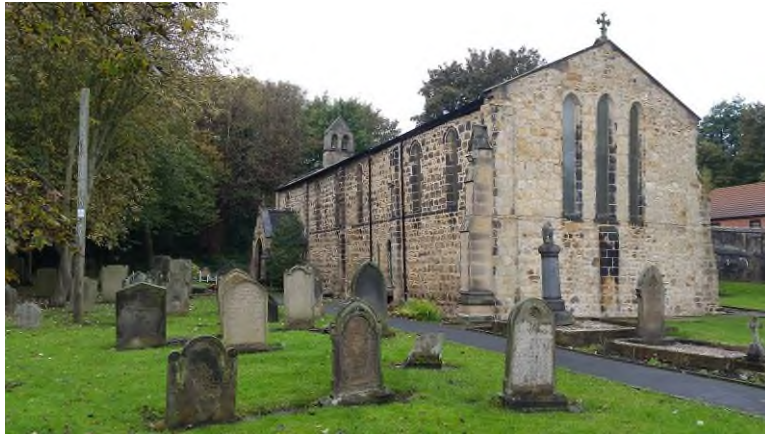
E elevation – Water table is good, the walling is generally is random rubble much patched over the years, it has a central buttress discoloured through pollution, there is a step in the wall with original buttress on the N side and corner rectangular buttress on the S side, which is then further backed up by a more modern Victorian buttress. The end of this wall appears to feel very ancient.

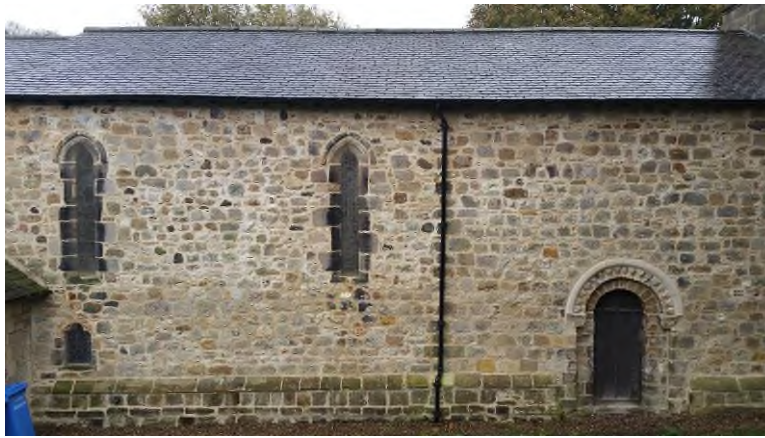
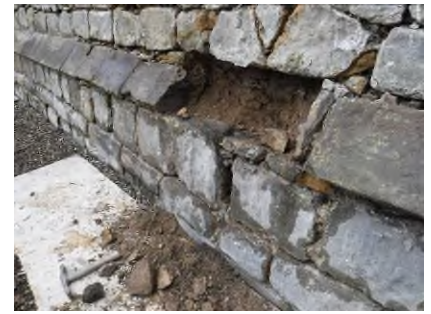
W elevation – The top part of the gable was repointed in 2017 in NHL 3.5 mortar and it is a little whiter than the sandier mortar below it. When inspected from the scaffolding it is found to be harder than the new NHL 2.0 pointing. The walling is good it does have some magnesian limestone built-in to it though it is predominantly sandstone.

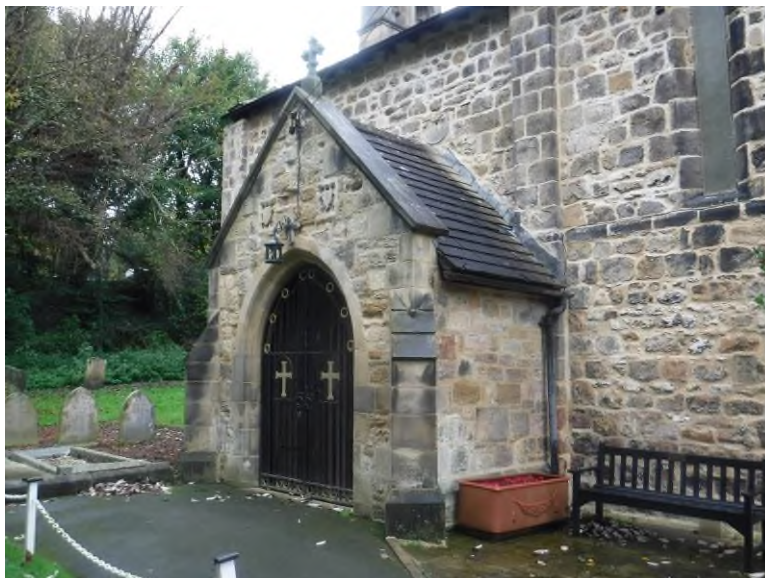
Porch:

Walling is all generally sound, it has at the S, two shields built-in above the doorway these are eroding now but generally ok. At

the W is part of a magnesium limestone looking stone, is there a moulding to it, it is actually possibly just erosion.

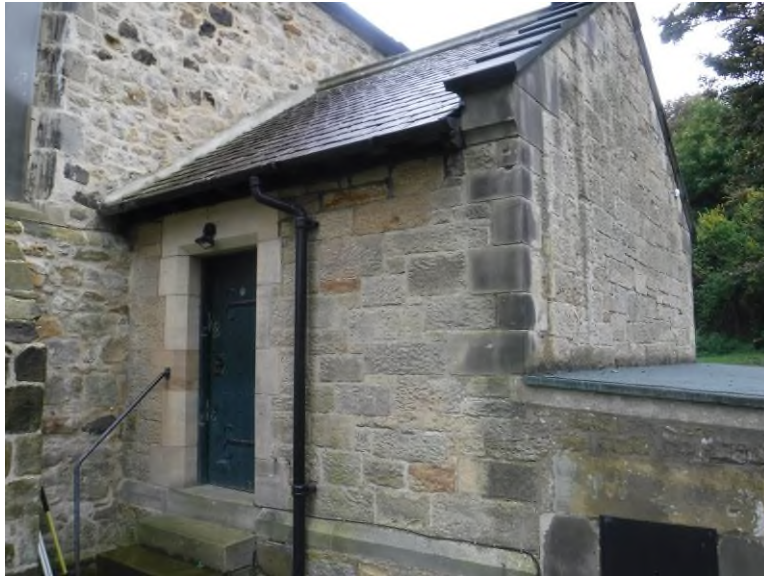
- **Vestry:**

Random course squared stonework in good condition, the corners have ashlar quoins they are all ok as do the doors. This wasn't repointed during the recent works as it was in good enough condition. It has a three light window on the W side with chamfered surround in ashlar, all ok.

Recommendation: none

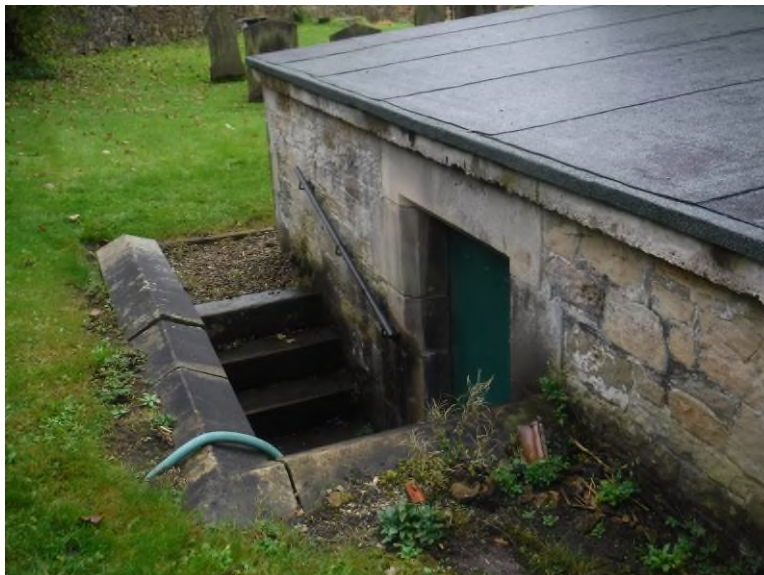
- **Boiler Room:**

Walls are generally ok but a bit cement pointed and some slight open joints. It looks a bit grey down by the steps but is generally ok.

Recommendation: none

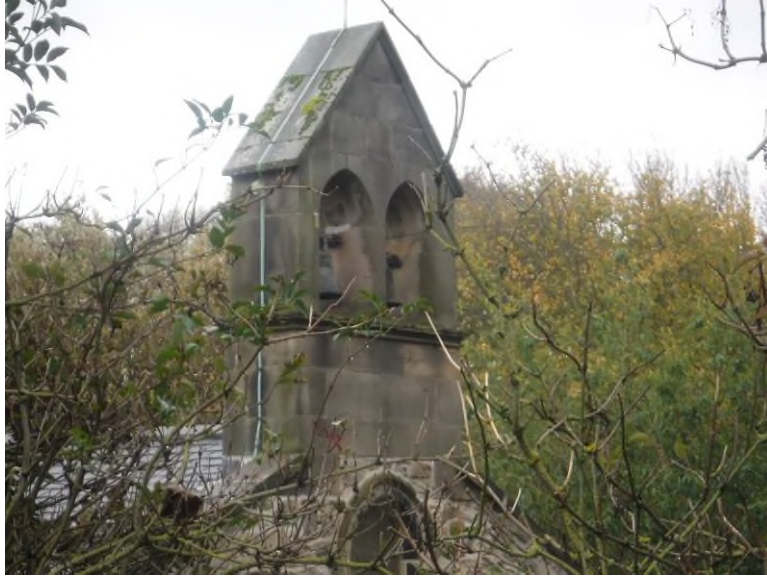
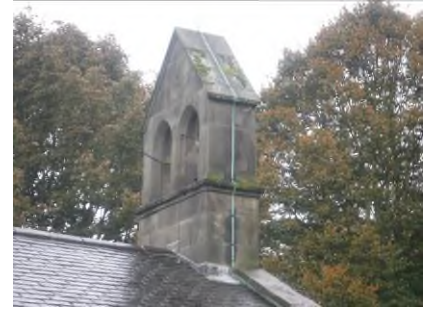
Bellcote:

Two bell bellcote in ashlar stonework formed at the W end, a small chip out of one of the stones (see image from 2017) reported in the last QI was repaired in plastic mortar in the 2017 GPOW works and appears ok.

Recommendation: none

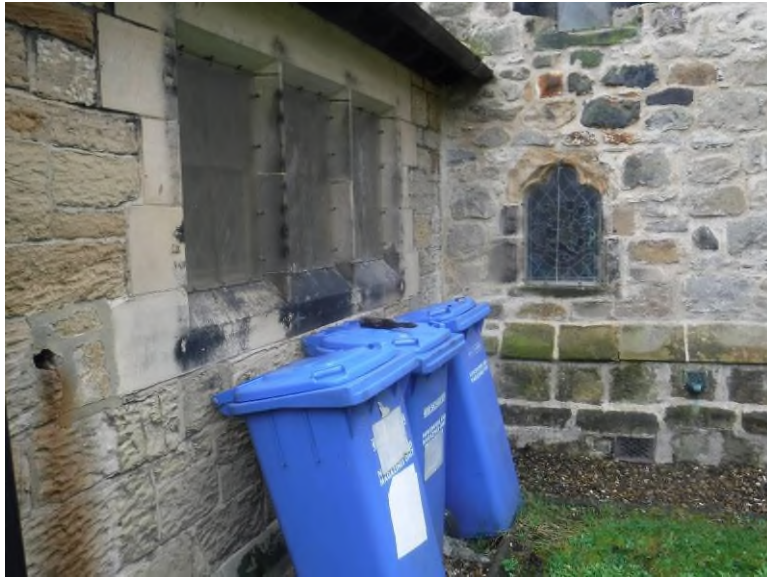
Much eroded trefoil head to nave but ok

Square head chamfered three light to vestry. Ferramenta looking a bit rusty and covered with polycarbonate a bit dirty could do with a wash.

The Vestry door is a boarded door with false hinges and rusty ironmongery, catches slightly at the threshold.

Recommendation: ease vestry door, derust ferramenta of vestry window, replace the aged window protection and clean the glass.

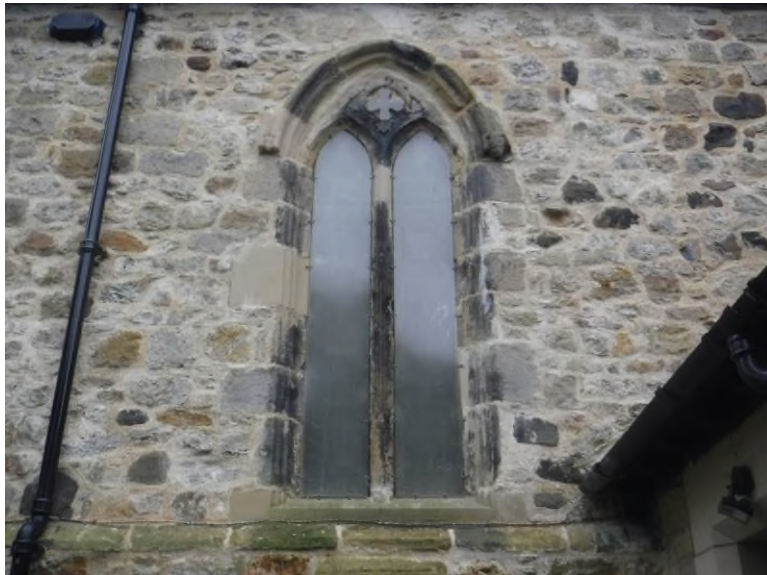
Twin light lancet to chancel with quatrefoil inset, the hoodmould has been repaired in two places in the past and one element of the mullion at the springing as well as a jamb stone replaced. The bottom of the mullion is slightly eroded but looks ok.

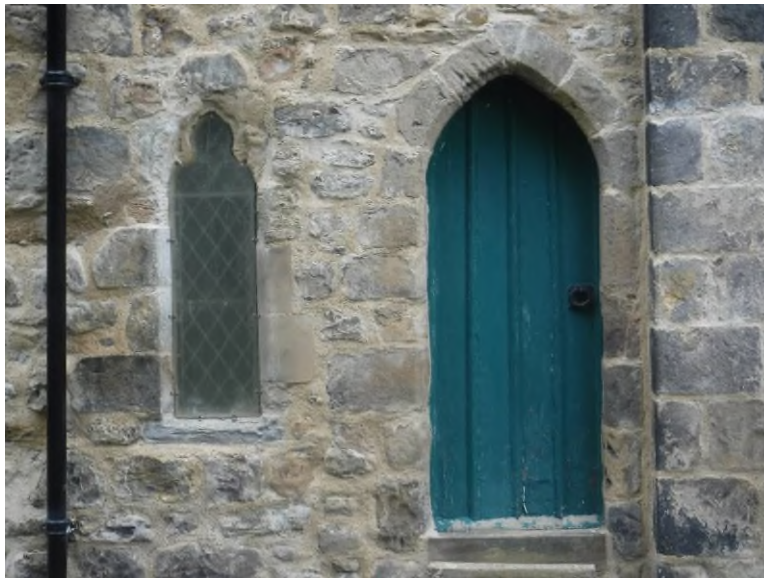
Chancel doorway:

Formed by chamfered lancet arch with green painted vertical boarded door (same style as the porch door), pointed into the opening and this door is not in use, it has a very basic step to it which is barely propped up on some cobbles.

Recommendation: none

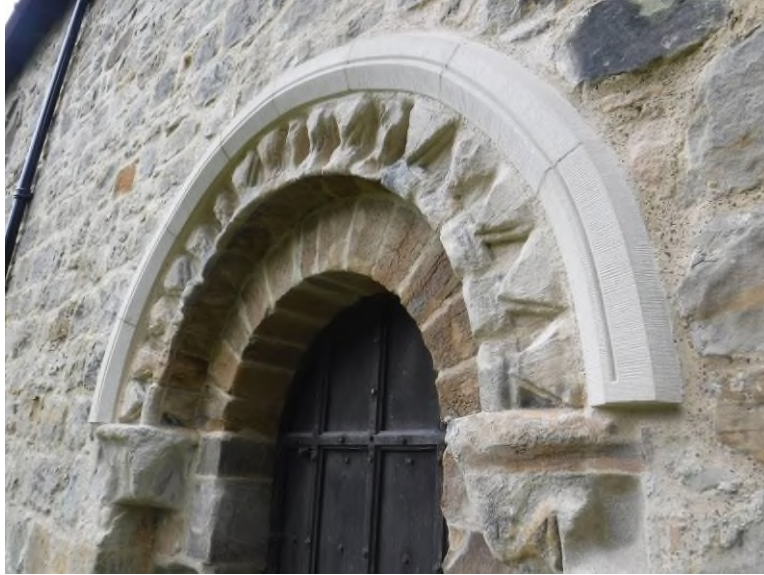
- **Chancel N door**

This has been extensively restored by Skillington Workshops who have consolidated the arch mouldings. The hood mould has been replaced. Oak boarded door within in natural finish, nail head, this door does operate but is not regularly used.

Recommendation: none

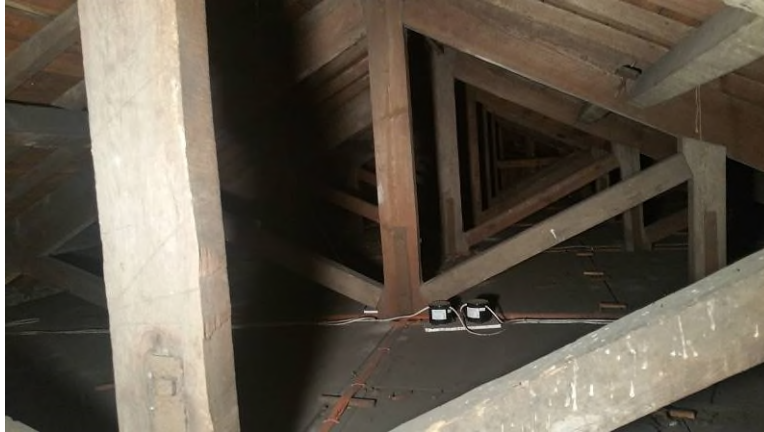
- **Nave:**

There are no roof timbers on show as the nave and chancel have boarded ceilings below them. There is an attic over the nave that the author has been in in 2017 when the west end walling works were carried out (the window lintel was renewed) and no defects noticed at the time. There are bees in the chancel roof.

Recommendation: none

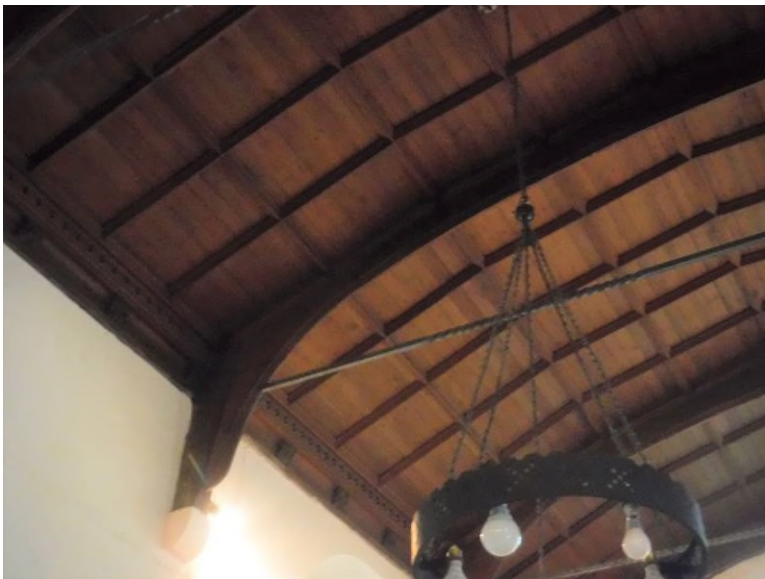
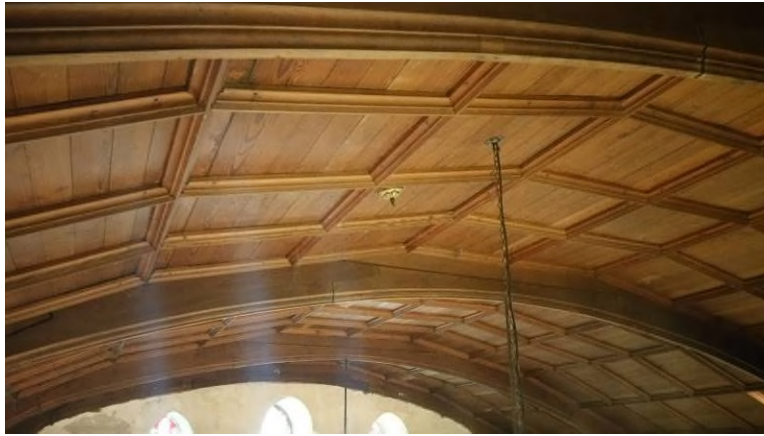
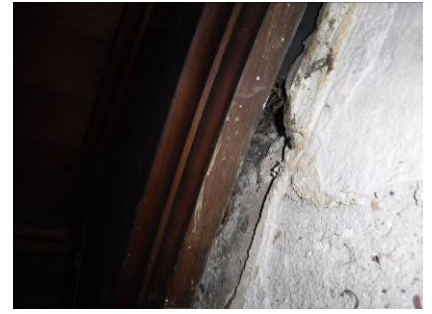
Chancel:

Has more elaborate arrangement than the nave with five trusses, three have metal tie rods, the trusses have curved beams and they form four bays which have ribbed and narrow boarded panels between them, all in natural finish, the general condition of these are good. There are gaps to the perimeter of the roof and roof dust and dirt is falling through gaps. Unknown if insulated (probably not much space to fit it in).

The ceiling gaps to the W and E gables are wide. An attempt to fill them was made in the 2019 works with expandable foam tape that has been partially successful. Some parts are dropping and to be pushed back. It was always only a temporary measure as grant funds didn't allow a more consolidated and costly approach.

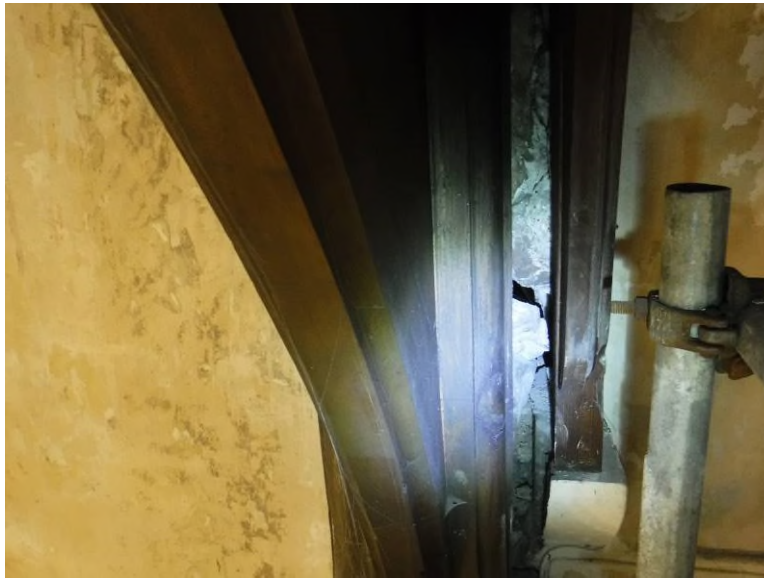
D Chancel Arch:

The space between the nave and the chancel is effectively continuous, though there is a form of arch created by the chancel truss shape and posts coming down the side which in turn support the screen and this arch appears ok. But there are gaps evident at high level at the junction- which must have occurred since it was installed in 1907. There are voids in the masonry and so it would be wise to consolidate this when there are other repairs to do in the area.

Recommendation: consolidate gaps

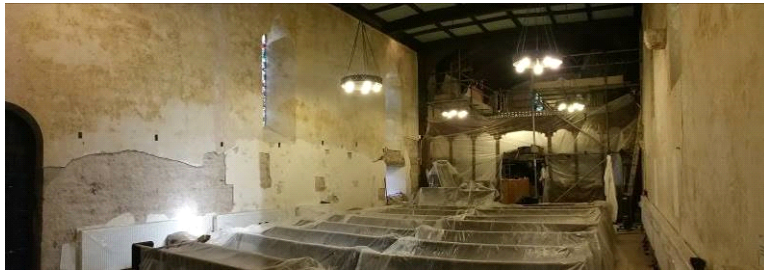
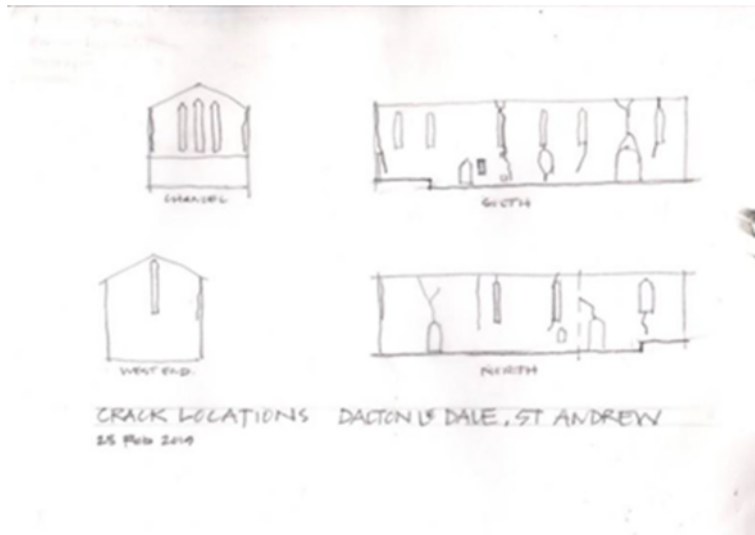
The walls were stripped back to plaster in the 2019 works and this revealed gypsum plastered cracks of 1958 repairs.

They feature at all the windows at the nave and predominantly at the S and E. The gypsum covers concrete/cement underlayment. There was no movement evident to the wall cracks but there is at the chancel.

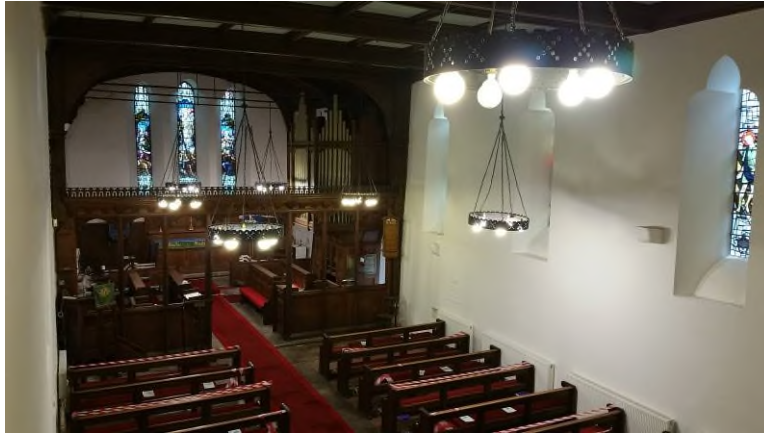
The church has been comprehensively decorated apart from the vestry, in Earthborn Claypaint following the removal of the previous paint layers.

The principal reason why this occurred was that a lime wash painting in 2011 which was seeking to remedy previous decorative failures itself failed and was discoloured combined with also salt and lose of plaster occurring on the N side,

Recommendation: brush down salts, redecorate after a long period of drying out has occurred.

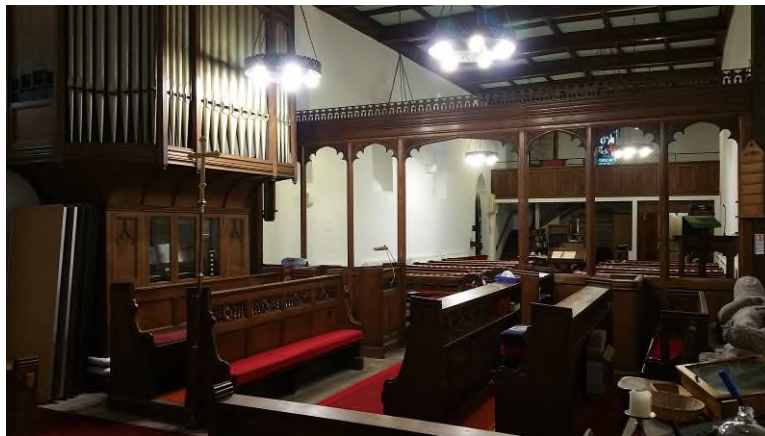
Fine ornamental screen (1920) between the nave and the chancel with cresting, blank shields and six open lights all firmly fixed.

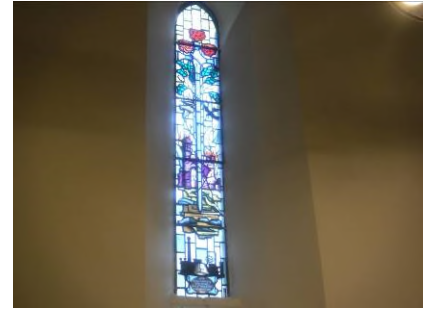
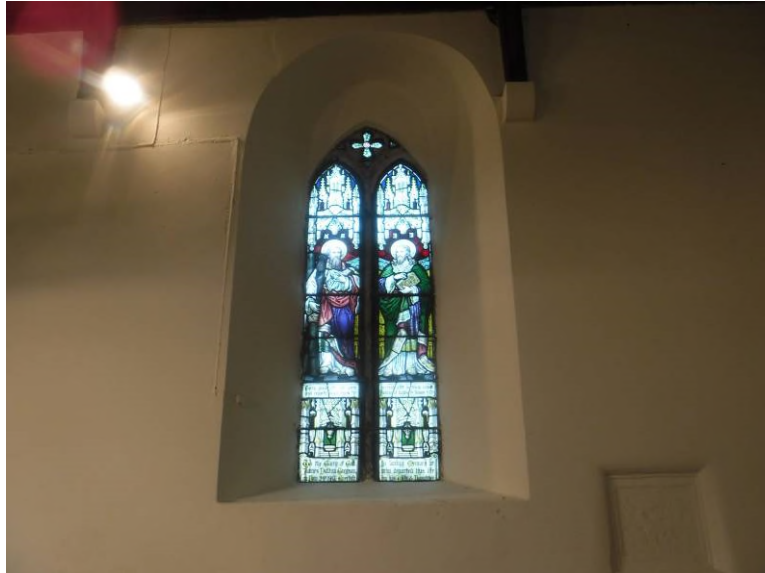
Two light pictorial in memory of James Gregson, slight buckling, saddle bars slightly rusty but ok, the centre mullion is a bit thin but that is the design of it.

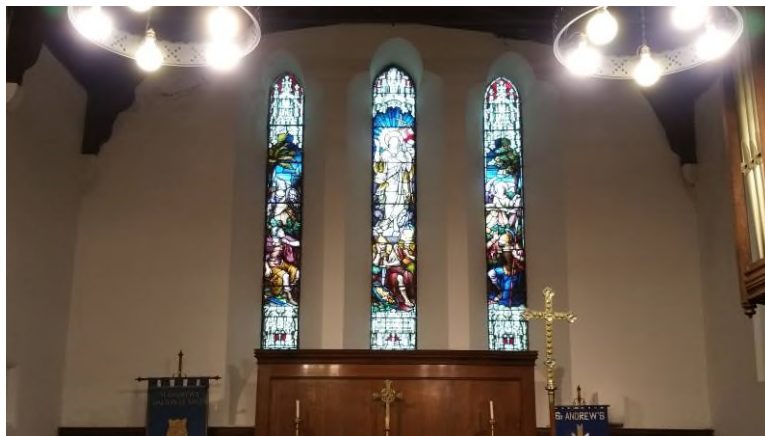
E – Three light dependant, memory of Caroline Gregson, pictorial, good.

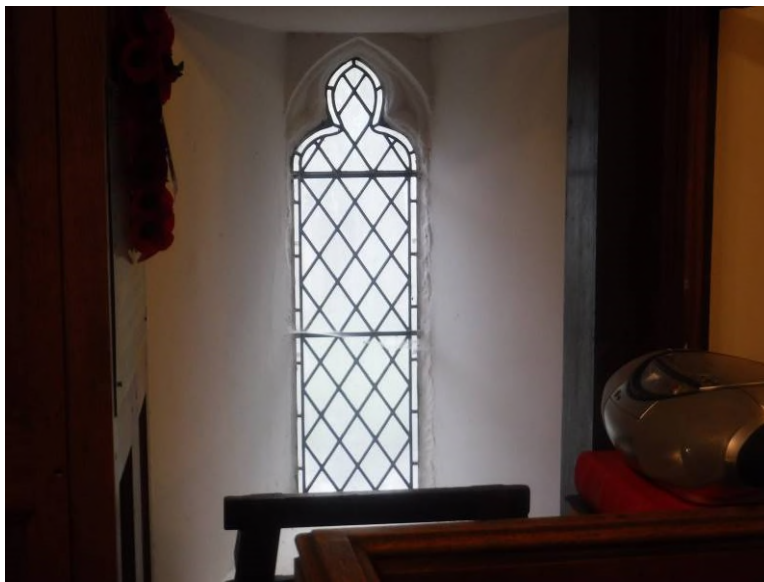
Trefoil headed same as the Annie Seth window, the organ, plain glazed diaper pattern in good condition.

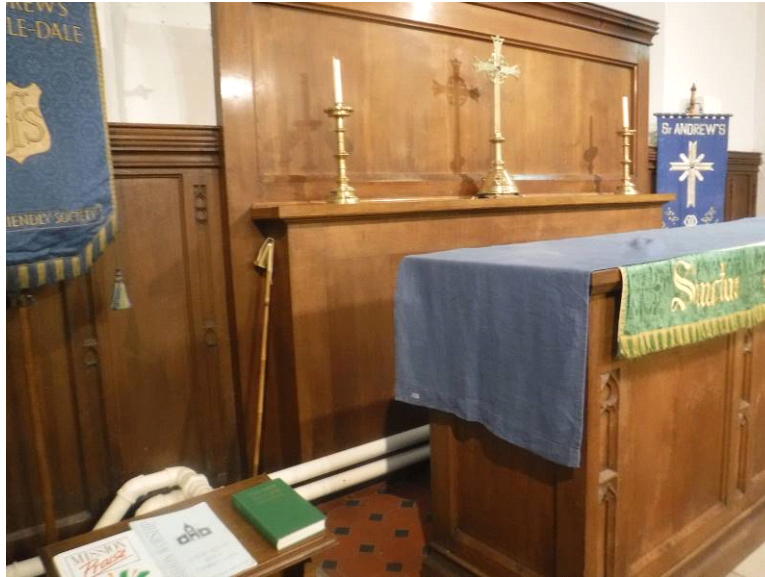
Reredos:

Simple oak panel (1907) behind the altar is ok, alongside that is oak panelling in good condition though there are some paint marks on it.

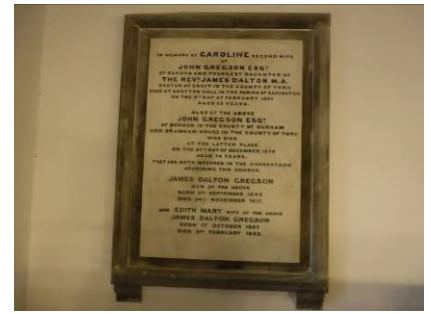
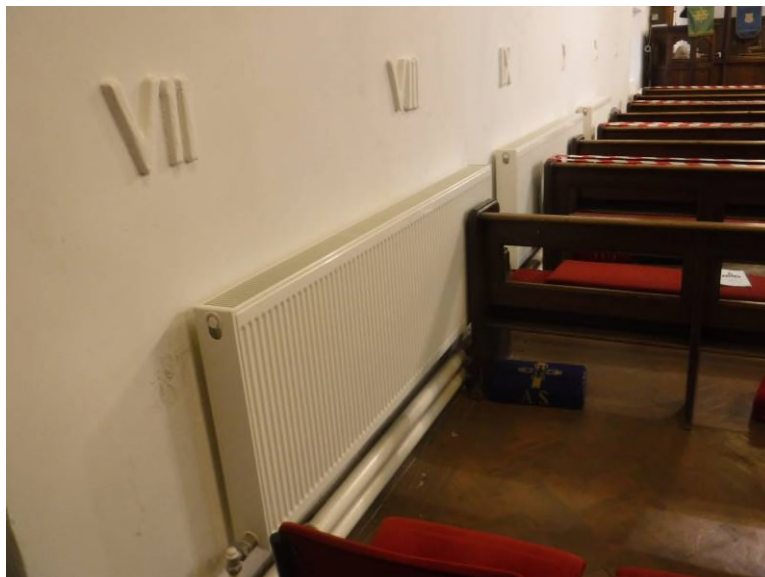
Below gallery, relocated Gregson memorial tablet which is a pedimented rectangular frame, this was in a previous position, there is some damp showing to it around its perimeter.

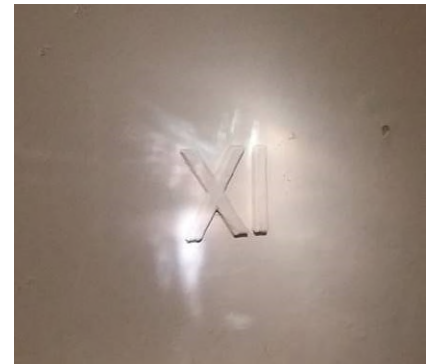
Roman Numerals on the N wall, these were found to be made out of plaster so their provenance is not that clear. Thought to be a sundial of sorts. That seems not to make sense but then the sun shone during the inspection and at about 3pm picked out XI...

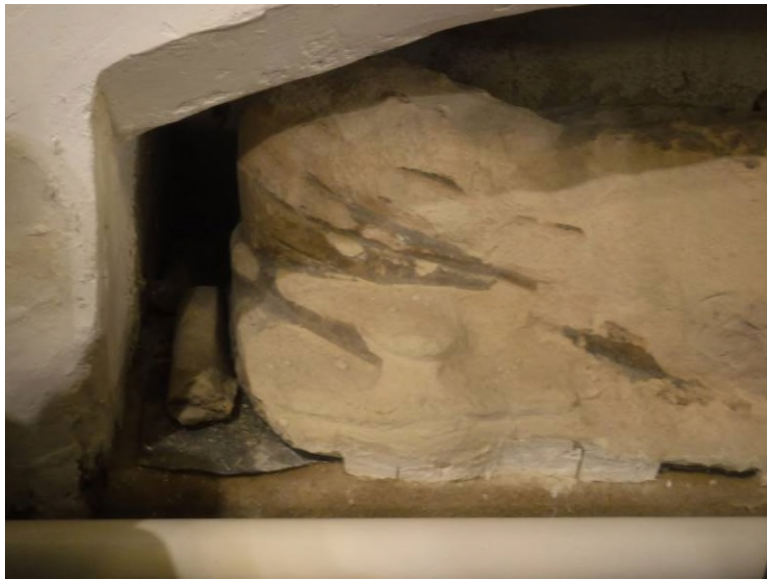
Effigy of Lady Matilda c. 15 within a probably damp arch—certainly not well ventilated. Laying on lead and slowly eroding away. She was planned to be on top of the chest tomb in the chancel according to the 1907 plan. Might she go back?

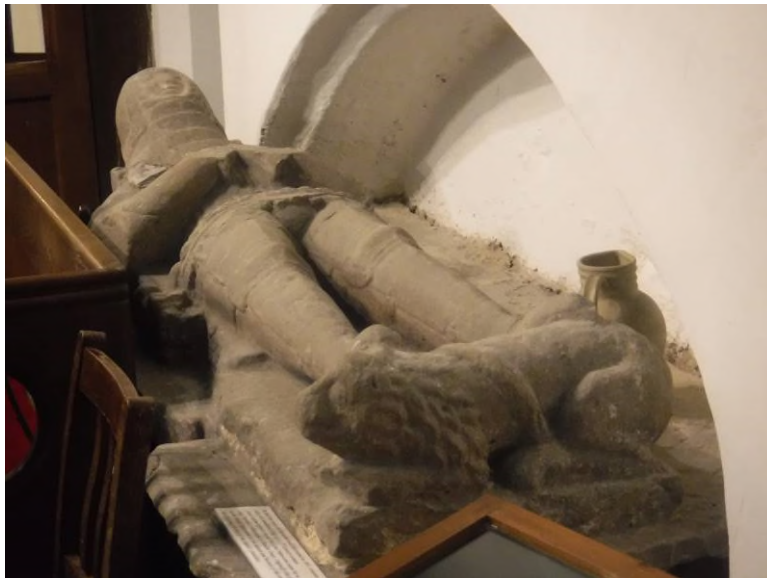
Effigy of Sir William Bowes, 1420, far better condition, he is outside of the arch.

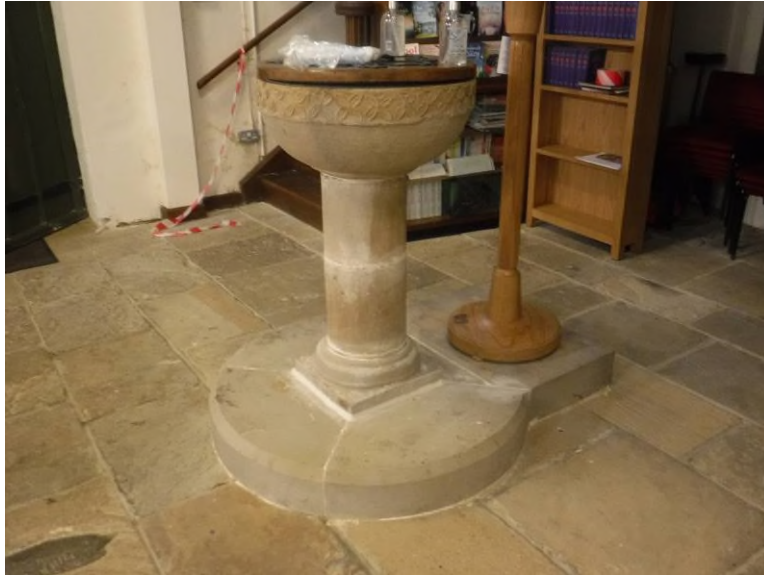
C13 Bowl font on baluster set on circular plinth. The shaft was redoweled as part of the 2019 works. It has an oak cover.

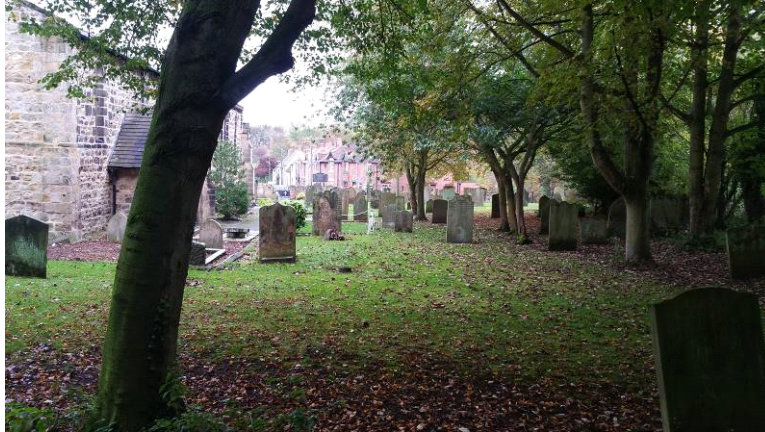
The graveyard is mostly grass with tarmac paving to the S porch, there are numerous headstones some rather ancient, most appear to be in fair condition, nothing obviously wrong apart from the erosion to some of them.

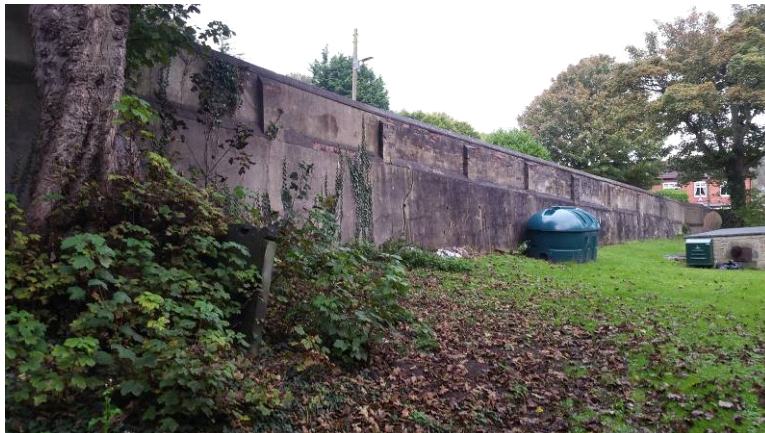
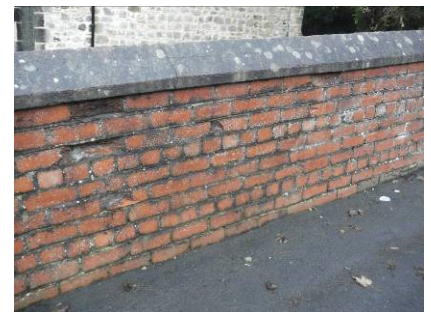
N side –Buttressed brick wall on top of a probably, concrete retaining wall, both are cement rendered. Holds back the high level road. The masonry on the road side in brickwork is ok, on the inside the render is coming away a bit, there is also signs of cracking to both the wall and the retain, though they seem old There are drainage pipes. Are these active and adding to the water level at the N?

It is a bit overgrown towards the W end.

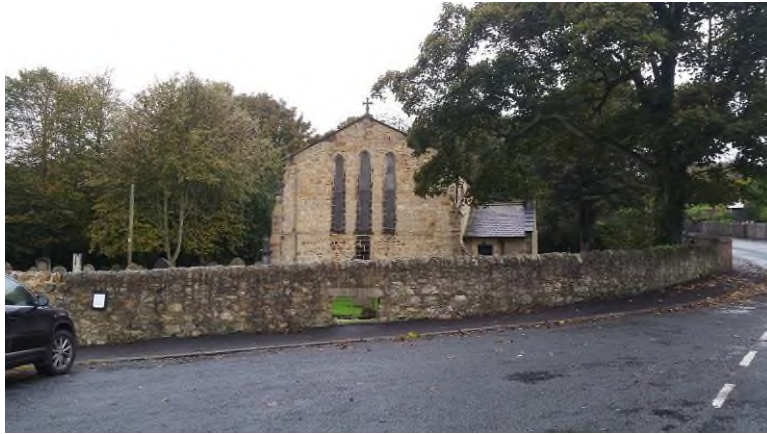
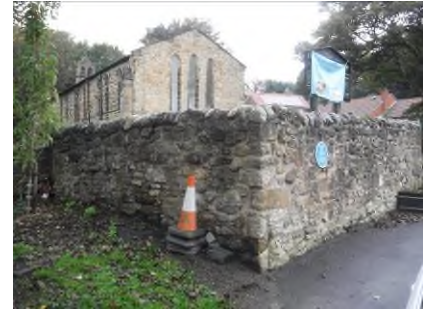
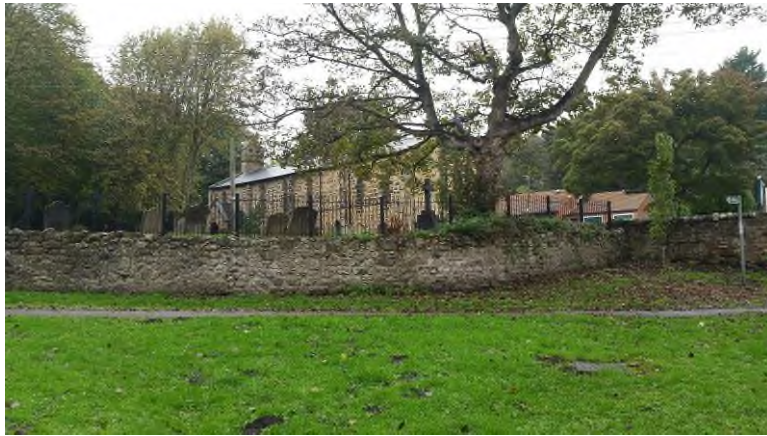
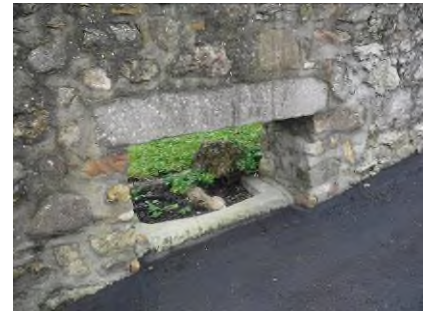
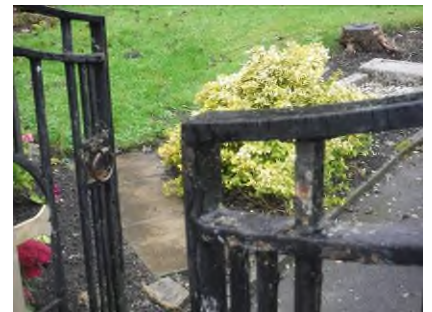
E side – Curving stone wall in fair condition, one tree quite close to it in the N E corner, metal gate and that is ok.

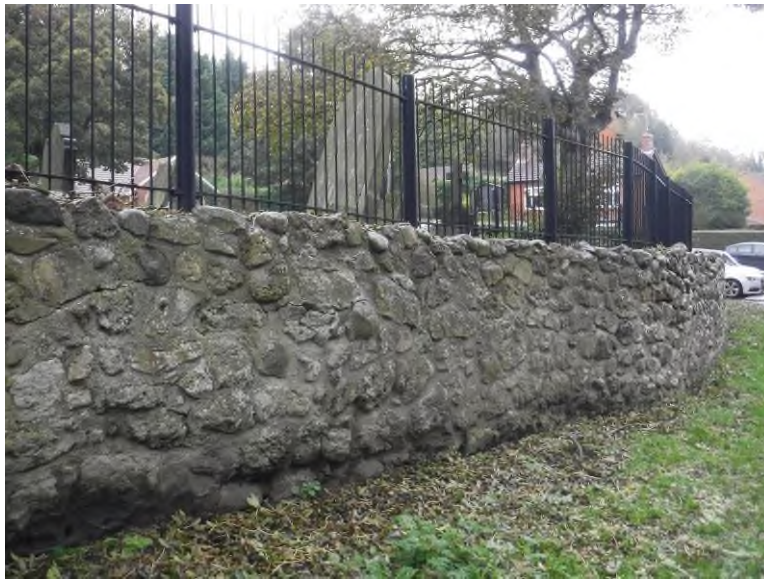
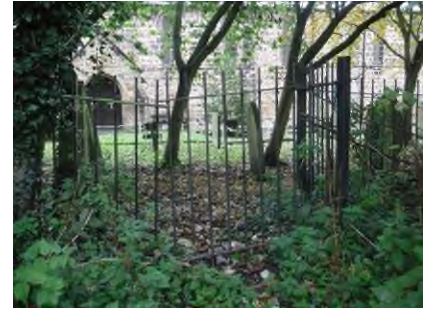
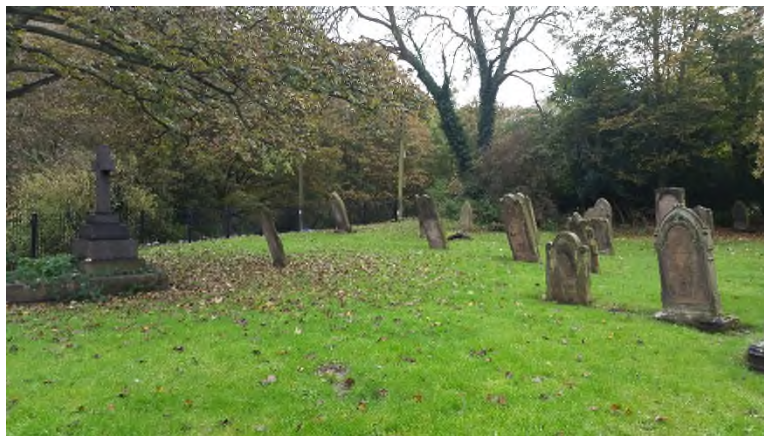
S side – Modern metal railings on top of a stone retaining wall holding back the graveyard with a drop of approximately six feet to the other side, seems ok. Large Ash tree close to the W end. There is a few changes of direction of the fencing probably around old tree stumps and there are holly's now growing in amongst these. This looks out onto the play area and some parts of the fencing are breaking down now.

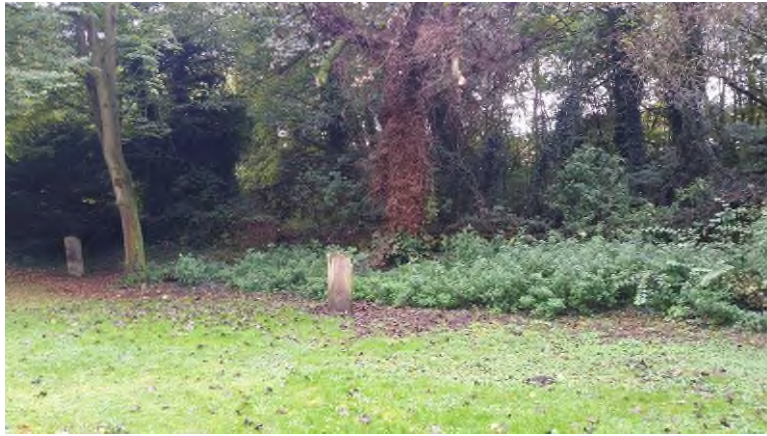
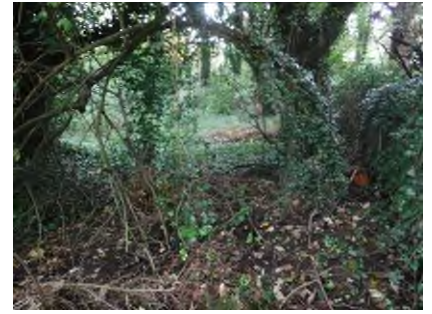
W side – tumbled down low stone wall in fairly poor condition, which has quite a bit of ivy growing over it, beyond this is a rough wood copse area.

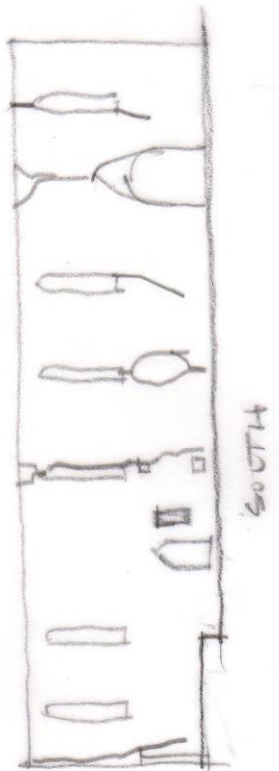
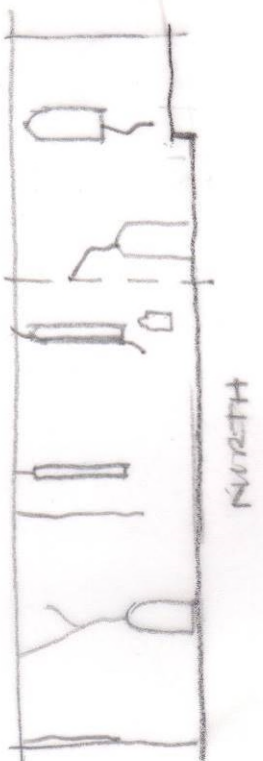
CRACK LOCATIONS DACTON & DALE, ST ANDREW

1. 7-10-2019
Crack Locations
25 Feb 2019
