**QUINQUENNIAL INSPECTION REPORT
OF
HOLY TRINITY, DARLINGTON**

**DIOCESE OF DURHAM
ARCHDEACONRY OF AUCKLAND
DEANERY OF DARLINGTON**

QUINQUENNIAL INSPECTION AND REPORT

September 2020

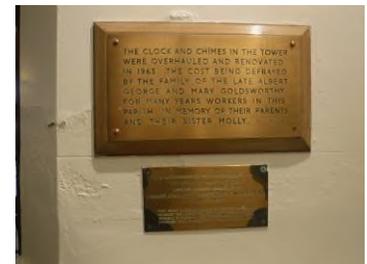
- D **Clock:** The original clock was made by Harrison and Son of Darlington in 1850 and the quarter chimes were added later in June 1892. Reconditioned in 1963 by Potts & Son, currently not working but booked for repair.

Recommendation: Carry out repair.

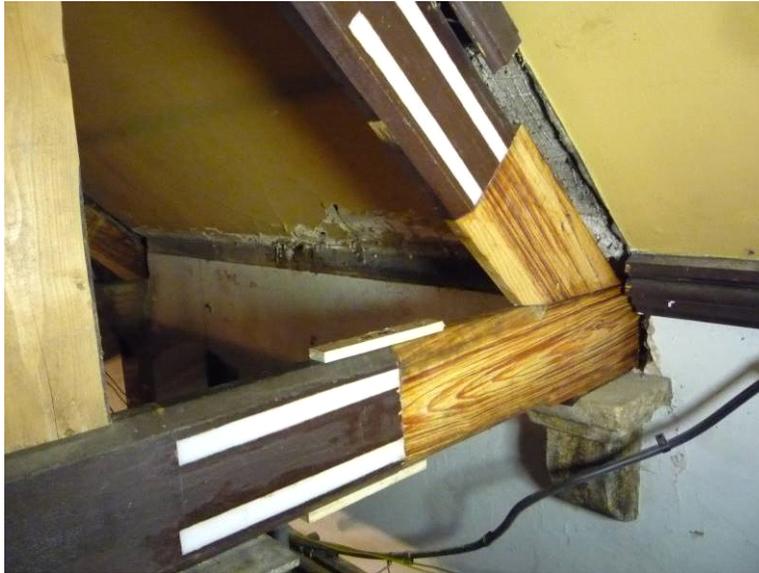
Repaired rotten truss feet,

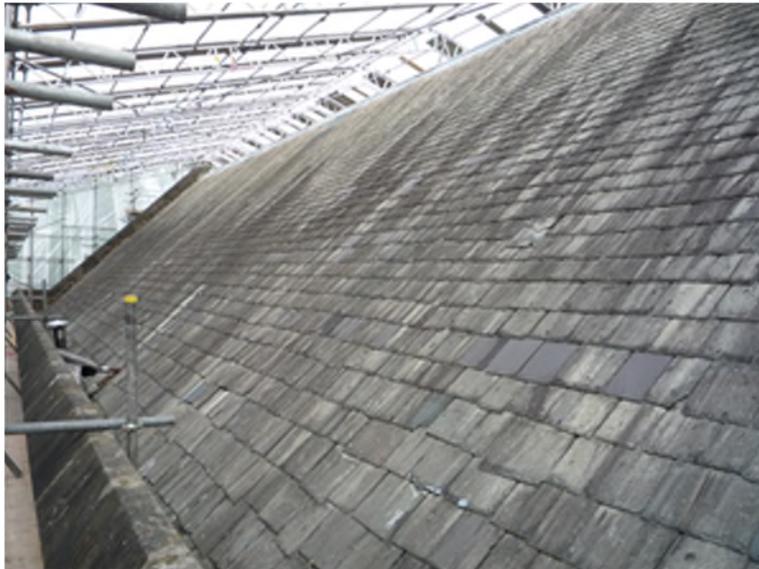
Re-roofed nave and aisles, repaired gutters *(image is 'before')*

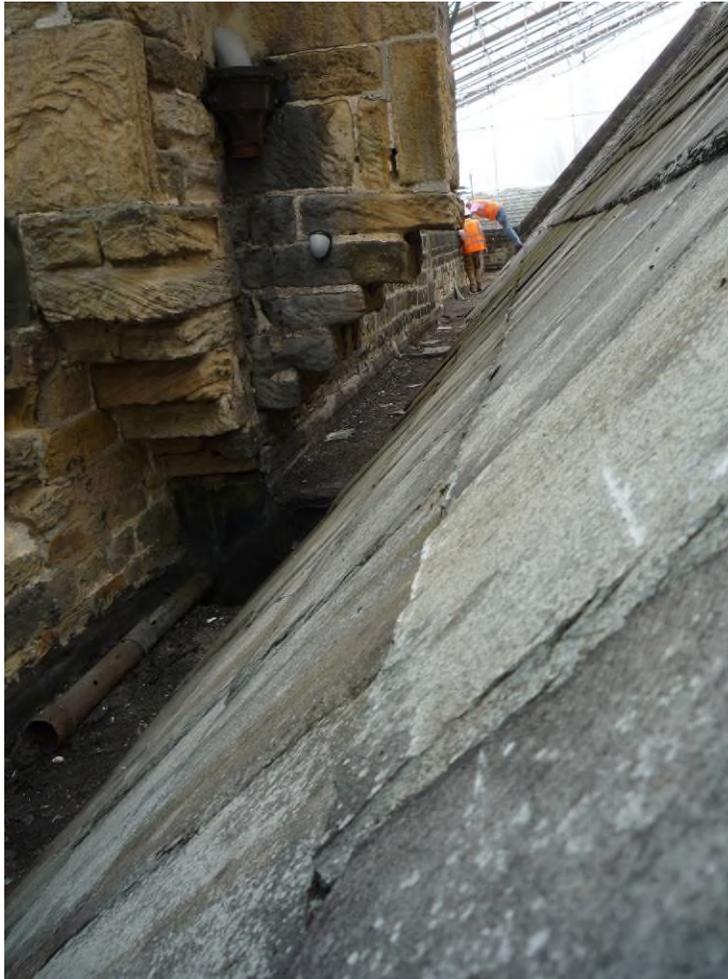
Repointed base of south of tower (making use of roof scaffold) west gable and parapets internally. *(image is 'before')*

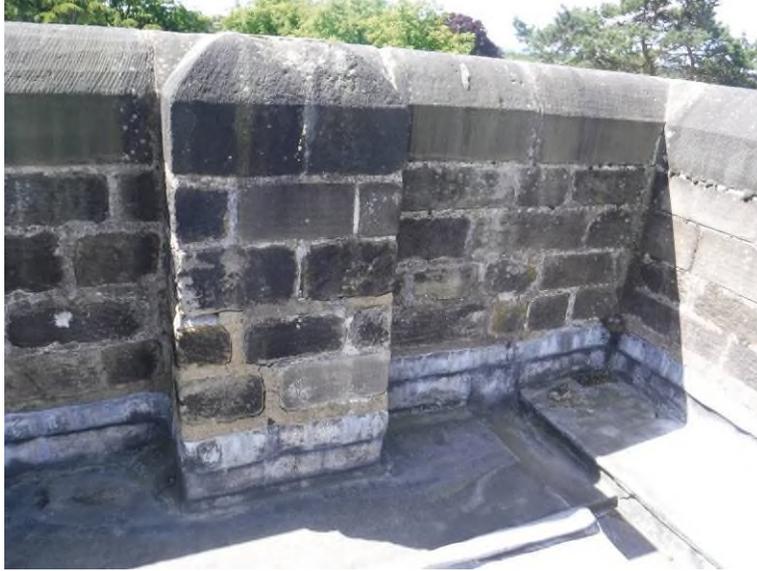
C Tower Roof:

Hollow roll leadwork looking quite old now, the rolls are a bit deformed but serviceable, it has multiple patches in leadwork in the past and they seem to be holding up. Some graffiti on it. The flashings are all ok to the masonry. There is a fairly shallow parapet gutter in lead and there has been a patch-up repair at the step- might this be glass fibre, I can't really tell, it looks a bit botchy. It has been painted up as if to give this a little bit more life. But I can't tell how long it's got. Keep under review.

The stonework parapet surrounds the roof and this is generally sound. There is one buttress on the south side whose masonry is breaking apart a little and could do with re-pointing.

Recommendation: repoint buttress

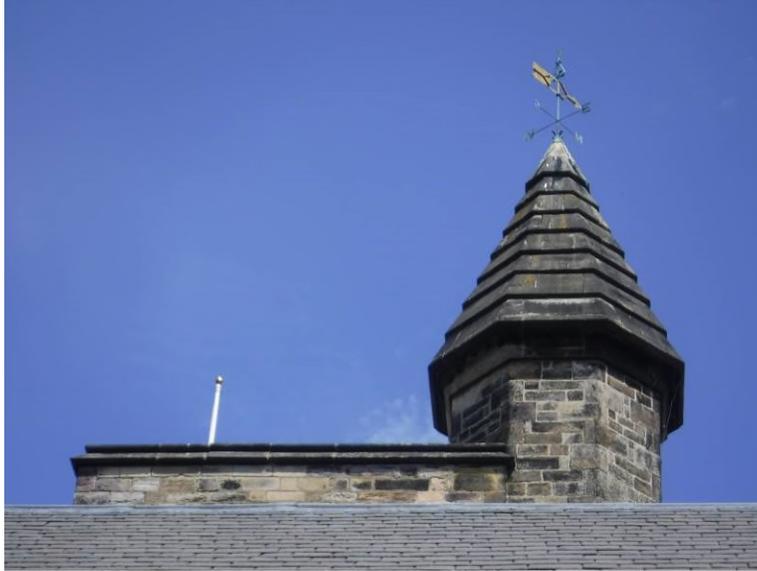
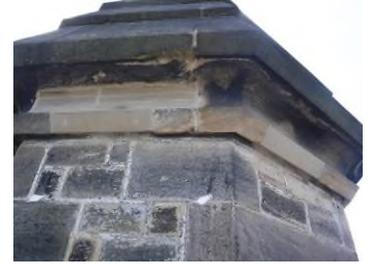
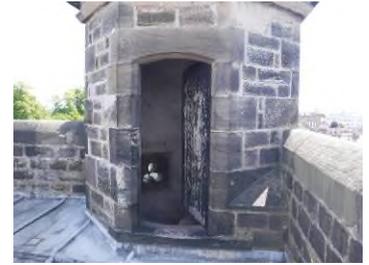
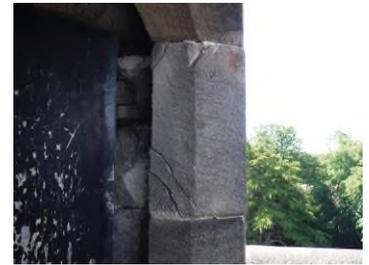
Tower Spirelet:

Octagonal stone roof that has some wear and tear on it but generally seems ok. It is crowned by a weather vane (restored in 1973) and this is the support for the lighting conductor terminal. Below the spire is an octagonal turret, this is where the entrance door to the roof is, there has been some repairs to the bottom moulding under the spire that I can see on two sides. Below that the general masonry is ok, a couple of open joints, one caused by a rusting door hinge. A plain boarded door which has lost its decoration.

The inside of the spire roof is open and the stainless steel fixing down for the weather vane looks good. The spire itself is made from honey and a lighter coloured sandstone, some open jointing looks all sound from the outside so a repoint on the inside is questionable, there is some salt showing to it.

Recommendation: update door, improve draught proofing.

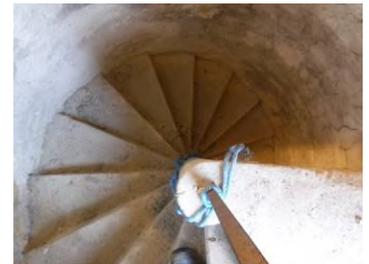
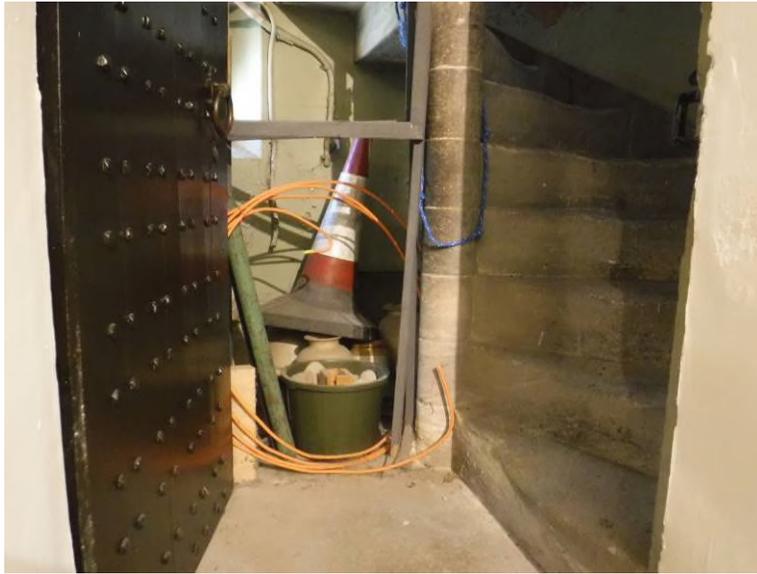
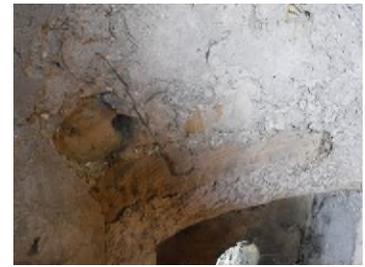
Tower Stairs: At the upper stages of the stairs there is quite a lot of dust that has blown in off the roof that could do with being removed. There is some erosion to the treads but nothing that needs repairing. The walls are lime pointed, quite coarse, and there is quite a lot of shrinkage, but it is doing its job and its holding its surface. There are some areas that are becoming loose but there is nothing really poor about it. Can be left. The top landing has a staging that must be for access up to the underside of the spire to put a ladder on.

There are plain glass trefoil windows within the stair tower, the top most is the most eroded, and the two lowest trefoils have

cracked glass. They need a good clean down of flies and cobwebs to see them better.

The walls up to the ringing room are smooth plaster, painted with a green dado. The decoration is suffering a little from damp.

At the bottom of the stair tower there is a collection of lumber underneath the stair which could do with clearing out and there is also some old cable.

Recommendation: sweep down and inspect windows, clear out lumber.

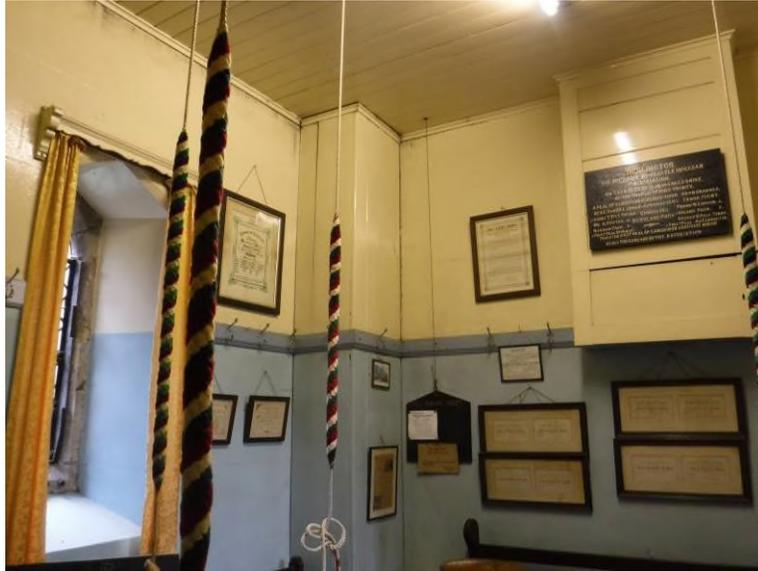
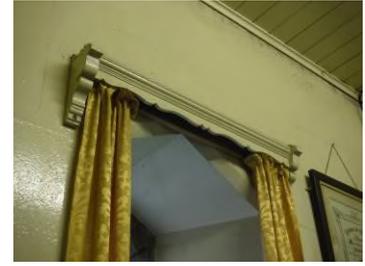
Ringling Room:

- **Ceiling** - Boarded ceiling is ok, some slight dust coming down at the margins but to be expected.
- **Walls** - Plastered and painted with a high dado with plenty of coat hooks running around, no obvious cracking on the walls apart from in the north east corner by the fireplace, the flue might be blocked off but can't really tell, I think an attempt has been made as there is a broom handle stuck up it, is there a chimney pot somewhere?

- **Floor** – Sturdy floor, carpet covered with a collection of dead flies on it.
- **General** – There are six bell hanging ropes, there are curtains with an ornate pelmet covering the windows, the windows themselves are somewhat rusted up and don't look as if they have been opened for a while, the room also contains a cupboard for a set of thirteen hand bells with a plaque saying *John Warner & Sons bell founders to Her Majesty, Cripplegate, London*. The room has various old pew furnishings, there is a little bit of damp on the northern wall not dissimilar to the breakdown of decoration that you see on the stair, the door into the room is ok.
It is a lovely historic room.

Recommendation: sweep up, look at making the ventilation work - if the ringers need it.

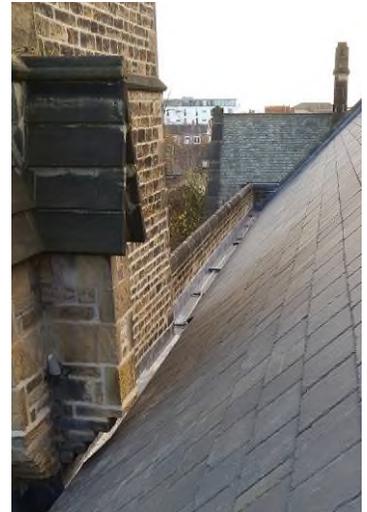
South side - Repointed bottom part in 2015 with some stone replacement. Image from roof completion inspection November 2015. Upper part could be repointed when the next opportunity arises.

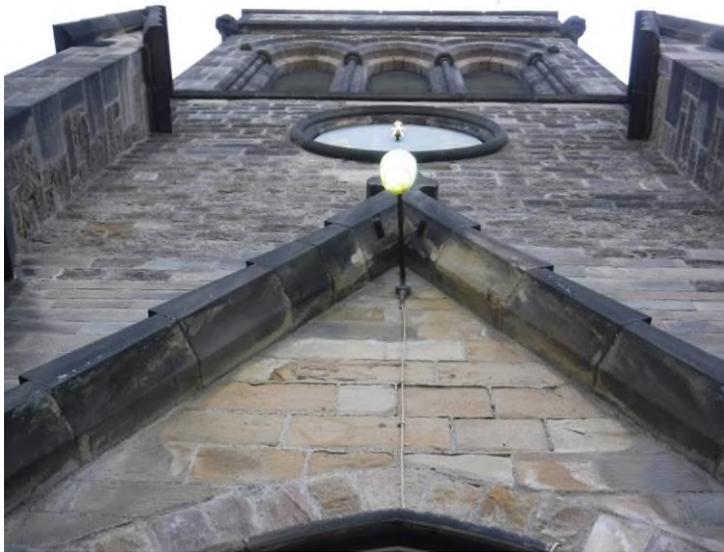
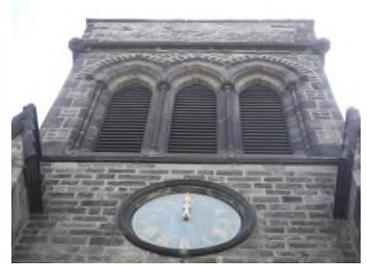
North side

The parapet is ok, and again, cement pointing to the three lancet louvre and there looks to be a little bit of wear at the bottom of the shafts.

Walling below that is ok.

This elevation features the entrance door surround, it has very heavy stone water table for a roof which all looks intact, though there is some damp coming in somehow because the arch is damp particularly on the western side, so there is something not quite right here, it might just be the design.

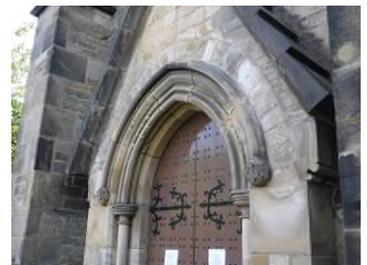
One of the arch stones has eroded more than the others, possibly because there was just a fault on this one on the bedding line but there does look to be damp to it. The nook shaft looks to have been replaced as has some of the door surround stonework. Slight shaling of some of the stonework and a bit of a loss of moulding on the western most kneeler. The buttresses either side look ok.

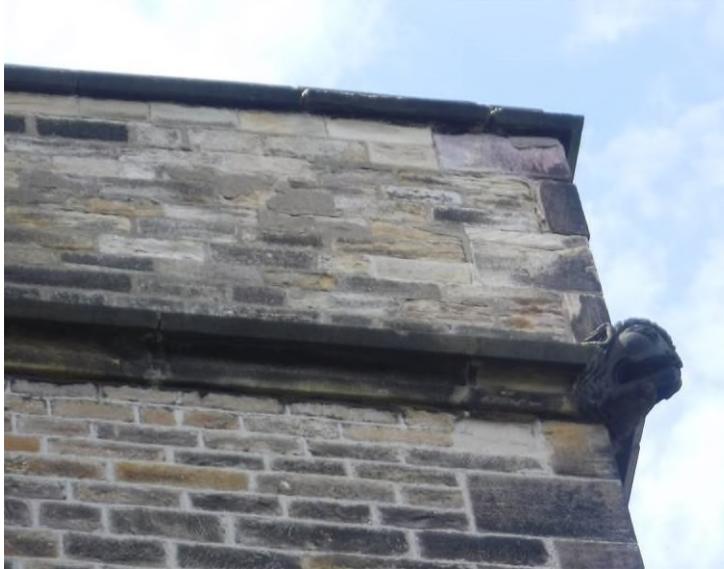
East side –

The parapet stage has a couple of eroded stones and a bit of a weakness at the quoins perhaps. Might be some open joints at the large string moulding, the stages below that have been cement pointed and there has been some stonework repairs I think, but it is all generally sound.

To one side is the stair tower that has been repointed in one go at high level which seems ok. There is just one area by the downpipe at ground floor level where there is some stone erosion but it will survive.

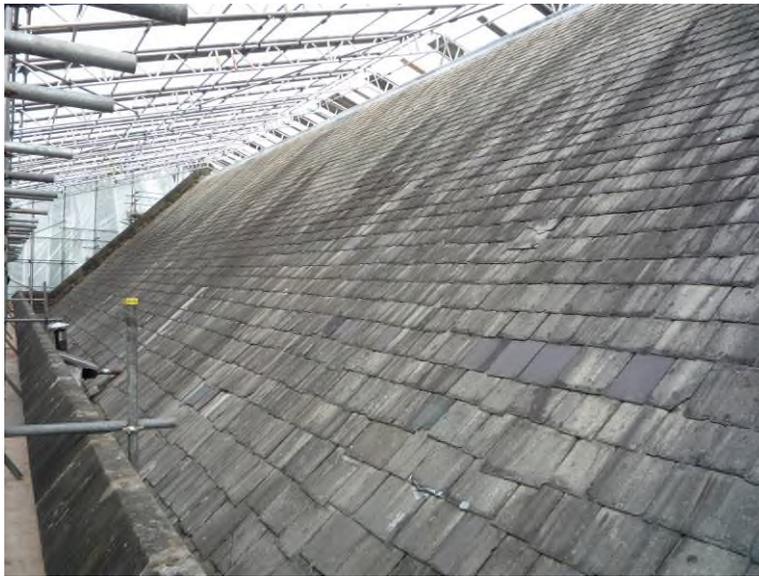
Life expired, patched and no longer viable

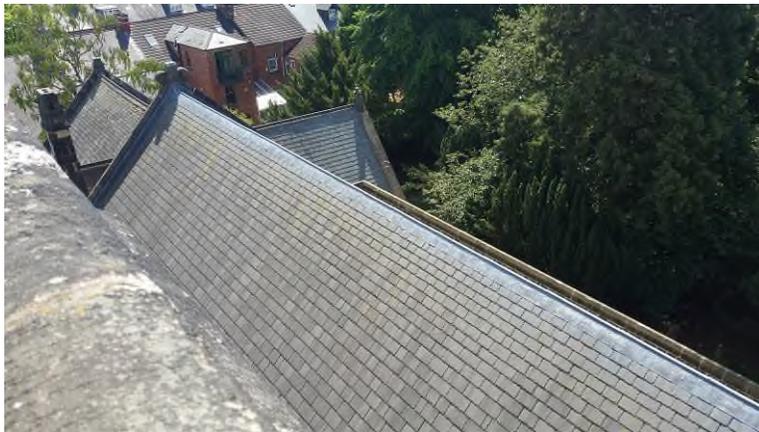
Tent in 2015 before replacement work began

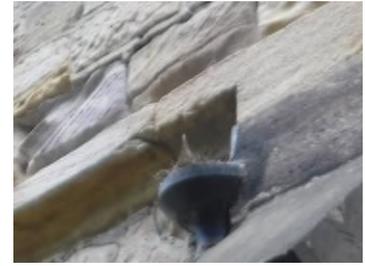
South Transept has a gutter leak on the east side.

Recommendation: revisit north drainage report and decide best course of action for repairs. Overhaul the gullies so that they receive their rainwater fully and remake surrounds and fit grids as required. Redecorate metalwork. Repair gutter leak to s transept e side. Check the system in a downpour.

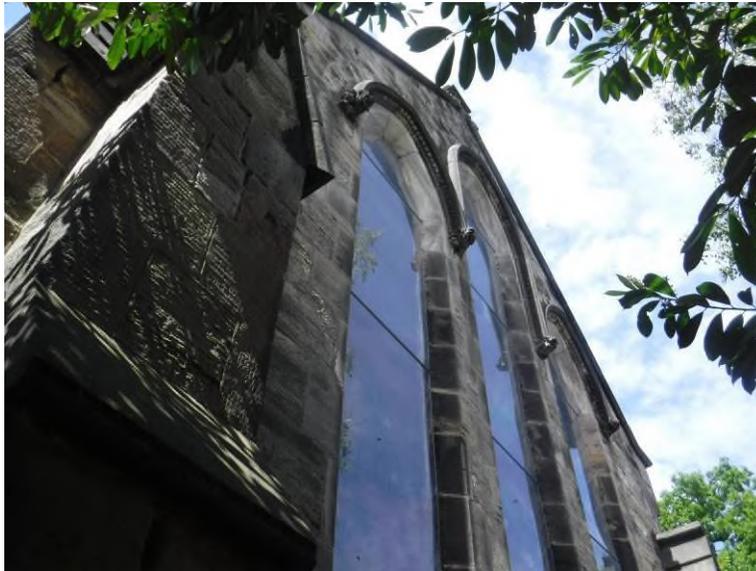
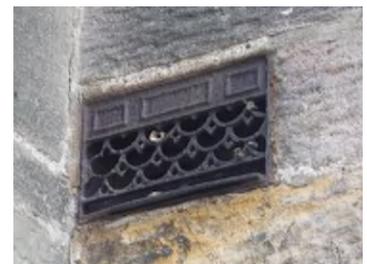
- **Chancel:**

The north side corbelling looks good. There is a bit of a rusty air grate in it and some erosion to the stonework but sound enough.

The west gable water table looks good, the relieving arches underneath it have open joints and some stone erosion, in fact there are a couple of stones that aren't laid on bed and work is wanted here. There is also some slight movement at the kneelers particularly on the south side. Hood moulds to the triple light window are ok, some slight erosion to the foot of the middle window cill. There are bees creating a home in the air grate on the south side.

The south side corbel is ok. There is an old crack between the two windows at high level running right down to the ground and looks to have cracked the stones in the past but it has been

Recommendation: none

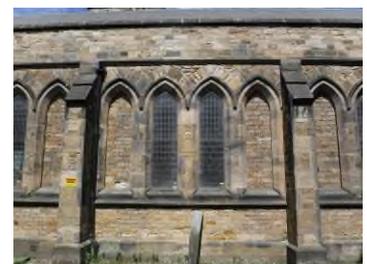
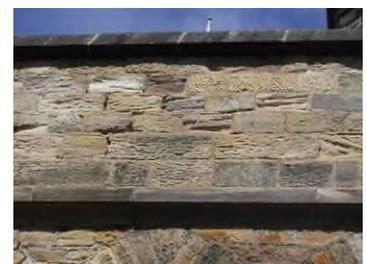
Which didn't extend to replacing some of the walling and there is a requirement for 10 possibly 12 stones at the eastern end to have work done to them.

Bay one: Four window openings, two of them blocked in, rather crudely repointed in masonry, some open joints. Lower part of the wall below the window is ok but pointing coming away and evidence as to why cement pointing is bad. Unused door, black painted looks like there is rot in one corner of it.

Recommendation: replace/plastic mortar repair eroded stonework and repoint

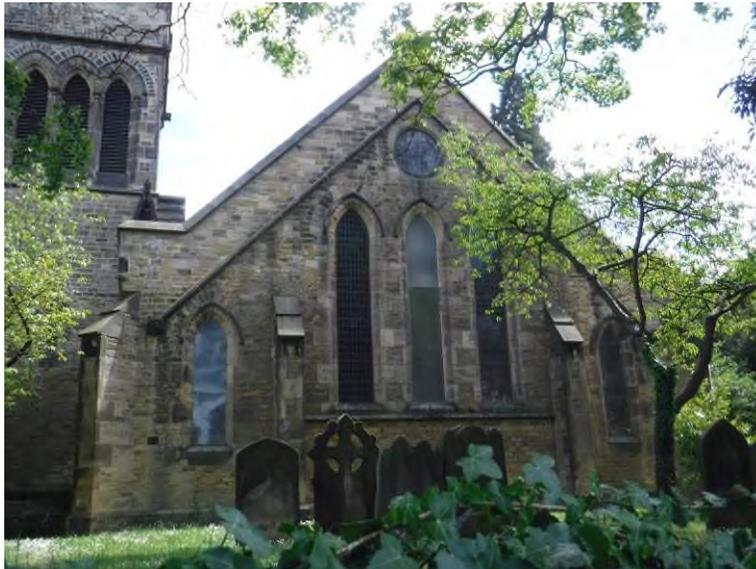
- **West Gable:**

Water table repointed as part of 2015 roof works, the apex has lost its cross. Some of the walling at high level was also repointed above the window raking stringcourse. Interestingly there is damp showing at the northern cheek and that there is also slight damp on the inside. Central window Lexan is coming apart and the other windows are unprotected. The remainder of the walling looks ok, there are a couple of open joint areas at two of the lancets. Angular buttresses and a bit of open jointing at the raking stonework tops.

Recommendation: repoint

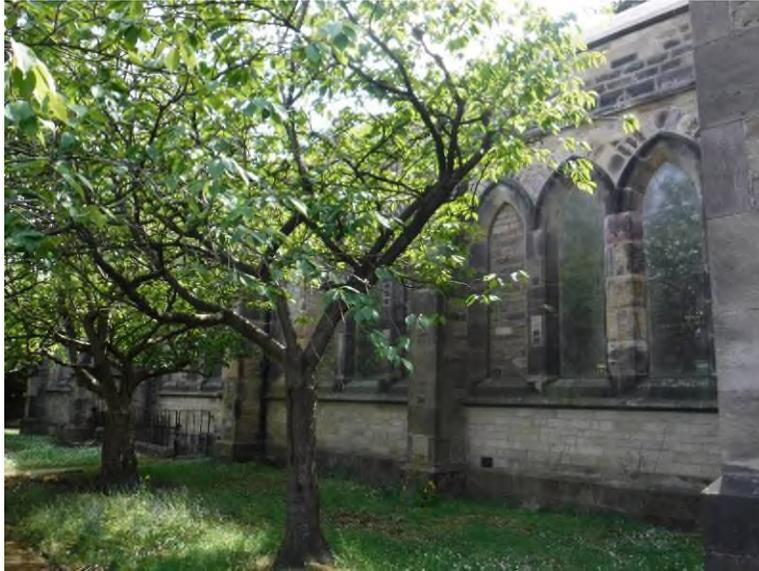
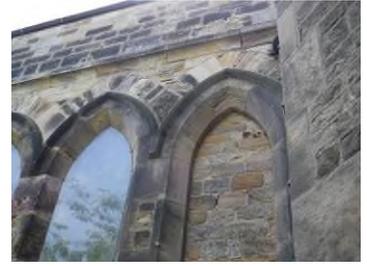
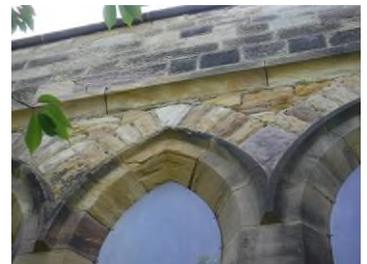
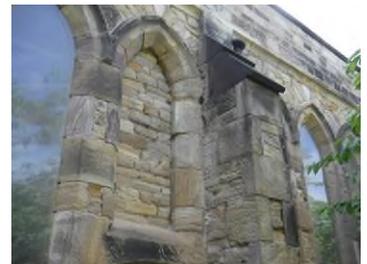
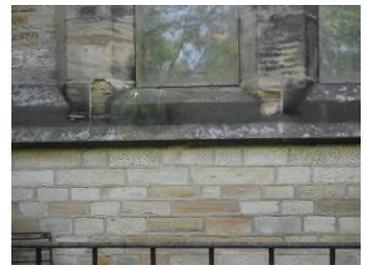
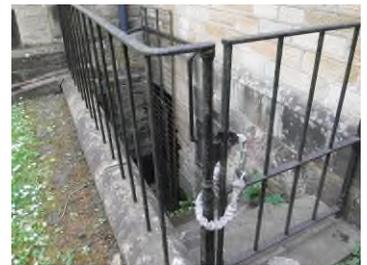
North side:

Bay one: Parapet ok though there are open joints to the underside of the corbel, a bit worn and at around about the centre of the windows it is beginning to be eroded at the lancet arches. One stone at low level eroding.

Recommendation: repoint

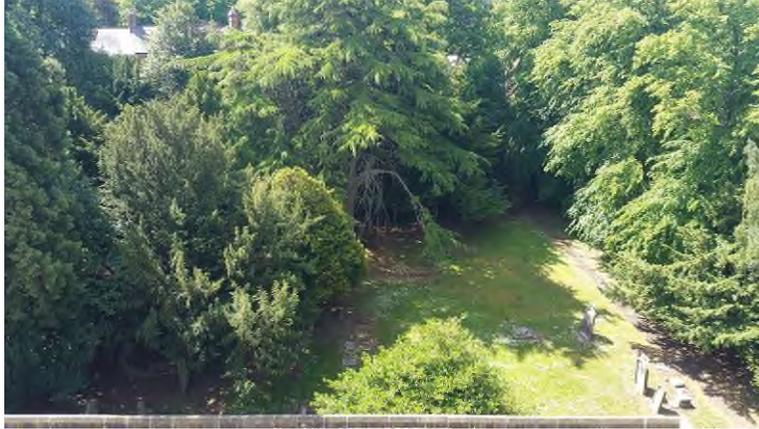
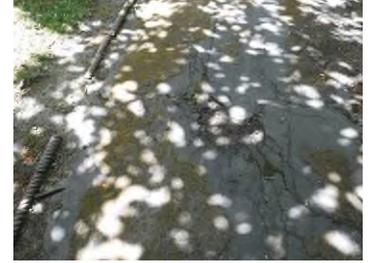
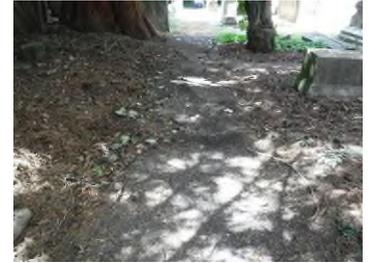
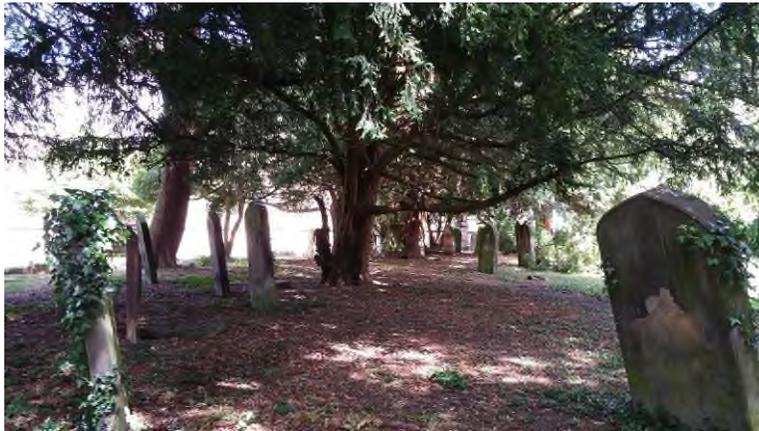
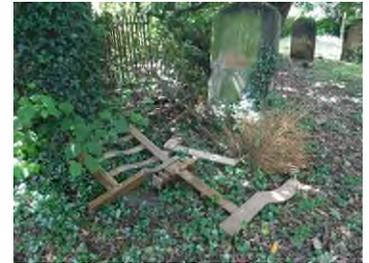
Churchyard:

Within the churchyard are undulating tarmac paths, some tarmac missing on the north side and the roll top kerbing is uneven and missing in places, it looks a little down at south side.

There has been some tree management but the south still feels rather full and the tree cover does provide some screening for anti-social behaviour. The south east gate was padlocked at the inspection. Is that permanent to deter intruders? The east boundary is getting full now and its clearing back would protect the wall- that is suffering root invasion to break the stones and would improve surveillance.

Recommendation: redecorate gates, repair guarding, remake entrance steps, repoint open joints

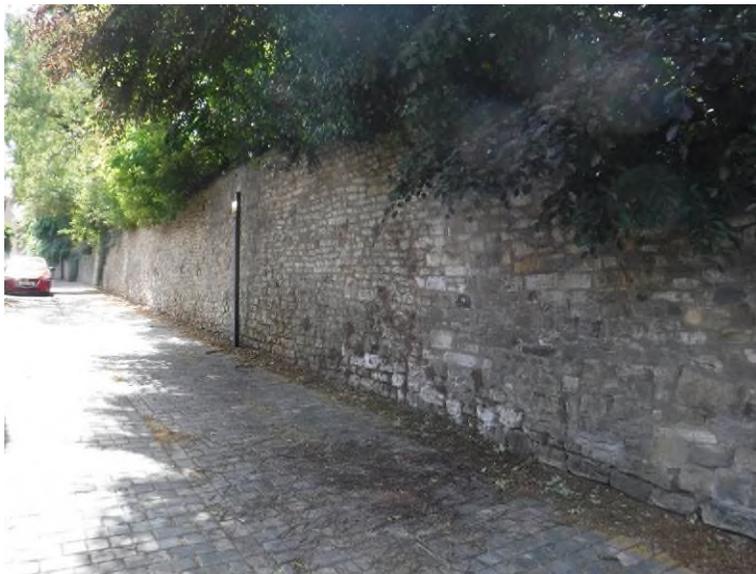
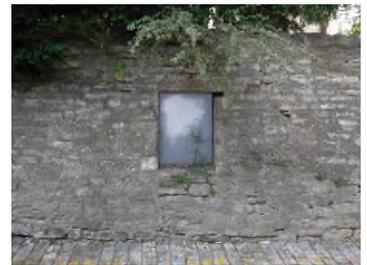
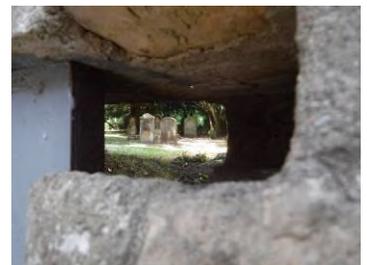
D East side:

Very tall stonewall in generally fair condition, it is retaining the churchyard, there is some damp showing at low level, some ivy growing over the wall tops and particularly the conifer trees are beginning to encroach into the yard. There are some openings in the wall into the churchyard wall that have been filled in with laminate sheeting.

Recommendation: remove tree cover, ivy and invasive plants, trim back. Repair coping and wall joints, tidy up redundant memorials and remove scrap timber and detritus.

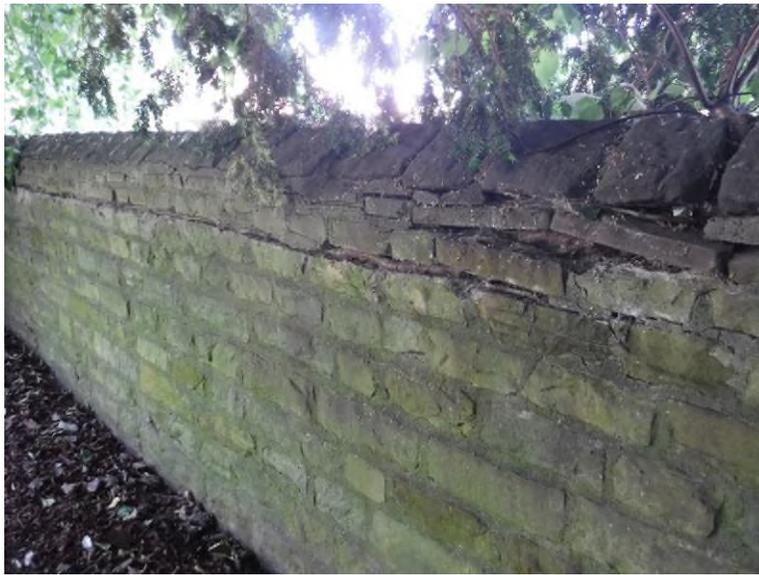
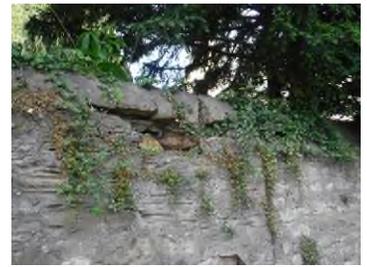
Root encroaching into the wall head breaking the stones

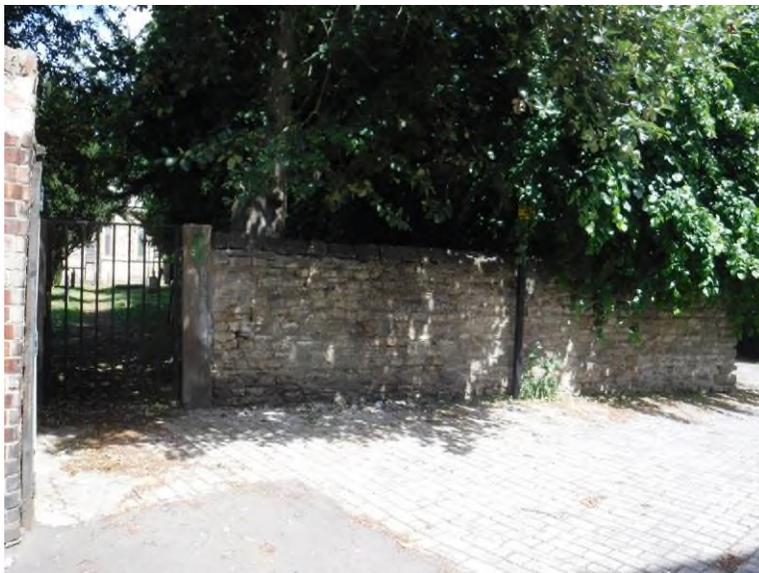
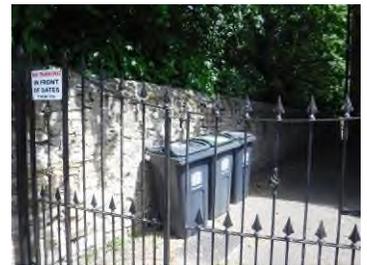
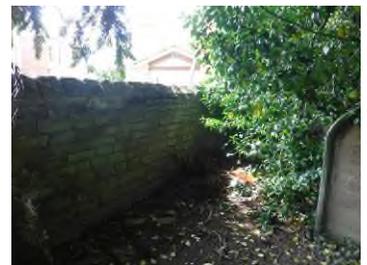
South side:

Viewed from the outside stonewall returning round from the east. The coping stones are coming apart by the gate posts, rather low quality gate that is padlocked presently and you can't get back into the churchyard on this side. A bit of a crack at the corner of the wall. Trees very dominant they are overhanging

into the alley rather significantly, the majority of the boundary is on to a private house.

Recommendation: reduce tree cover and repoint crack, remove graffiti

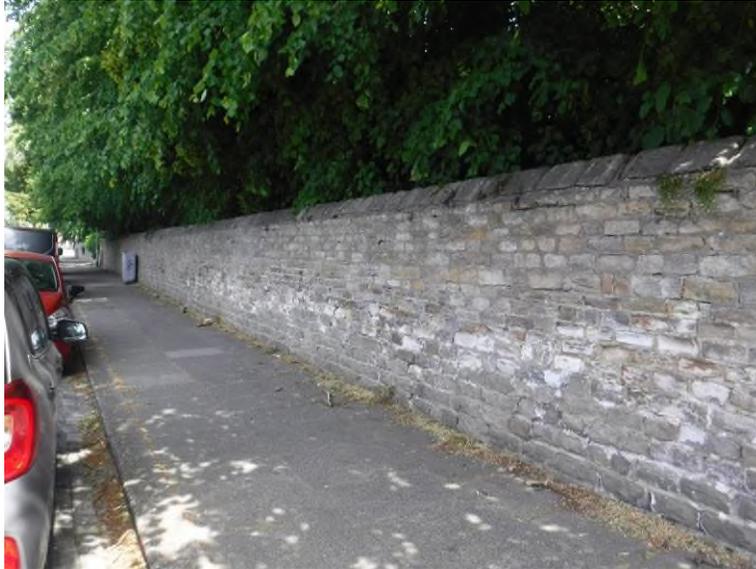
West side:

This is a higher quality coursed stonewall, some erosion midway up I guess and that this is probably the level of the raised ground behind it, it seems to be more of a problem at the southern end. There are many open joints and some stones missing. Entrance on the west side no doubt an original metal gate much dilapidated no longer working. The sandstone piers are fair but are eroded and they have lost the over mantel light.

Recommendation: repoint open joints, repair, redecorate and reset the gate

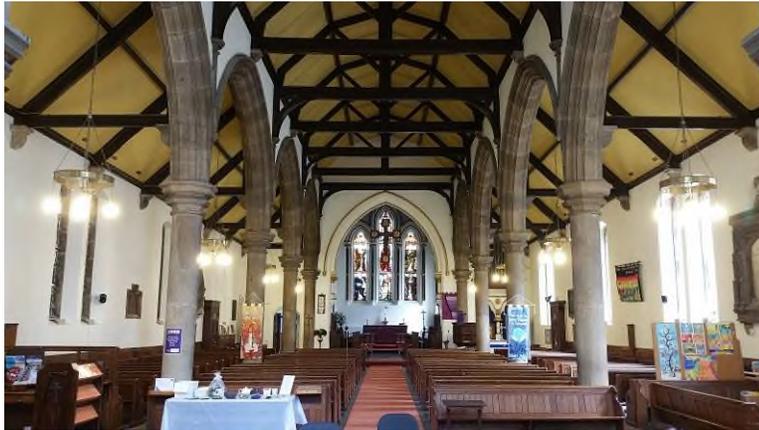
D **Nave and Aisles:**

This comprises a central nave and two aisles. The 2015 re-decoration to the nave and aisles is holding up. There are patches at the cheeks of the west end and the west side of north aisle and this looks due to damp coming through the wall due to missing external pointing. There is no evidence of the previous water damage by the organ in the eastern part of the north aisle.

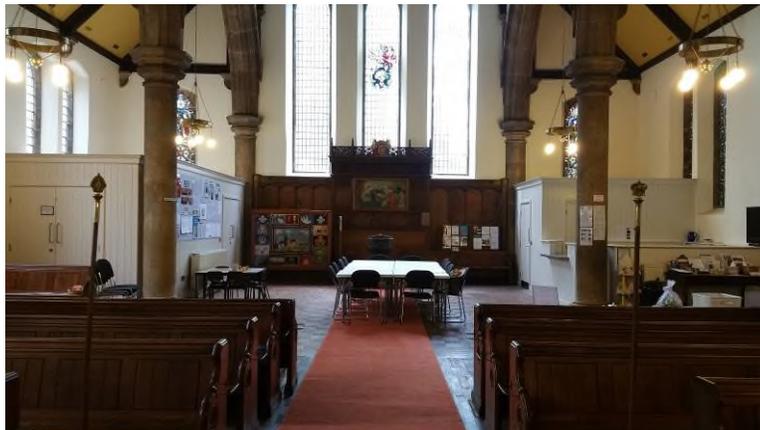
Servery and Store:

At the west end are new servery and store facilities installed in 2016 which comprise a servery with sink and two w.c's, one of which is for disabled use. The servery door rattles in the frame a little, the lobby door on the inside has lost its rose. Knots are beginning to show through the paintwork. It seems too soon to redecorate.

Some loose parquet tiles in front of the servery.

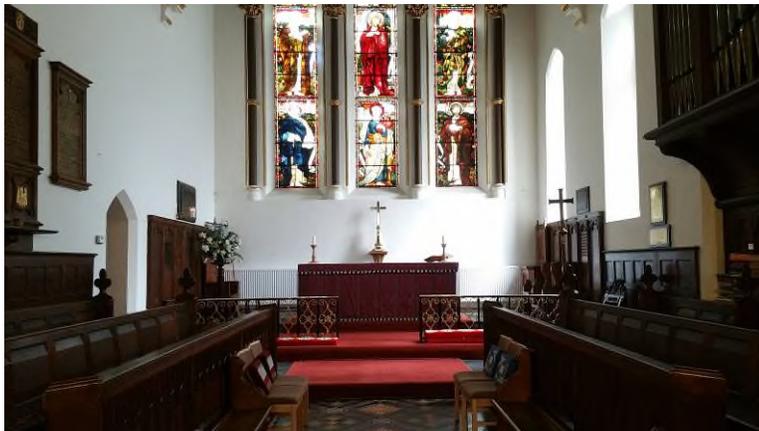
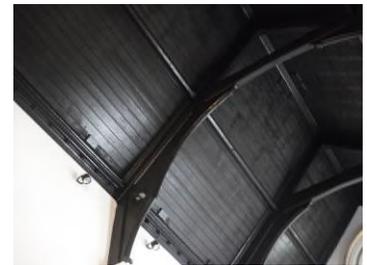
- **Chancel:**

- **Ceiling** - The decoration on the ceiling is blooming slightly. It didn't get re-decorated as part of the 2015 works.
- **Walls** – These are all good. Apart from one area where the decoration is coming away in the north east corner. There is no cracking to the chancel arch.
- **Floor** – The floor is a combination of Minton tiles in the choir and the sanctuary has green marble. The circulation in the sanctuary is covered in carpet in the style of the aisle.
- **General** - Tablet and chancel cross and additional tablet for the great war and world war II, altar rails brass in good condition, also a Bishop's chair in oak and pair of chairs.

Recommendation: none-

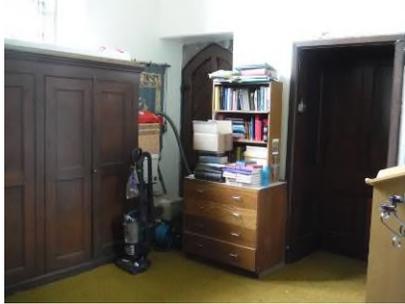
B Choir Vestry:

This room was painted out as part of the 2016 works and is quite a remarkable transformation considering its earlier condition. The floor is the basket weave parquet seen in the nave. The room has a redundant fire place. The room has various original pitch pine cupboards.

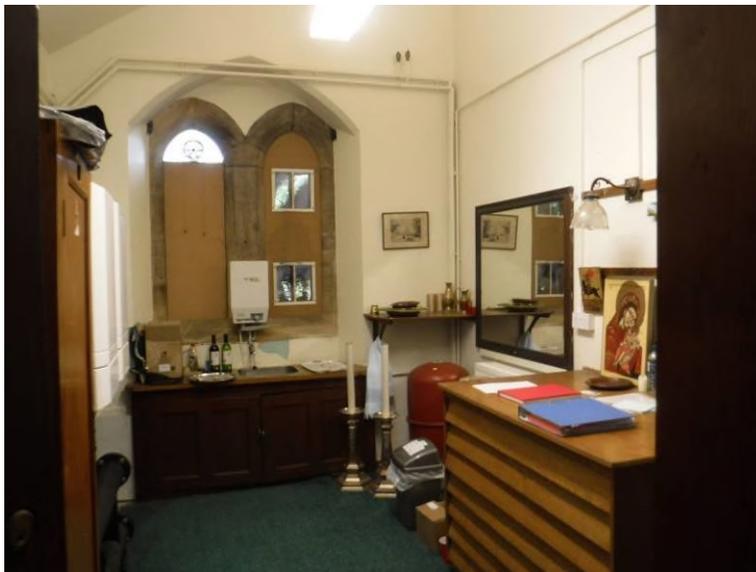
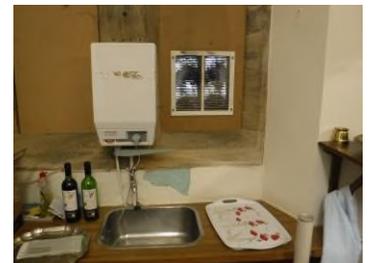
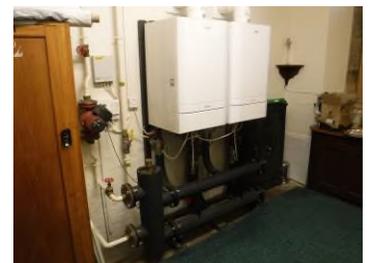
C Vicar's Vestry:

Plastered out and painted ceilings and walls, ceiling patch replastered in the 2015 GPOW works. Basket weave parquet with a temporary carpet laid over. Twin lancet window and this has been modified to provide a ventilation for the boiler, a fire has been lit in the past against one of the outside grills and this remains a fire risk, the infill board seems to be MDF and it might be worthwhile to consider up-grading that, the window to its side has been completely blocked off and has Lexan sheeting.

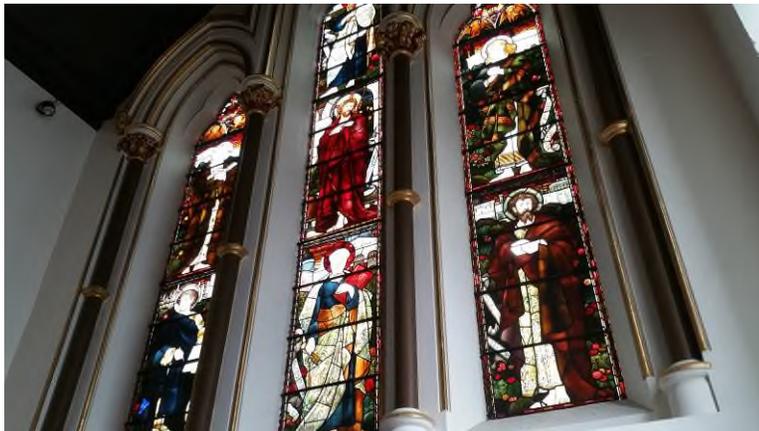
- **Windows:**

The majority of the glazing is clear leaded though it does appear obscure because of the dirt on the polycarbonate. The north side of the nave has the pictorial glass as does the west end of the nave. The chancel east has triple stained glass and all of this looks in good condition.
