St Herbert's Church

Quinquennial Report

19 April 2023

QQ Surveyor: Peter Lewis BSc MSc MRICS MCMI

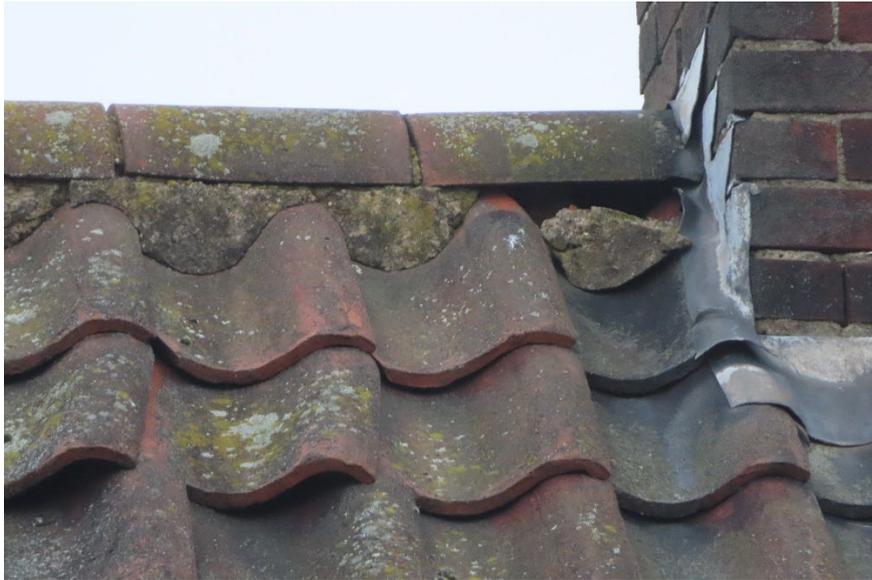
3.1.2. The ridge was finished with clay ridge tiles. It was noted that there was missing and eroded mortar bedding to the ridge in a number of positions. It was further noted that 1 of the ridge tiles was showing the early signs of loosening. It is recommended that the mortar bedding is patch repaired and that any loose ridge tiles are re-bedded on fresh mortar again when safe high-level access is available.

Photo 9, Example of loose mortar bedding to ridge tiles

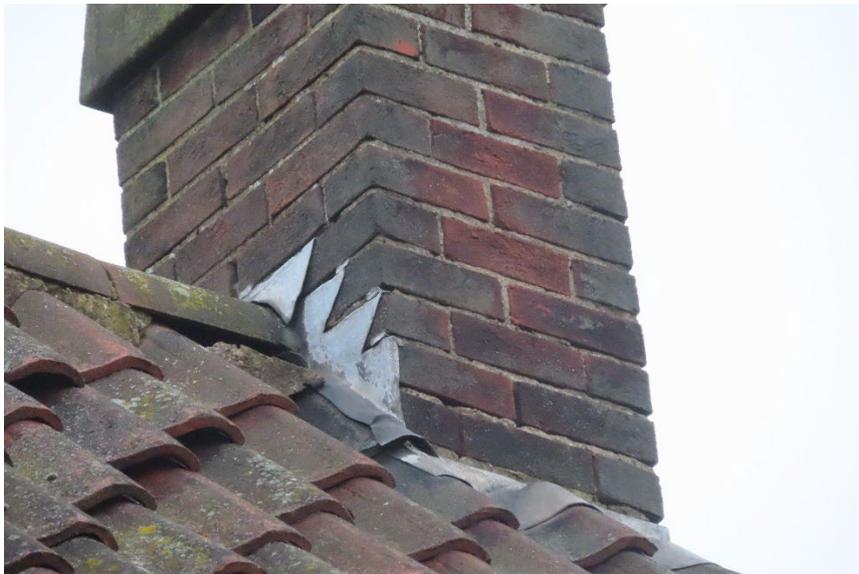
3.2.1. There was a single chimney stack to the south end of the ridge fitted with a clay cowl pot. The stack was of brick construction with a stone capping. There was the onset of erosion to the pointing on the west and north elevations. It is recommended that these areas of pointing are patch repaired.

Photo 10, condition of chimney stack pointing

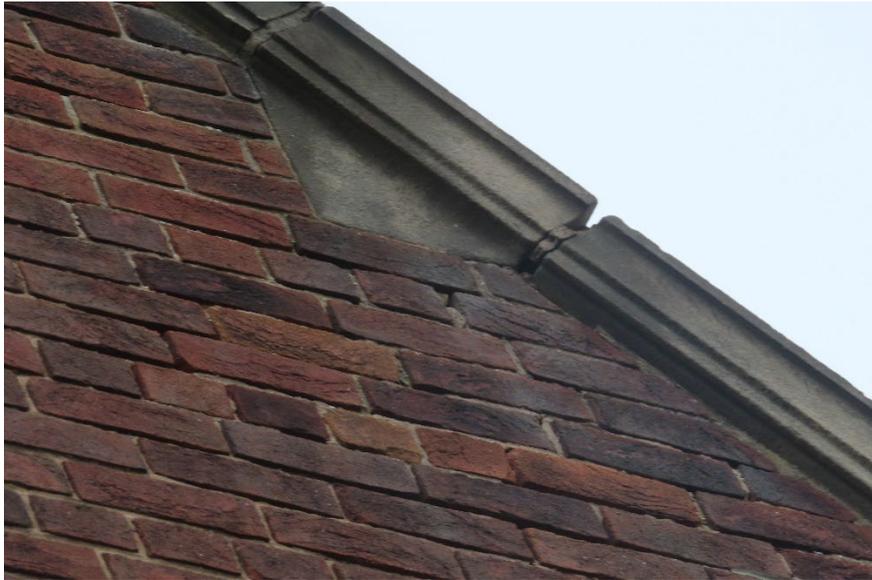
3.2.2. There were stone copings to the no south gable and the parapets to roof 3 and 4. It was observed that there were gaps in the pointing to the copings to the gables. These could lead to water ingress into the wall head. Causing internal dampness and damage to the brickwork.

Photo 11, Example of gap in coping stones to South gable

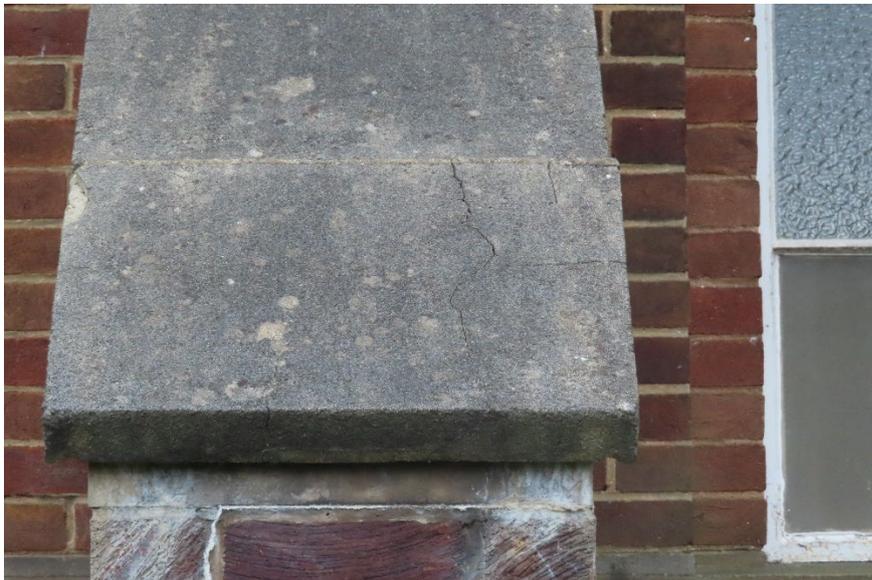
3.2.4. There were concrete flag copings to each of the buttresses. It was observed that there was damage to cracking to the lower coping on the lower section of buttress 2. It is recommended that this flag is replaced.

Photo 12, crack to capping stone of buttress 2

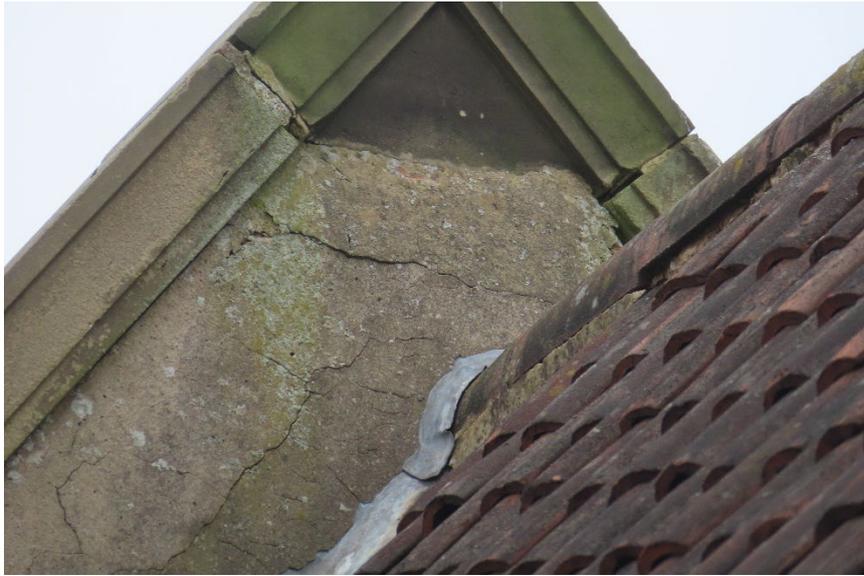
3.4.3. The render to inside face of South gable was cracked and delaminated. This will allow moisture to penetrate the brickwork which will likely lead to damage to the underlying brickwork with frost attack.

Photo 13, Cracking to render on inside face of South gable

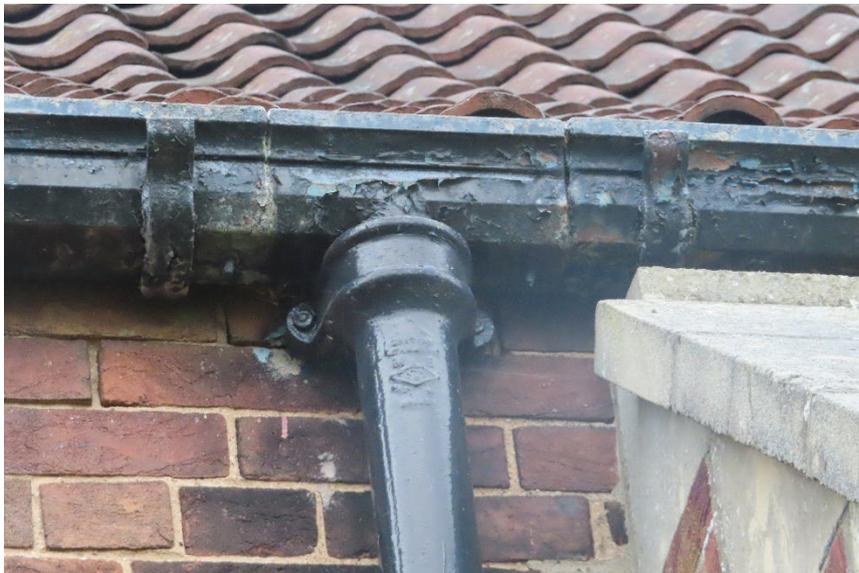
3.3.1. The original rainwater goods were of cast iron. There was extensive deterioration to the decoration. There was damp staining to the wall between buttresses 6 & 7 where the gutter was leaking. It is recommended that the rainwater goods are redecorated, and that the opportunity is taken to reseal any joints.

Photo 14, Example of decoration of rainwater gutters

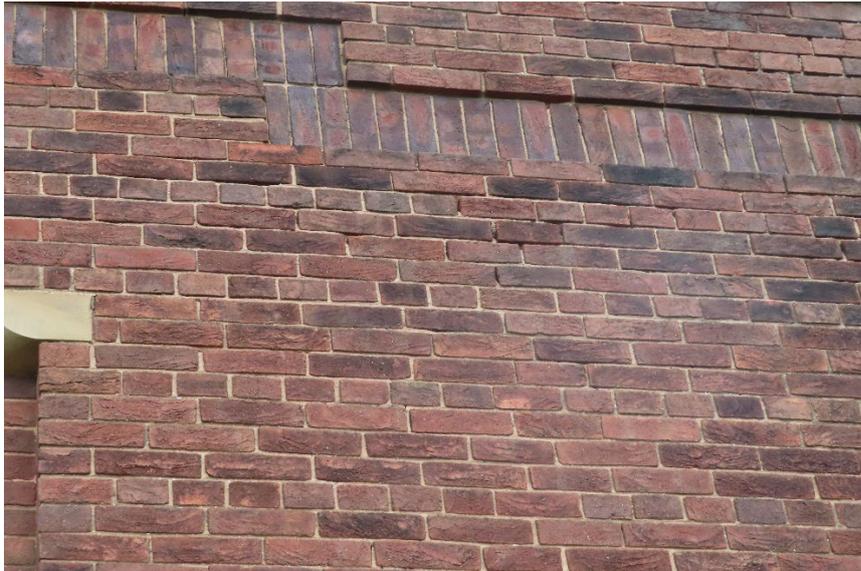
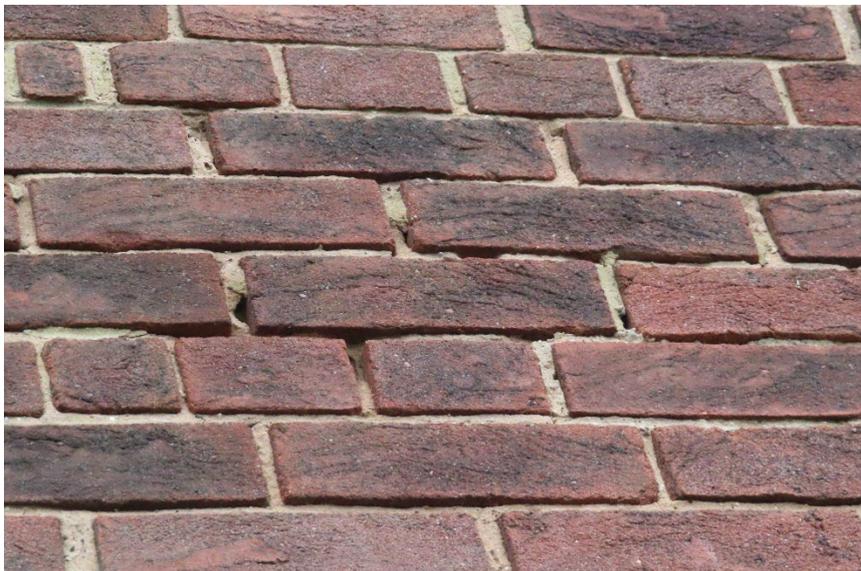
3.4.2. The brickwork was generally observed to be in good condition however it was noted that there were areas of pointing erosion on all elevations which are in need of patch repairing.

Photo 15, Example of area of erosion to pointing

Photo 16, Example of area of erosion of pointing

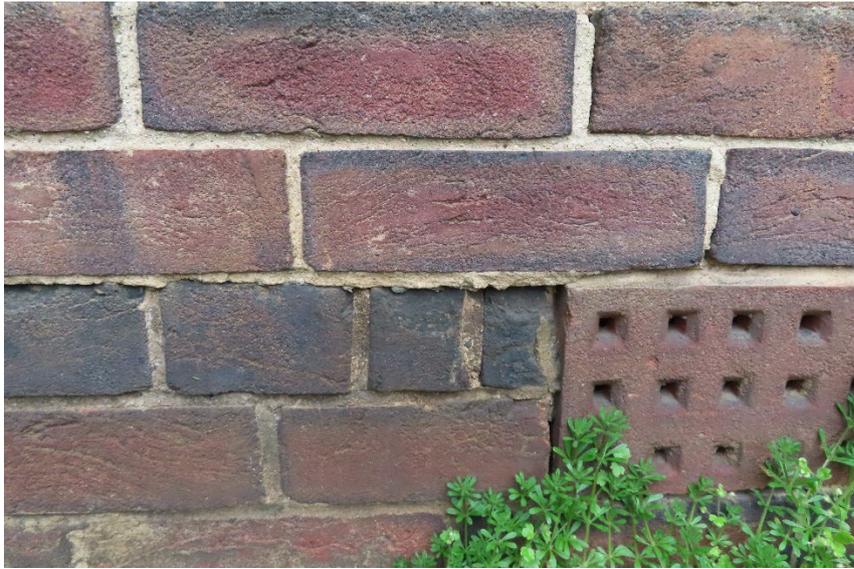
Photo 17, oversailing of brickwork at DPC level between buttresses 7 & 8

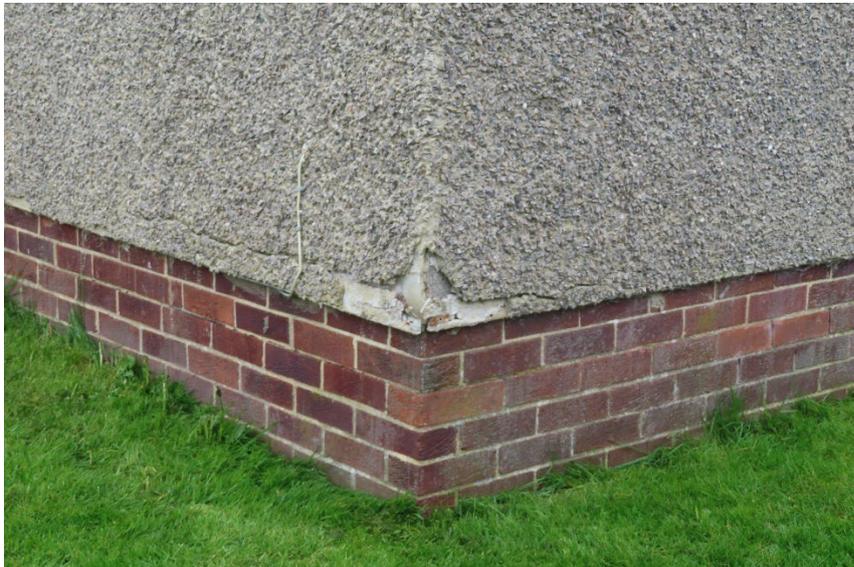
3.4.7. There was render finish to elevations 4 and 5. Tapping with a hammer identified there was areas of delaminated render above the drip bead. It is recommended that the loose render is hacked off and these areas are patch repaired.

Photo 18, Cracked and delaminated render

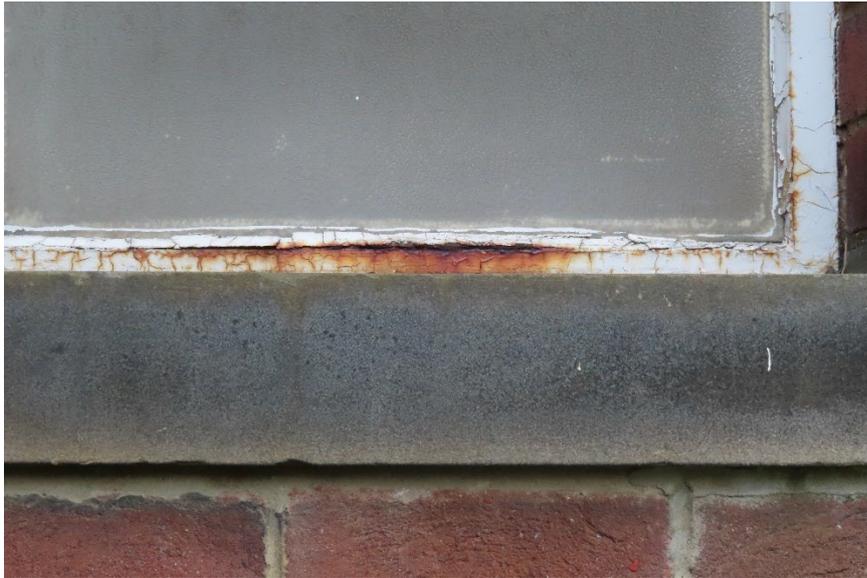
3.7.1. There were steel Crittall windows and fixed lights throughout the church, while the windows appeared to be of an aluminium. There were signs of the onset of corrosion on many of the church windows and areas of missing putty. It is recommended that all of the windows are redecorated.

Photo 19, Corrosion and poor decoration to steel Crittal window

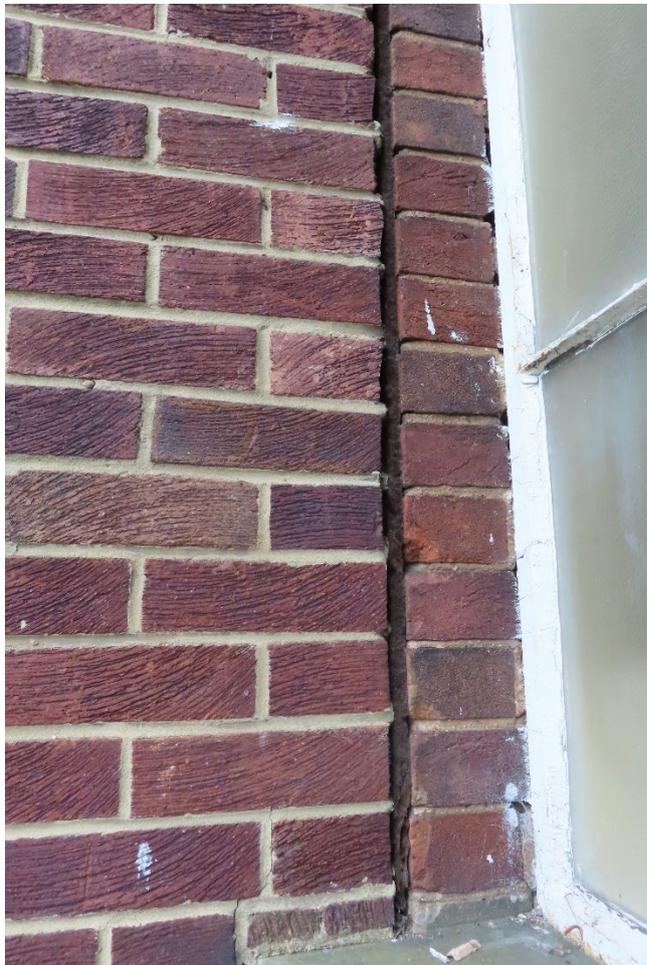
3.4.5. There was a gap in the expansion sealant between the church hall and church. It is recommended that this is refilled.

Photo 20, Open expansion joint between Hall and Church

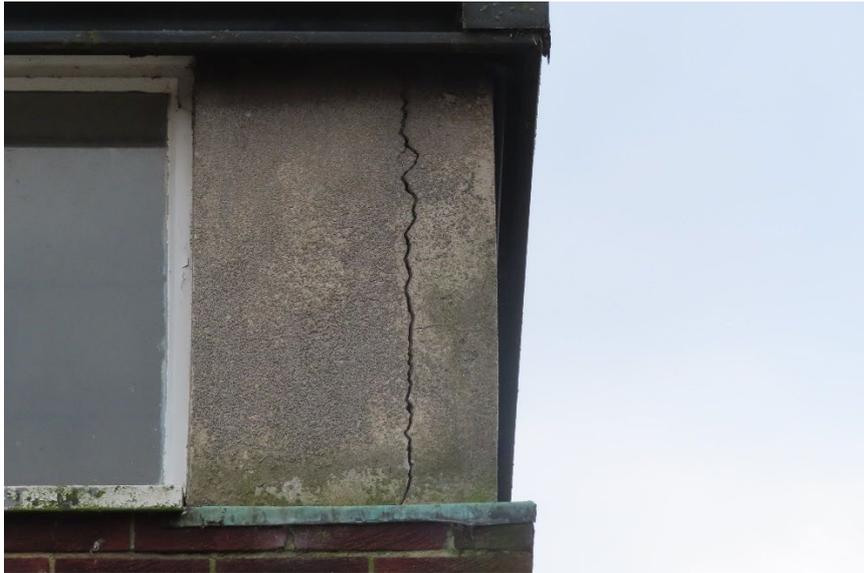
3.4.8. There was a rendered finish above the brickwork to elevations 5, 7 and 8 to the structural frame. It was noted that there were vertical cracks adjacent to the corner. It is recommended that the render is hacked off and the underlying structure inspected to confirm if the defects extend into the concrete frame.

Photo 21, example of crack to render over structural frame of the Hall at high level.

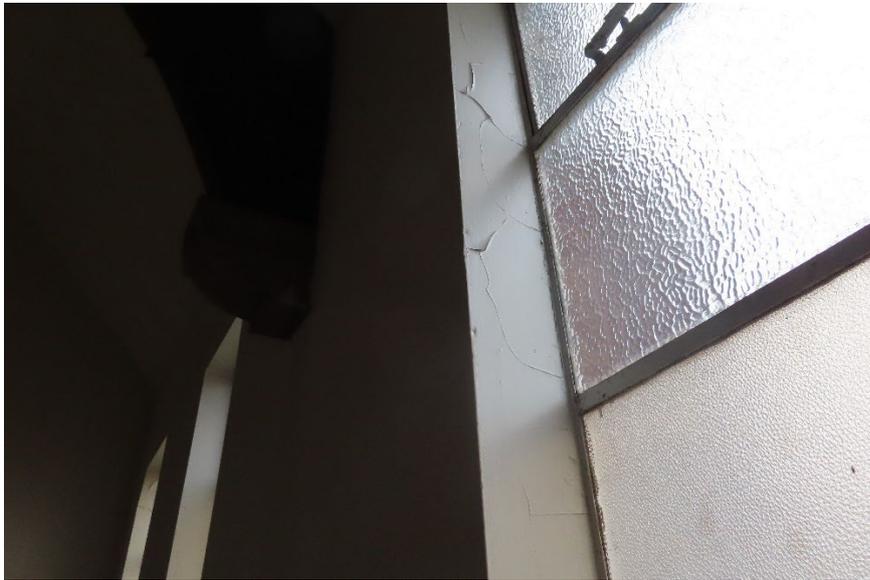
- 4.1.3. There was widespread cracking to the plaster finish. It was also of note that there was a vertical crack to the plaster adjacent to the electric lighting cabling. This surface cracking may be associated with the cracking of the vinyl paint. It is recommended that areas of the underlying plaster are uncovered during redecoration and any minor cracks refilled.

Photo 22, example of cracking to internal paint finish

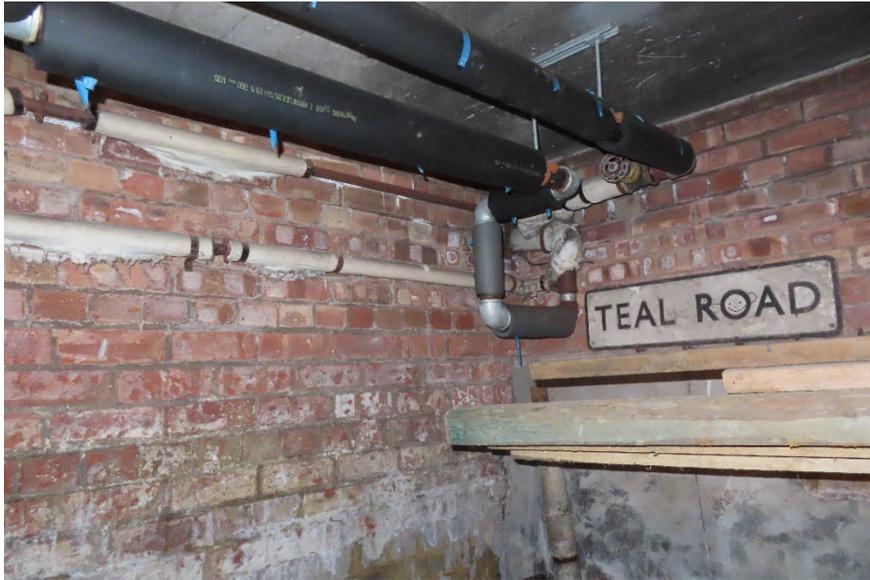
3.8.3. The redundant pipework was covered with disturbed insulation. This may contain asbestos and it is recommended that this is surveyed immediately as it was loose.

Photo 23, Disturbed old insulation to boiler room, possibly asbestos

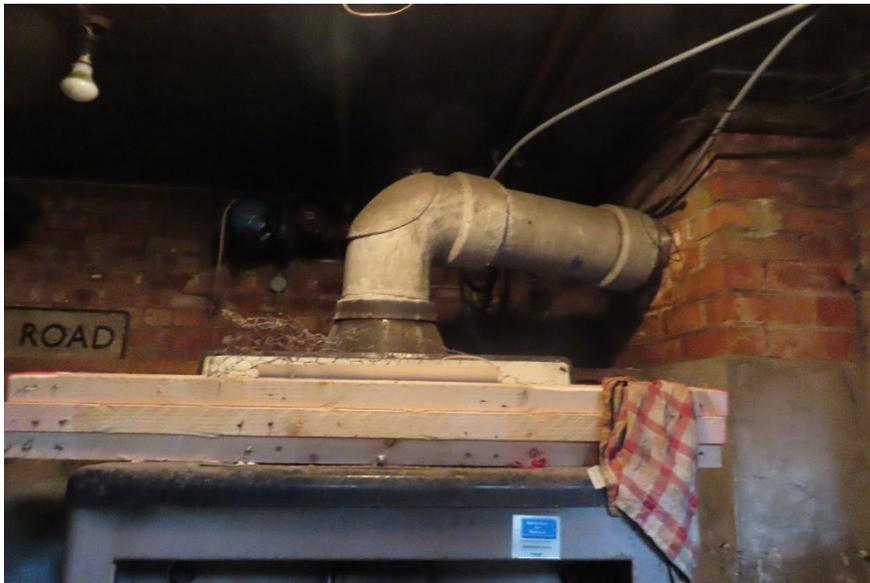
Photo 24, cement flue to old boiler possibly asbestos

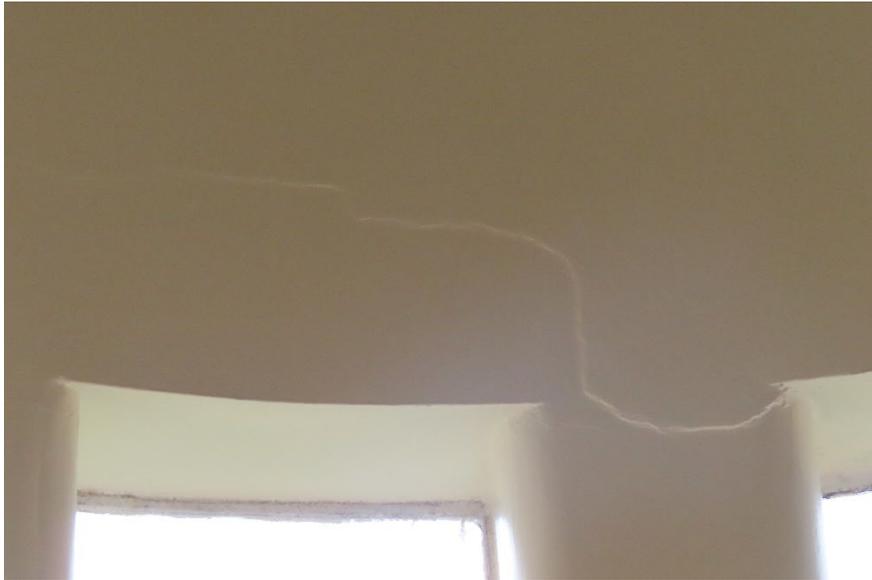
- 4.1.5. There was evidence of repairs to cracking to the plaster finish above the windows to the stairwell. These should be kept under observation.
- 4.1.6. The walls to the north first floor storage area were unfinished. The brickwork was observed to be in good condition.

Photo 25, repaired crack over stairwell window

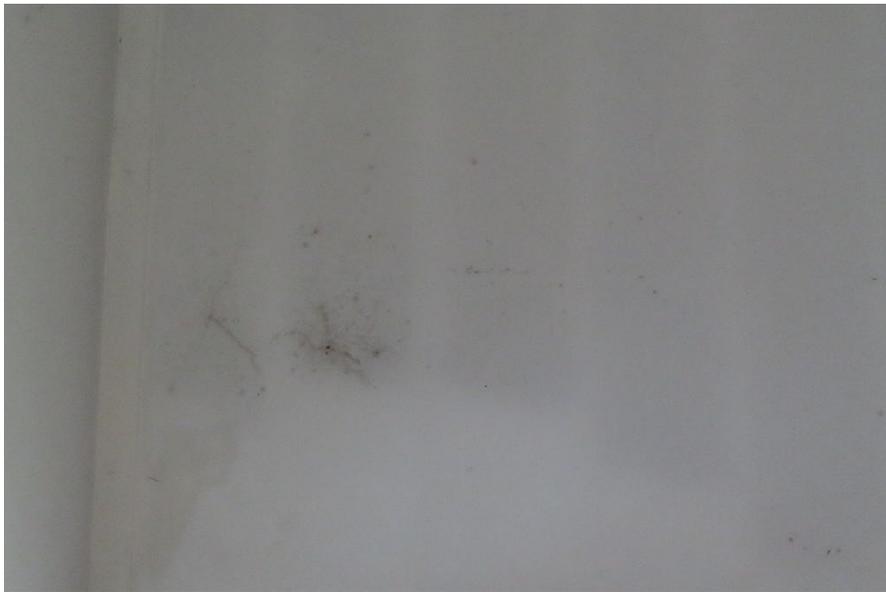
4.2.4. There was also evidence of deterioration to the paint finish to the west elevation ceiling adjacent to the south wall .

Photo 26, staining to the nave ceiling South West corner

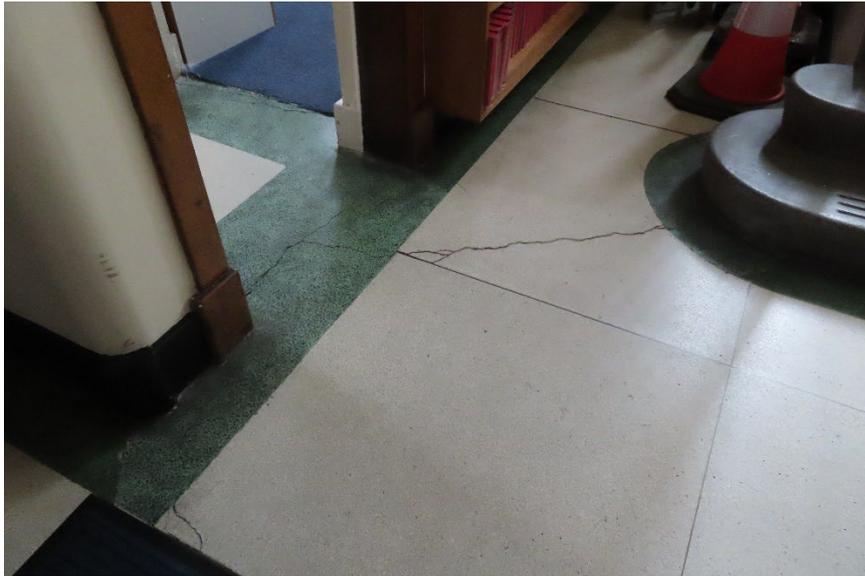
4.3.1. There was a solid floor to the entrance hallway, WC and cloakroom. It was noted that there was cracking to the finish at the bottom of the stairs at the entrance to the cloakroom, as well as the floor being slightly raised in this area indicating some movement of the floor slab. It is recommended that the cracks are repaired with cementitious mortar and the floor kept under observation.

Photo 27, Crack to entrance floor

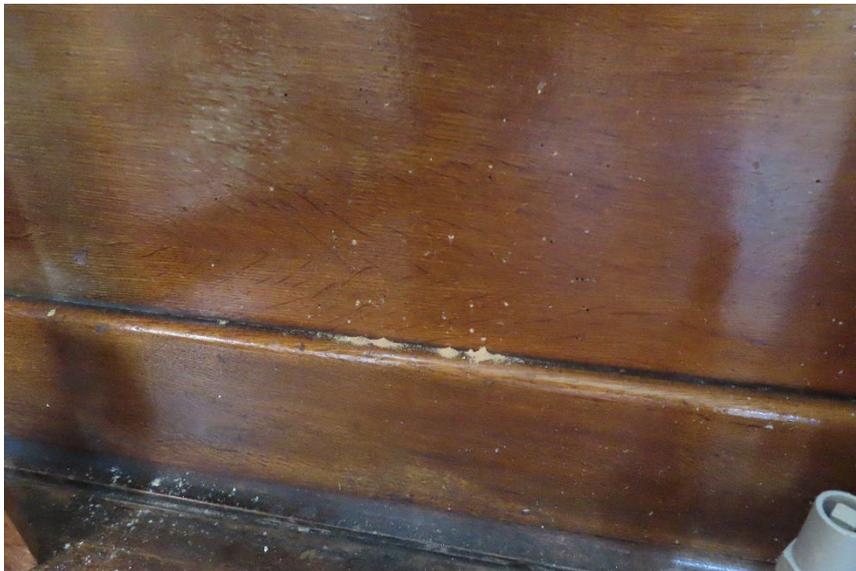
4.9.2. There was an area where infestation in the panelling by wood boring insects visible near to the entrance to the Vestry. It is recommended that subject to the Asbestos survey that the timber is opened up and treated with insecticide over an extended area to guard against further infestation. On going observation of all panelling is recommended in case that the infestation has already spread further.

Photo 28, Evidence of infestation by wood boring insects of wall panelling

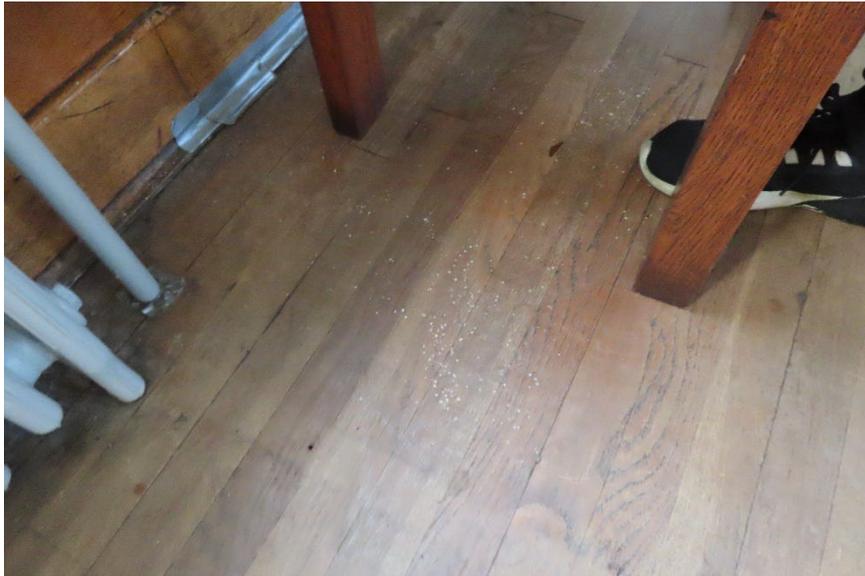
Photo 29, Evidence of infestation of floor boards

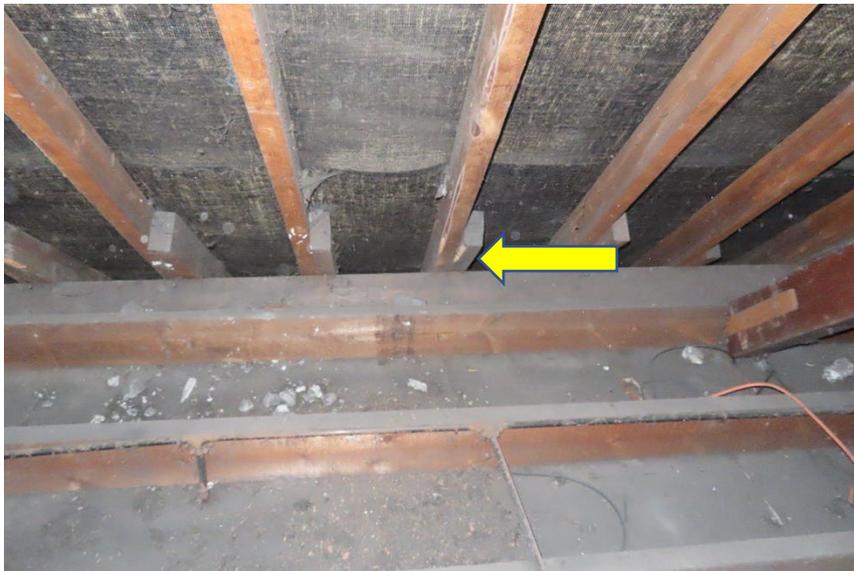
4.8.2. It was noted that there was the onset of infestation by wood bearing insects visible in the rafters over the nave to roof 2. It is recommended that the timbers are treated with insecticide to guard against further infestation and degradation of structural ability.

Photo 30, evidence of infestation of rafters above purlin

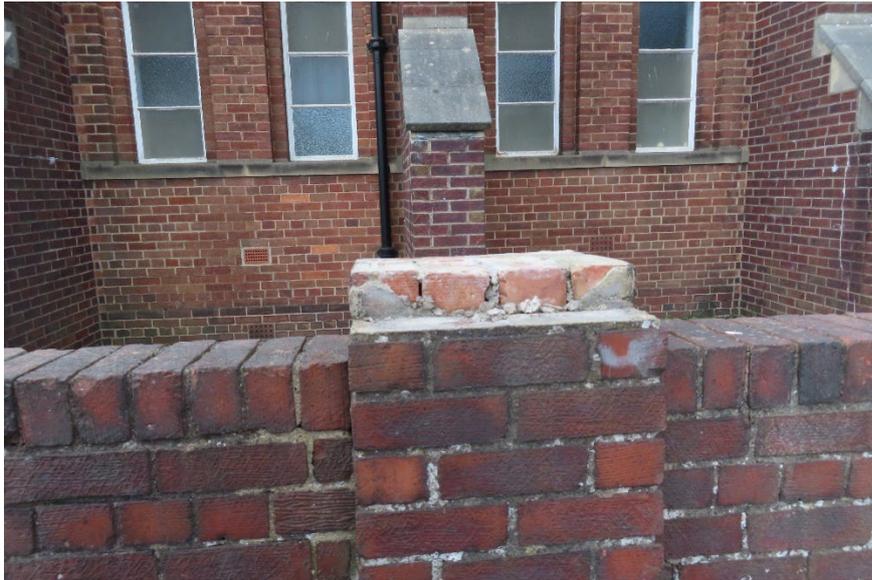
- 7.1.1. To the south boundary was a timber picket fence which was observed to be in good condition.
- 7.1.2. To the east and north boundary was a brick wall with pillars. There were a number of missing bricks to the pillars on the east elevation. The brickwork to the north end of the east wall and also the north wall was showing significant signs of deterioration with spalling bricks and eroded pointing. It is recommended that the brickwork is patch repaired.

Photo 31, Example of damage to boundary walls

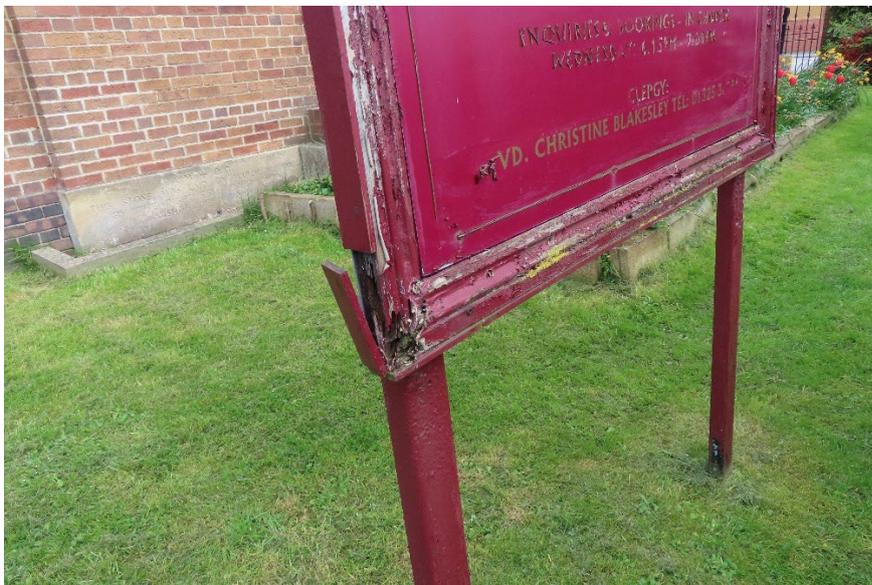
- 7.1.9. The timber sign board to the south was on steel posts. The timber was showing the onset of wood rot and deterioration to the lettering. The timbers could be patch repaired promptly otherwise the board will likely need replacing.

Photo 32, decaying timber and poor decoration of sign board

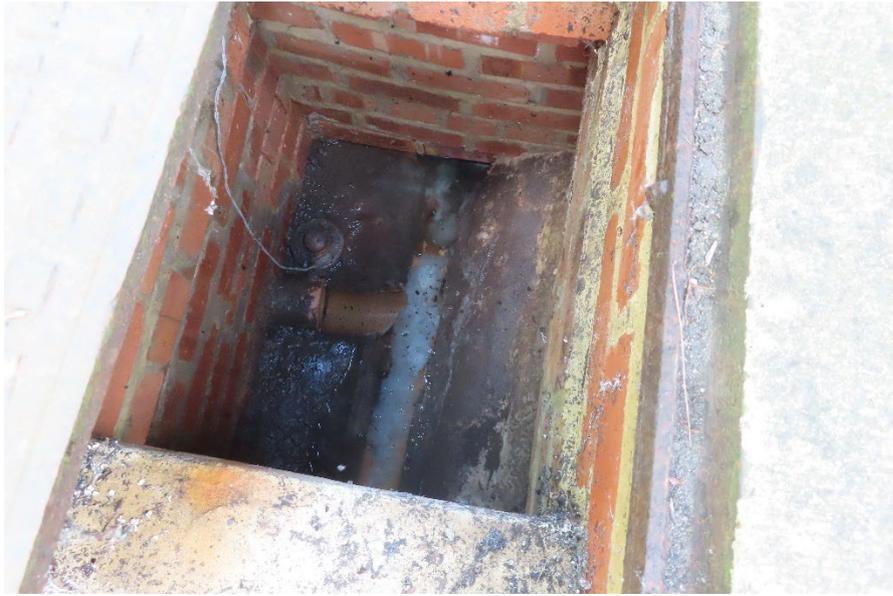
- 7.1.11. Drainage inspection hatches were lifted to the west and south. In the hatch nearest to the south pedestrian gates, there was water holding within the drain. It is recommended that the water board are contacted to check for blockages. It is likely that the blockage occurs outside the property of the church.

Photo 33, Blocked drain adjacent to entrance gate
