# PARISH CHURCH OF ST MARK WITH ST PAUL DARLINGTON

## QUINQUENNIAL INSPECTION REPORT 2023

**Date of inspection:** 01.03.23

**Ref:** 23014

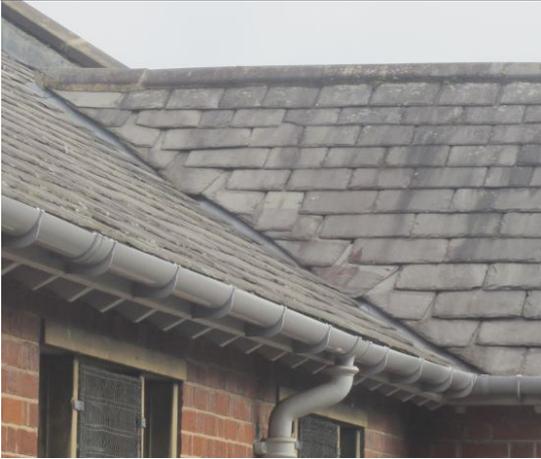
Roofs and upstand walls – there are slipped slates by the valley between the Organ Chamber and the Nave/Chancel roof. These need re-fixing. There is a missing slate on the east slope of the Tower, replacement is needed. There are damp patches at high level on the east wall of the Sanctuary and on the west wall of the Chapel. This is thought to be caused by open joints and poor bedding of the gable copings. Re-bedding and repointing of the gable copings is needed. The mortar to a number of the verges is poor – localised raking out and repointing is needed.

Slipped slates by valley of Organ Chamber roof

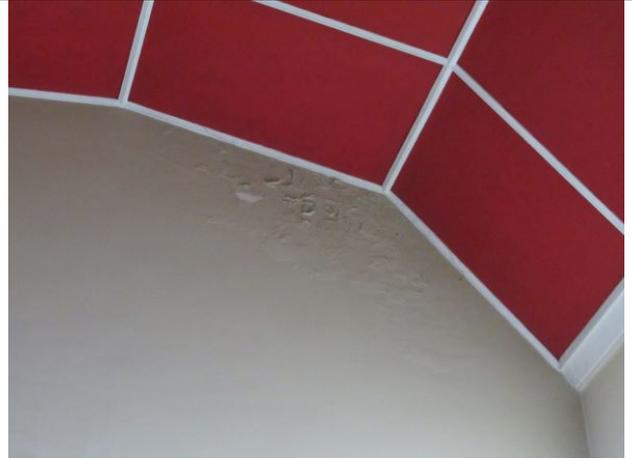
**Copings** The gable copings to the Sanctuary east gable, Chancel east gable and Nave west gable have open joints which require repointing. This is thought to be the cause of water ingress and flaking paint at high level in the Sanctuary and Chapel gable walls. B

<b>External walls</b>	The plastered and painted external walls are generally in good decorative condition with the exception of the following:- a) Chancel – some flaking paint below ceiling on east gable wall b) Chapel – some flaking paint on west gable wall The dampness is thought to be due to poor bedding and open joints in the gable copings – see 4.4. Once the leaks is fixed and the damp has dried out the flaking paint should be removed and the wall redecorated. c) Porch, Clergy Vestry & Kitchen – would benefit from redecoration.	D
<b>Brick piers</b>	The fair faced brickwork piers in the Nave are in good condition.	
<b>Internal walls</b>	The plaster and decoration are generally in good condition apart from the Clergy Vestry and Kitchen which would benefit from redecoration.	D

Chancel East wall – flaking paint through leak

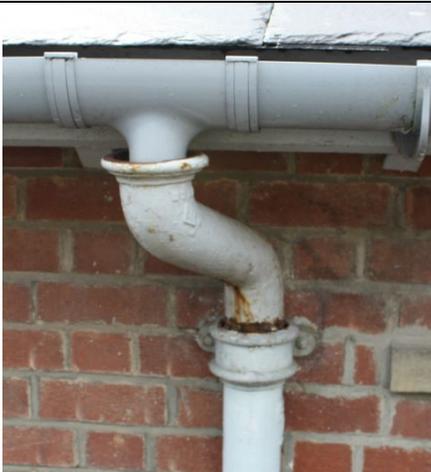
Rusting cast iron downpipe collars

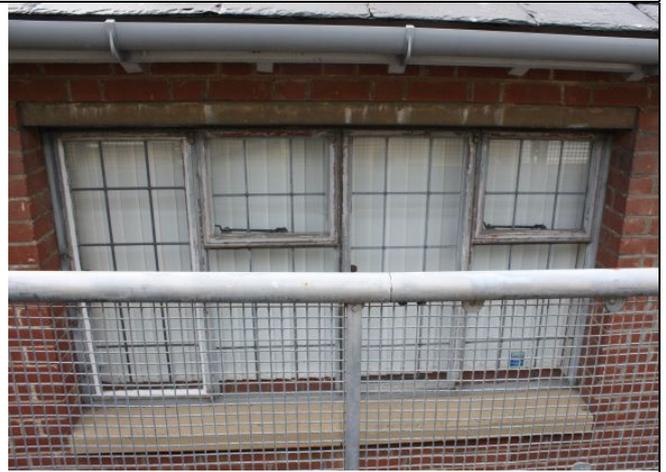
Windows – the metal frames windows of the Vestries, Toilets and Tower have flaking paint and need re-decoration along with the mesh window grilles to the Baptistry window. Replacement of discoloured polycarbonate covers to the Chapel and Sanctuary windows should be considered.

Rusting metal framed windows

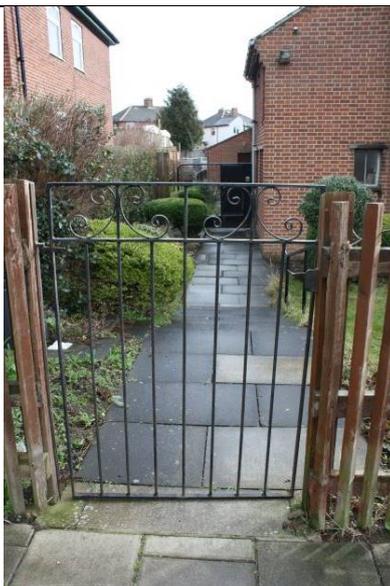
Fencing near Boiler house security gate: the close boarded fence needs re-staining.	M
<b>Gates</b>	The wrought iron gate on the west boundary does not close properly. The timber posts need re-aligning to correct this.	M
	The metal security gates to the Hall grounds are in reasonable structural condition but has the paint has flaked off the top rail and the side panel. Redecoration is needed to prevent rust.	M

Misaligned west gate

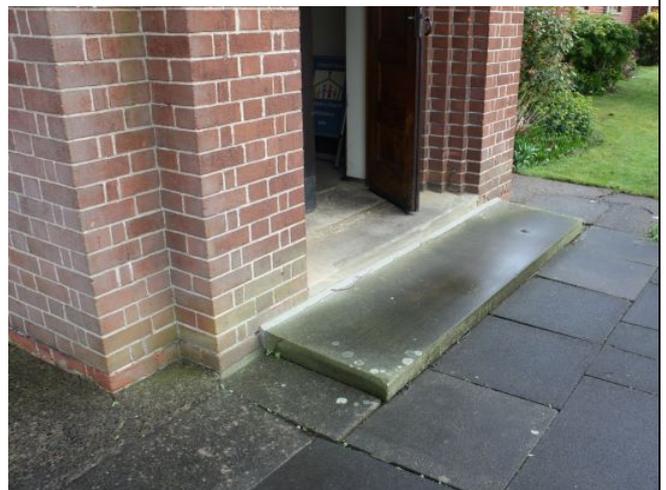
There are two steps into the building at the main entrance and a single step from the Nave to the Chancel. Consideration should be given to providing level access into by the formation of a shallow ramp from the Porch to the public footpath.

2No steps into Porch – consider re-laying paving flags to a gentle slope to give wheelchair access
