PARISH CHURCH OF ST MARK WITH ST PAUL DARLINGTON

QUINQUENNIAL INSPECTION REPORT 2017

Date of inspection: 28.11.2017

Ref: 17021

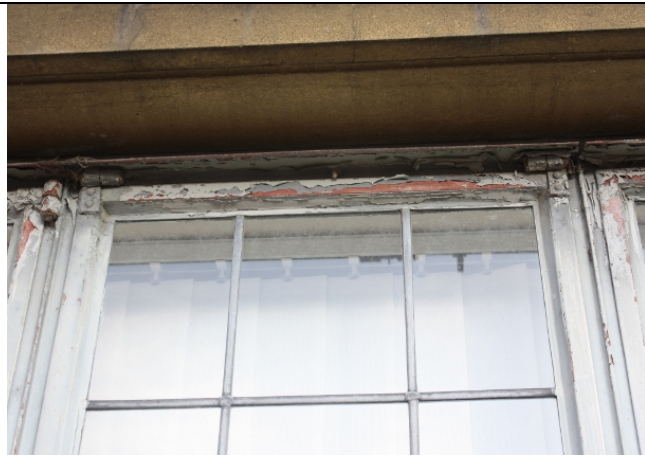
| Framing | The metal frames to the windows are generally in fair condition given their age. However they are in need of re-decoration especially those to the Vestries and Toilets etc. | B |

Flaking paint to metal windows

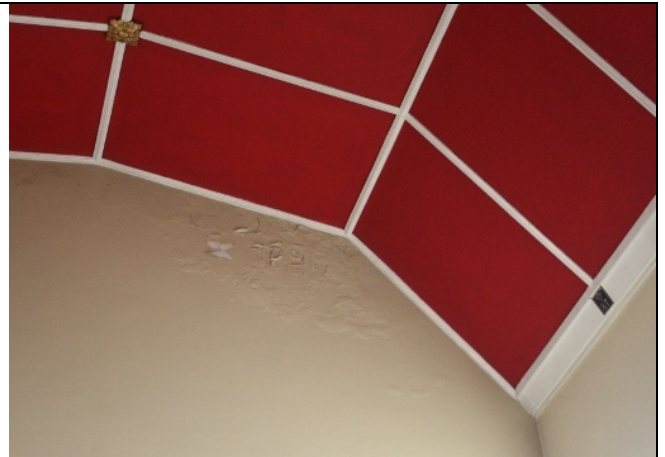
| Copings | The gable copings to the Chancel east gable and Nave east gable have open joints which require repointing. This is thought to be the cause of water ingress and flaking paint to the Chancel east wall at high level below the ceiling. The bedding to the Nave east gable copings is breaking away on the west side above the flashing and the pointing between the copings is open. Re-bedding and repointing is needed. | B B |

| External walls | The plastered and painted external walls are generally in good decorative condition with the exception of the following:- a) Accessible toilet - discoloured marks on west wall. b) Chancel – some flaking paint below ceiling on East gable wall. This is thought to be associated with poor bedding and open joints in the gable copings – see 4.4. Once the leak is fixed and the damp has dried out the flaking paint should be removed and the wall redecorated. | D D |

Chancel East wall – flaking paint through leak

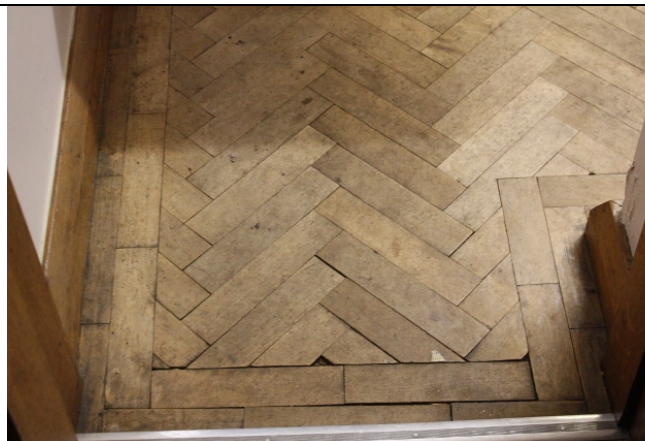
Chancel The parquet flooring is loose in places. Re-bedding is recommended. D

| Sanctuary | Again there are loose wood blocks. Re-bedding is recommended. | D |
| Vestries | The maple parquet flooring is in fair condition throughout. However the blocks are loose in places. Re-bedding is recommended. | D |

Loose wood block flooring

| Category | Action item | Estimated cost (£) (excl. VAT) |
|---|---|---|
| D | Re-bedding of loose parquet floor blocks to Chancel, Sanctuary, Vestries (5.2) | 300 |

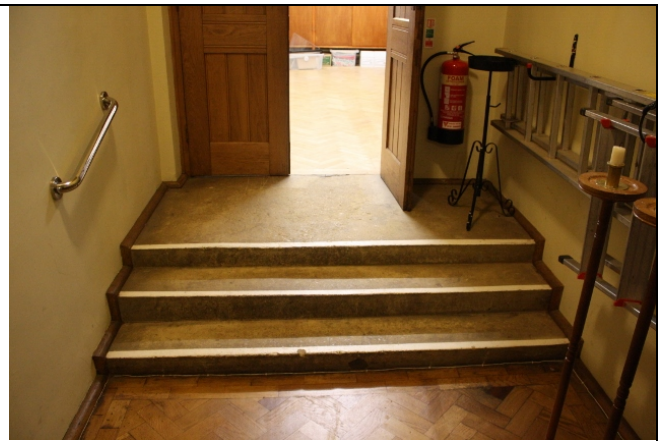
| | The surface of the concrete screed by the top landing by the Choir Vestry is looking worn and the bottom step is chipped. Consideration should be given to providing a protective vinyl finish to the steps and upper landing. | E |

Bare & deteriorating concrete floor finish

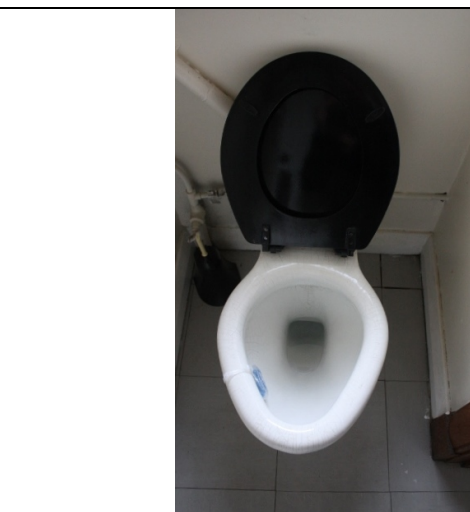
There are self-contained toilets to the Clergy Vestry and Choir Vestry. The original wc pan and high level cistern to the Choir Vestry was replaced in 2016 with a modern close coupled toilet but the original wc pan and HL cistern to the Clergy Vestry remains. The pan is badly crazed and therefore unhygienic. The wc should also be replaced with a modern close coupled toilet (ideally with a dual flush cistern) which would also be more water efficient. D

Crazed wc pan

| Category | Action item | Estimated cost (£) (excl. VAT) |
|---|---|---|
| D | Replace crazed wc pan and cistern to Vicar's toilet with modern version (8.0) | 750 |

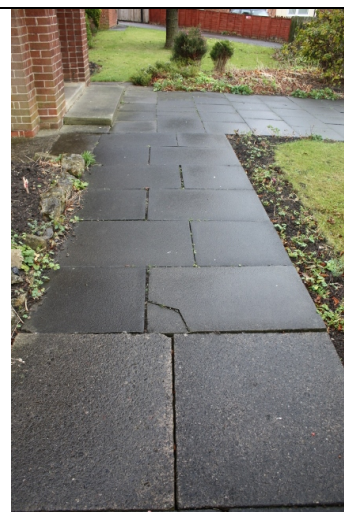
There are two steps into the building at the main entrance and a single step from the Nave to the Chancel. Consideration should be given to providing level access into by the formation of a shallow ramp from the Porch to the public footpath. E

Although some precast concrete paving flags were levelled in 2012 there is still some unevenness and raised edges on the south and west sides of the church. These still pose a tripping hazard and further levelling is recommended for safety reasons. C

Stepped access/ uneven flags
