All Saints, Deneside, Seaham
(CH. No 94)

Quinquennial Report
On the architect's inspection of

23rd June 2023

Sarah Harrison RIBA

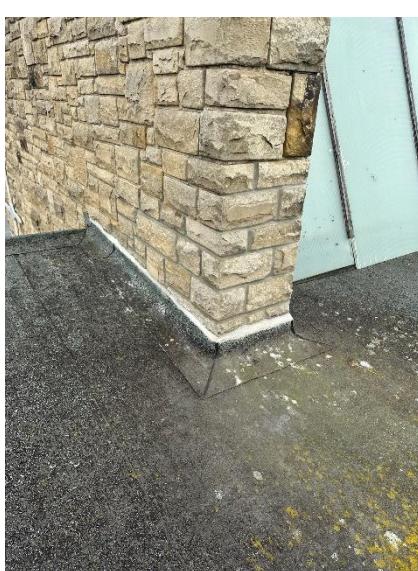
Figure 4 - N. felt upstand.

- 2.1 The single large mono-pitch is covered in green mineral felt with kerbs at the rooflights, low upstands at the side verges, and an integral gutter at the bottom edge with two outlets.
- 2.2 Felt condition is generally ok, though showing its age, the abutment to the stonework has been recently re-pointed. However, the felt itself has not been replaced, so still doesn't have deep bed into the stonework and corner joints are slightly open, which could further open to allow water ingress.

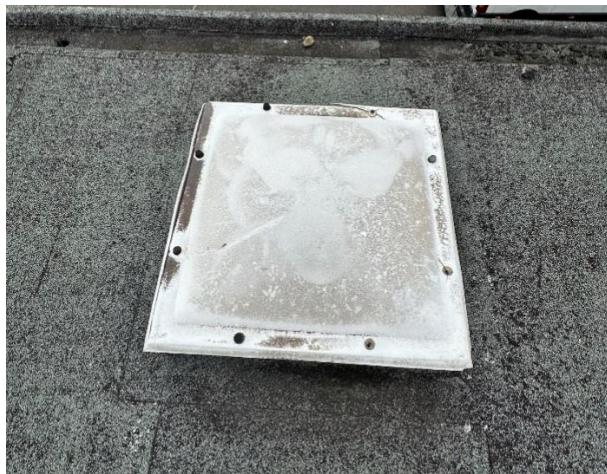
1	Flashband fixed corner	11	Only 3/12 fixings remain
2	ok	12	4No fixings missing
3	Rusted fixings water trapped under edge	13	ok
4	3No fixings missing, broken corner	14	Ok, poor decoration internally
5	Two fixings missing	15	6No. fixings missing
6	ok	16	3No. fixings missing, corner temporarily patched
7	Appears ok but seal failed and decoration inside poor	17	ok
8	Additional holes in edge allowing water to penetrate	18	ok
9	Fixed in 3No places with flashband, poor decoration internally	19	Major crack to corner, 2No fixings missing – leaking internally
10	Cracked corner and moisture on the inside	(Numbering rooflights from top left - see plan)

Figure 6 - Roof light 19 - cracked

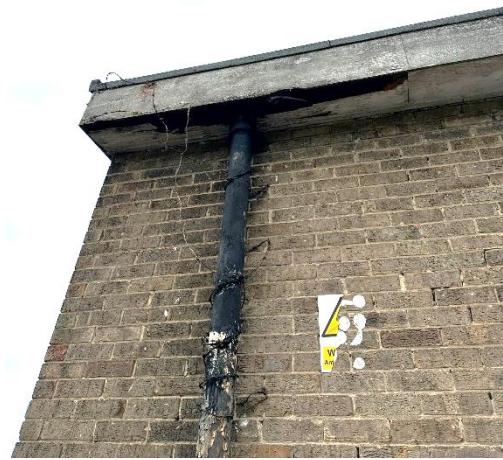
Figure 7 - NW soffit as item 2.5

2.5 The integral felt gutter is mainly fair but there was reportedly a hole in the felt by the N pipe. The timber framing and the board soffit under the gutter has collapsed due to water getting into the structure in this area.

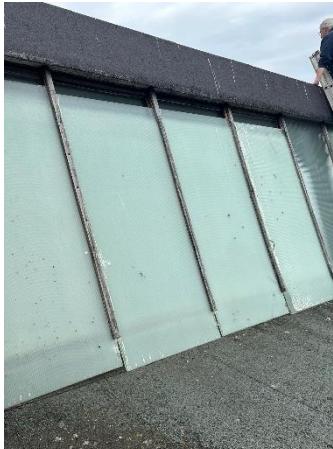
Figure 8 - Glass over sanctuary

2.6 At Sanctuary a steeply sloped strip of Georgian wired cast glass in hardwood mullions lights the altar from above.

2.7 Protective wired cast glass with oak cover strips was added over the whole rooflight. The outer glass is cracked and the frames are rotten and deteriorating, metal straps installed to keep the glass in place have heated and straightened, allowing the glass to fall in most locations and allow water ingress above. This is now arguably worsening the condition of the timber below as it provides an area for the water to gather beneath, therefore timber to the base beneath the secondary glazing is also in poor condition, as per figure 9.

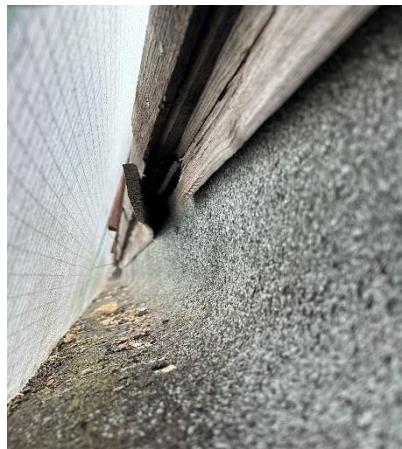
Figure 9 - Underside of slipped glass

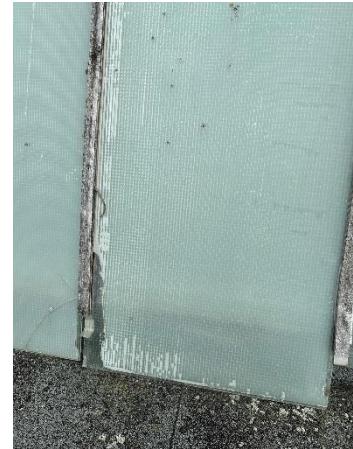
Figure 10- visual of Item 2.6-2.8

2.8 Over half of the secondary glazing is now sitting directly on the felt roof, which may cause damage to the felt and the secondary glazing is masking the condition of the mullions below, serving no other purpose.

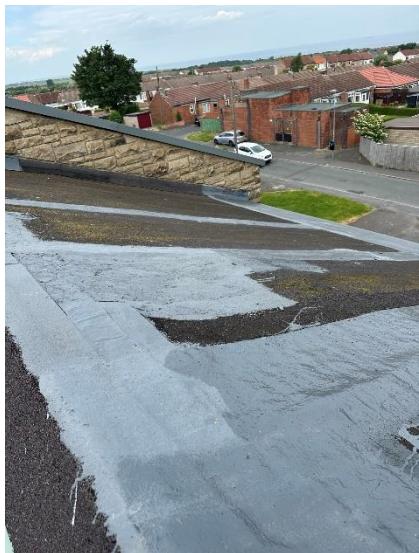
Figure 11 – N side of sanctuary roof

2.9 The steeper black mineral felt over the Sanctuary seems much older. It had previously been patched and has now seen further major temporary repairs. The overall condition is poor, the full roof requires re-felting as a large number of joints are now patched.

C	Strip Sanctuary felt roof and recover with Sarnafil or other high-quality membrane and refurbish gutter and pipes	2.9	£2,000 - £9,999
Category D - Requires attention within the quinquennial period.			
D	Renew all cracked and broken rooflights or those with broken seals.	2.4	£0 £1,999
D	Clean laylights and re-decorate all lightwells	9.2	
Category E - A desirable improvement with no timescale.			
E	Raise door mat with sheet of blockboard	19.1	£0 £1,999
E	Remove or manage the SE and NE shutters to make sure they never prevent escape	6.3 & 20.3	
Category M - routine maintenance. This can mostly be done without professional advice or a faculty.			
M	Repaint the metal crosses	6.6	£0 £1,999

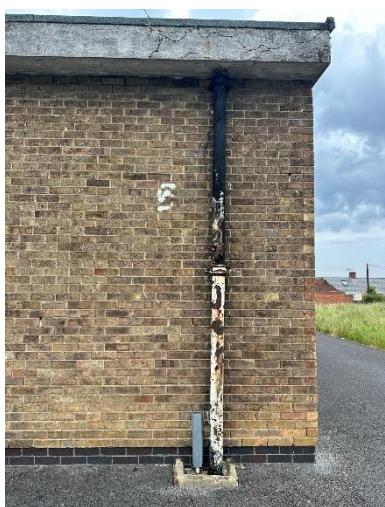
Figure 14- SW downpipe

- 3.1 At Nave NW and SW sound cast iron pipes drop from the integral felt gutter. Anti-climb paint is flaking and is defective in its purpose, both very rusty with loose barbed wire. The south downpipe is slightly loose, one bracket fixing requires tightening.
- 3.2 Two gulleys to the west, which also take the Kitchen and basin wastes. The south gully looks ok the cement flaunching is coming away slightly. This gully has an upstand from the tarmac level. Similar to the north with no upstand.
- 3.3 The Sanctuary roof has new half round gutters, downpipes and fascia board. The south lower bracket is loose, looks to have been pulled out of wall (possible vandalism).
- 3.4 Gulleys to the east is blocked with soil, these need to be cleared to allow free flow of water.

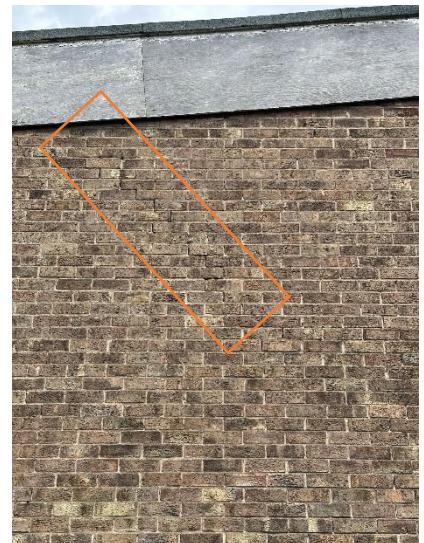
- 4.3 Open joints in the cast stone window cills to both N & S sides and two broken cill ends on S side.
- 4.4 Minor diagonal cracks in joints in the upper half of the walls (two at S wall, one at N half of W end) appear unchanged from photographs in previous report. These should be pointed to better monitor.

Figure 17 - Minor diagonal crack as item 4.4

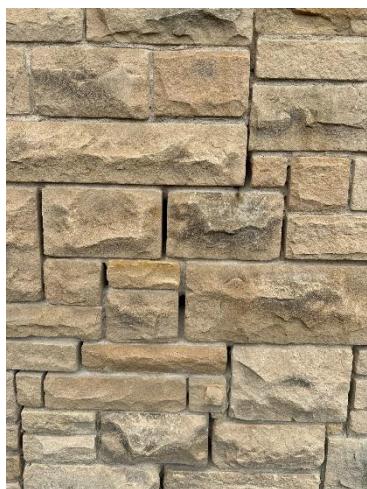
- 4.1 Fair face cavity brick, with slightly recessed pointing. Some large gaps in mortar, particularly at perp joints. Worst on the S, E & W sides, to a lesser extent on the North, the problem is a very soft mortar and appears to have worsened since the last inspection. A large infill to the west looks to have been a previous wider door opening and newer mortar is holding up well in this area.

Figure 18 - mortar gaps at low level

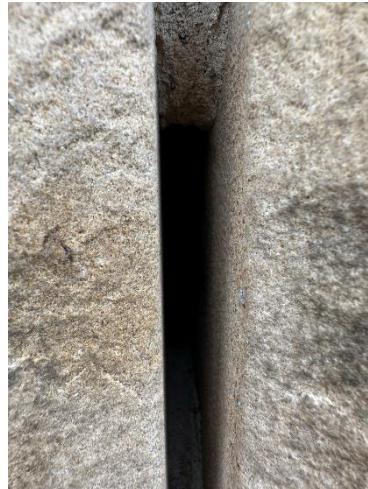
- 4.5 Squared semi coursed sandstone cavity walls to the sanctuary end have the same issue as the brick at item 4.1, soft mortar has eroded severely. In some locations there are large gaps, where the cavity can be seen into. This requires re-pointing as a matter of priority.

Figure 19 - open joint to cavity

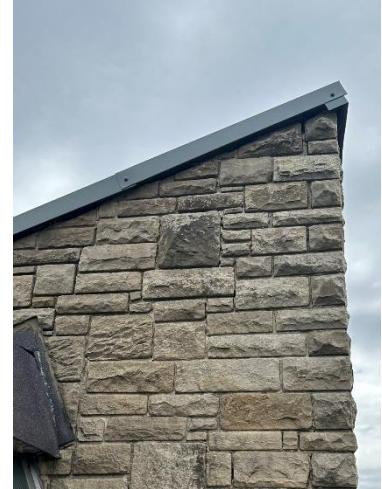
Figure 20 - high level open joints

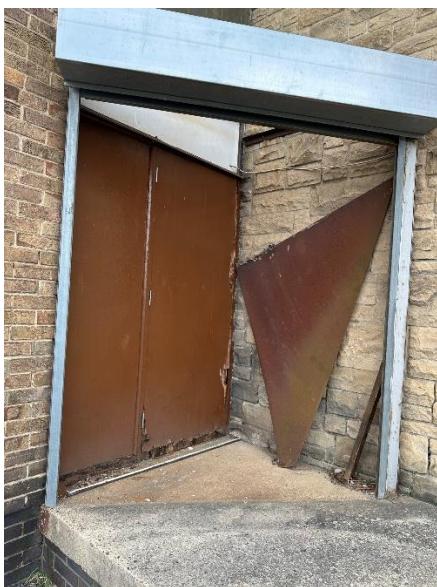
Figure 24 - S door and canopy

- 6.2 Main entrance doors to the west appear sound are stained flush ply with brass ironmongery. Some layers of ply look to have partially delaminated in the past, but a recent coat of paint is now protecting the face well. The galvanised external shutter box is rusting at each end.
- 6.3 Escape doors and side panels at SE and NE are plain painted ply with aluminium panic bars internally. A motorised galvanised roller shutter sits angled in front of these to both sides, slight rust to both.
- 6.4 The north door is rotten at the base of the side panel. The south doors are severely damaged, with a rotten leading edge and base. These doors will not last much longer in their current condition, when opened the door does not close easily.

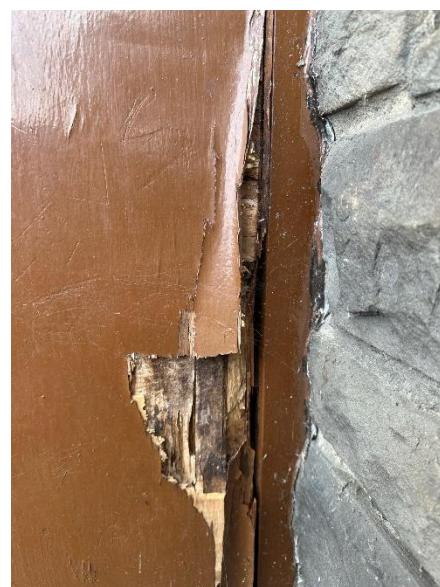
Figure 25 - Leading edge of door

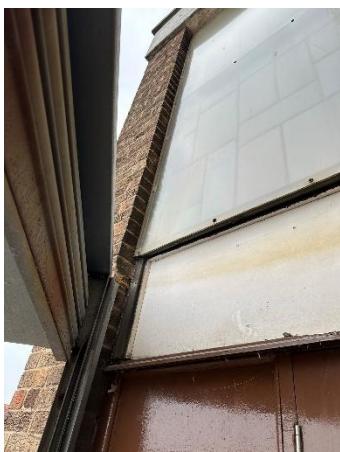
Figure 26 – Former canopy seating

6.5 The triangular spaces between the escape doors and the shutters are loosely roofed with rusting steel sheet, unsupported and drooping to the North. The S sheet has fallen completely and now sits propped next to the wall. A prior bed of silicone still remains on wall.

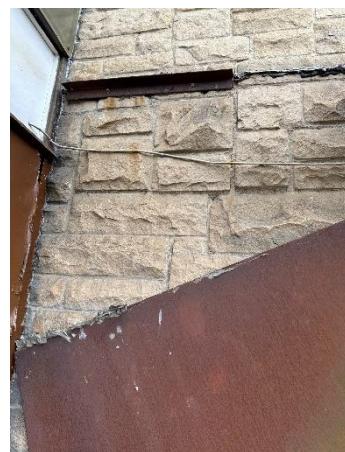
Figure 27 – Mastic to wall

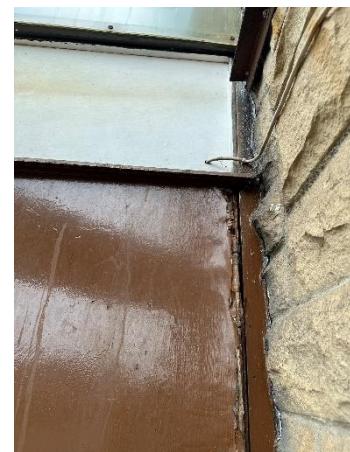
Figure 28 – Weathered frame

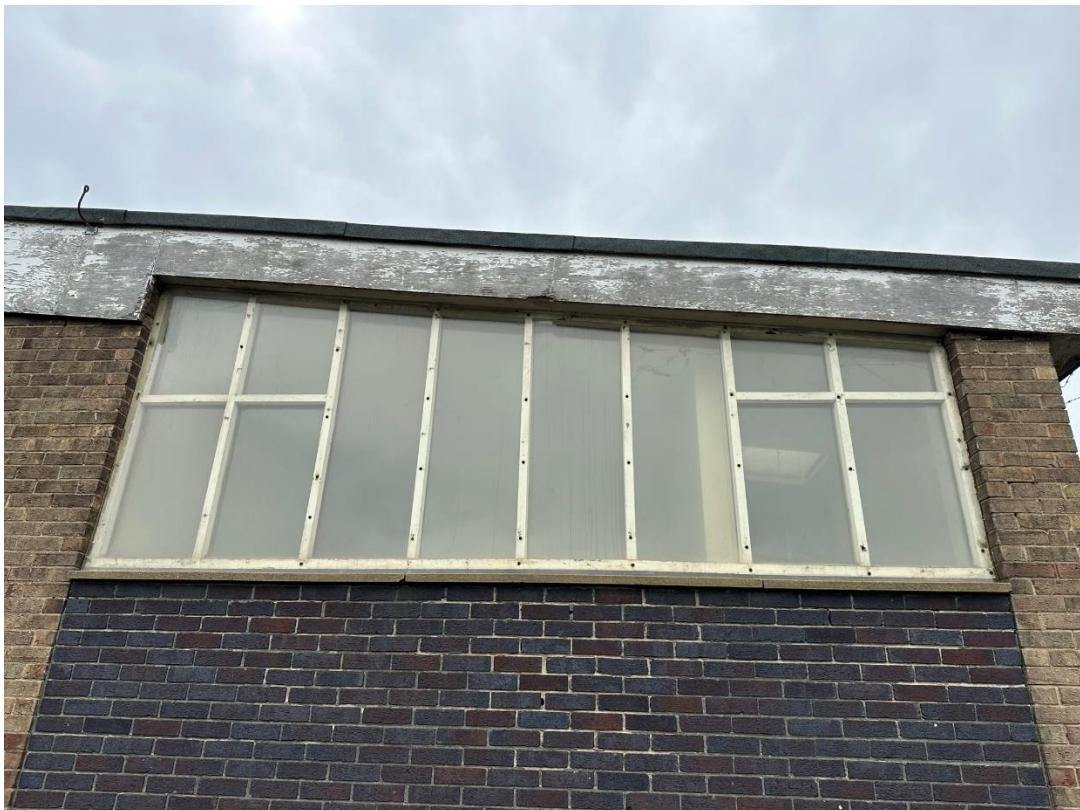
Figure 29 - Large high-level windows to NW

- 7.1 Rectangular panels of glass over the Nave escape doors, with leaded random rectangular tinted glass with polycarbonate protection, clouding at SE, screwed to the timber frames. The timber frames have no decoration and beginning to rot at the base and edges, these need to be decorated to preserve their integrity.
- 7.2 Large high level softwood windows to the north and south elevations have multiple frames with plain glass. A cracked pane at each of Kitchen, Vestry and Ladies. Protected by large single sheets of polycarbonate. No ventilation and the fixings to the north have all lost their caps and are rusting.

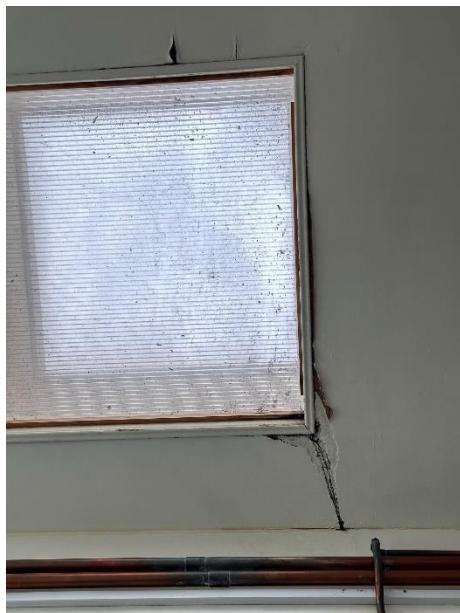
- 9.5 Plasterboarded ceilings at small rooms ok except very slight cracks at Ladies and cracked under Gents rooflight, which appears to have worsened, water damage evident.

Figure 30 – Crack and leak rooflight 19

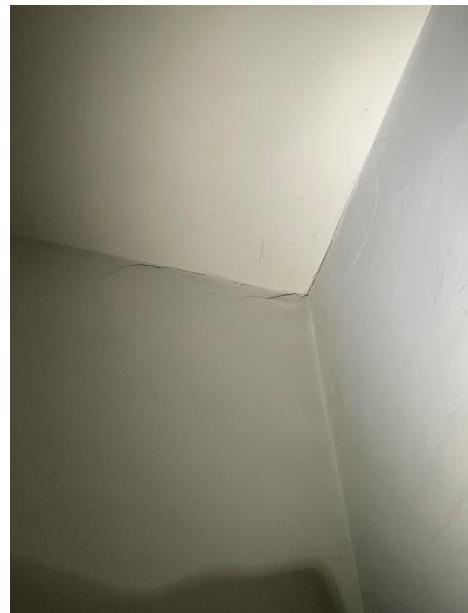
- 9.6 To the boiler room there are cracks to the ceiling junctions at all walls, this should be monitored.

Figure 31 – Boiler room ceiling as item 9.6

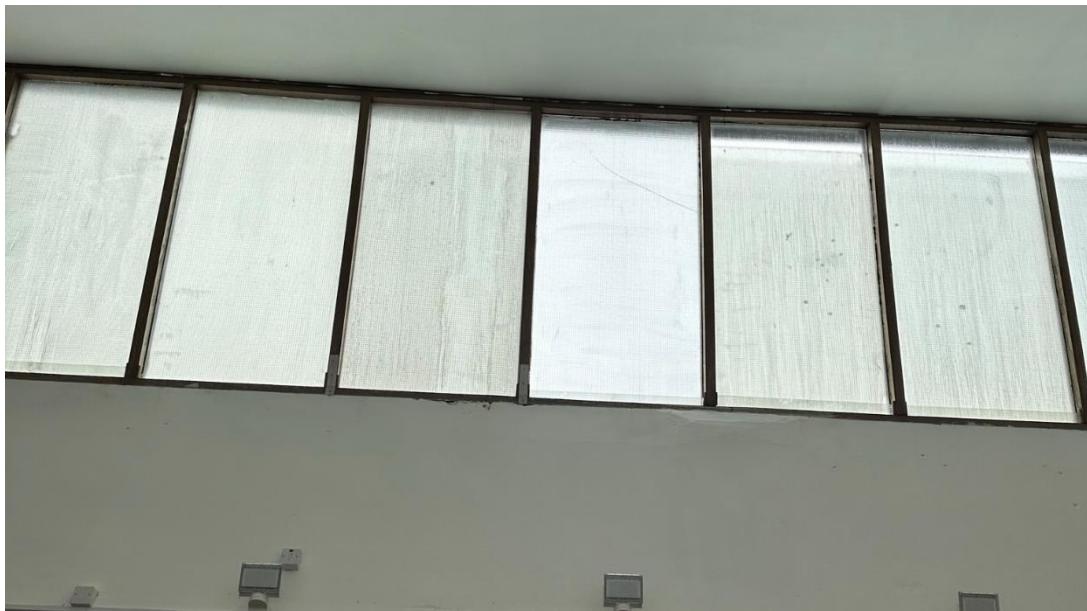
11.2 Sanctuary differentiated by exposed stone sides and painted plastered E wall. Plaster textured except middle third smooth and was different colour, now painted to match. Stone to north and south sides appear to be stained as if there was a leak in the past, possibly due to flashing above which has been improved since the last report. Plaster damage below the high-level windows at the mid-point suggests a leak in the glazing.

Figure 32 - Windows above sanctuary as item 11.2

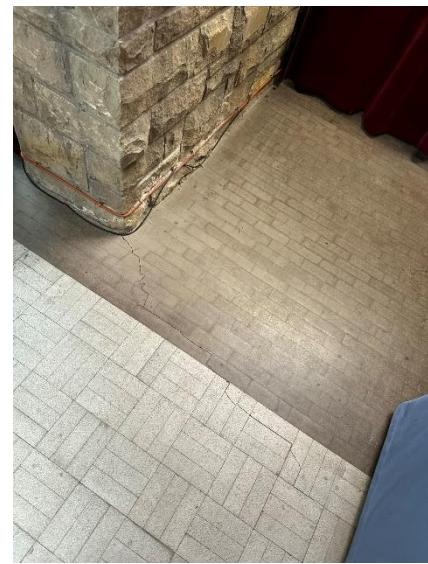
13.1 Nave Granwood composition tiles in two shades of grey with wide strip of red carpet at centre walkway. Some cracking to floor tiles emanating from south corner of sanctuary stone wall.

Figure 33 - Crack in flooring as item 13.1

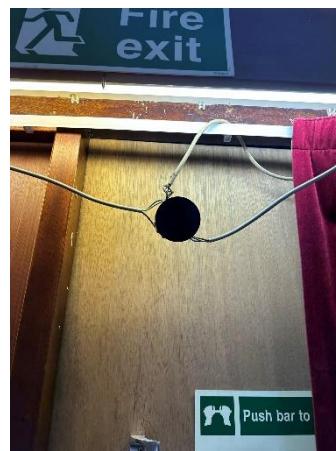
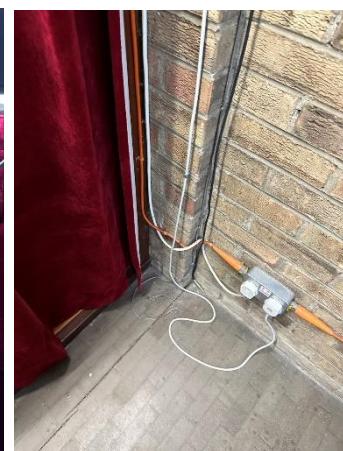
16.2 Loose redundant grey cable next to south escape doors. Junction box hanging loose over northern escape doors.

Figure 34 - Hanging JB as 16.2 Figure 35 - loose wire

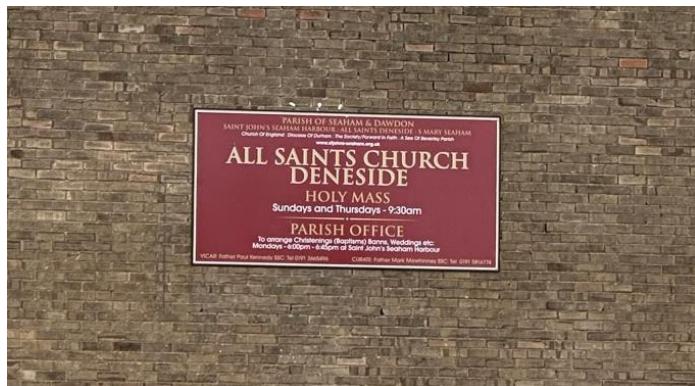
22.3 A new simplistic sign church E wall has been installed.

Figure 36 - New sign to E facade
