**INSPECTION OF CHURCHES MEASURE**

**CHURCH OF ST. JOHN THE BAPTIST  
LOW DINSDALE, DARLINGTON, COUNTY DURHAM**

**QUINQUENNIAL INSPECTION 2017**

**QUINQUENNIAL INSPECTION REPORT 2017**

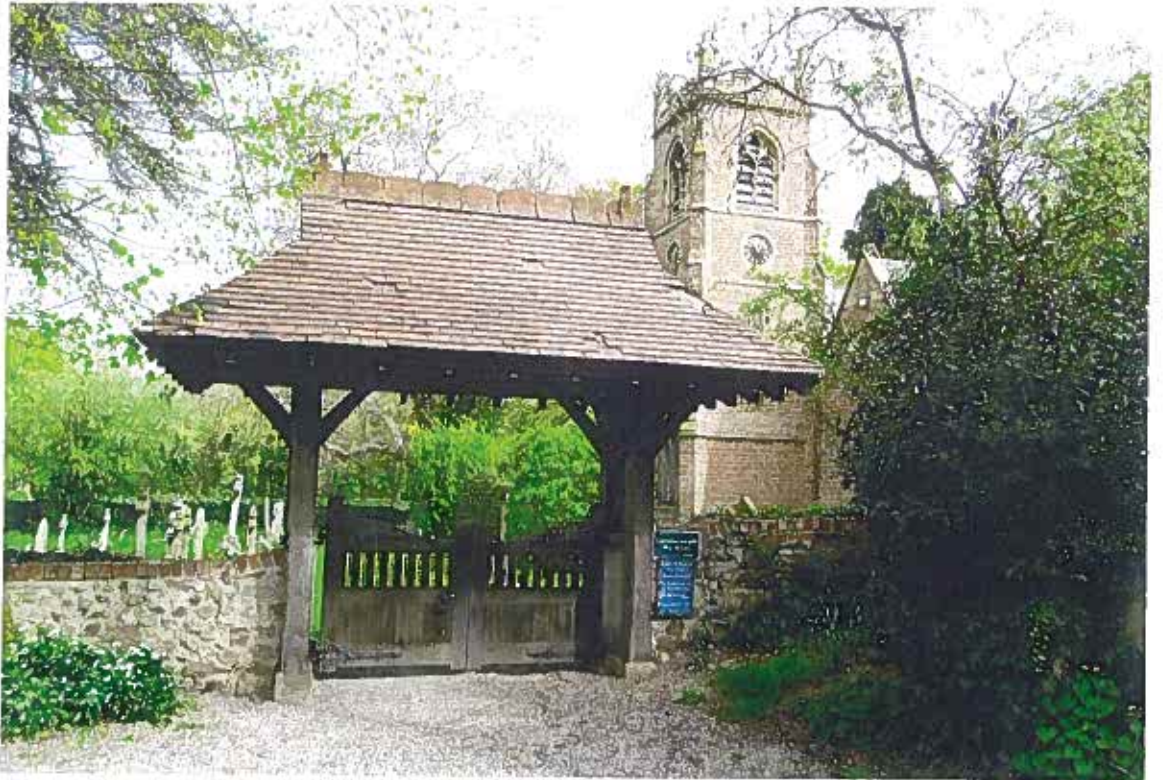
1

- 7.1 The Churchyard continues to be maintained in a tidy and respectful manner.
- 7.2 More roof tiles to the Lych Gate have damaged by falling branches from overhanging tree since the last Inspection.
- 7.3 The condition of trees around and within the site need to be carefully assessed and monitored.
- 7.4 The vulnerability of the oil storage tank which is the ongoing subject of review with options for replacement.
- 7.5 The continued need to ensure regular examination and clearing out of debris, leaves etc. from channel gullies, abutting South-West elements of Church in particular.

1. Lych Gate from Forecourt. Note damaged roof tiles
2. Lych Gate from Churchyard. Note damaged roof tiles.
3. View from South West
4. Tower from South West

- 8.3 Replacement of broken tiles to Lych Gate roof per item 7.2 (B) (£450)
- 8.4 Regular clearance of channel gutters per item 5.11c. (D) (In house).
- 8.5 Maintain regular monitoring of vegetation growth and debris blockage of rainwater goods and channel gutter to Nave/South Aisle abutment per items 5.10c and 5.12c. (D) (In house)

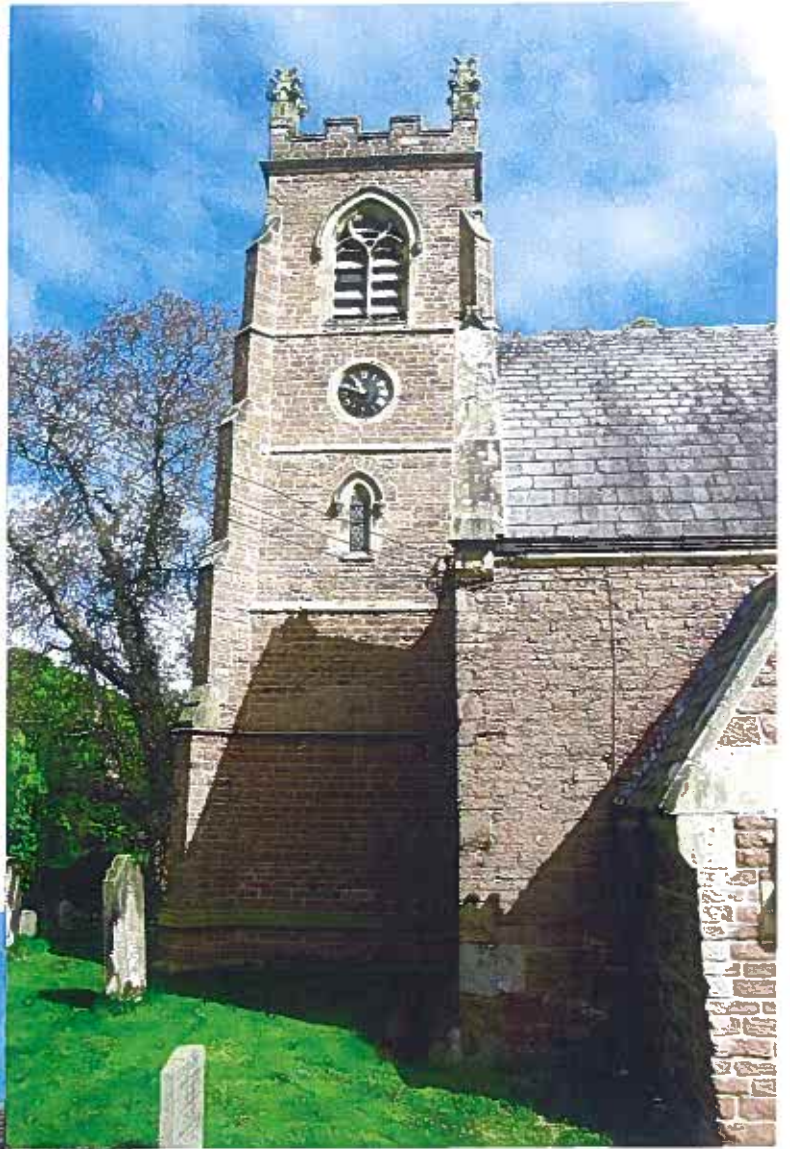
5

- 2.2 In April 2015 concerns were raised with respect to the stability of the outer skins of stonework on the South elevation of the Tower at the third and fourth lift levels in particular. This also included the stability of the stone framing to the related window opening as viewed from the interior. Following detailed appraisal by Blakett-Ord Conservation Engineering in collaboration with David France : Stonemason remedial measures involving stainless steel stitching, cementies, void grouting and some stone replacement including stabilisation of string courses was completed to the South face in January 2016. A watching brief is meanwhile being maintained on the West and North faces of the Tower where there are some more minor concerns re stonework stability.

b) Stonework to this face have been the subject of significant remedial action (See item 2.2). This remains in sound condition.

5. Tower from South following stonework remedials
6. Accessible Toilet extension to South Porch
7. South face of Chancel
8. East Gable to South Aisle
9. View from North East : Vestry plus access stair to basement Boiler Room

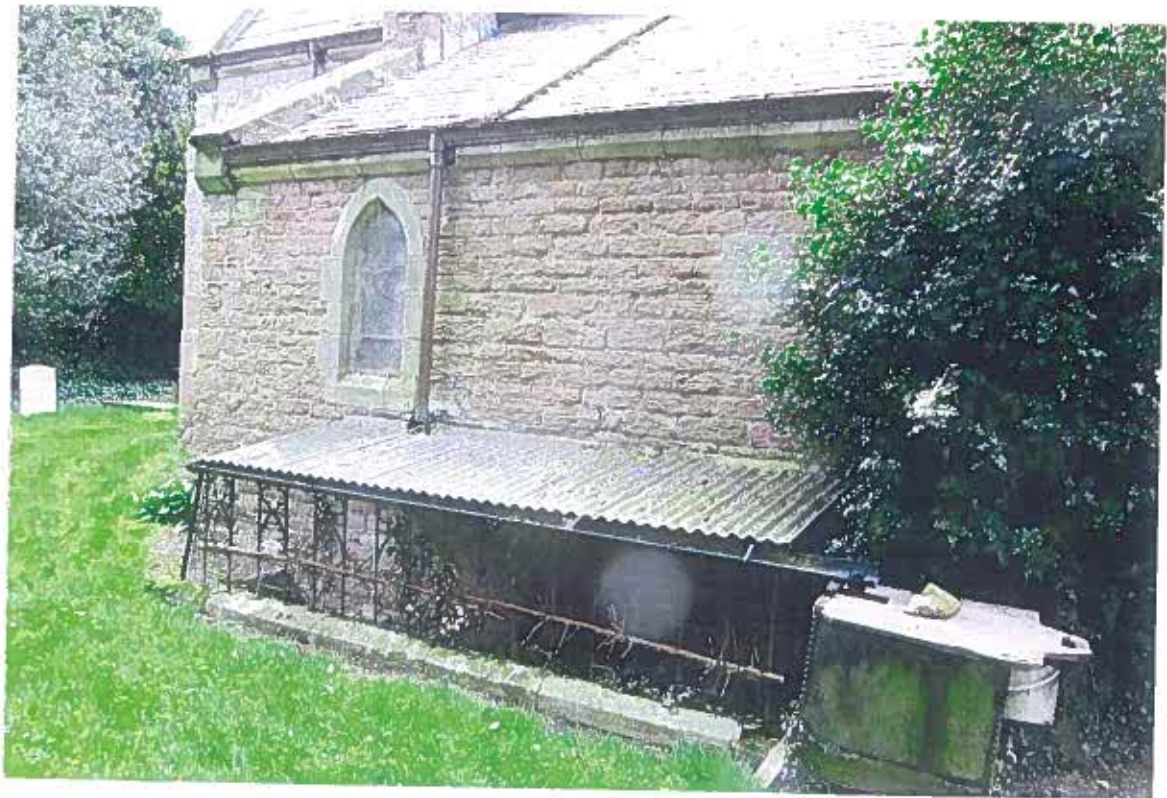
10

c) Abutment of corrugated steel roof to basement access stair and Vestry window cill formed in "Flashband". Need to be kept under review.

10. North face of Vestry plus corrugated steel roof to basement Boiler Room.
11. South Porch with door to Accessible Toilet.
12. Accessible Toilet
13. Window to South face of Tower following remedial stabilisation

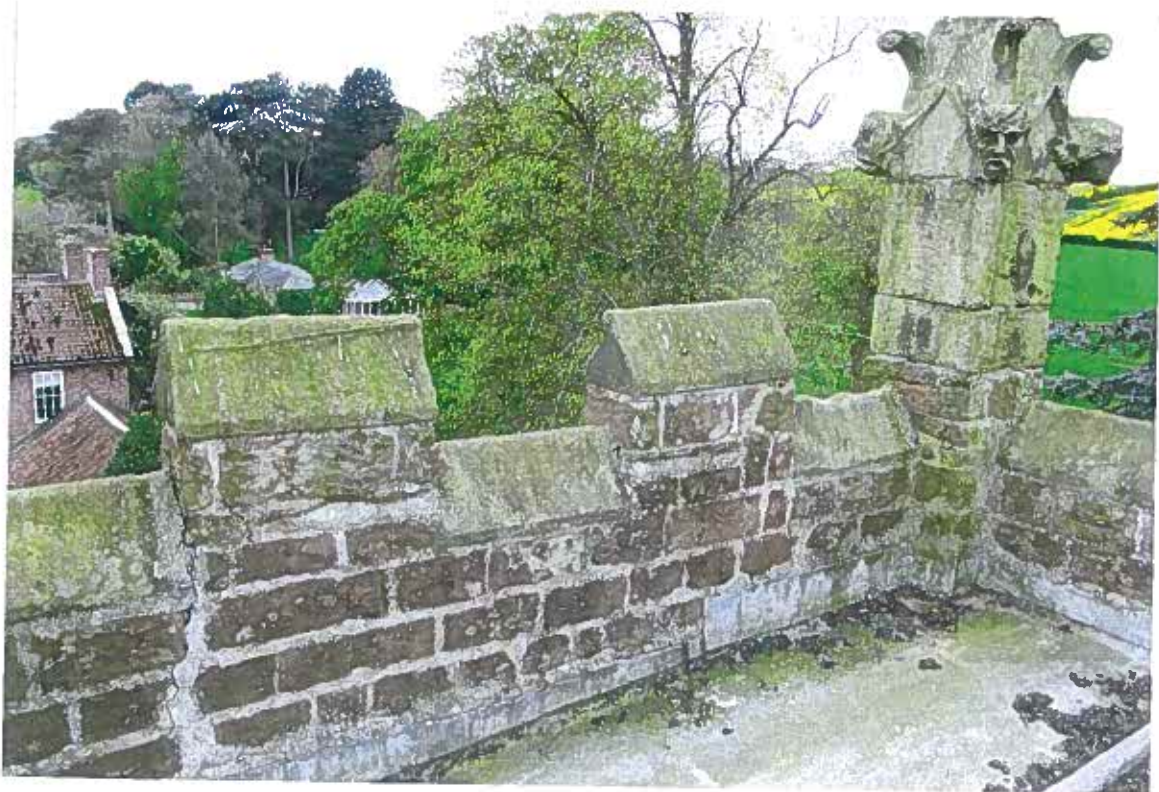
14

a) Pinnacles and copings remain in relatively sound condition but with localised vertical cracks which have been the subject of remedial pointing in the South parapet. (See close inspection from Tower roof and related photograph). This needs to be regularly monitored.

14. Parapet to South face of Tower plus pinnacle. Note vertical crack
15. South East corner pinnacle to Tower
- 16 North West pinnacle to Tower. Note leadwork

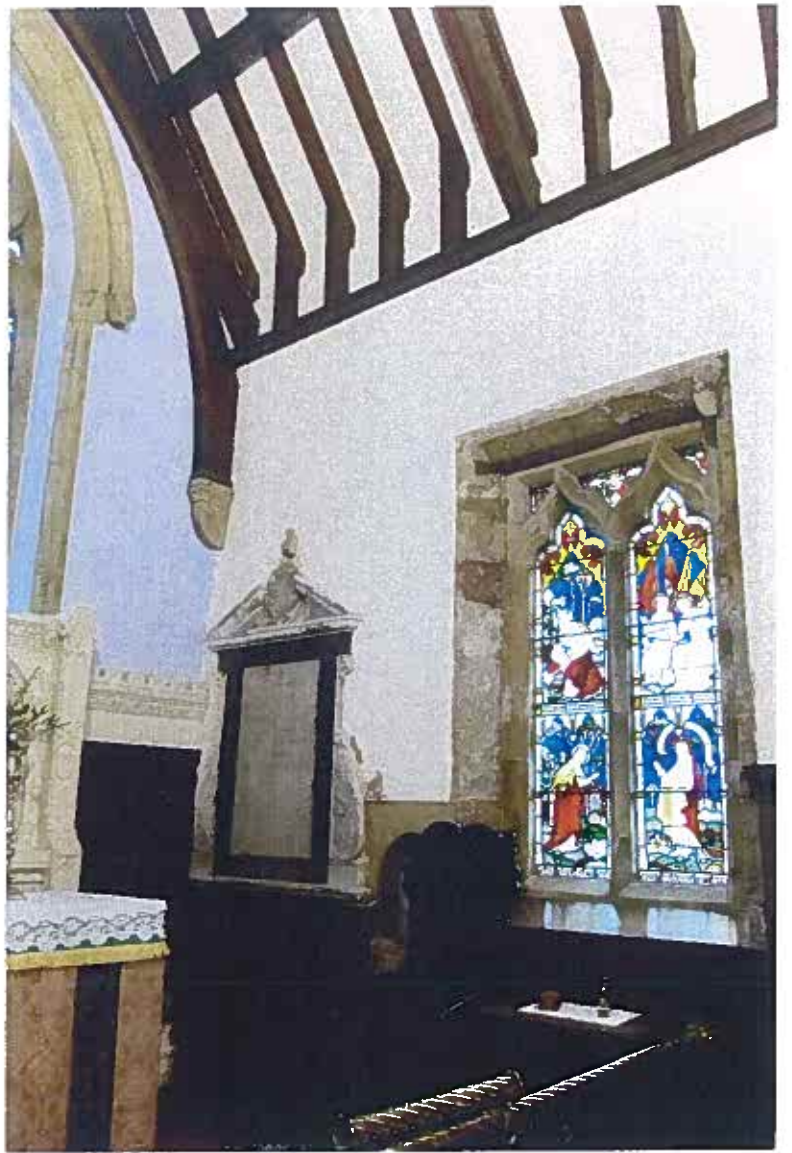
25

- 6.1 The major refurbishment and redecoration works completed in May 2004 remain predominantly sound but with some localised damage as a consequence of subsequent and some historic points of rainwater ingress. These are principally in the South East corner of the Chancel, the East gable of the South Aisle and above the entrance Porch. These are the subject of ongoing monitoring and remedial action by Property Wardens but would benefit from a more substantial/long term remedial solution..

20. South Aisle looking East. Note new floor tiling and relocated font
21. Nave looking East to Chancel
22. Chancel
23. South East corner of South Aisle with relocated font.
24. Nave looking West toward Tower base. Note new Kitchennete
25. South East corner of Chancel. Note historic efflorescence
26. High level plaster efflorescence to South Aisle wall above South Porch
27. Plaster efflorescence to Nave/Chancel arch

- 8.6 Consider completion of protection of all elements of stained glass windows by external security grilles per item 6.14 (C) (£700)
- 8.7 Maintain regular monitoring of historic points of rainwater ingress and remedial works to internal plaster/decoration. This should involve careful scraping off of areas of efflorescence, brush cleaning of the surface, application of an anti-fungicidal wash and subsequent remedial lime wash decoration of the dried surface.. This is likely to be an ongoing process until residual fungal spores are neutralised. See item 6.1(B) (£850)
