**St NICHOLAS
DUNSTON**
(281)

QUINQUENNIAL REPORT
on the architect's inspection on

11 May 2023

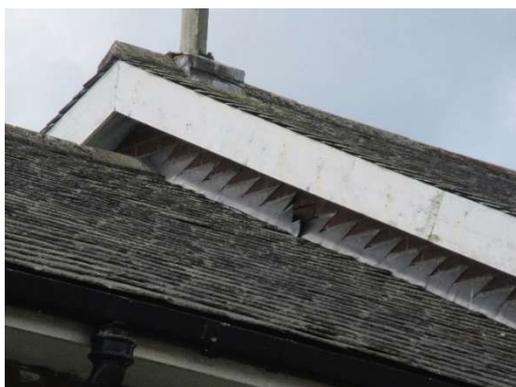
11. Roofs slightly diminishing grey Westmorland slates with concrete ridge tiles – where many joints are open. All slates appear sound but a few are uneven. The slate verges project slightly over timber bargeboards. Timber fascias and wide soffits overhang the eaves and gables.
12. Lead valleys at the N and S Transepts appear sound.
13. Lead flashings and invisible lead back gutter where Tower intersects roof.
Stepped lead flashings where Chancel roof abuts Nave wall.
Sound except one piece of flashing at the top N side is loose from the brick joints.

loose flashing unchanged since 2018

Refix lead flashing between Chancel and Nave	13
Prepare and paint Porch gutter, bargeboards and palings and gate at SE Garden	18, 83
Point open joints at many window cills	25
Restain handrail in SE Garden	28
Remove and poison sapling at balanced flue	57
Remove plants and point open joints in boundary walls	82

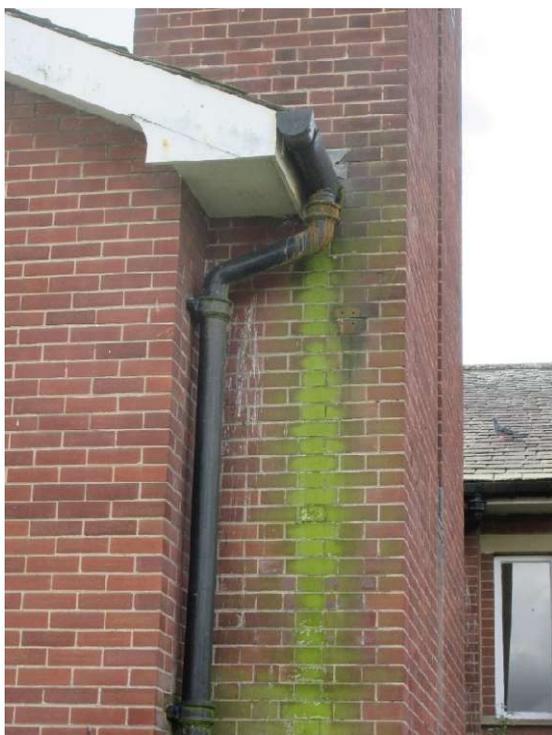
15. Deepflow half round cast iron gutters on brackets on fascias. 4” round cast iron pipes to swan neck shoes over gullies. Paint good except poor over Choir Vestry door.
16. Green streaked bricks at N end of Tower and rust from top pipe joint shows that pipe is or has been blocked.

Clear gutter and pipe N of Tower and wash down pipe and brickwork	16
Renew small rainwater pipe at SW wc	19
Clear out blocked gullies	20
Repair plaster at Narthex and decorate	37
Obtain new Periodic Electrical Test report in 2023, act on any significant recommendation and keep in Log Book	62 and Addendum

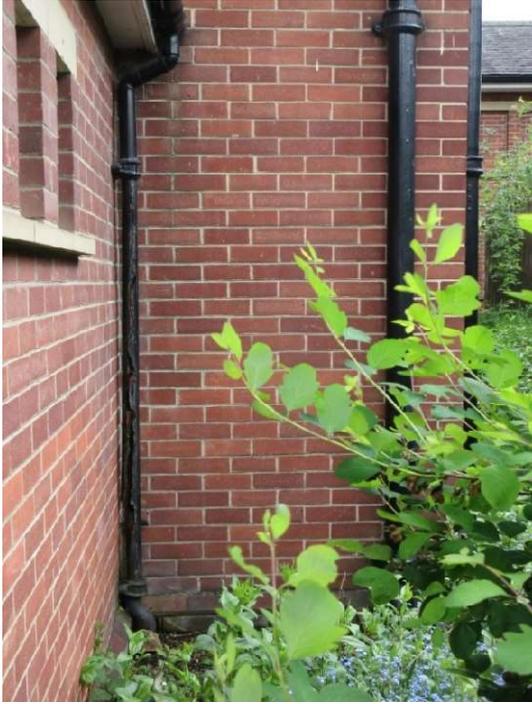
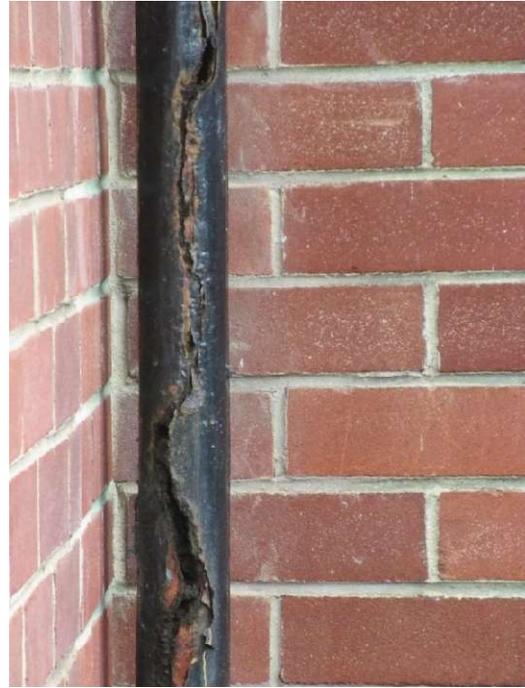
17. Small pipes from the Tower top gutters turn into the brickwork and out again into its back gutter. Holes through the bricks inside the cut out cross allow access to the internal rainwater pipe.
18. Around the Porch roof a small white painted channel gutter, rusting by the outlet. Plastic gutter at wc.
19. Small cast iron downpipes at both. The whole wc pipe is cracked lengthways, rusted and leaking, perhaps into the brickwork. Replacement now needed.

Split pipe in corner of W wc

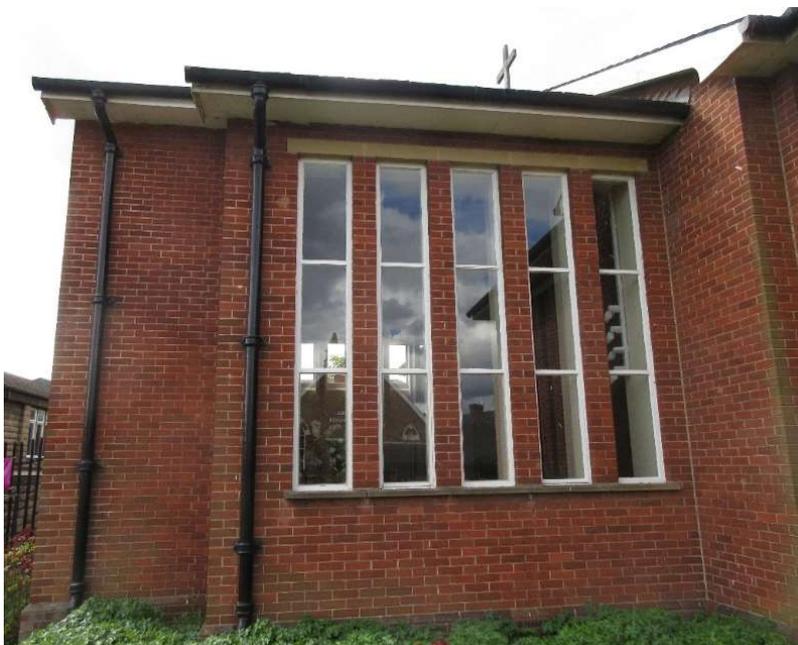
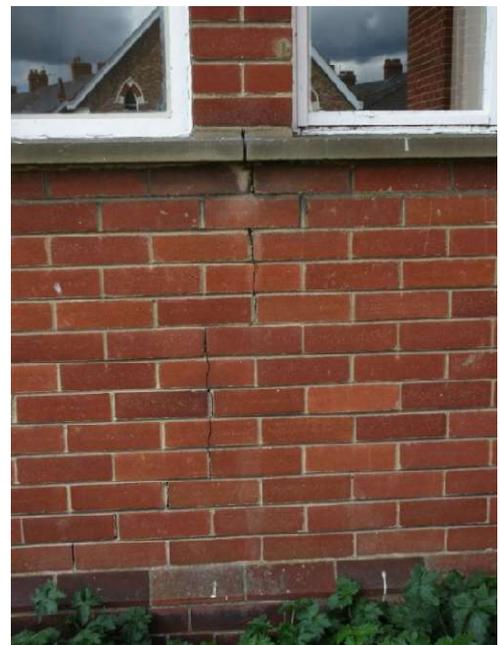
Cracked brickwork under N Chancel windows

22. Two signs of minor past movement are:
- a narrow vertical crack L of the outer Vestry door down from the first Vestry window cill level through bricks and joints and
 - a vertical crack under the N Chancel middle cill, narrowing downward, suggesting past slight heave (para 10) or spread to the E.

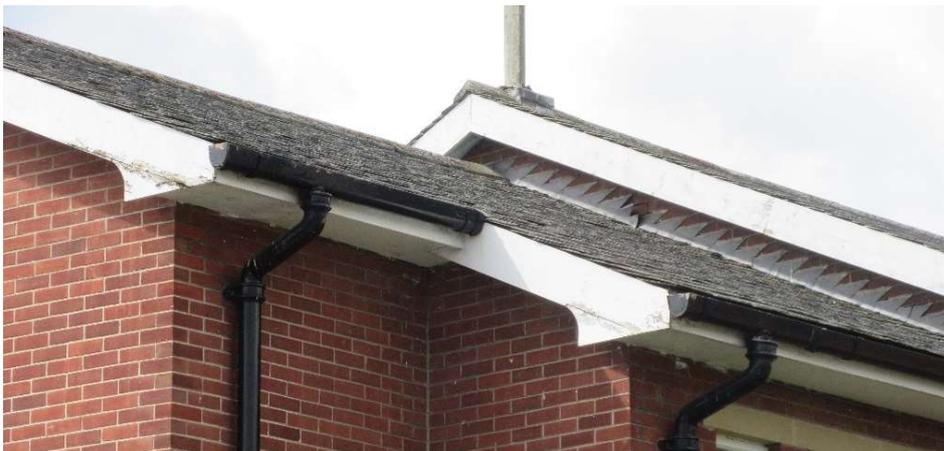
Bargeboards at NE

26. Galvanised cross on E end of ridge. Galvanised steel windows and round steel posts at the Entry canopy. Painted timber roof bargeboards and eave soffits. At both W Nave corners timber covers are missing from the soffit ends, exposing minor rot at the bottoms of the bargeboards. Otherwise paint good but flaking increases at remaining bargeboard joints.

EITHER replace missing parts of bargeboards and paint OR add white plastic covers over bargeboards and soffit fronts	26
-------------------------------------------------------------------------------------------------------------------------	----

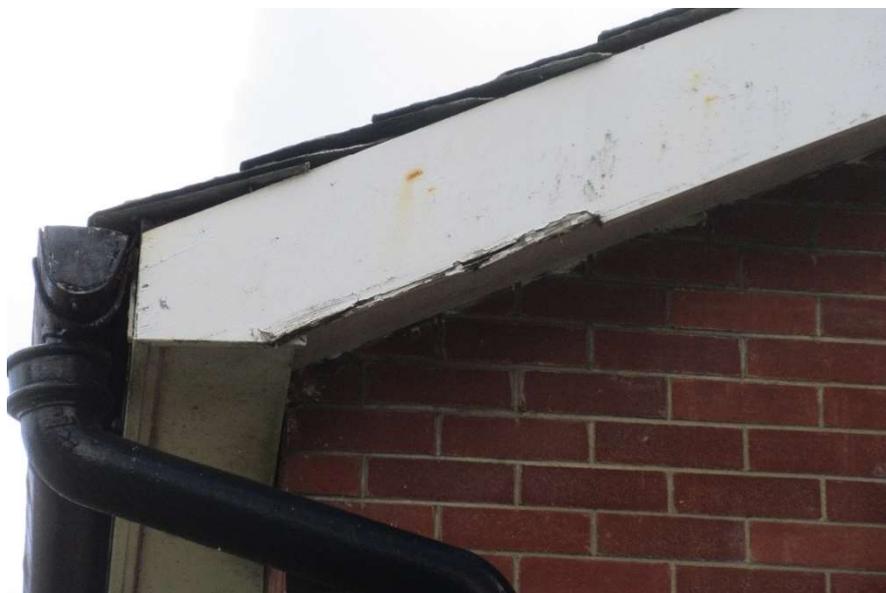
Minor decay of bargeboard where swept timber cover missing at NW Nave

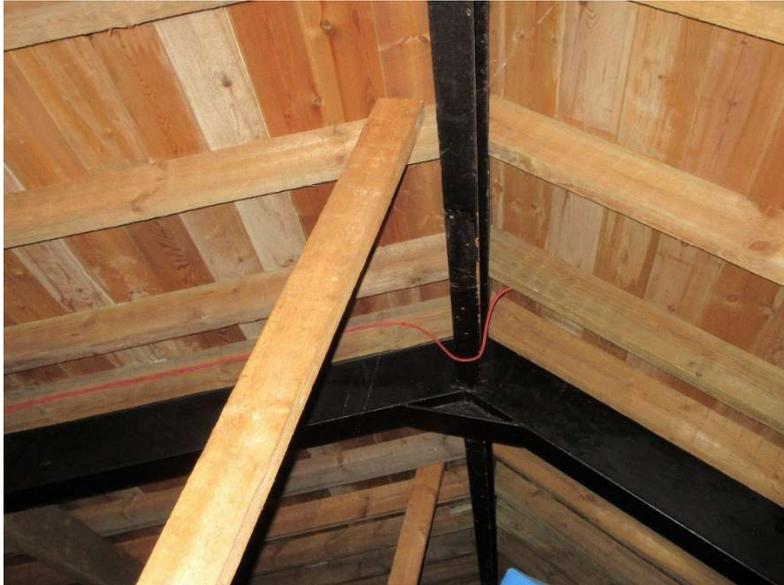
Clergy Vestry roof

29. Over Clergy Vestry visible timber purlins and rafters on steel frames and ridge.
Remainder of building concealed but likely to be similar. No sign of defect.

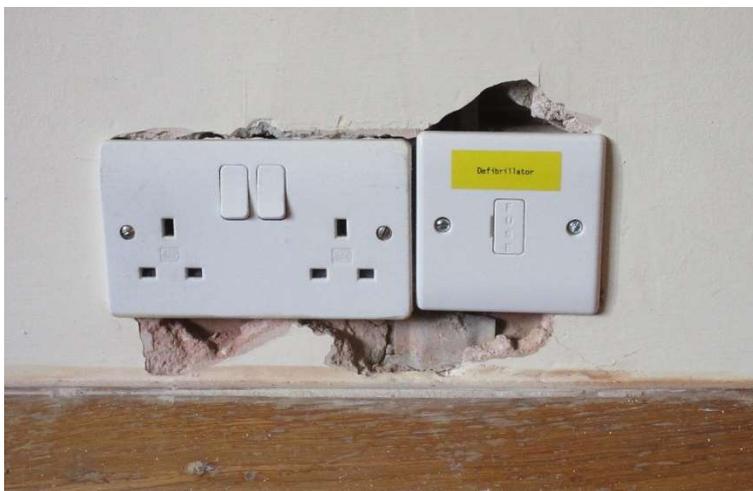
37. All plaster and paint is good except at Narthex plaster broken for new sockets and spur through wall for added defibrillator.

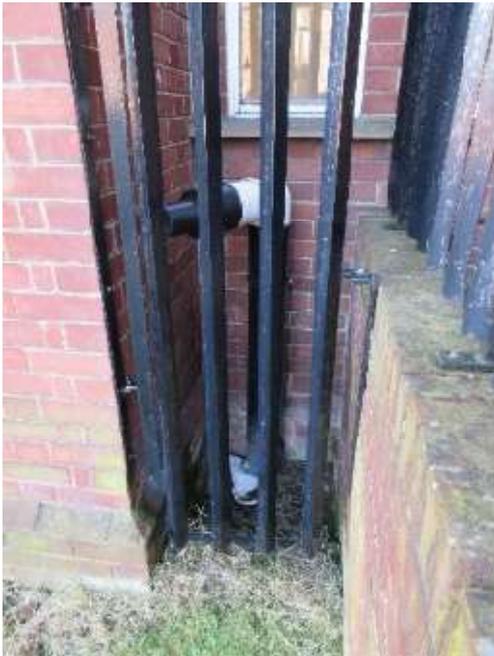
Balanced flue in 2018

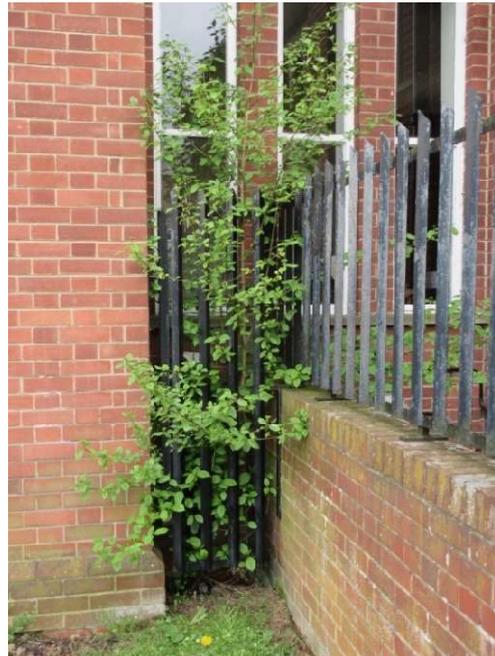
56. A large basement Boiler room with gullies in the concrete floor and at the bottom of the external steps which run clear. Nearly dry at inspection.
Water runs continually into the corner gully from a small pipe at basement floor level which may drain ground water from under the Nave.
57. Central heating – reported effective - by a large kerosene boiler fed from tanks in a second basement chamber with galvanised external access hatch not entered. A fusible link to cut off the supply.
A large metal balanced flue terminates just above outside ground level, protected by steel palings. The flue is becoming overgrown by a sapling inside the palings.

becoming overgrown in 2023

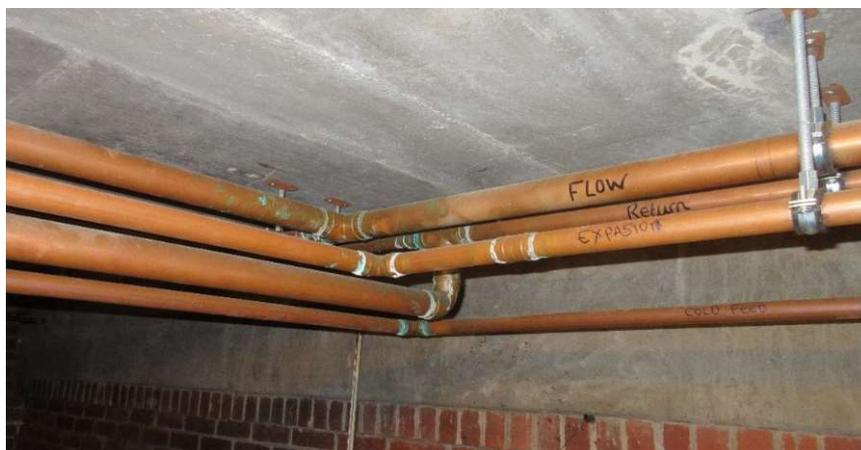
58. High level copper circuit pipes in the Boiler room are uninsulated so some waste of heat, though that heat may help to keep the Boiler room dry. Adding sectional foam lagging would improve economy and could be easily removed if new damp appears in the Boiler room.

Unlagged heating pipes in boiler room

If draughty improve the brush seals at both pairs of Nave doors	35
Lag the hot pipes in the Boiler Room	58
Rebuild wc off Narthex to wheelchair standard with baby change	79

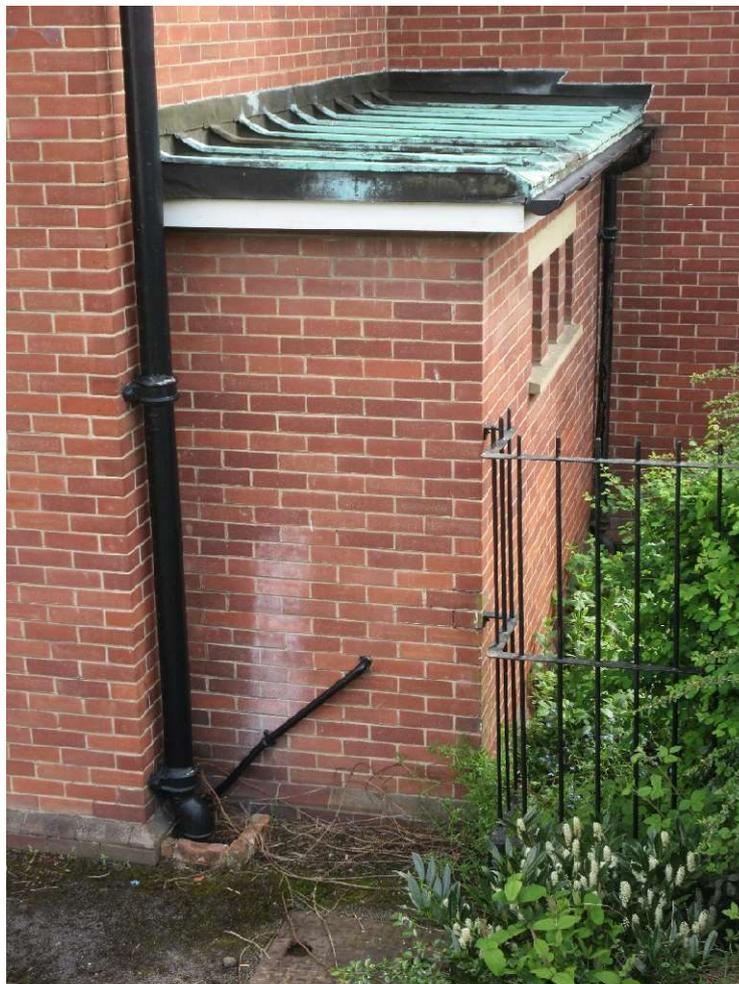
78. The Nave is level to the Chancel step. No clear space for chair users to sit with other worshippers.
79. No access to the wcs, Clergy Vestry or Gallery for chair users and poor for the infirm. Good handrails at the stairs but due to tight spaces further improvement of access to the upper levels is not practical. The wcs being narrow, improvement to wheelchair standard would involve demolition and rebuilding the wc off the Narthex which would not be difficult.

The wc off the Narthex – not difficult to rebuild wider for wheelchair use

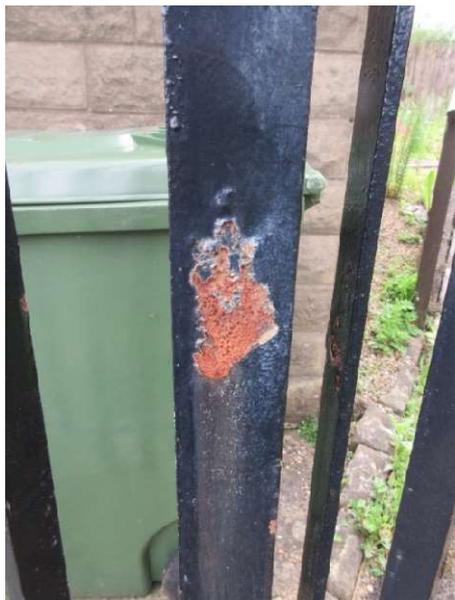
Typical rust at SE gate and railings

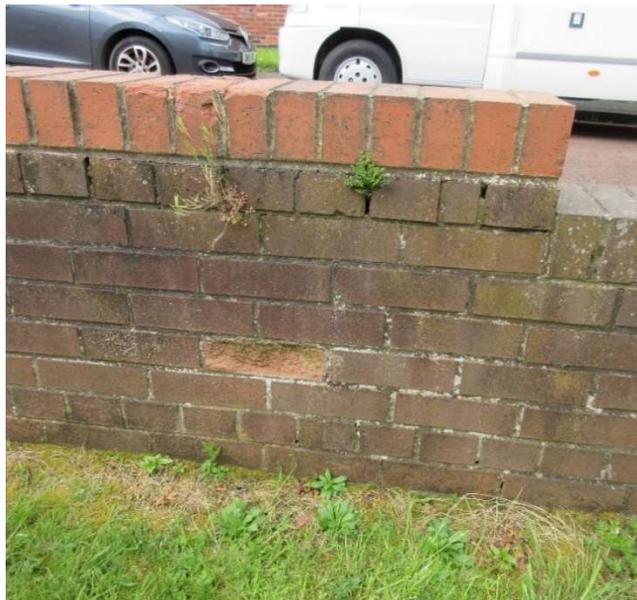
Plants in open joints and a failing brick at School Avenue boundary
