**St NICHOLAS  
DUNSTON**  
(281)

**QUINQUENNIAL REPORT**  
on the architect's inspection on

**21 February 2018**

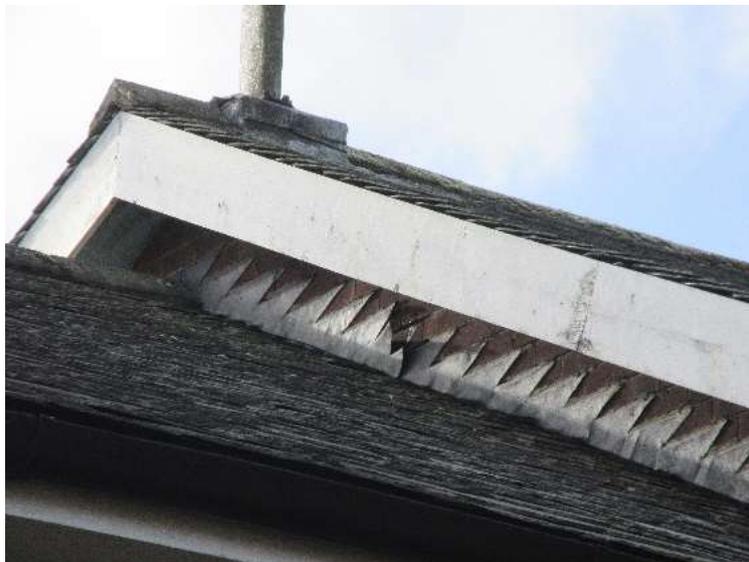
10. Roofs covered in slightly diminishing grey Westmorland slates with concrete ridge tiles – where many joints are open. All slates appear sound but a few are uneven. The slate verges project slightly over timber bargeboards. Timber fascias and wide soffits overhang the eaves and gables.
11. Lead valleys at the N and S Transepts appear sound.
12. Lead flashings where Tower intersects roof (and lead back gutter not visible). Stepped lead flashings where Chancel roof abuts Nave wall. One piece of flashing at the top N side is coming loose from the brick joints. Remainder appear sound.

Refix lead flashing between Chancel and Nave 12  
Renew small rainwater pipe at SW wc 16

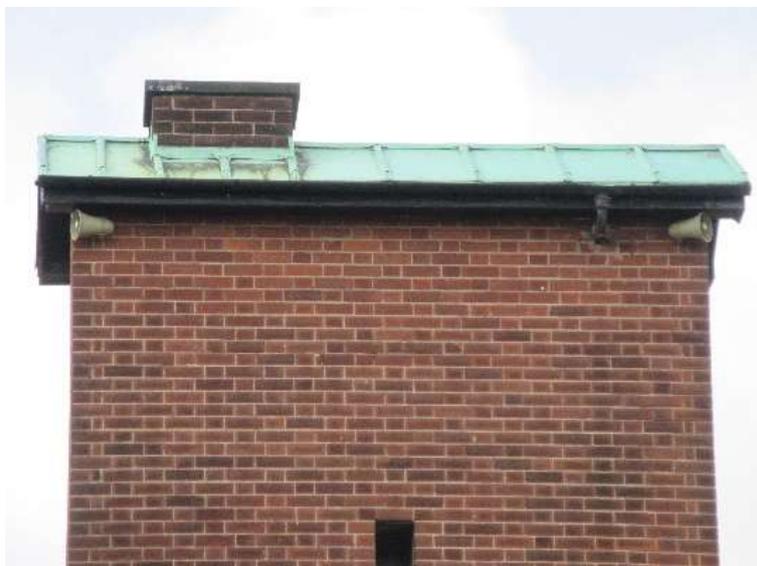
13. Small flat roofs at NW (open Porch) and SW (wc off Narthex) abut the brick walls. Copper with capped battens, covered with non-setting deterrent and disguise paint. Pitched capping on Tower similar copper but unpainted. All appear sound.

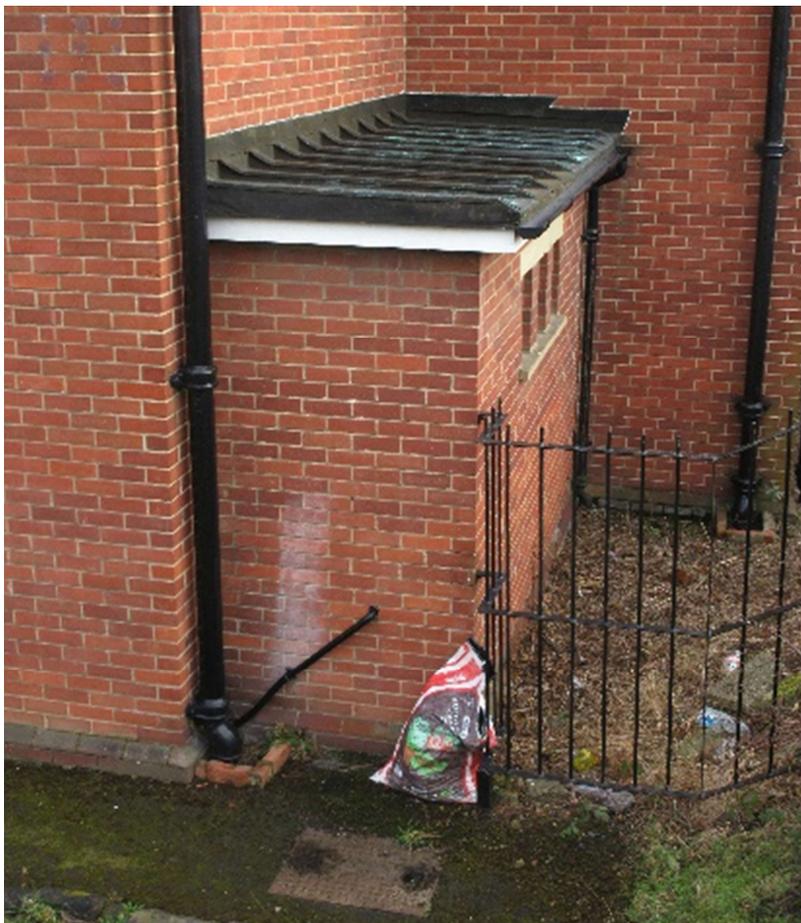
14. Deepflow half round cast iron gutters on brackets on fascias. 4" round cast iron pipes to swan neck shoes over gullies. Paint good.
15. Small pipes from the Tower gutters turn into the brickwork and out again into its back gutter. Holes through the bricks inside the cut out cross allow access to the internal rainwater pipe.
16. Around the Porch roof a small white painted channel gutter, beginning to rust by the outlet. Plastic gutter at wc roof. Small cast iron downpipes at both. The wc pipe is cracked lengthways, rusted and leaking, perhaps burst by ice if blocked.

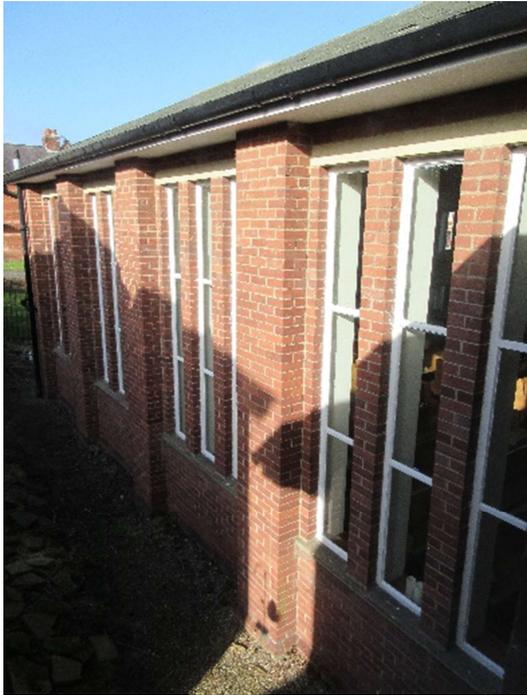
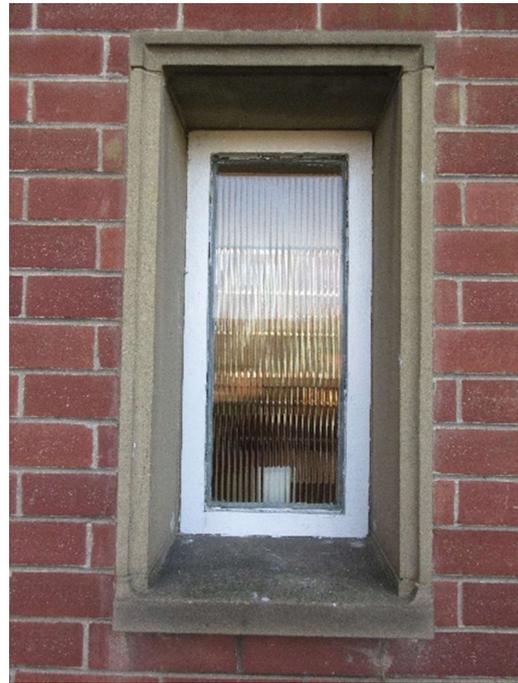
22. Good quality narrow artificial stone lintels and throated cills in good condition. A round window in the W gable. Elsewhere single windows and some larger assemblies of windows. Open joints at some cills should be carefully pointed in moderate strength lime mortar to prolong their life.

Prepare and paint Porch gutter, bargeboards and  
palings and gate at SE Garden 16, 23, 79  
Point open joints at some window cills 22  
Restain handrail in SE Garden 24

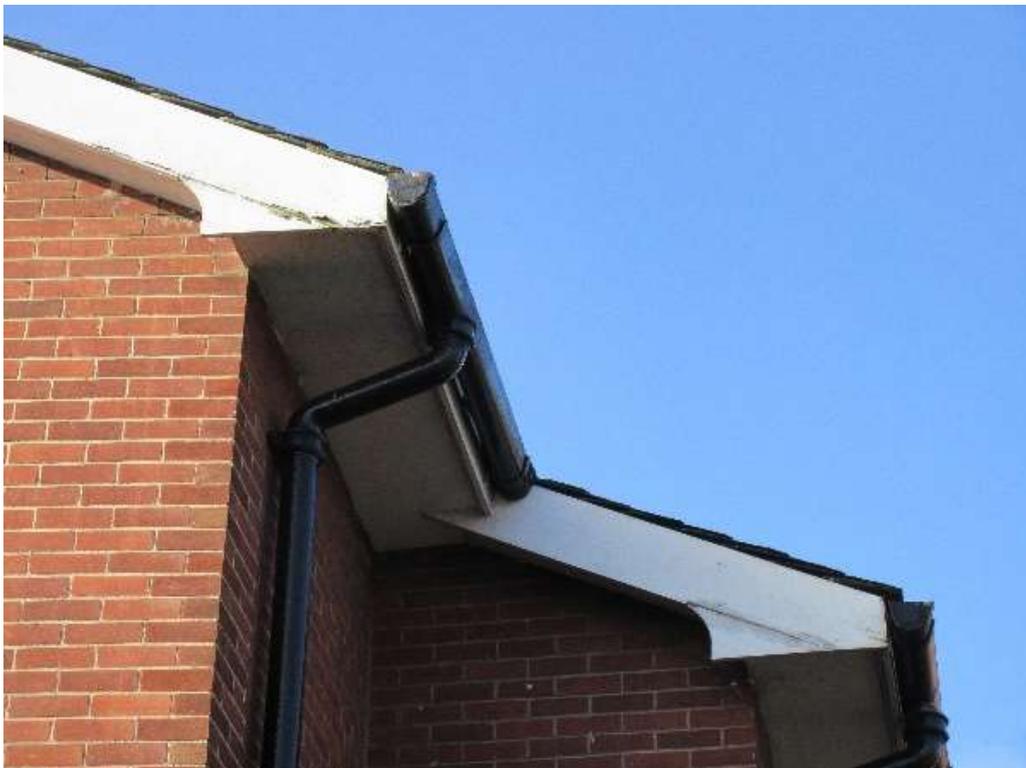
23. Galvanised cross on E end of ridge. Painted roof bargeboards, eave soffits, galvanised steel windows and round steel posts at the Entry canopy. Most paint good but flaking at some bargeboard joints.

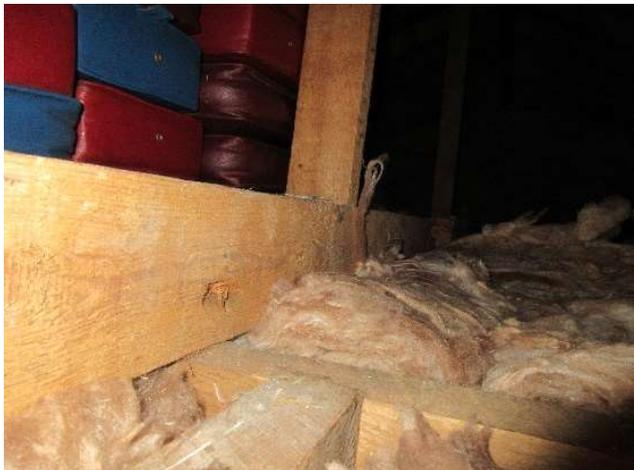
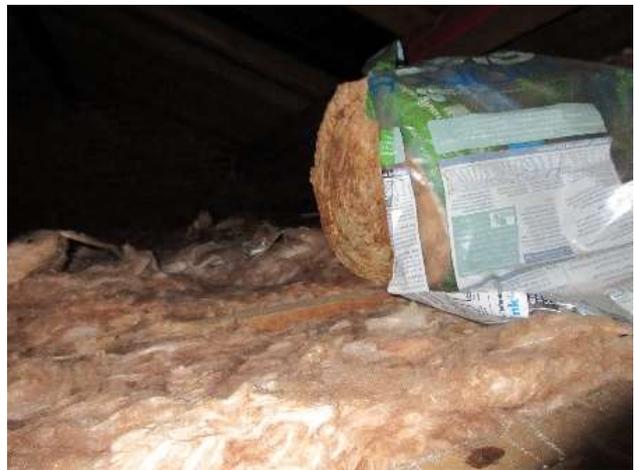
26. In Church small flush mineral tiles fixed as a shallow vault across the whole of the Nave, Chancel and N Transept. Painted white and sound though some lines of joints are open perhaps due to seasonal movement of the frame above. The Transept 'vaults' intersect the Nave at curved cover beads. A vertical tiled bulkhead links the Nave and lower Chancel vaults. No ready access and unlikely to be insulated.
27. The tiles are pierced for many recessed downlights and fissured to prevent unpleasant echo except plain over the organ to reflect sound.
28. The Narthex, wc, Choir and Clergy Vestry ceilings are sound painted flat plaster. The accessible void over the Clergy Vestry has stored material and recent insulation quilt between ceiling joists and another unused roll of quilt which might be spread over the joists to thicken part of the insulation.

Spread the unused quilt over the Clergy Vestry ceiling 28  
If draughty improve the brush seals at both pairs of Nave doors 31  
Lag the hot pipes in the Boiler Room 54

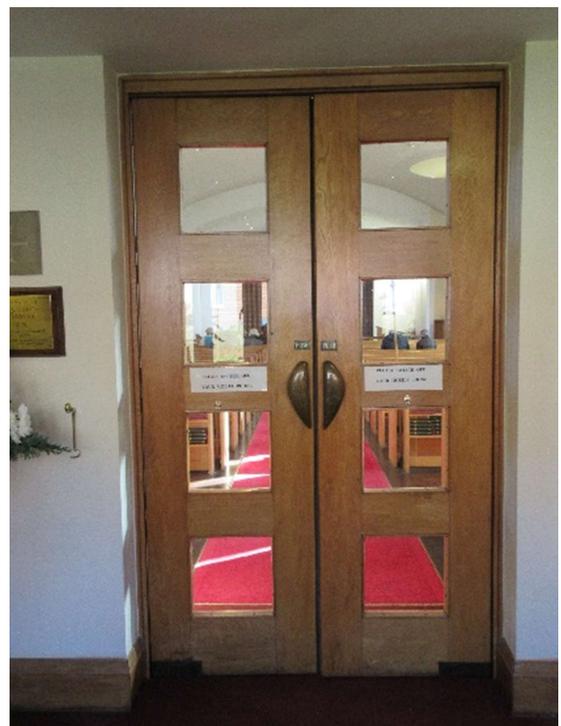
30. Between Narthex and Nave simple small oak framed glazed panels in wall.
31. At the W and S of Nave pairs of well made double acting glazed oak doors with floor springs. Clear glass at W, obscure at S. Good brass push/pulls. Projecting tenons show the timber has shrunk and draughts pass wide gaps all around. A draught brush has been fitted at the meeting edges of the W doors but it is so stiff and wide that the doors do not close fully. If draughts are troublesome it may be possible to find suitable seals for all edges.
32. The room doors are painted flush ply with slightly moulded painted architraves. A closer on the Clergy Vestry door does not overcome the latch spring. At the Choir Vestry and wcs door closers and brass pulls only.
