The Chapel of the Venerable Bede

College of St Hild & Bede

Quinquennial Report

Date: October 2022

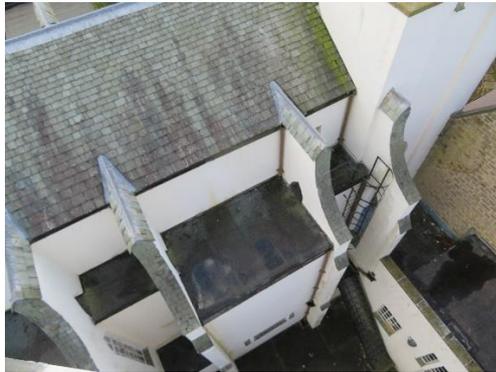
Photo 1, General arrangement of roofs and buttress.

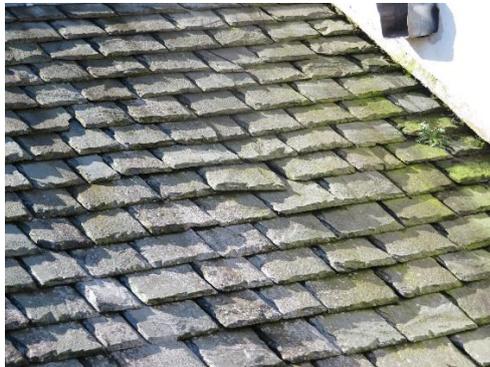
- 2.1.1 The main roof to the chapel was a dual pitched roof finished with green Westmoreland slates laid to diminishing courses. The slate abuts the tower wall to the west and slightly overhangs the gable to the east. There were 25 defective slates in total which included missing, cracked or slipped slates. The location of which can be seen on drawing R19/360/009.

Photo 2, Example of slipped slate to north elevation

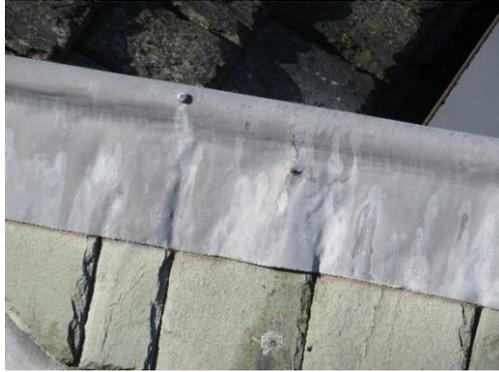
- 2.1.2 The main roof was intersected by the apexes of the buttresses which were dual pitched and finished with Westmoreland slate and the ridges capped with lead. There were holes and cracks in the lead on a number of ridges and there was a missing end cap to one ridge on the south elevation.. There were a number of

damaged slates to the apexes. Locations on drawing R19/360/009

Photo 3, Example of holes and cracking to lead capping of buttress apex

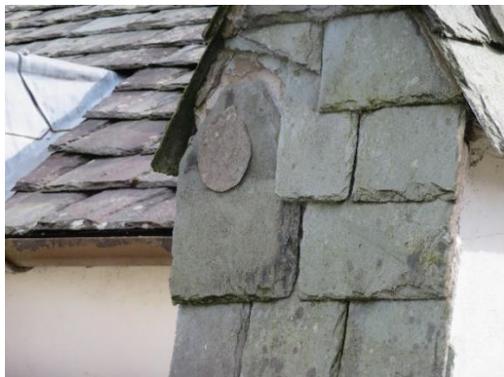
- 2.1.3 On the upper sloping sections of the outer faced of the buttresses were hanging slates, as there were to the lower set backs. The slates were attached with mortar. A number of these slates had been lost.

Photo 4, Example of slipped slate to buttress

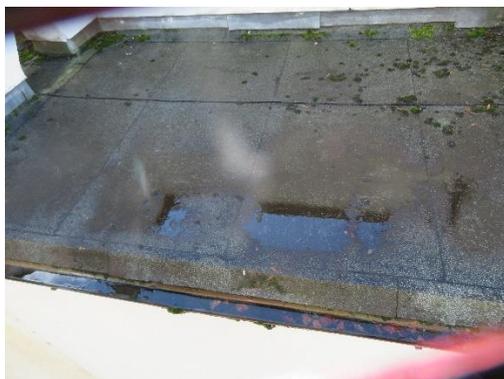
- 2.1.4 The valleys to the buttresses in line with the eastern gable drain directly onto the render resulting in staining.
- 2.1.5 There were flat roofs finished with bituminous felt between the buttresses. These were on two levels. The higher roofs ran through openings in the buttresses. Puddling was observed on roofs FR4 and FR16 which may indicate deterioration to the underlying substrate. There had been patch repairing to the felt of roof FR15 and 16. Otherwise the roofing felt was observed to be in good condition. See drawing R19/360/005 for roof identification.

Photo 5, Puddling on flat roof

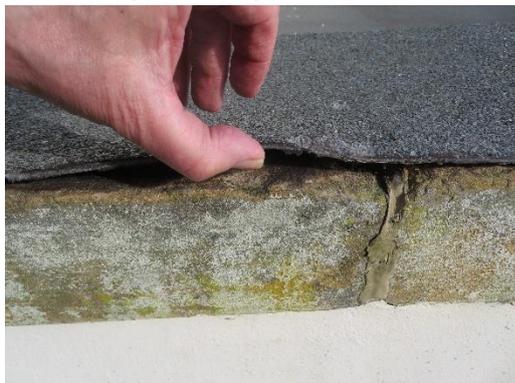
- 2.1.6 The vestry flat roof was finished with bituminous felt that extended up and over the parapet wall. The felt was in good condition although on top of the parapet there were lifting outer edges to the felt.

Photo 6, Lifting felt to Vestry parapet

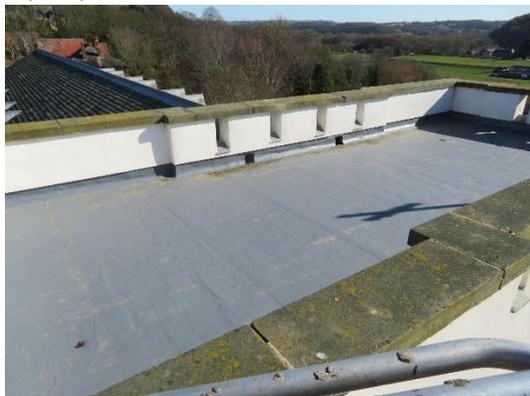
- 2.1.7 The tower roof and stairwell roofs had recently been renewed and finished with a liquid plastic roof membrane. There were both in good condition.

Photo 7, New plastic roof membrane to tower roof, gaps in the pointing to the coping stones.

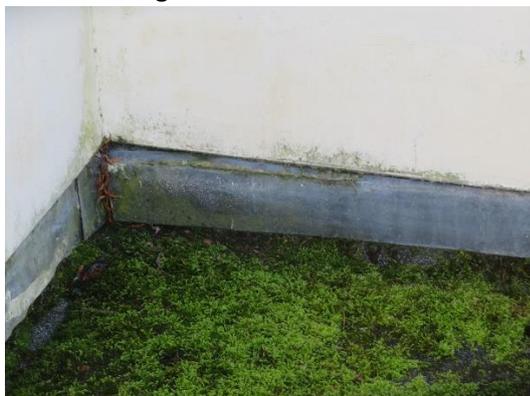
- 2.1.8 There were lead flashings over the felt upstands of the chapel flat roofs running up to the render drip beads. There were displaced lead flashings to FR1 and FR5 and loose flashing to FR19.

Photo 8, Example of slipped flashing over flat roof interface

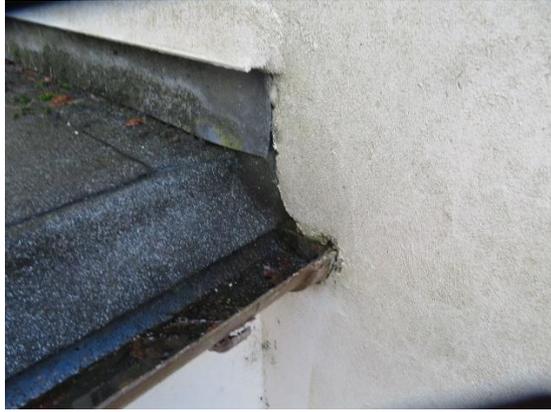
- 2.1.9 The lead flashing to the roof interface to the tower was painted and appeared to be in good condition.
- 2.1.10 Incomplete flashing to cover felt adjacent FR9.

Photo 9, Gap between flashing and roof felt upstand

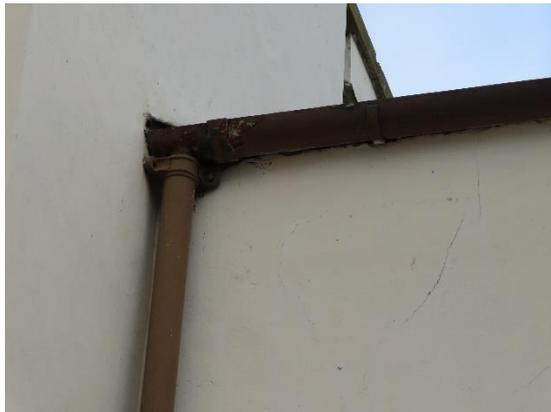
- Broken gutter FR9, FR8
- Retained water FR14, FR2
- Cracked downpipe FR6, FR5
- Bracket defect FR12, FR13

Photo 10, Displaced gutter joint

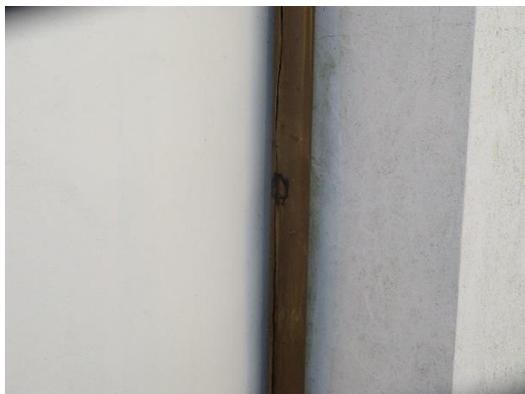
Photo 11, Cracked downpipe

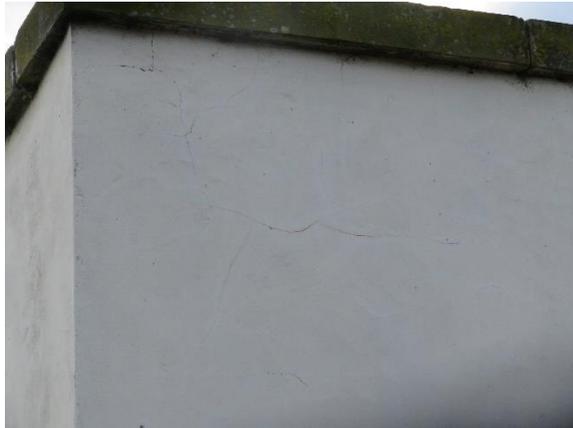
2.4.3 Crazed cracking as seen below the parapet copings to the tower and FR10.

Photo 12, Crazed cracking to render

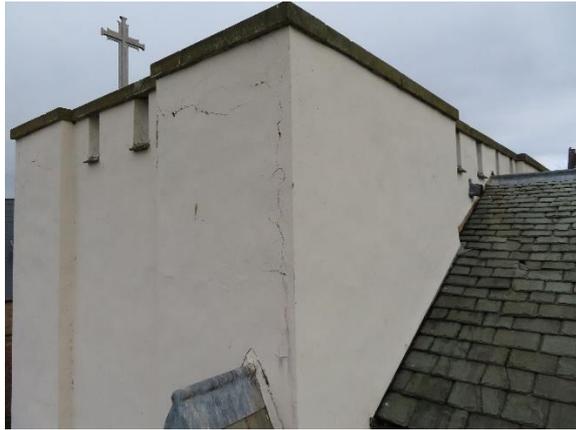
Photo 13, Cracking to south face of tower

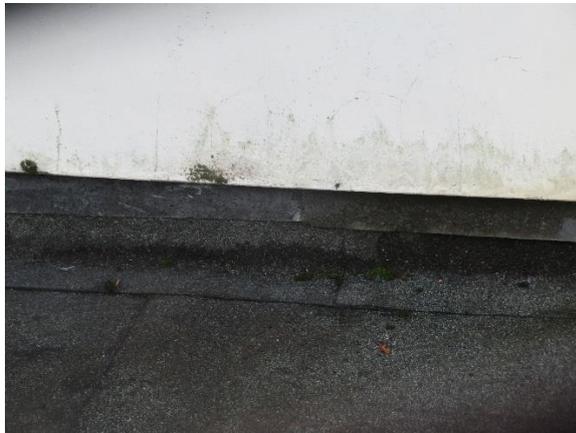
- 1.5.2 There are cracks to the render above the flashings to the flat roof sections to the chapel, these may be allowing water ingress putting the roof beams at risk and contributing to the mould growth on the internal surface.

2.4.4 Vertical cracking observed above drip beads over flat roofs.

Photo 14, Example of vertical cracking over drip bead over flat roof

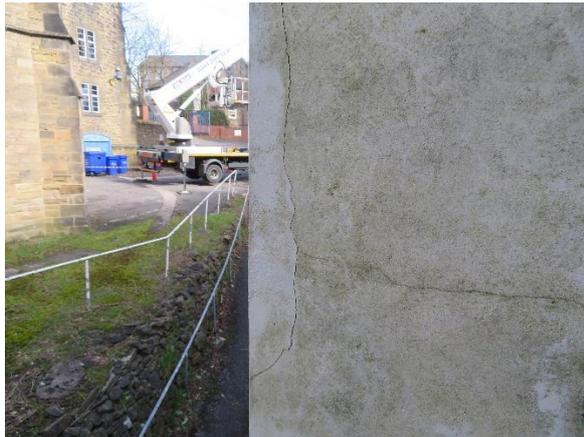
2.4.5 Vertical cracking and delaminating render to buttresses.

Photo 15, Example of vertical and horizontal cracking on buttresses

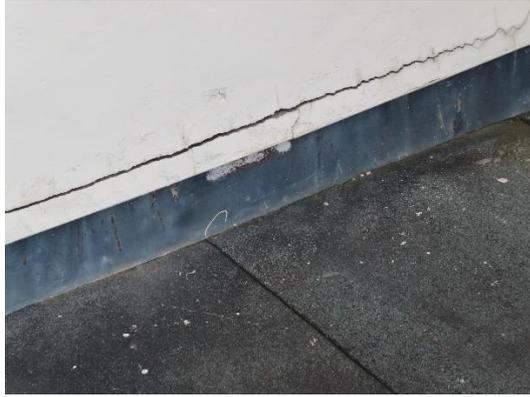
2.4.6 Horizontal cracking above drip bead over flat roofs which may compromise weather protection.

Photo 16, Example of horizontal cracking over lead flashing over flat roofs

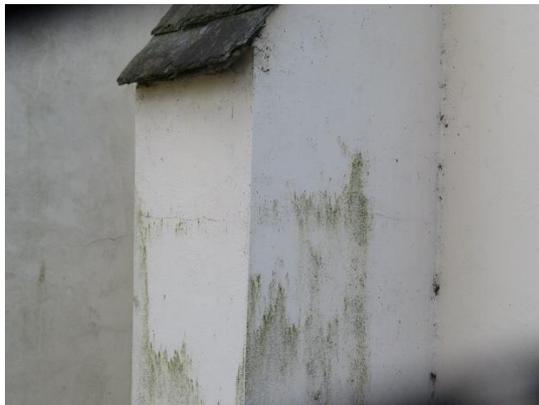
2.4.7 Regular spaced fine horizontal cracking to buttresses

Photo 17, Regular spaced cracking to render on buttresses visible externally and internally

- Carbonation had not reached the depth of the reinforcement.
- The horizontal cracking to buttress render did not occur at the location of the internal horizontal reinforcing rings
- There was evidence of the horizontal cracking in the render of the buttresses extending into the concrete frame.
- There was no evidence of Chloride attack
- There was evidence of active sulphate attack but this was within the concrete voids and did not extend into the microcracks that were present in the concrete and render

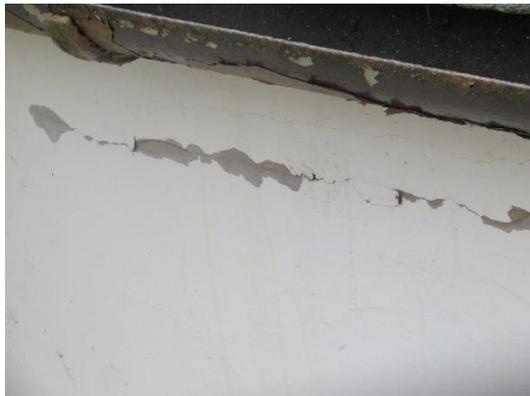
2.4.8 Horizontal cracking below rainwater gutters.

Photo 18, Example of horizontal cracking under rainwater gutters

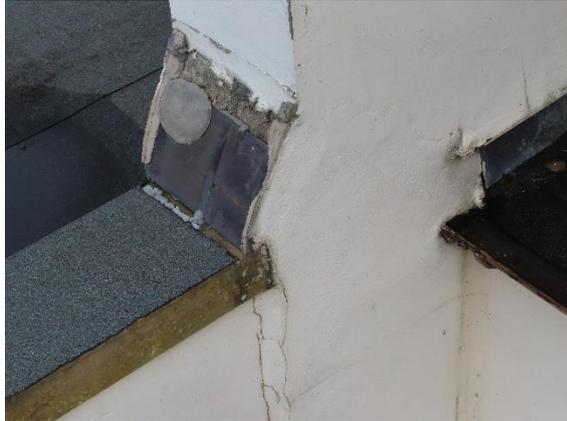
2.4.9 Vertical cracking at junctions of vestry parapet coping to buttress.

Photo 19, Cracked render and slipped slates at junction to vestry parapet

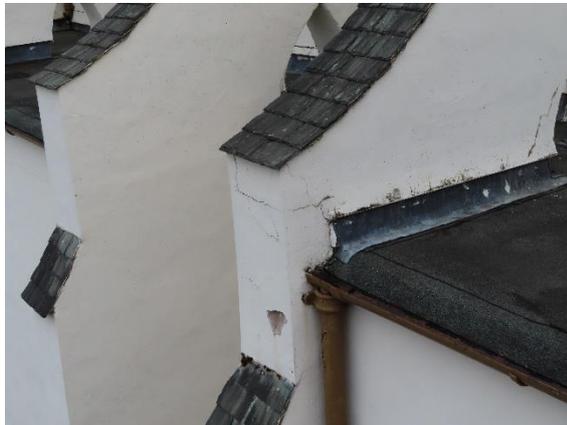
2.4.10 There was a hole in the render to buttress B17

Photo 20, Hole in render to buttress 17

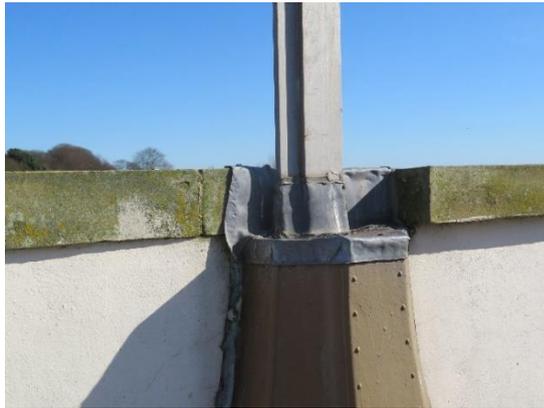
- 2.5.2 The metal cross fixed to the west tower parapet was in good condition however there were gaps in the seating of the lead capping to the stone base of the cross.

Photo 21, Lead capping to cross base

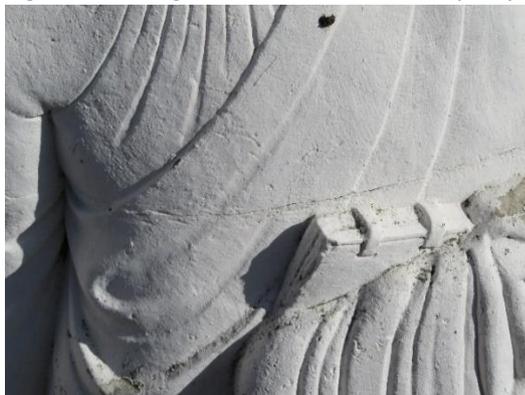
- 2.5.3 The painted stone statue of St Bede sat on top of a fluted corbel clock housing and within a simple niche on the west tower elevation. The statue was showing some signs of damage; a broken nose and open joints between the stone sections.

Photo 22, Cracks at the junction of the statue elements

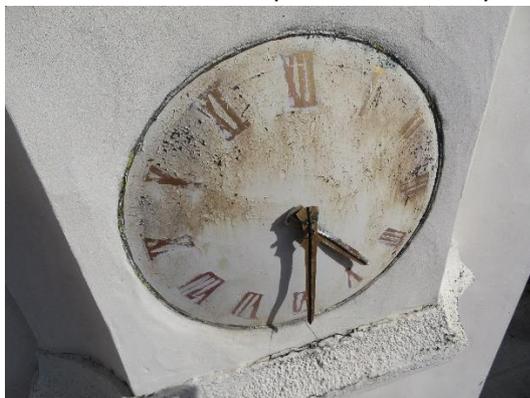
- 2.5.4 To provide some protection to the statue there was a half octagonal faceted hood extending out from the cross base over the statue. The sheet metal was in good condition although the paint finish was in need deteriorating.
- 2.5.5 The clock, with a 2'6" open convex face, was not operational. The decoration to the clock face and pointers was in poor condition. See independent report on clock condition concluded by "Smiths of Derby".

Photo 23, Deterioration of finish to clock face

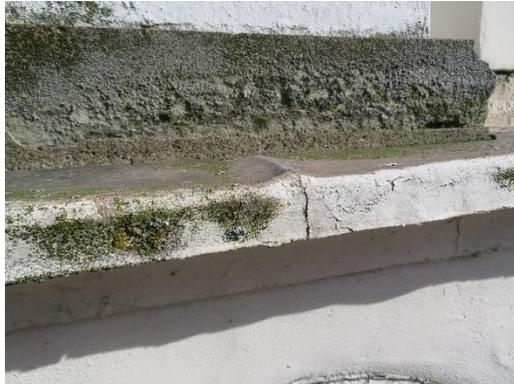
- 2.5.6 The fixed bell was in good condition while there was some face corrosion to the bell clapper. The manual and rope pull and auto chimer to the clock were not operational.
- 2.5.7 There was cracking to the lead capping to the statue base over the clock.

Photo 24, Crack in lead to statue base

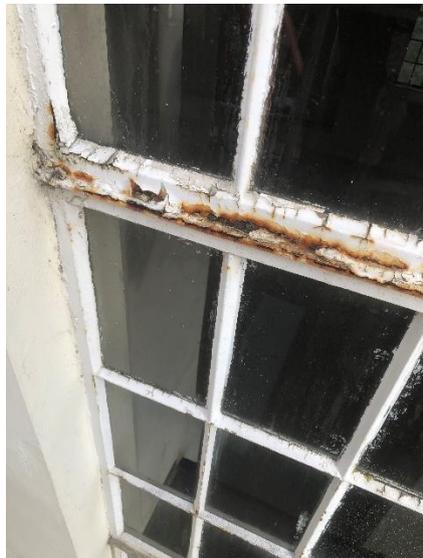
- 1.5.3 The steel Crittall windows are generally in poor condition and there is a risk of failure to some of the frames if subjected to high wind loads.

- 2.6.1 There were rendered reveals with arched or square heads and steep slated sills, which were observed to be in good condition.
- 2.6.2 The windows were single glazed steel framed (Crittall) multi paned windows which were a combination of rectangular or shaped to arched heads.
- 2.6.3 The steel window frames were in poor condition showing evidence of broken glazing and corroding and distorted frames. In addition, most of the ventilating panes were seized and inoperable.
- 2.6.4 There is a risk of frame failure to some of the windows if repairs are not conducted within the next two years.

Photo 25, Example of corrosion to window frames

2.6.5 An independent survey of the windows was conducted which concluded that 31 frames could be repaired in situ but 16 would require removal and restoration within a specialist workshop. A full schedule of photos is available.

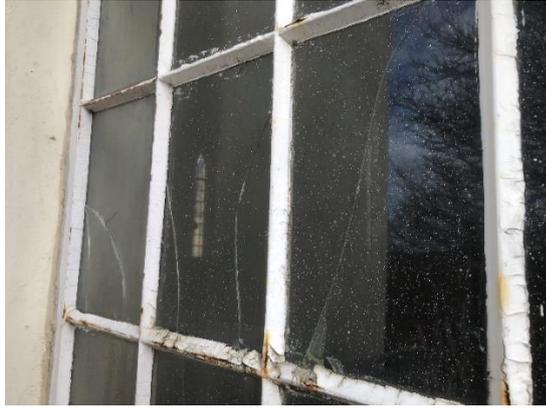
Photo 26, Example of broken window glazing

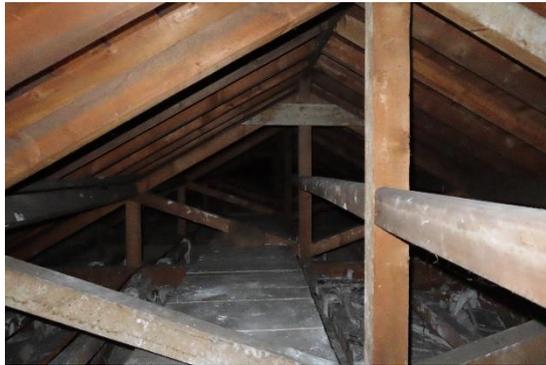
2.7.1 The Chapel timber roof structure comprised king post trusses and one purlin to each elevation. The timbers were observed to be in good condition with no evidence of infestation by wood boring insects.

Photo 27, Roof Structure

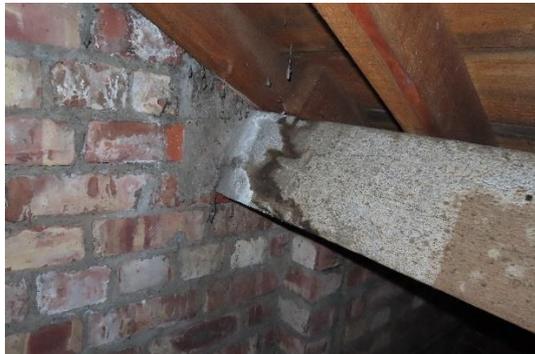
2.7.2 There was evidence of water ingress onto the purlin ends inset into the tower masonry.

Photo 28, Evidence of water staining to purlin ends

- Implement recommendation of Fire Risk Assessment
- Establish monitoring and further sampling of render and concrete cracking
- Establish monitoring of southeast corner floor
- Treat west purlin ends with fungicide to guard against wet rots
- Increase internal temperatures to 13-15°
- Repair below ground drainage
- Relay external concrete paving (trip hazard) to north
- Accurately measure entrance door ashlar to provide information for later restoration.

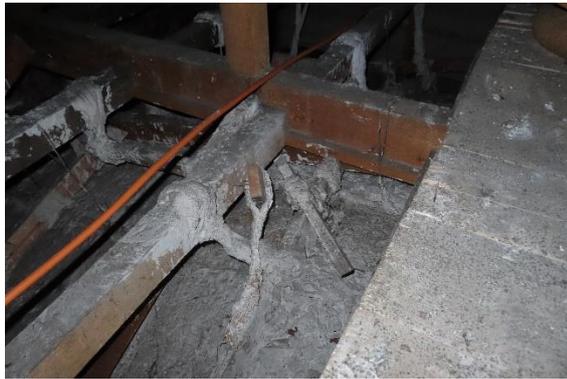
- 2.8.1 There were sections of part flat, part half barrels in the side set backs and plain barrel vaults and cross vaults through the centre of the chapel.
- 2.8.2 The curved plaster to the set backs was hollow and is likely to be on wood or metal lathes.
- 2.8.3 The plain barrel vaults were on metal laths with wire mesh support for the plaster. These were observed to be in good condition.
- 2.8.4 The cross vaulted ceilings were of fibrous plaster supported by timber laths. Generally, these were in good condition although one hanging fibrous support was noted to have broken. NB. it is important that fibrous plaster ceilings are inspected on a regular basis as they are particularly vulnerable to water ingress which can lead to collapse.

Photo 29, Broken support for fibrous plaster of vaulted ceiling

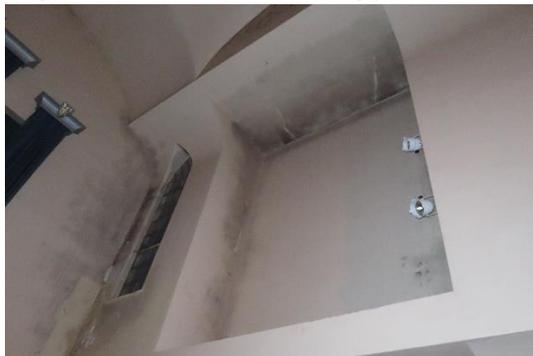
- 2.8.5 The internal paint finish to the walls and ceilings was in very poor condition with large sections of mould, lifting paint and salt damage.

Photo 30, Example of mould to ceilings and walls

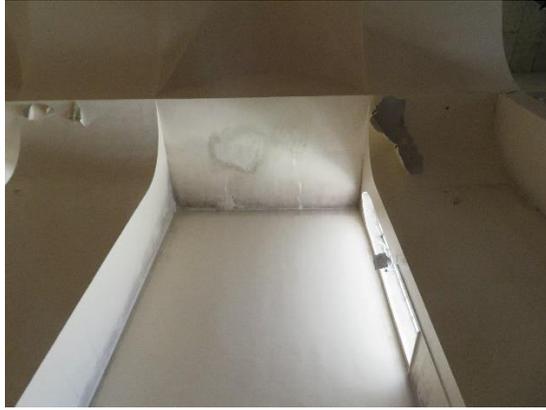
- 2.8.6 There was flaking paint to the curved ceiling sections adjacent to the organ loft.

Photo 31, Example of lifting paint and staining to ceiling

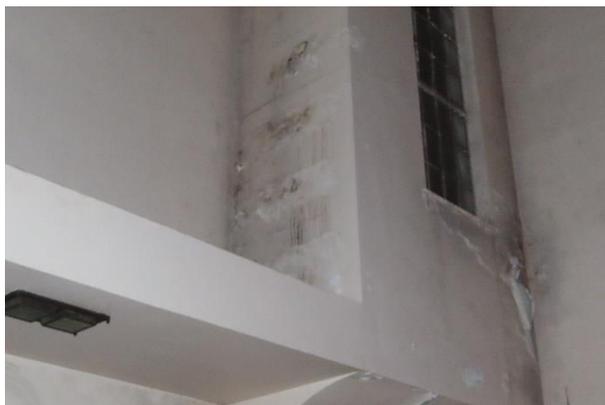
- 2.10.1 The internal walls were finished with directly applied plaster. The paint finish was in poor condition with extensive areas of mould and surface deterioration.
- 2.10.2 There was cracking of plaster and flaking paint to the northeast corner
- 2.10.3 To the lower northeast corner there were regular oblong shaped area of stained and flaking paint to the upper reveal.

Photo 32, Cracking, mould and discolouration to NE corner

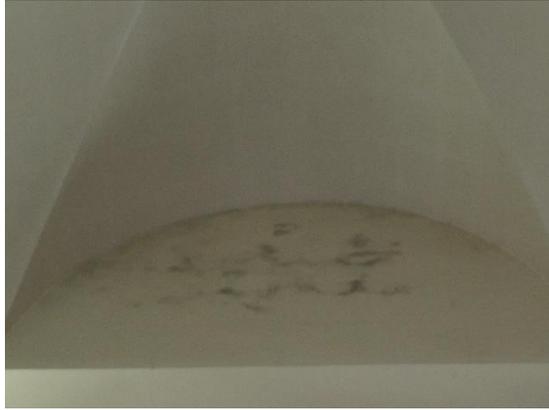
- 2.10.4 To the reveals of the south set backs there were horizontal cracks in the plaster finish, similar to those observed externally.
- 2.10.5 There was mould developing to the plaster faces of the arched sections of walls between the portal frames.

Photo 33, Mould to arched sections between frames

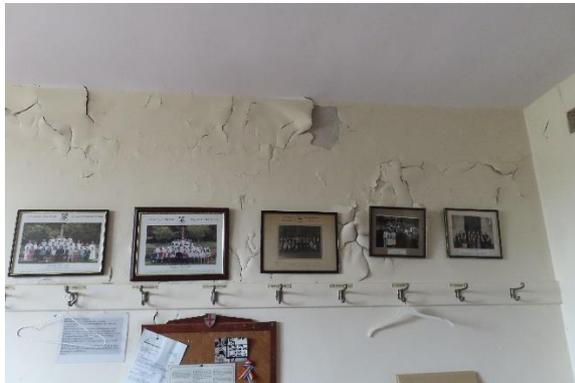
- 2.10.6 There was badly flaking paint to the vestry walls below the air vent to the east wall and on the west wall below where the lifting roof fell was observed externally.

Photo 34, Flaking paint to vestry west wall

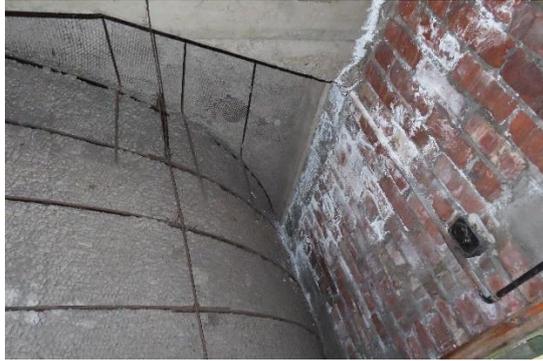
- 2.10.7 A specialist report on the wall paint by Hirst Conservation was conducted which concluded.
- The most recent paint was an unsuitable synthetic paint.
 - Earlier layers are indicative of limewash or distemper
 - No lead was found in the layers.
 - Colour matching of earlier layers identified layers of NCS 0505-G80Y and NCS 0505-G90Y.
- 2.10.8 The report recommended the full renewal of the paint before redecorating and recommends conducting a paint stripping test to identify a suitable solvent that would not cause damage to the underlying substrate.
- 2.10.9 It was observed that there were salt deposits on the internal faces of the wall brickwork in the roof void indicating previous penetrating damp, no close access was available to test for current damp levels.

Photo 35 Salt deposits on inside brick face. Metal frame and mesh structure of barrel ceiling

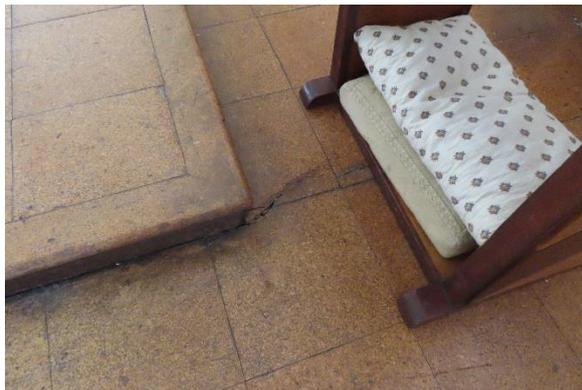
- 2.12.1 There were solid floors throughout finished with cork tiles. The chapel centre aisle appears to be a later finish.
- 2.12.2 While the chapel floor was generally showing some signs of discoloration and there were some areas where localised impact damage was visible, the floor was generally in fair condition
- 2.12.3 There was cracking of the tile finish to the southeast corner of the raised altar plinth. Indicative of floor movement.

Photo 36, Cracking to cork tile at corner of altar

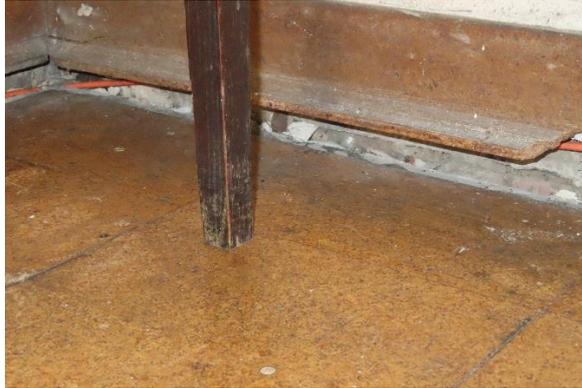
- 2.12.4 There was an open gap between the floor and the skirting to the southeast corner adjacent to the altar indicating possible settlement of the floor slab. The area should

be monitored to establish if the movement is ongoing.

Photo 37, Gap between skirting and floor in SE corner

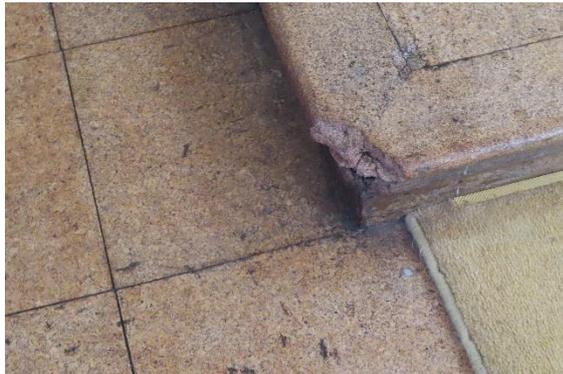
- 2.12.5 The raised bench platforms to either side of the chapel have older cork tiles in generally fair condition.
- 2.12.6 The cork noses to the bench and altar platforms have been inappropriately repaired with softwood and resin in a number of locations.
- 2.12.7 To the corners of the altar platform there was localised damage to the cork finish. Consideration should be given to renewing nosings with a more robust but matching material. However if under floor heating is to be considered during a refurbishment the full floor finish will need replacing.

Photo 38, Damage to corners of altar platform

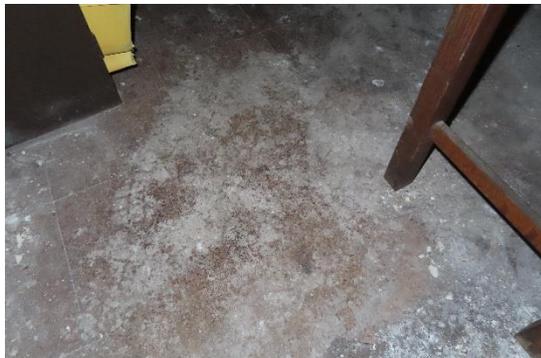
- 2.12.8 The cork tiles to the solid organ loft floor were badly discoloured (probably from tower works) and those to the vestry were damaged near to the sink.

Photo 39, Discolouration to organ loft floor
