QUINQUENNIAL INSPECTION REPORT

CHURCH OF ST. AIDAN

FRONT STREET, FRAMEWELLGATE MOOR, DURHAM, DH1 5BL

MAY 2022

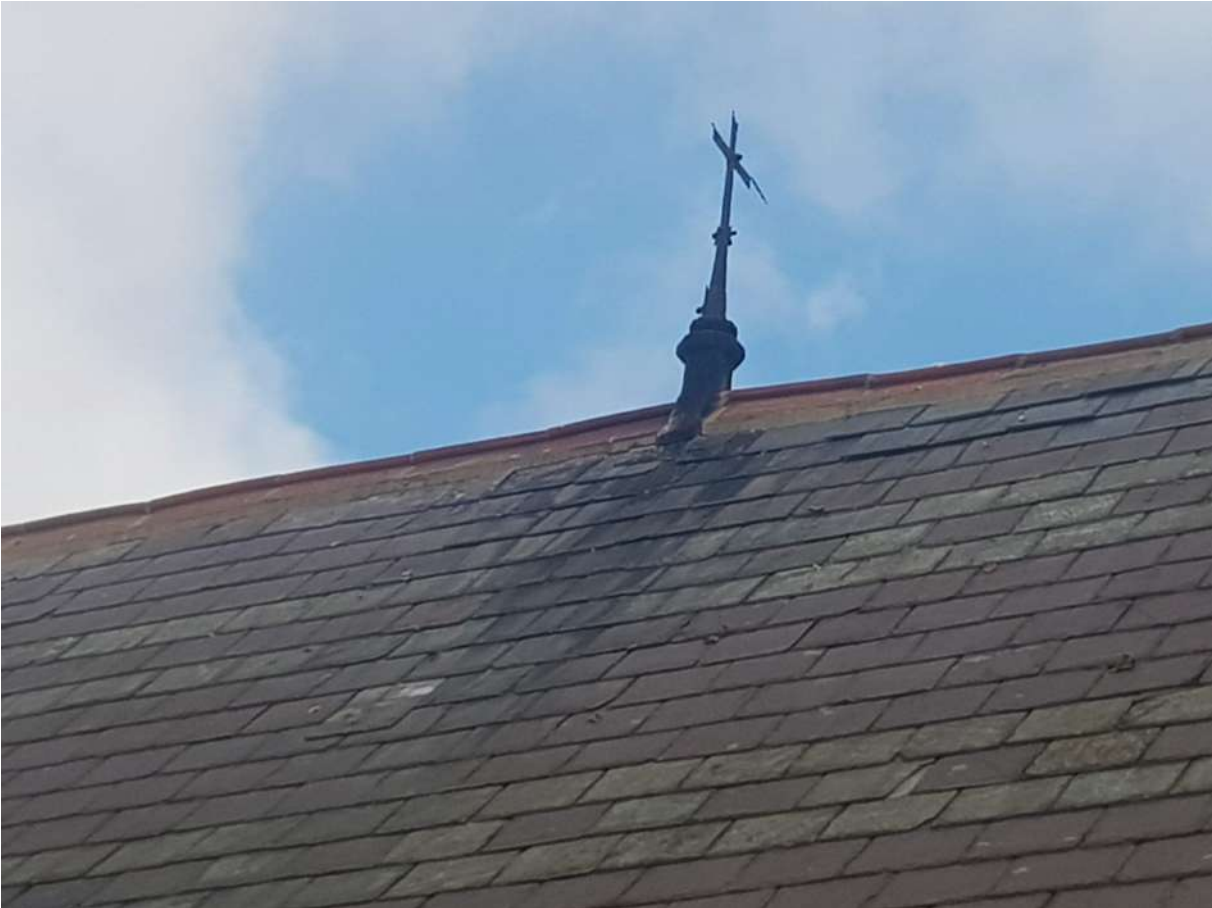
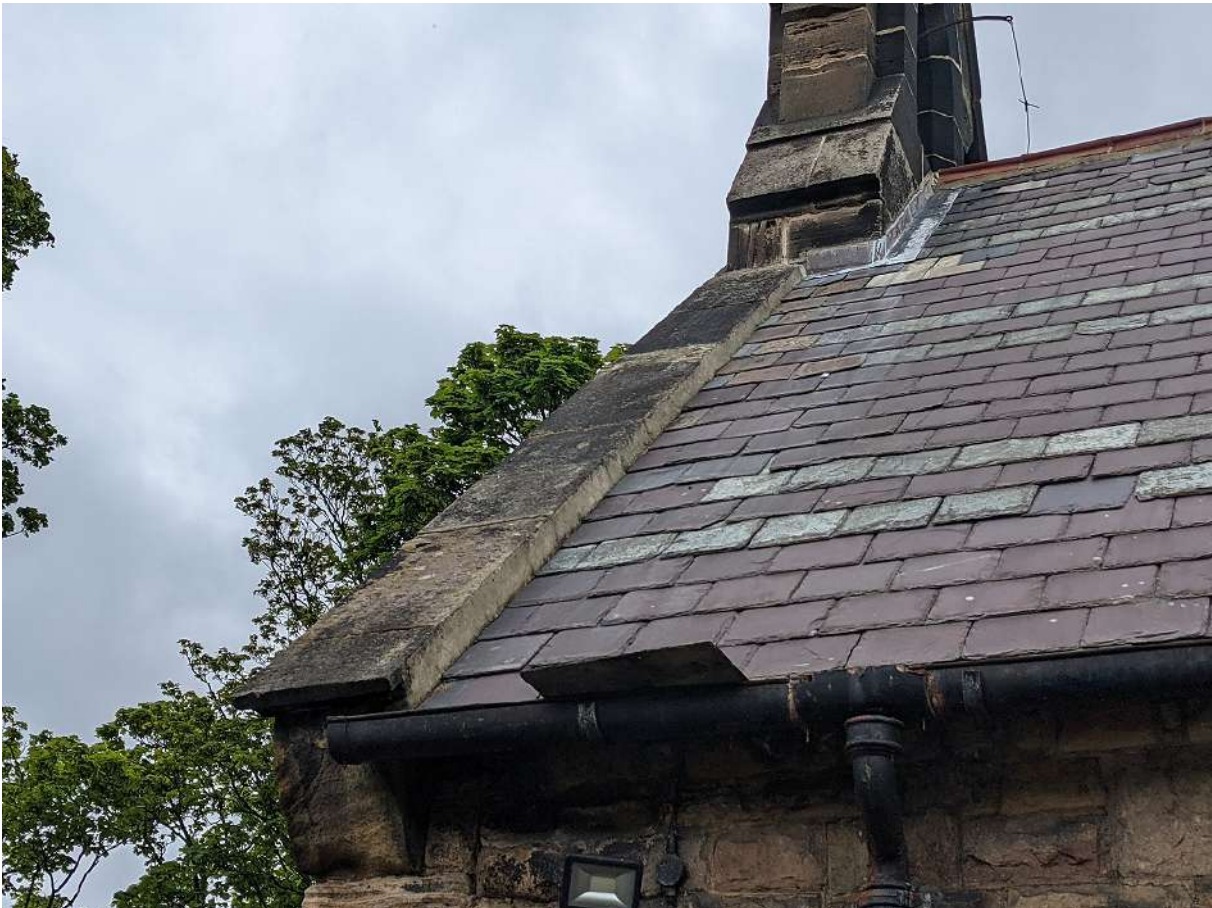
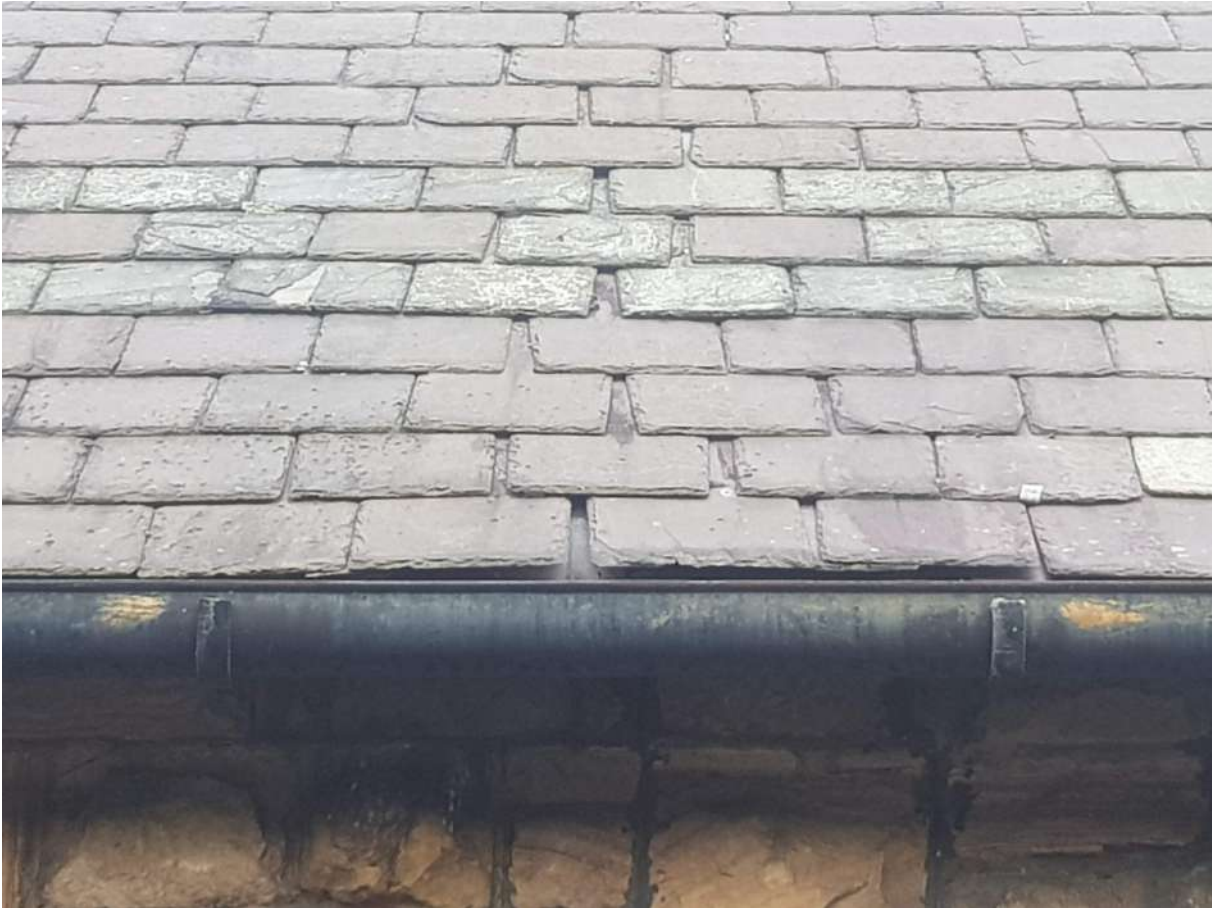
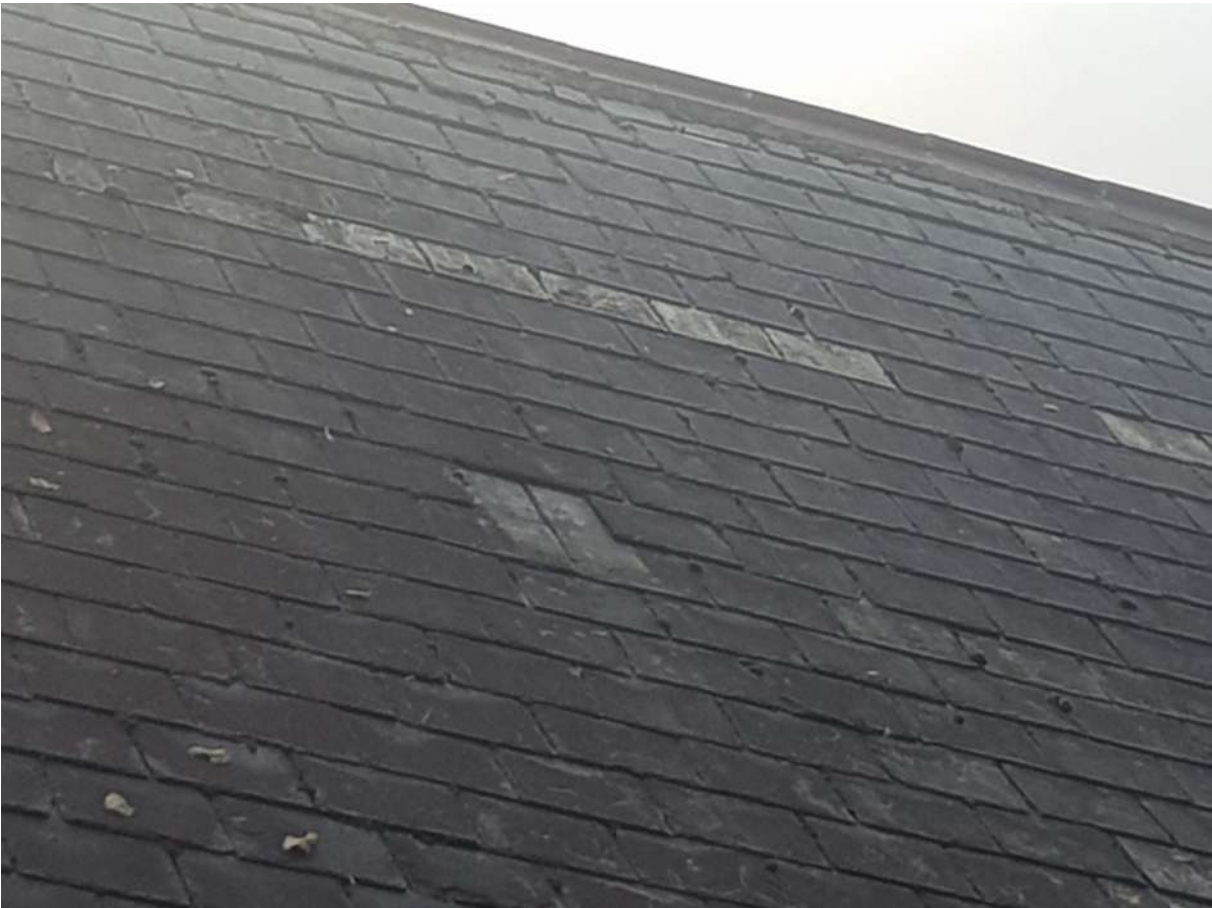
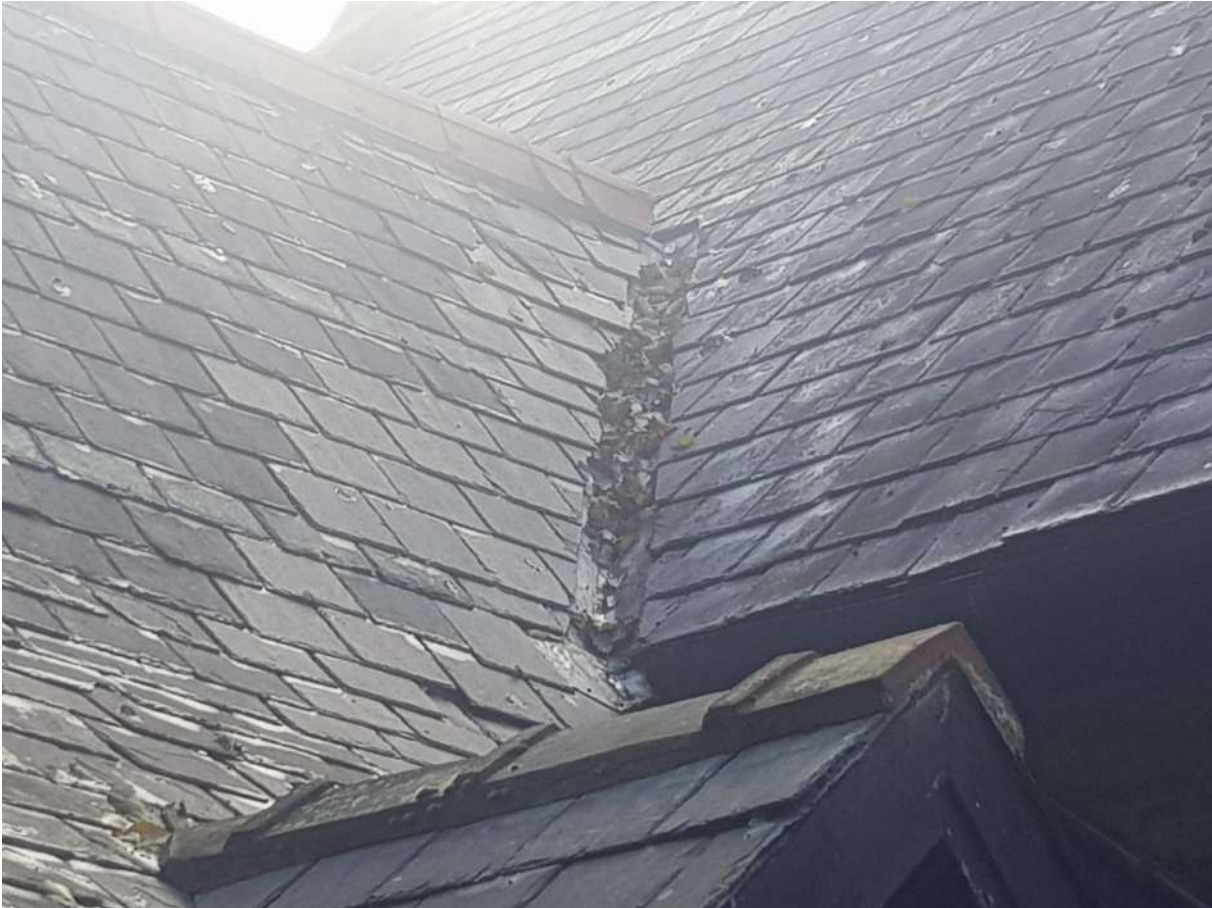
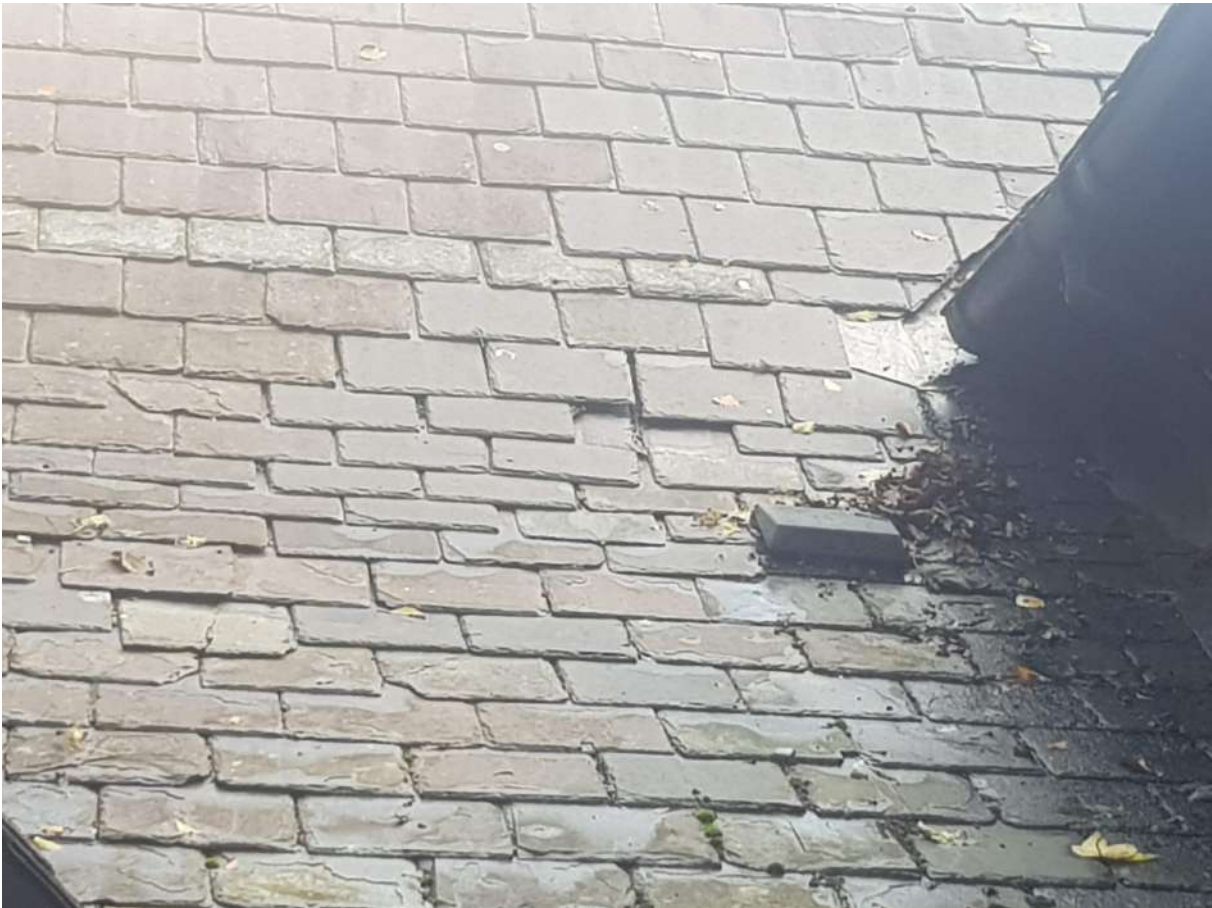
- 3.1.1 The previous QIR reported increasing concerns over the condition of the roof covering. At that time there were incidents of areas to the roof covering where previous slate repairs have been carried out. The nature of these repairs vary considerably and range from introduction of metal wire tingles and/or lead straps, flash banding of split or cracked slates, insertion of alternative slate substitutes and bitumen glued/bonded slates. All of these repairs are temporary in nature, none of which are adequate.

Five years on the good news is that the roof covering continues to maintain a weathertight condition albeit the condition reported five years ago remains the same. There is the occasional slipped slate to both roofing slopes and one slate is noted sitting in the south gutter, west end. Some moss build up is evident to the north slope of the roof covering.

Carry out slate repairs by a competent and experienced roofing contractor.

- 3.1.4 It is recommended that as a routine item of maintenance the roof should be examined and repairs undertaken on a twice yearly basis.

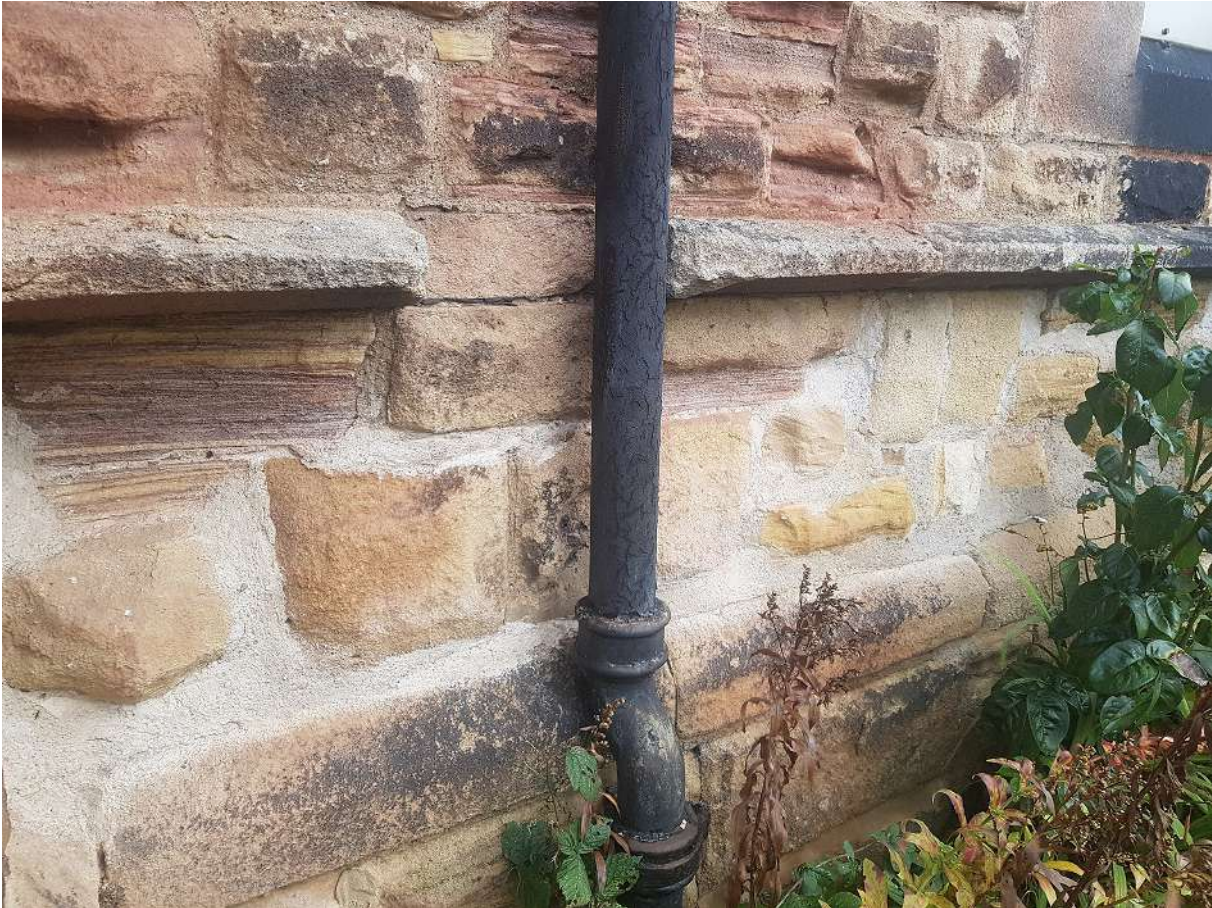
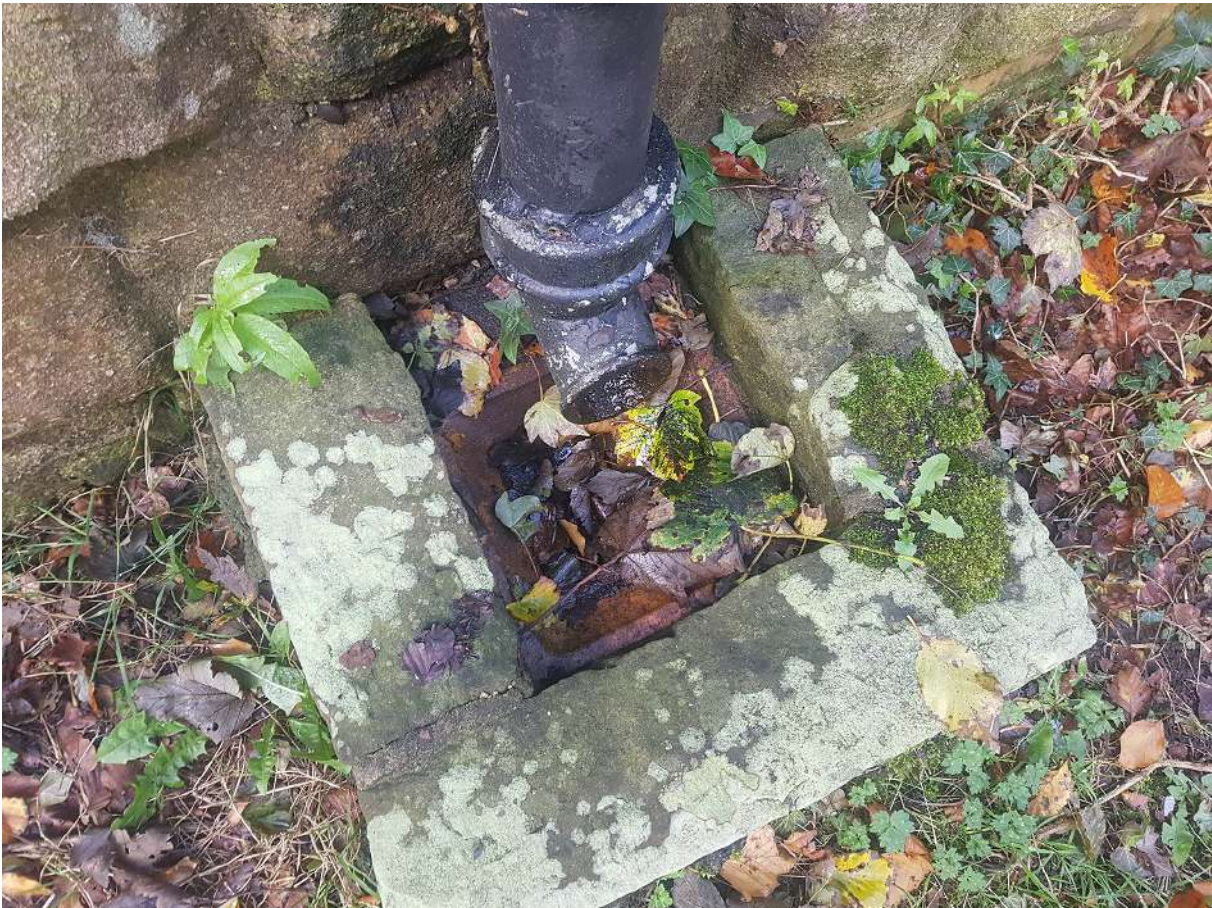
- 4.1.1 All gutters and downpipes appear to be in a sound, satisfactory working condition, albeit could do with refurbishment over the course of the quinquennium period.

R3 Carry out refurbishment (including dismantling and recaulking of the joints) of the rainwater goods by a competent and experienced roofing contractor.

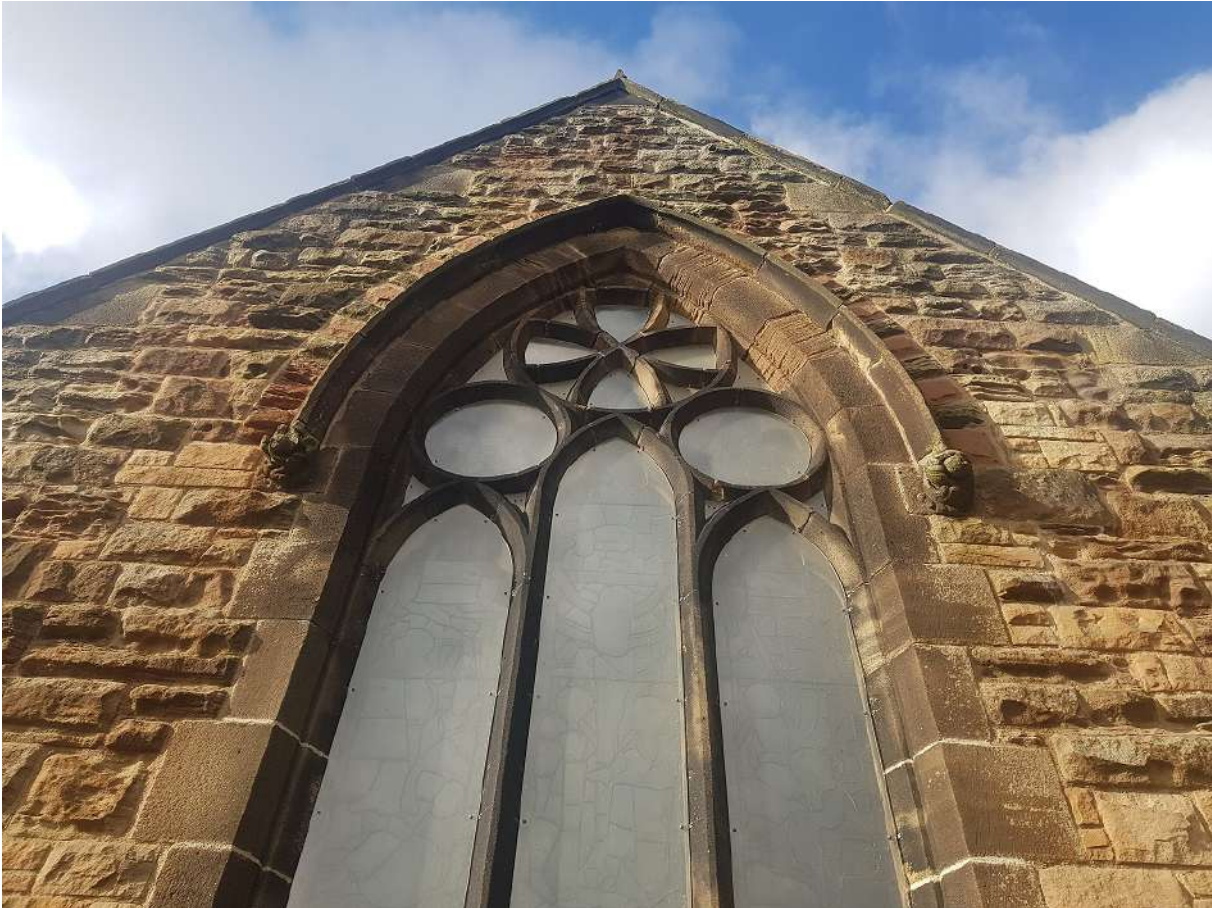
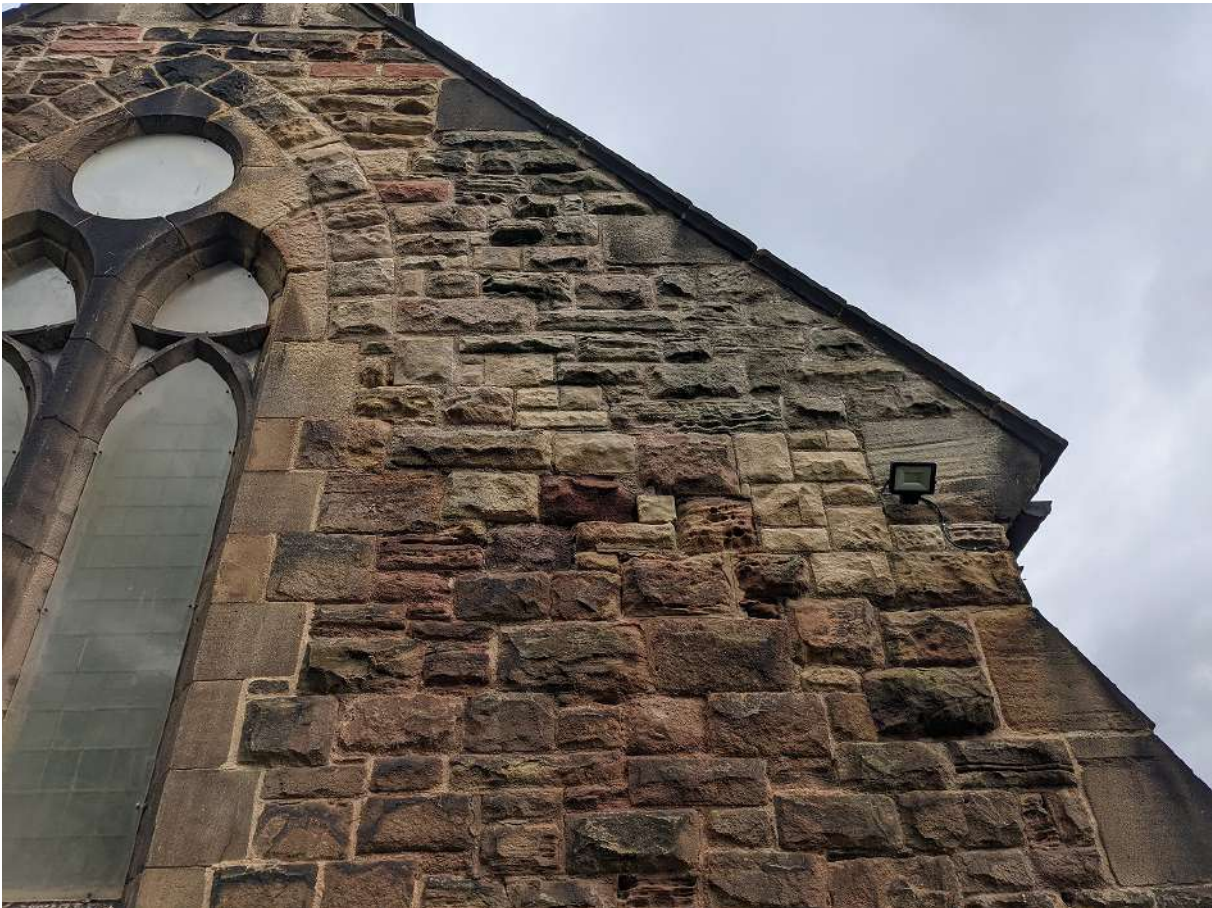
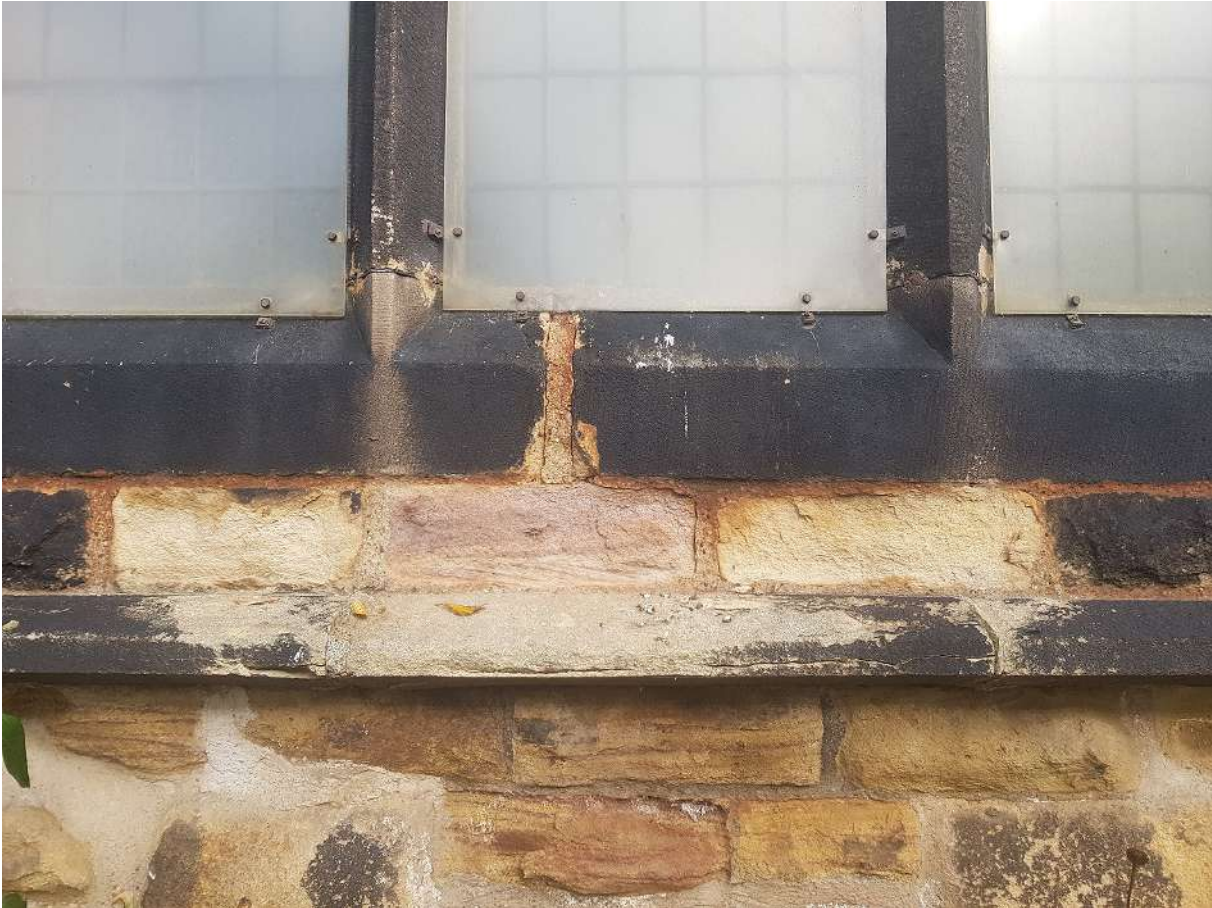
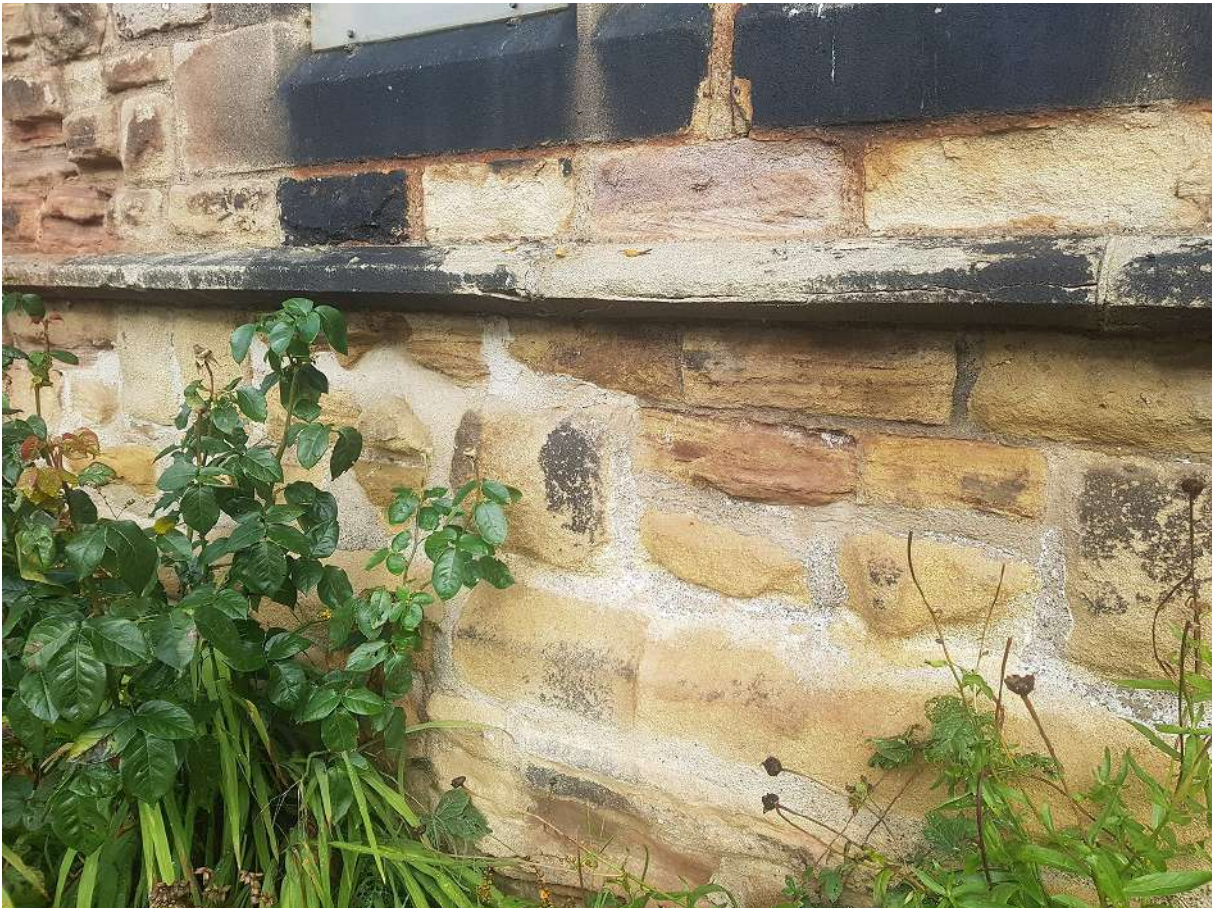
- 7.1.1 Masonry repair work has been carried out approximately 10 years ago focusing on the east and west gable ends and buttresses replacing eroded stones and repointing in a lime:sand mortar.

The condition of which continues to be found in a sound, satisfactory condition. The west gable end takes the brunt of weathering and as such a couple of areas of open voids due to a combination of eroded stonework and loss of pointing material are noted.

It is recommended that a lime:sand mortar repointing specification and methodology is drawn up and repairs executed to correct defective areas.

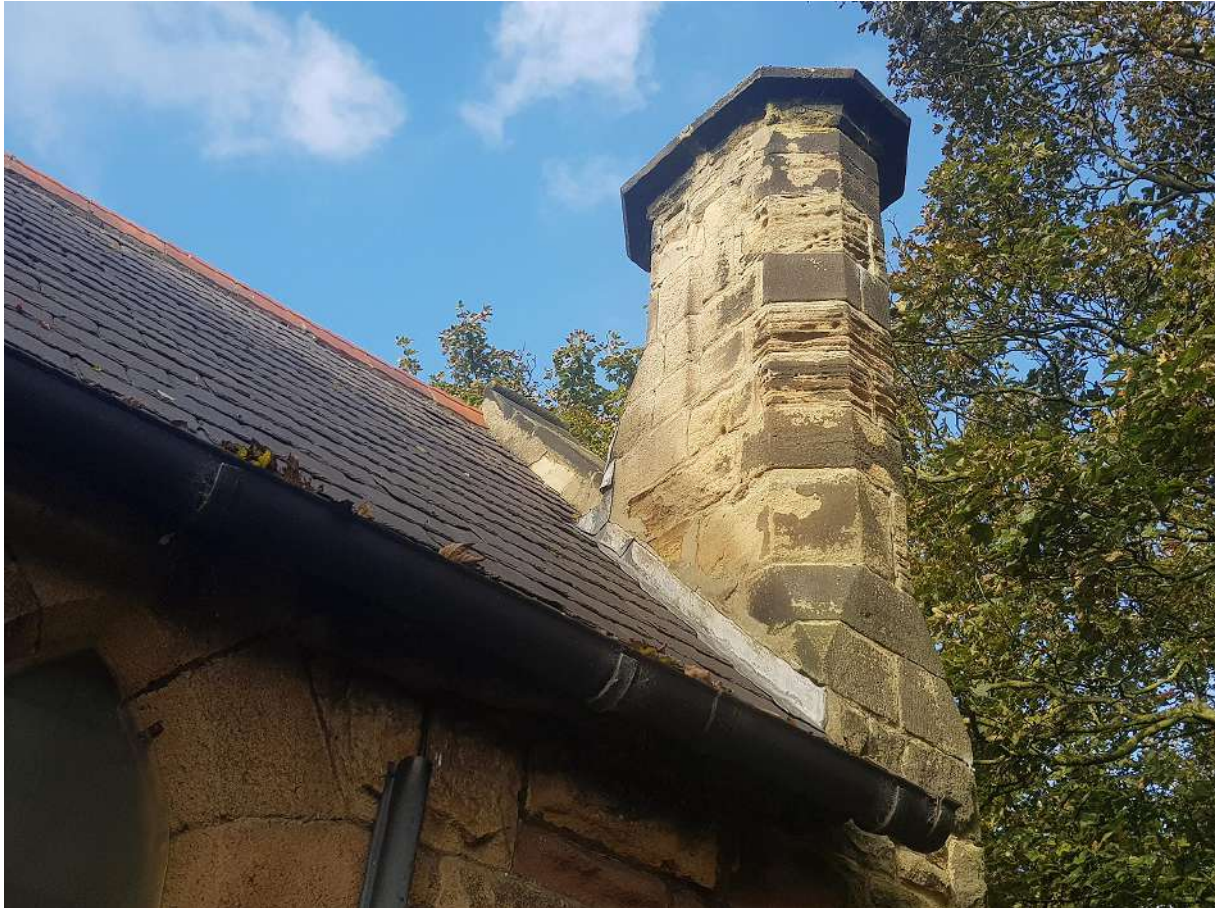
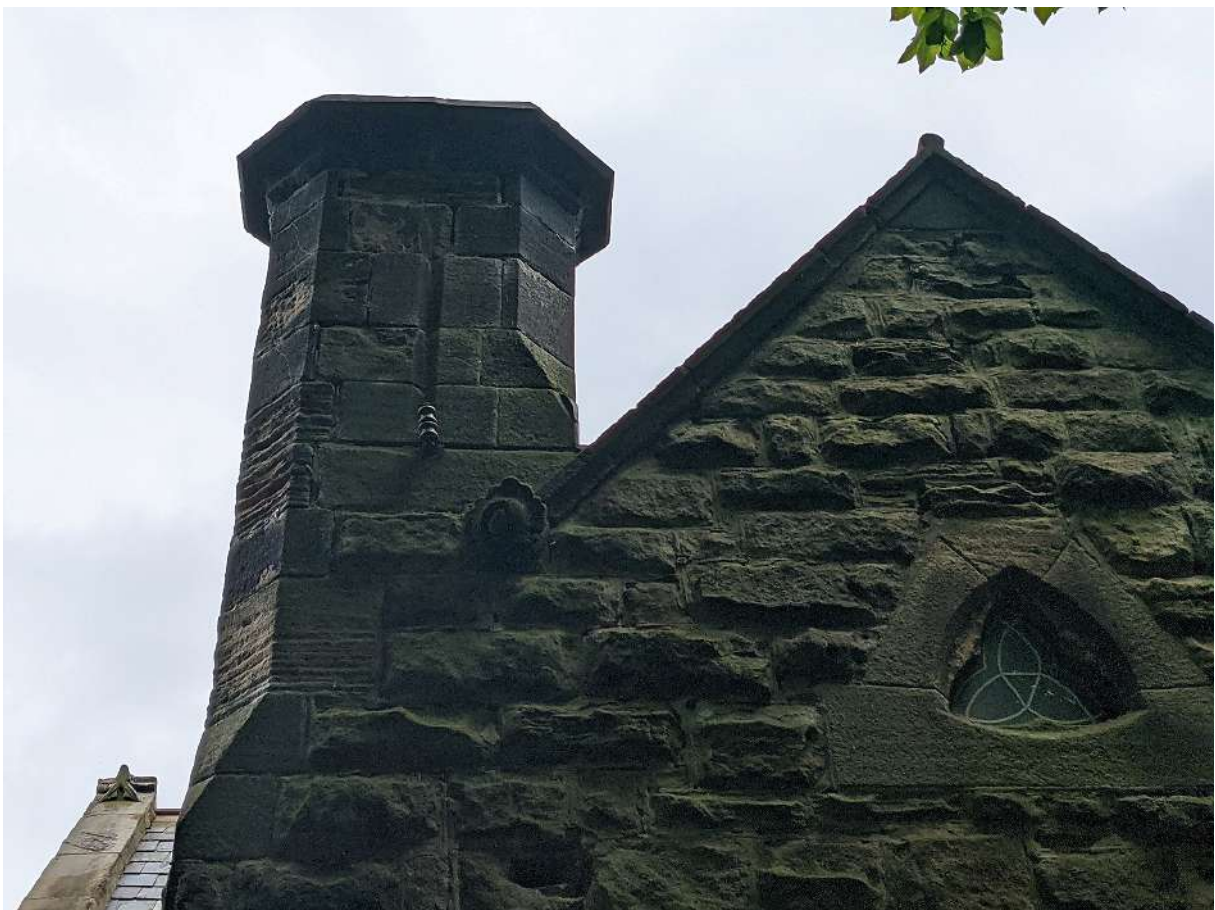
- 7.2.1 The stonework is generally in a better condition than that of the nave and chancel with only occasional eroded individual stones.

Repointing however remains in a variable condition with an eclectic mix of mortar mixes and workmanship in evidence. There is use of cementitious mortar and areas where the mortar is smeared over the edges of stonework, thus losing some definition of the individual stone units.

It is recommended that a lime:sand mortar repointing specification and methodology is drawn up and repairs executed to correct defective areas.

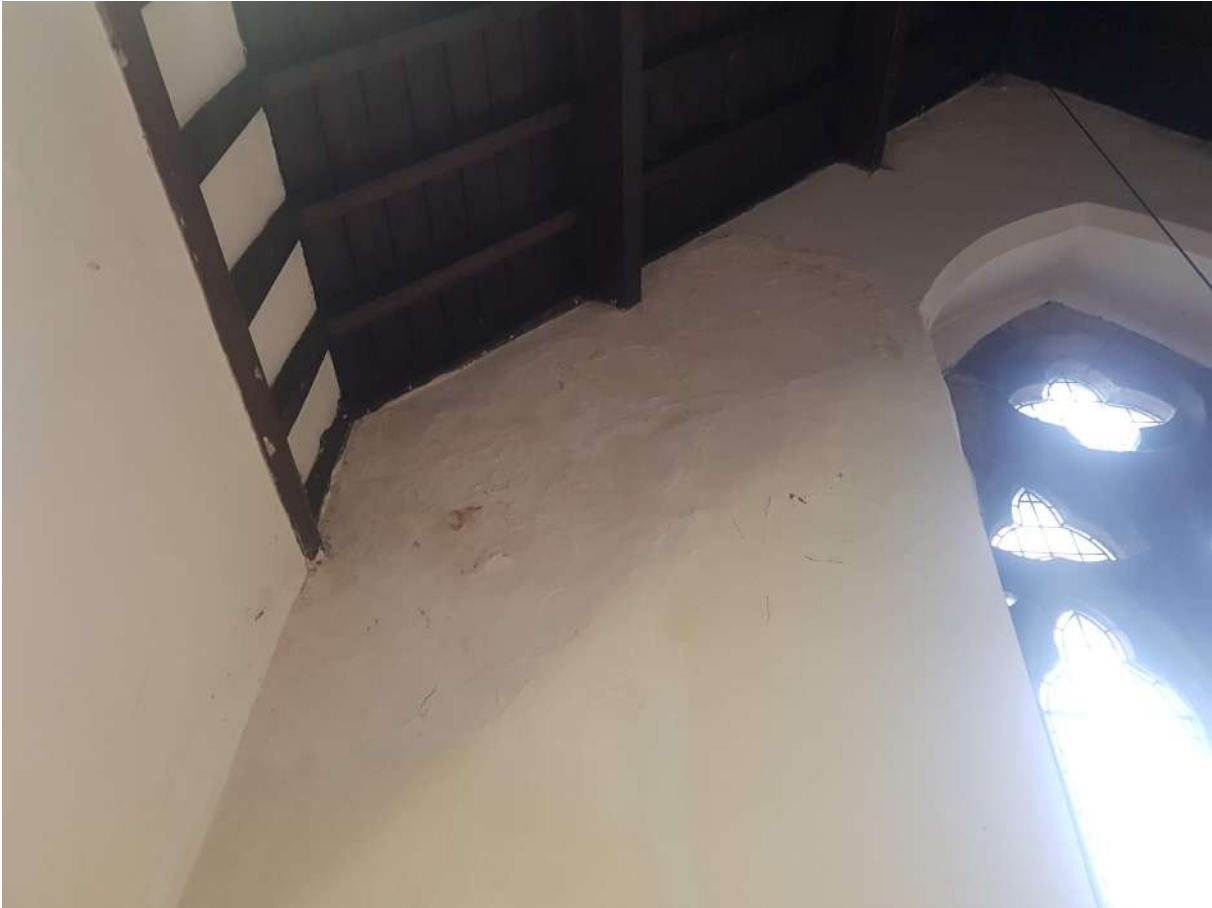
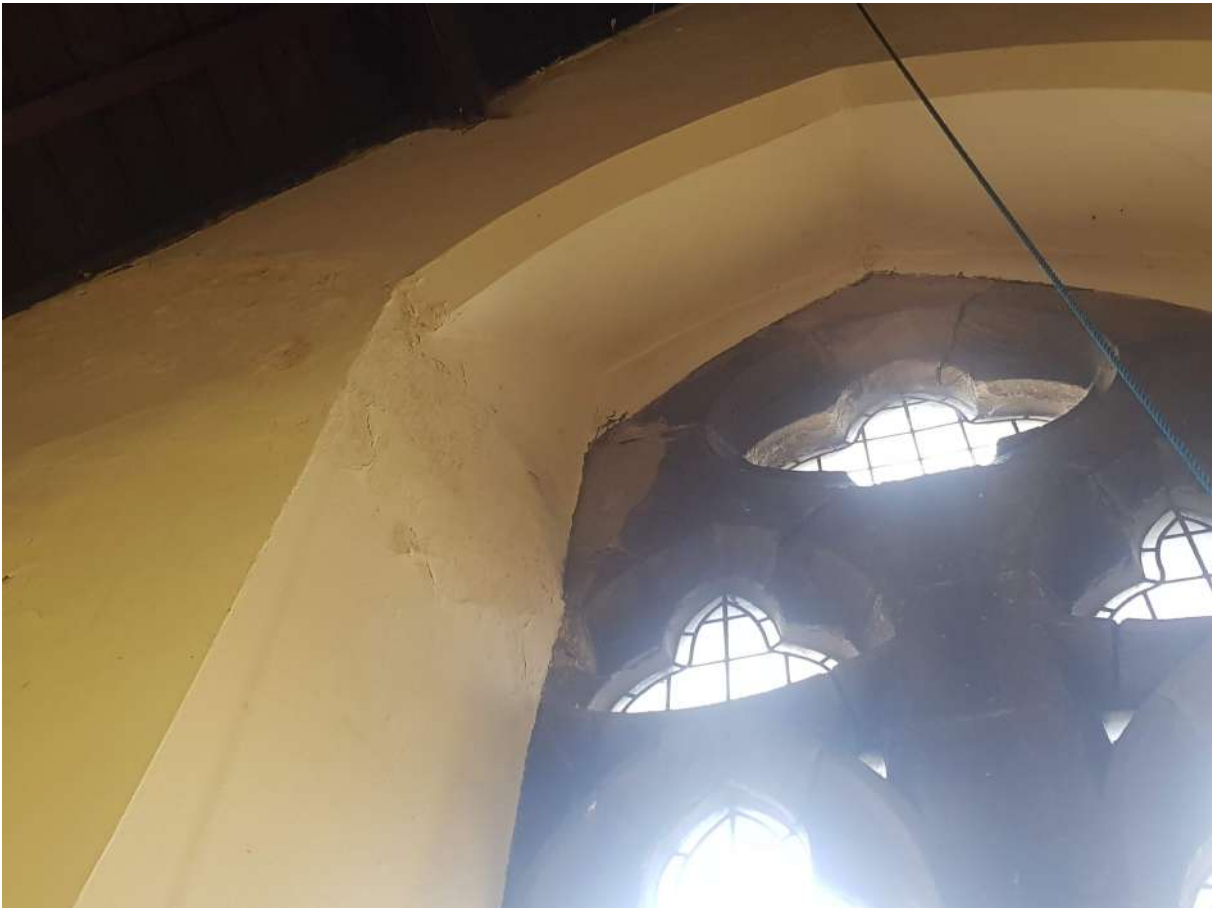
17.1.1 All generally in a sound, satisfactory condition.

Plasterwork above several window heads shows signs (some slight, others more pronounced) of hairline cracking. Exceptions to the stable condition of walling finishes include:

1. Nave West End (south side at high level) – signs of disturbance to the painted finish due to moisture penetration, manifesting in flaking paint, loose plasterwork and efflorescence. Dampness seen bleaching into south jamb of west window.
2. Chancel East End (north side at high level) – early signs of bulging and linear cracking to plasterwork suggesting degree of separation from masonry backing.

R0	It is recommended to carry out further visual and if needed intrusive inspection of the plasterwork condition in these areas.
-----------	---

R2	17.1.2 Carry out plasterwork repairs following correction of defects highlighted via investigation work carried out in item 17.1.1.
-----------	---

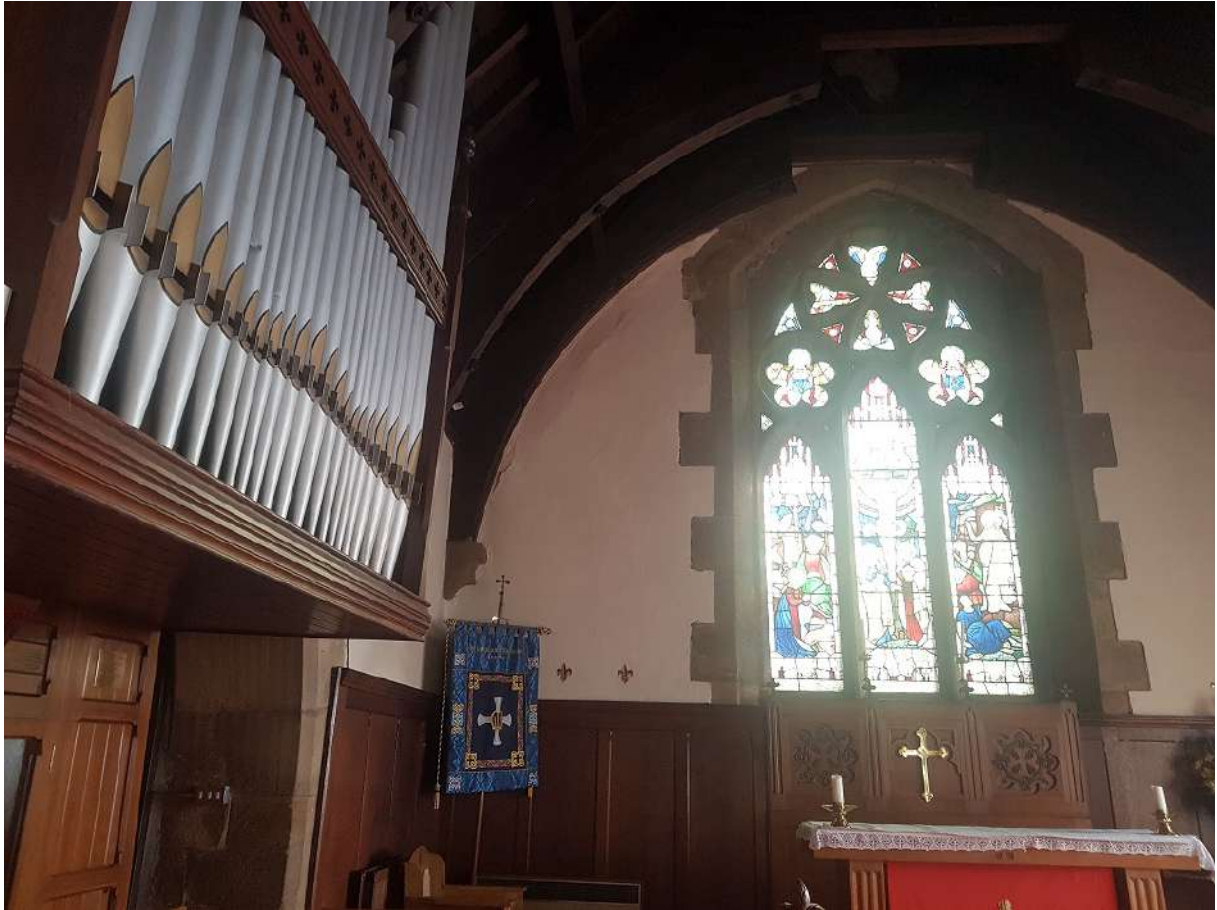
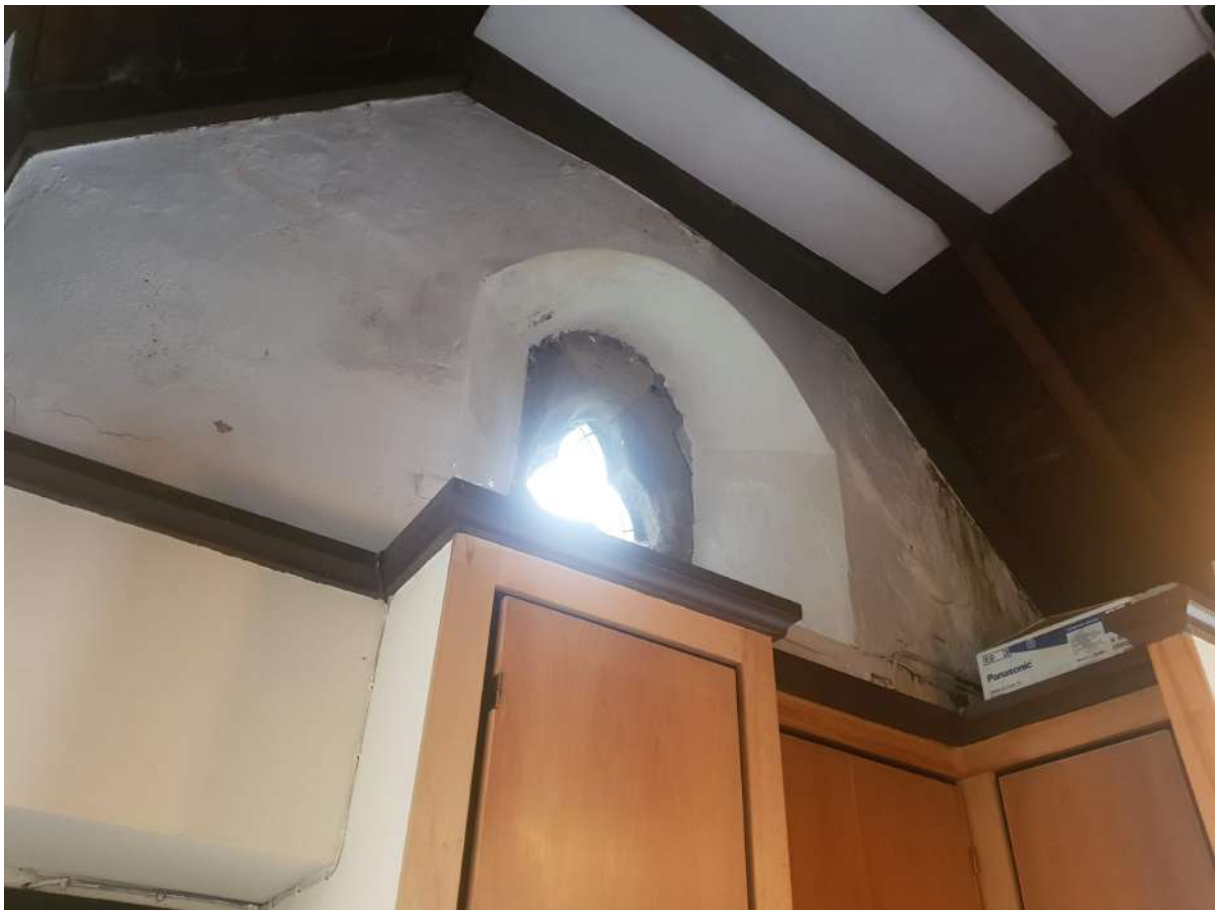
1. Vestry North End (high level) – There is evidence of increasing disturbance to the plaster finish to the north elevation, east side bleaching across to the existing trefoil window. There is efflorescence present on the painted surface and paintwork is starting to bubble and breakdown.

Reasons for this defect may well be linked to the condition of the water tabling as described in item 6.2.1.

It is recommended that lime : sand plasterwork repairs is carried out, followed by redecoration.
