QUINQUENNIAL INSPECTION REPORT

DURHAM, ST GILES

**QUINQUENNIAL INSPECTION AND REPORT
March 2017**

David Beaumont BA (Hons) Grad Dip, RIBA, AABC

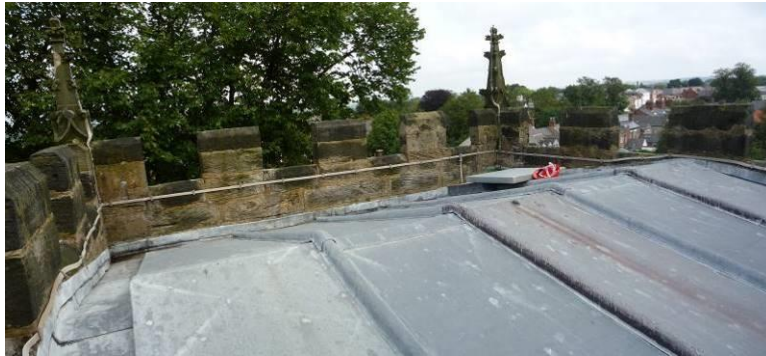
B Tower Roof:

Lead covered, in fair condition. Slight cracking at the flashing to the parapets which could be attended to when attending to the roof areas.

Recommendation: check all pinnacles for soundness, repair pinnacle

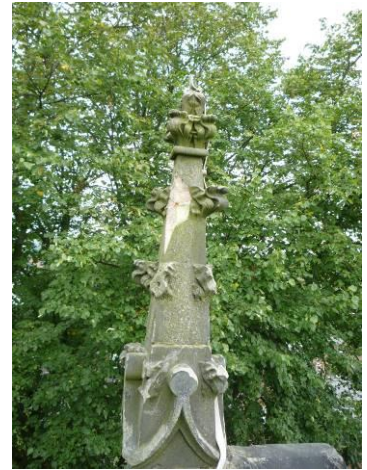
North west pinnacle stone fractured which was taken down during the inspection.

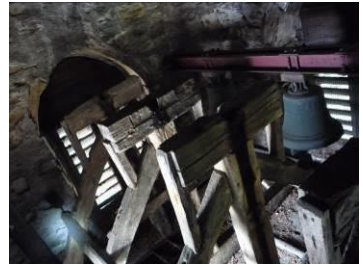
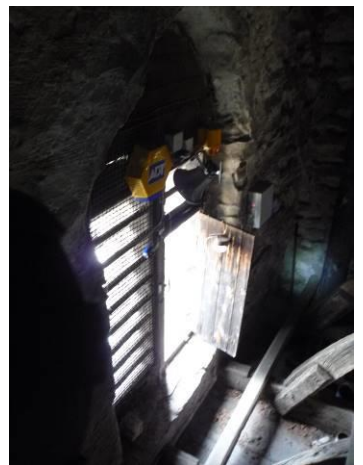
Belfry:

- Ceiling – Exposed, boarded with one central beam. Supported purlins and boarding in good condition.
- Walls – Lime washed and heavy cement pointing and there are some deep pockets of erosion, particularly to the west and south faces and these should be looked at. They have an impact on the structure of the tower.
- Floor – Lead lined with two outlets on the east. Quite a large build-up of leaf litter on the floor.
- Windows – four louvered windows with mesh that has broken down and will allow birds in.
- Large medieval bell frame with some woodworm, though this looks dormant.
- Door – onto nave roof formed through the louvers has rusting hinges and loose cabling for the roof detection system.
- Contains three bells hung from the rusting steel frame, operated by clappers connected to ropes down to the tower ground floor.

Recommendation: repair walling stonework, clear floor leaf litter, repair mesh, ease roof access door and clip loose cable, derust bell frame and paint

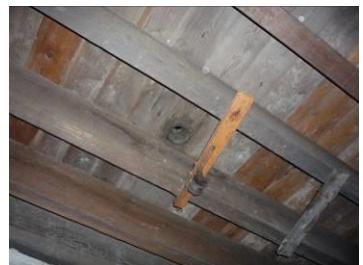
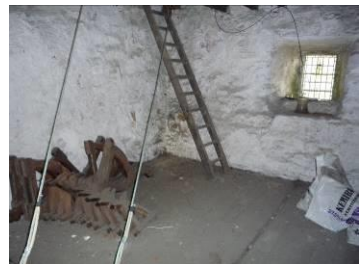
Deafening Chamber:

- Ceiling – boarded with exposed joists, in good condition though there are some holes from previous bell ringing arrangements.
- Walls – lime washed and in good condition.
- Floor – boarded, in good condition.
- The room contains various bits of lumber and old pew ends which should be cleared out.
- The wooden ladder gives access to the belfry above and a grab handle should be installed at the head of the ladder to assist passage onto the belfry floor.

Recommendation: clear lumber, add grab handle at head of ladder

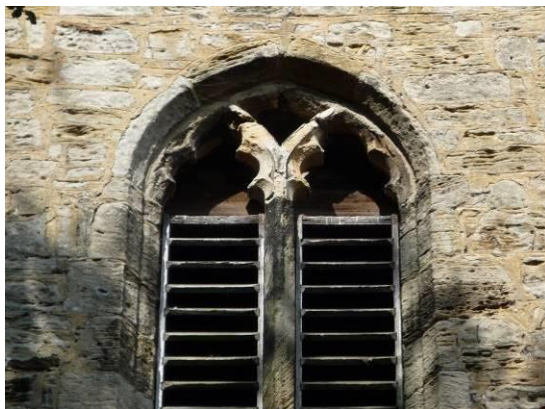
- South elevation –

- Upper – erosion to the Y tracery, rust showing on the ferramenta to the deafening chamber window.
- Middle and lower – stonework okay.

Carry out selective stone walling repairs, assess tracery condition and repair as required, Redecorate louvre boarding.

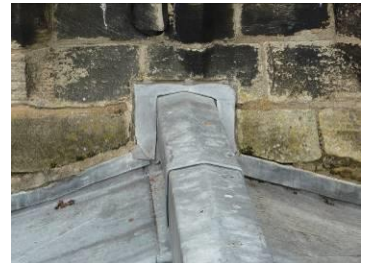
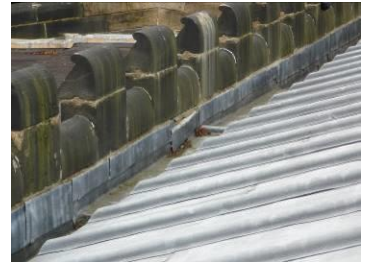
Nave:

- West abutment - Small area of pointing missing against tower
- North parapet - Okay
- East abutment - Open joints at the flashing
- South parapet - Slipped flashing mid-way along the length.

Recommendations: consider changing mineral felt coverings to more longer lasting finishes, repair loose flashings and repoint open joints to walling and chancel/nave watertabling, repair south aisle parapet gutter lining over Lady Chapel, remove leaf guards

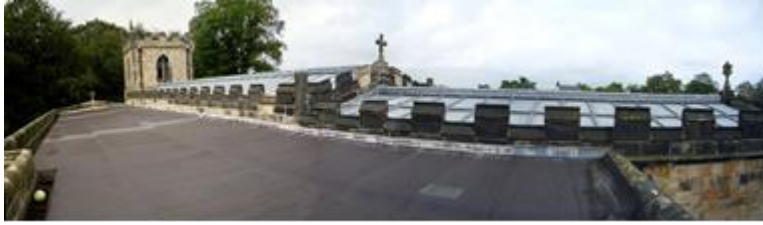
South aisle:

Formerly a lead roof, but now covered in mineral felt which has had some patching, it would be worthwhile understanding when this was installed to gauge better its life expectancy.

- West abutment – okay
- North abutment – one piece of lead flashing coming away
- East abutment – flashing in mineral felt with some cracking to the pointing.
- South abutment – okay. The parapet gutter in the south-east corner appears to be sunk and is back falling and this has potential for providing water ingress into the Lady Chapel below.

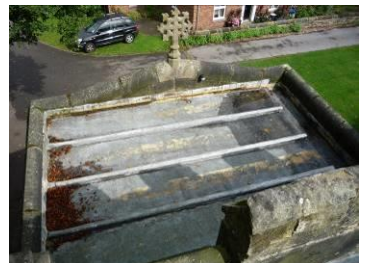
Porch:

The roof is in lead work with lead flashings, these appear all okay though there is some leaf build-up and some yellow painted onto the roofs is now eroded away. This is probably for detection purposes perhaps?

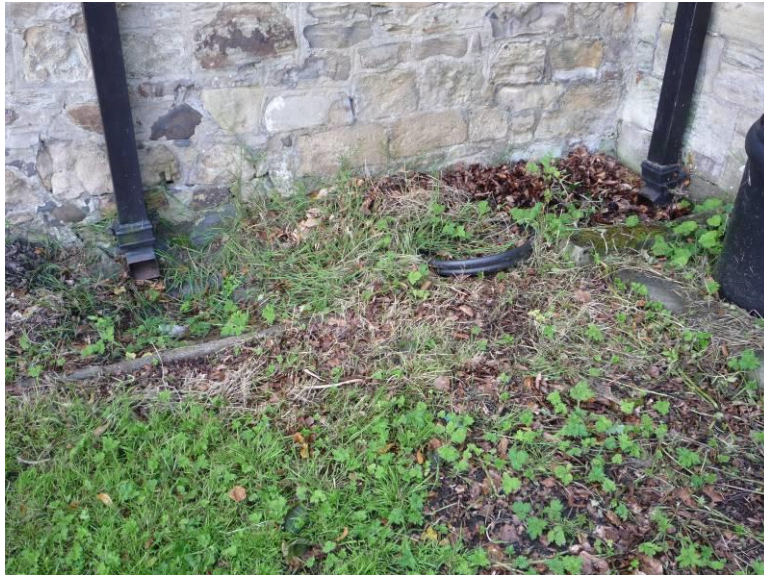
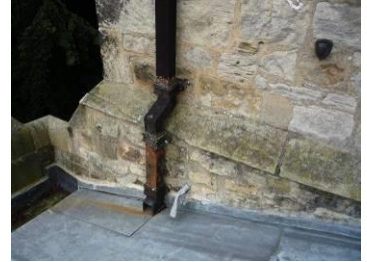
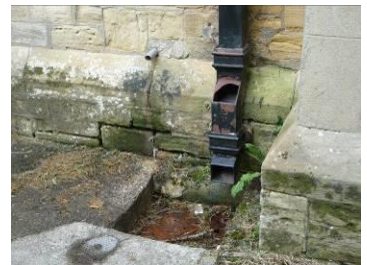
B RAINWATER GOODS

The roofs are all drained by parapet gutters that lead to wide, lead lined outlets to modern hopper heads to Victorian square section downpipes. The majority of the downpipes are sound, however there are some loose feet to the downpipes. Anti-climb paint has been put onto the upper reaches of some of the pipes.

They lead to clay gulleys with grids, some of which are metal sheets with holes in. Some of those are silted up and covered with vegetation. The concrete channel that lines the church, similarly so is weedy and needs cleaning out.

Recommendation: The rainwater downpipes need a complete review and repairs carried out to loose and broken items. The gulleys and perimeter channels need clearing. Renew anti climb paint

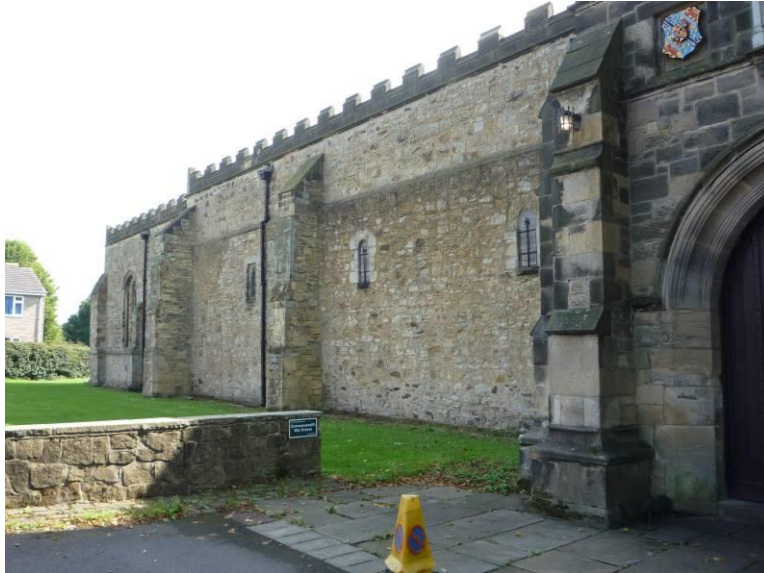
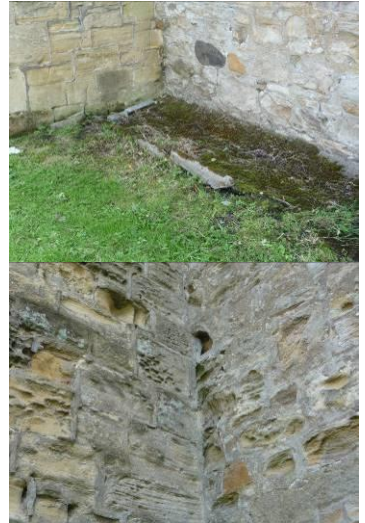
Nave:

Medieval wall cement pointed, however in very good condition. Some isolated pockets of erosion, one at the return of the porch and around the north door and junction to chancel.

Recommendation: Update the walling assessment carried out by the Jeremy Kendall and plan for a significant round of repairs

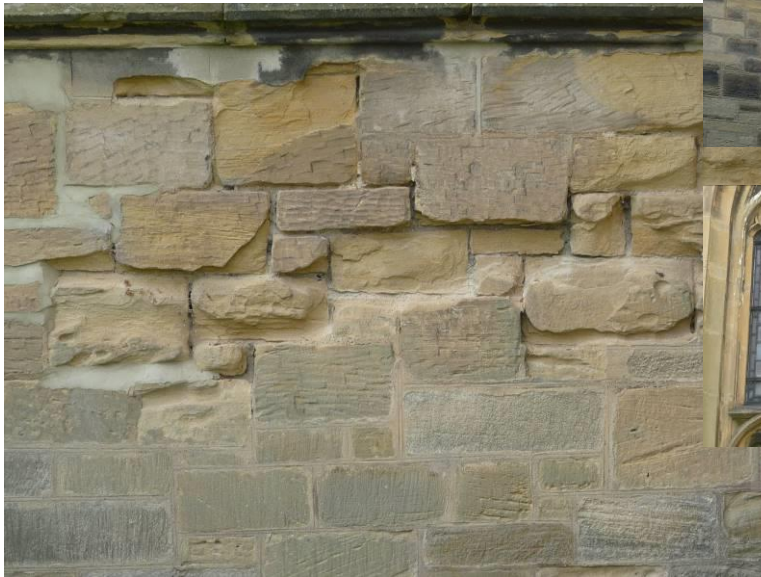
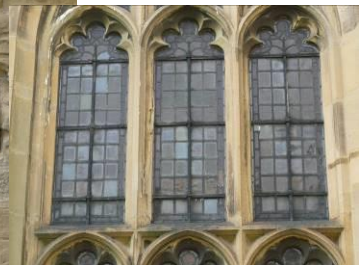
Organ chamber:

- East – open joint and fractured stone on parapet above string course. Splitting to mullions of window.

- Major loss of stonework below string course adjacent to boiler house.

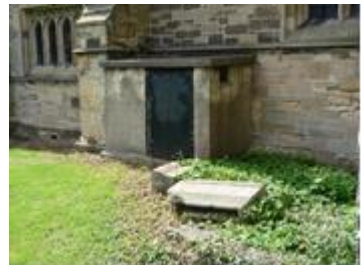
Blower House:

Brick structure with rendered walls coming away. Concrete roof in reasonably good condition. Has a metal faced door with twin locks that is okay. Internally contains the blower mechanism. Some slight salting on the walls which could do with being brushed down.

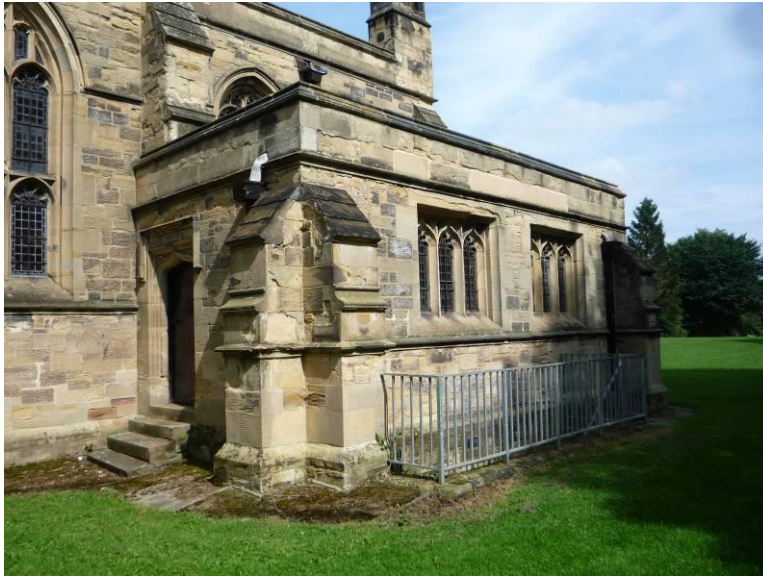
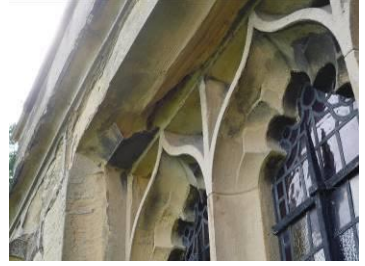
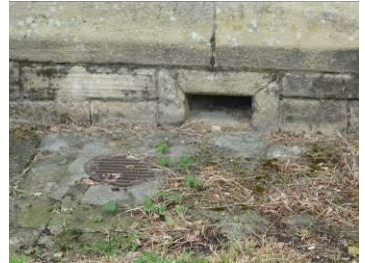
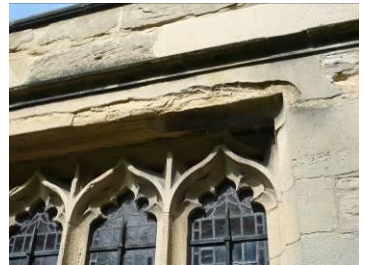
Vestry:

- East – walling generally okay, but the lintel to the four-light window has severe erosion in its south end. Below it, the opening for the former coal hole is unguarded and requires mesh to it.
- South – stonework flaking at parapet and has seen recent replacements. The lintels to the windows are degrading, as are the mullions.
- West – contains a bolted, metal faced timber door with its hood moulded inscription above beginning to become eroded now. This door isn't used. The steps are tilting downwards slightly. The buttresses to the vestry are laminating. Former anti-climb paint painted on the top stage is worn off now.

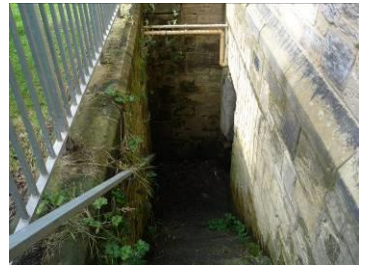
B Boiler house:

Stepped area to boiler house is okay, though the retaining wall at the side of the steps has open joints. Internally, the boiler house has barrel vault brick ceiling, painted black no doubt to try and reduce damp penetration. This has worn away now and there is salting to the roof.

- Walls - stonework with occasional brick patching that are okay. Coal chute hole is open to the outside and allowing in dust and leaf debris.
- Floor – brick and soil, undulating but reasonably fair.
- Room contains the new boiler with Grundfos pump and condensate pump.
- Room contains racking for storage of kayaks for the Scouts and the room is rather full of that and other

items. There is also rot to some loose timbers that need removing.

Recommendation: repoint open joints to stair retaining wall, provide guard to coal hole chute, remove lumber and rotten timbers, reassess room condition, treat remaining timbers if considered necessary

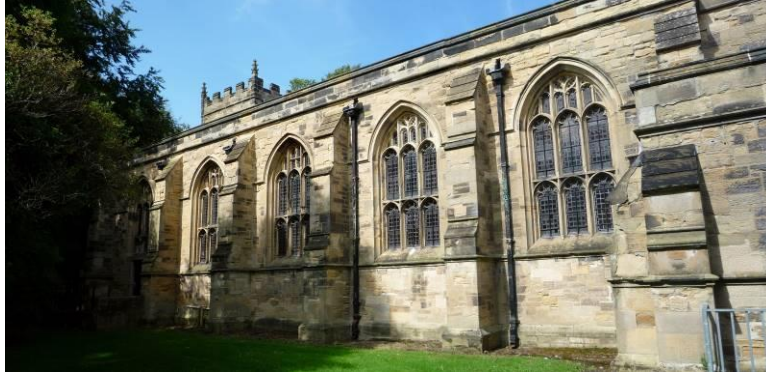
South aisle:

- South - This elevation is the most decorative of the elevations and suffering from major stone erosion to not just the walling but also the windows. It is undergoing a period of renovation and there is further work to do. Stone erosion, in particular over the whole of the elevation and a combination of de-shaling and new stonework is required. Of greater concern, perhaps, is the condition of some of the mullions and they are splitting at their junctions.
- A comprehensive survey of the stonework was carried out by Jeremy Kendall a couple of years ago and it is recommended that this be brought up to date and a comprehensive restoration programme be put in place.
- West – the raking parapet has open joints and some stone degradation on the south side. Also, the string course is broken at that point. The window similarly is suffering from a fracture to the mullions of the tracery.

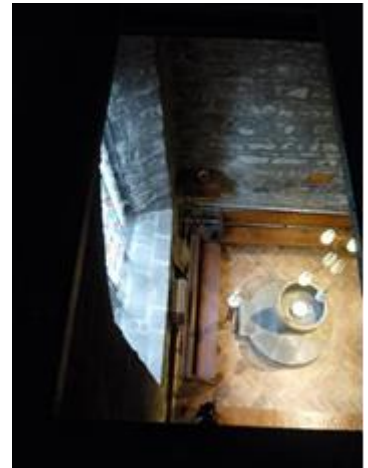
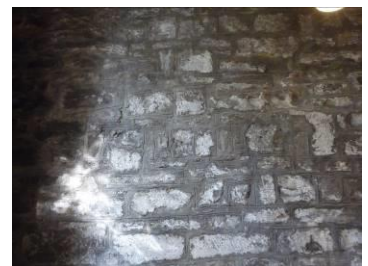
Tower Baptistry:

- Ceiling – flat ceiling with boarding with exposed beams, all look in reasonable condition.
- Walls – heavily cement pointed with some slight cracking, possible 1-2mm on the south side. The west wall contains the window. The tracery mouldings look okay from the inside.
- Within this space is the font and ringing mechanism for the bells.
- Floor – narrow parquet flooring with some wear to it, but reasonably fair.

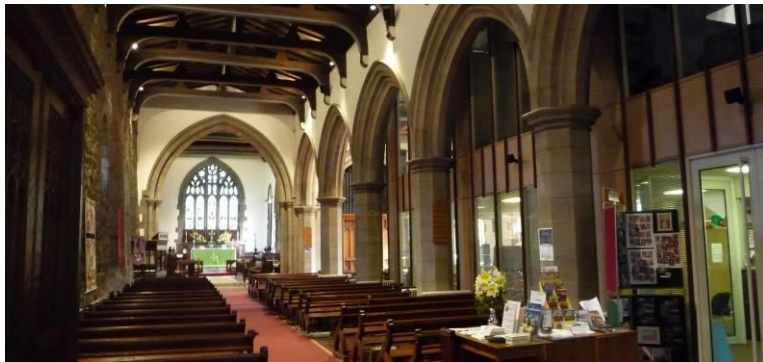
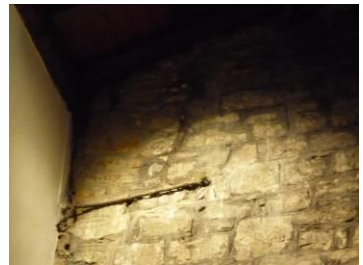
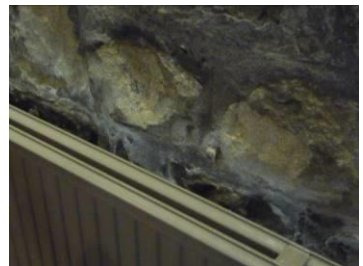
Nave:

- Ceiling – exposed boarding with horizontal beams supporting ridge and purlins. Only a couple of areas of water marking, though these will probably be from the previous leaking roofs. Some woodworm established to beams at the west end when redecorated in 2016. Only seen at the outer edges of the beams and not affecting structure.
- Walls –
 - West – slight crack at high level by the pipe, heavily cement pointed. The arch has a slight crack and the final stone at the apex doesn't look quite right but will do.
 - North – this is the medieval wall leaning outwards. Very little defect to it, apart from at low level by the radiators where there is some slight lamination of the stone which is down to the cement pointing.

- East – this contain the chancel arch and all looks sound though there is damp at the bottom of the base of the shafts.
- South – this is formed of a five-arch arcade and is part of the Victorian restoration works. No cracking above the arcade and recently decorated. The arches are all sound, as are the columns, apart from their bases towards the western end where there is a loss of detail, though structurally they are all sound.

Recommendation: arrange inspection of woodworm in nave

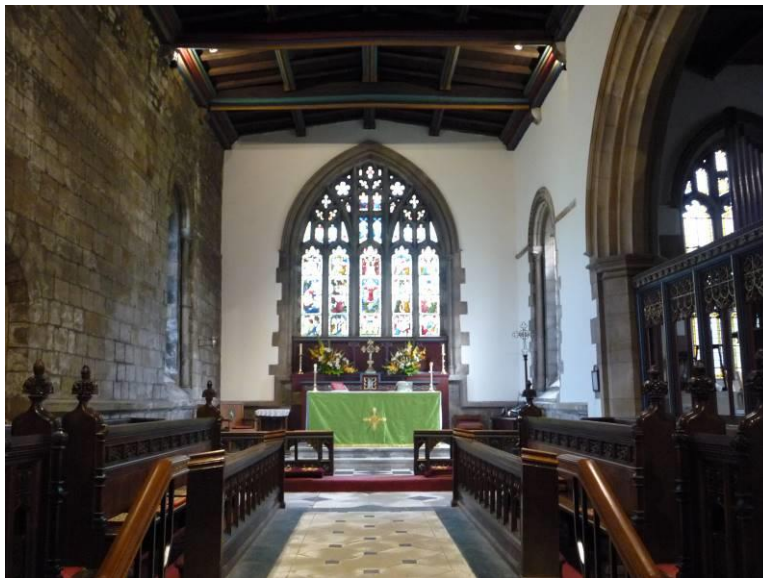
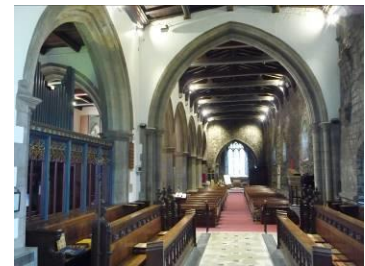
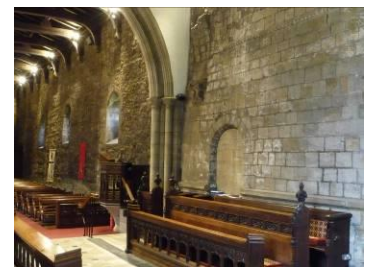
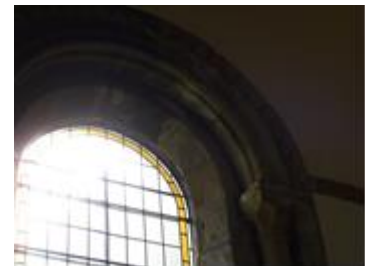
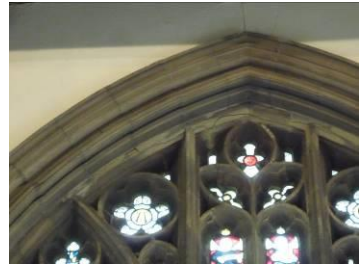
C Chancel:

- Up two steps.
- Ceiling – as the nave. Slight crack to the final beam, but this is a joint which has been bolted in the past and looks sound enough.
- Walls –
 - West – features the chancel arch. No cracking. Same as within the nave.
 - North – some very heavy, nasty cement around the middle of the wall at high level. There are remnants of lime wash showing on the wall, also part of a former arch blocked in north doorway. All looks like sandstone. The window is okay, though there is some slight wasting to the eastern most nook shaft end.

- East – plastered apart from low level which is exposed ashlar stonework. Both appear okay. The window apex has a large horizontal crack in it and there is also some settlement to the arch stones looks historic, but with the evidence of cracking on the outside it suggests that there has been some wall head spread. Overall the tracery is in fair condition on the inside. The church report that the crack above the apex is new.
- South – recently decorated plaster wall, looks okay. The window within it is okay.

- Floor – marble at the sanctuary and all reasonably okay. Within the chancel is flagstones with slate inserts and whilst they show signs of damp, they are all serviceable.

Recommendation: further technical assessment of east gable

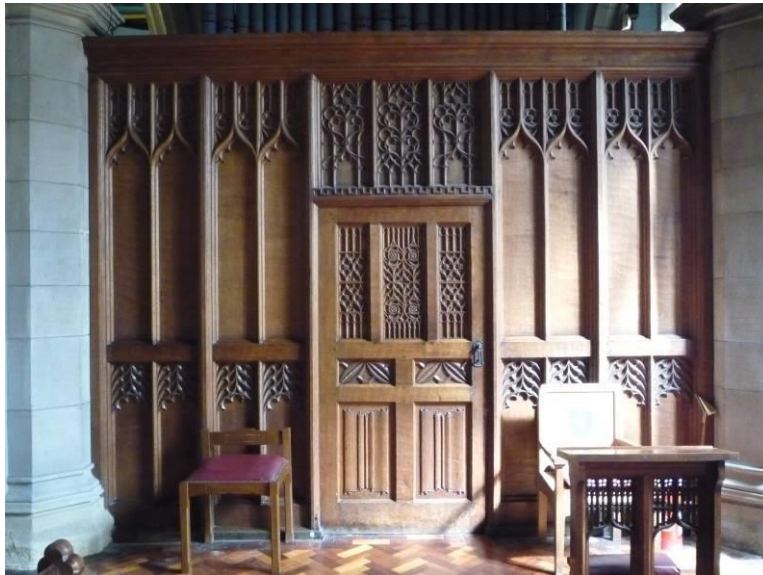
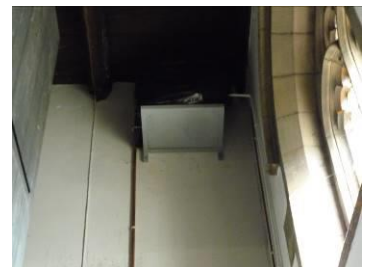
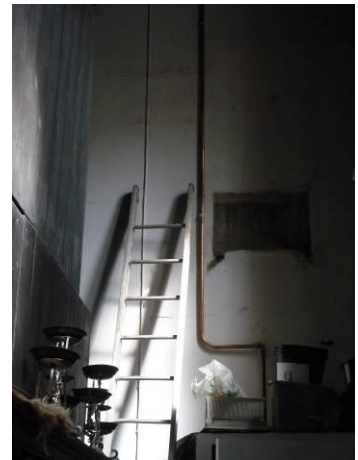
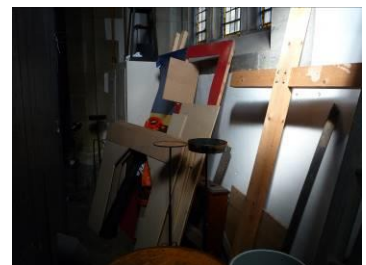
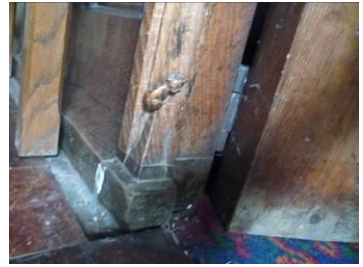
B Organ Chamber:

- The space is filled by the organ.
- Ceiling – same as the Lady Chapel. There is some white marking to the boards at the eastern end, is this historic? The parapet gutter is recommended to be remade above it.
- Walls –
 - West – arch leading onto the Lady Chapel in good condition. Below this is a fine oak screen, perhaps by Walter Thompson of Kilburn.
 - North – arch into the chancel. Some degradation of the stonework at the apex possible. Problem with the flashing to the roof?
 - East – plastered wall, has a large window in it with buckling glazing. The wall is okay but there is a lot of lumber around here and a header tank.
 - South – seems reasonably fair, some slight creasing but the windows seem okay.
- Floor – solid carpeted floor.

- The room contains the organ, interestingly there is some quite big erosion at the eastern arch at the chancel. The room contains quite a bit of lumber, maybe some shelving would help? Also, vestments and the electrical fuse board.

Recommendation: check boarding when carrying out the gutter repair, also flashing against chancel may be poor and leaking on to the organ arch, clear out lumber, and provide shelving for the retained items. Assess the glazing buckle

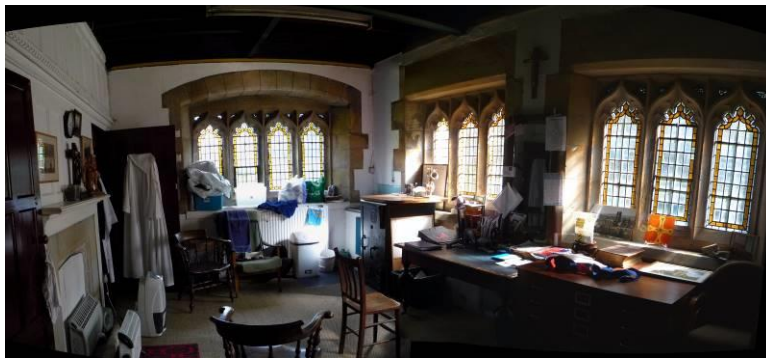
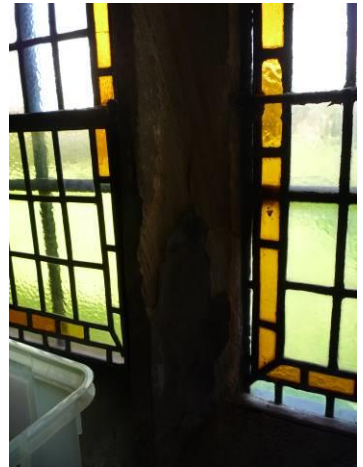
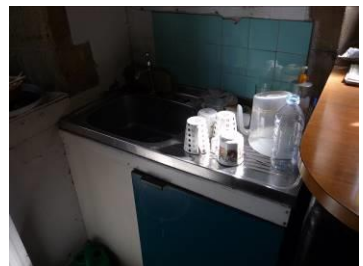
C Vestry:

- Ceiling – Exposed boarded ceiling, no evident defect.
- Walls –
 - West – plastered, some flaking. Slight crack at the lintel to the doorway but looks generally okay. The door is bolted up and the recess has some low-level damp by the bottom hinge.
 - North – panelling at high and low level with former fireplace. Two recesses for robes and for the safe. Crack to the fireplace surround.

- The room has a collection of different heaters and dehumidifiers.
- East – plastered, seems to be okay with a four-light window. Part of the mullion is breaking away because of the rusting ferramenta.
- South – two windows, some splitting to the mullions.
- Floor – possibly suspended with carpet.
- Baxi boiler in small cupboard.

Recommendation: include the windows into the stonework assessment

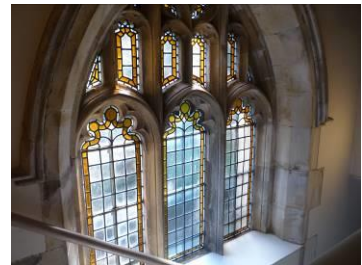
- Carpeted and creaking at the lower flight. The upper landing has a large south window to it and this has a lot of salting on it and the lamination of the mullions that can be seen outside is beginning to start on the inside. It has had cement repairs in the past.

Recommendation: Needs dusting down and be a part of the walling repair scope.
