St Giles, Durham
County Durham, DH1 1QQ
DIOCESE OF DURHAM
Quinquennial Inspection

CONDITION SURVEY 2023

Prepared on behalf of the Parochial Church Council

by Ian Wells B Arch RIBA AABC

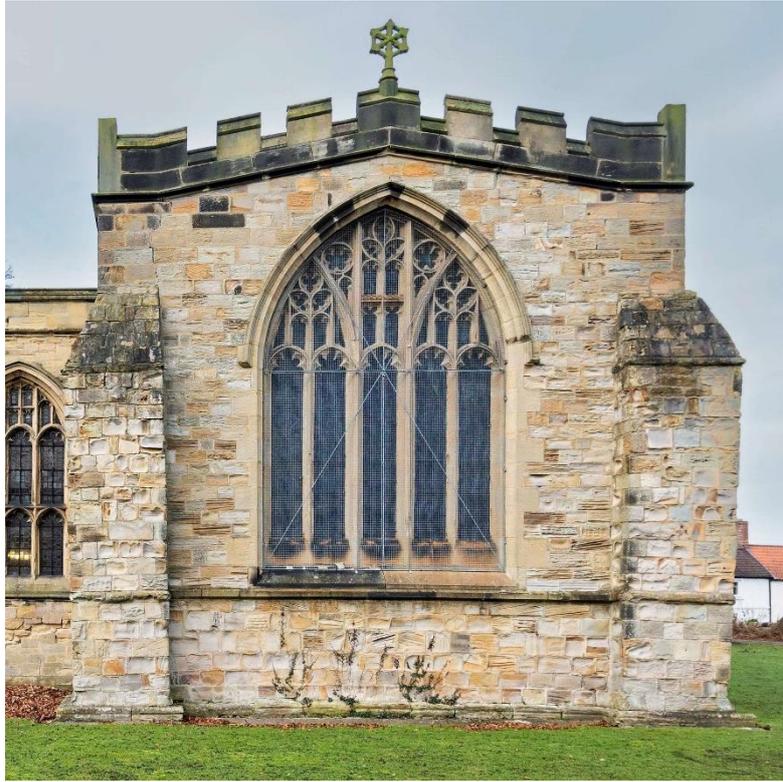
Chancel East Elevation: severe stone erosion.

Leaning south buttress, crack over south buttress, fallen shards of stone caught in window mesh.

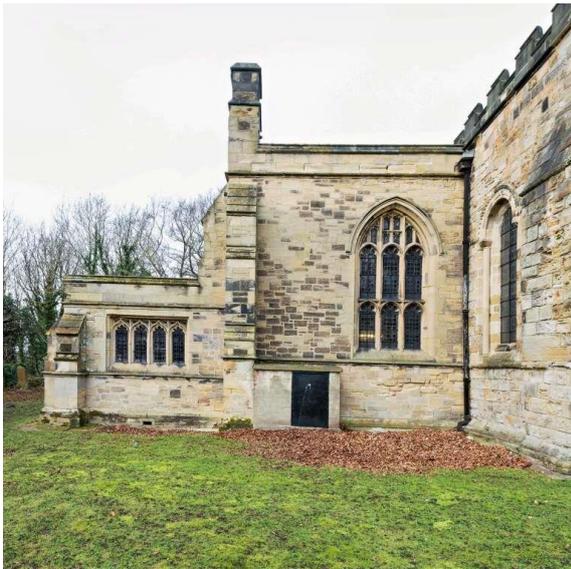
East Elevation: severe stone erosion.

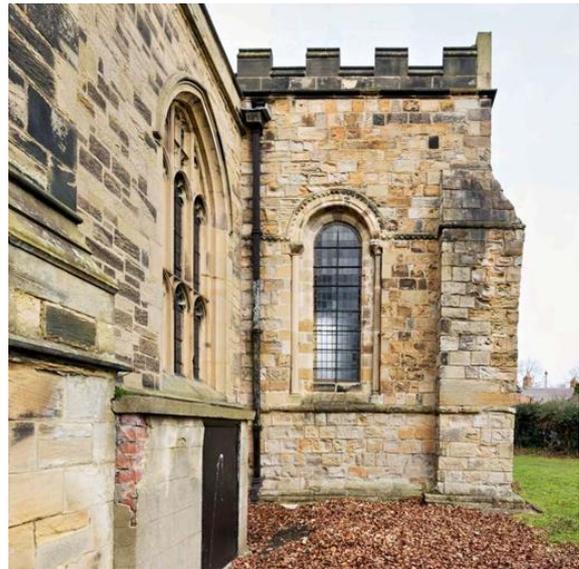
South Elevation: some recent repairs to window.

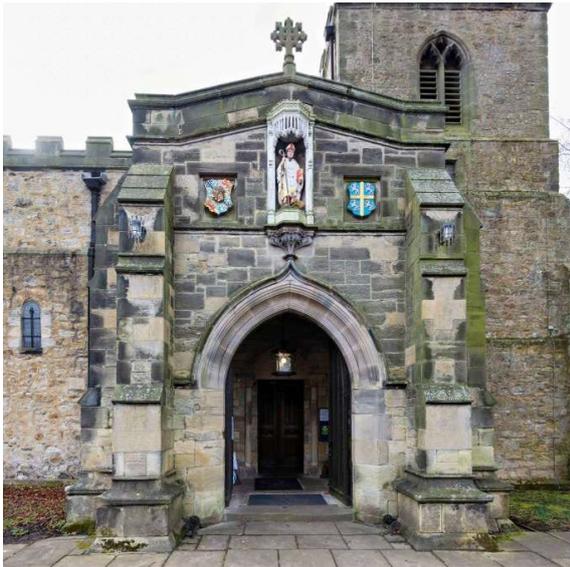
*North Porch: north elevation
Statue and shields recently restored*

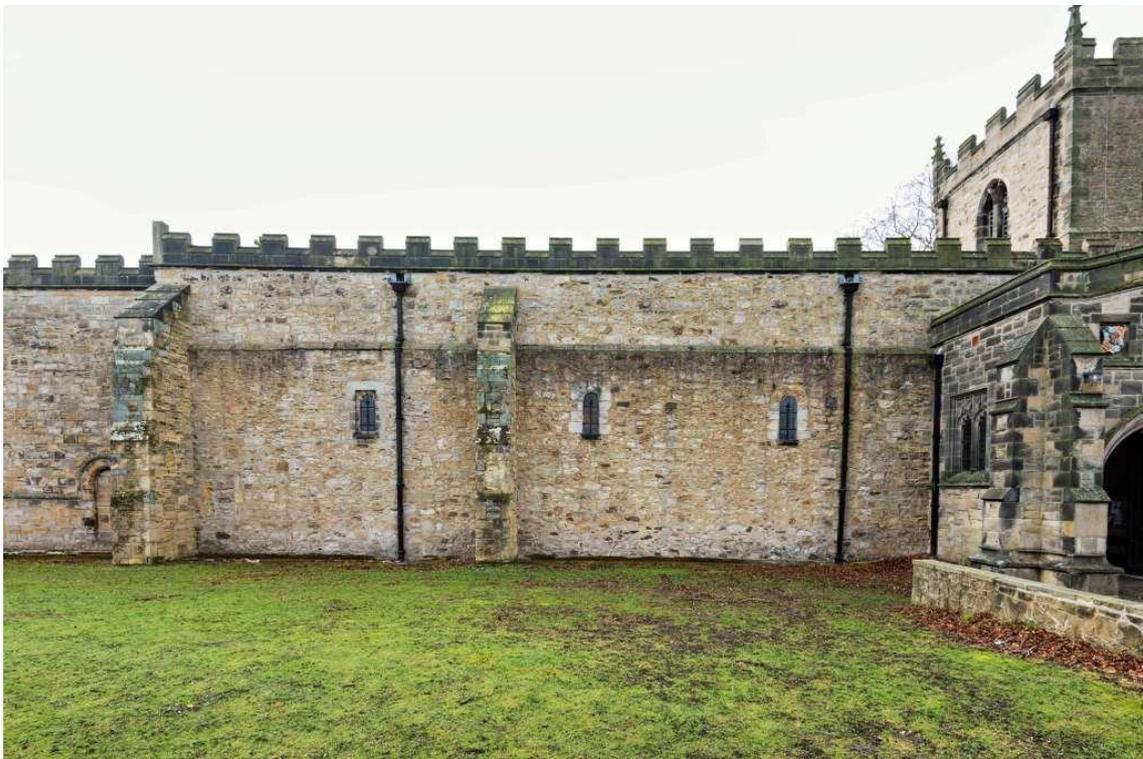
North Elevation of Nave: oldest masonry below the string line.

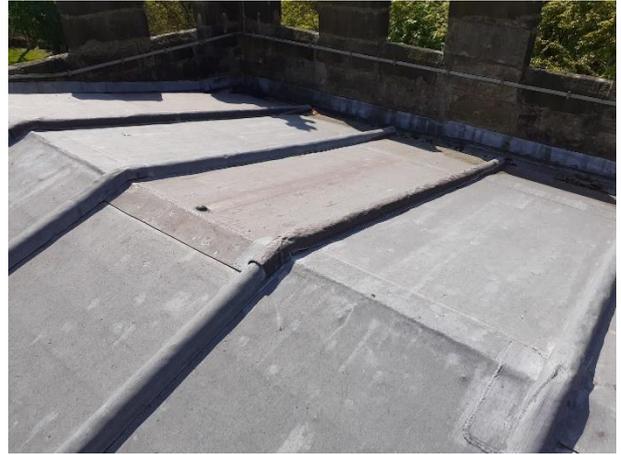
Tower Roof: Lapped ridge with patch repairs

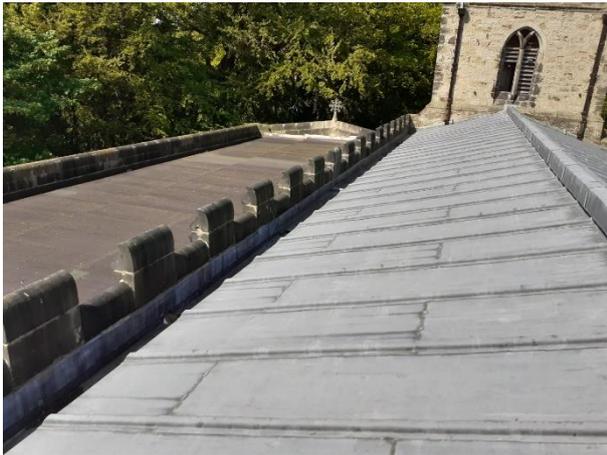
Nave roof south pitch in lead rolls with ventilated ridge and south aisle in stepped bitumen felt

A substrate of softwood timber boards with a bitumen felt weathering dating from the late 1900s. Three 75mm steps are evidence that this roof was originally clad in lead. A bitumen felt gutter runs along the south parapet. Lead flashed abutment upstands to the north, east and west parapets. Currently, this all appears to be in acceptable condition, but it really should be replaced with a longer life material.

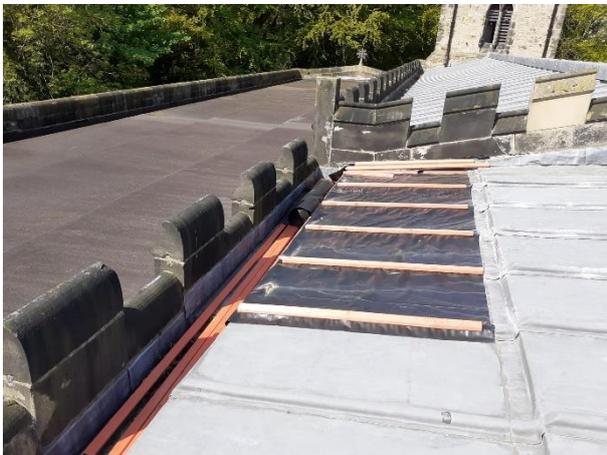
Chancel roof south pitch with temporary repair following lead theft.

The recent lead theft has revealed that lead corrosion is occurring on the underside of the lead weathering. A coating of lead carbonate was found on the underside of the lead trays. This implies that the warm humid air from the church interior is getting to the underside of the lead and condensation is occurring.

The new trays fitted after the theft have been painted with a chalk compound to help reduce corrosion. Further investigation is required to understand fully why the corrosion is occurring.

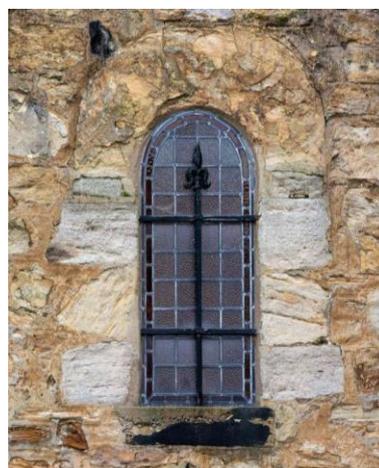
Circa 1112 Stonework

The lower three quarters of the north wall of the nave. This is probably the best quality stone used in the building and the most sheltered from the prevailing winds.

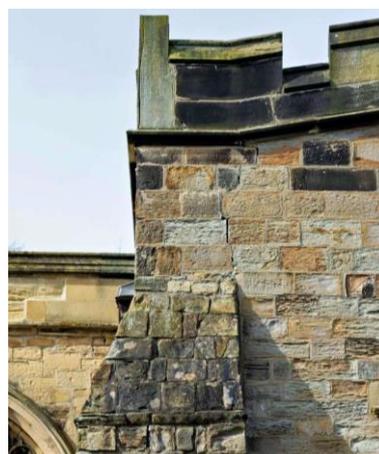
Circa C1195 Stonework

The chancel. There is a significant crack in the east elevation near the southeast corner. It is apparent inside and out; the advice of a structural engineer should be sought.

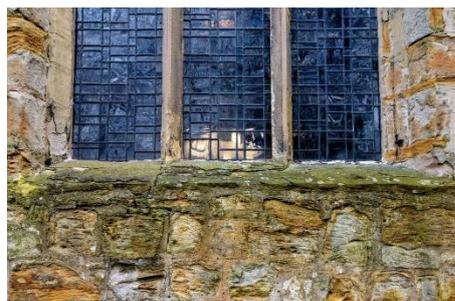
13th / 15th Century Stonework

The tower. Overall, in poor condition with poor repointing and stone exfoliation. The tracery is particularly poor.

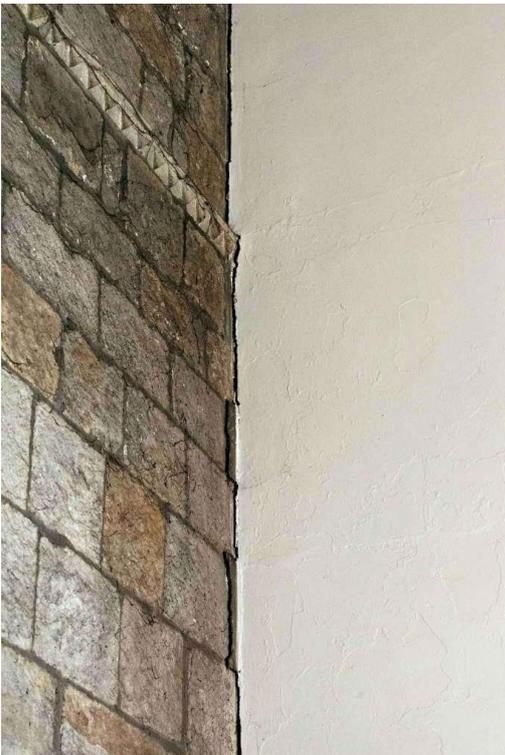
Northwest corner of chancel with movement crack

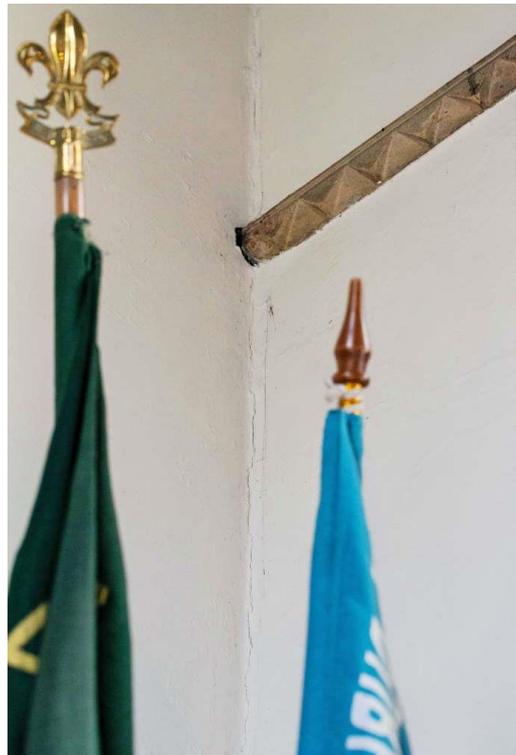
Southeast corner of chancel with movement crack

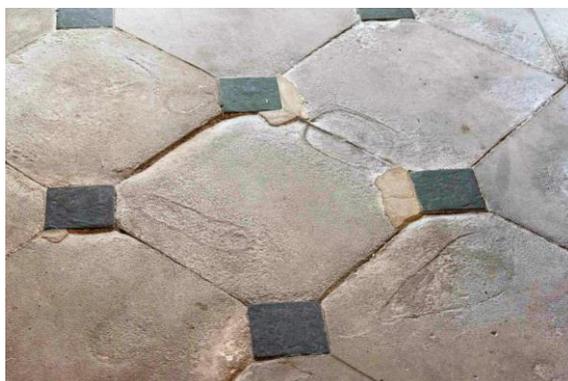
Chancel

Sandstone, slate and marble flagging. Some wear to the sandstone but nothing of particular concern.

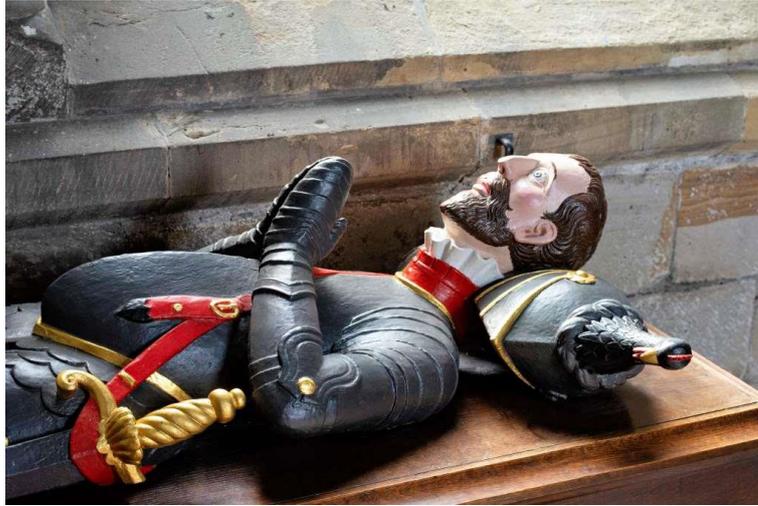
John Heath Effigy

Dating from 1590. Carved in timber and recently skilfully restored and decorated.

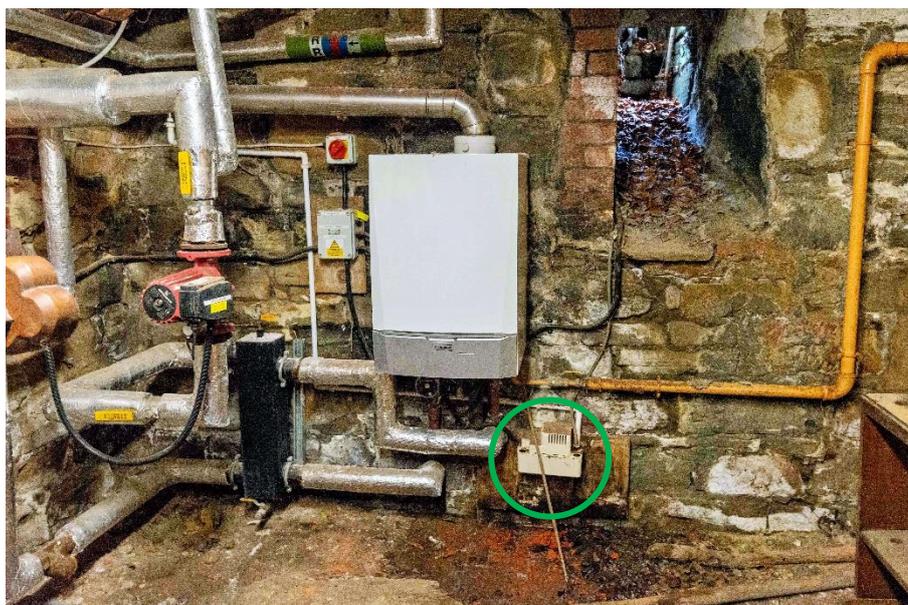
Main Church Boiler: located in the basement below the vestry, it appears to take its combustion air from the room and the flue appears to run in a duct to the original boiler room chimney. There are no pressure vessels in the boiler room, so it appears that the header tank in the organ chamber is still in use. There are oxide stains near the condensate pump below this boiler. It therefore appears the pump may not be working.

The main church boiler in the basement.

Condensate pump ringed in green. Gas supply mustard yellow.

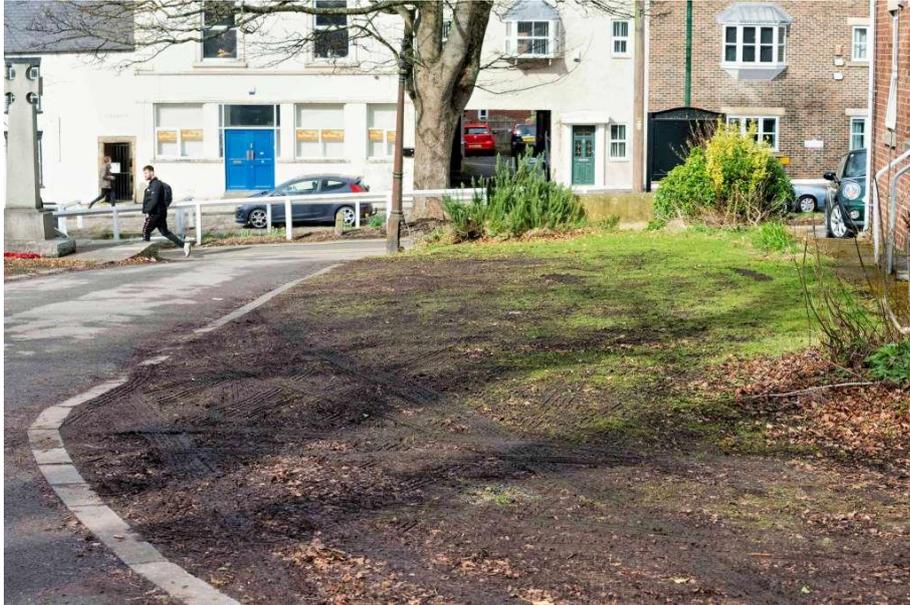
The east side of church drive is used for parking, particularly by neighbours: this is unsatisfactory.

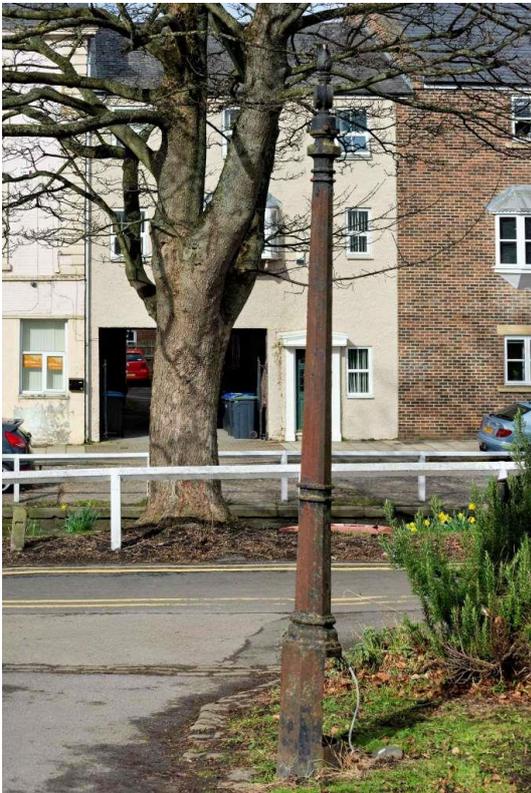
An historic but unkempt cast iron light standard.

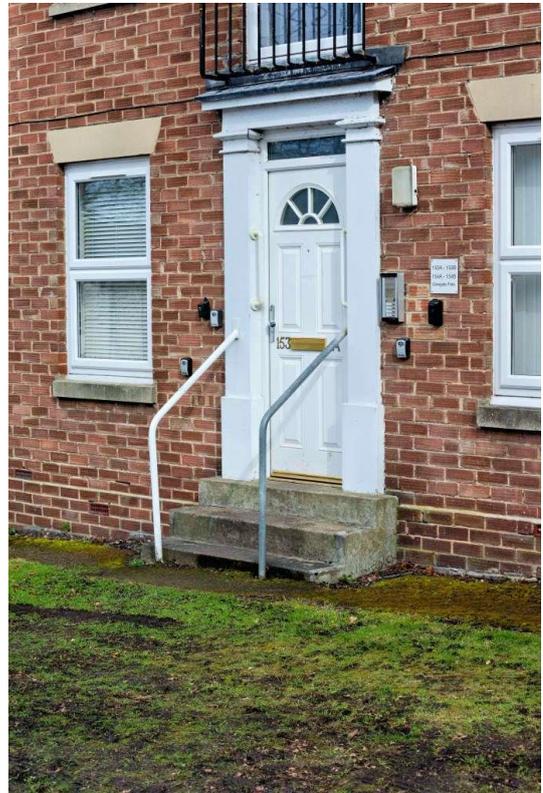
The neighbouring property's communal access door leads to parking on the grass.

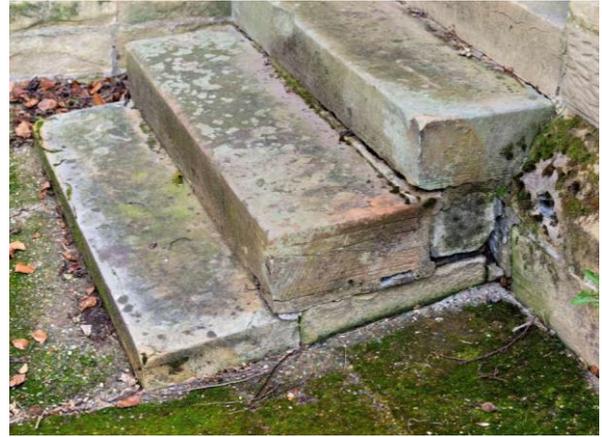
Vestry escape doorsteps: uneven, settled and without a landing platform. They must get very icy in winter.

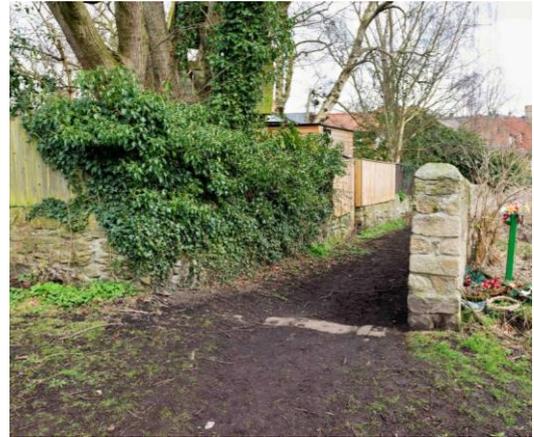
*The entrance to the Ancient and 1927 churchyards
requires a gate.*

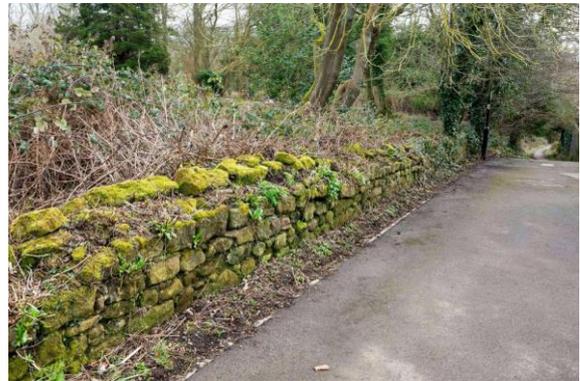
*Decaying wall adjacent to a public highway,
the east boundary of the 1870 churchyard.*

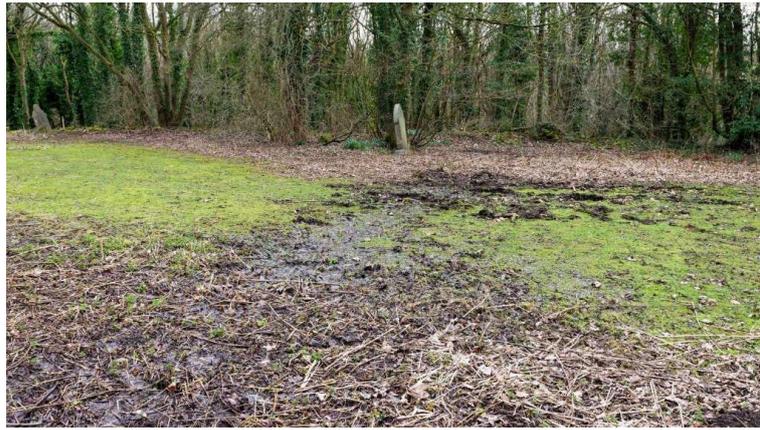
The natural spring, in the 1870 churchyard, which is making the ground very boggy.

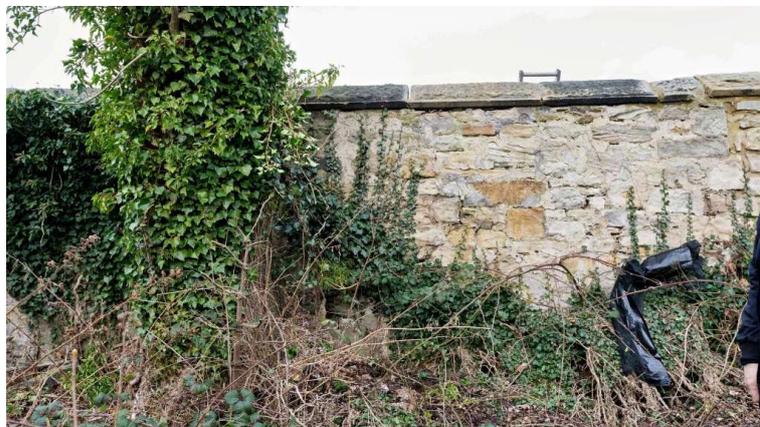
The neighbouring allotment holder is using a ladder to tip rubbish over the wall into the 1870 churchyard.
