IAN NESS
ARCHITECT
26 GROSVENOR PLACE NEWCASTLE upon TYNE NE2 2RE
tel & fax
(0191) 281 2559
i.ness@btinternet.com

18 May 2020

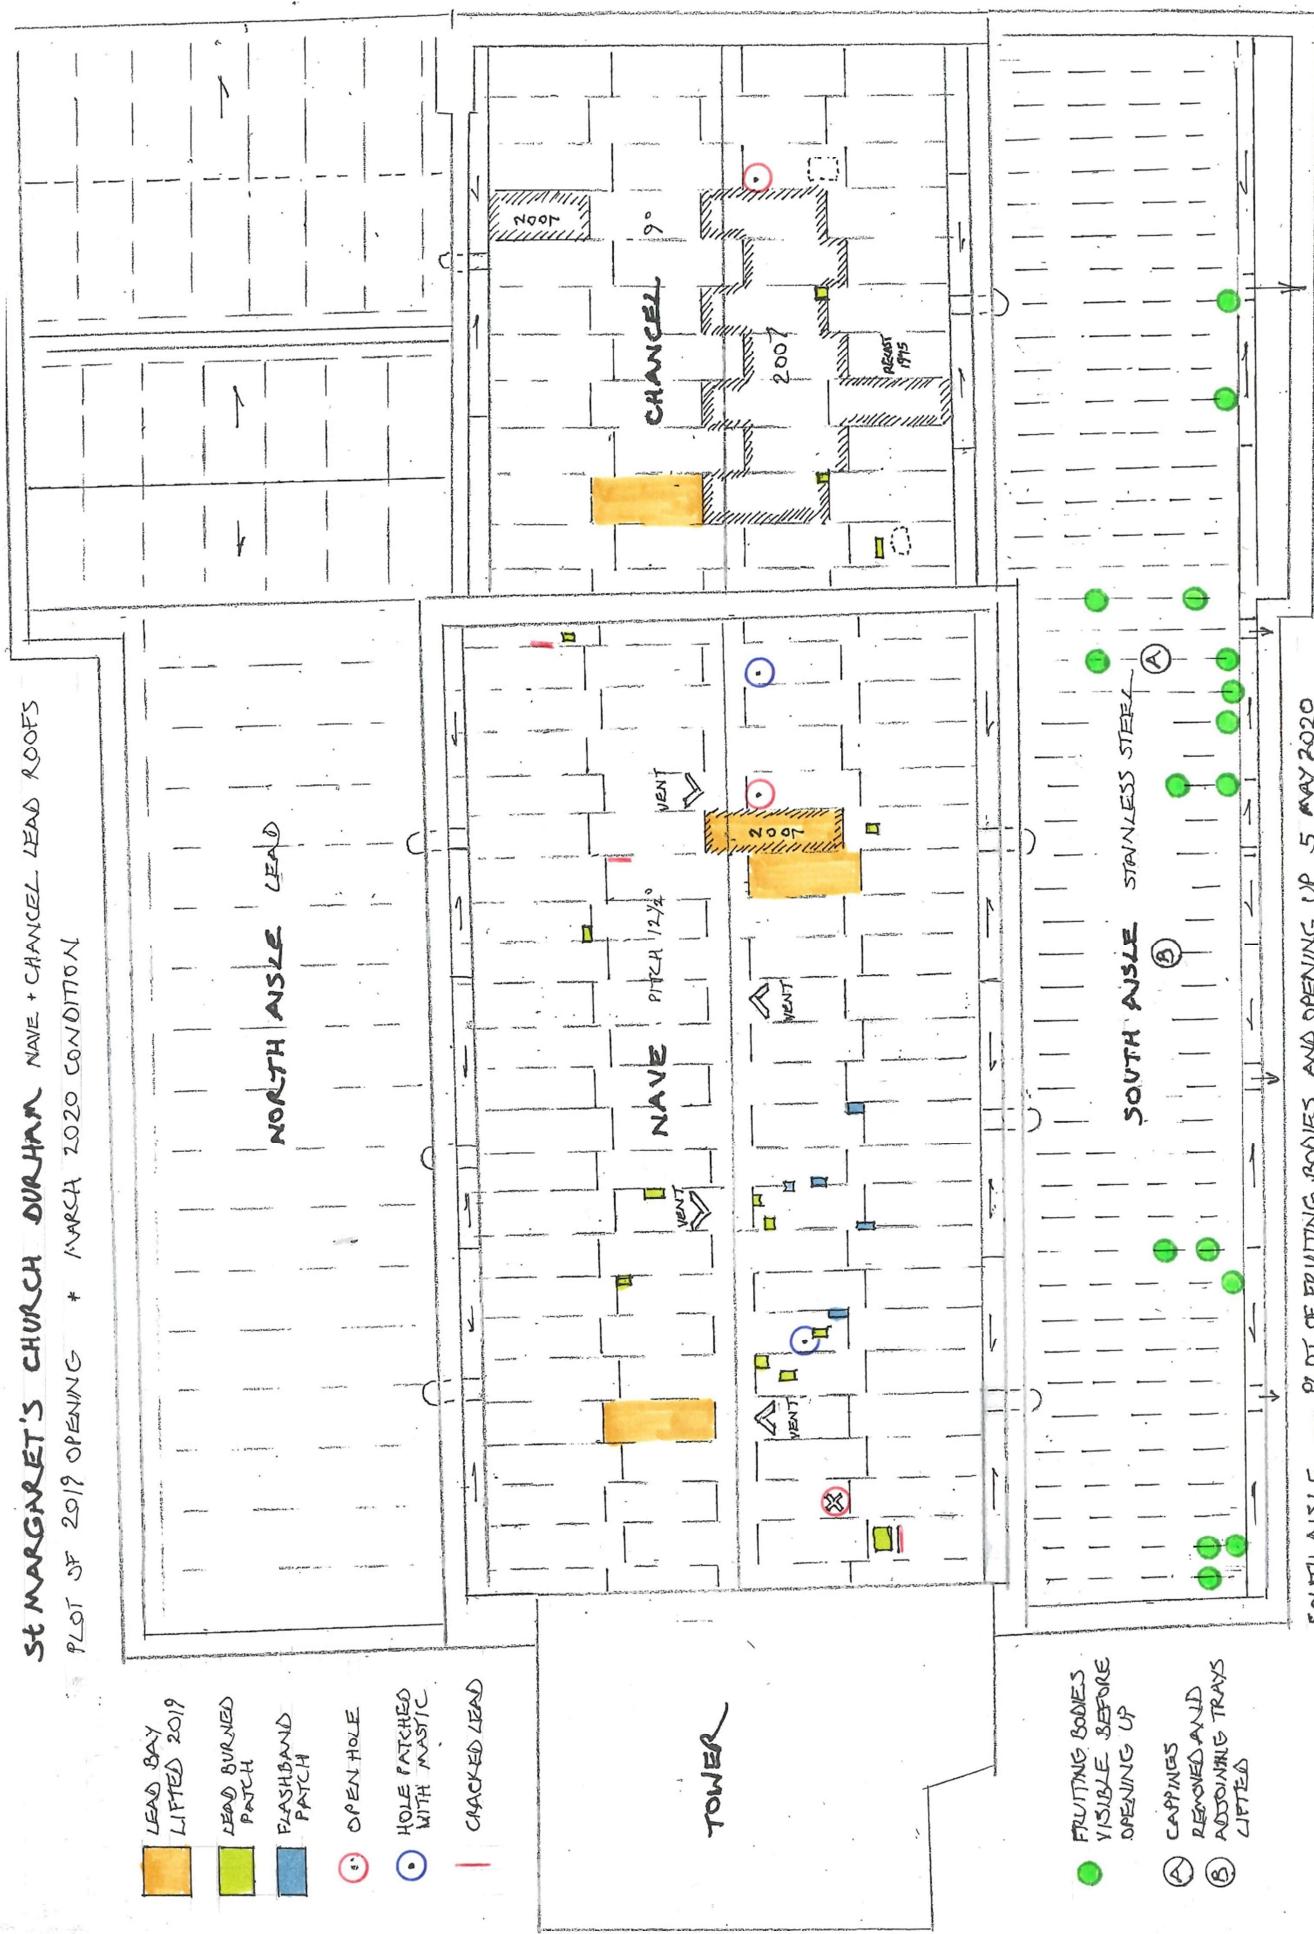
SOUTH AISLE — PLOT OF FRUITING BODIES AND OPENING UP 5 MAY 2020

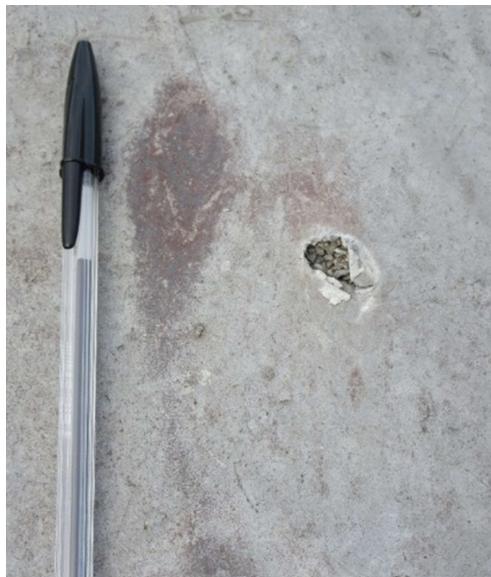
The **Nave** lead may be older. Only one bay apparently renewed in 2007 but there is widespread patching at S and some at N. Overall some 25% bays have lead burned or temporary flashband or mastic patching. Two small holes are open. Two old lead bays were lifted in 2019 and thick corrosion found. One 2007 renewal was opened and found to be protected by paint and building paper except at unprotected laps. It is reasonable to expect all or most of the unprotected Nave lead to be corroded.

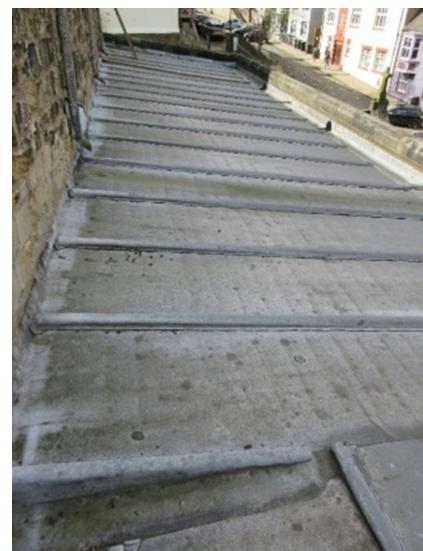
25. **S Aisle** stainless steel laid on sound deadening reinforced plasterboard 2011 after lead theft. Wood batten rolls with upstands against clerestory and gable upstands.

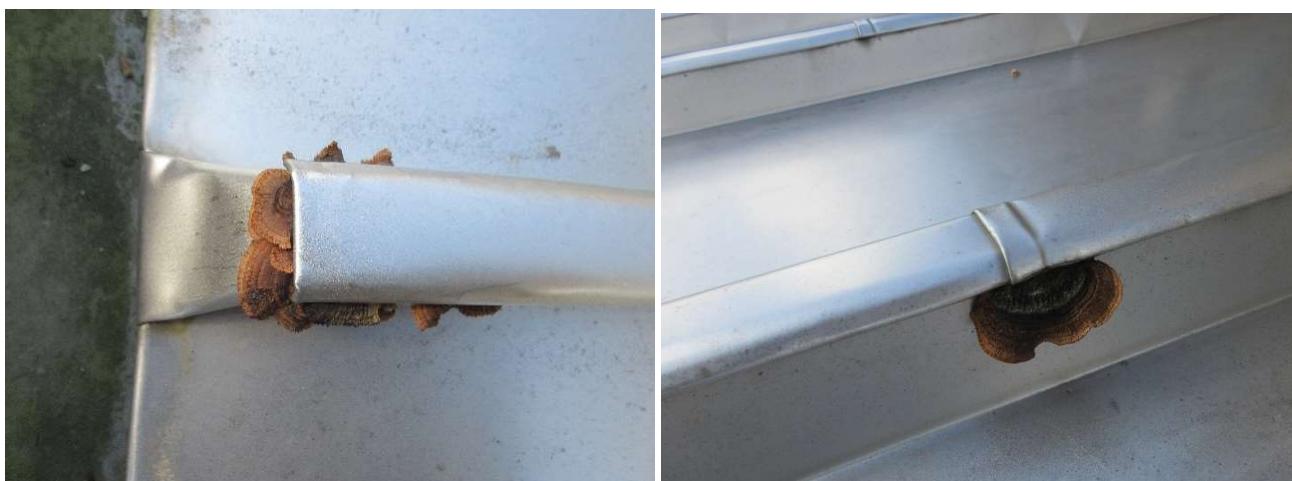
26. At the top of the steel well made lead apron flashings with lead burned saddles over the steel caps.

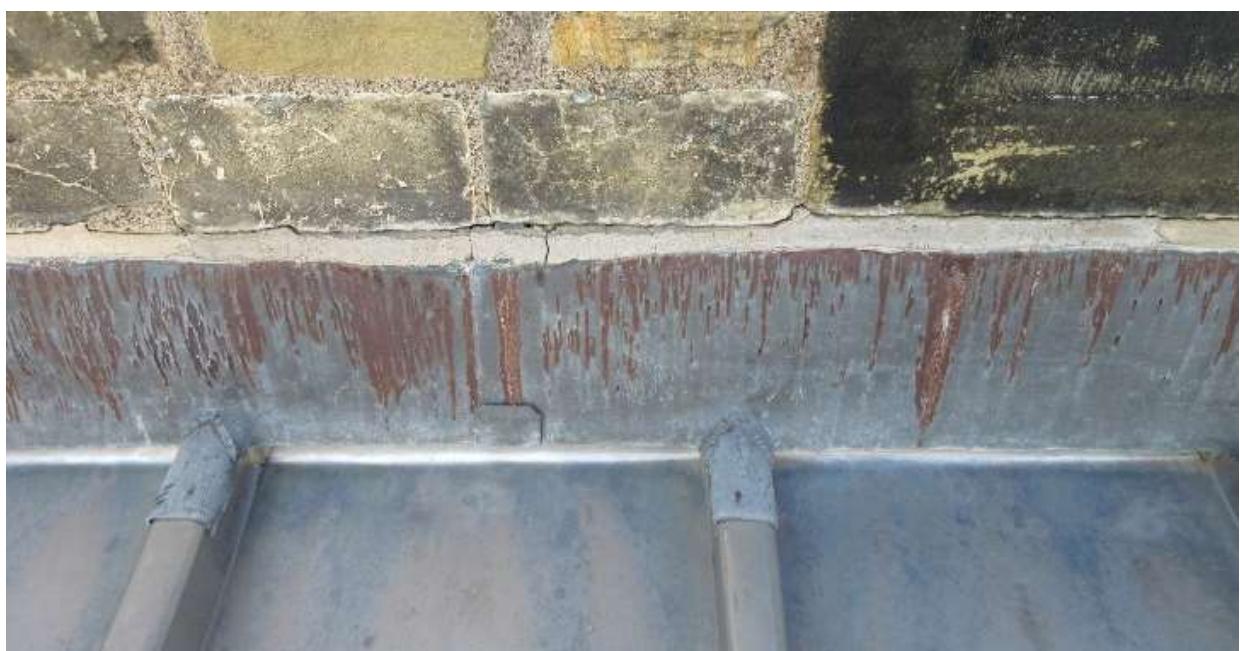
Cracked pointing at flashing at top of stainless Aisle roof

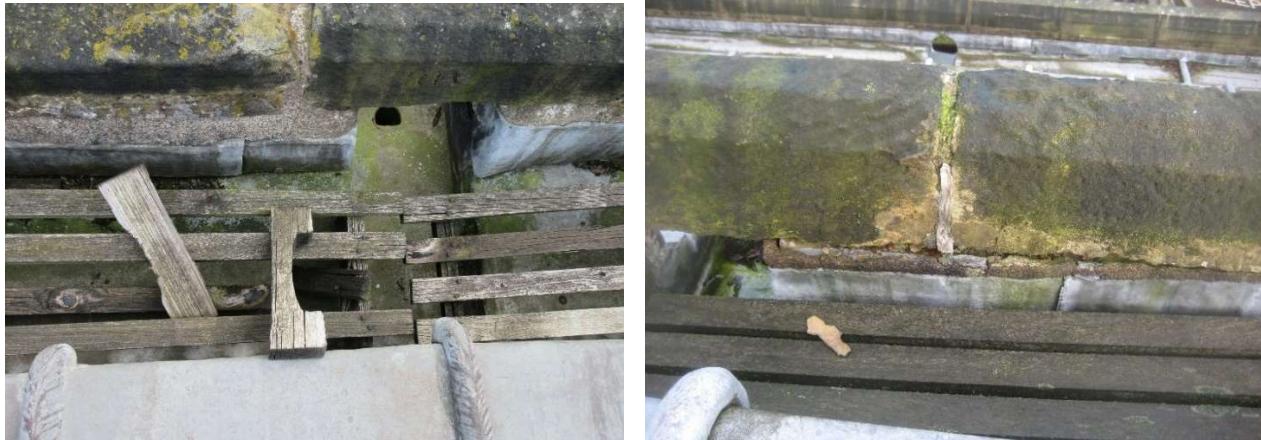
28. Lead cover flashings over the parapet gutters are mainly good. Some past fatigue splits due to thermal movement are covered with short pieces of extra flashing. Parts of the N Nave flashings are loose and need to be changed to wider lead or at least refixed and/or repointed, especially next to the Nave NW outlet.

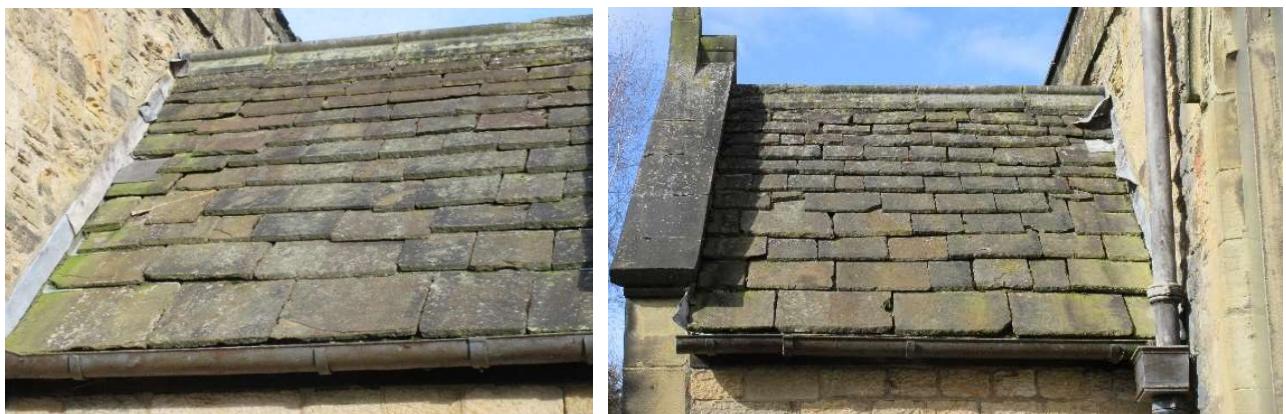
32. **Organ blower/wc** roof felt (1987?) on a concrete slab falling S to an eaves gutter. Turned up into the Vestry wall and into the brick backing of a N upstand.
Oddly the felt upstand does not reach the N stone coping but leaves the top brick course exposed.
Plants grow in its decayed bricks and pointing and the E end of the felt upstand is loose.
The felt roof is part hidden by a sheet of loose plywood. Visible parts appear sound.

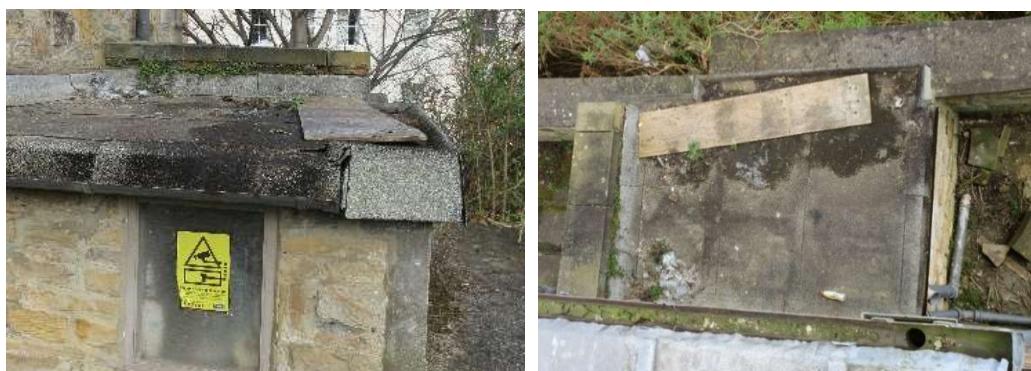
Rainwater System, Drainage

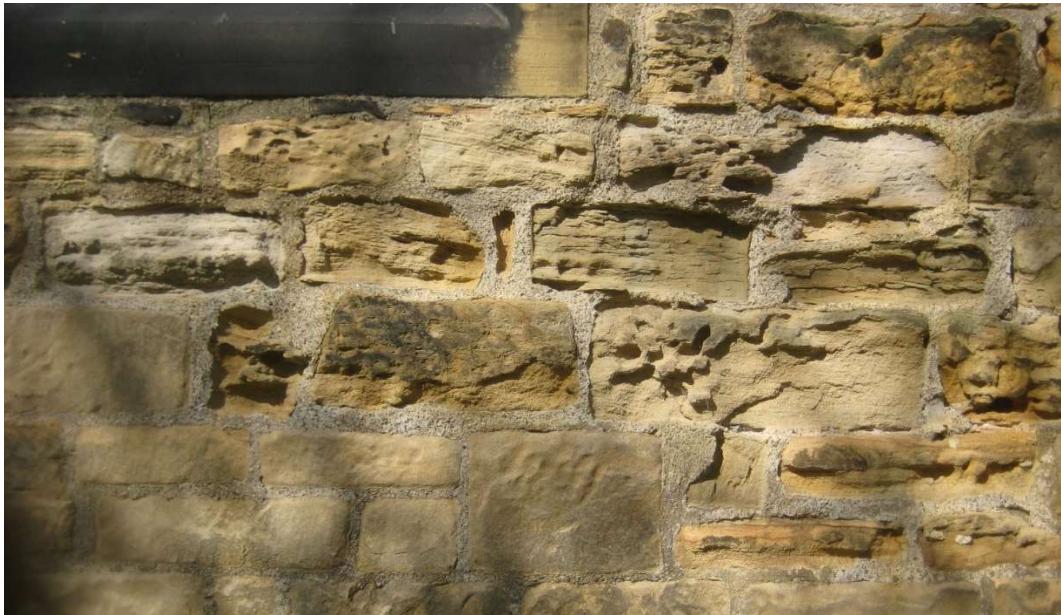
Typical stone decay (S side Chapel) accelerated by hard pointing which is left forward of the stones

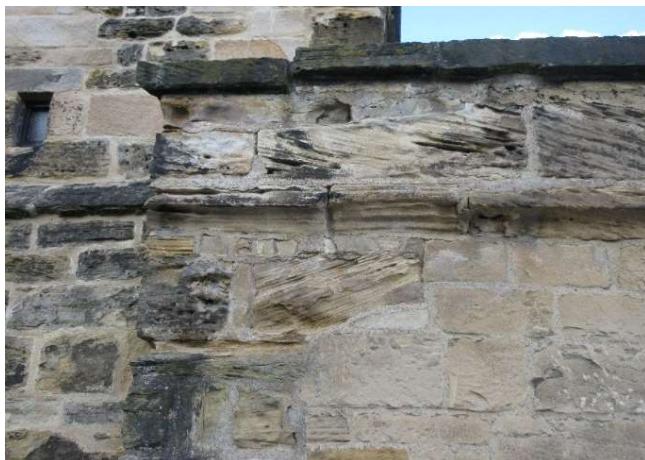
W end of Nave S clerestory parapet

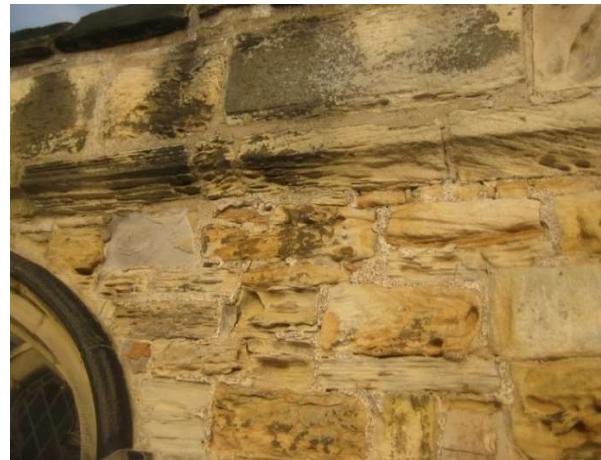
Typical decay near E end of the Nave S clerestory
soft beds in corbel course, surface decay of one stone and decay pockets at others

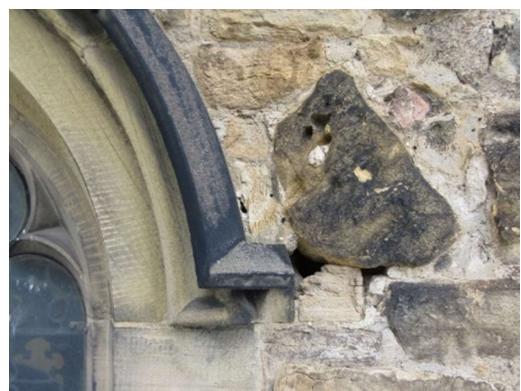
At part of the Clerestory bottom inserted stone slips help to hold the Aisle flashings. At its E end an earlier projecting course protects the flashing.

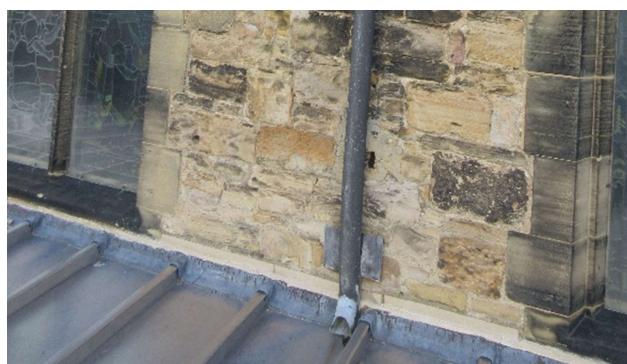
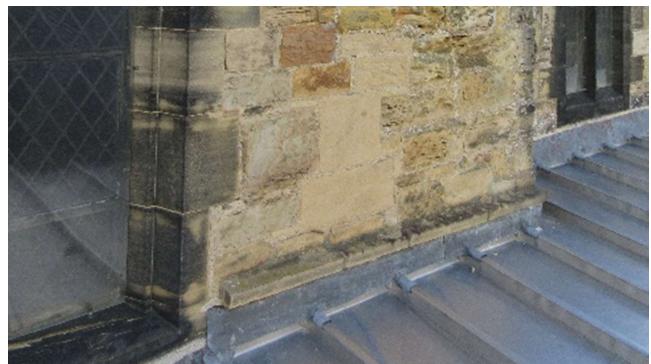
49. **Chapel E** – The copings and top corner renewed in 2017 with drips inside and out, on damp proof course and with full lead cladding inside the E parapet. Now sound.
 Wall repairs similar to Chancel E and now fair.

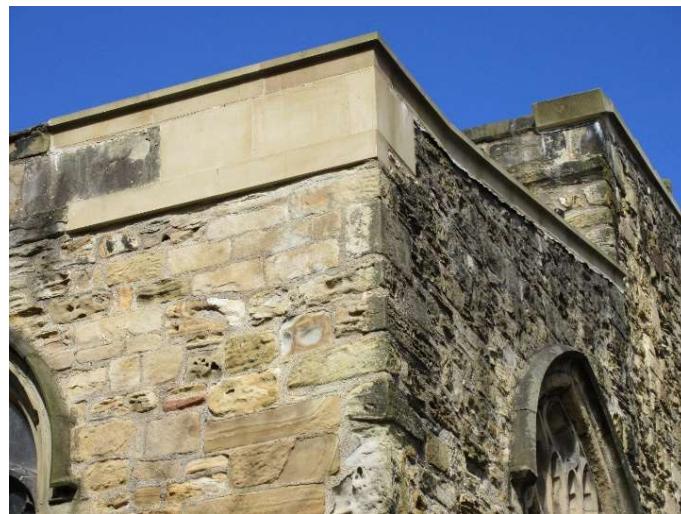
50. **Chapel S** – Parapet fair but most coping joints poor. Wall mainly sound but about 20% of stones are honeycombed or decaying back behind hard pointing. Three quoins are decaying. Sounder at low level. Repointing would slow decay. A tall built-in monument Watson 1756 has beautiful letter cutting mostly intact. Very slight further loss since last report. Its Gothic framing is severely decayed but unchanged.

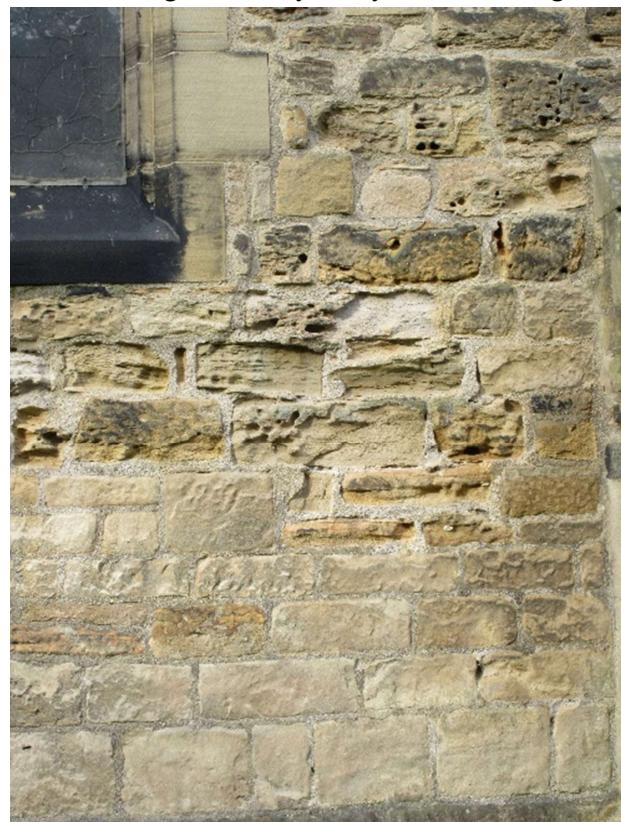
Typical stone decay at hard pointing at E end of Chapel S side

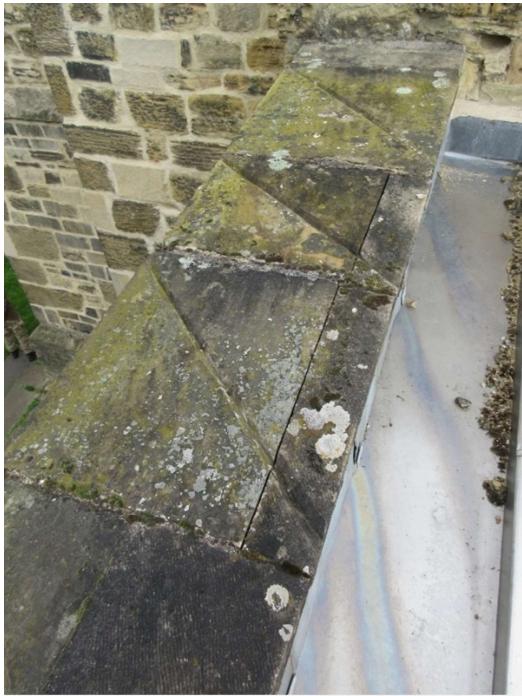
51. **S Aisle** – similar but less decay. The masonry between E side of Porch and Aisle window is mostly sound so the plaster damage inside may have been caused by past overflow from one of the hoppers (para 38)
52. **S Porch** – mostly good but some stone decay over the arch, which is very slightly rotated out at the SW corner. Some loss of pointing at W quoins.
53. **S Aisle W end** copings have been repaired with new stone bonded to the existing copings. While sound, the adhesive lines are open at top and need filling to exclude water. Bedded on lead damp proof course. Wall mainly sound.

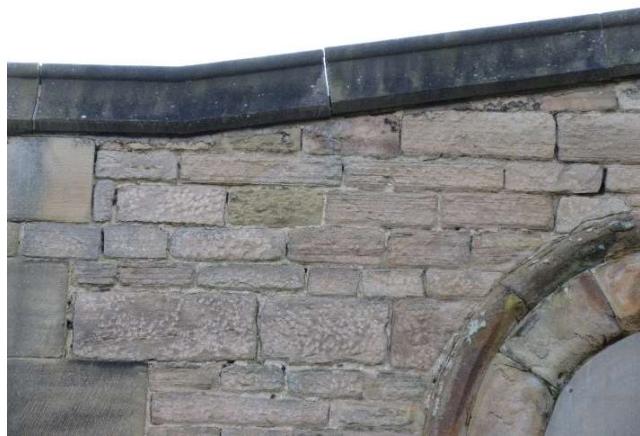
W end of N Aisle – open coping joints leading to stone and pointing decay at the top of the wall

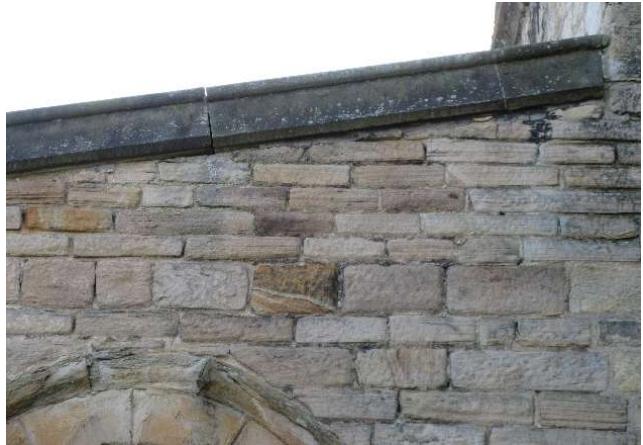
56. N Porch – sides coursed as Aisle, fair. Gable ashlar with good stepped copings and narrow joints, mostly open. Slight movement at W side of arch, almost certainly initial settlement. Open joints between the W quoins and the W wall.

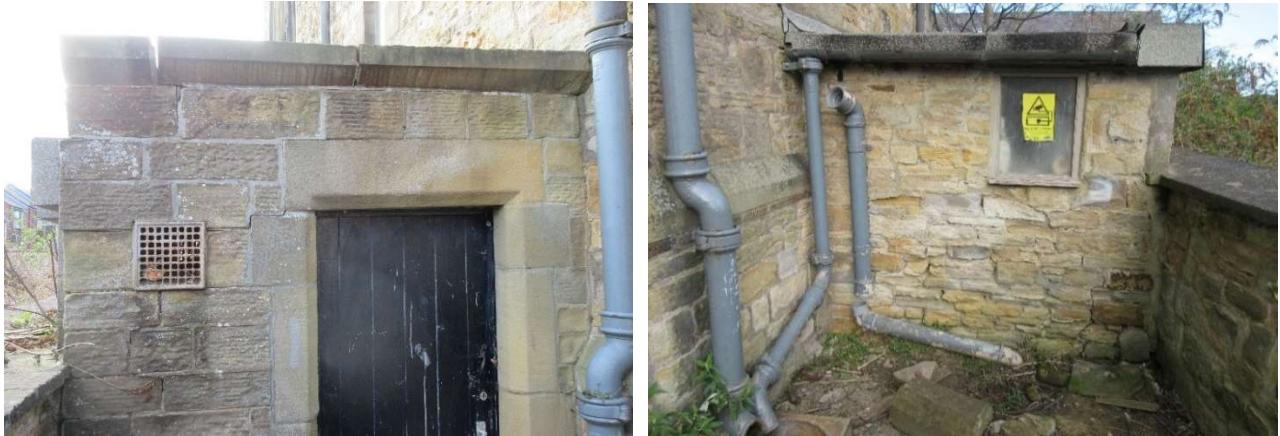
59. Organ blower/wc – Joints of the N parapet stones and backing bricks (para 32) remain open. Minor cracked joints in the N wall remain after recorded movement in the supporting retaining wall.
E side over retaining wall appears to be concrete or very thick render with roofing felt dressed over.
S wall extensively decayed especially at low level.

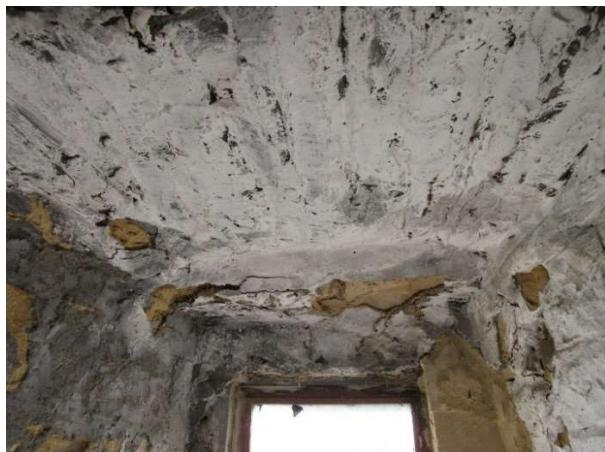
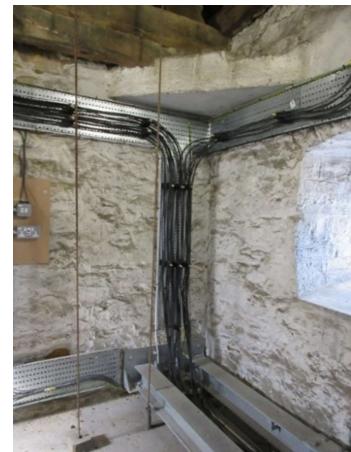
gap over one S louvre

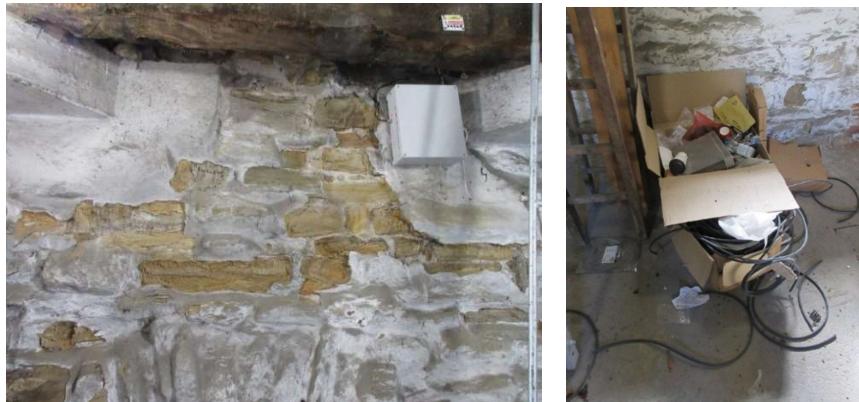
67. At mid height in the belfry short diagonal concrete beams cast into the masonry may stiffen the masonry or stitch the corners together. Parts of an old heavy timber bell frame (at outside set back level) are now cast into the concrete.
68. The internal walls of the belfry are whitewashed. Internal decay at many stones. Salts brought through by damp getting in at (former?) external decay can be seen at the damaged stone surfaces inside. The lower belfry is more decayed than the upper. A few stones at S and W and especially E are deeply decayed. Decay seems to be very slow and the masonry is fair overall.
69. The telecoms installation including cable trays is neat but a large box of rubbish should be cleared.

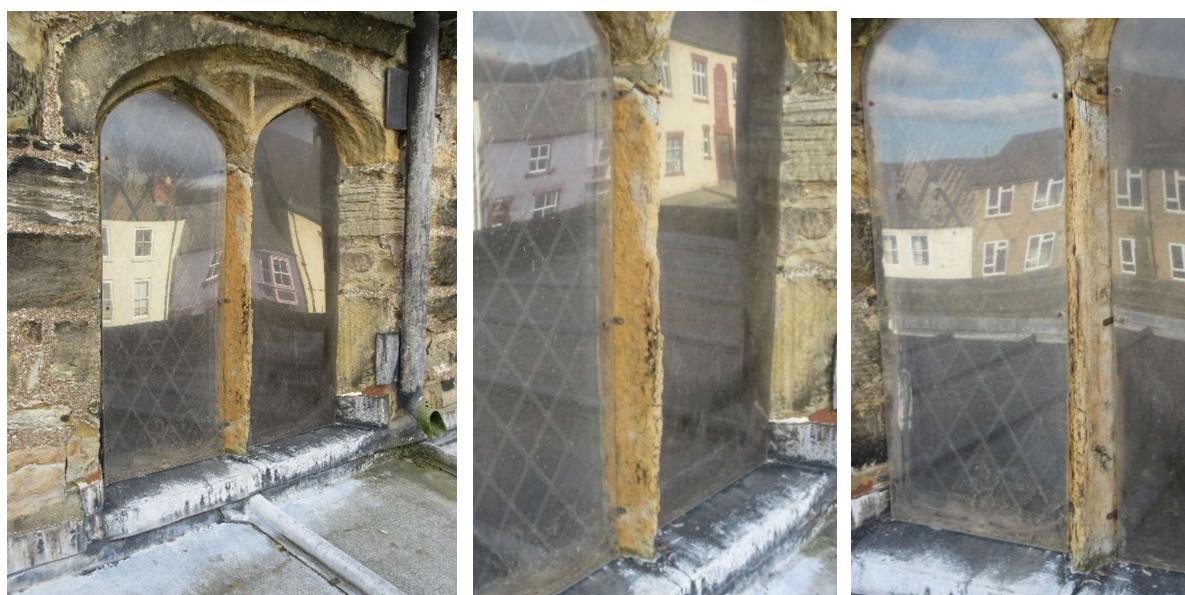
Nave N clerestory – two two light windows without hoodmoulds, mostly good, cills are lead clad outside.
 E mullion has minor decay at bottom.
 W mullion is edge bedded and generally delaminated with old mortar patching but seems unchanged.
 Chancel N clerestory - two two light windows without hoodmoulds, good, lead over cills
 Baptistry - all renewed 2017.

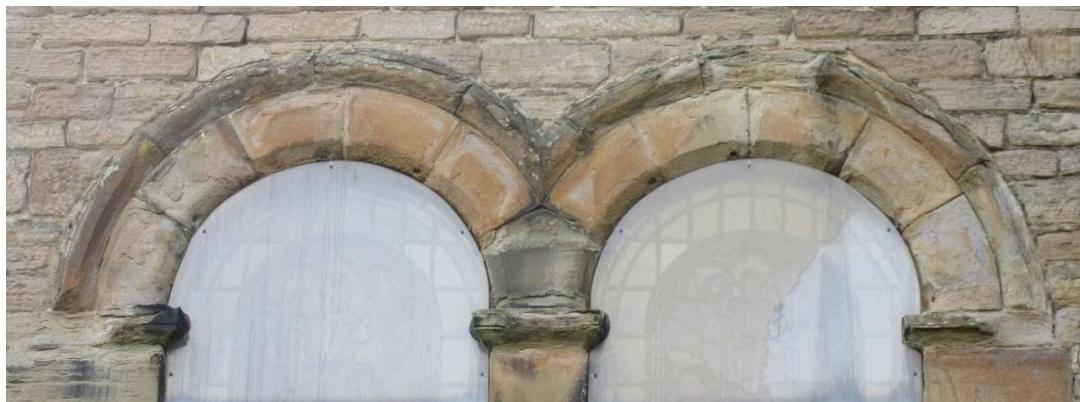
72. N Porch arch – as S Porch but very tight joints. One joint slightly open and one slightly displaced.
73. N of N Aisle – three windows good except open joints in hoodmoulds begin to decay at their undersides and from some arch joints.
74. Organ Chamber – door and two windows good except minor decay from open joints in the string course and upper hoodmould.
75. Vestry - good

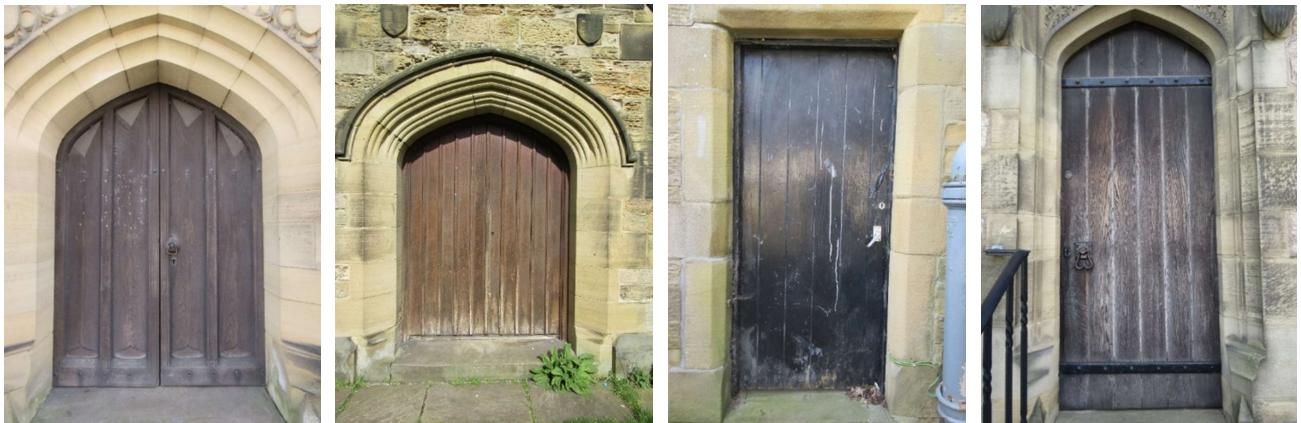
80. S Porch simpler cover moulds over batten doors. Exposed to sun and stain weathering at bottom.

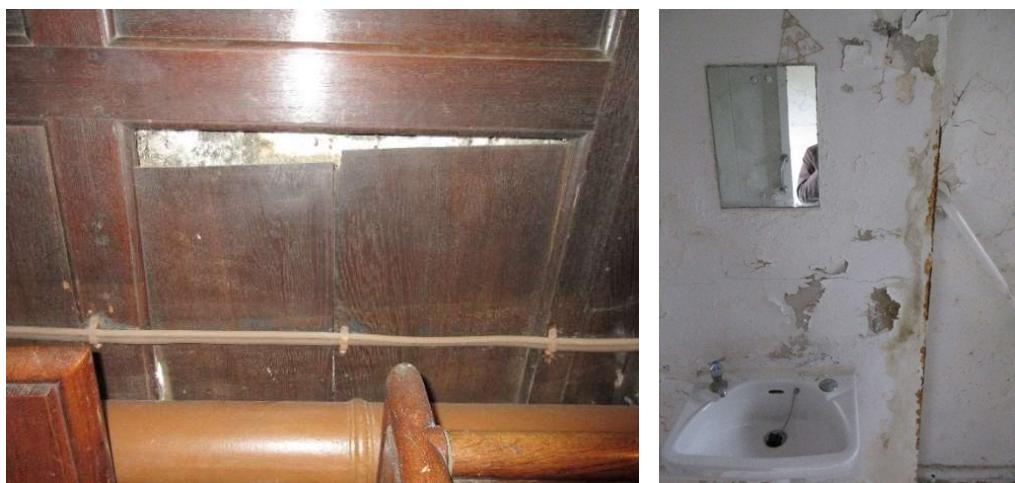
103. In NW Aisle corner good modern joinery forms a bench with small cupboards beneath, shelves and display boards. Mesh panels let out heat from the hot pipes.

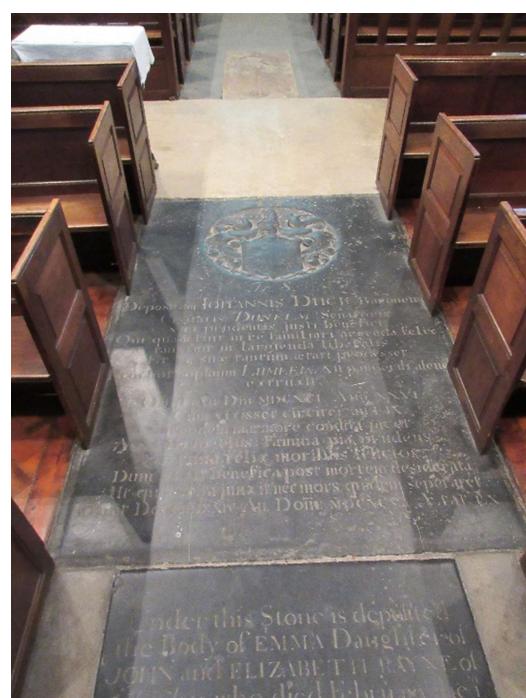
S Aisle – three window set, each two light, Ascension, He is Risen, I am the Resurrection, all well painted, good condition but dirty

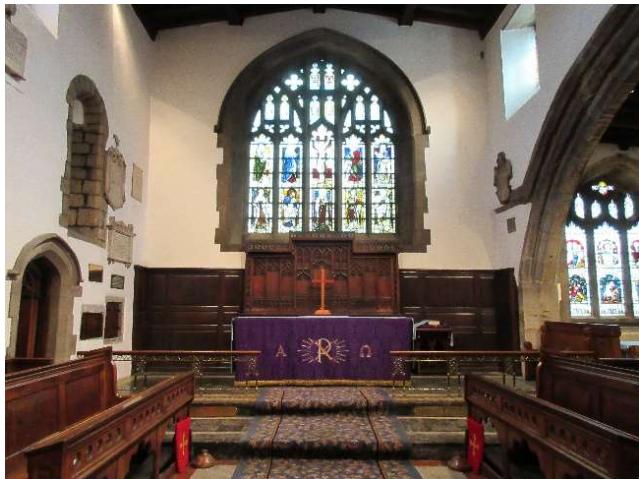
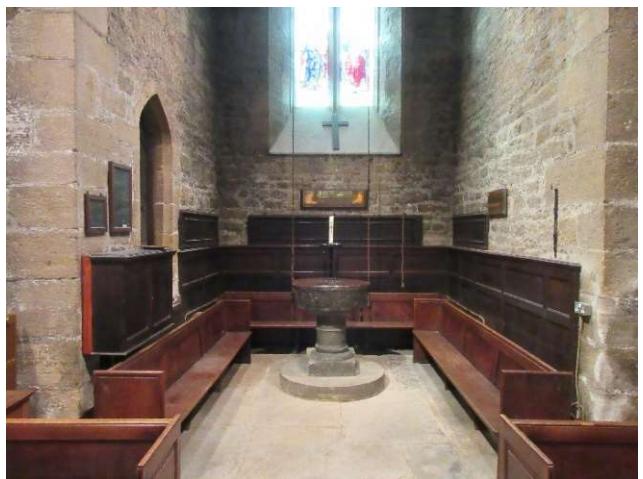
123. Font 12th century Frosterley marble bowl and pedestal on a sandstone step. Lead lined with outlet.

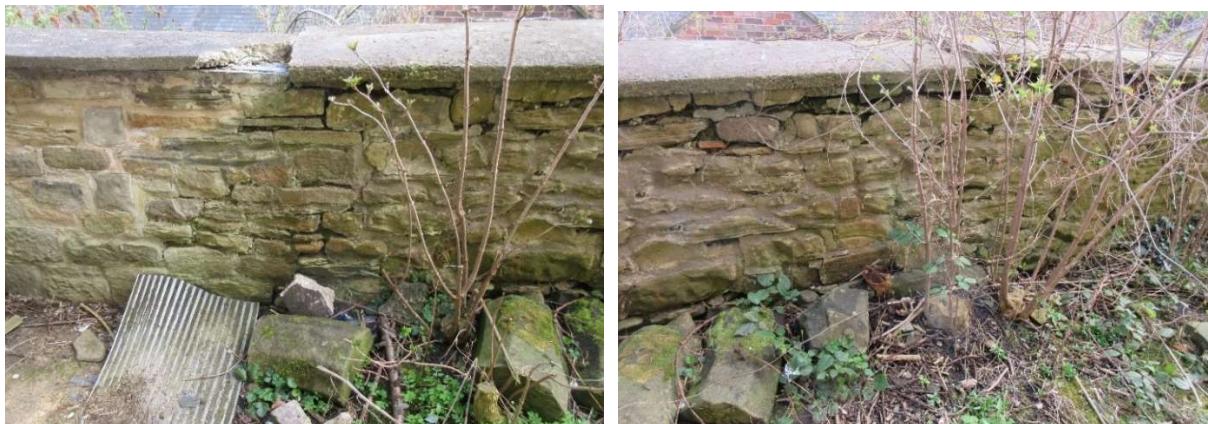
E retaining wall S of the Blower/wc

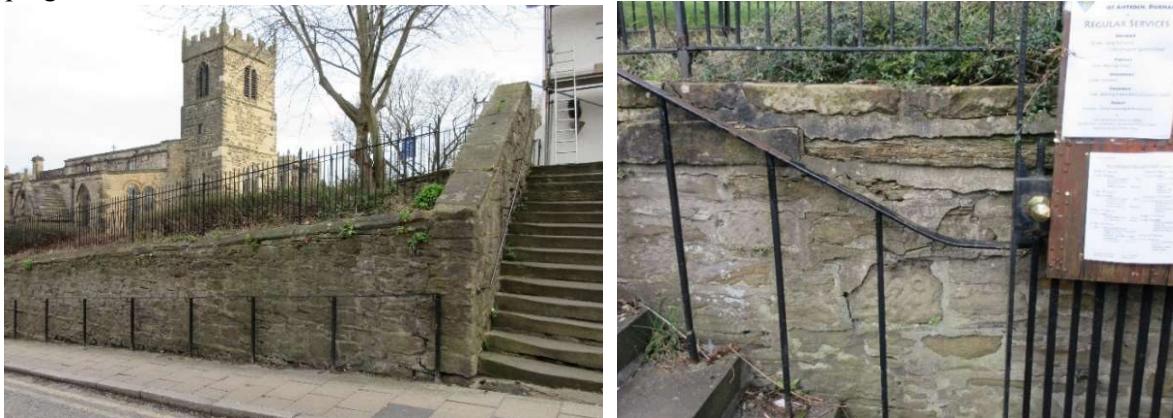
155. At Crossgate a stone retaining wall at back of the steep pavement and a parallel upper retaining wall with iron railings and a sloping planting bed between. In the middle of the retaining walls, gate piers and retaining wall returns flank steps up to the N Porch.

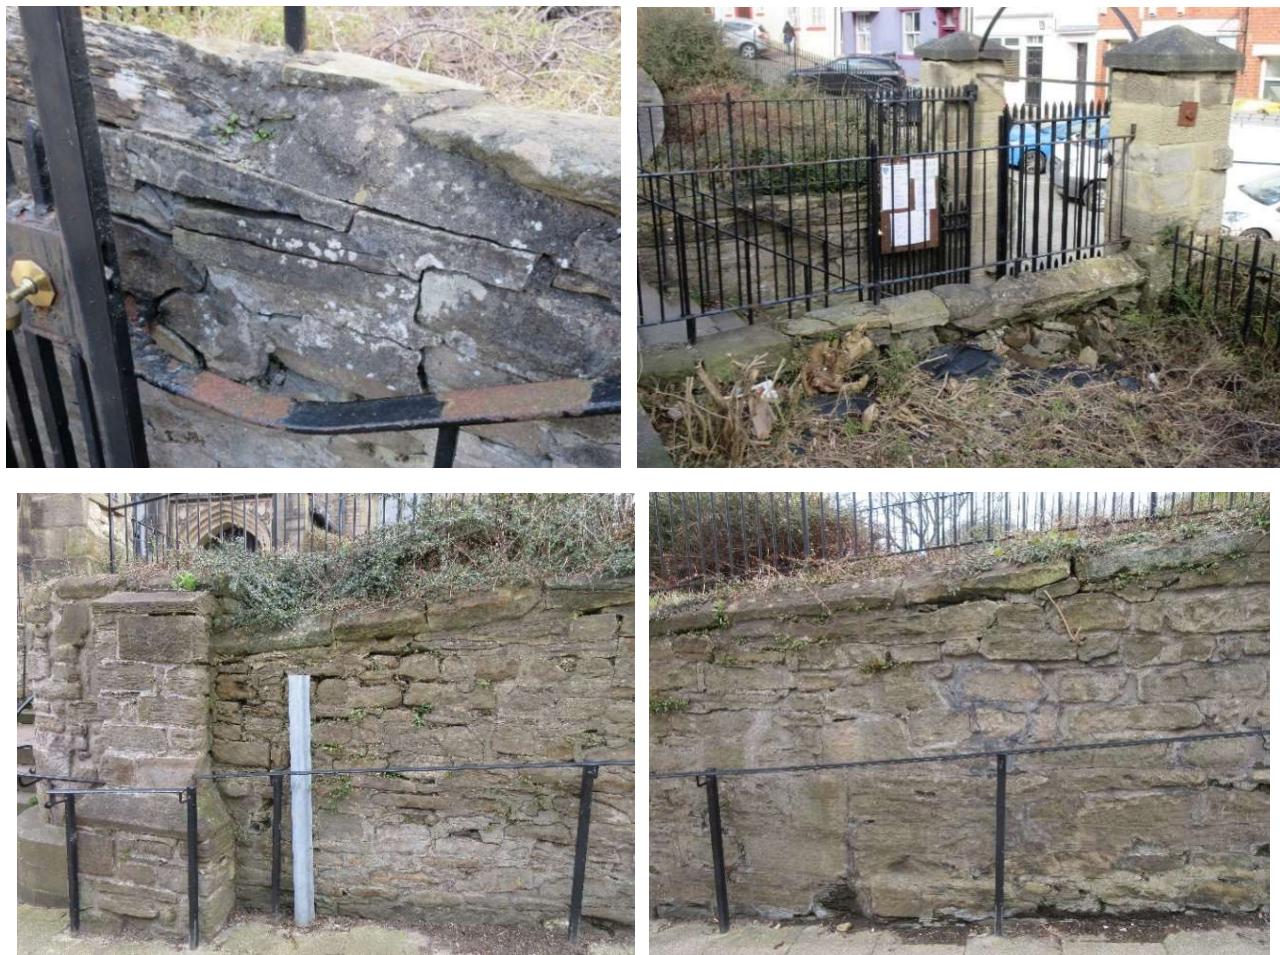
Above the entry steps the outer wall mainly stable but its many open joints with plant growth need to be at least pointed to keep stable. About 30% of the main retaining wall joints are open especially near the steps. Some sign of bellying out due to pressure behind and loosening of bond in the wall.

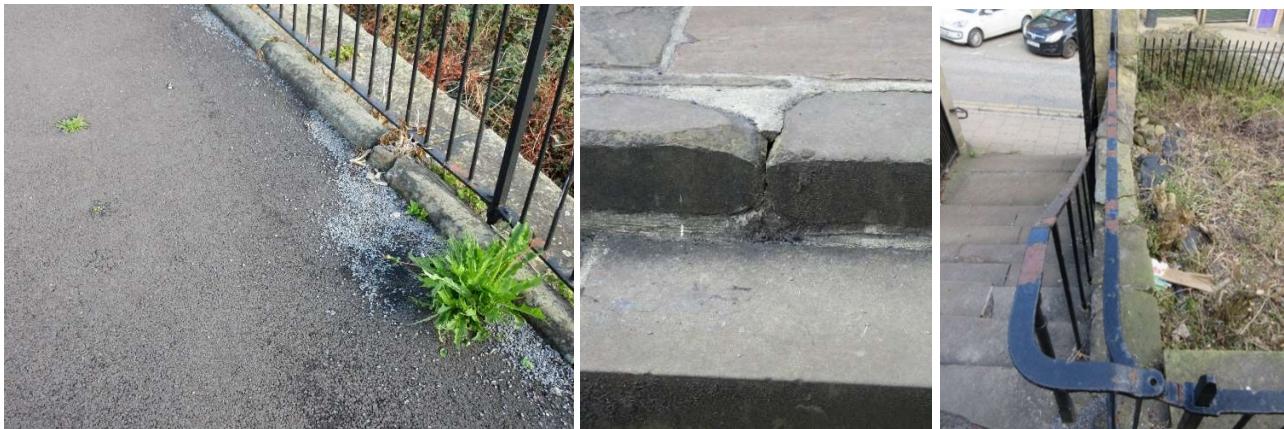
156. A steep path from the NW gates down to church was concrete cracked and uneven in parts. Now tarmacked over and mainly sound though some plants come through. Well used by the public.
157. A sound level flag path from the SW corner around the Tower. Stone flags outside the N Porch are decayed at some edges, now pointed. Concrete paving along the N of the Organ and Vestry is sound. Flag paving outside the wc is subsided, cracked and sometimes ponded.
158. A low retaining wall W of the Tower in the style of dry stone walling with an inset block of slate announcing the interment of ashes appears stable at present but needs to be checked for movement from time to time.

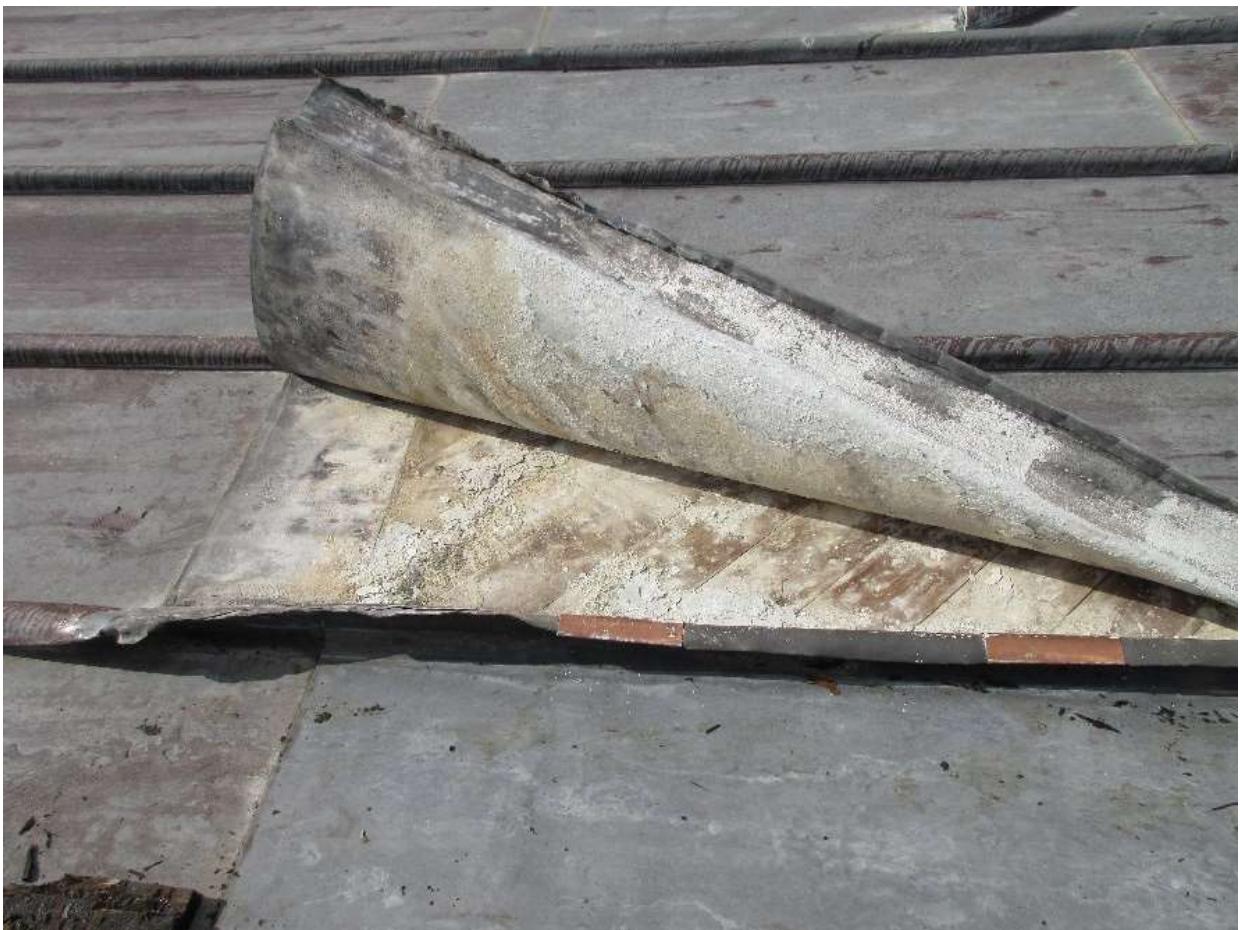
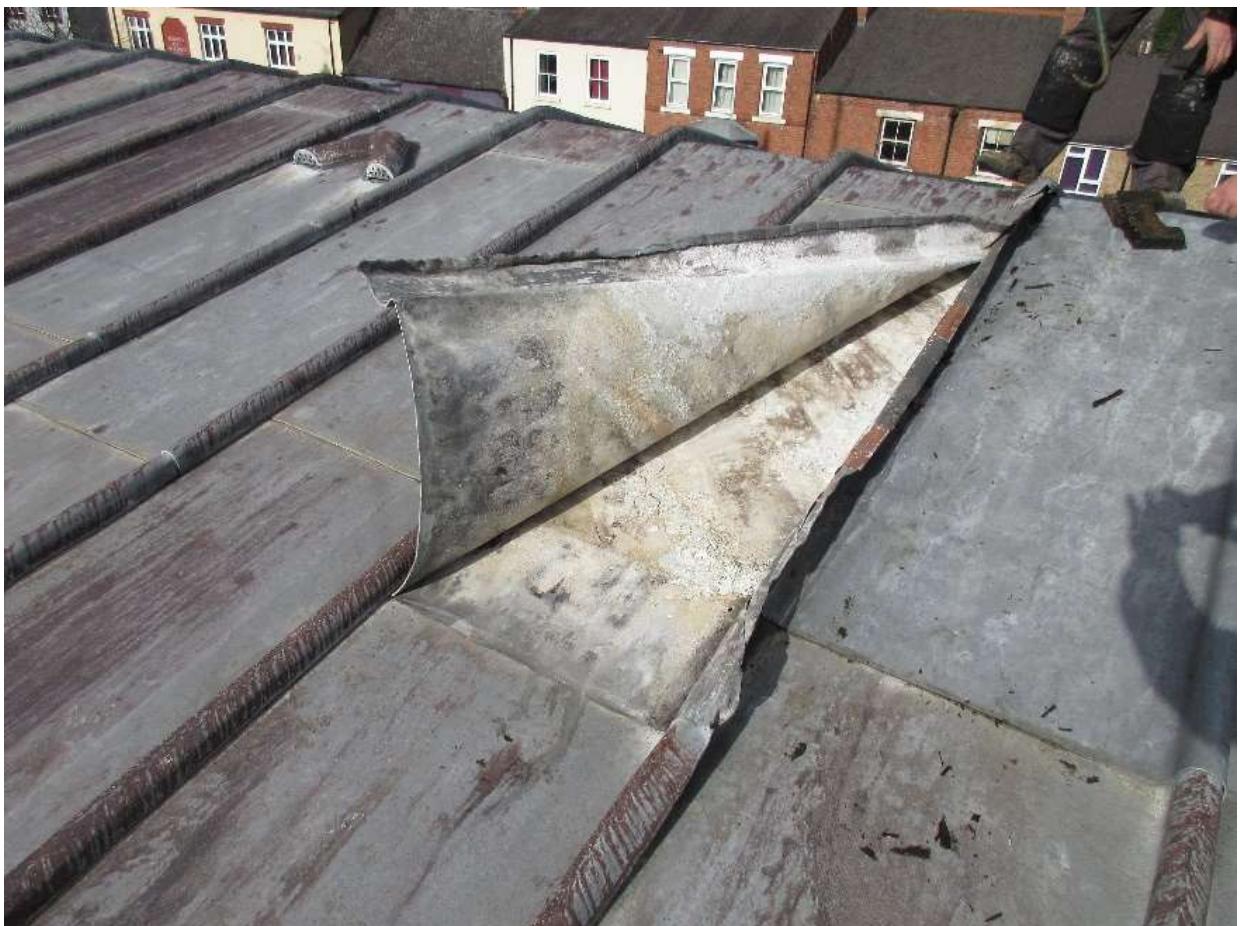
Heavy corrosion under a S bay near the Nave ridge

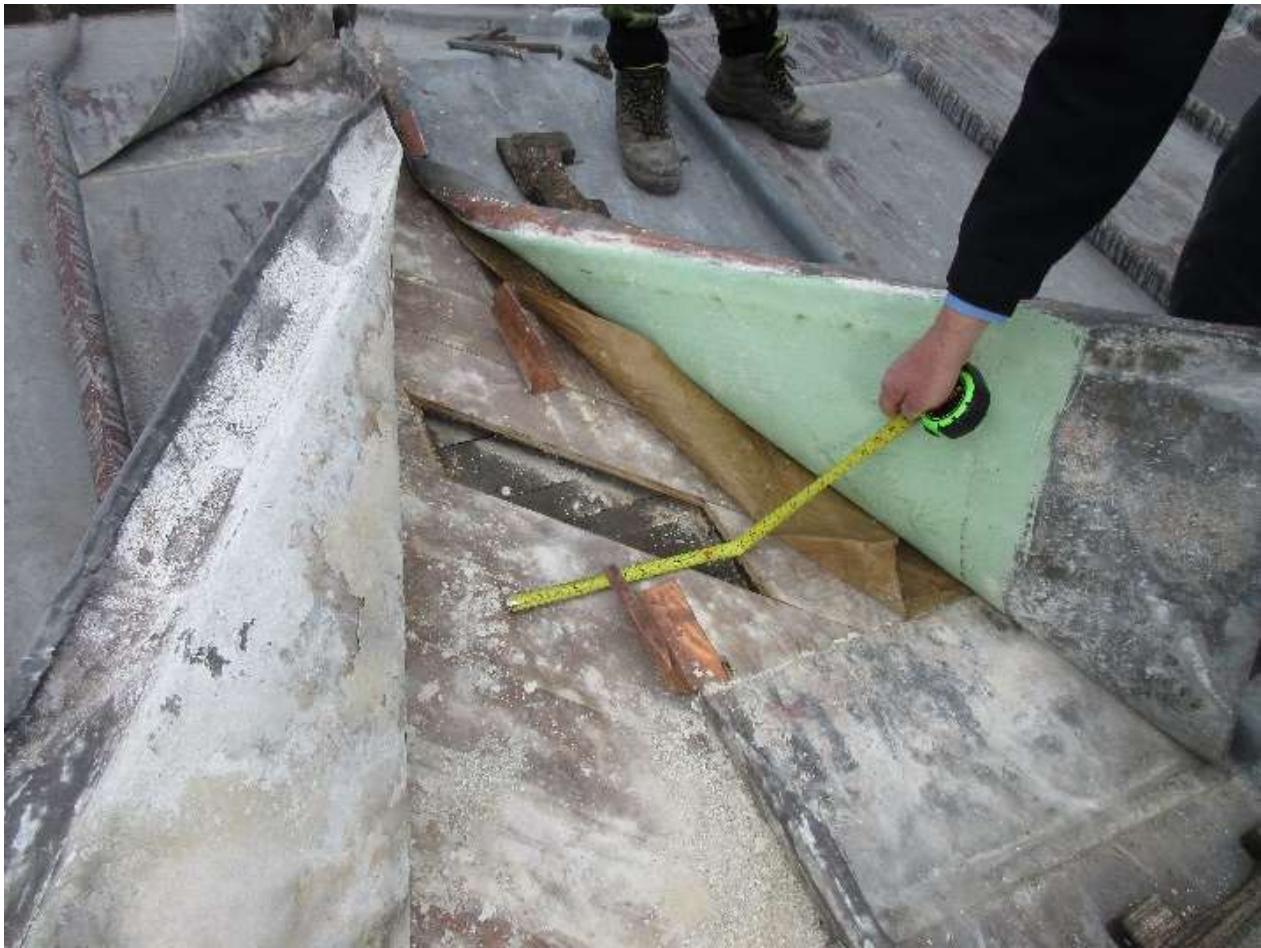
Same after lifting of the adjoining 'renewed' bay
