IAN NESS
ARCHITECT
26 GROSVENOR PLACE NEWCASTLE upon TYNE NE2 2RE
tel & fax
(0191) 281 2559
i.ness@btinternet.com

18 May 2020

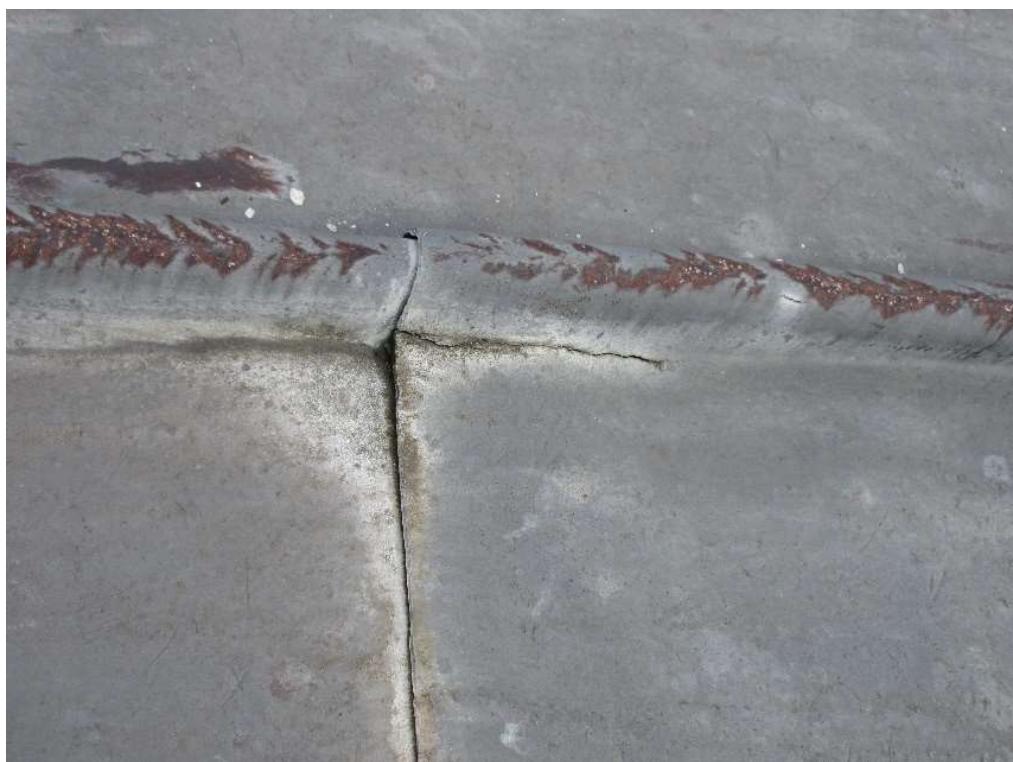
A diagonal outer board cut out, showing the gap between the decks is only 1", not sufficient even if there were continuous ventilation all along ridge and both eaves

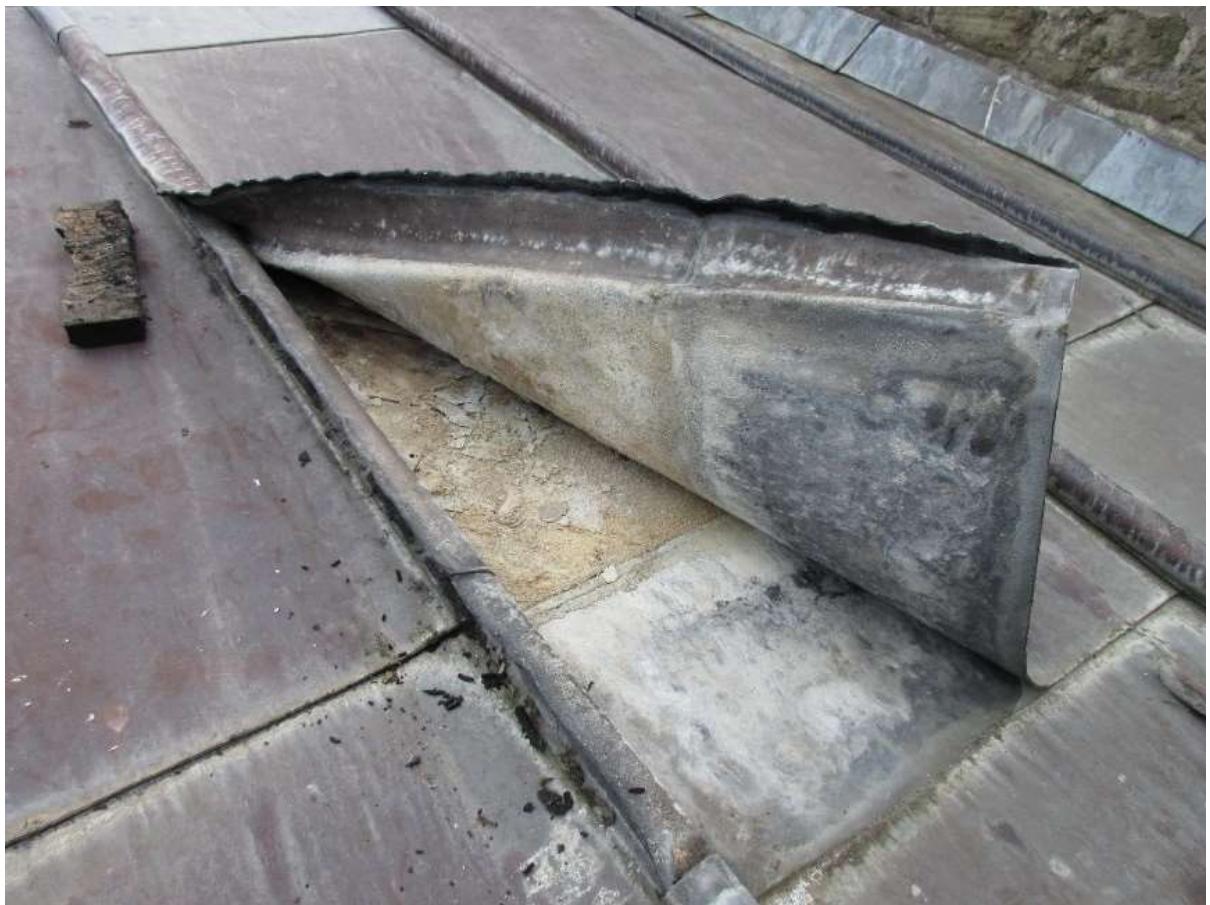
N side Chancel – thick corrosion
