**St Mary the Less, Durham**  
(St John's College Chapel)

**Quinquennial Report**

**3<sup>rd</sup> November 2022**

**Sarah Harrison** BA(Hons), gCAP, MArch, PGDip, RIBA

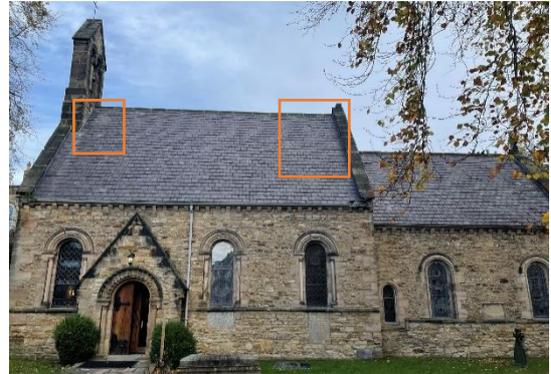
Figure 1- Nave roof – south side

6.1 **Nave** roof to the South has a small cluster of slipped slates to the top eastern side, together with a mis-aligned slate centrally. The slates near the bellcote abutment were undulating but satisfactory. To the North side, no visibility from ground level and access to an adjacent building was required to obtain a partial view which appeared sound.

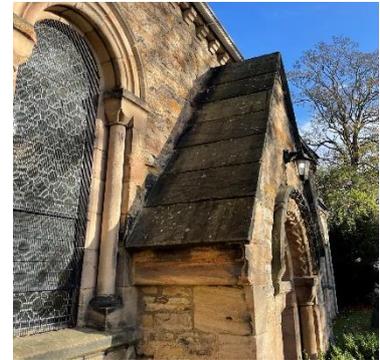
Figure 2- Porch Roof

6.3 At the **Porch and Bellcote** very large stones, generally sound, joints slightly open between stones, but not to the full depth of the joints,

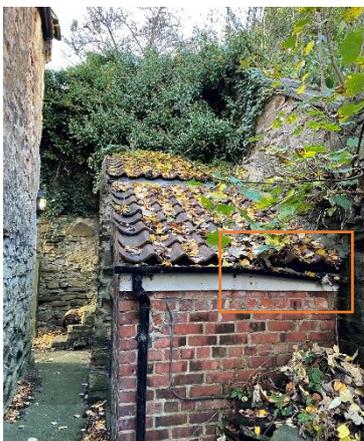
Figure 3 - Gutter to outbuilding

- 7.4 The fascia on the outbuilding adjacent to the northern wall is rotten, leading to the collapse of the gutter at one end.
- 7.5 Vestry gutter blocked with leaves, downspouts from here and N. nave discharge onto sodden soil above concrete to the rear of the boiler house, it is unclear where the final discharge point is for this area.

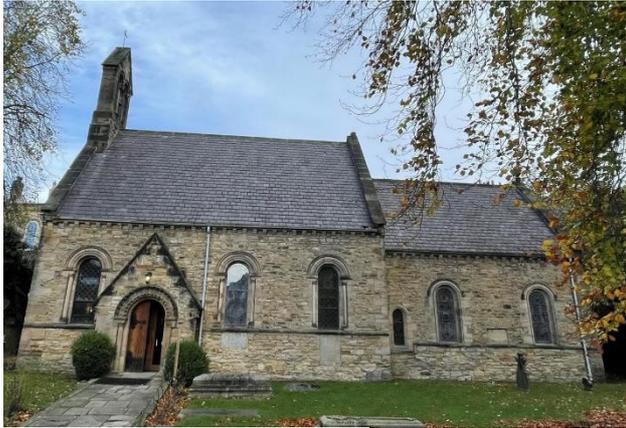
Figure 4- South Elevation

8.1 **South Nave and chancel** are probably in the best condition of all facades as they have seen very little modern intervention. However, at the southeast corner two eroded quoins at low level, which were suggested for replacement in the last QI still remain and are worsening. Other areas of erosion are visible mainly to chancel, these should be considered as part of a longer-term replacement scheme. Some re-pointing of joints is also necessary, mainly to the lower courses. These are only facades to have corbels, which generally appear in good condition, one to the west has base missing.

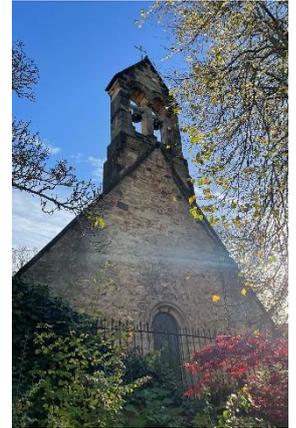
Figure 6- West Gable

8.5 **West Gable** - there are some severe erosion to stones, particularly to the top where the wall is more exposed. There has also been large areas of poor-quality overpointing causing face erosion and open joints. No attempt has been made to point around the cables to the new bells installed over five years ago. The window cill is delaminating.

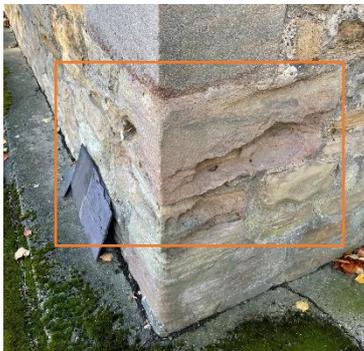
Figure 7- Crack to NE window

8.3 **North Chancel** – a mixture of stone and brick around windows. The stone condition is poor, particularly at low level beneath the window at the east end. Large areas of over pointing have led to the mortar becoming proud of the stone, particularly at high level. A cracked stone cill to the E window and cracking

below, the cill has deteriorated further since the last inspection, possibly due to the removal of vegetation.

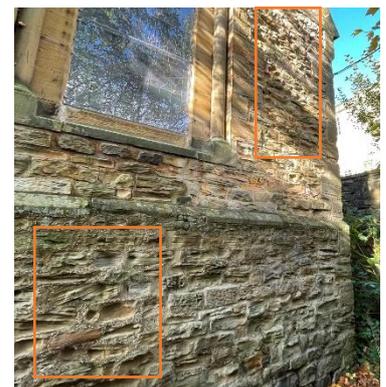
Figure 8 - East Gable erosion

8.2 **East Gable** – The stonework is generally poor and extensive re-pointing is needed, particularly adjacent to window and at low level. Stone replacement is required in a number of places to prevent further erosion and water penetration. There is some erosion to the hood mould of the window. A crack from the bottom RHS of cill runs to the ground, this appears to be historic and has been re-pointed at some time, this has re-opened and is currently between 0.5-2mm.

8.2.1 East gable of nave at upper level sees some erosion

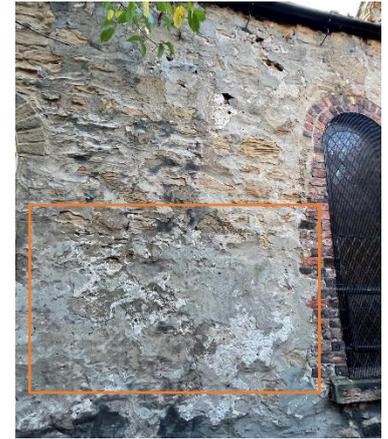
Figure 9- North Nave overpointing

8.4 **North Nave** -this wall is in poor condition with extensive overpointing that has become almost a render. The hard overpointing has led to vast areas of erosion behind the face leaving pockets of voids. There are brick surrounds to two windows and a different type of stone to the smaller window. The large voids behind the overpointing could trap water and lead to further erosion of the softer stone.

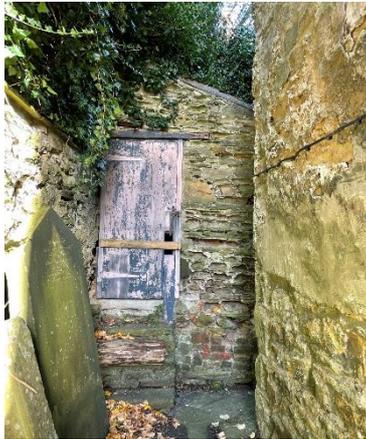
10.1 – side path to stores

8.6 **Sore/ organ blower chamber** – the stonework is particularly poor with significant erosion of many stones affecting the structural capability of the wall. At this stage complete re-building is required. The brick area is in better condition, no access was available internally, but the previous report suggested a rotten wall plate due to the gutter at item 7.4.

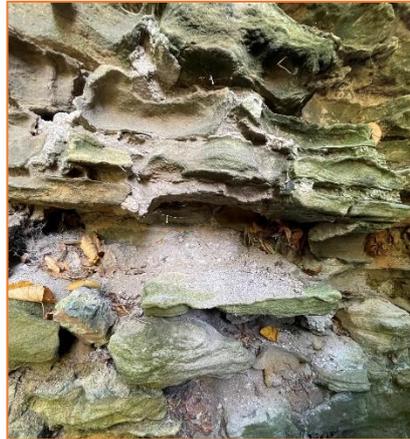
10.2 – area of stone completely loose

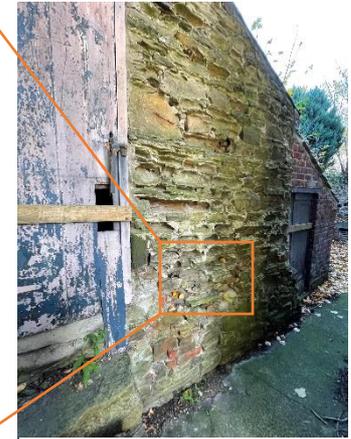
10.3 – wall area to be re-built

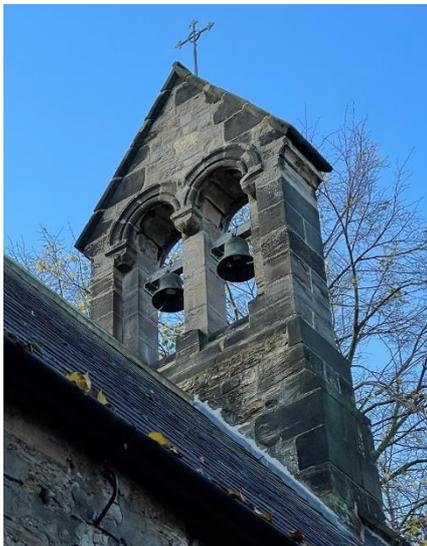
11 – kneeler to bellcote

9.2 There is erosion on the northern side to the high-level kneeler, this doesn't look severe at this stage. From ground level, there looks to be two large stone cappings to the base of the bells, closer inspection on the condition of these and the presence of any additional flashings would be beneficial. There is erosion of stonework just above the abutment flashing on the east and some erosion to the lower stones on the west face, to the areas of softer stone.

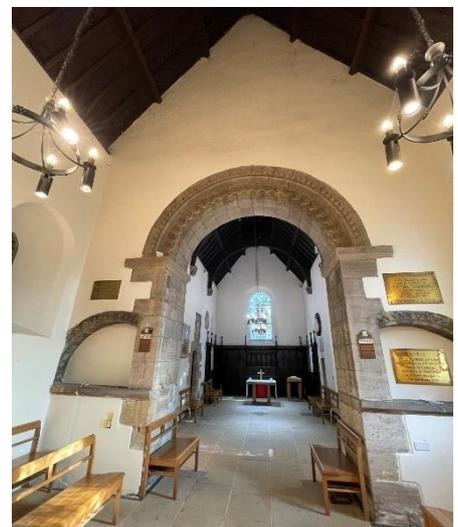
Figure 16 – Chancel Arch

13.2.1 **Chancel arch** – One stone to the southeast at the base has seen an inordinate amount of erosion, this is likely due to rising damp in this area. This could have been exacerbated by the UFH installation, but there is no available records of this area prior to the inspection.

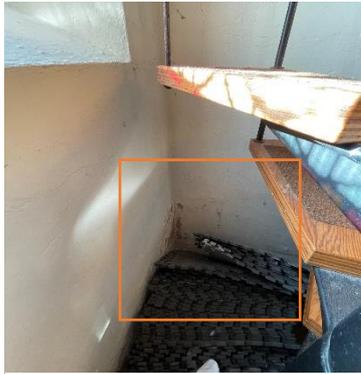
Figure 17 – SW Corner with damp and hairline cracks

13.1.2 There is a small area of rising damp in the southwest corner with the plaster showing signs of efflorescence. There are a number of small hairline cracks to the west wall, one originating just above the damp area and tracking up to the south west corner. Another to the south wall at the western most window cill.

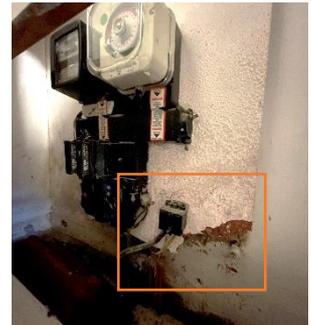
Figure 18 – Electric Supply

13.4.1 Inside the vestry cupboard is the incoming electric supply and consumer unit. The lower incoming supply is on a back board which has started to deteriorate due to the damp behind penetrating through.

20.2 As per item 13.4.1, the current incoming supply to the vestry is attached to a board which is degrading, therefore replacement of this board is required by a competent person.

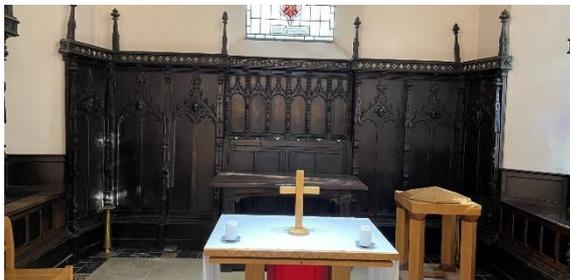
Figure 19 – Reredos Screen

14.3 Reredos screen - C17th carved panelling which has cherubs' heads, Gothic tracery and pinnacles, in a dark stained oak, there are several pieces missing including 2 No carved flowers to top and rail in the first bay to the north. SE pinnacle looks to be slant.

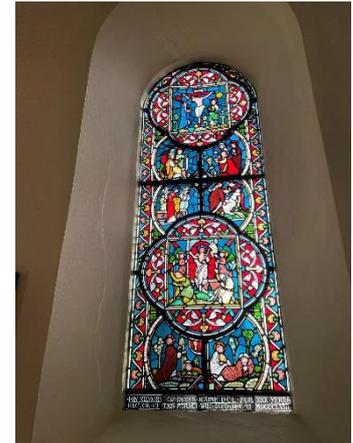
- 'NVBEM ERIPIAM' clear diapers with shield at high level, yellow and blue margin, dirty. PC externally.
- 'In memory of James Raine' very bad bow to the middle panels, light penetration through lead at several areas. PC externally. In urgent need of repair.
- Clear diapers with red and yellow margin, glass severely bowed in several locations. Mesh protection externally.

Figure 20 – Glass in urgent need of repair

10.1 There have been a number of polycarbonate protective panels inserted in single sheets and pointed in. This is not a recognised way of installing protection and may have contributed to the severe bowing of some of the stained-glass panels to the south, due to heat build-up, worst to the windows adjacent to the door. Obtain report from stained-glass specialist such as Chris Chesney, Iona Art Glass to conserve bowing panels.

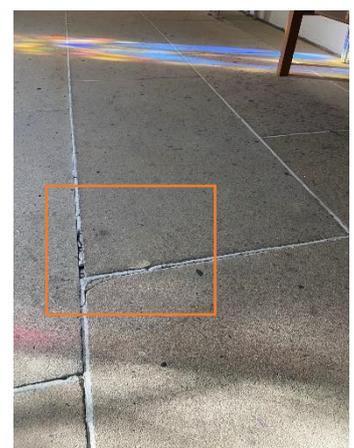
17.1 The sandstone paving flags are badly marked with candle grease, which greatly spoils the appearance. In the last Report it was noted that several flags were cracked presumably due to thermal movement with the underfloor heating and these cracks have worsened. The same problems with the floor are evident in the Chancel, one paviour near to the Vestry door is lifting at one corner and moves freely.

Figure 22 – Floor lifting

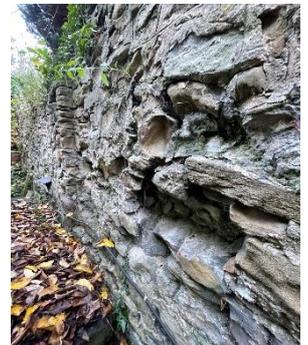
Figure 25 – North Boundary

26.1 The boundary wall on the north side is in very poor condition and require extensive repointing and stone replacement. This work would need to be done in cooperation with the Cathedral. The vegetation growing out of and over the wall should be removed. The stone wall to the west of the church has collapsed and is protected by hoarding. This wall is Cathedral property.
