**QUINQUENNIAL INSPECTION REPORT
OF
EASINGTON LANE, ST. MICHAEL AND ALL ANGELS**

**DIOCESE OF DURHAM
ARCHDEACONRY OF SUNDERLAND
DEANERY OF CHESTER-LE-STREET**

QUINQUENNIAL INSPECTION AND REPORT

DATE November 2022

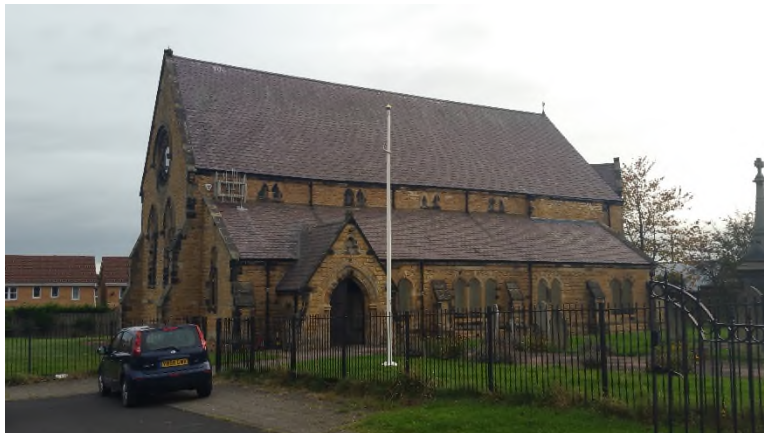
B Nave:

South side – Angled terracotta ridges bedded ok, some chipped slates one probably losing its fixing, there has been some repairs in none-matching towards the eastern end. W abutment is mortar flaunching to watertable not much upstand on the

watertable & wonder if there is even lead work. The slates probably go underneath the overhang of the watertable. E abutment is a mitred hip which leads onto the chancel apsidal end and I'll include that here.

The slating is generally sound on the apse. Flashings have been stolen and been replaced in lead alternative. The cross at the apex is missing part of its arm. At the W end the stone cross has gone in the past, there is a terminal here as there is also on the W end.

The slating to the apse roofs looks ok. And their ridges are ok as well. There is a loose slate sat in the gutter in the NE corner and this area has seen many repairs in the past so there is a bit of a patchwork of different slates.

North side – Some loss of slating towards the E end just above the chimney stack, there is a bit of moss on this elevation, slight undulation to the slating at the eaves a couple lifting and one definitely missing and some loose at the eaves. E abutment is to the aps hip which is ok. W abutment same as the other slope looks ok.

Recommendation: replace slipped slates

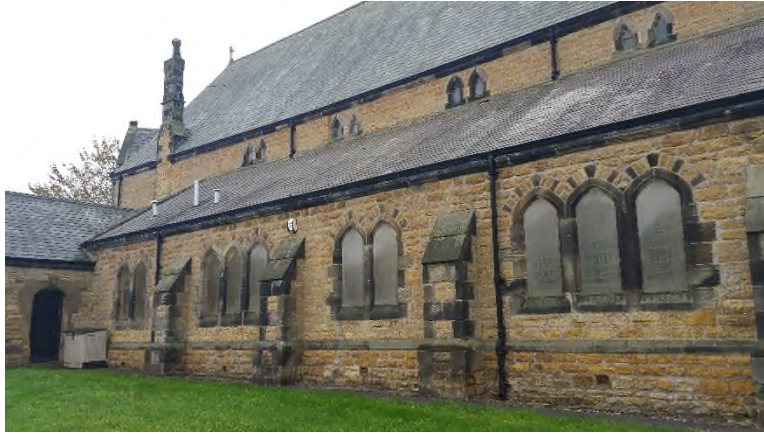
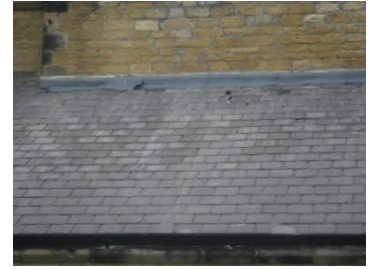
B South Aisle:

This is a lean-to slated roof ridge flashing is up to the nave clerestory, it is in cement and been patched but generally sound. Towards the E end has had lead alternative flashing recently, the W end of it does not look as if it has terminated very well. Slating is generally ok there are a couple of slipped slates. W abutment same set up as the nave, very thin flaunching I think there is a bit of lead behind it, yes I see a soaker. One bit of the ridge pointing coming away at the bell. E abutment cement again to the watertable and it looks like this is breaking down a bit, water has a chance to get behind the flaunching that looks ok it is just a little bit cracked. Hole in roof at east end.

Recommendation: replace missing slates

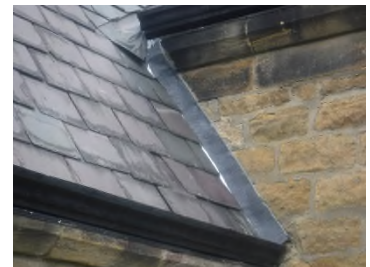
B Porch:

This has been patched in non-original slates where they have cracked when stealing the flashings. It is ok, new cement ridge bedding a bit ham-fisted, flashing replacements look a bit rubbish and the poorly executed silicone pointing is coming out. Quite a poor job. The abutment flashing to the gable is cement, cracking on the W slope and E slope. The watertable looks ok, the ridge cross is missing.

Recommendation: refix abutment flashing

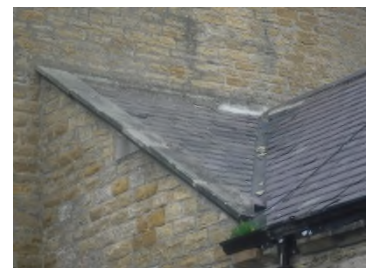
B Vestry:

East side - Ridge bedding just about ok, has been patched at the top of the valley, general roof is ok, one slipped slate still in the gutter and a few cracked, this has a lead replacement valley with mortar in it and a few loose slates and the other side of that valley underneath the chimney it slopes up to its ridge against the side of the nave and that looks as if it is losing its pointing. I can't see the back of the watertable. The main roof gable has mortar flaunching - skinny and doesn't look great, also the

watertables aren't level here and I don't quite know why. There is a crack to one of the kneelers and it has just shifted a bit and humped, I think it has a chimney at the apex without a pot.

West side – Same story as the E not able to see into the valley easily other than to note it is all in mineral felt and I also can't see the gable of the N aisle.

Recommendation: fix loose slates and inspect surrounds when up there.

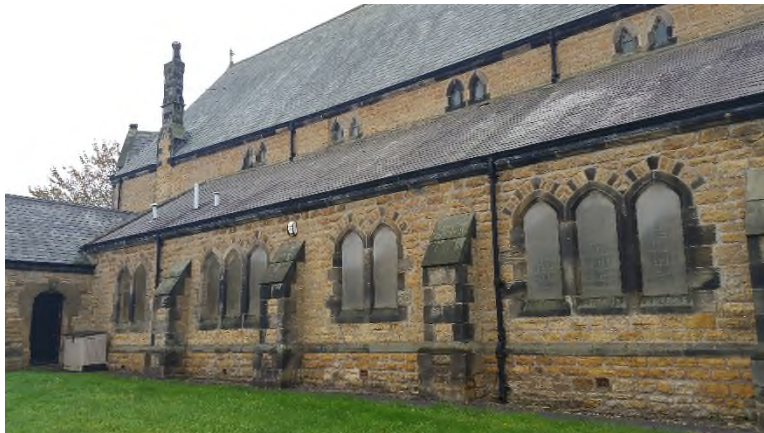
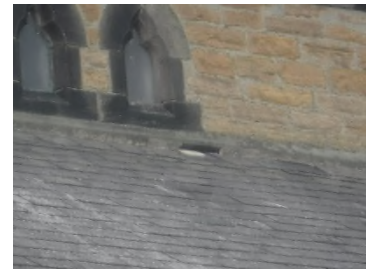
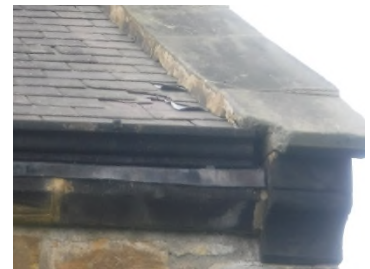
M North Aisle:

The general slating is fair, the problem is at the head where they are slipping out from the abutment to the nave clerestory, one area of the mortar pointing is out and I don't think it has lead at the head at all. It also happens on the south. Big job to make it good again. But it seems there's no water ingress. Keep an eye on it

East abutment – Flaunching looks ok.

West – Flaunching looks to be breaking down a bit at the foot and there has been some attempt at soaker repair here I think or is that the old soakers showing through? I can't tell. There is a slate missing here too and the kneeler is wonky here, in fact they are all slightly irregular here and I can't see why.

Recommendation: monitor

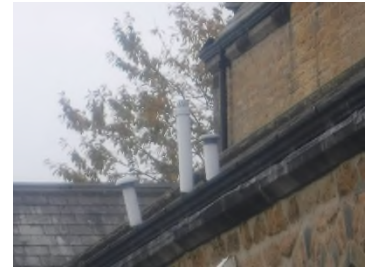
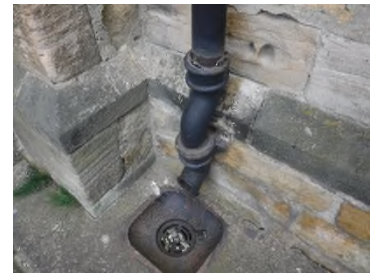
B It looks like the originals are all in place, that is ogee cast-iron gutters with circular downpipes and collars and these sit on lead flashings on to projecting angled corbels, overall they are sound I think, there is some grass growing in them and they should be regularly inspected. They lead into salt glazed gullies and these are ok and they have their grids, some of the gullies are cracked and some of the grids have parts of themselves missing but they are still all effective, the decoration is wearing out on them now. Some of the pipes have been sealed with silicone at low level which is unnecessary they should be allowed to be open because you can tell if they are blocked because they overflow. One loose downpipe on the S side E end on the apse and the porch E side is loose.

They are generally rusty but can be reconditioned they don't need it just yet perhaps another five years.

Gutter leak to north nave western end.

Vestry East side – There is grass growing in the gutter here.

Recommendation: refix loose downpipe, replace lost grids, fix gutter leak

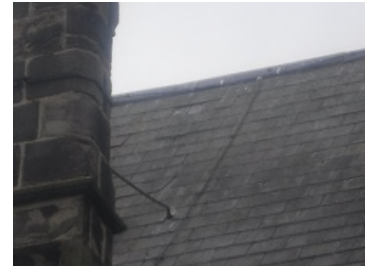
Nave North side – Eastern side looks ok above this is a masonry chimney stack quite tall has been repointed and retained by a metal rod and a brace around the upper part of the stack that looks to be rusty and the concern might be that the fixings will rust out over time, next time the steeplejack is about it would be worthwhile asking them to check this and in fact the lighting cable is loose around here as it is in other places because they have yet to come back and fix it so I need to check that.

Recommendation: investigate west gable watertable on north slope and fix down watertable stones if required. Inspect chimney restraint.

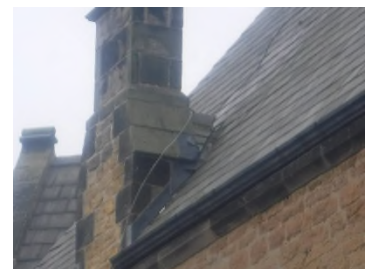
The western end is as the S but here there are more open joints in the walling particularly in the middle section and there is a gutter leak above that.

West gable – Apex cross missing, watertable generally good, the northern slope seems to be a bit more irregular and it is odd why it should be like that, the built in ones are obviously in their fixed position but why are the unbuilt-in ones lifted slightly are they slipping, are they unrestrained? That might be it? And the N bottom one is that going to slip? It might want restraints, generally the walling is fine as are the buttresses.

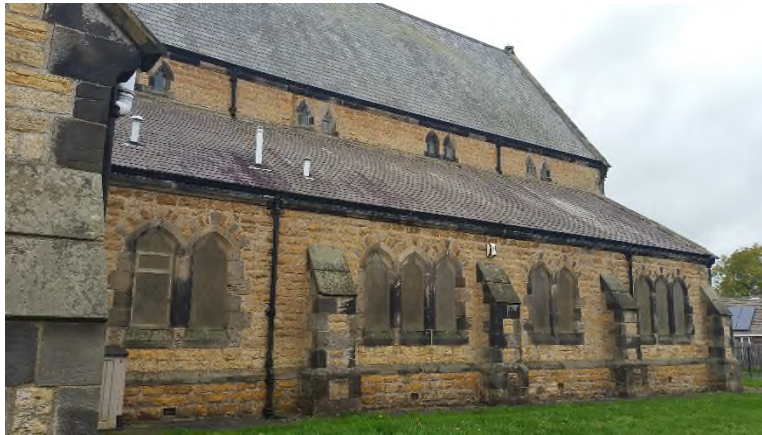
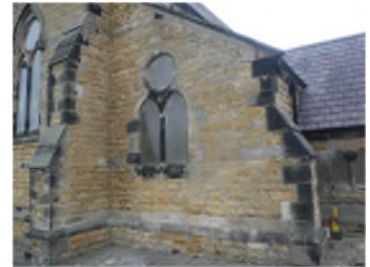
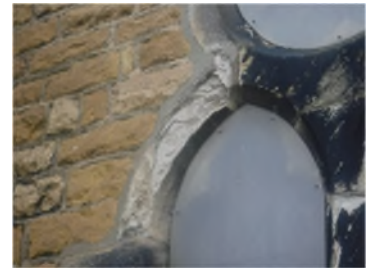
- **South Aisle:**

This features, as it does everywhere else on the church, lancet windows sometimes in pairs or in triples. There has been some replacement jamb stonework and more recently the mullions on the triple, one open joint to the one closest to the porch otherwise satisfactorily. The polycarbonate is a bit grey and green but it will do. Delamination of the west end double window will need replacement in time but will last 10 years or so.

Recommendation: none

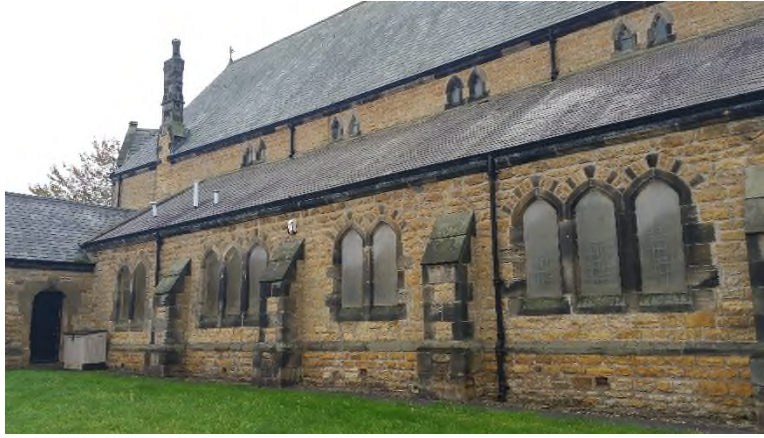
- **North Aisle**

It is the same design as the S aisle except they have two triple windows here and the masonry ashlar surrounds are fine. The polycarbonate is looking rather grey. The eastern most window seems to be in an aluminium frame possibly to provide a ventilator which can't open because there is polycarbonate stopping it.

West side – Circular windows and two lancets forming a group, all the masonry is ok and grey polycarbonate as before.

Recommendation: none

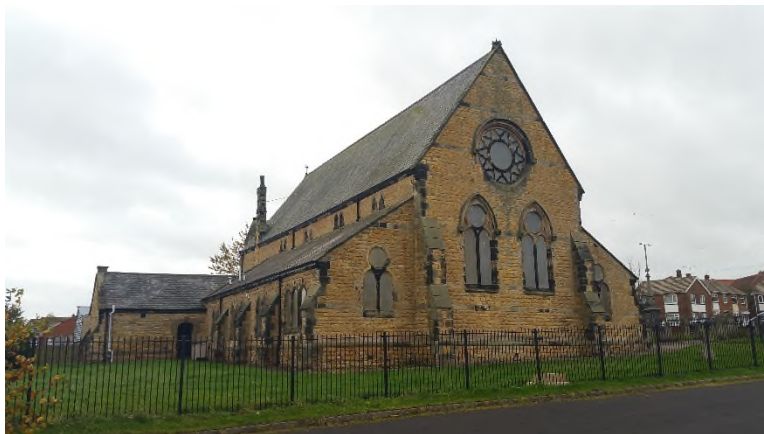
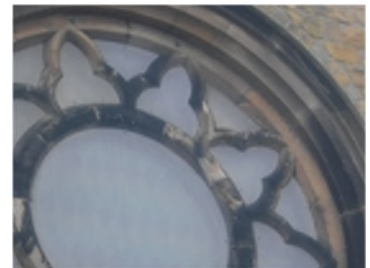
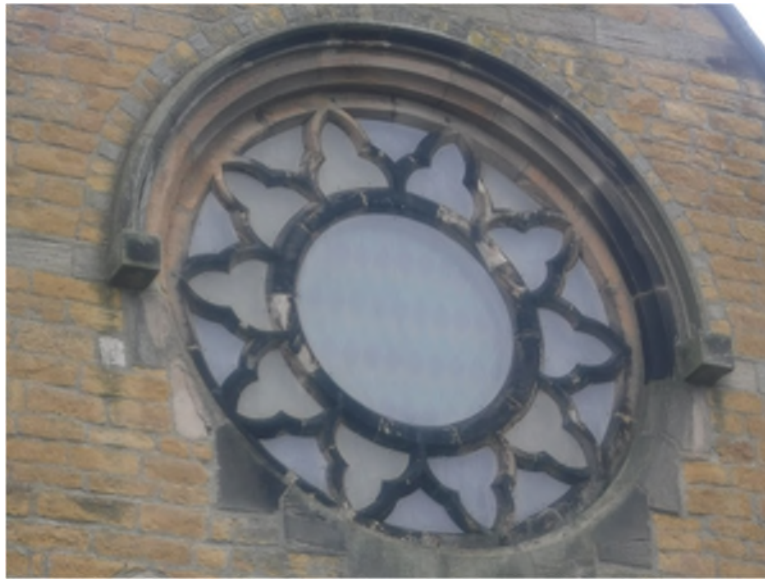
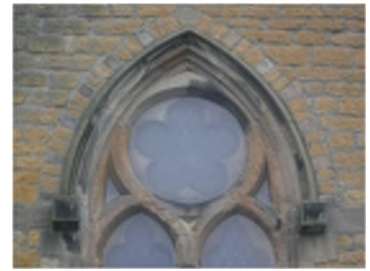
- **Nave West End**

The window tracery is all good though there is a chip out of the circular W window at high level (rusting metal dowel?) though the inside doesn't look bad at all so it is debatable whether it is needed presently perhaps a war chest needs to be put in place for this item in ten to fifteen years perhaps.

Central rose window, hoodmould looks ok, some wear on the northern side of the inner reveal. The radiating trefoil tracery looks ok. The inner ring has a chip out of it at the one o'clock position and I wonder if the tracery might be a little poor, there has been some shouldering in cement in the past so it has seen some repair. It is probably the dowel joint that has rusted and broke the inner circle.

Below that a single window comprising a pair of twin lancets with circular tracery and the hoodmoulds are ok. A little more wear on the twin lancet on the S side but ok and minor open joint on the cill on the N side.

Recommendation: none

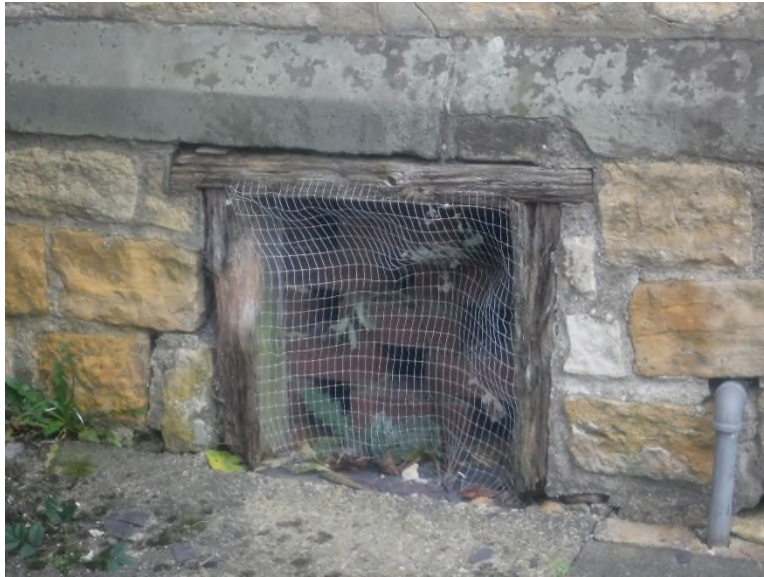
- D** The vestry has timber framed ventilators leading to the boiler room and these are now rather rotten and the mesh

is giving way on them.

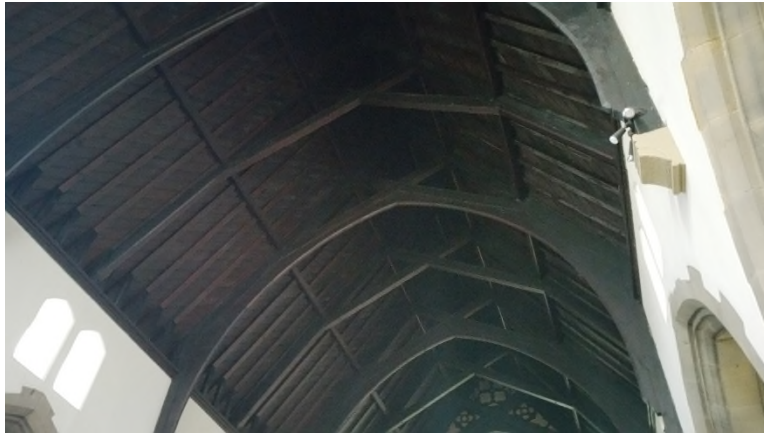
- **Nave:**

Exposed scissor trusses with extended feet to stone corbels and they support purlins and rafters, they all look ok.

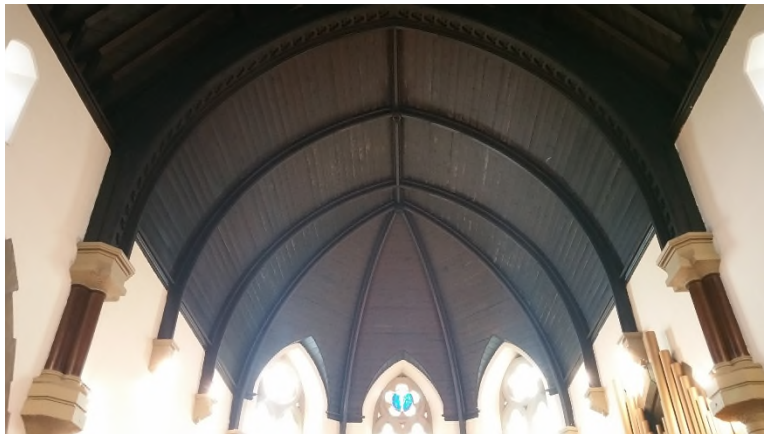
Chancel:

False ceiling of curved members down to corbels and all of these are ok, between the two is a chancel arch formed of boxed truss

with quatrefoil moulding which come down onto stone piers with high level terminations and they are ok.

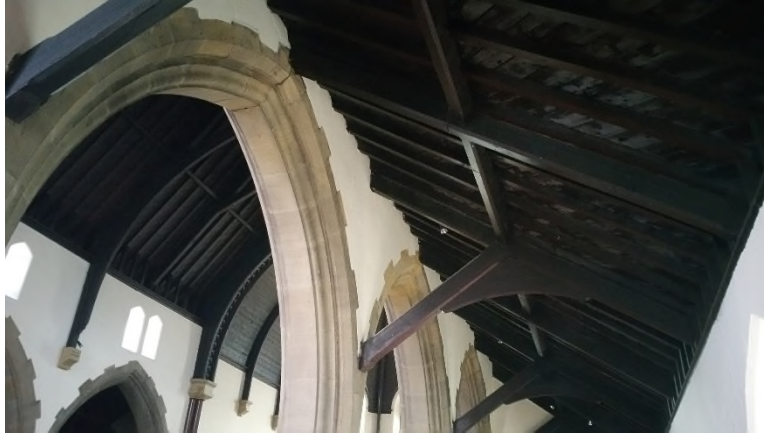
M North and South Aisles:

These are lean-to structures with simple trusses formed of a principal rafter and a strut, these struts go back to the arcades and are moving, the N isn't able to be inspected as it's now enclosed by the aisle partition, but there is evidence on the N at the W end of movement. The majority of the movement is on the S side where it looks like the S aisle wall head is bowing out because the three intermediate trusses supported by the arcade columns all are moving out of their sockets, the worst being in the middle and that is approximately 30mm, but it looks to be old movement which I think has two stages of movement looking at the paint marks on them, probably the initial first settlement and then gradual over time and the question is, has it stopped moving? Is it as a result of timber shrinkage that has pulled these members out? It could possibly be so, if they failed I doubt the roof would collapse but it is worthwhile checking what the N is looking like above the screen to get a better idea of that, but externally there are no obvious problems.

I also wonder if the shoes have been retro fitted? The backs of the shoes aren't all the same thickness, so are not a 'set' so might they have been fitted at different times? No that can't be the case because how could they fit them in, it doesn't make sense.

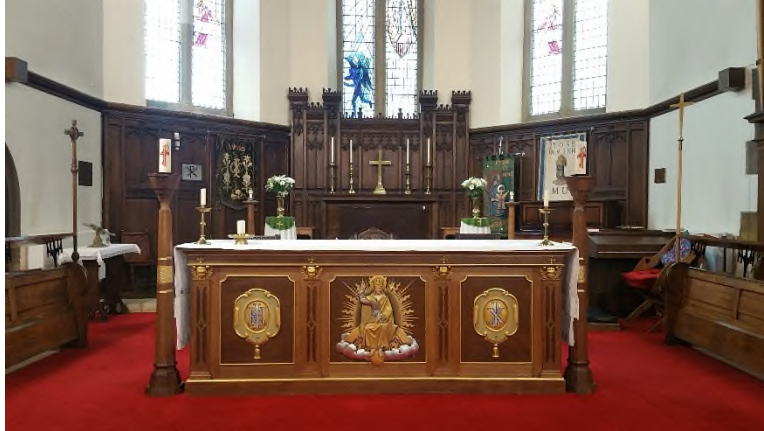
- **Panelling:**

The sanctuary has panelling linked to the reredos and that has recently been fixed back and that is ok.

Recommendation: none

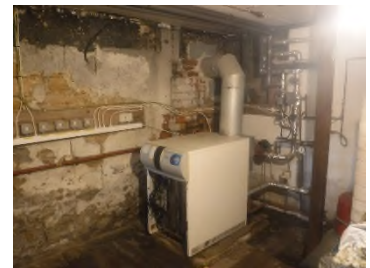
The room contains the gas meter and the Ideal Concord CXA boiler which they are thinking of replacing.

There is an elementary prop holding up the boarding or not, it is not quite obvious what that is doing.

Recommendation: clear out debris, check for a working sump pump, establish cause of flooding, renew duck board, establish what the prop is doing.

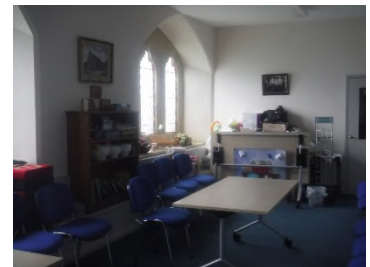
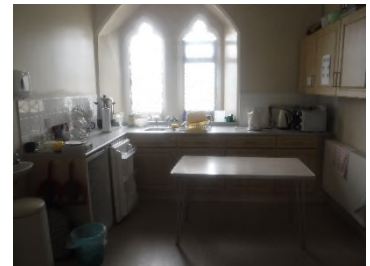
Servery:

Basic servery providing facilities for beverages and light meals, properly fitted out with separate wash basin – ok.

Recommendation: none

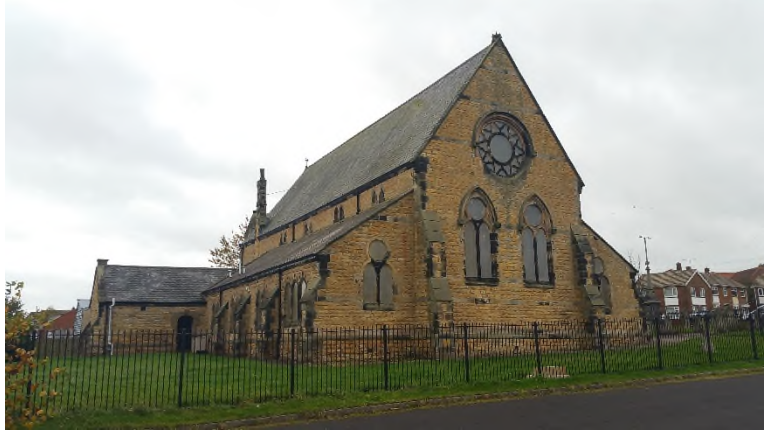
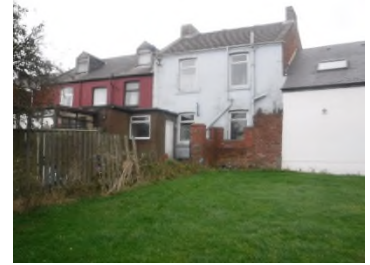
Boundaries:

The boundaries are in pretty good condition apart from the SE corner which looks into a neighbour garden which is rather ramshackle and might the church consider putting another fence up here just to tidy it up a bit and improve the look of the graveyard? It is domestic fencing belonging to houses on the E and N side. On the W and S it is recent metal railings which are looked after by the Local Authority. To the W is a carpark which is available for church use, Is it the churches carpark- in their ownership?.

Recommendation: check boundary ownerships and repair responsibilities
