**St Mary, Easington**  
(46)

**Quinquennial Report**  
On the architect's inspection of

**11<sup>th</sup> November 2025**

**Sarah Harrison RIBA**

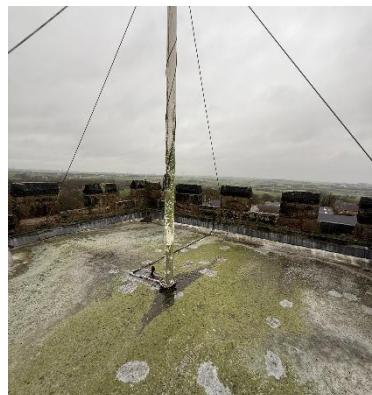
Figure 1- Tower roof

6.1.1 The tower has a reinforced concrete roof slab with downstand beams and shallow falls towards the north and south, draining to two outlet pipes on the east side that discharge via hoppers, both of which are completely blocked. The concrete roof was historically left exposed, and by 2002 water had penetrated the slab, causing reinforcement corrosion and localised spalling. A liquid membrane reinforced with fibreglass was applied in 2004. This coating is now more than twenty years old and shows widespread patching, flaking, holes and tears, including failure around the hatch and the north-east outlet. While it has been patched repeatedly and may tolerate one final round of repairs, full renewal of the roof covering is recommended. There is a lot of silt build-up on the roof, particularly at corners.

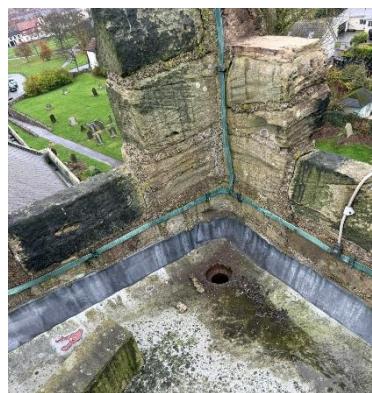
Figure 2- Stone removed

6.1.2 The parapets consist of single-stone copings with coarse-grit pointing. The southeast crenellation was loose at the time of inspection and due to its position over the entrance, an emergency call was made to David Ferguson's team to come and make this safe by removing the stone and resting it on the roof. All should be checked regularly to ensure their stability. Additionally, to the southwest corner there is a heavily weathered stone which may need replacement soon to ensure the stability of the stones above. To the base of the parapet there is a lead flashing, this has a large split on the west side but otherwise generally sound.

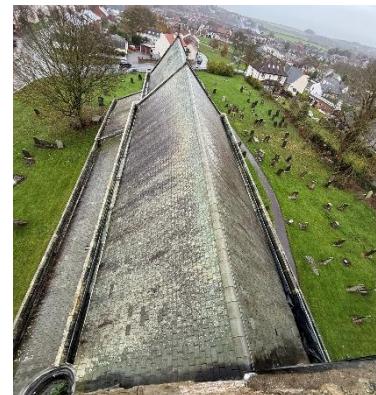
6.2.1 To the southern slope of the nave, nearest the tower there are several slates which have lifted or have broken corners. There is one broken slate near the ridge, furthest from the tower.

Figure 3- Nave roof from tower

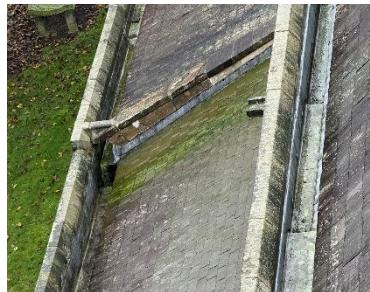
Figure 4- Watertable over N Aisle

6.5 The **north aisle** also has green Westmorland slate with lead soakers and cover flashings against the nave. The watertable to the vestry is much taller and has a lead flashing and mortar flaunching which is breaking apart. Again, green algae staining in line with nave outlets. As noted in the last quinquennial, the watertable here is laminating and this is causing leaks into the wall below, this area needs to be thoroughly addressed with replacement of the watertable stones and replacing the cracked mortar beneath.

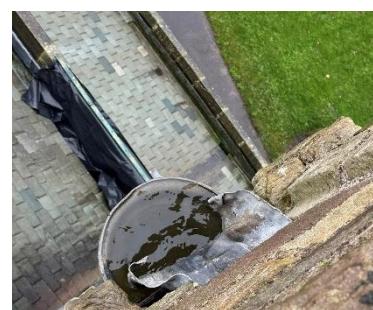
Figure 5 – Overflowing hopper at Tower

7.2 The tower has two outlets through the roof leading to lead hoppers, which fall onto the nave slates, this is currently putting a lot of pressure onto the nave box valley which is missing its lead. Currently also overflowing at the time of inspection.

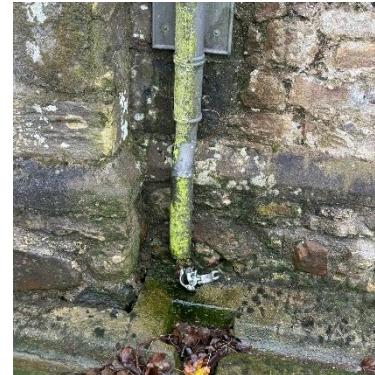
7.3 At ground level, downpipes generally discharge over cast iron grilles into continuous concrete ground gutters formed in shallow trenches around most of the building, with the exception of the vestry, organ chamber and tower. The grilles may connect to soakaways, although no positive drainage has been confirmed. Localised blockages were noted at several grilles, with soil and leaf build-up restricting discharge. In places the downpipes do not discharge into the gulley and would benefit from shoes as the base of the wall in very damp.

Figure 6 – downpipe short of gulley

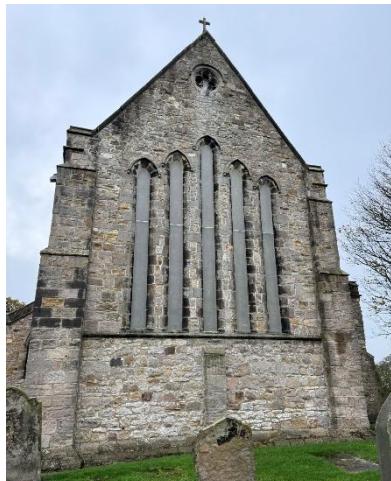
Figure 7 – East Elevation

8.1 **East Gable (Chancel)** – The water table to the east gable is steeply pitched, with generally sound masonry and buttresses. There is an open joint at the apex and a crack to the south kneeler. Above the northernmost lancet there is also an open joint within the stonework. Some outward movement is evident at the outer edges of the wall head, more pronounced on the south side, consistent with movement noted in the previous quinquennial inspection. This appears slightly more active than previously recorded and should be monitored, with particular attention to the south kneeler.

8.1.3 The stones to the watertable require re-pointing and it would also be wise to check the stability of the finial cross when this is done.

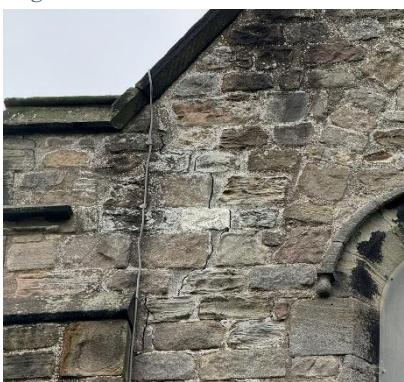
Figure 8 – Cracking at kneeler

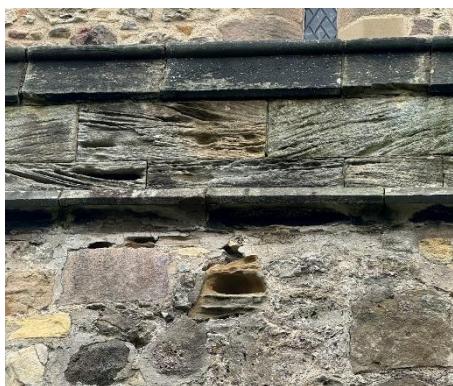
8.3.1 At the **east end**, there is also a crack to the left-hand side of the window sill and an open joint. The same issue is evident at the parapet with delamination

Figure 9 – S Aisle stone decay

to the watertable. These defects should be scheduled into a scheme for repairs and replacements in the next 10 years

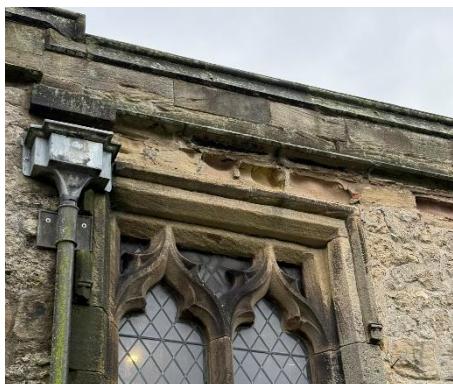
8.6.2 On the **north elevation**, extensive cement pointing is present, with numerous open joints, particularly at low level and around the buttresses. Past leakage from rainwater pipes has resulted in localised wetting of the wall surfaces and erosion of the underlying stone. The parapet is generally serviceable, though some joints would benefit from repointing, and the stonework immediately

Figure 10 – N Aisle stone decay

below is heavily eroded. The eastern window on this elevation shows poor stone condition above the opening, which should be programmed for replacement as part of the next repair phase, as should the replacement of the missing stone above a former blocked doorway which has been reported several times in the past.

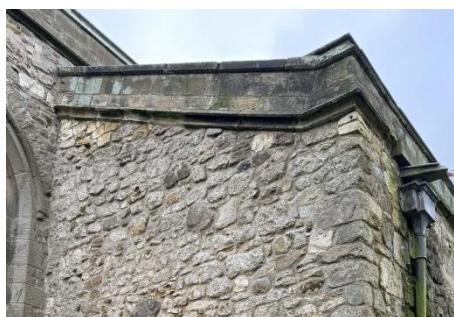
**8.7 Organ and Vestry** - The parapet is generally serviceable, although there is slight lamination to one of the stones. There is localised decay beneath the string course, which appears to have been subject to earlier patch repairs. A pronounced crack runs down adjacent to the easternmost window, though mentioned in the last QI no photographs for comparison. There are also records of remedial works in this location in 1981, and the current bellying of the masonry may relate to those earlier interventions and appears unchanged. The wall surface is noticeably eroded beneath the downpipe and shows significant green staining.

Figure 11 – E end of N aisle

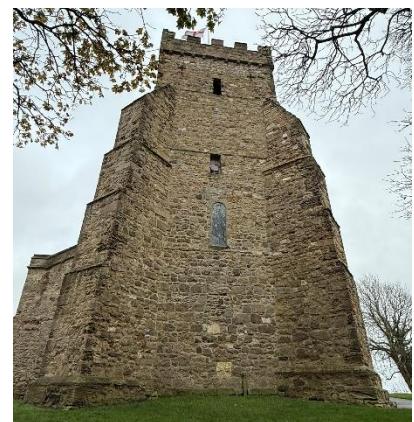
9.2.1 **West elevation** – fair condition, low level has some pleasant grave slabs built into the wall. Some open joints at low level and a patch of eroded stone centrally, though not currently requiring action. The northwest buttress has some heavily eroded stones; one looks to be missing and should be replaced to prevent water ingress here. To the southern buttress the condition at the top is also poor and there is quite a wide mortar joint at high level, some stone consolidation here may be advisable. To the top stage, two cross anchors can be seen but the height and screening by trees makes the condition difficult to comment on at this level.

Figure 12 - W tower elevation

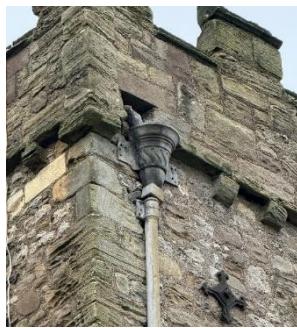
9.2.2 **North Elevation** – Erosion of the crenellations and string course below, appears worse than other sides. Two cross anchors to the top stage and one to the stage below. Large buttresses at base and some open joints at plinth level. Above the easterly buttress there is a small area of stones which would benefit from re-pointing as it correlates with an area of damp internally – see item 9.5.2.

Figure 13 – Tower hopper outlet

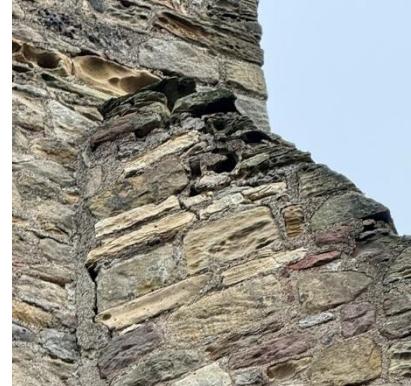
Stone walling is generally in ok condition; the top projecting band has some erosion and needs to be monitored. As noted in section 6.1.2 one of the merlons was loose and had to be removed for safety, all should be checked. There is also a small pocket of erosion over the south aisle. Top of buttresses are eroded, which means water must penetrate into the stone here and some consolidation should be considered.

Figure 14 – Erosion to top of buttress

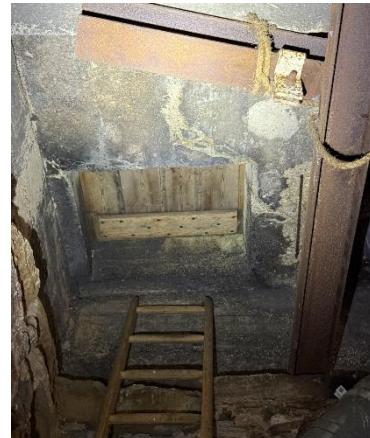
9.3.3 **Access** within the belfry is awkward in places. The exit from the ringing room ladder would benefit from additional grab handles, as would the top of the belfry timber ladder. The intermediate walkway between ladders is poor, consisting of a single timber plank supported on two steel beams with unprotected gaps on either side. The timber pole ladder from this platform to the roof hatch is in fair condition;

Figure 15 – Hatch to roof

however, the hatch itself is heavy to operate when standing on the ladder, particularly in the absence of handrails or guarding.

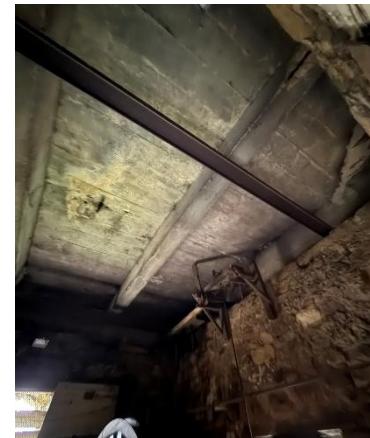
9.3.1 **Ceiling / Roof Structure** - The tower roof comprises an approximately 200 mm thick reinforced concrete slab with deep downstands of around 300–400 mm bearing onto the masonry walls. Localised spalling is present beneath the east beam and at the west end adjacent to the roof hatch. A crack was noted on the west side in the vicinity of the flue, and a rusting reinforcement bar is visible at the south-east beam end. The extent of any progression since earlier reports is unknown and should be monitored and reviewed as part of the design of any future roof-replacement scheme. There is some erosion to the stonework adjacent to the ladder at the west end, all of which are mentioned in previous reports.

Figure 16 – Structure of roof

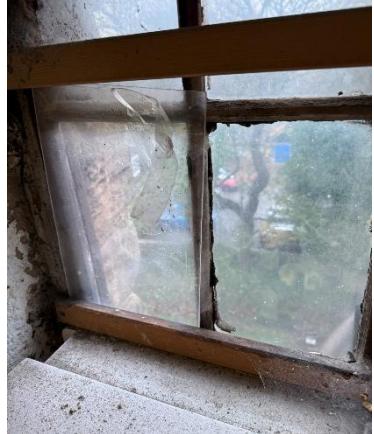
Figure 17 – window in ringing chamber

9.4.4 **General Condition and Access** - The room would benefit from general cleaning and redecoration, as areas of paintwork are breaking down. The west window is in poor condition, having been damaged previously, and presents a risk of bird ingress. The window has a loose pane of glass leant up against the frame, this require repair. This window also serves the security alarm installation. The door catches on the carpet, and access is awkward, with the key stored on a string within the room, requiring twisting at the top of the stair to operate. Access to the belfry is via a long ladder, which is difficult to use; an aluminium ladder has

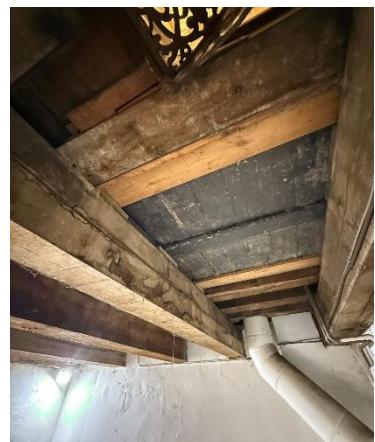
9.5.1 **Ceiling / Structure** - The ceiling is generally in fair condition but shows areas of staining, the cause of which is unclear and may be historic. Large timber beams supporting the floor above appear sound overall some beams have pronounced shakes, likely attributable to natural timber movement, and does not currently give rise to concern.

Figure 18 – ceiling beams

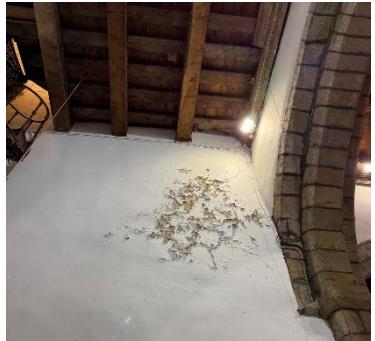
Figure 19 – damp patch to tower

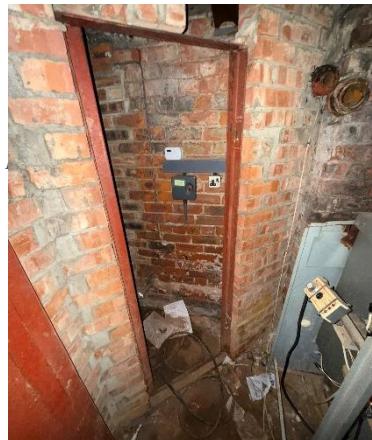
9.5.4 **Access and Fire Considerations** - The flagged floor is supported on light steelwork of varying sizes. In some locations the end bearings appear limited, and there is concern as to whether the steelwork has adequate fire protection, particularly given the presence of the boiler below. Access to the ringing chamber is via a metal spiral staircase which, while steep, appears structurally sound. The stair partially descends into the boiler room below.

Figure 20 – boiler room entrance

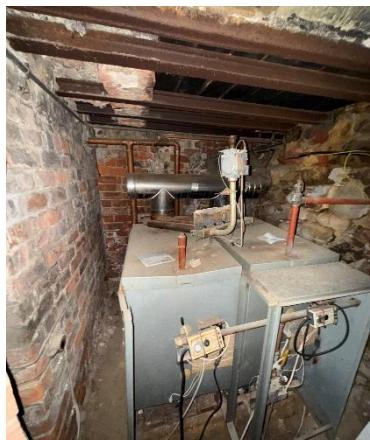
Within the space there is a brick enclosure, likely intended as a fire box or fire separation for the boiler; however, this is ineffective in its current form. The metal door to this enclosure is missing, and there is a noticeable smell of gas within the space.

Figure 21 – boiler room

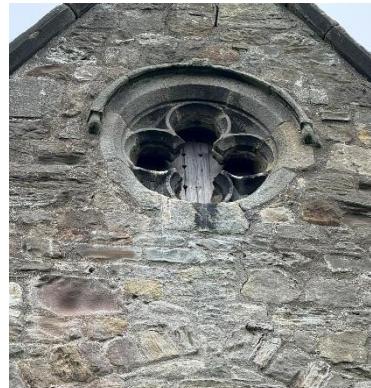
10.1 **East Gable of Chancel** – The east gable contains a stepped five-light lancet window with a quatrefoil opening above. The lancets appear in fair condition, although the presence of grey polycarbonate protective covering obscures the glass joints and limits close inspection. The quatrefoil at the apex shows bird fouling, and a timber backing board behind the opening appears to be split.

Figure 22 – E gable quatrefoil

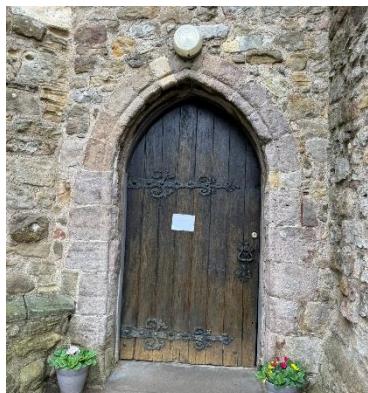
Figure 23 – Tower door

10.6 **Tower door** – The door is a vertically boarded timber door with a pointed arched head, fitted with decorative wrought-iron strap hinges and an iron ring handle. The timber is weathered, particularly towards the base, and there is a noticeable gap at the bottom of the door. The stone surround to the arch is heavily eroded and formed of mixed stone types, with areas of slate packing. The pointing to the arch and jambs is breaking down, with a significant open joint at the lower right-hand side of the opening, and further deterioration to the pointing evident within the internal face of the arch.

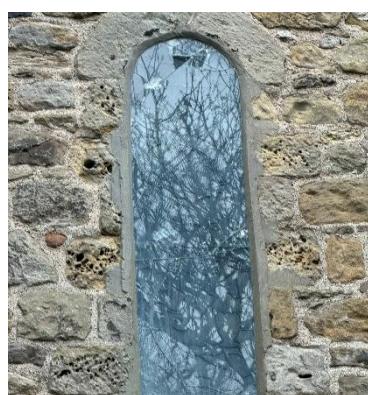
Figure 24 – Pictorial glass window

10.7.3 **Pictorial glass window** – This window contains pictorial glass and is externally overglazed with glass. The pointing to the surrounding masonry is primitive and the glass protection is broken, perhaps from birds flying into

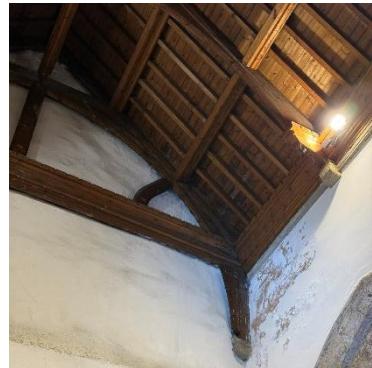
Figure 30 - Nave West

**12.2 Nave** - The nave roof is formed by five trusses supporting purlins, rafters and sarking boards. The trusses are of bowstring form with longitudinal beams at the tops of the arches, and braces down to stone corbels. The ends of the trusses are understood to be anchored to the tops of the clerestory walls as part of previous stabilisation works. Evidence of historic outward spread is visible, and appears to be approximately 50 mm in places. Wall heads are infilled. Water marking is present at the west end, thought to be historic but should be monitored.

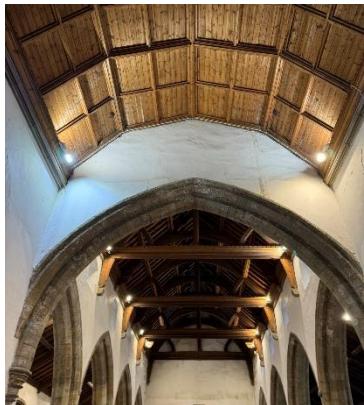
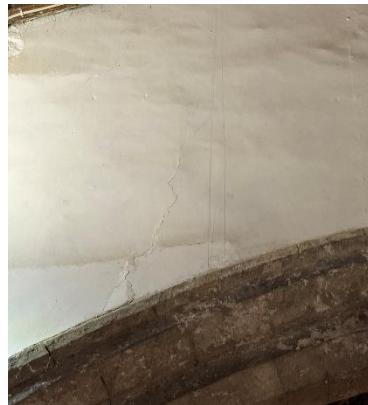
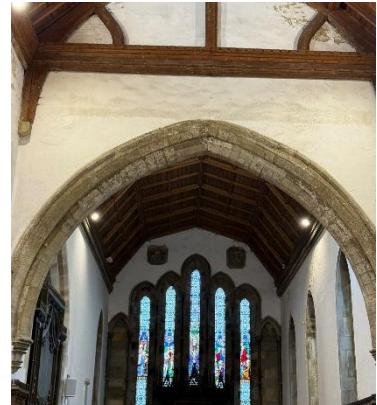
13.2 The **chancel arch** is a slightly flattened, double-chamfered pointed arch with hoodmoulds to both sides, mottled by remnants of historic limewash. While generally sound, there is an open joint to the south side and diagonal hairline cracking rising close to the apex at both sides, again both noted previously.

Figure 33- Chancel Arch

Figure 34- historic cracking at arch

Figure 35 – opposite side of chancel arch

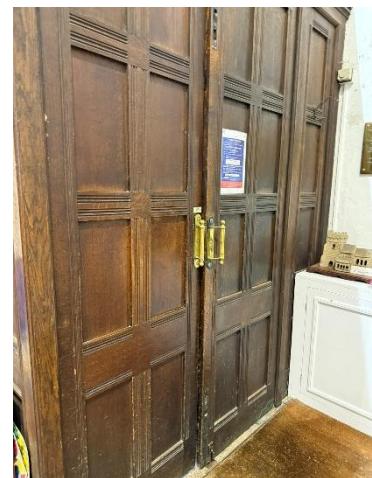
15.5 The **draft lobby** is formed at the tower. The latch to the outer door does not engage properly and there are gaps around the door, resulting in noticeable draughts. The inner door to the nave is generally serviceable but does not close as effectively as it should, and the lower flush bolt is inoperative. There is some dampness to the walls at low level. Overall, the doors are serviceable but would benefit from adjustment and minor repair.

Figure 42- Lobby doors

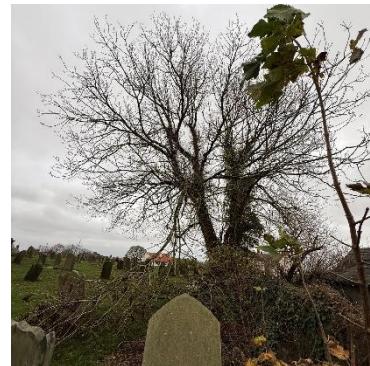
Figure 48- Tree with broken limb

27.2 Given the number and proximity of mature trees along the boundaries, a tree survey should be carried out by the local council, with an ongoing record of tree condition maintained.

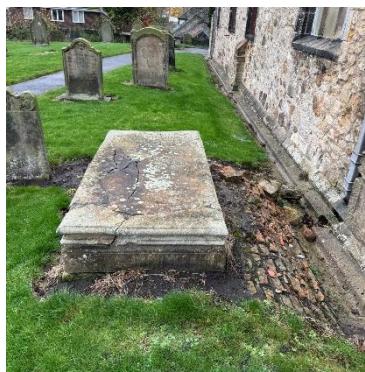
Figure 50- Broken grave slab

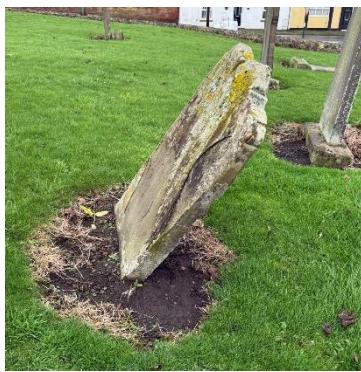
Figure 51- Leaning gravestone

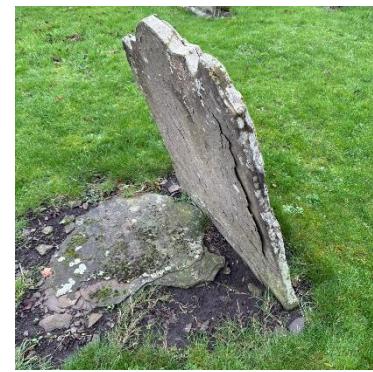
Figure 52- Delaminating gravestone
