**QUINQUENNIAL REPORT on the**

**THE CHURCH OF ST EBBA**

**EBCHESTER**

Date of report: 17<sup>th</sup> July 2019

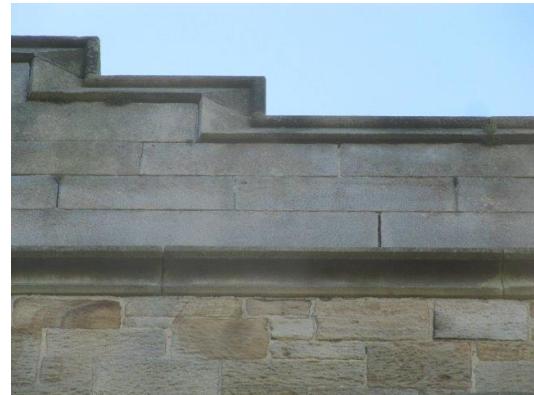
General view of the South side of the church Open joints to Tower parapet

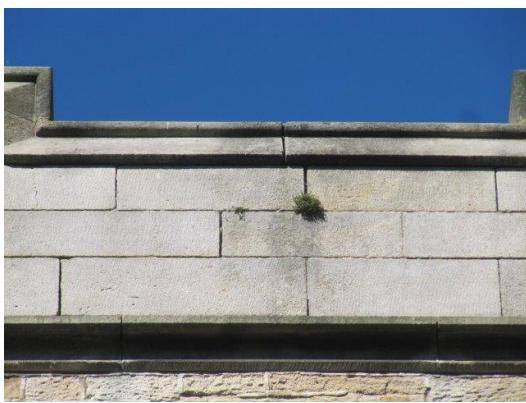
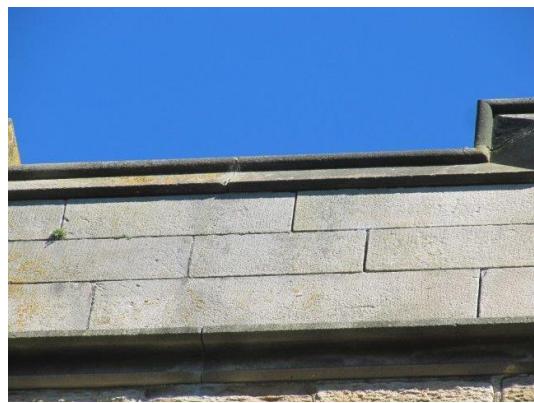
Open joints, cracking and vegetation growth to Tower parapet

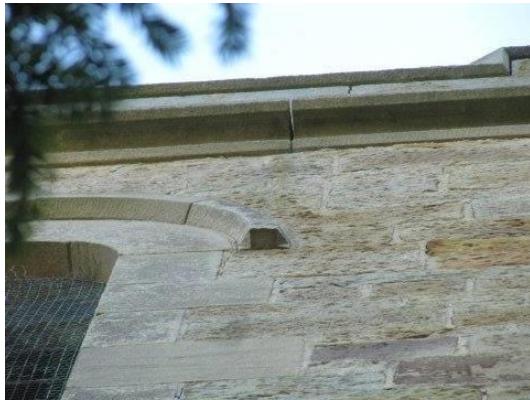
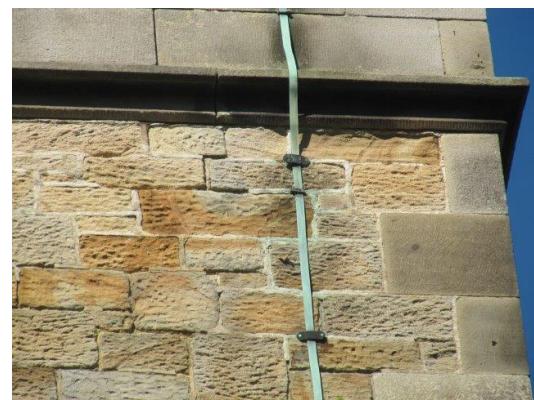
Open joints to string course and in section of wall below the parapet on the tower

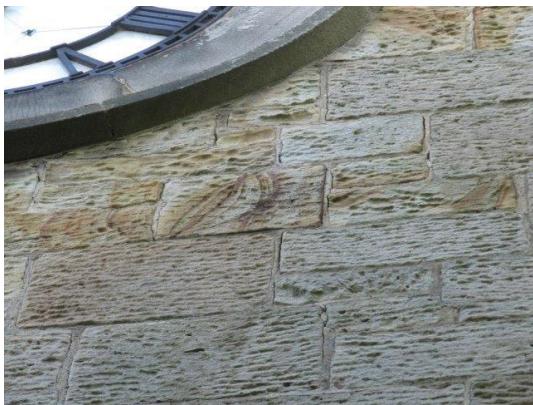
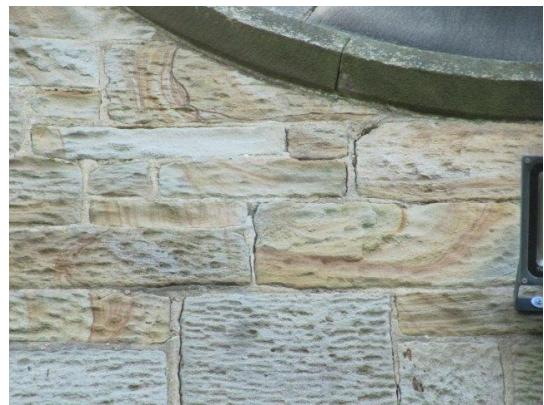
Cracking below the West (left) and North (right) clock faces

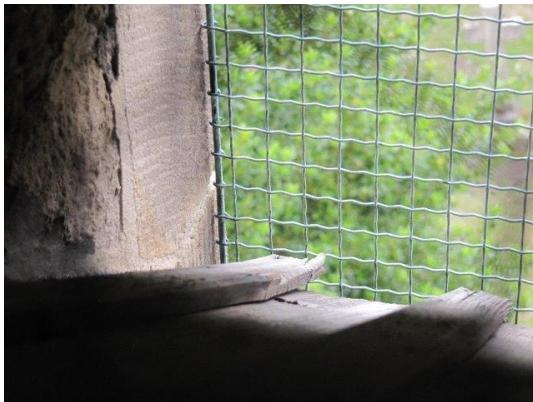
Damage to louvres/cover strips

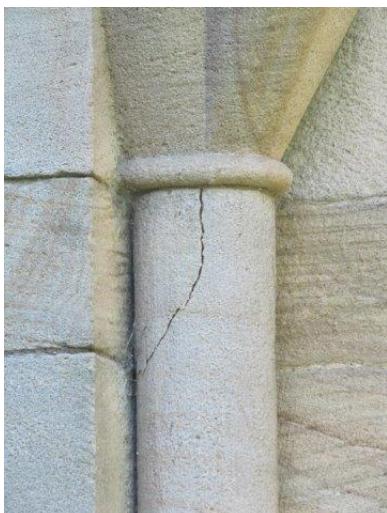
Cracking to pilaster of East Chancel window

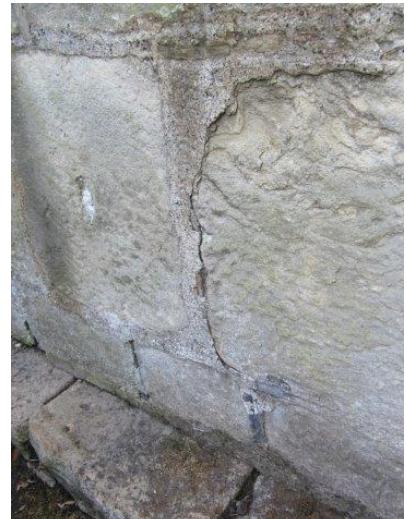
Cracking to mortar between larger stones on East wall of the Chancel

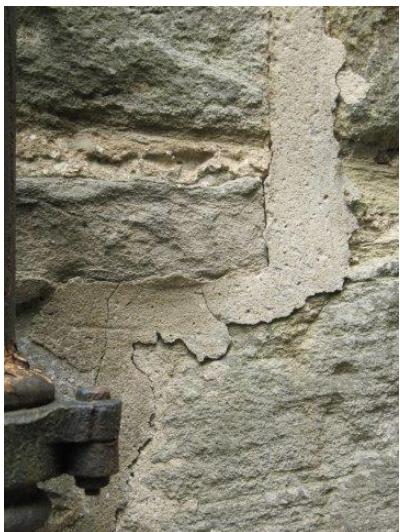
Cracking starting to reopen on South wall of Chancel

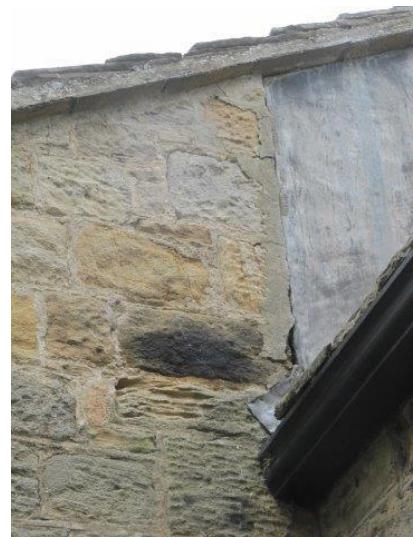
Failing mortar to side of lead on East gable of the Organ Chamber

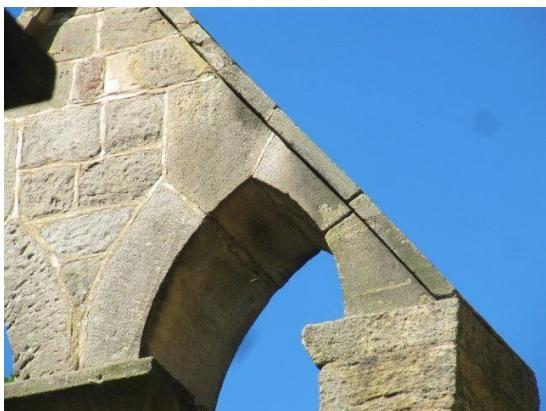
Open joint on east side of Bellcote

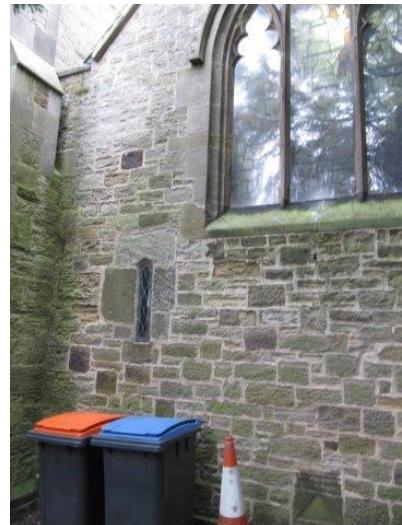
Green algae to corner between tower and West wall of the Nave

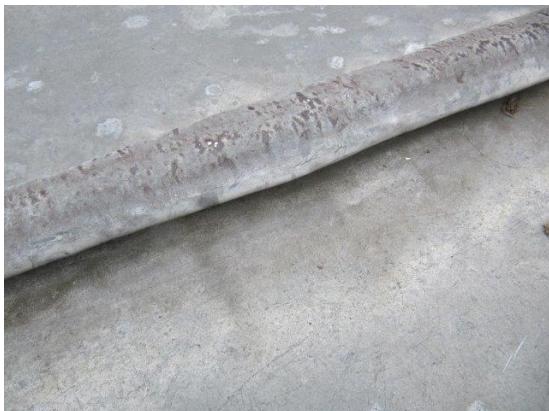
Deformed lead to rolls and cracking to lead bay on tower roof

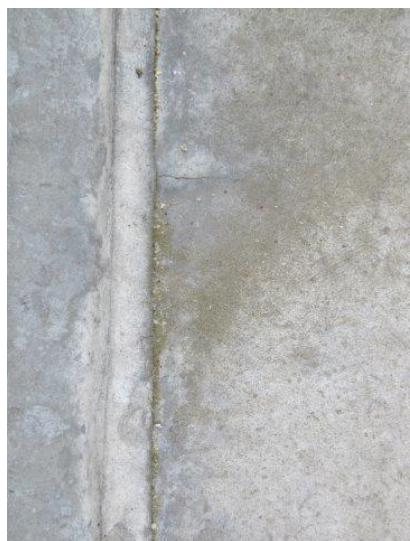
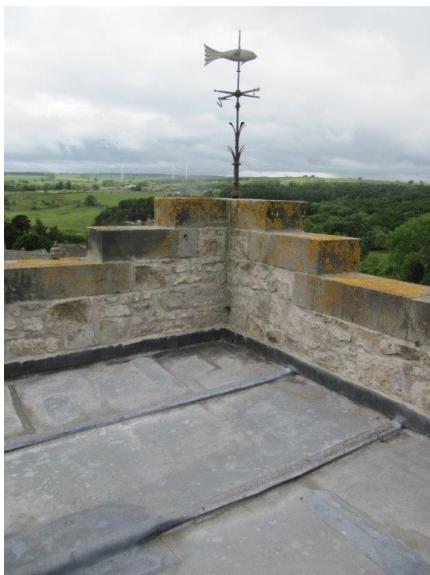
Previous patching to lead of tower roof

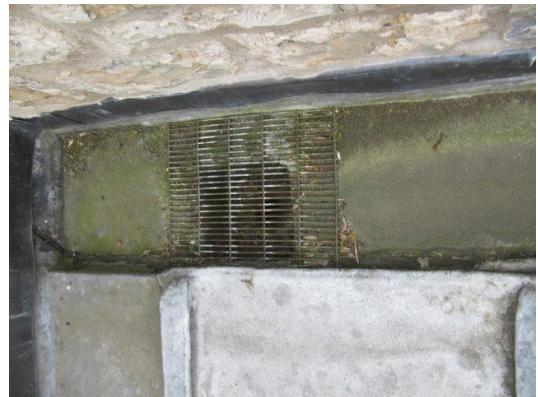
Gutter guard traps debris

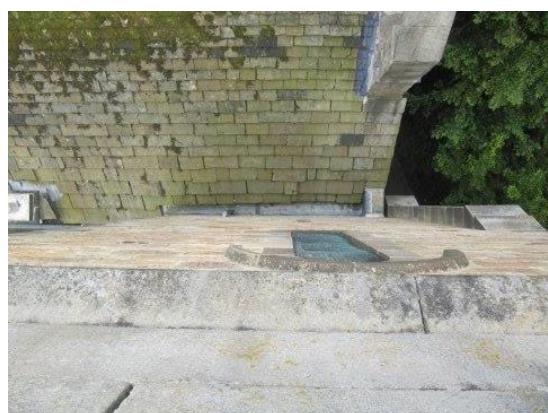
Raised base to weathervane

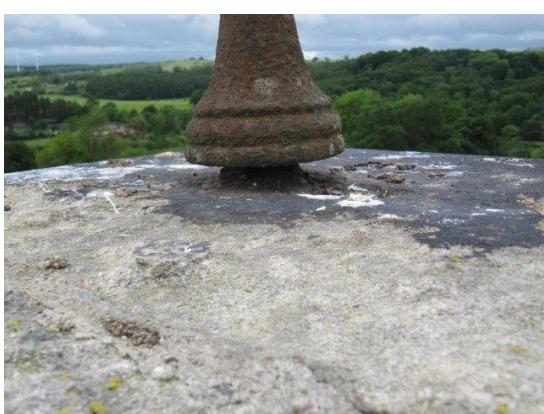
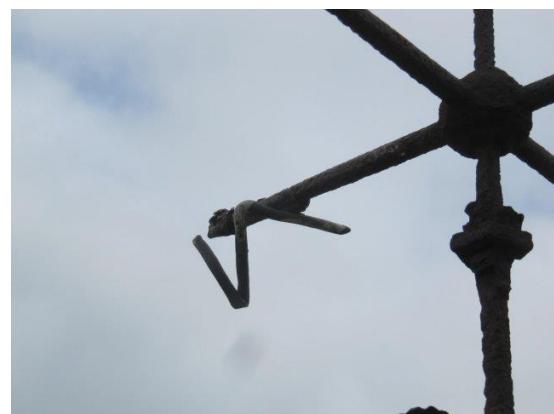
Rusting metalwork and damaged and loose compass point to weathervane

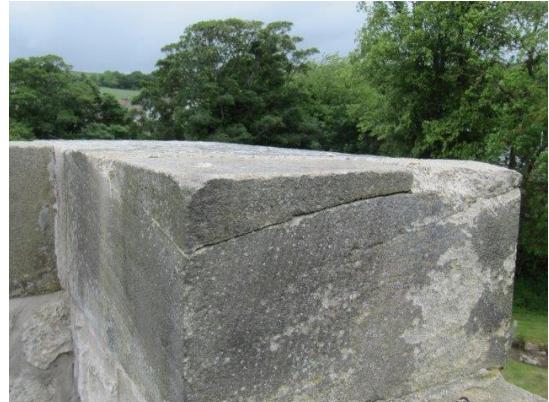
Cracked and loose stone to tower parapet

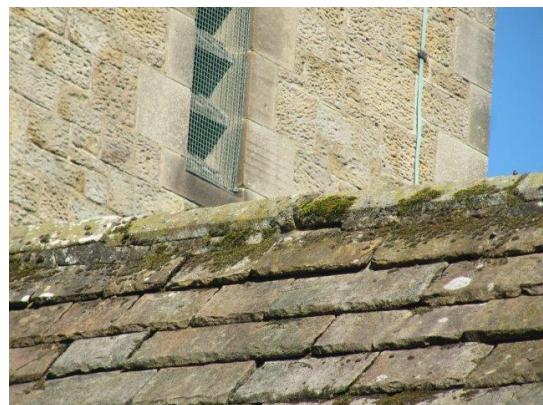
Missing bedding to ridge on Nave roof

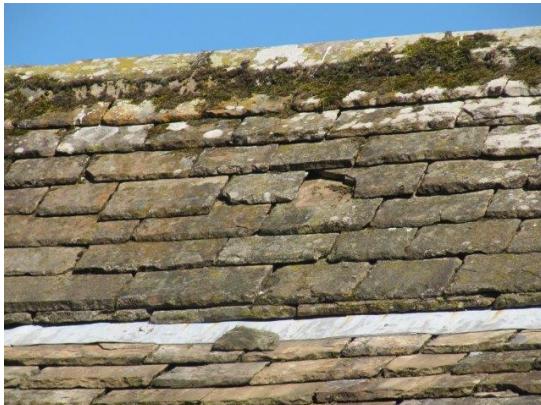
Cracked slates on Nave and vestry roofs

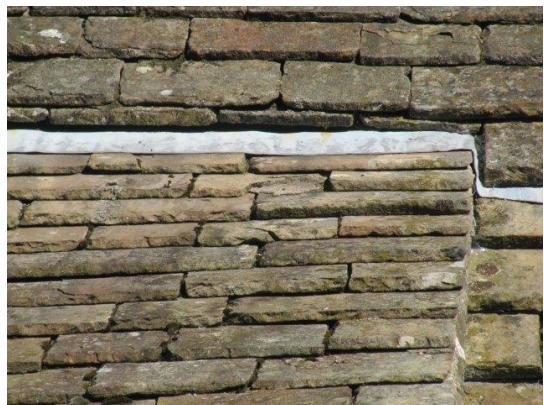
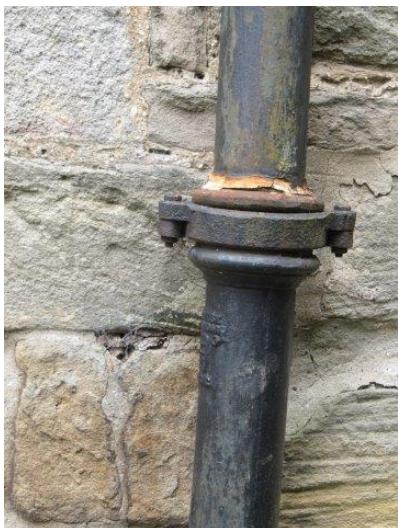
Rusty downpipe with damaged sealant to joint

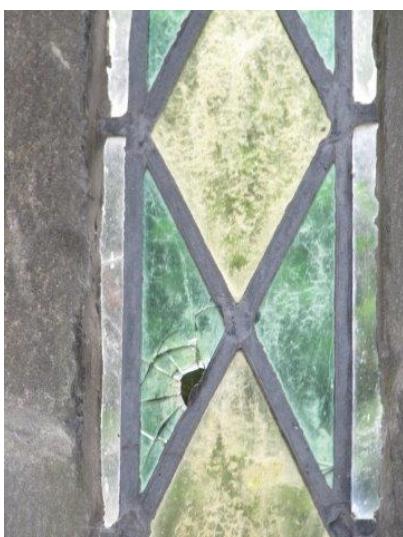
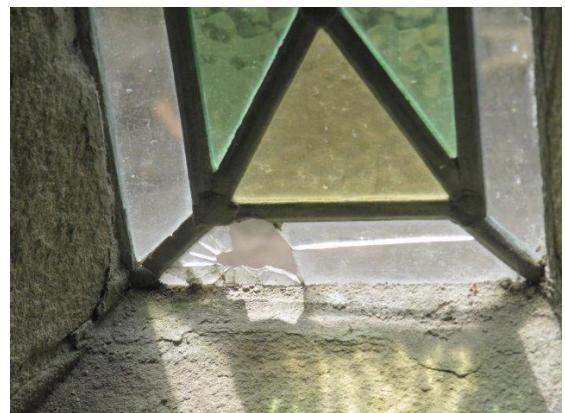
Cracked glazing to windows

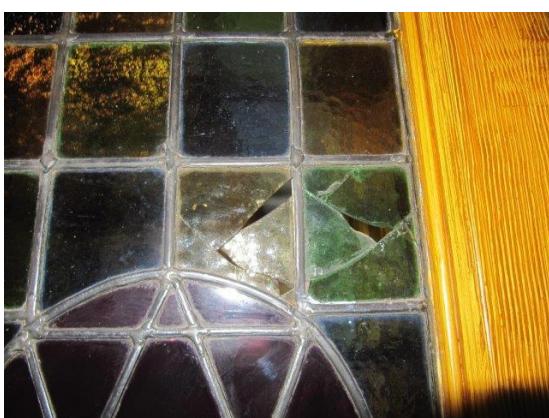
Cracked and loose glazing to inner tower door

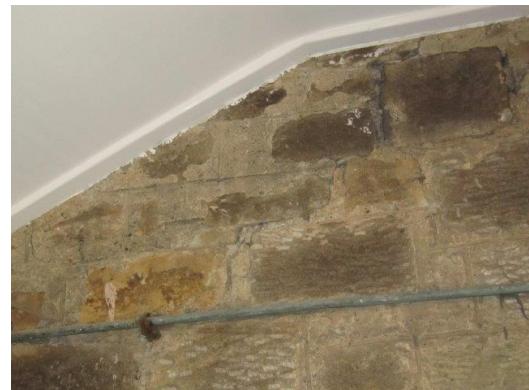
Cracking to East wall of boiler house

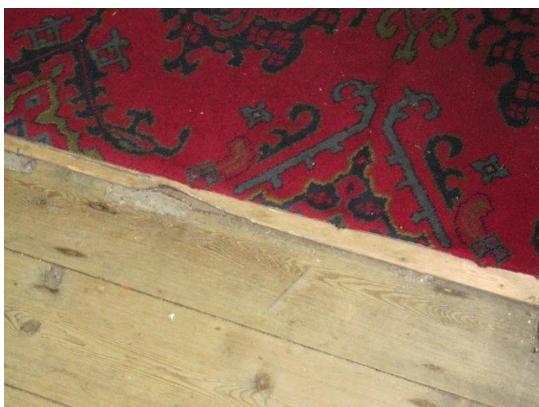
Loose and damaged timber edging near font and cut/damaged boards to East of Nave

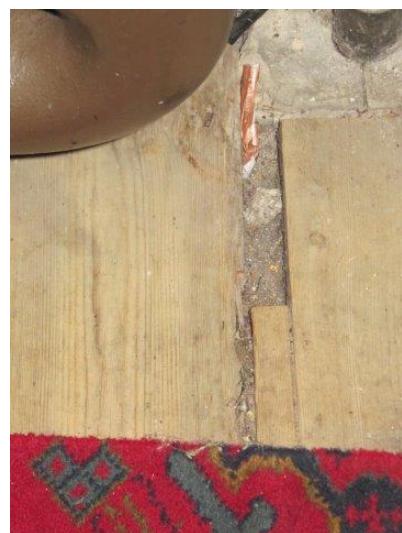
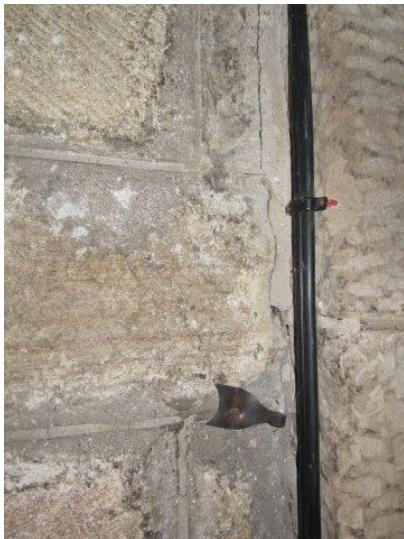
Cracking to North West corner of Nave

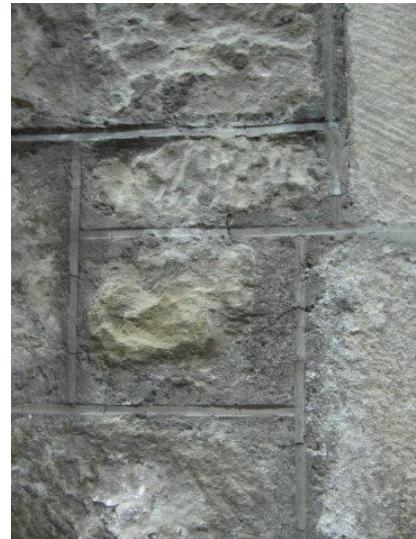
Hairline cracking through mortar to West Wall of Nave

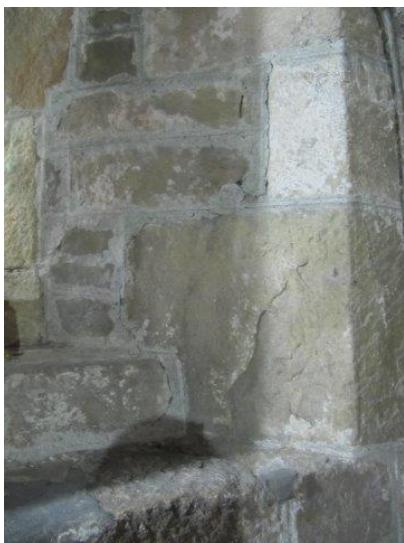
Cracking to window on North wall of Chancel

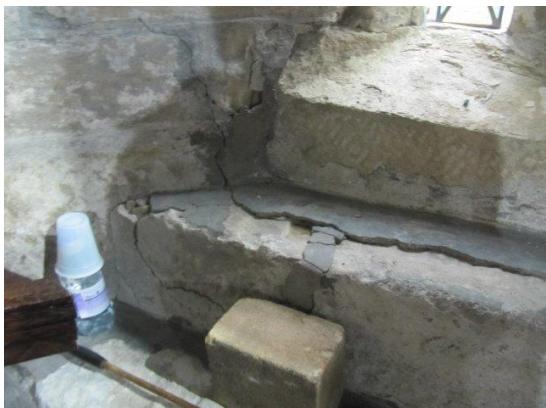
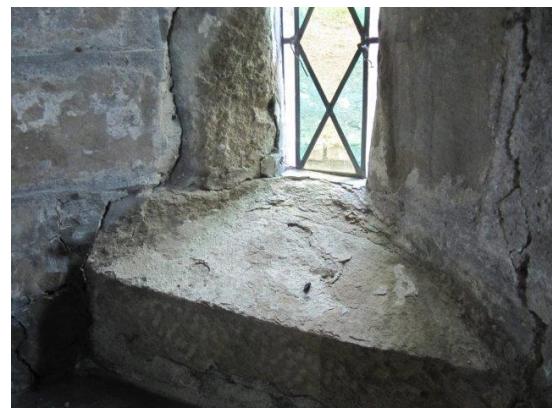
Cracking and failed mortar repair to W9 on South wall of Chancel

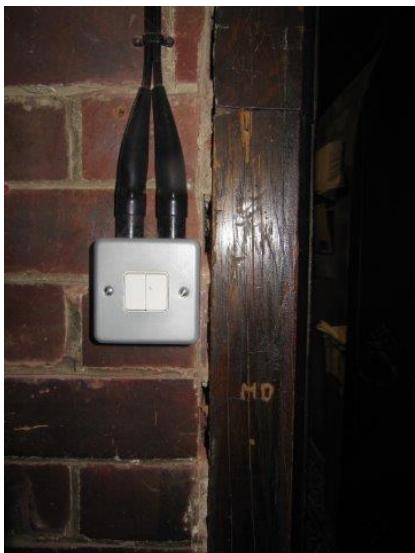
Cracking around door frame to organ chamber

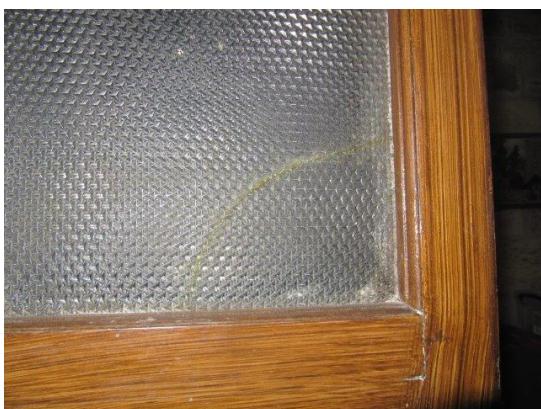
Repair to cracked glazing of vestry door

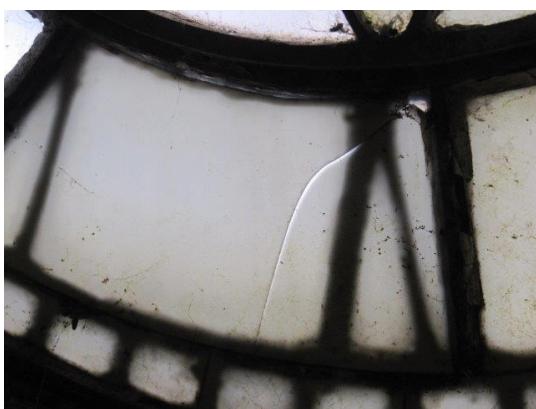
Cracked glazing to clock face

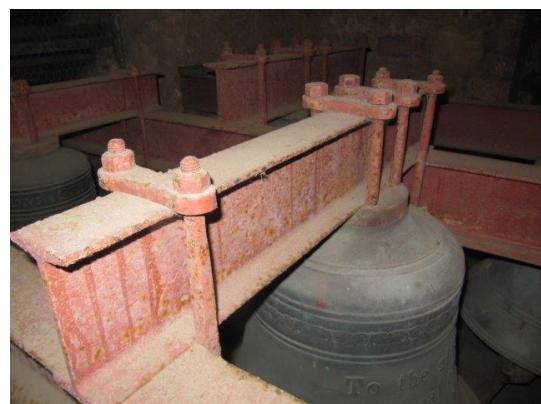
Rust to metalwork supporting bells

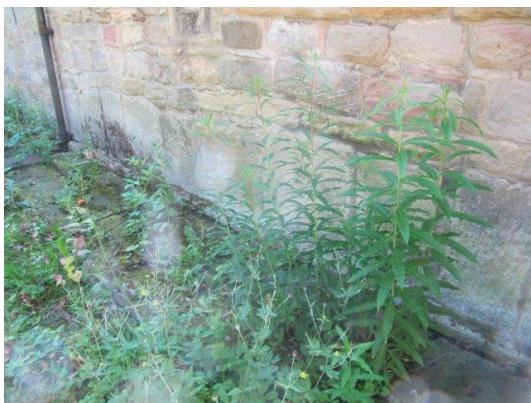
Vegetation growth to North of Cancel

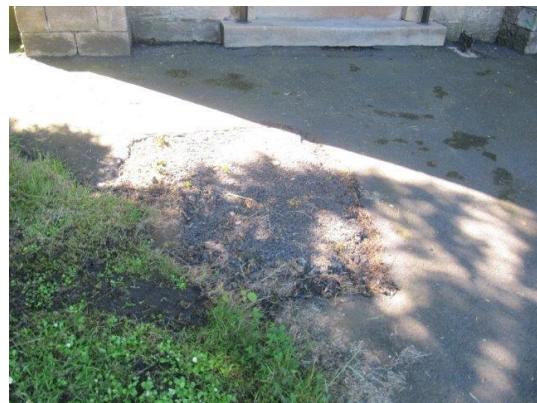
Failed patch to main tarmac path

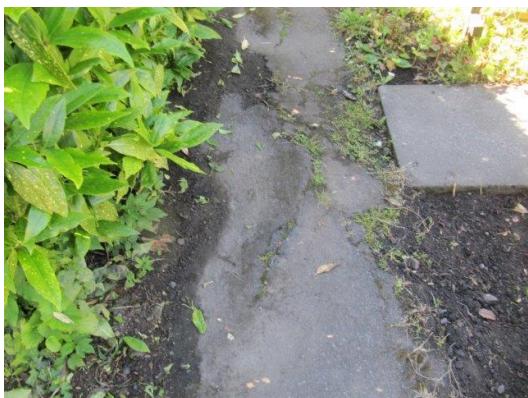
Uneven and damaged tarmac path  
To Garden of Remembrance

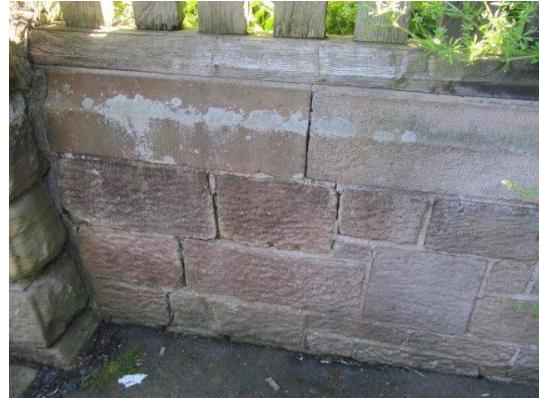
Cracking to wall of lych gate

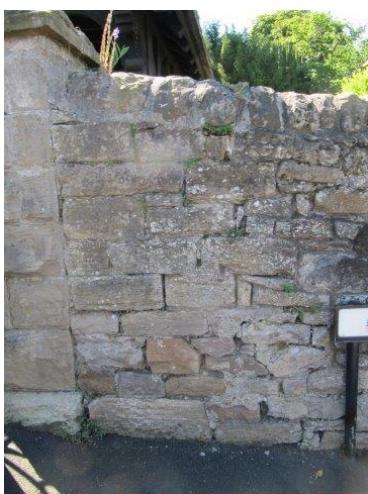
Open joints to Northern boundary by main gate
