St John's Church
Eggescliffe

Inspecting Architect Ulrike KNOX RIBA AABC

Report on Quinquennial Inspection
13th April 2021

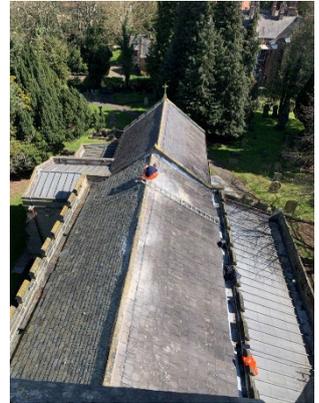
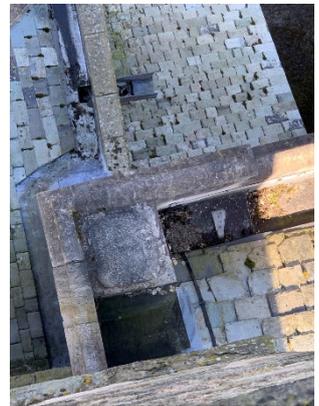
To the west end around the old flue, there have been poor repairs.

To the south side the gutter appears to be in better condition and is clearer, although there is still some pointing lying in the gutter.

There is some flash-band on some of the slates. About half way along the elevation a slate has almost entirely sheared off and the remainder of it is lying in the gutter. There are also a few other cracked and broken slates. These were being attended to during the inspection.

Ridge pointing has been lost and is in poor condition.

- B • Clean and check north nave gutter (being done on day of inspection)
- B • Replace broken and missing slates (approx 4 no.) (being done on day of inspection)
- B • Repoint area of ridge stones (being done on day of inspection)
- B • Redesign area of flat roof between old flue and tower wall – finish in lead and drain to slates or side gutter.

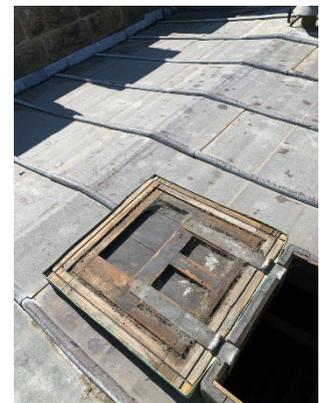
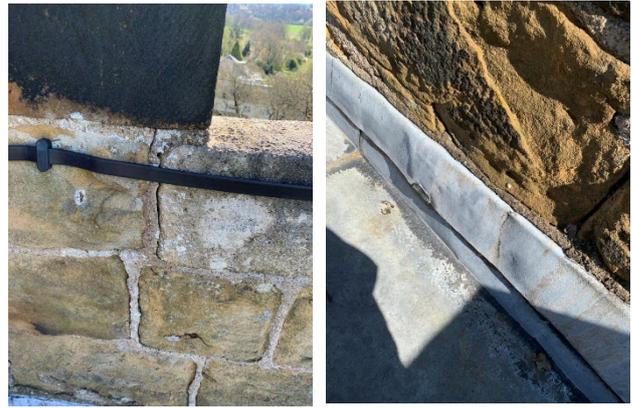
It was noted that one stone to the west elevation has a crack all the way through it and the joint below is also open. There are other open joints. This requires pointing. Some of the stone work is deteriorating and this should be monitored. There is a crack to the cover flashing to the east side.

- C • Re-point stonework to the parapet.
- D • Monitor deteriorating stonework.
- B • Repair/replace lead cover flashings and point in using leadmate.

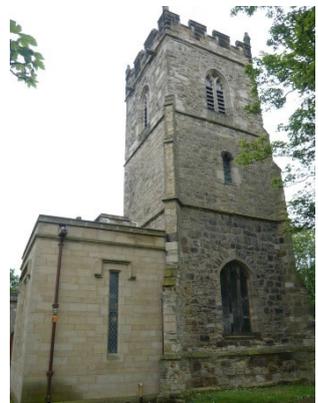
2.7.2. **Condition:**
It is in rubble and generally the stone work is sound. The lower section stonework is suffering some erosion and hollowing out of the stone and creating cavities. Since this is at relatively low level, we could consider filling this with a conservation mortar.

2.7.3. The tracery to the window appears to have a crack in the left hand mullion at the top. The protective glazing is polycarbonate and in reasonable condition.

2.7.4. The bell ringing chamber above has a timber framed window and plate glass glazing. Below it there is an over-flow pipe. The over-flow

pipe has been cut off at the wall. The pointing in this area is good and the window and surround appears to be in good condition.

- C • Mortar repairs required to larger stone cavities at lower level on tower west elevation.
- C • Make stone repair by indent to the left window mullion to the lower west window.
- C • Reinstate moulding to the string course of the belfry on west face.

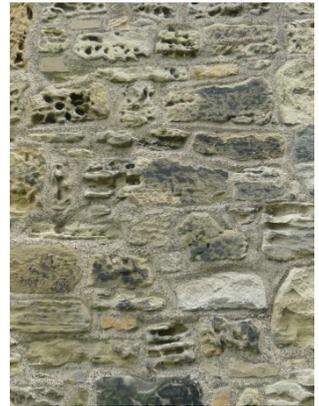
2.7.5. To the Upper Stage Belfry, the window has been relatively recently repaired and is in good condition. There are timber louvres to the Belfry in good condition. The stone work is beginning to erode, however is still in reasonable condition.

2.7.6. The string course above the Belfry is generally good except for one section which has completely fallen away. Renewal of this important weathering stone should be considered. The parapet has crenulations. The second merlon from the left has a crack in it which has been mentioned from the roof part of the report. This has been pointed, but could be more aesthetically sympathetic.

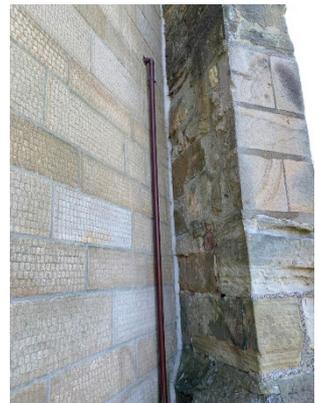
The stone work is in good condition, however there appears to be some dampness occurring at parapet level and staining. This may be due to poor flashing on the roof. It is noted that the over-flow has stopped dripping and the wall has been cleaned. The movement crack at the junction with the tower has been pointed, this needs to be monitored.

- B • Monitor movement crack.

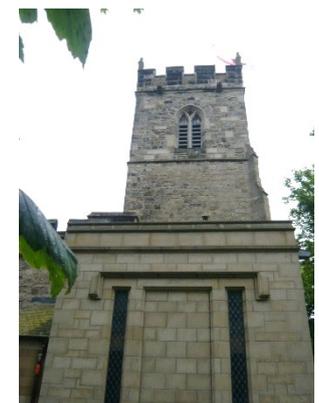
The first stage is well pointed and in good condition. The second stage has an opening to the Belfry which is also in good condition. There are some areas of weathering, however it is generally satisfactory.

2.9.3. To the string course above the Belfry, there are 3 no string course stones which are weathered and we should consider renewing them. The adjacent stones have already been replaced. There is also movement to the north east corner and some joints have opened up.

- D • Reinststate moulding to the string course of the belfry on north face.
- C • Point open joints and monitor for movement.

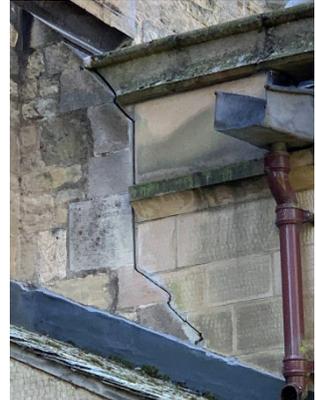
There has been movement and a crack has formed between the new building and old. This should be monitored

Above the off-shoot, there is an unsightly section of stainless steel. This does not look particularly good.

- B • Continue to monitor pointed up vertical joint.
- A • Point open joint above roof level (lower)

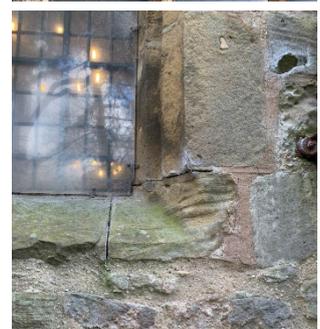
To the east window, this is of older stone and there are areas of weathering at the head of the window which require repair. Certainly the second from the left voussour has a number of defects which should be repaired. This may be done with a conservation mortar as the area could be neatened up substantially. There are also open joints to the bottom right of the window.

- C • Provide mortar repair to the voussoirs to the east window on north nave. Also repoint the open joints.
- C • Point at low level.

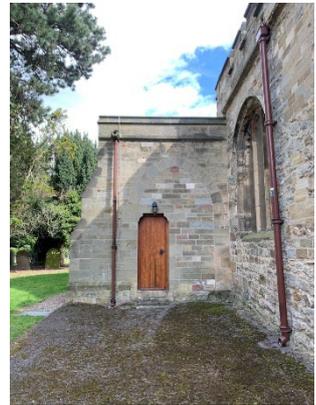
At close inspection some of the joints are open, particularly within the copings and the blind arch. There are also open joints to the left of the door. These require repointing.

- B • Repoint joints at parapet level and copings.

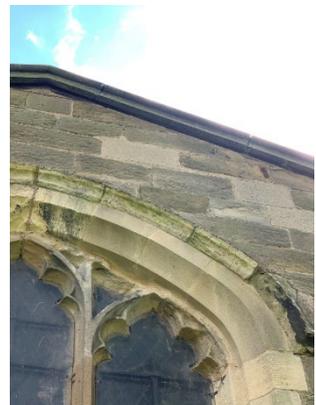
The coping joints are open and require repointing.

- B • Repoint joints at parapet/coping.

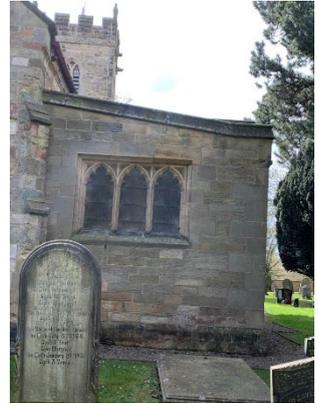
The stonework is in reasonably good condition, but there is one open joint above the window head. This should be repointed within five years.

- C • Repoint open joint above the window head.

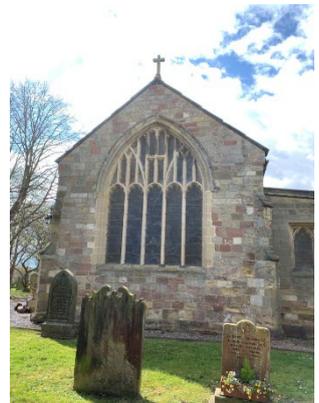
- 2.17.2. **Condition:**
The tracery has been substantially renewed. Generally the elevation is in good condition apart from a number of weathering stones at low level. These should be monitored and will in due course require renewal.

- 2.17.3. **Recommendations:**
- M • Monitor weathering stones at low level.
 - C • Clean behind the polycarbonate.

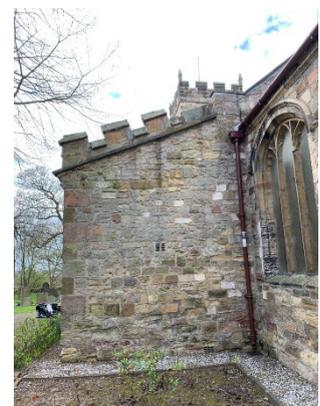
- 2.18.7. **Condition:**
The stone coping has lost some of its pointing towards the top. The coping should be pointed. The rest of the stonework appears to be in satisfactory condition.

- 2.18.8. **Recommendations:**
- B • Point stone coping to the east face of the south aisle.

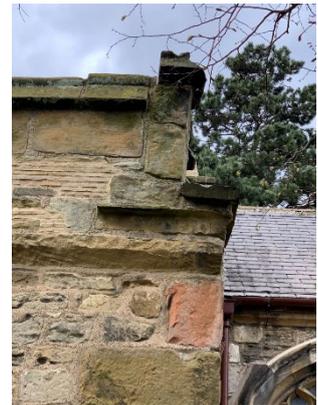
A number of the stones have been repaired using the tile method which is quite successful. The pointing to this elevation, apart from where the new tile repairs have been made, appears to be rather hard and sitting proud of the stone work. The colour is quite good, however it is not ideal for the stone and it should be considered for replacement.

- M** • Monitor effect of cementitious mortar on the stone on the south elevation and schedule replacement in due course.
- B** • Take down east end coping and re-set. Point all copings and tabling.
- B** • Point window head – one joint.

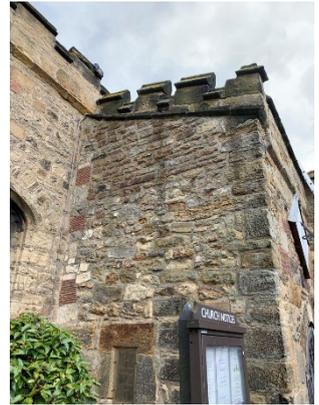
- 2.20.2. **Condition:**
Generally in good condition but parapet and tabling have open joints and are letting in water.

- 2.20.3. **Recommendations:**
B • West elevation of south porch - Point coping and tabling.

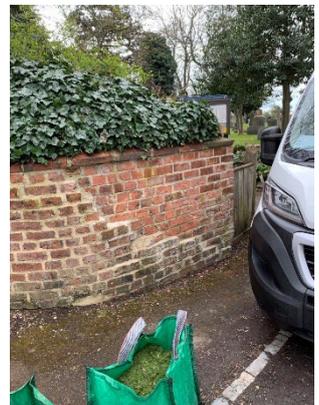
- 2.21.1. There is an extensive Churchyard with many mature trees. It is closed and entirely maintained by the local authority. They check the trees and all of the Church monuments for stability and safety.
- 2.21.2. There is a notice board in good condition.
- 2.21.3. The pathways are generally sloped in tarmac and accessibility into the building is good.
- 2.21.4. The brick boundary wall to the east requires repair.

- 2.21.5. **Recommendations:**
B • Repair brick boundary wall at east where pointing has been lost.

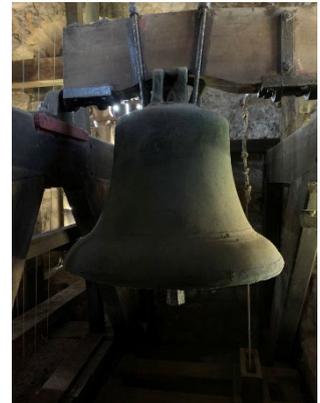
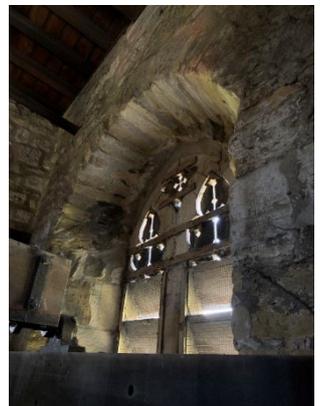
Also provide a light and a handle at the top of the first ladder.

- B**
 - Improve access to the tower roof by fixing the ladder at the top, and provide a grab bar and light.

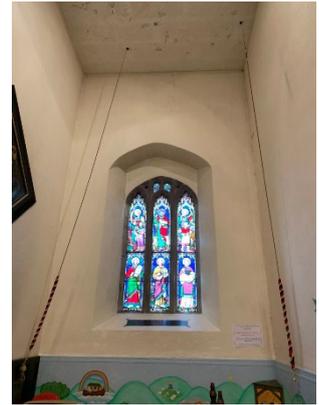
The ceiling of this space has a number of areas of paint loss where it is flaking away. This is likely to be modern emulsion paint and ideally should be stripped back and lime washed as the walls are.

At the apex of the arch there is a crack and this extends up within the Tower space and along the ceiling. Adjacent to this crack there are two other joints which have been very poorly repaired in the past. These should be cleaned back and all of them repointed and monitored for further movement within five years.

- D • To the tower arch internally point open joints and monitor for further movement.
- E • Strip the emulsion off the ceiling and repaint with a more suitable coating.
- D • Repair the stained glass. Clean behind protection.

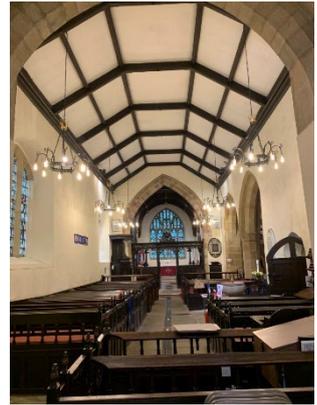
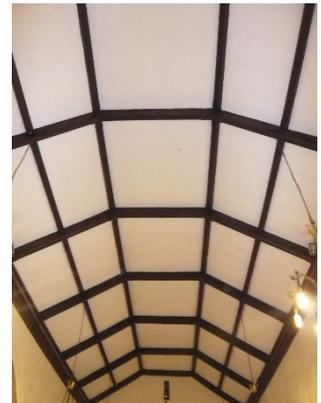
It was noted that at the west end at low level, some of the plaster work has fallen away from the wall due to damp. There is also another area of damp looking plaster work, half way down the Nave between the two windows. This may coincide with the down-pipe beyond.

Further disruption to the paint work and plaster work is evident in the corner at the Chancel Arch behind the pulpit. The rainwater disposal at this area should be checked for defects. The area close to the pulpit looks like it has been patched up in the past using gypsum plaster. It would be best to remove this and re-plaster with lime plaster once the wall has dried out. Elsewhere, the state of the walls is reasonable but the decorations are tired and dirty.

There is just one crack noticed to the stained glass.

- D** • Remove gypsum plaster close to the pulpit and re-plaster with lime plaster once the wall has dried out.
- B** • Ensure the rainwater goods on the north nave are running freely at all times. Carry out a drainage survey to determine the state of the drains.
- B** • Repair cracked stained glass.
- D** • Redecorate overall with lime wash.

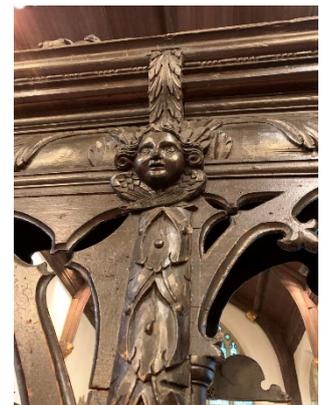
The condition of the timberwork is fragile and it is of outstanding significance. The report by McBain highlighted a number of essential repairs and improvements to improve longevity. The recommendations must be adhered to.

- A • Put into action the recommendations by Rupert McBain for the repair of the Cosin style timberwork.

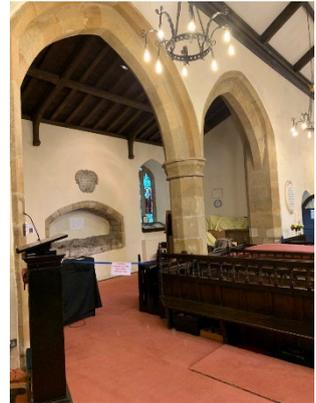
3.6.2. To the south there is a niche for the effigy. The stonework around here has been poorly pointed and would benefit from cleaning back and repointing.

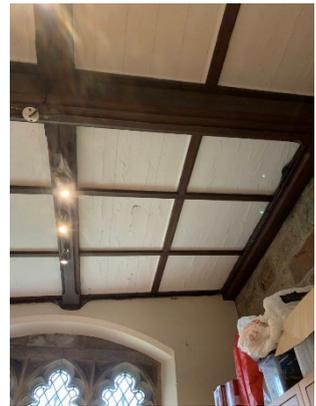
The ceiling is panelled and boarded. The paintwork is flaking and lack of ventilation might be a problem.

- C • Redecorate ceiling and improve ventilation.

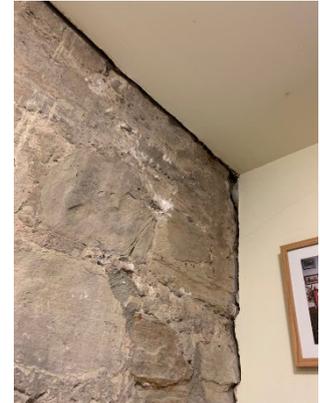
3.10.4. **Condition:**
All appear to be in good condition, except for a significant crack along the beam to the ceiling and at the junction with the Church.

- E** • Clutter should be reduced to allow easy access for wheelchair users to the WC.
- B** • Fill and monitor cracks along the beam to the ceiling and at the junction of the north extension with the Church.

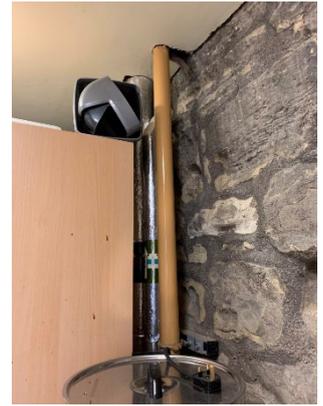
There is a crack at the junction of the ceiling plasterboard and stone walls (approximately 10mm) and wall plasterboard and stone wall (approximately 15mm).

- M** • The boiler should be serviced regularly.
- A** • Cause of movement to be commented on by structural engineer. Fill and monitor.

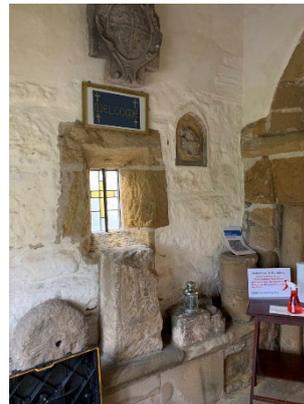
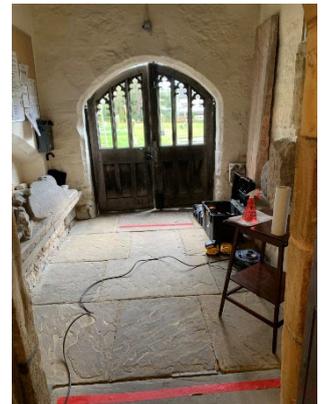
The limewash finish at higher levels is beginning to flake away and damage is evident but generally the space is in reasonable condition.
