**The Church of the Holy Trinity,  
Eggleston, Co. Durham**  
DIOCESE OF DURHAM  
Quinquennial Inspection of Churches

West Elevation

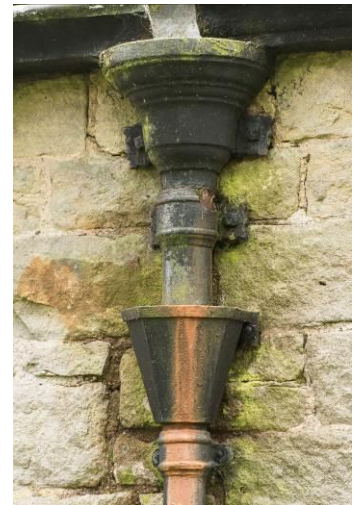
**1.4 Stains indicate pipe is blocked**

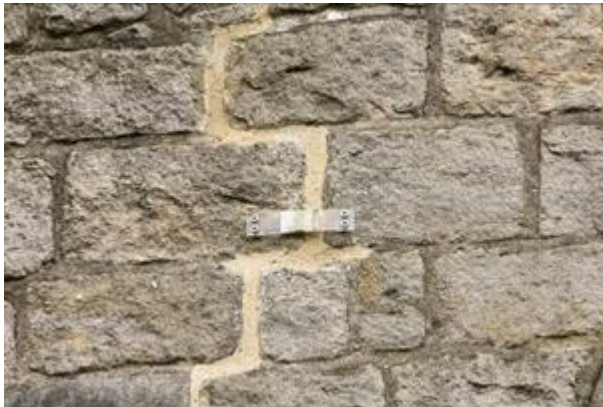
4.2 Vertical crack in the west gable

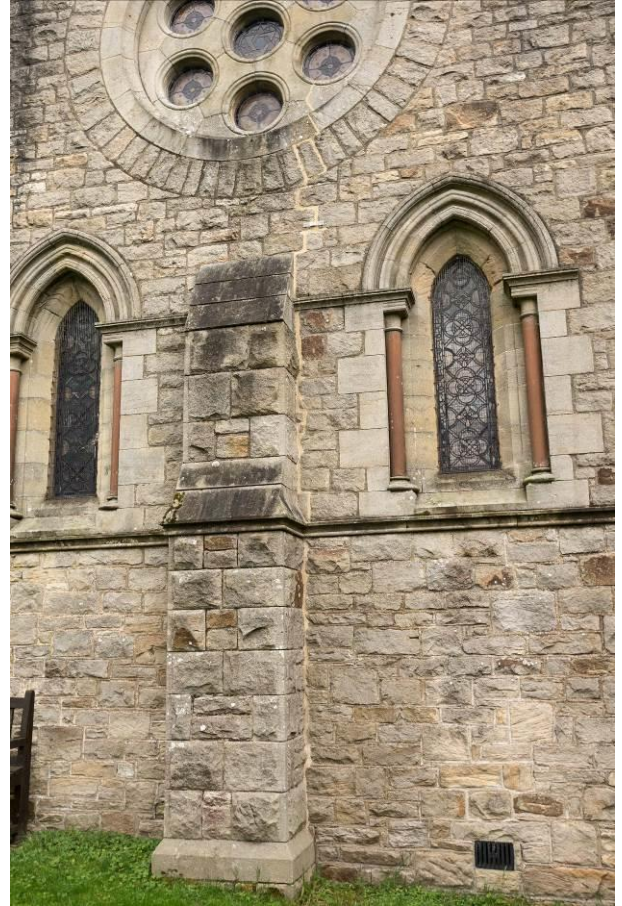
4.3 Full height of crack to west gable

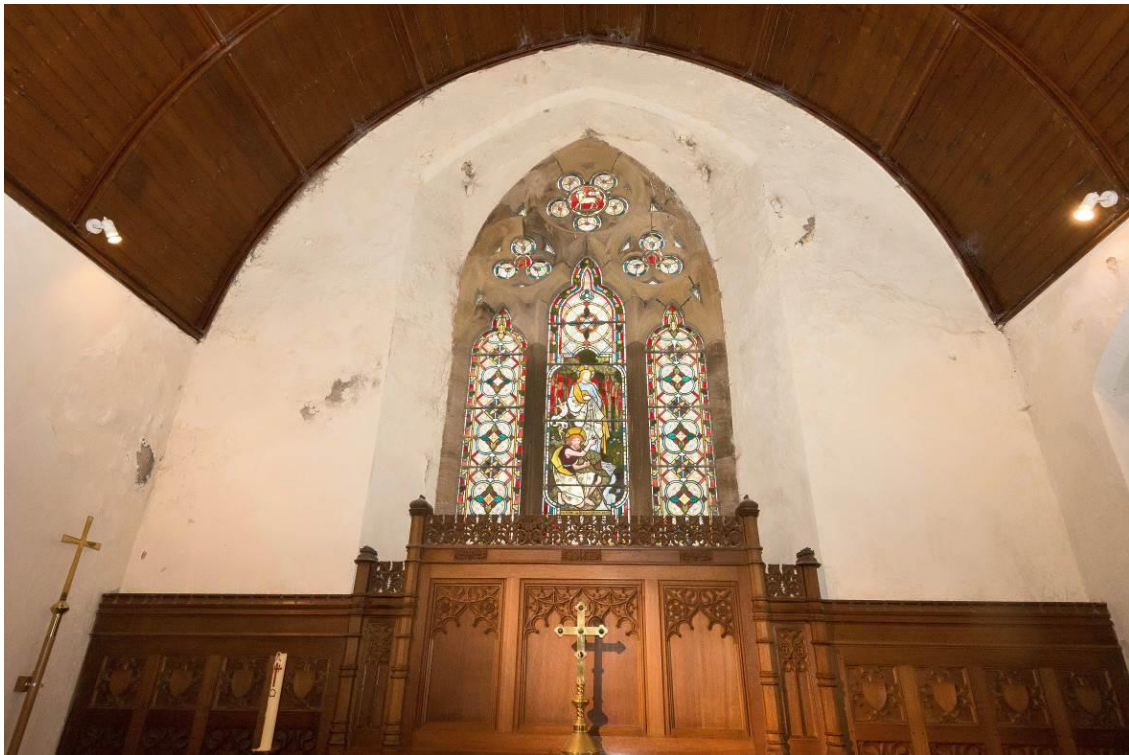
5.4 East gable of Chancel

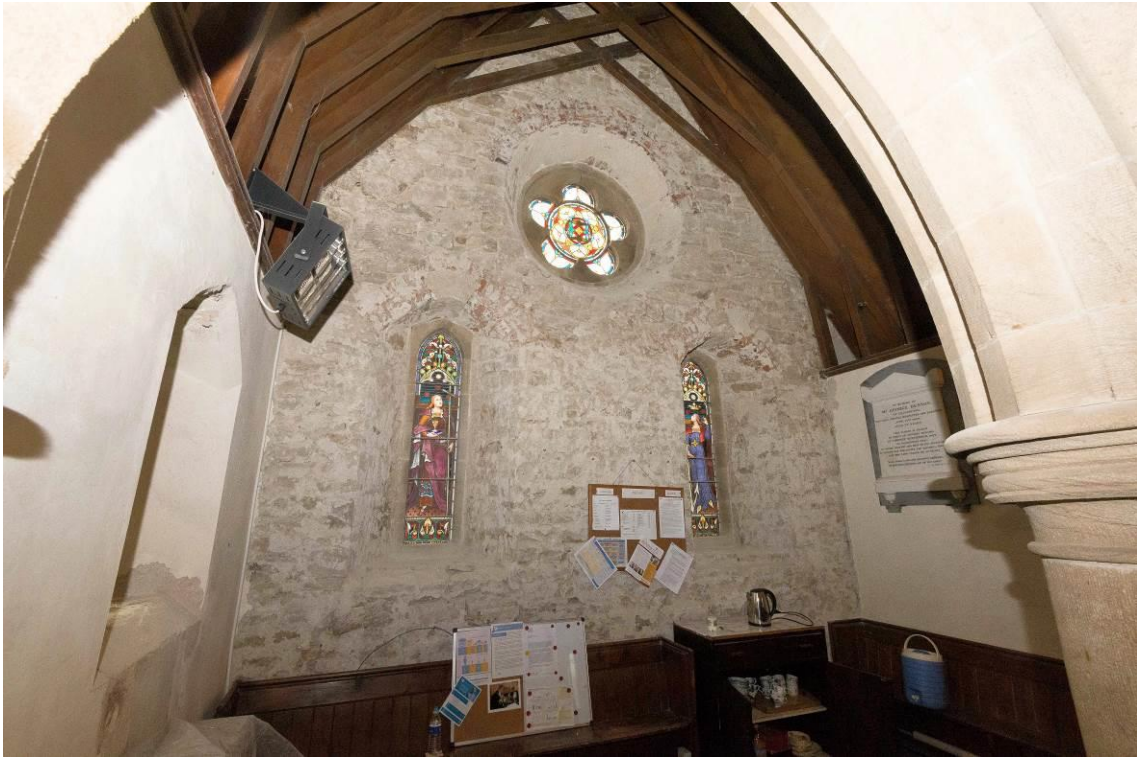
**5.5 South gable of Transept.** Plaster recently removed after severe water damage.

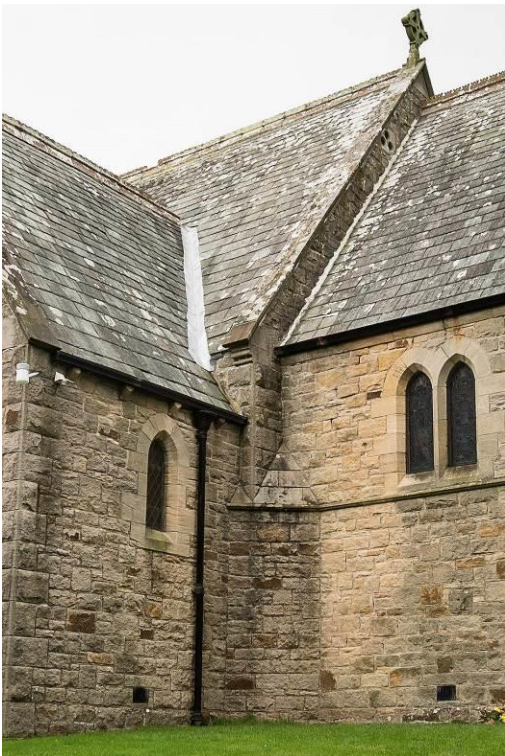
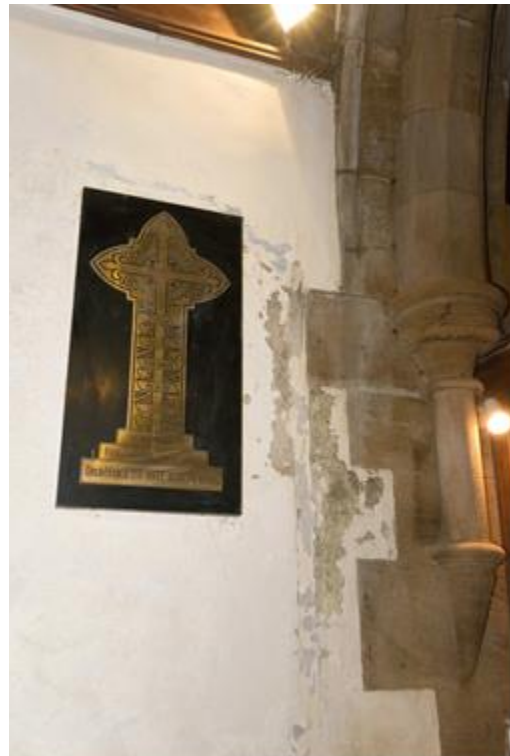
**5.6 Severe water ingress at south side of Chancel arch.**
