2018 Quinquennial Inspection

St.Thomas Apostle and Martyr

Eighton Banks, in Gateshead

30 January 2018

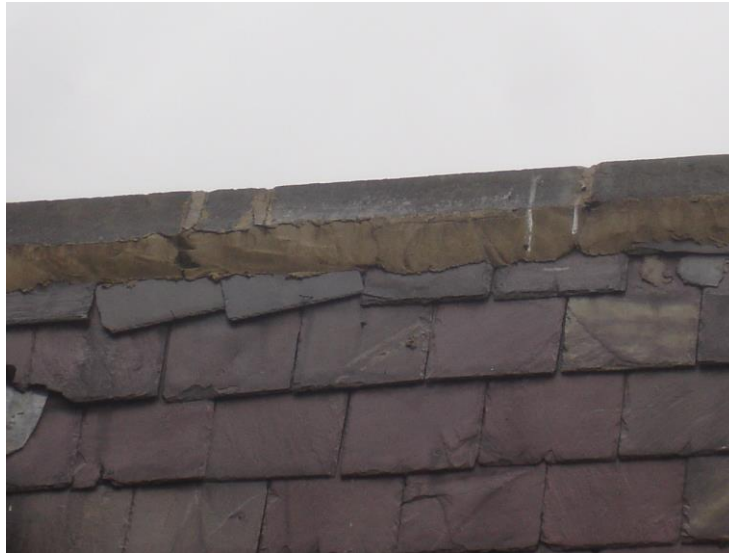
Several slates are broken or dislodged, especially along the ridge.

The ridge pointing is in poor condition.

Action: Within Six Months

- *Repair slates*
- *Repoint ridge in lime*

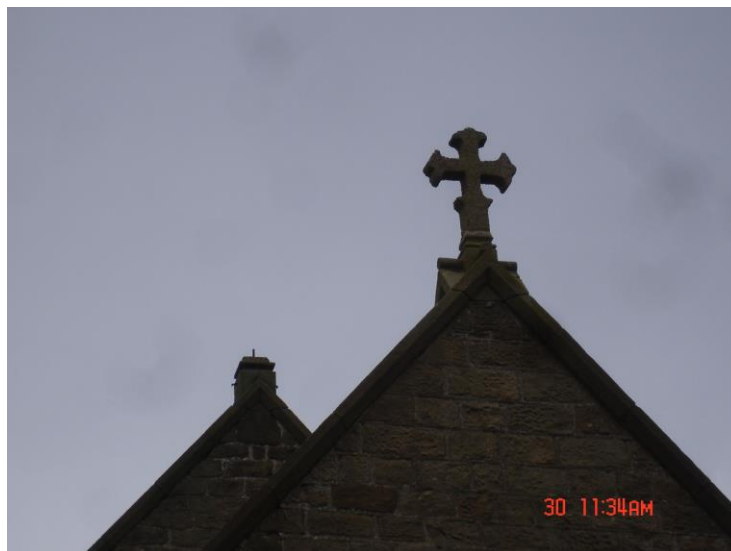
4.2.9 **Missing Cross at Junction of Nave and Chancel Watertable:**

It is noted that the masonry cross at the junction of the nave and chancel watertable is missing; there is evidence of the original protruding locating dowel.

Action: Desirable

- *Replace Cross to match the adjacent design*

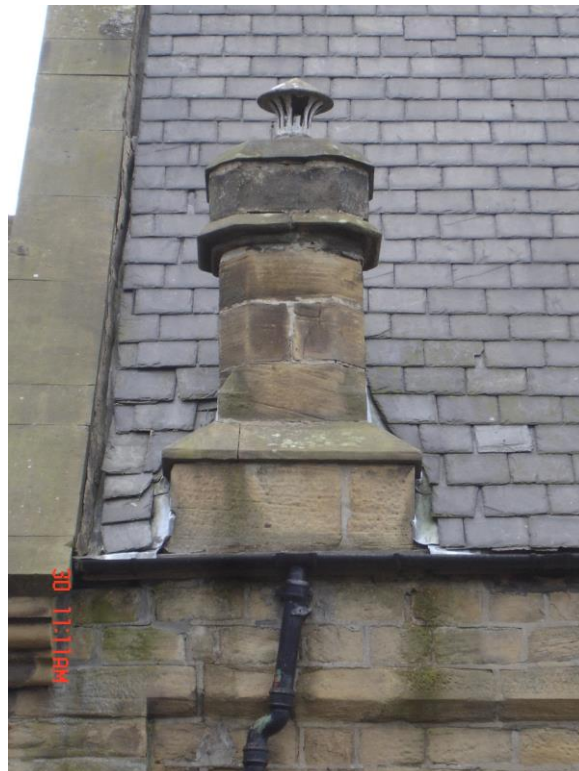
Black plastic half-round gutter and clips in reasonable condition.

Black painted cast-iron pipes and brackets in reasonable condition, although localised realignment adjacent to the easterly flue would be beneficial.

Action: Within Six Months

- *Realign pipework adjacent to easterly flue – also note slates as item 4.2.6 above*

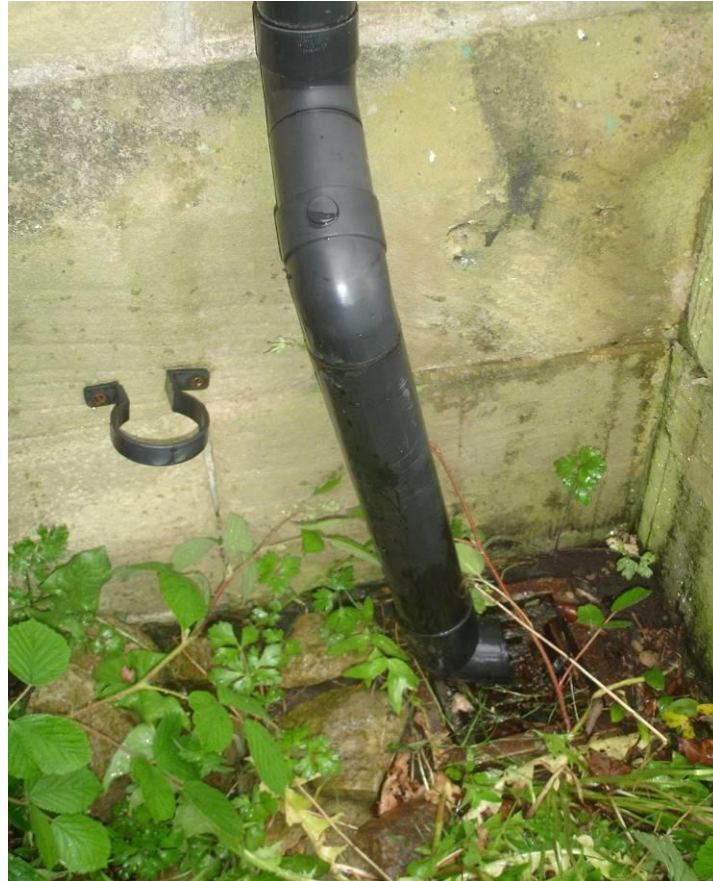
4.3.7 **Porch West:**

Black plastic half round gutter, with cast-iron clips and pipe in reasonable condition, with the exception of the rainwater pipe alignment to the gully, where the pipe has been redirected away from the insitu bracket to discharge directly into the gully. There also appears to be a slight backfall to the gutter.

Action: Within Six Months

- *Realign rainwater pipe and relocate bracket to suit*

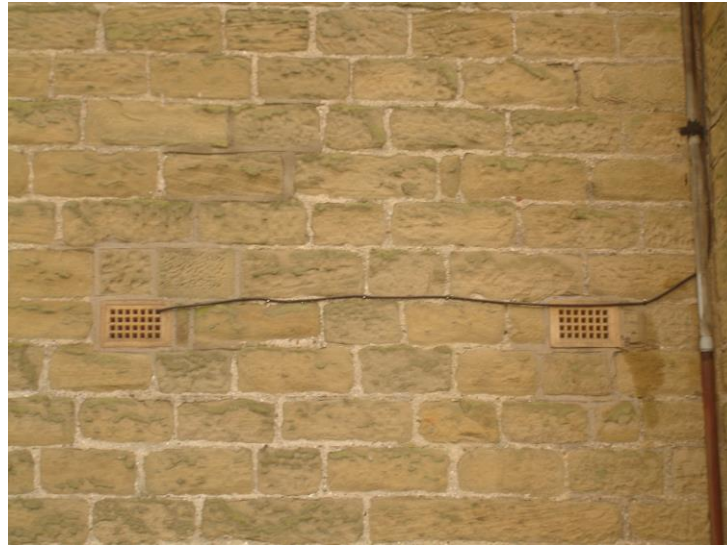
The cabling serving the bell ringing mechanism has been poorly routed on the external wall, and is inadequately clipped.

Action: Within Twelve Months

- Rationalise the cable route and provide additional clips

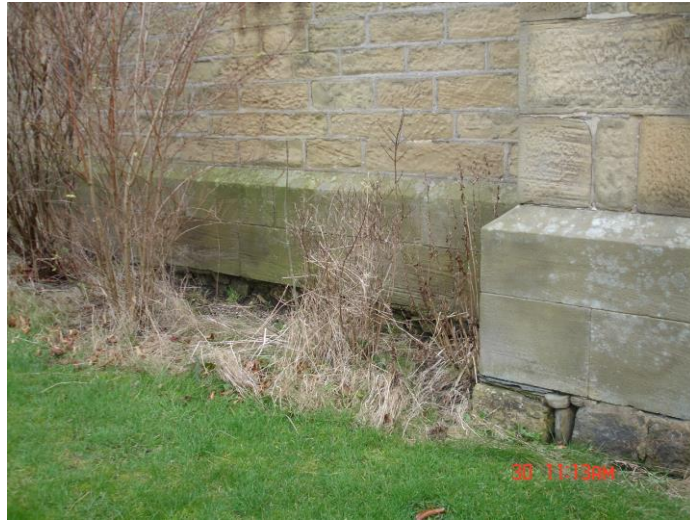
There are quite a number of areas where the stonework is showing signs of erosion and this process may well have been accelerated by the heavy cement-rich pointing work carried out in the past. As the stone erodes the pointing remains and becomes slightly proud, creating a gap that allows water behind the pointing making the situation worse. Water migration through the cement-rich pointed joints is also interrupted, exacerbating the decay cycle and encouraging freeze-thaw erosion.

Unfortunately, there has been some recent 'strap pointing' in what appears to be a cement-strong mix and this will have a seriously deleterious effect on the stone. Stonework pointing should always be carried out in a NHL lime mortar appropriate to its location, and finished flush with the stonework and tamped with a churn brush to an approved sample. This traditional methodology will allow water to run freely down the face of the wall, and to evaporate naturally through the breathable stonework and lime pointing.

In addition, it is noted that the ground levels to the east of the building appear to have been lowered or eroded away, which has partially exposed the wall foundations and slate coursing. There are many open joints at this low level, which require lime repointing.

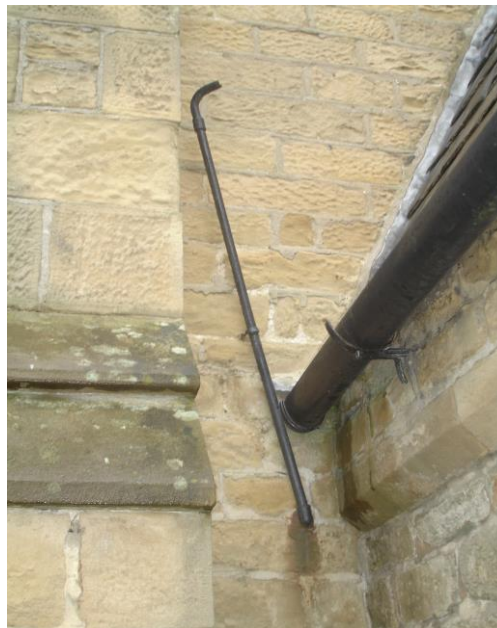
4.5.2 **Nave South Wall:**

There are areas of masonry which would benefit from localised lime repointing, but the wall is in reasonable condition.

The redundant conduit pipe between the porch west wall and adjacent buttress should be removed.

Action: Within Twelve Months

- *Brush down eroding stonework*
- *Lime repoint as necessary*
- *Remove redundant pipe*

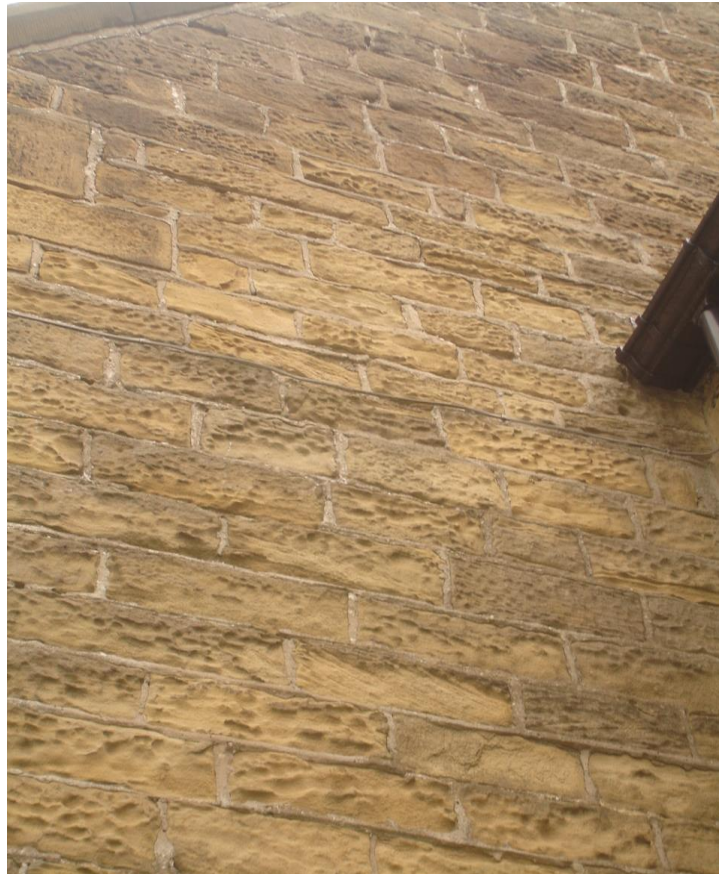
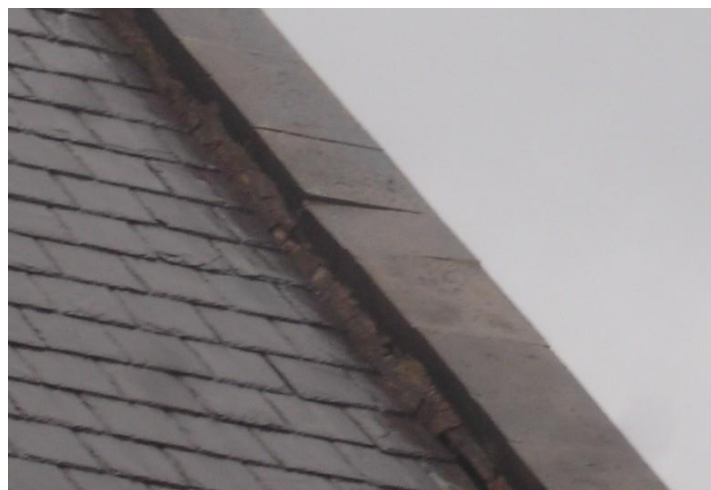
4.5.3 **Nave East Wall:**

Stonework erosion due to inappropriate or lack of pointing is particularly in evidence and the wall will continue to deteriorate unless appropriate action is implemented.

Several watertabling slabs to the east gable have settled, and require rebedding, repointing and reparing in lime. Note item 2.5 above regarding Wensley Roofing Limited instructed work.

Action: Within Twelve Months

- *Brush down eroding stonework*
- *Lime repoint walls and watertabling as necessary*
- *Rebed, repoint and repara watertabling slabs*

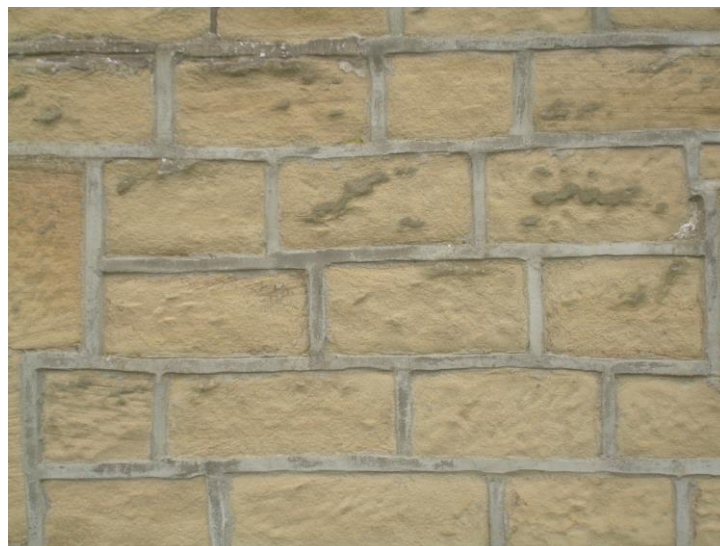
4.5.8 Vestry North Wall:

There are areas of masonry erosion evident, exacerbated by the cementitious 'strap pointing', which should be removed carefully by hand and repointed with lime; the west kneeler would benefit from localised lime repointing.

Action: Within Twelve Months

- *Carefully remove 'strap pointing' by hand*
- *Brush down eroding stonework*
- *Lime repoint as necessary*

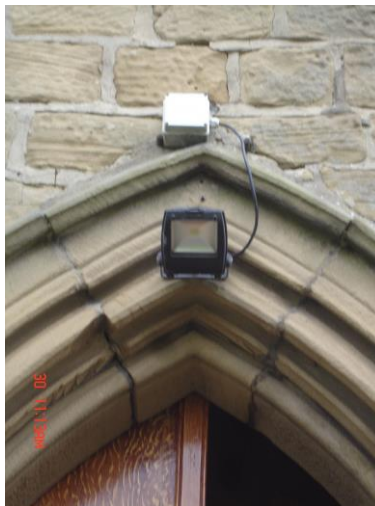
4.5.11 Porch:

There are areas of masonry which would benefit from localised lime repointing, but the walls are in reasonable condition; the gable peak above the door is in particular need of repointing, with hungry bed and perpend joints in evidence. The dressed keystone to the Gothic entrance door has open joints which requires repointing, and there is evidence of historic movement which appears to have been arrested; this should be monitored.

Action: Within Twelve Months

- *Lime repoint walls, keystone and watertabling as necessary*

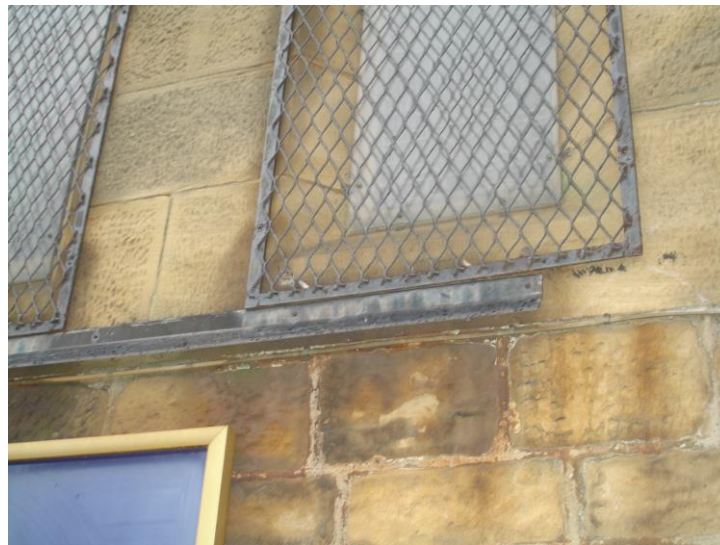
- 4.6.2 All windows are protected externally with both polycarbonate and painted steel grilles. The grilles are unsightly and positioned on the face of the wall with intrusive fixings into the stonework rather than joints, which is unconventional and unlikely to have been approved by the DAS. Although the grilles appear to have been painted, there is unsightly rust staining on the sandstone walls beneath, which is almost impossible to completely remove. The location of the grilles does not allow the rear of the grilles to be maintained or painted, which has exacerbated the rusting, and also precludes maintenance and cleaning of the polycarbonate beyond.

As the polycarbonate provides any necessary protection, it is recommended that consideration be given to removing the grillage to both negate further rust staining and improve the external visual quality of the building.

Action: Desirable

- *Remove external rusting grillage*
- *Investigate techniques and sampling for removing the rust stains*
- *Consider either polyester powder coated or stainless steel replacement grillage if considered a necessary secondary safeguard to the glazing. If this was considered, the removal of the polycarbonate might also be appropriate*

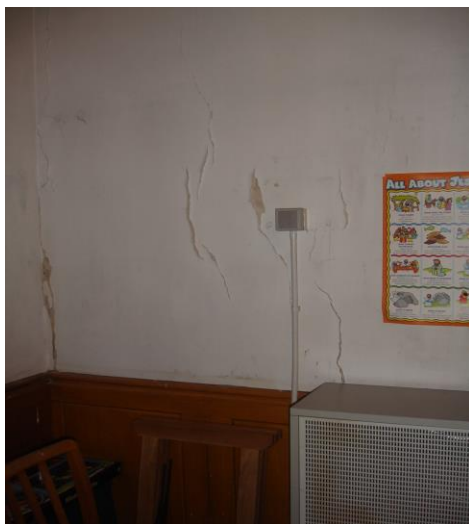
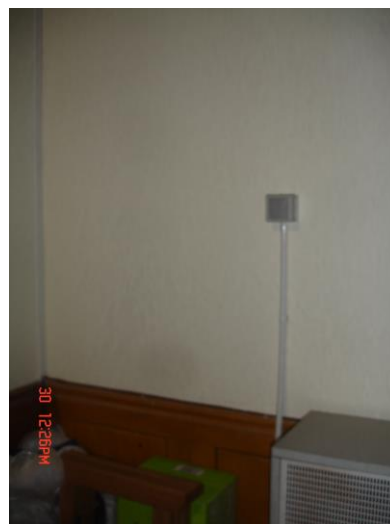
An historic movement crack to the north wall does not appear to have deteriorated since the previous report, and has been infilled as part of the recent redecoration works as indicated below:

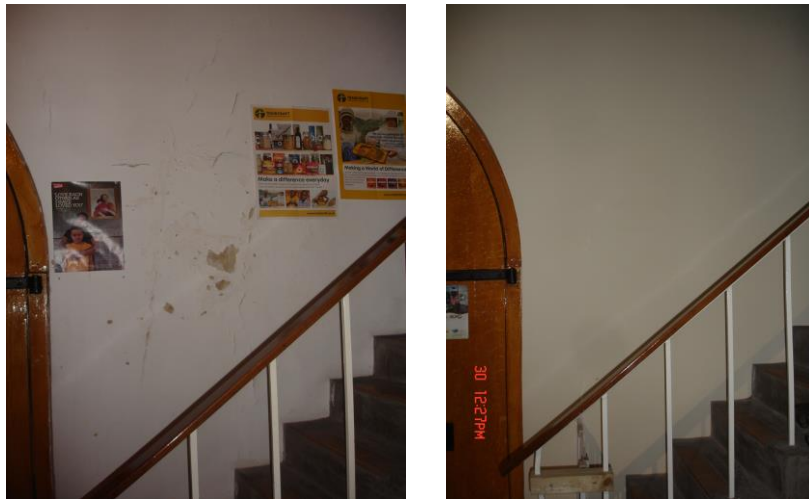
Similarly, evidence of water ingress adjacent to south main entrance door appears to have been resolved, with redecoration being completed successfully as below:

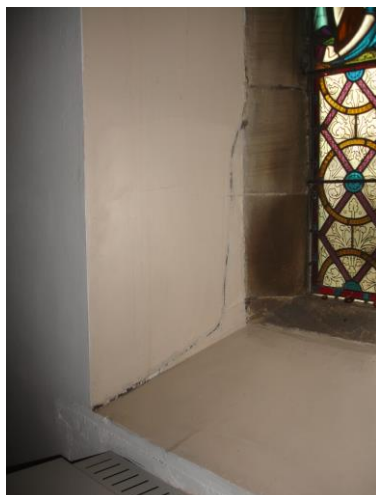
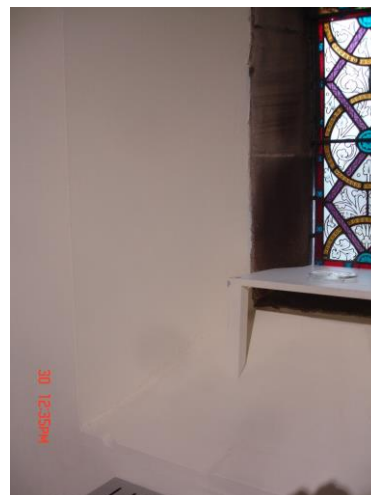
An historic movement crack to the south wall window jamb does not appear to have deteriorated since the previous report, and has been infilled as part of the recent redecoration works as indicated above:

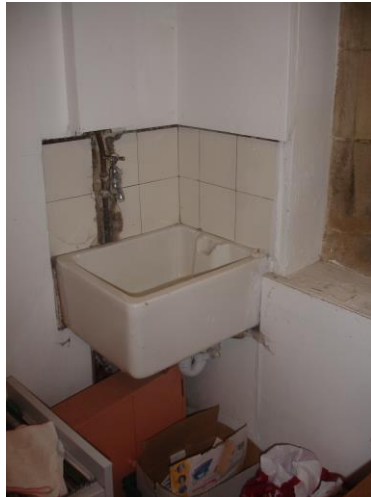
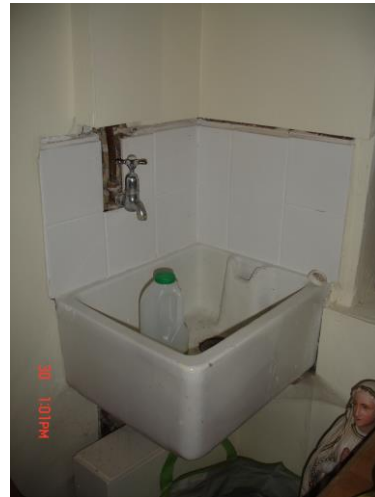
The electrical cupboard is in poor condition with missing panelling and binding doors.

It is noted the tile splashback to the Belfast sink has been improved since the last report:

Action: Within Six Months

- *Make good or replace the electrical cupboard*

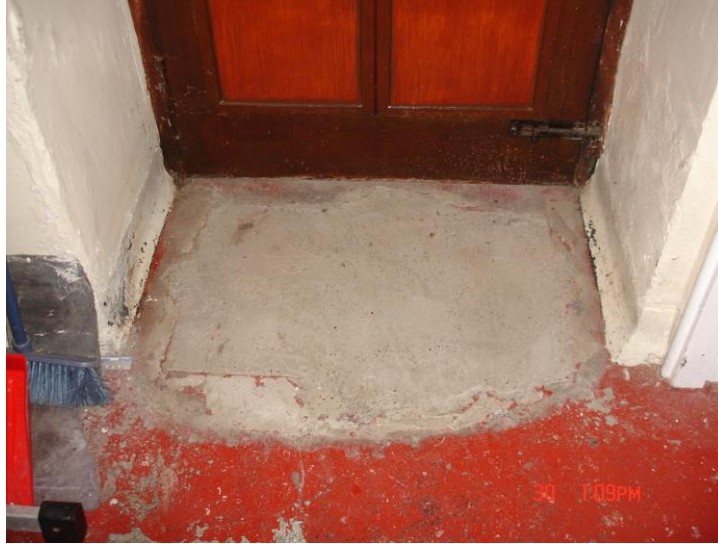
The concrete floor is painted. The recessed floor matwell has been infilled with concrete:

Action: Desirable

- Repaint floor

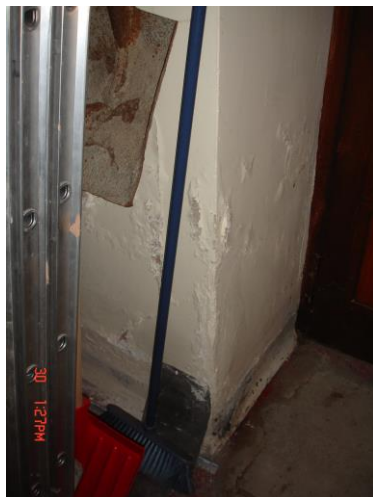
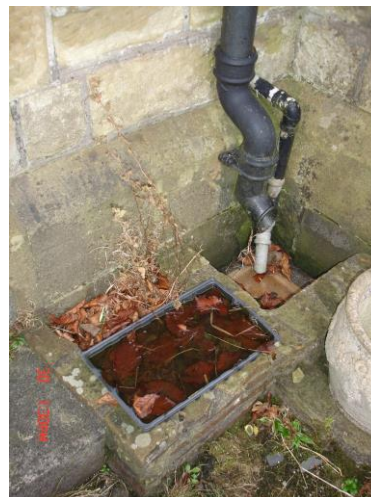
A stainless basin is located within the lobby, which doubles as both a general sink and toilet basin. The low level toilet has exposed services, with unprofessional pipework runs. The toilet door binds.

The walls have recently been partially redecorated, but there remains evidence of water ingress to the lower external door jamb, which may be attributed to the partially blocked rainwater pipe gully and raised 'bed' beyond:

Action: Desirable

- Rationalise and decorate services; adjust toilet door to negate binding
- Ensure external gully and 'bed' remain clear of leaves and debris to facilitate drying out

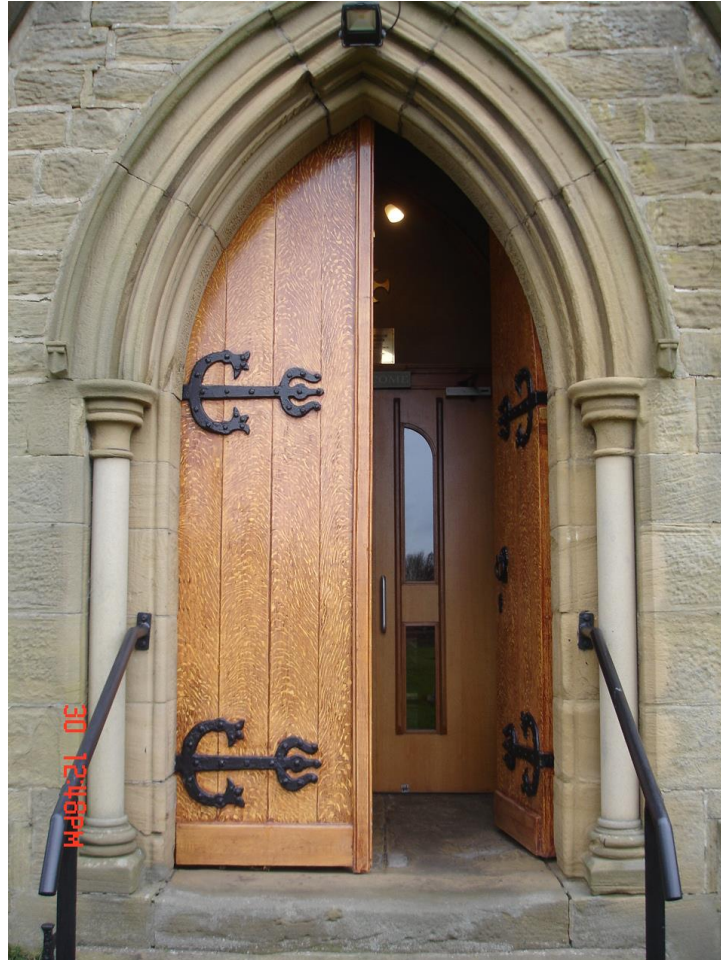
The access into the church via the main porch is not inclusive or DDA compliant. The mild steel external handrails, whilst functional are not considered of appropriate design.

Action: Desirable

- Consider remodelling the planning layout of the porch and main entrance to make DDA compliant, and introduce associated appropriate handrails

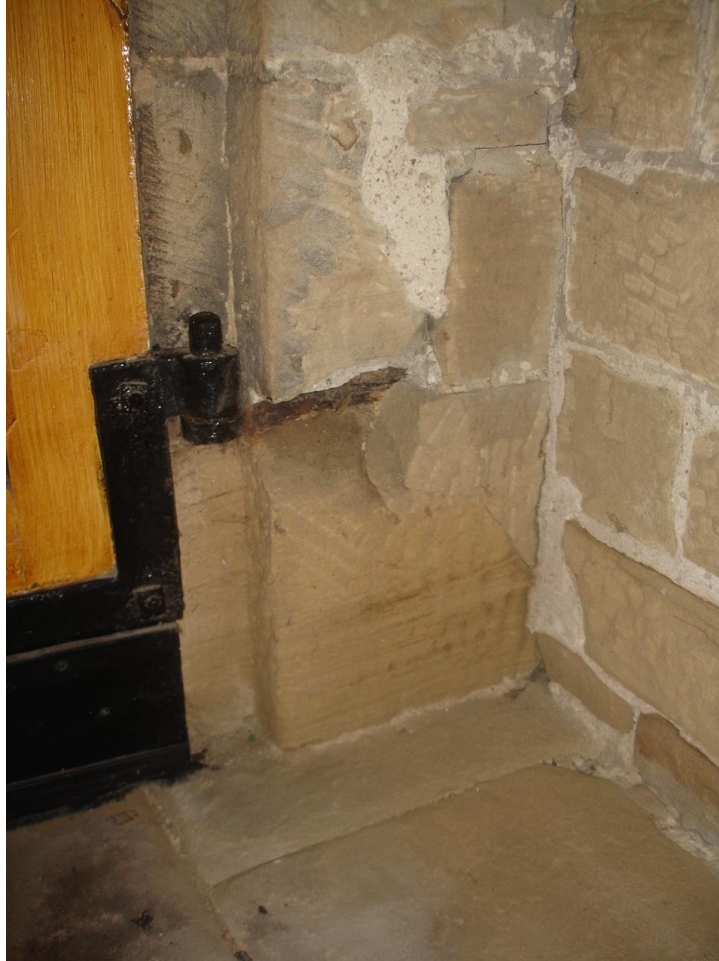
Rust jacking of the lower west external door hinge has caused a failure to the sandstone which requires appropriate indent repair.

- Clean rust from wrought iron hinge and indent repair associated damaged sandstone

Action: Desirable

- *Carefully remove all cement-rich pointing, clean sandstone of excess mortar and repoint with lime*

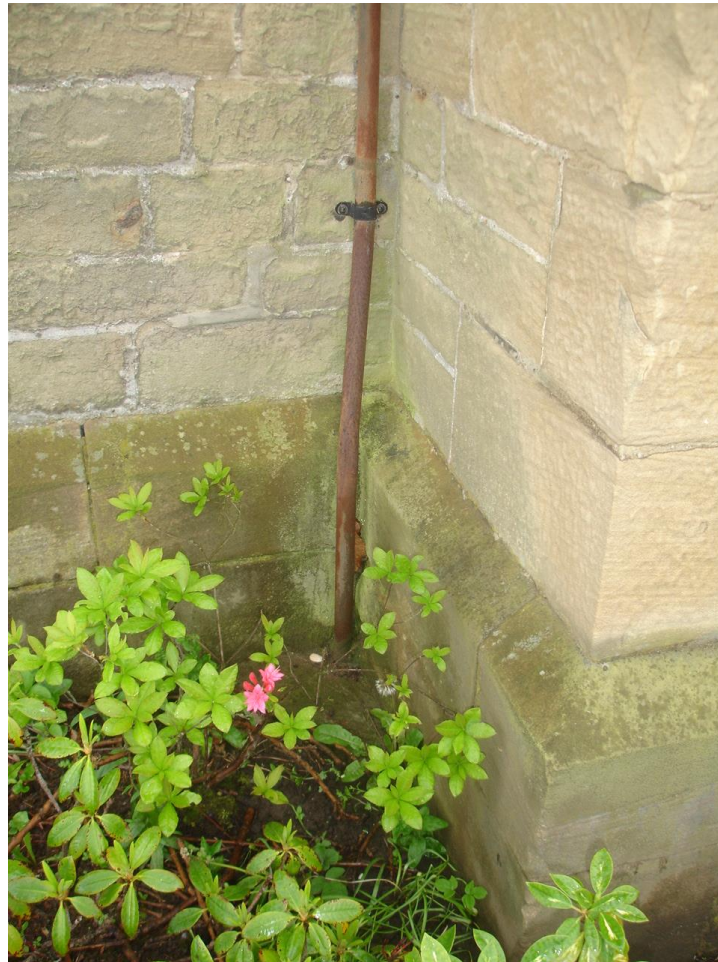
4.10.1 The lightning conductor runs within a galvanised steel conduit at low level, with no apparent means of testing for correct earthing. It is essential that the conductor is tested, and repaired or replaced as necessary, by a specialist with a copy of the report and certification kept within the Church Log Book.

Action: Within Six Months

- *Test and repair, or replace, the lightning conductor as necessary*

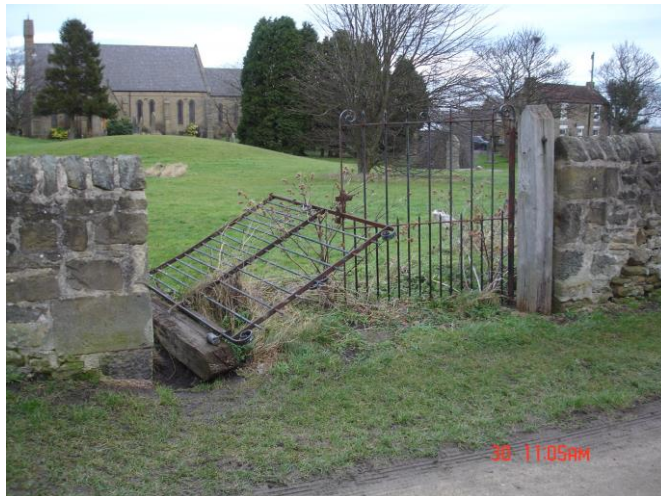
- 4.14.1 The stone boundary walls generally are in reasonable condition, but it is apparent that regular maintenance is not being carried out by the local council as is understood to be their responsibility; the condition of these walls will deteriorate rapidly, especially at their copings and bases, should this not be implemented. Gates on the south boundary are damaged and dangerous, and should be repaired as a matter of urgency:

Localised rebuilding, indent repair and repointing to the boundary wall stonework is required.

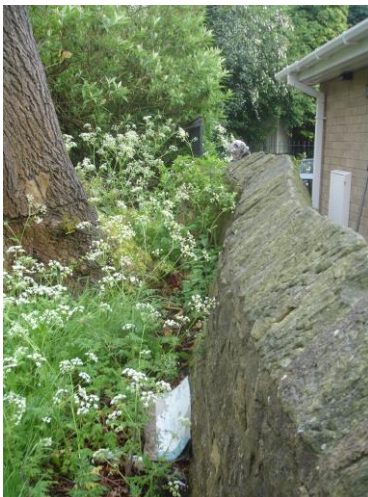
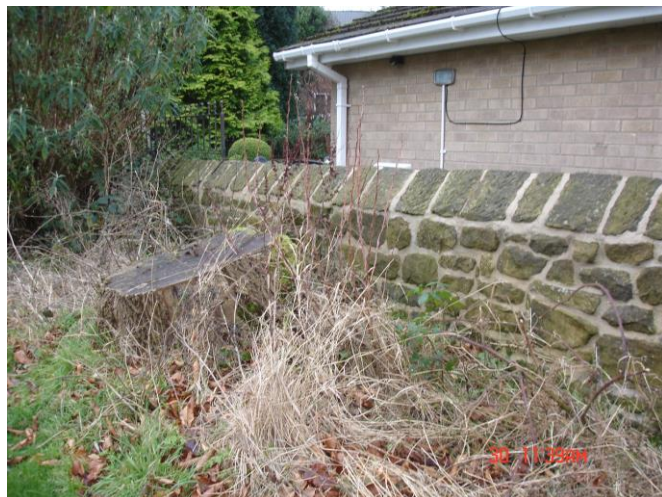
It is noted that a tree has been removed to the west boundary with the associated wall locally rebuilt as indicated below:

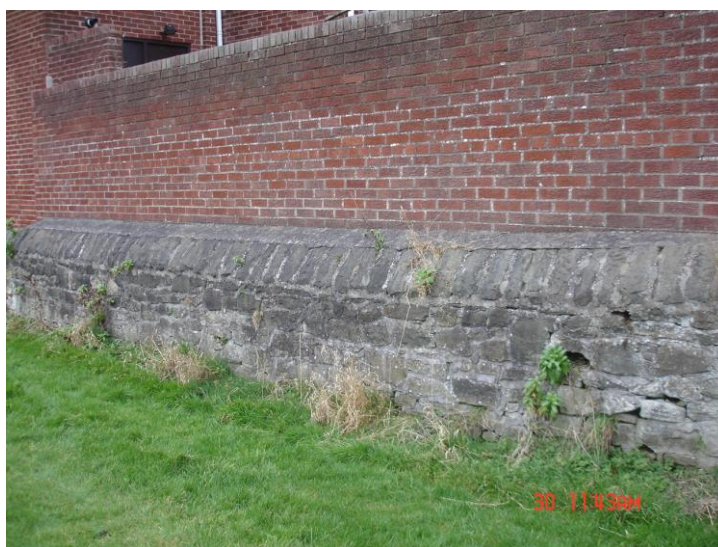
Part of the north-west boundary appears to be acting as a retention wall to a domestic garage at higher level. The wall is deteriorating at its lower level, and due to the imposed loading from the garage and retained substructure, there is potential for structural failure, with the resultant partial collapse of the supported garage.

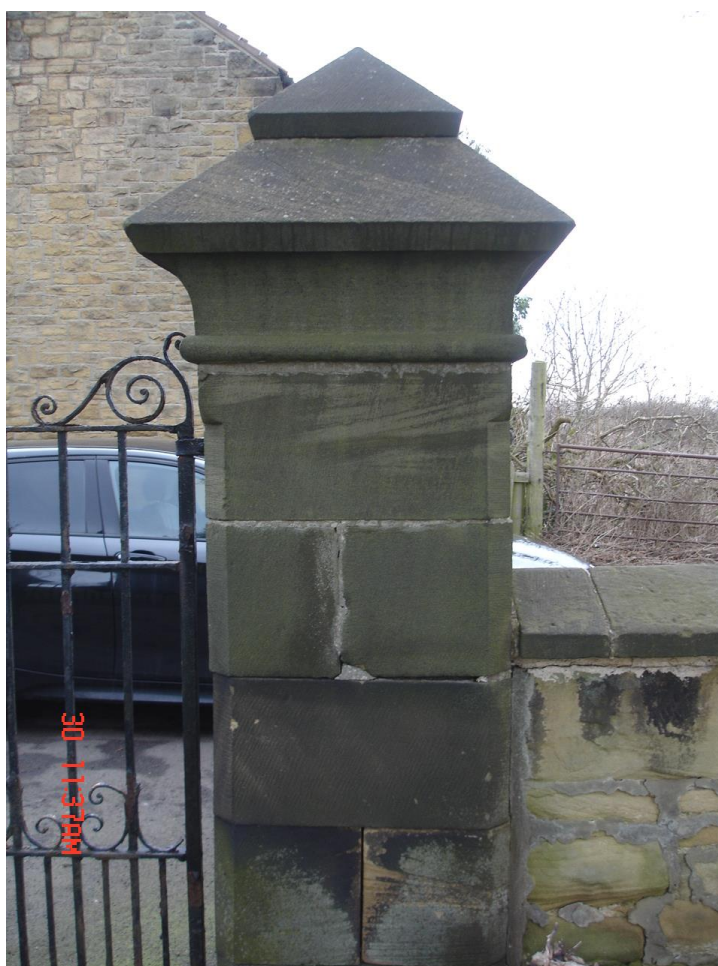
The south pillar to the main east entrance gates shows evidence of incremental rust-jacking associated with the wrought iron hinges:

All three sets of original wrought iron gates are in need of urgent maintenance, with serious rust jacking in evidence, which requires careful cleaning, preparation and redecoration if the safe and efficient life of these gates are to be maintained. This applies to both the gates proper and the pillars or posts.

Action: Within Six Months

- *Repair wrought iron gates, pillars and posts*

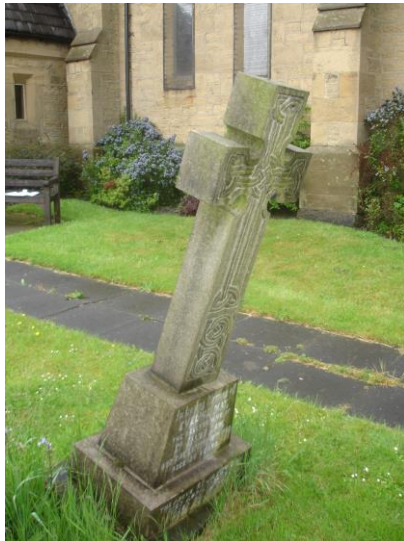
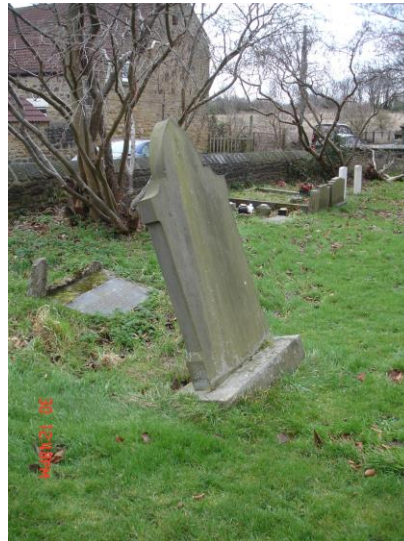
4.15.1 There are several tombstones within the graveyard have either fallen over, or are leaning dangerously:

Action: Desirable

- *Carry out an inspection of all memorials, with a view to repairing*
- *Carefully remove all cement-rich pointing to the war memorial and repoint with lime*

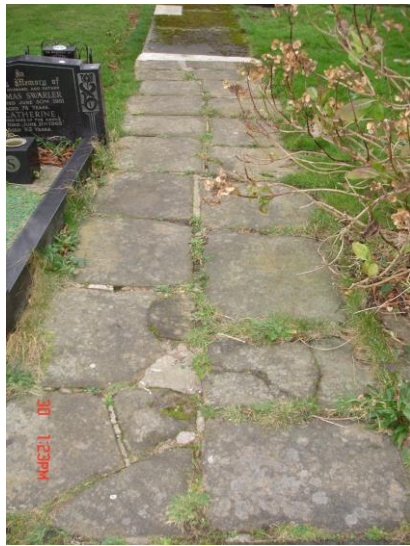
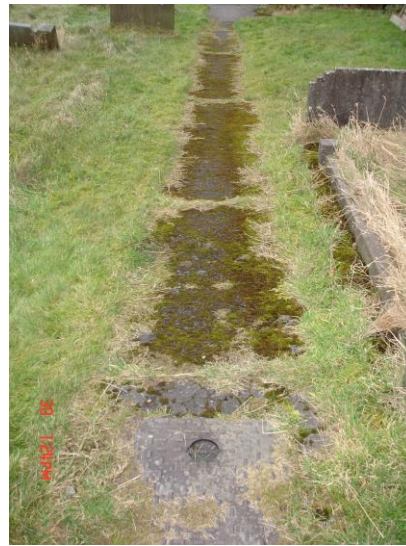
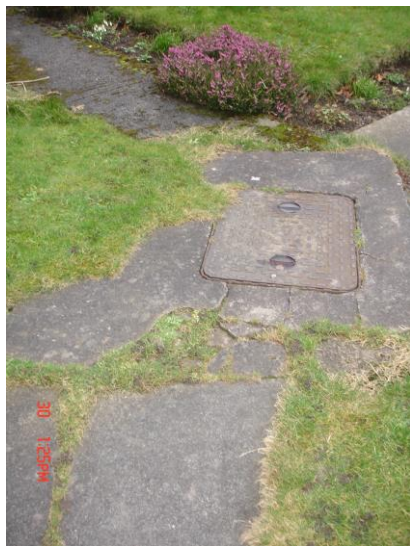
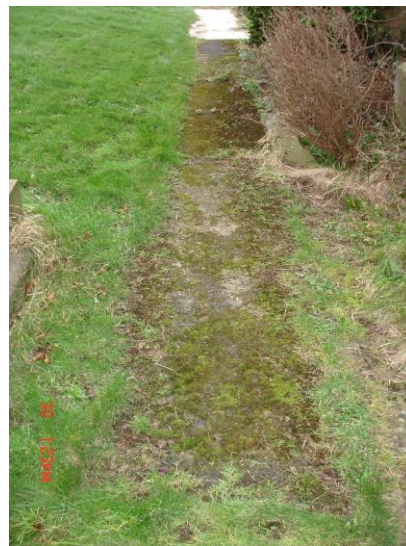
5.6 DDA access around the building should also be considered, with repairs required to broken and uneven public paths around the building; moss should also be cleared from all paths:

Action: Within Six Months

- *Repair, level and clean all public external paths around the building*
