**Quinquennial Inspection Report
The Parish Church of St. Thomas, Eighton Banks
Archdeaconry of Sunderland
Diocese of Durham**

David Jowett - Architect, BA, DipArch, RIBA
25 Roseworth Avenue
Gosforth
Newcastle upon Tyne
NE3 1NB
Tel: 07788 710204
email: david@davidjowett-architect.co.uk

16 February 2023

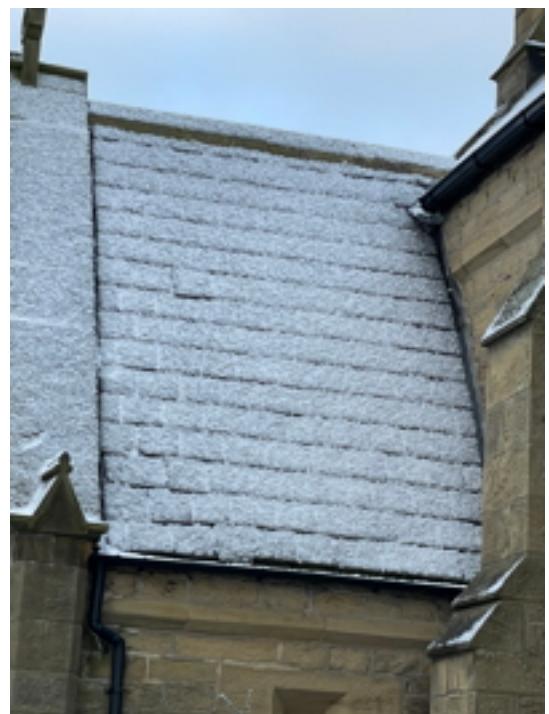
South roofs generally appear in satisfactory condition with one slipped slate to Nave south elevation west end. Slipped slates to Porch east and west elevations. Some slipped slates to north elevation west end at eaves. North Vestry and Chancel roofs in satisfactory condition. Valley gutter between vestry and nave not visible from ground level.

Porch East Roofs with slipped slate

Generally inspect roofs at close quarters by qualified roofer and carry out repairs as recommended including inspection of hidden valley gutter.

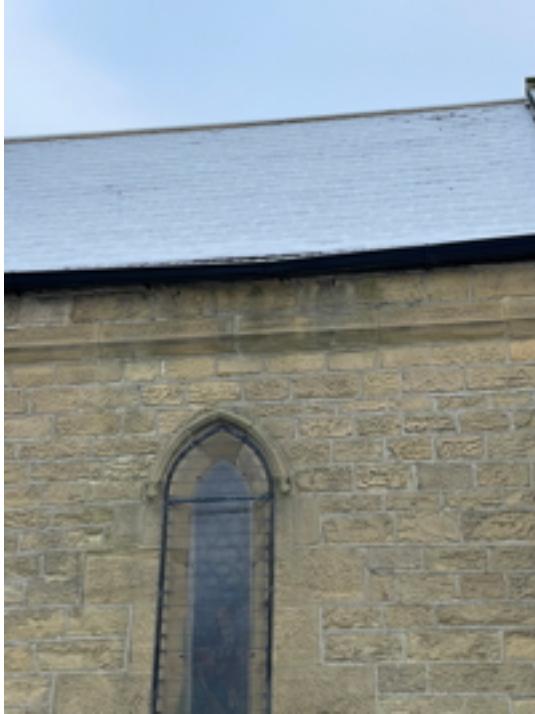
Gutters are generally clean. Several sections of guttering are misaligned, notably chancel south elevation, nave south elevation at the centre and porch west elevation where there is gap between the slate roof finish and gutter. This means that water is going behind the gutter onto the stonework and causing damp internally.

Chancel South Elevation gutter misaligned

Generally inspect roofs at close quarters by qualified roofer and carry out repairs as recommended including inspection of hidden valley gutter and adjusting gutter to South Porch west side.

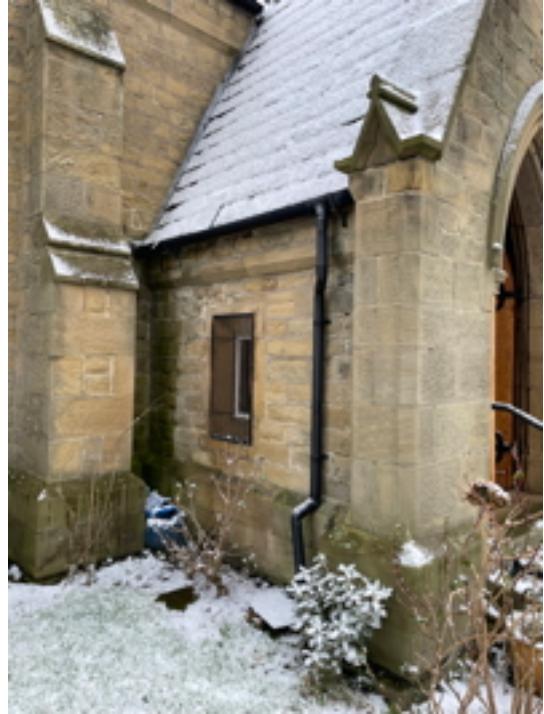
Porch West Elevation gutter misaligned

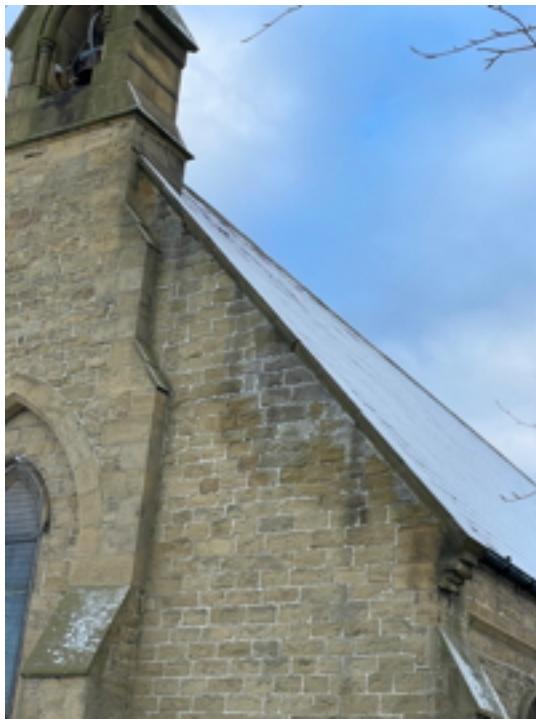
Nave west elevation south side gap in copings and damp stonework below

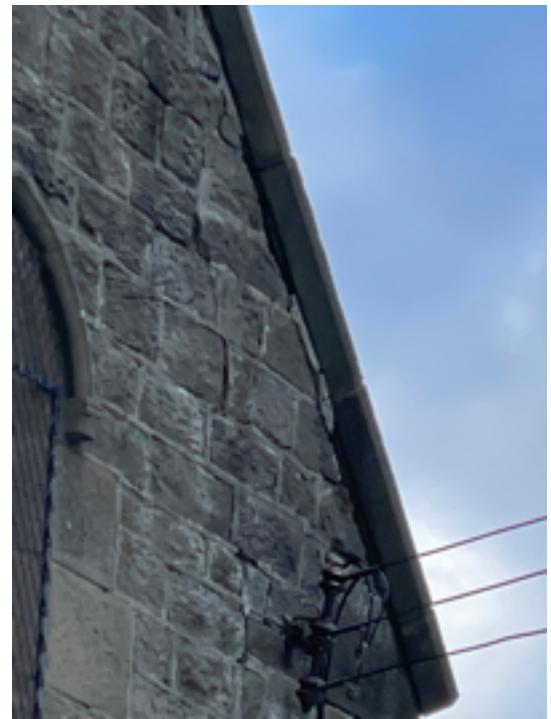
Chancel east elevation loose pointing below copings and to stonework below

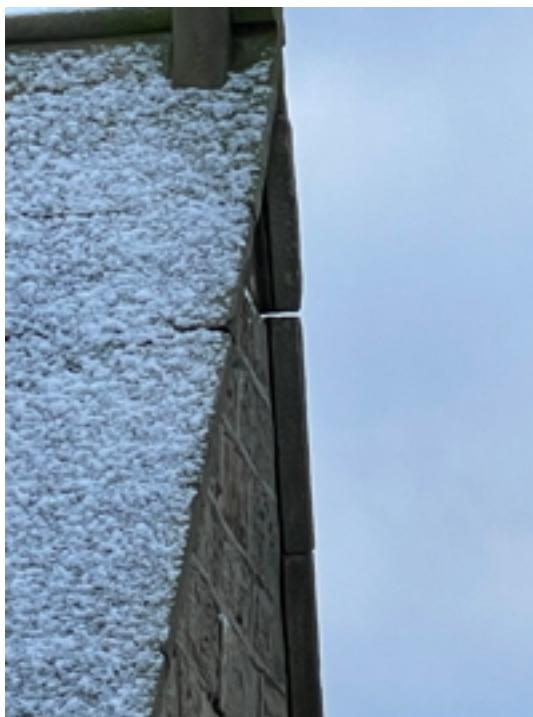
Porch east side gap in copings

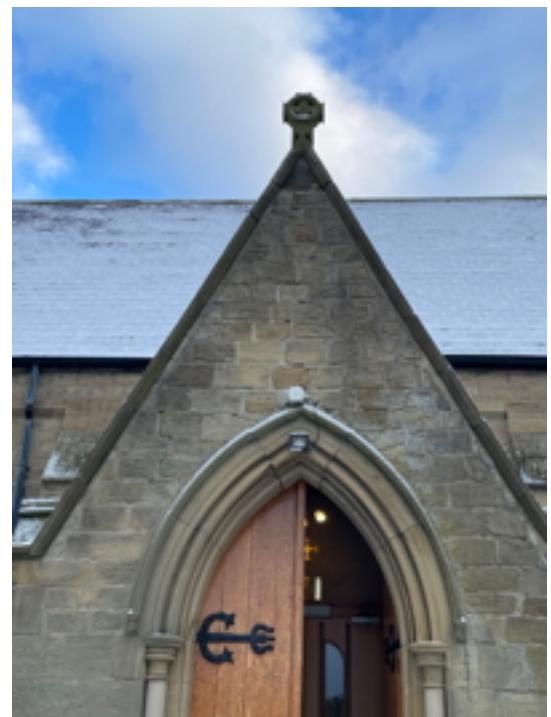
Porch loose pointing below copings at finial position

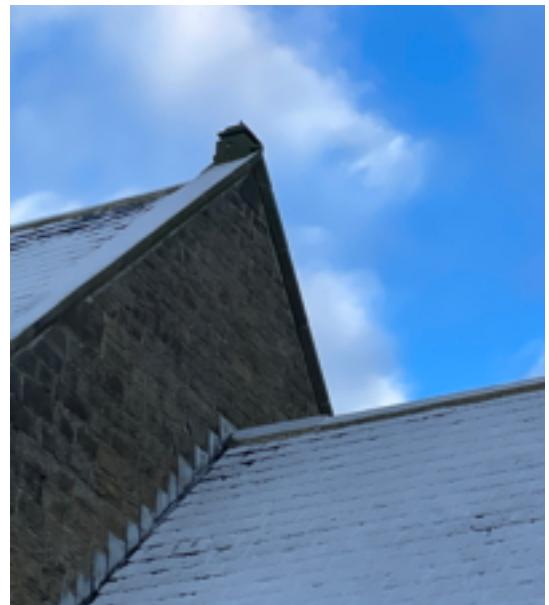
Nave east end missing Finial Cross

Replace missing finial to Nave east end. Cost Band 2– £2,000-£9,999.

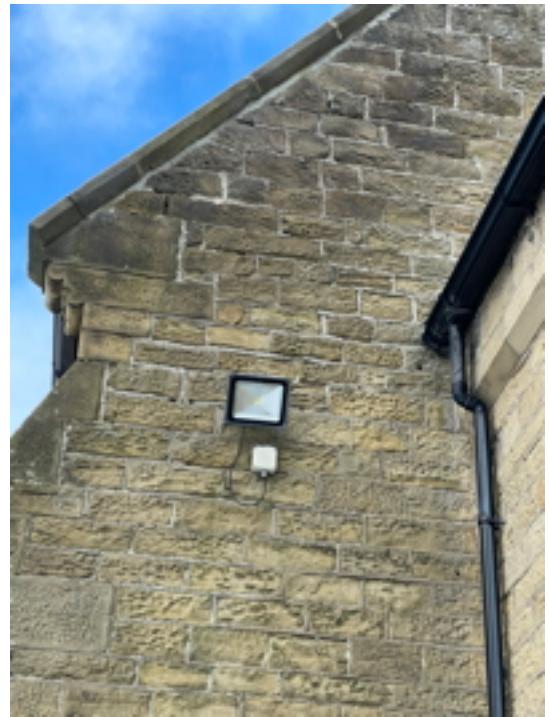
Chancel east elevation south side cement pointing

There are significant areas of cement rich pointing to all areas of the building. There are quite a number of areas where the stonework is now showing signs of erosion and this process may well have been accelerated by this cement rich pointing. At present none of this erosion is so significant at present to warrant stone replacement but this will be the case if the pointing remains as it is currently.

As the stone erodes the pointing remains and becomes slightly proud, which creates a gap that allows water behind the pointing thus making the situation worse. Water migration through the cement-rich pointed joints is also interrupted, exacerbating the decay cycle and encouraging freeze-thaw erosion.

Replace cement mortar with a soft lime mortar and undertake limited repointing of the original mortar all by a suitably skilled stone mason. Cost Band 3– £10,000-£29,999 (less in conjunction with works to coping stones)

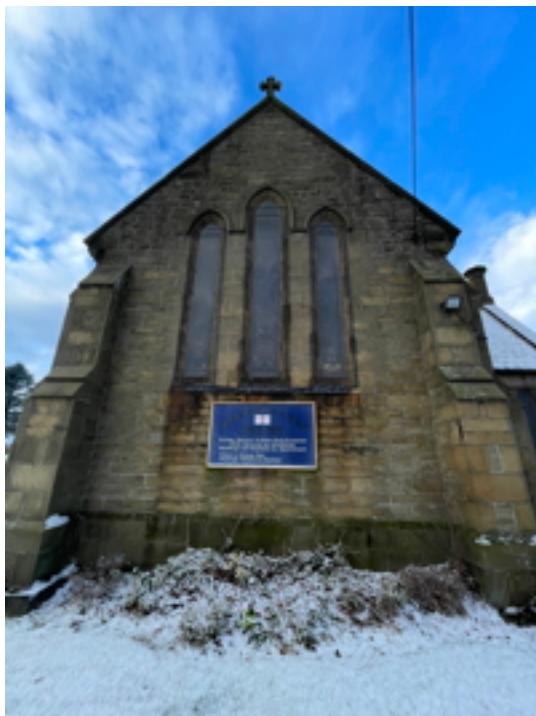
Chancel east elevation staining below window

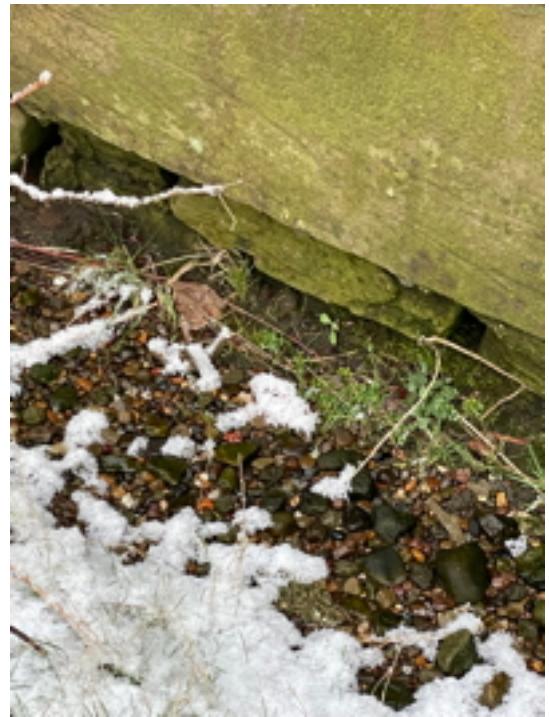
Low level ground erosion with open joints

In addition, it is noted that the ground levels to the east of the building appear to have been lowered or eroded away, which has partially exposed the wall foundations and slate coursing. There are many open joints at this low level, which require lime repointing.

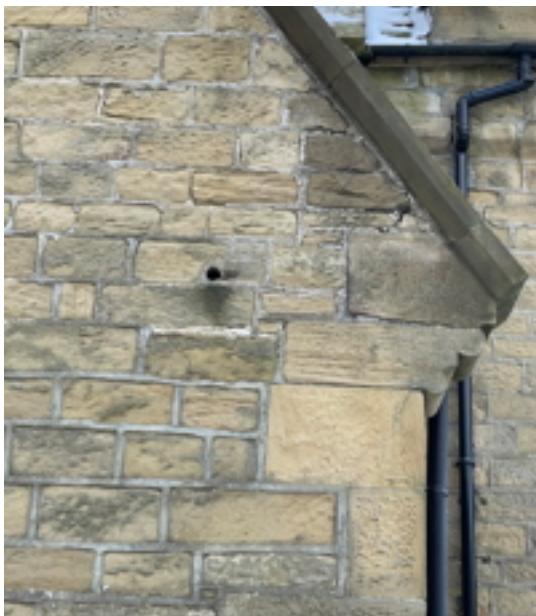
Vestry north elevation open joints and strap pointing

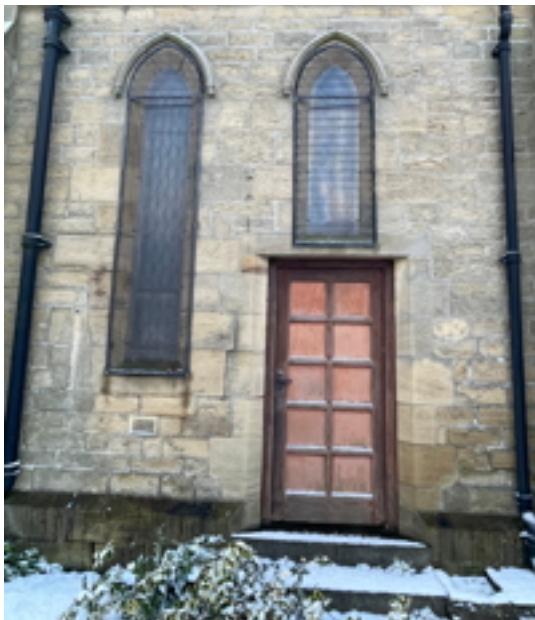
North Lobby north elevation door

The windows and Porch and Vestry doors all generally in good order. North Lobby door requires decoration and the varnished finish to Porch and Vestry doors needs attention. Rusting steel mesh grilles should be removed. Polycarbonate sheeting should be cleaned.

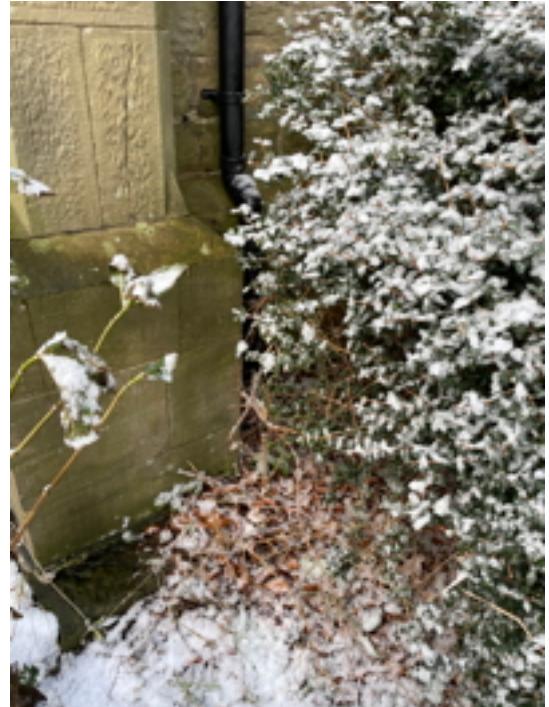
Sump obscured by foliage

Sumps are generally covered with foliage. Some protected with wooden boards to keep leaves out. Broken clay pipe at one sump location.

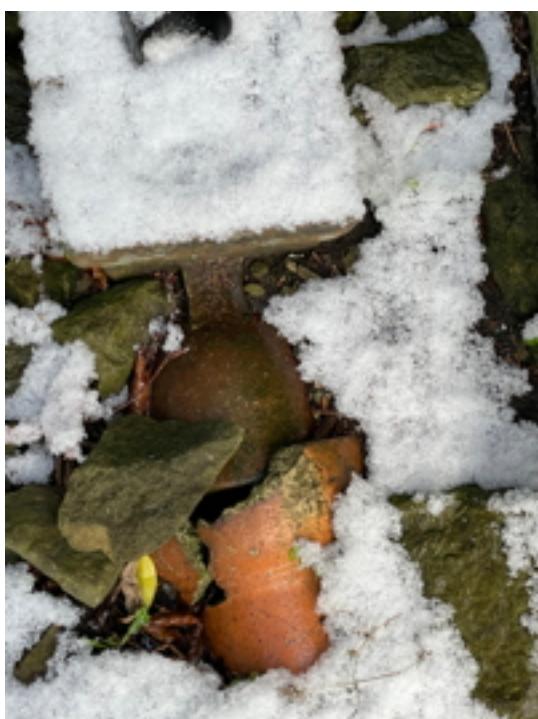
Sump with broken pipe connection

Repair damaged pipe connection to sump. Cost Band 1 – £0.00-1,999

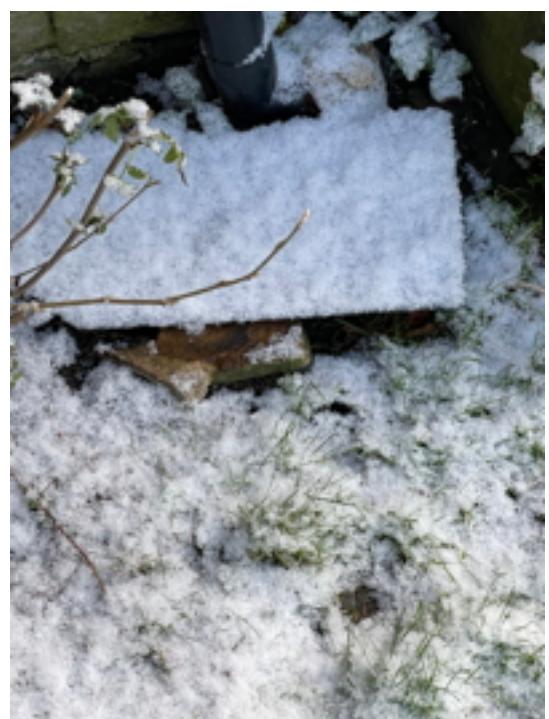
Sump with board over

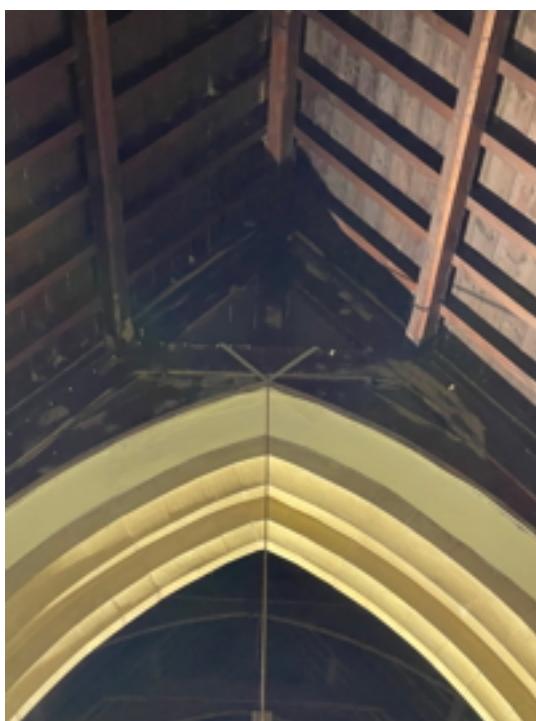
Chancel roof looking west with discolouration

There was no evidence from ground level of any problems to the Nave roof and generally to the Chancel. There is discolouration to the chancel roof at high level at the west end where the ridge meets the nave wall which could be rot. The last Quinquennial Report noted water penetration at this point which appears to have been successfully dealt with by Wensley Roofing.

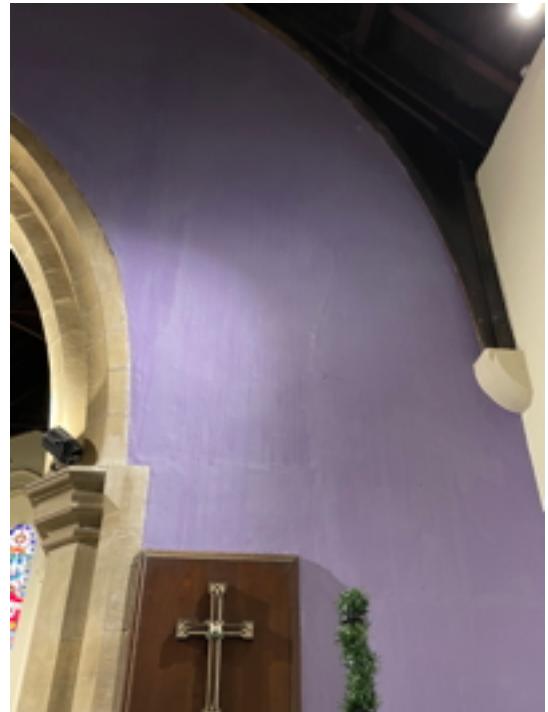
Nave east end streaking to wall

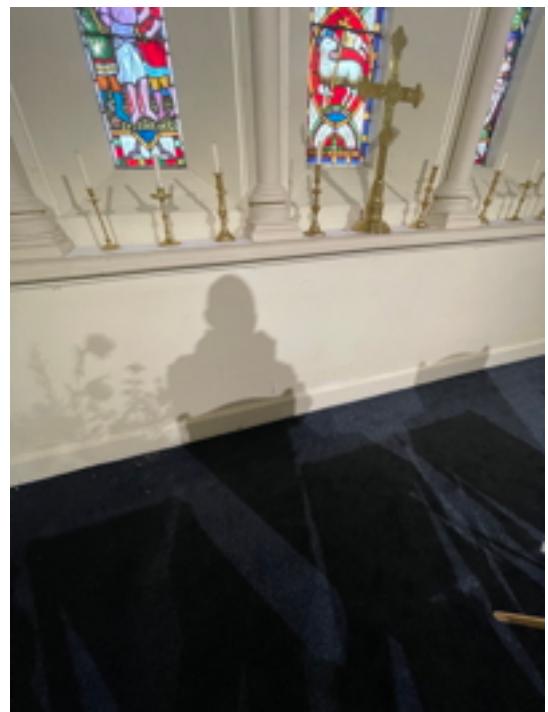
Flaking paint to Cancel wall at low level

An historic movement crack to the south wall window jamb does not appear to have deteriorated since the previous report, and has been infilled as part of the recent redecoration works. Damp to wall above gallery staircase has reappeared due to incorrect alignment of the gutter externally. The Nave east wall is streaked which appears to be from condensation. There is minor flaking to the chancel east wall paintwork at low level.

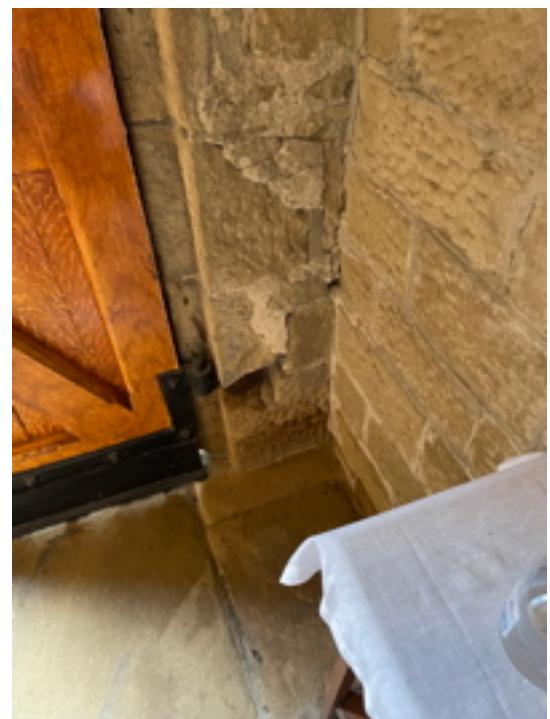
South Porch door hinge and poorly executed pointing

South Porch condition is generally satisfactory. However the walls have been partially repointed with inappropriate cement-rich mortar, which has been poorly executed and incorporates inappropriate mortar joints. Rust jacking of the lower west external door hinge has caused a failure to the sandstone which requires appropriate indent repair.

Clean rust from wrought iron hinge and indent repair associated damaged sandstone. Cost Band 2 – £2,000.00-9,999.

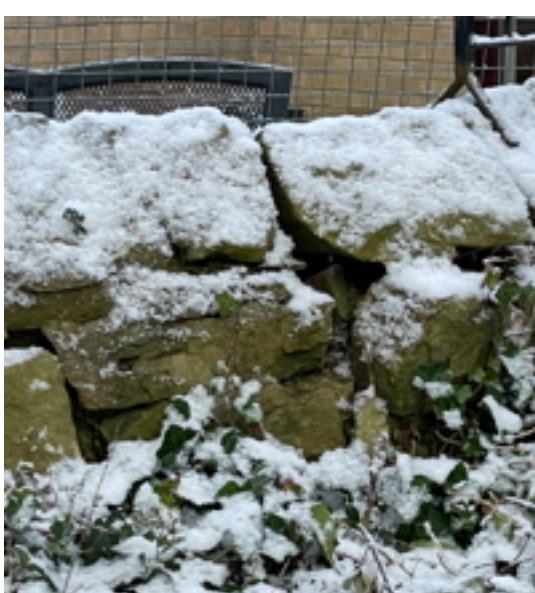
The majority of the walling is generally in a reasonable state of repair although there are a few areas that require repointing. Small areas of the west wall have loose stones and vegetation growing from the wall due to lack of maintenance.

West wall loose stones

Repair west wall, pointing loose stones with lime mortar and removing vegetation and repointing with lime mortar. Cost Band 1 – £0.00-£1,999.

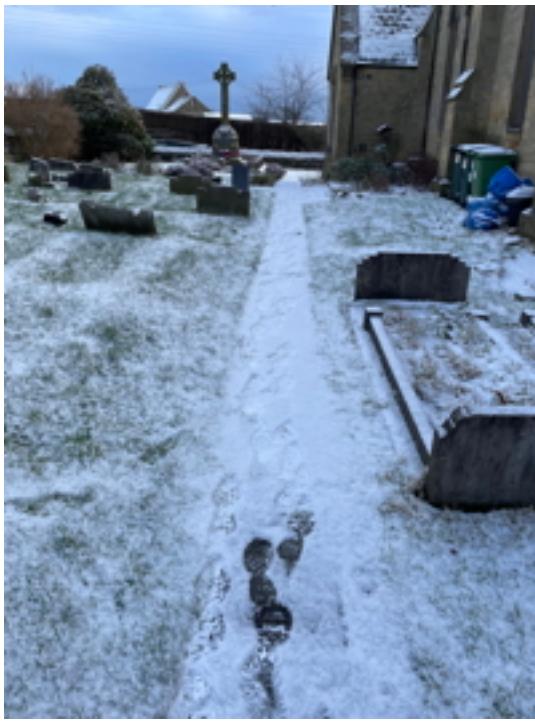
North tarmac pathway

The grass is well maintained. The pathway from the east gate appears to be in reasonable order. Tarmaced pathway to north shows signs of surface deterioration and, in places, has heavy moss growth. Flagged pathways have several uneven flags.

Resurface areas of deteriorating pathways and level flags. Cost Band 1 – £0.00-£1,999.

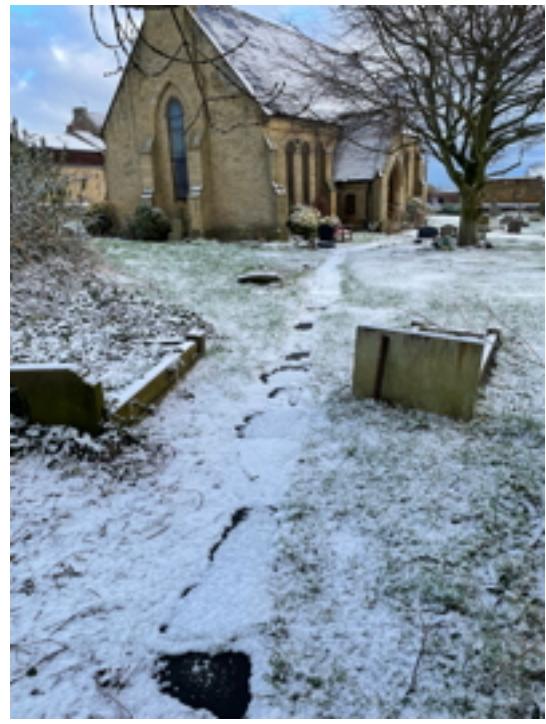
South west flagged pathway

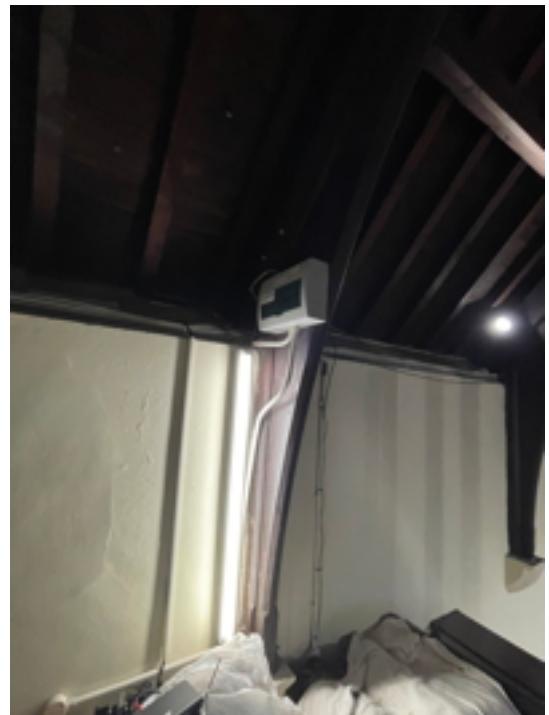
Gallery Consumer unit

Electrical system to be checked immediately by a registered NICEIC electrician and at least once every five years thereafter. Recommendations are to be acted upon and, thereafter, service records kept in Logbook. Cost Band 1 – £0.00-£1,999

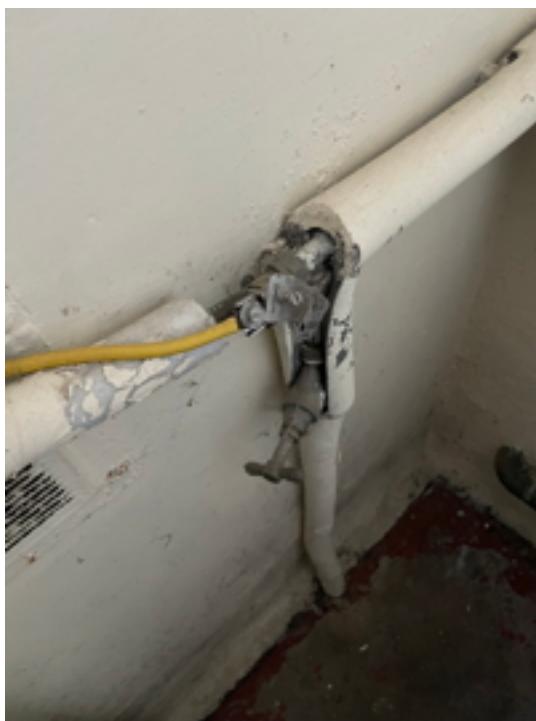
The incoming mains supply is in the WC.

All appears to be in working order. The main supply pipe should be checked to see if it is made of lead and, if so, replaced.

Check water main to see if it is made of lead and, if so, replace. Cost Band 2 – £2,000.00-9,999.

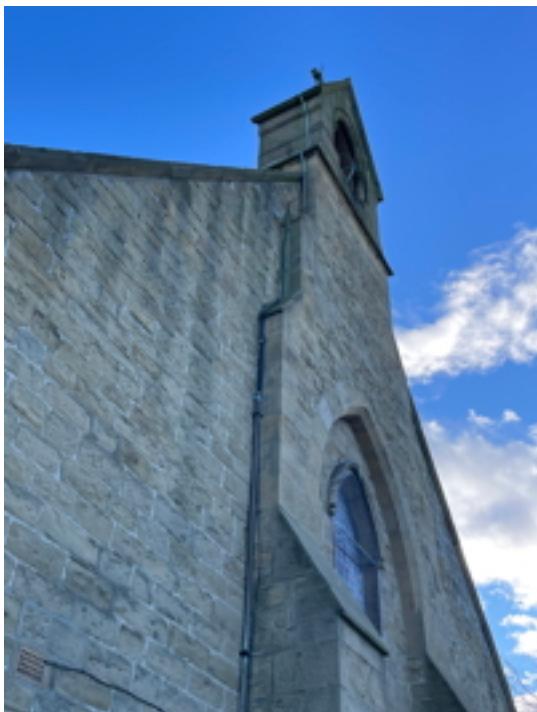
The lightning conductor was last tested in 2018.

Lightning conductor to be checked at least once every five years and recommendations acted upon and, thereafter, service records to be kept in Logbook. Cost Band 1– £0.00-£1,999.
