Diocese of Durham

ESCOMB
Saxon Church
(176)

QUINQUENNIAL REPORT
on the architect's inspection on

14 August 2017

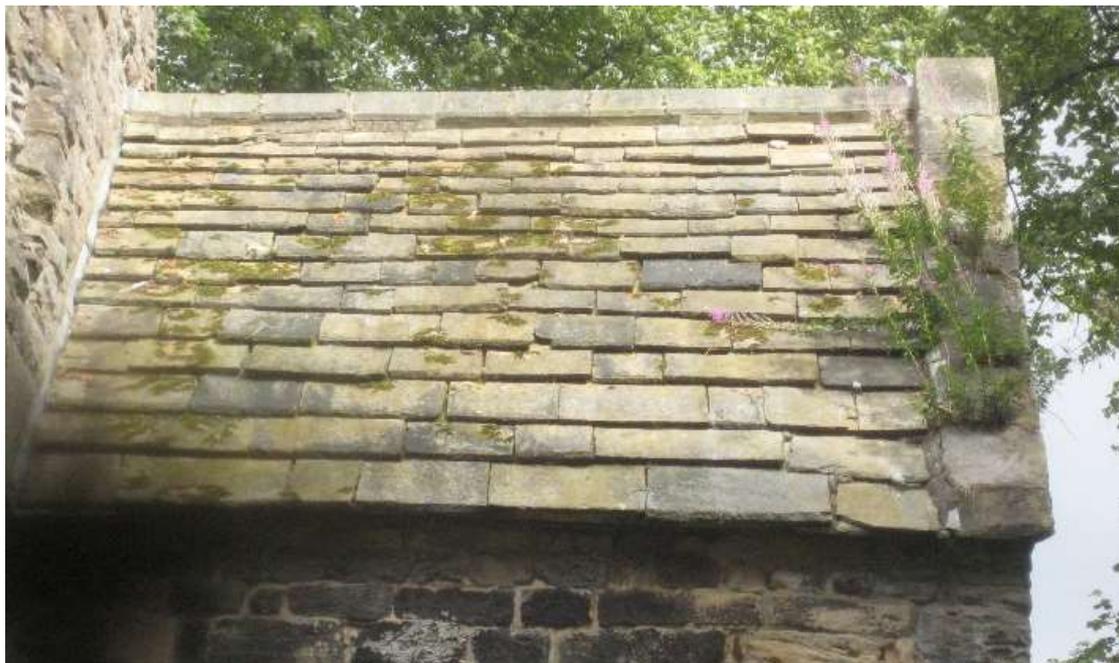
22. **S Chancel** slates uneven and some moss. Two at E held on thick lead strip clips. One by top E corner slipping and seems wedged in place by a stone under the next slate up.

S Chancel, plants in cracked fillets and watertable joints and wedged slate at top right

Replace broken stones at the bell and rehang bell	14, 41, 42
Rebed & repoint Chancel watertables and wall under, add stainless cramps if practical and refix loose slates	21, 22, 32
Replace cracked mortar fillets at Porch	24
Replace failed lamps	86
Service fire extinguishers	89

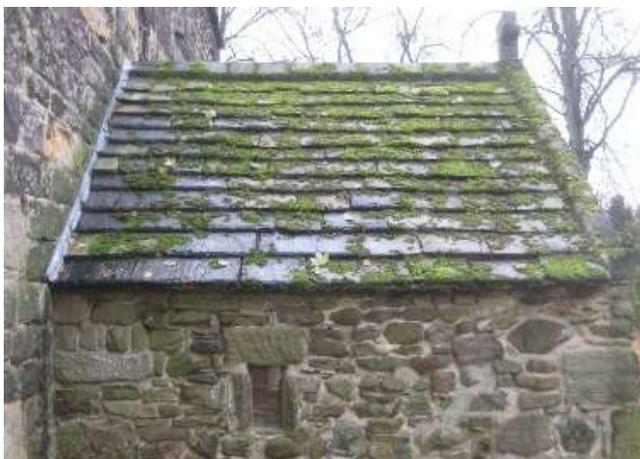
W porch

24. Widespread moss on the **Porch** slates which appear sound. Soakers and lead cover flashings against the Nave. Slightly torn at W despite their short lengths. Mortar fillets against the low S upstand, extent of cracks hidden by moss covering. The lead and mortar cracks may leak.

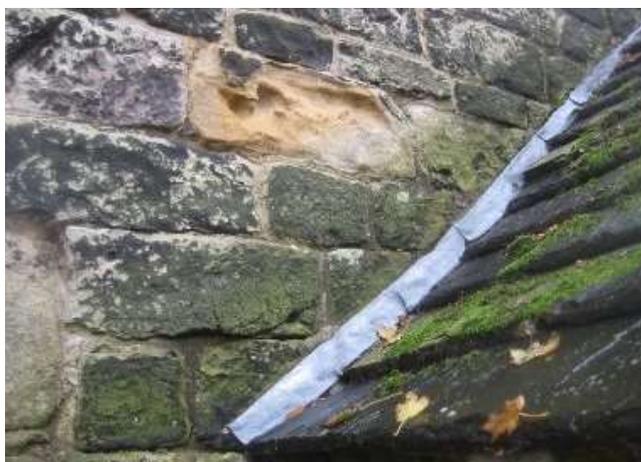
torn cover flashings against nave and decayed nave stone

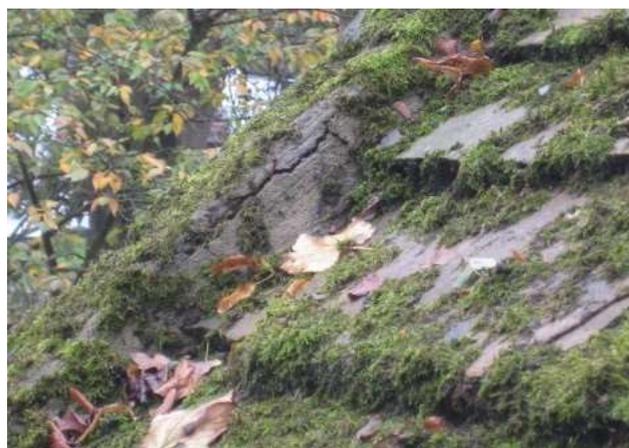
cracked fillet at SE porch (para 24)

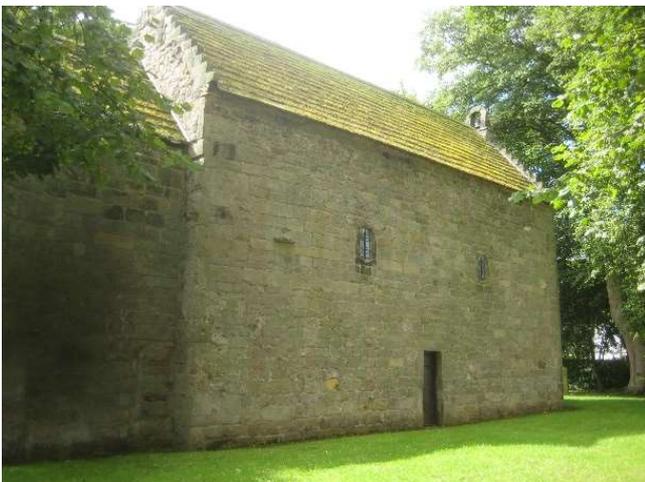
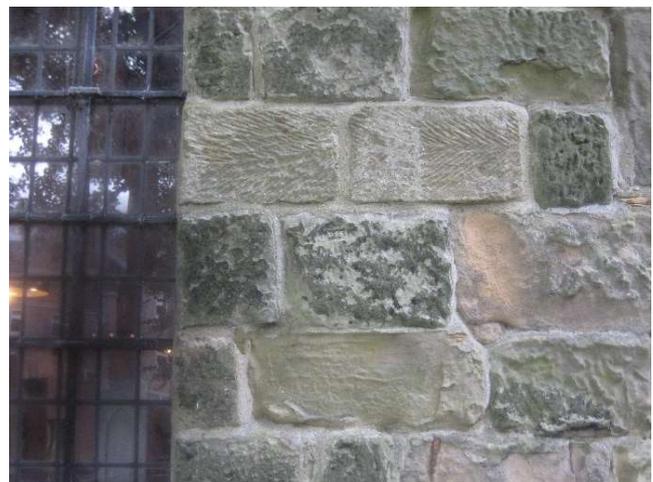
31. Last repairs 1989 by William Allison Ltd were discrete minor mortar weatherings in scattered decay pockets, pointing of top of Nave E gable and of the Chancel watertables. and a small number of stone indents under and next to the W window with herringbone droved faces, perhaps to match faint traces of original broaching or to distinguish them for future historians.

1989 indents with droved tooling by W window

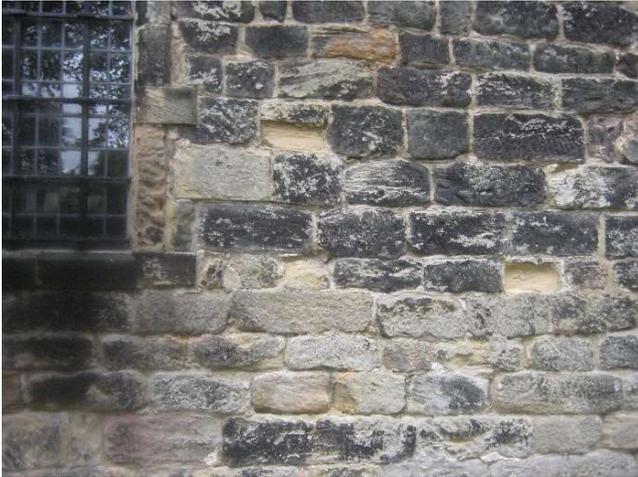
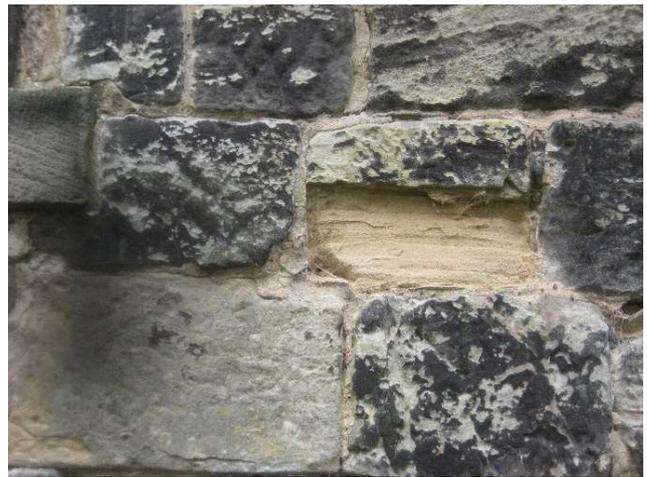
decay in random S Nave stones

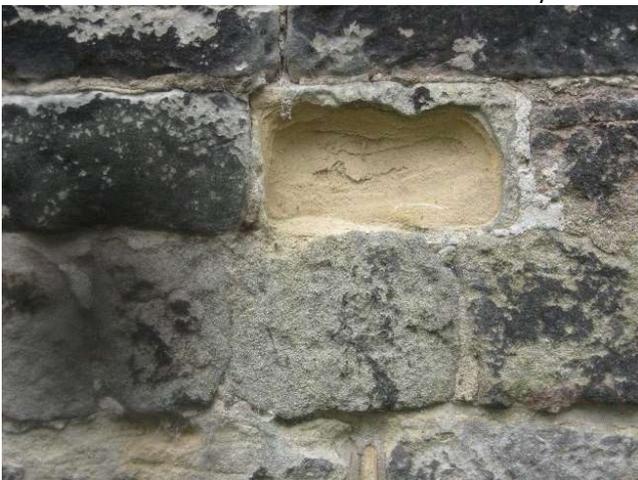
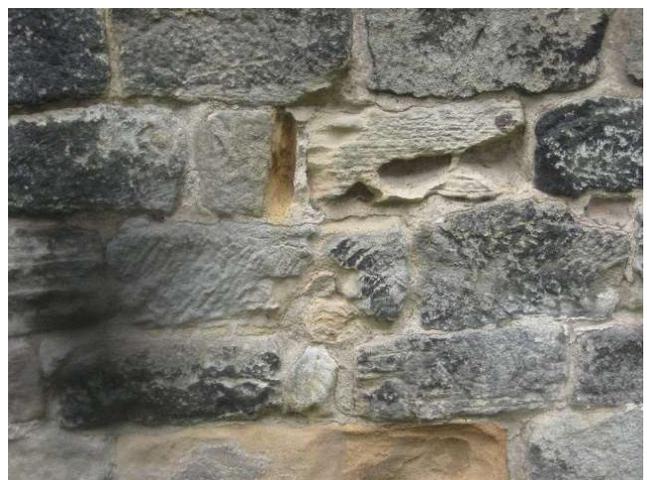
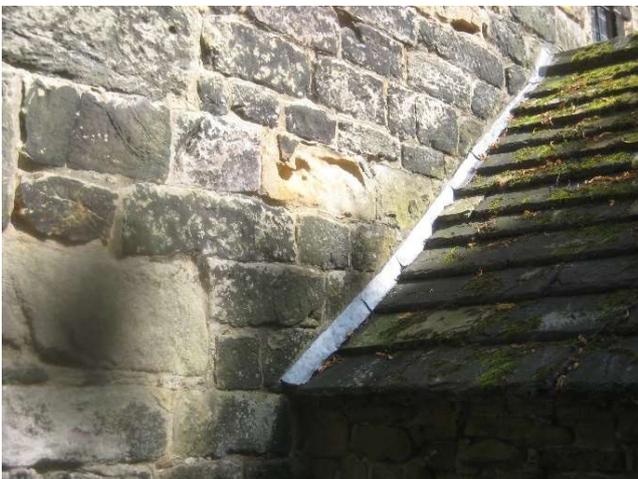
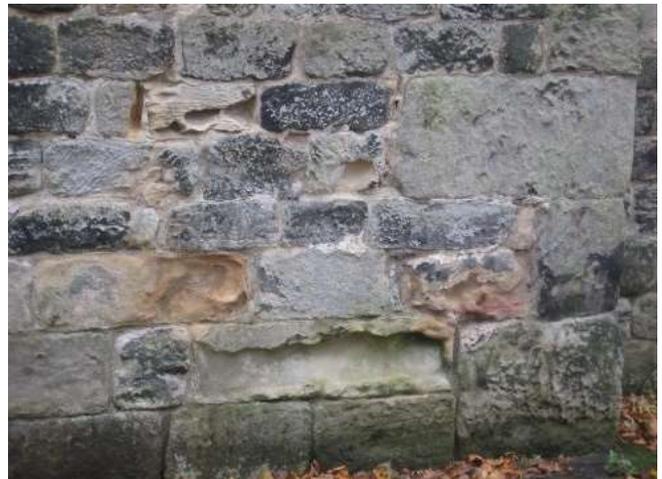
S nave bottom E corner, corresponding to damp inside

63. Some damp at bottom of Nave SE corner (rising damp or stone decay outside para 35) and very slight damp under the W window behind the frontal box/pew.

103. Repair of the broken masonry at the bell is needed.
Replacement of the most decayed stones at the Nave bottom SE corner and general change to French drains could help to reduce damp inside.
The remaining stone decay seems not to need repair at present and the cracking needs no more than periodic observation.

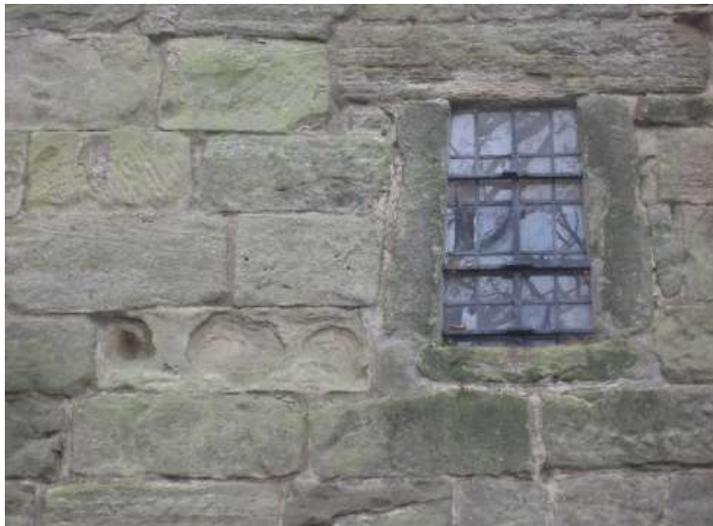
typical N nave

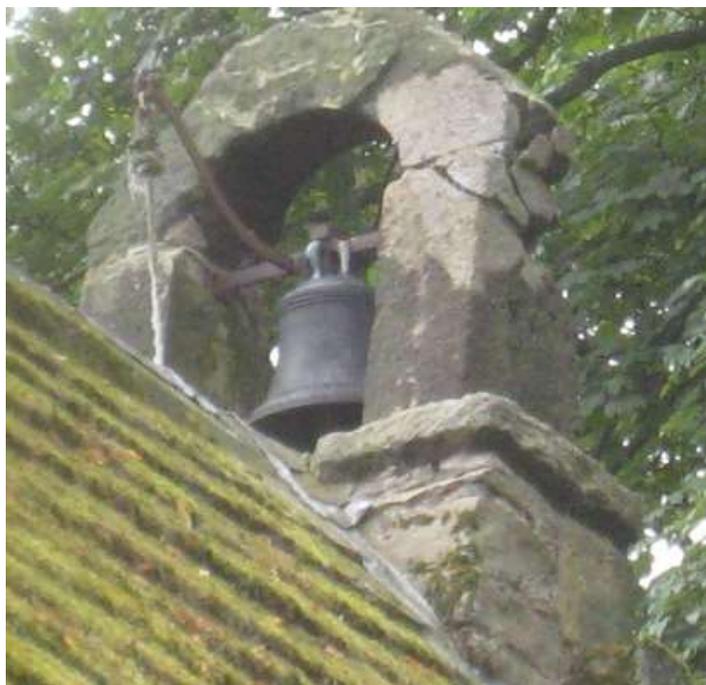
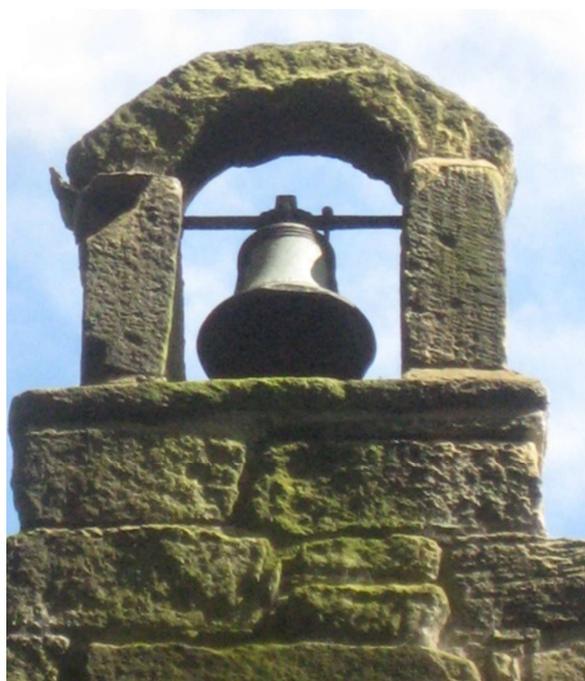
41. A suitably simple arch shaped stone stands on two stone uprights. The N end of the arch and top of the N upright are both mortar patched. A single bell hangs from an iron bar which is housed into the S upright and passes through the N upright which is broken around the bar. The breaks may cause the uncertain sound. Broken pieces part missing, part hanging off further than at last inspection. Otherwise masonry weathered but seems sound.
42. The bell, said to be 16C, is tolled by curved iron lever and rope through ridge. The bell itself sounds uncracked and fair but not certain. Since the last inspection a mason checked and reported no fault with the mounting but the broken stone now needs repair.

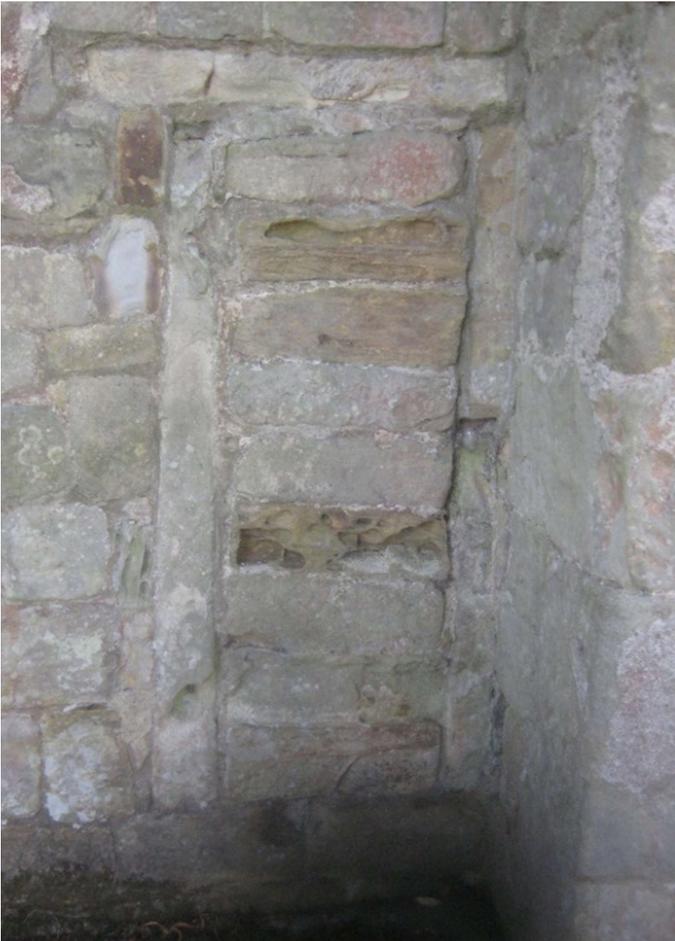
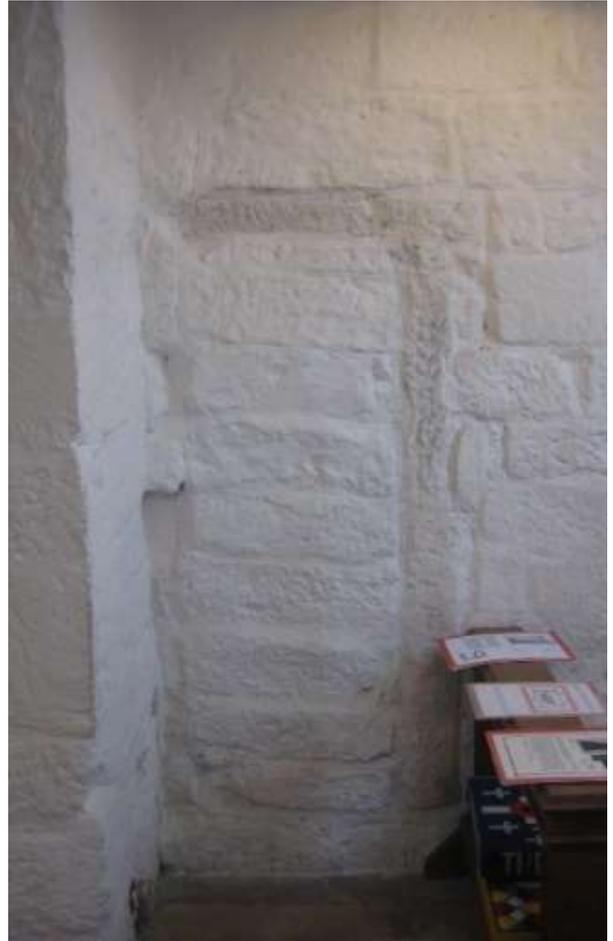
52. N Chancel – at blocked priest's door the lintel and both jambs, especially top of E jamb and mid point of W jamb are decaying back slowly. The third blocking stone from bottom was replaced in 1989. Two other blocking stones have deep decay pockets.

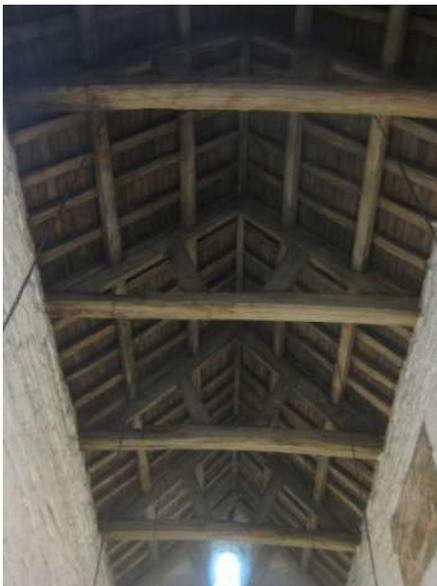
Nave

55. In **Nave** and **Chancel** massive unsawn timber trusses and purlins needed for the heavy stone slates add to the special character of the interior. Horizontal sarking boards. In the short Chancel trusses against gables take the roof load instead of it bearing on the gable masonry. Dendrochronology dates timbers about 1480. No access but no visible defect except woodworm holes. Recorded treated against woodworm 1985 by Durham Bat Group. Checks against new worm (new wood dust on the pews in the flight season May-September) would be prudent though given the height roof to pews it may be too disbursed to see.

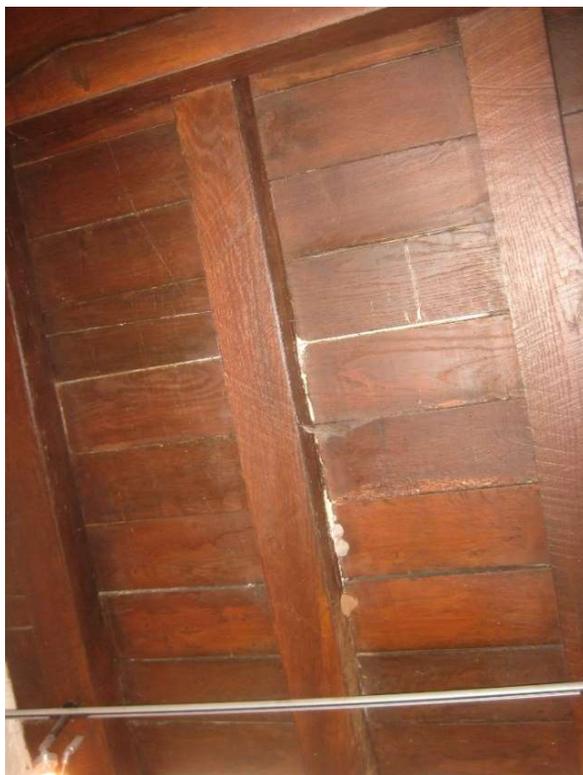
56. At **Porch** dressed and varnished softwood long purlins, ridge, rafters and sarking (Victorian?) all appear sound though the top of the E purlin, some rafters and a few board edges have some past rot varnished over and are soft to a probe. There is some sign of past board replacement. The dry rot fruiting bodies seen 2013 between the 2nd E rafter from Nave and the boards have died back since the 2013 slate repair. Condition of tops of boards unknown.

rot bodies 2013

Maintain a full Log Book including all past reports	10, 12
Report further sign of rot in the Porch timbers	13, 25, 56 - 58
Report any trace of new woodworm	55, 57, 58
Consider future of trees	95

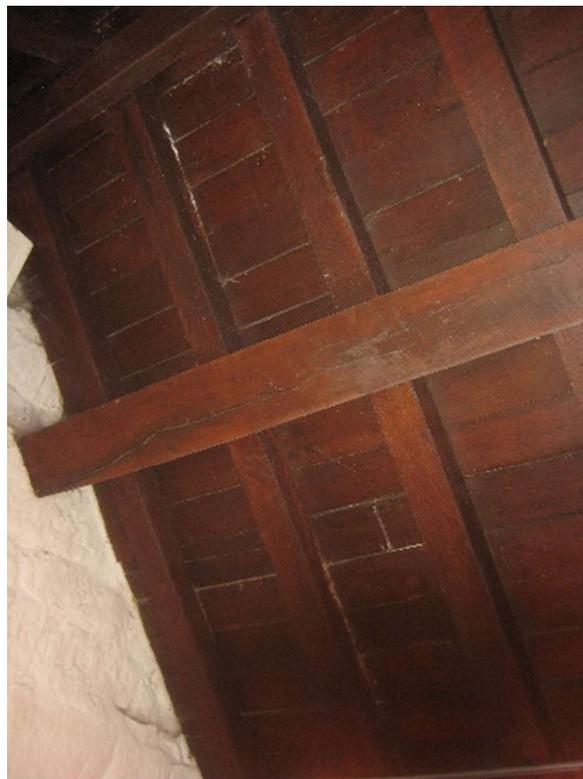
Porch E side

58. In sum in the past the Porch roof has been attacked and weakened by both worm and repeated rot but seems to remain strong enough at present. The slates, flashings and fillets must be kept in very good repair and the timbers checked annually for any new outbreak which might be enough to justify widespread timber replacements and perhaps full reroofing.

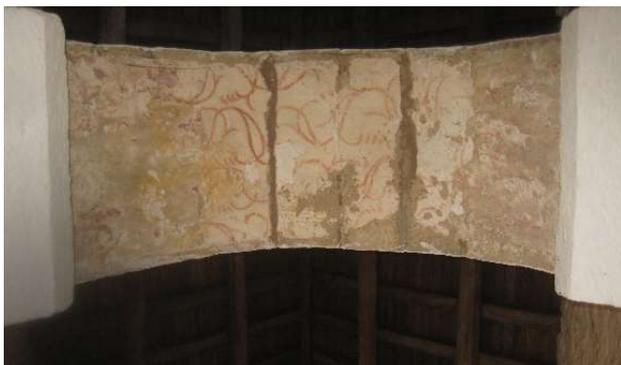
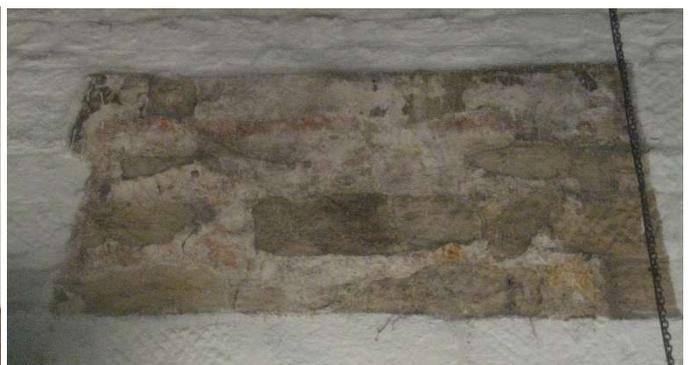
68. High on the N Nave wall a patch of ancient painted decoration survives on part plaster or wide lime pointing around unpainted stones, the whole framed by the limewashing. Arch and Wall painting both subject of a conservation report 2005 by English Heritage, appended.

Conserve the arch and wall paintings as 2005 report	4, 59, 68 and Addendums
Vacuum clean the limewashing	66
Clean all glass	70
Improve path surfaces and add path to N door for wheelchairs	91, 96
