**Quinquennial Inspection Report  
St George's Church, Fatfield, Washington  
Deanery of Chester le Street  
Archdeaconry of Sunderland  
Diocese of Durham**

26 March 2025

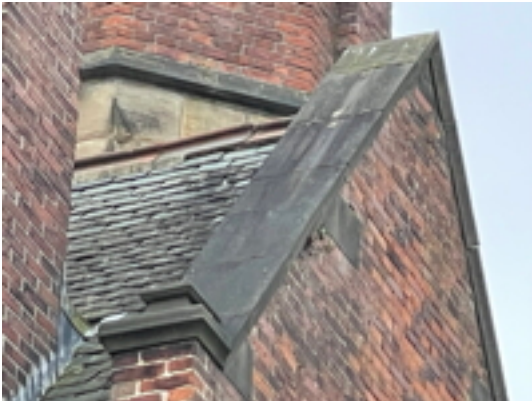
**Missing Ridge Pointing North Gable  
East Elevation**

Several chipped slates and a few missing and slipped slates to south elevation and north elevation east end. Not all areas are visible from ground level and should be inspected on a yearly basis by a reputable roofing company. The ridge tiles are generally uneven.

Replace all loose and missing slates. Cost Band 1–£0.00-£1,999.

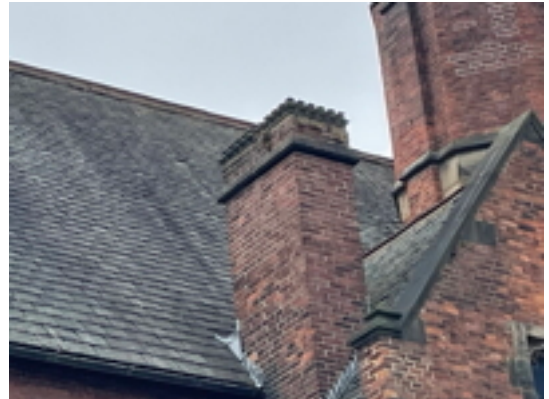
**Slipped Slates North Elevation**

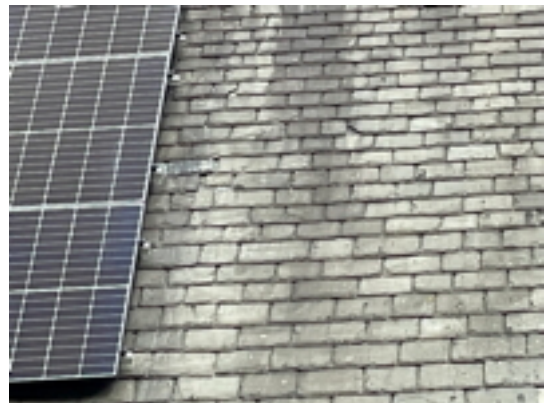
**Slipped/Broken Slates South  
Elevation**

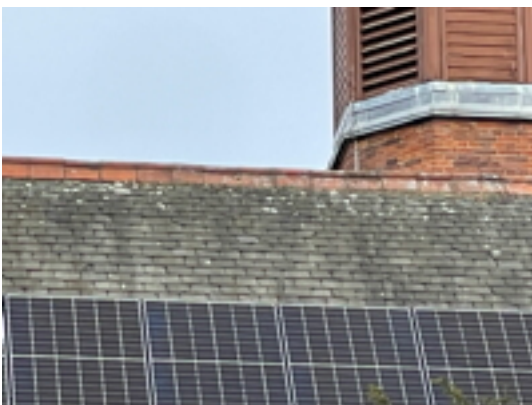
**Broken Slates South Elevation**

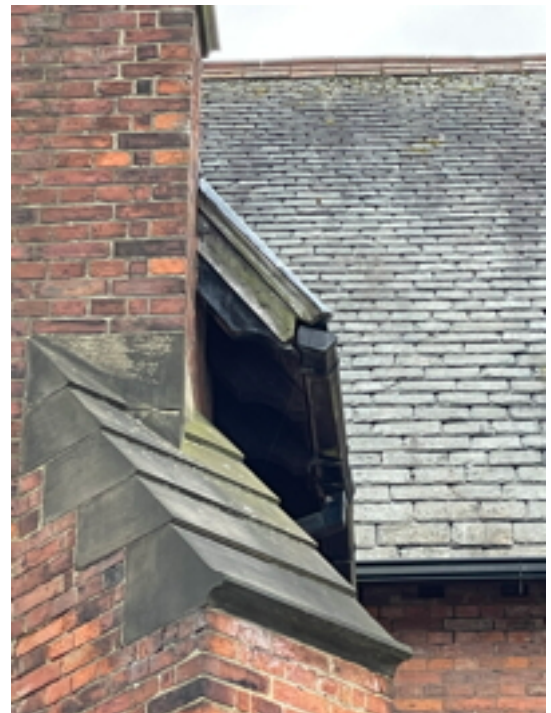
**Misaligned West Elevation Gutter**

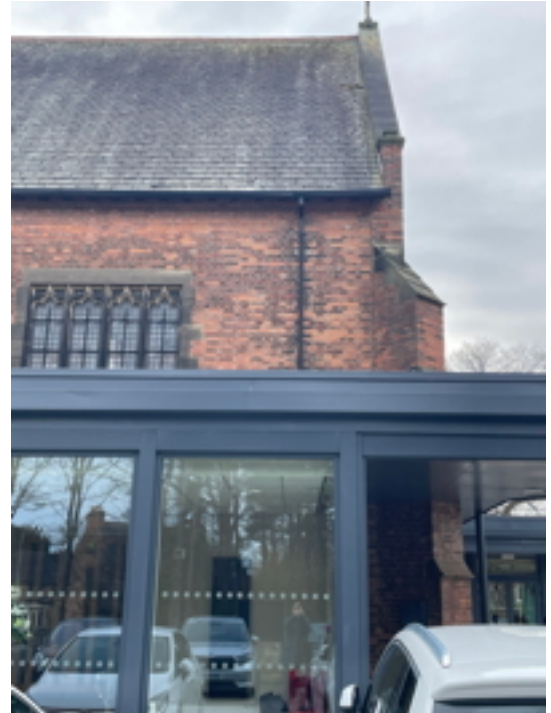
**North Elevation Rainwater Pipe Discharging over Flat Roof**

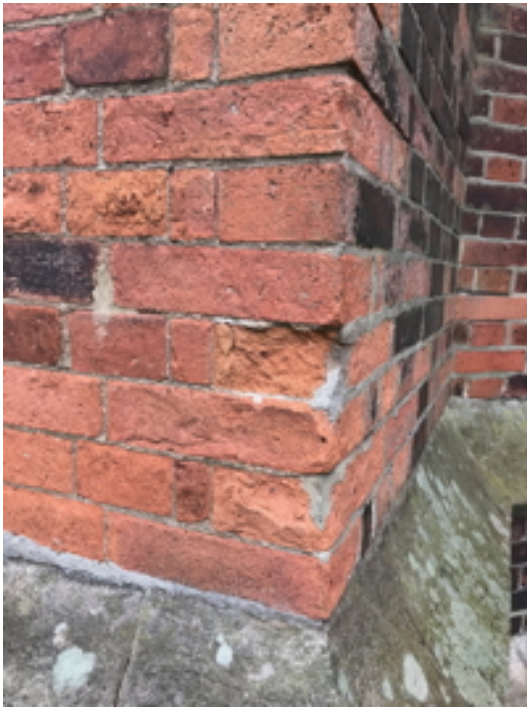
**Erosion of brick faces to buttress**

Some erosion of brick faces is visible. This is largely due to the brick being softer than the mortar, hence water is trapped in the bricks and frost action gradually destroys the brick. This will be an ongoing issue but careful attention to pointing and repairs will slow the deterioration.

Monitor brickwork and stonework deterioration. Cost Band 1-£0.00-£1,999.

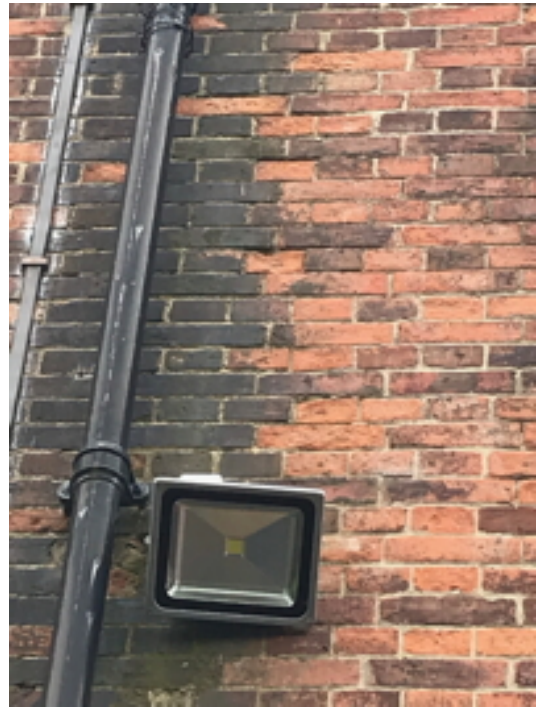
**Erosion of brick faces to North**

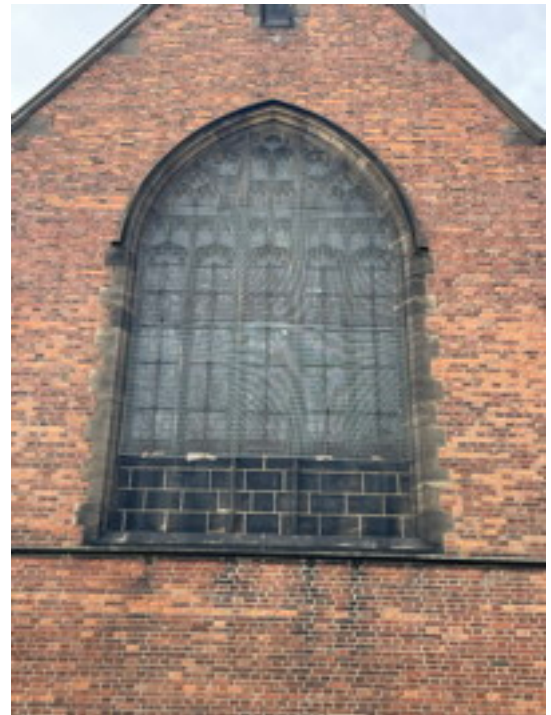
**East Window Metal Grilles**

Grille to east window is badly fitted and distorted. Both Grilles should preferably be replaced in polycarbonate.

Replace wire mesh grills with polycarbonate. Cost Band 2- £2,000.00-£9,999.

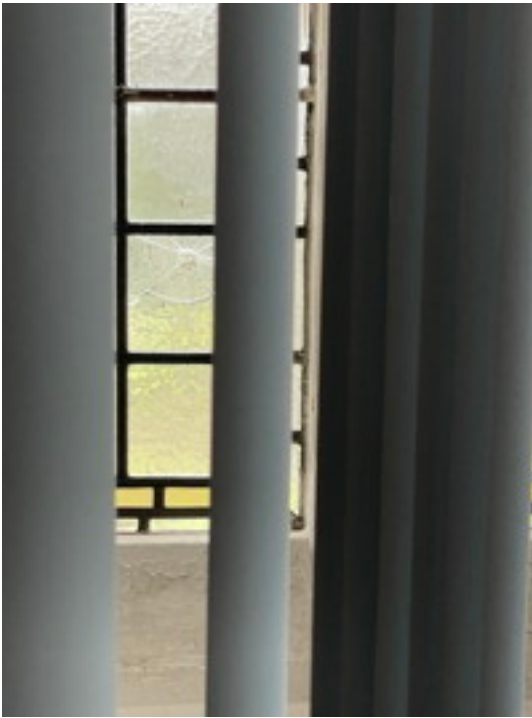
**Broken Vestry Window Pane**

Broken pane to vestry window east elevation.

Repair broken panes to Vestry window. Cost Band 1-£0.00-£1,999.

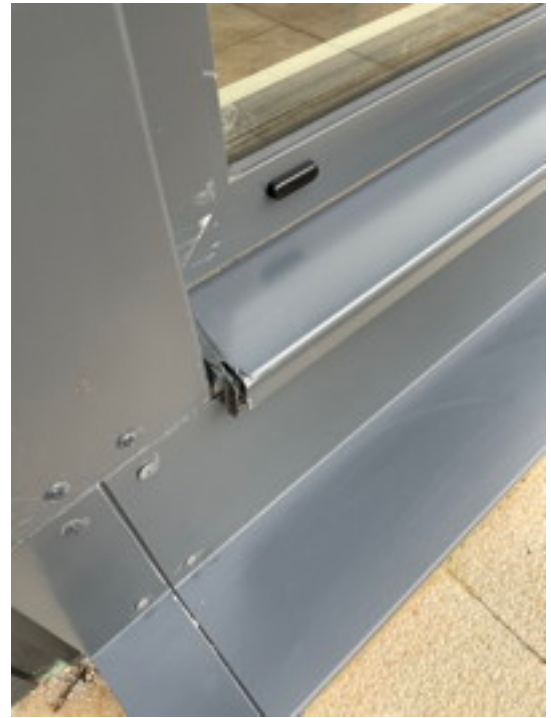
**Damaged End cap**

At the new extension there are two sections of missing cill end caps and a joint between the window frame and its framework support has opened up to reveal foam filler.

Undertake repairs to extension window under Defects/Faults liability period. Cost Band 1-£0.00-£1,999.

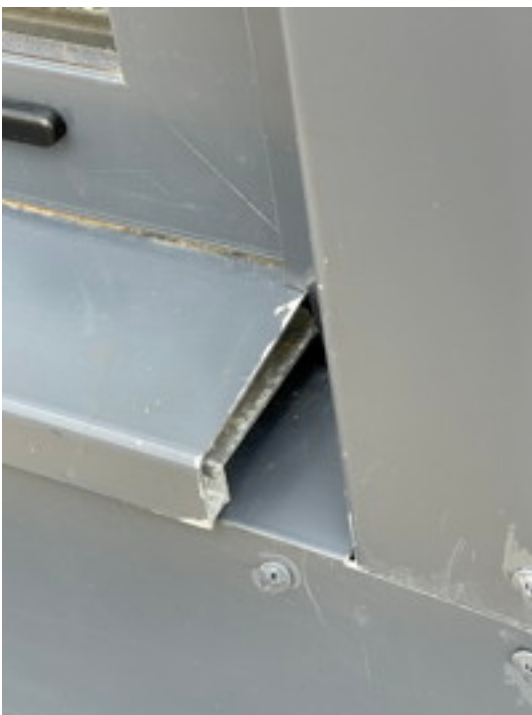
**Missing End cap**

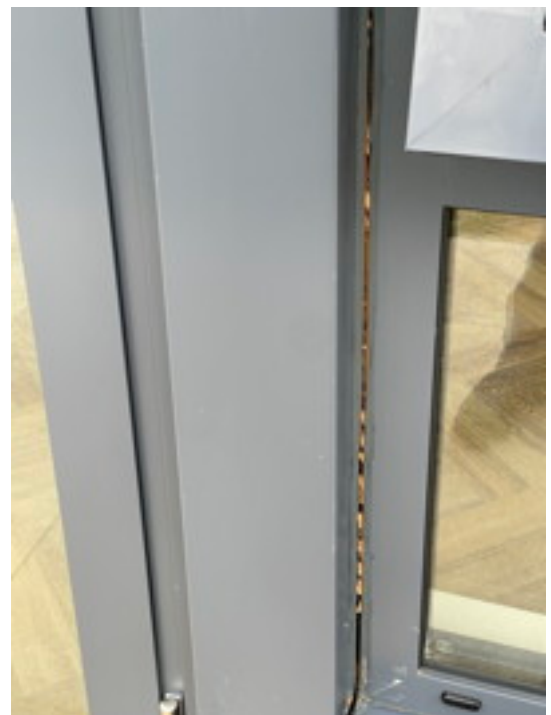
**Frame Gap**

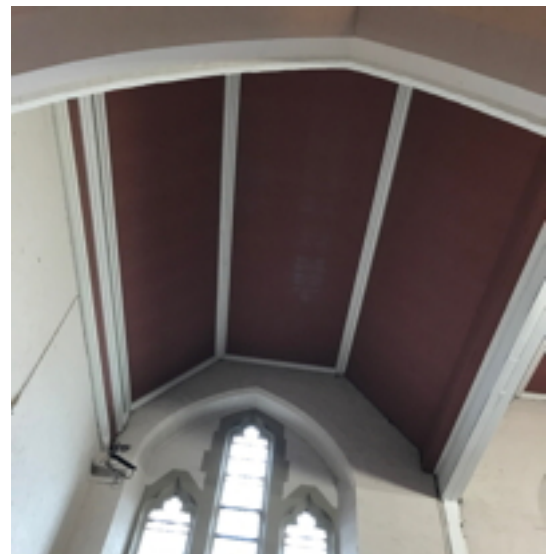
**North Aisle Ceiling**

All appear in good condition with the exception of the North Aisle where the timbers below the valley in the north wall show signs of rot, suggesting water penetration from the inaccessible valley detail above.

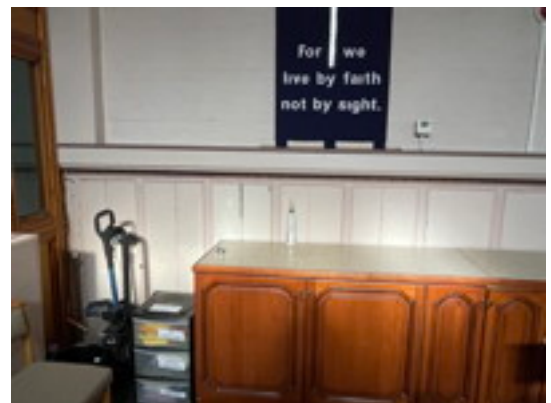
**Typical Shrinkage Cracking to Panelling**

Doors and screens are all in satisfactory condition. The panelling shows signs of shrinkage cracking as mentioned the last two reports.

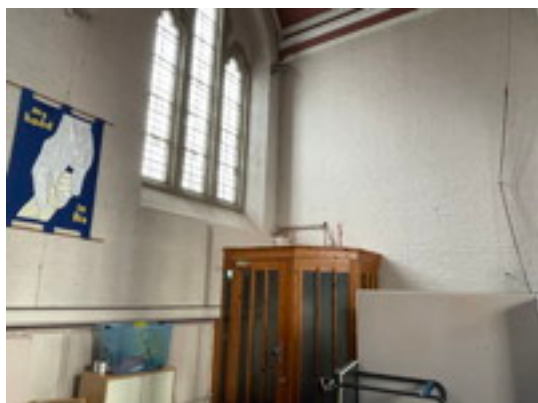
**North Aisle Walls Damage**

All is generally in satisfactory condition. There is some slight damage to make good where services have been installed in the north aisle.

Make good decoration under Defects/Faults liability period. Cost Band 1-£0.00-£1,999.

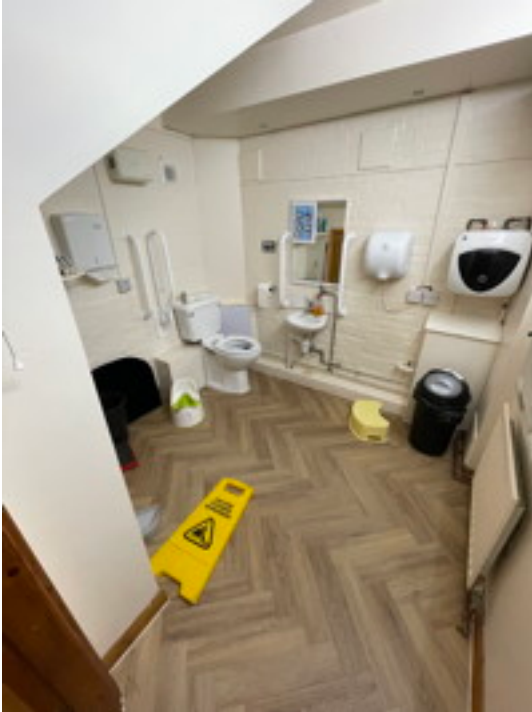
Main Church Accessible WC

All recently refurbished and in good condition. Emergency pull cord appears to be missing although sign in place.

Reinstate emergency pull cord. Cost Band 1—£0.00-£1,999.

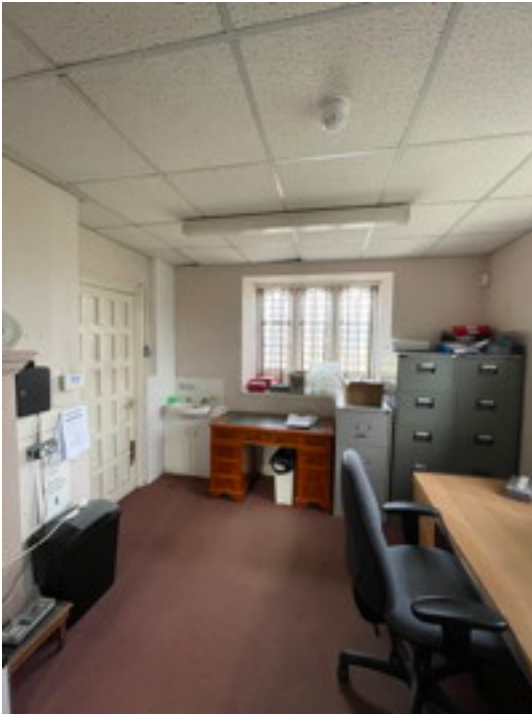
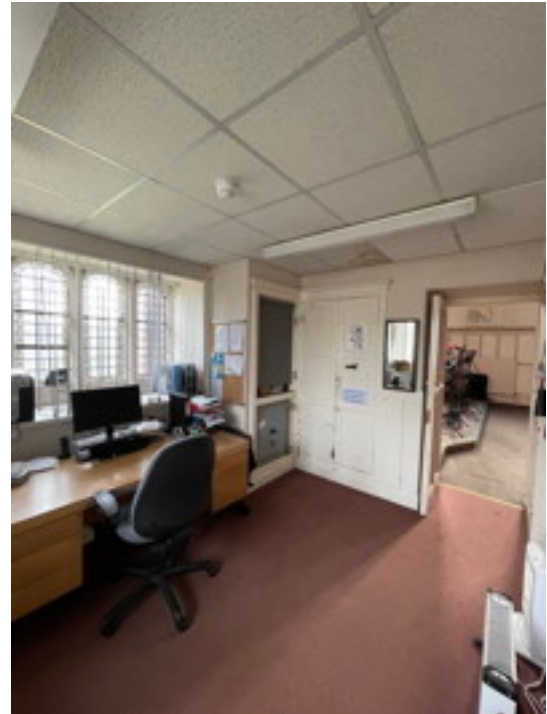
There are signs of staining to the ceiling (a different pattern to the previous inspection). This is an area below a valley gutter that is always vulnerable. The Vestry is all in satisfactory condition.

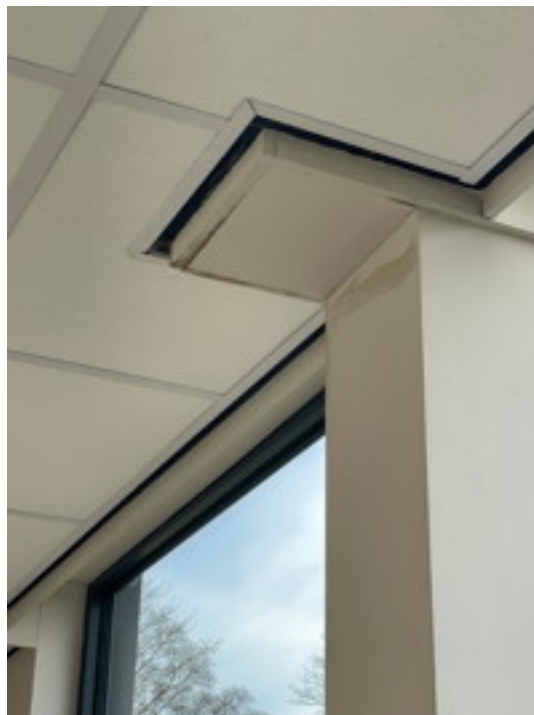
**Multi-Purpose Room Water Damaged Ceiling**

All recently completed and generally in good condition. Signs of water damage to ceiling indicating leak to roof finish.

Undertake repairs to roof under Defects/Faults liability period. Cost Band 1—£0.00-£1,999.

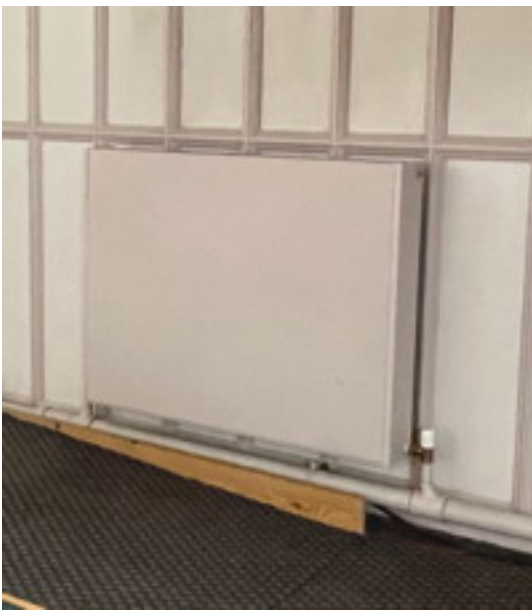
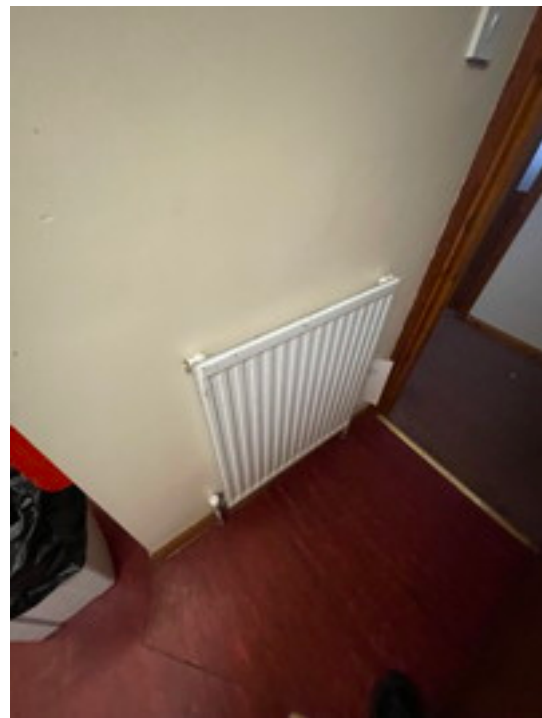
All appears to be in satisfactory order but it is noted that the main boiler is old and will require placement in the not to distant future.

Plan for future replacement of boiler. Cost Band 1-£0.00-£1,999.
