**Quinquennial Inspection Report  
Christchurch, Felling  
Deanery of Gateshead  
Diocese of Durham**

David Jowett - Architect, BA, DipArch, RIBA  
25 Roseworth Avenue  
Gosforth  
Newcastle upon Tyne  
NE3 1NB  
Tel: 07788 710 204  
email: [david@davidjowett-architect.co.uk](mailto:david@davidjowett-architect.co.uk)

13 November 2025

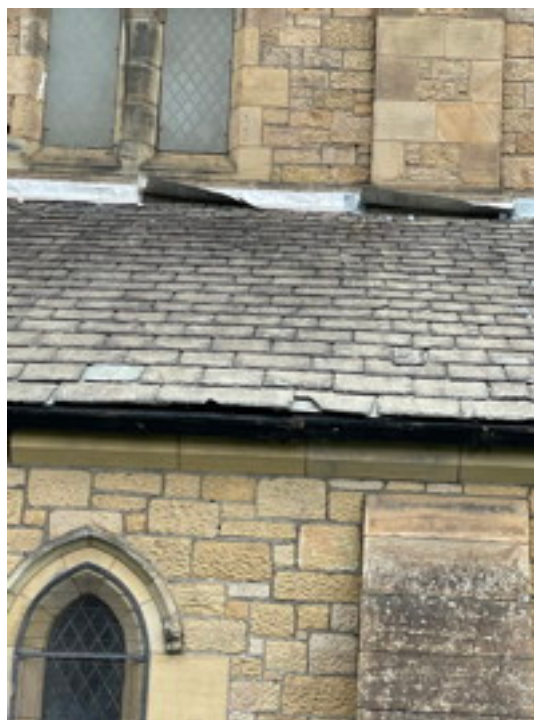
**South Aisle Displaced Flashings**

The south aisle and south porch roofs have been heavily vandalised and are in need of complete replacement. Some lead flashings have been displaced to the north aisle roof due to vandalism.

Replace south aisle and porch roofs. Repair missing and slipped slates generally and make good to all flashings. Indicative quote already received. Cost Band 5 £50,000 - £250,000.

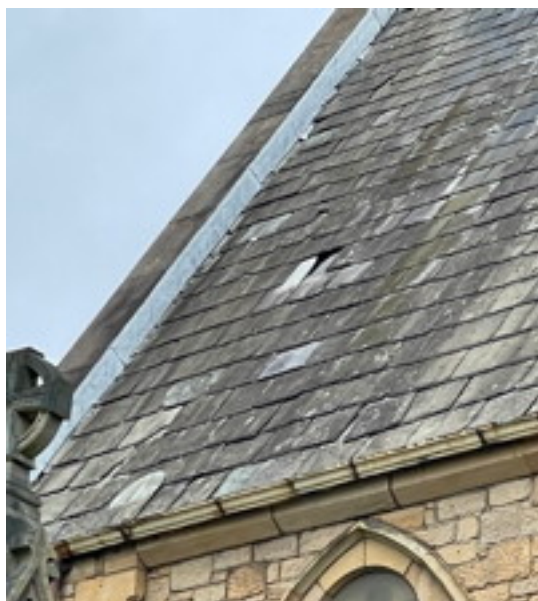
**Nave South Elevation Missing  
Slate**

The slating appears in generally in reasonable condition to the nave, organ chamber, north tile and vestry and vestry store roof with a few missing and slipped slates. The south elevation of the chancel has pulled away from the nave quite substantially. The priest in charge reported that the work carried out above ground in the 1990s as part of the underpinning of the east end was unsatisfactorily carried out and the movement seen here may either date from then or may be more recent.

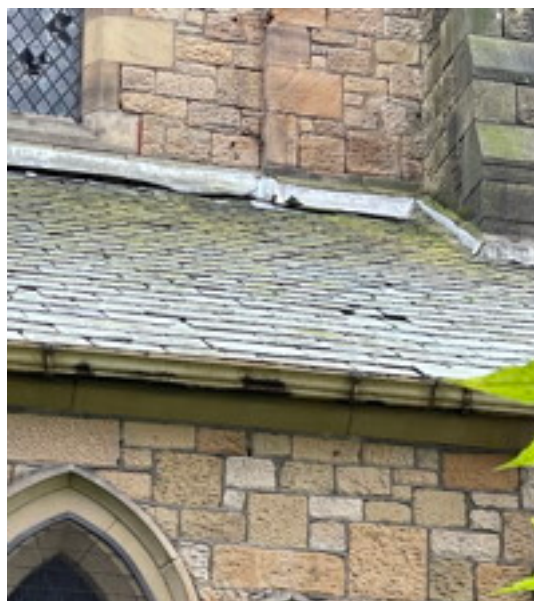
**North Aisle Displaced Flashings**

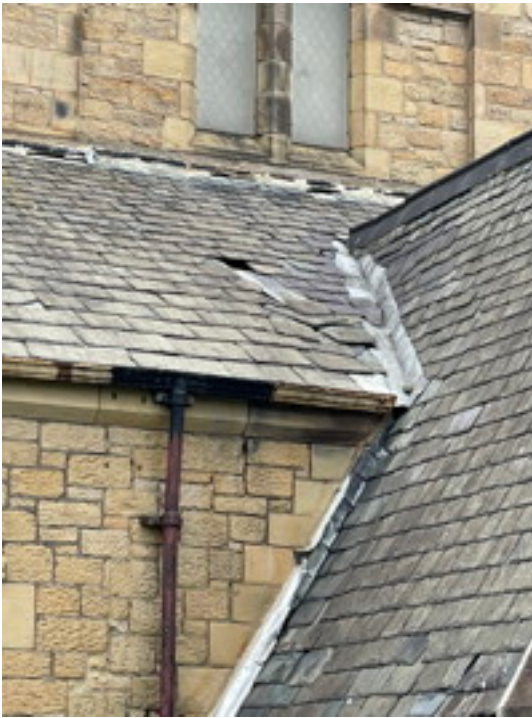
**South Aisle Missing Flashings and Slates**

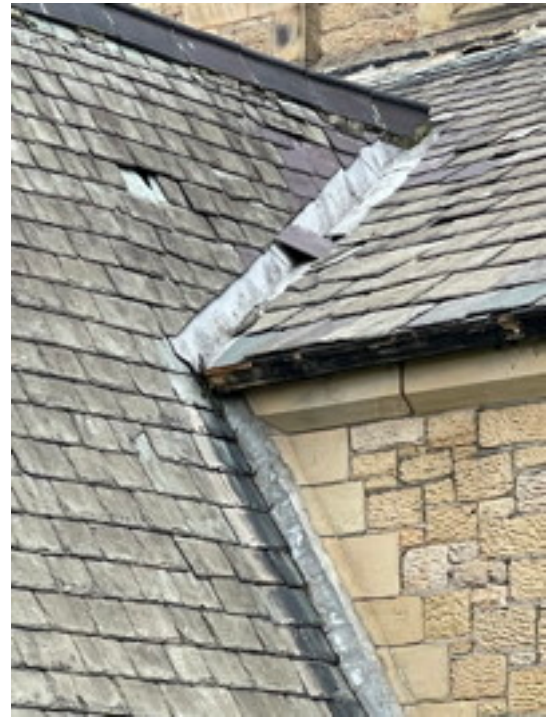
**South Porch Missing Slates**

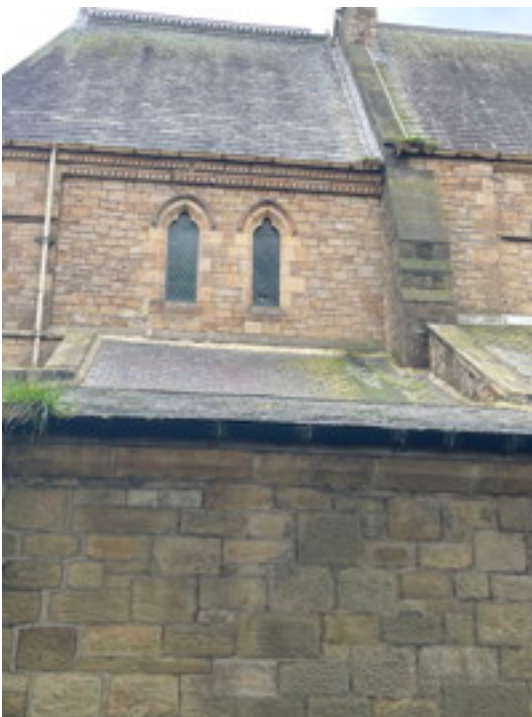
**Vestry Store Low Pitched Roof**

The vestry store roof appears to be pitched at around 15 degrees well below the minimum recommended for slate roofs.

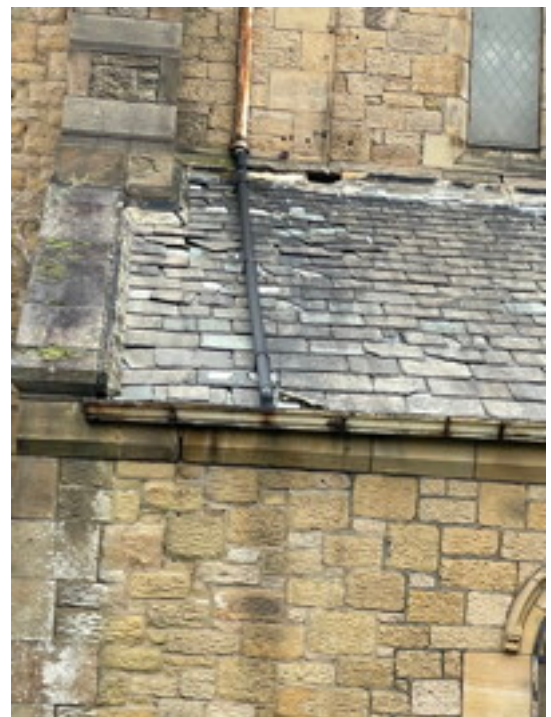
**South Aisle Many Displaced Slates and Missing Flashings**

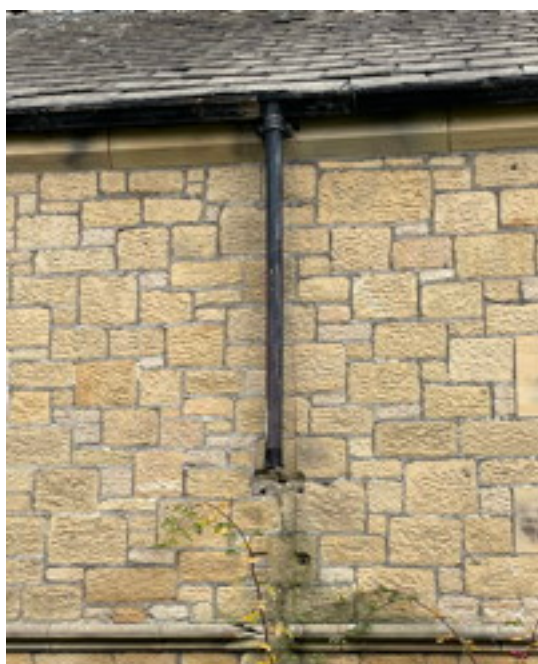
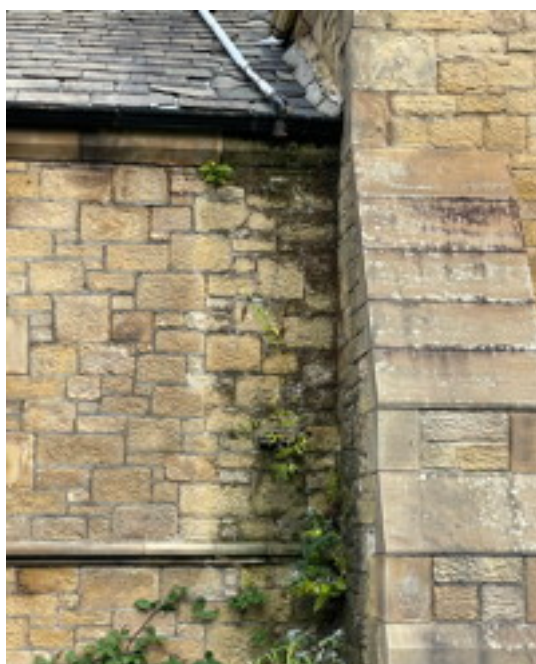
**South Aisle Missing Rainwater**

Missing down pipes to most of south aisle. Displaced sections of guttering. Many sections of gutters blocked. All cast iron rainwater goods are in urgent need of decoration and may well require full replacement.

Replace missing downpipes and make system watertight. Indicative quote already received. Cost Band 2– £2,000.00-£9,999.

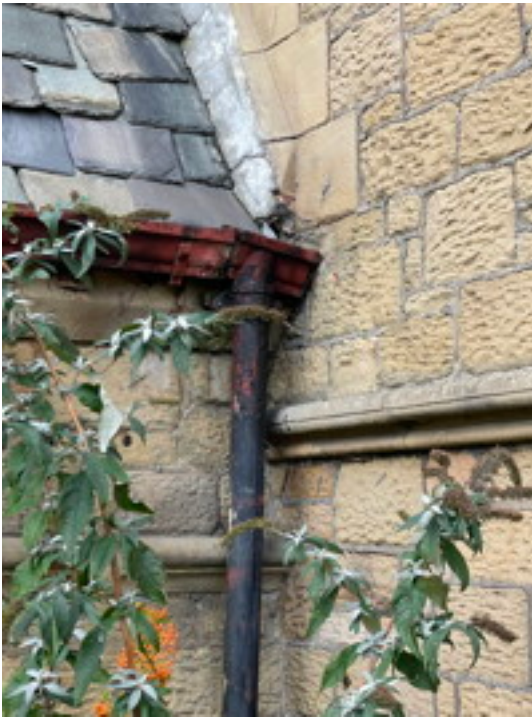
**South Porch Misaligned Gutter**

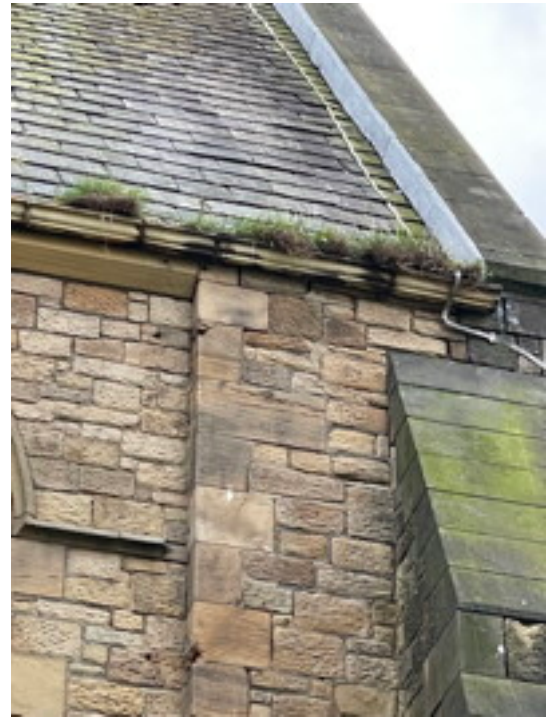
**North Nave Blocked Gutter**

Generally overhaul complete system and decorate, considering anti-climb rainwater pipes and replacement of cast iron with aluminium. Cost Band 3– £10,000 - £30,000.

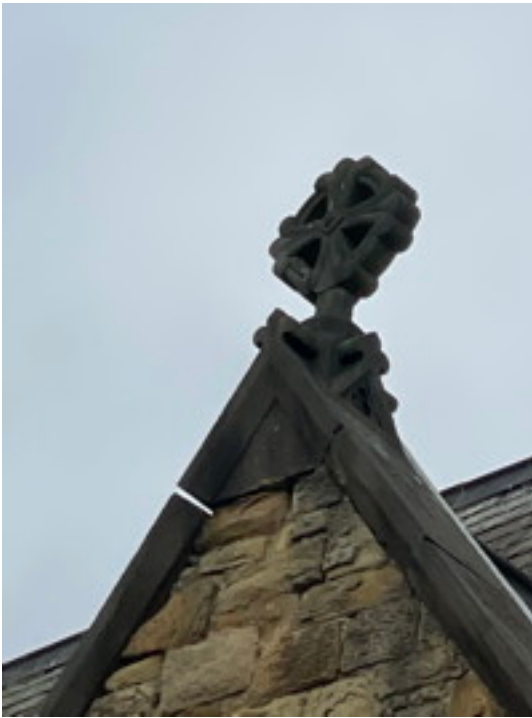
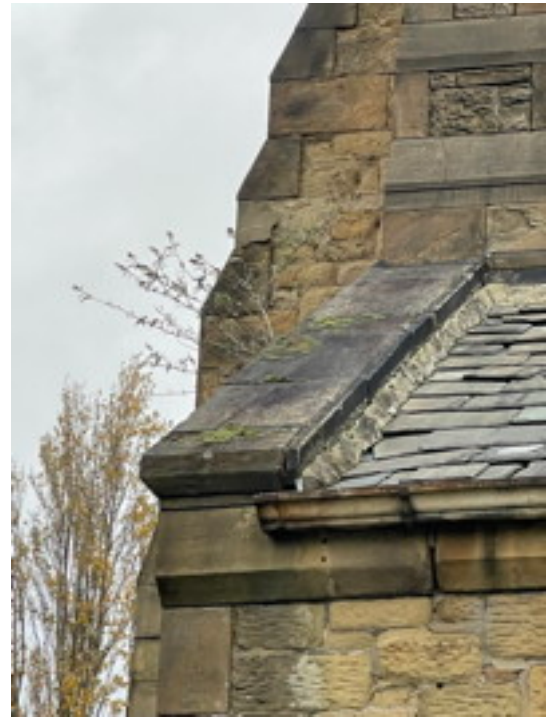
Open joint to south porch west elevation. Buddleia growing from south aisle west end. North aisle west end severely displaced following subsidence of Kitchen area. Plant growth below water tabling to vestry and vestry store east elevation. Flèche has some missing timber sections and many missing slates.

**South Porch Open Joint**

Repair misaligned water tables, removing buddleia and other plant growth, and repair flèche as part of general roofing repair works. Costs included in general roofing works above.

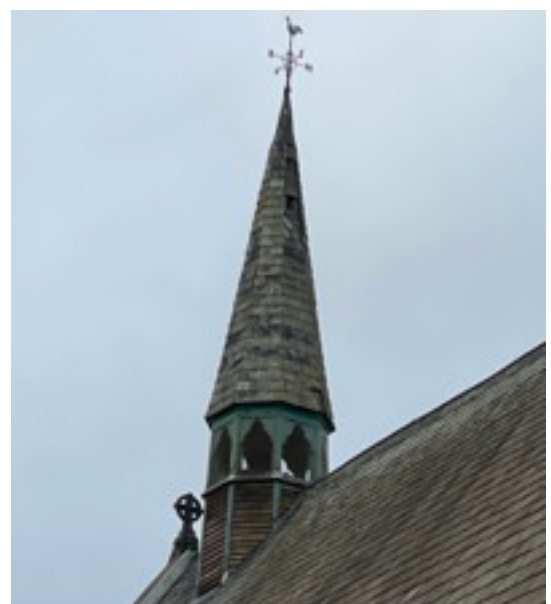
**Flèche Missing Slates**

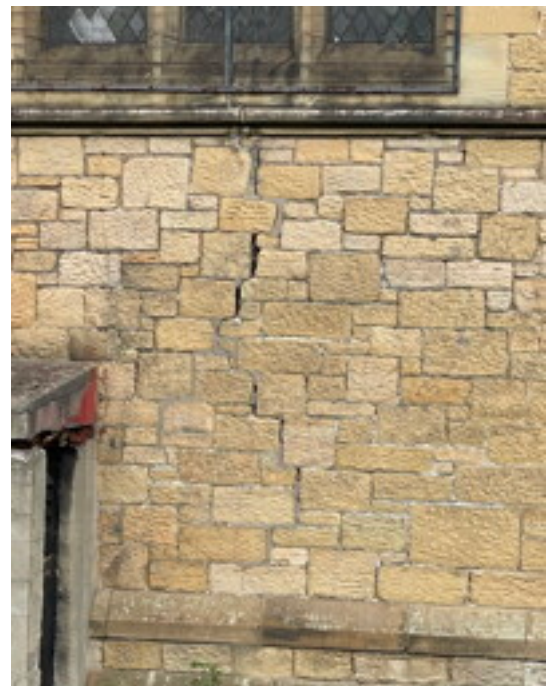
**Cracking to Organ Chamber South Elevation**

Several areas of cement mortar pointing. Previous movement cracks badly pointed. Substantial movement to north side of west elevation. Vegetation growing in stonework at missing rainwater pipe locations. Some areas of eroded stonework.

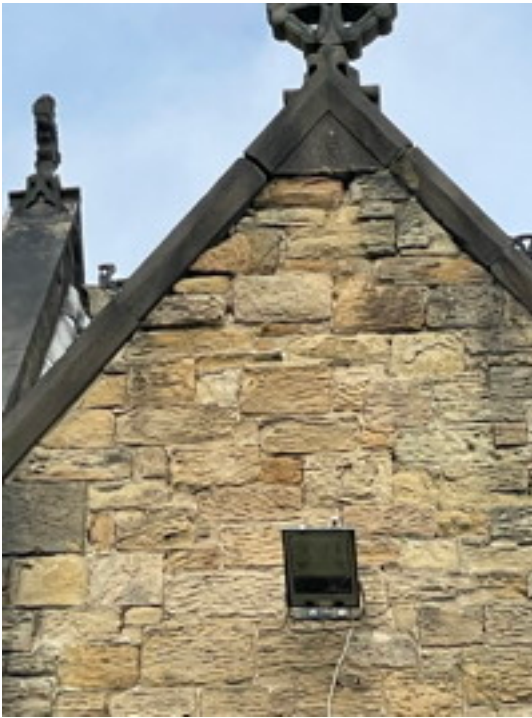
**Eroding Stone to Organ Chamber Gable**

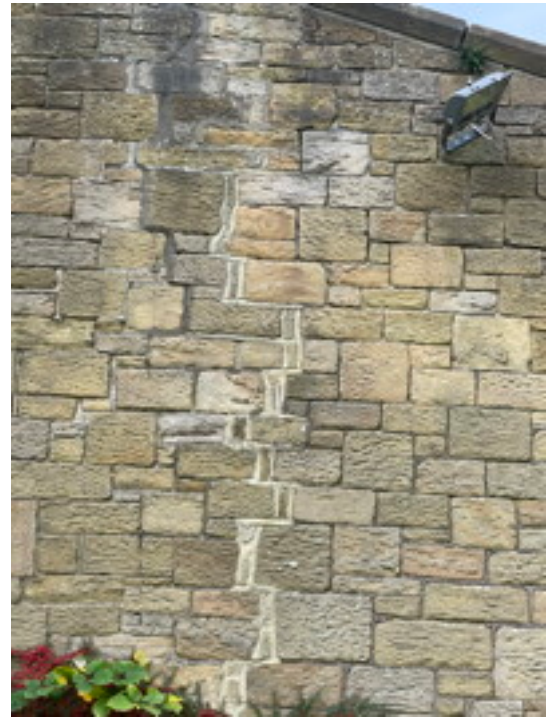
**Cracking to Vestry East Elevation**

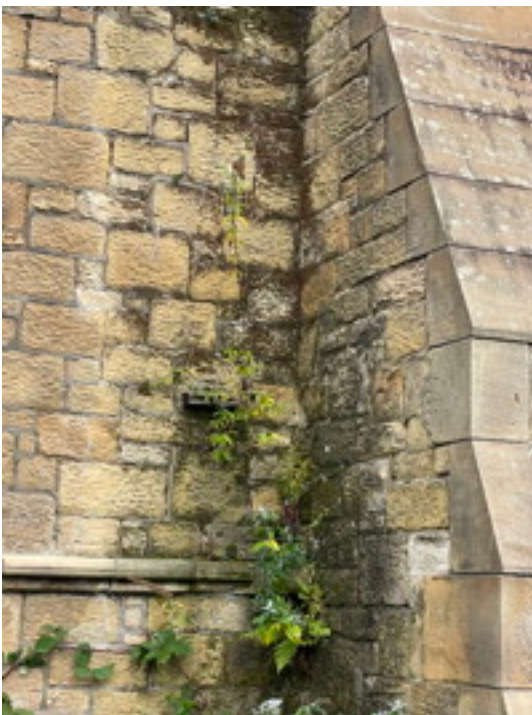
**Plant Growth and Missing Rainwater Pipe Location**

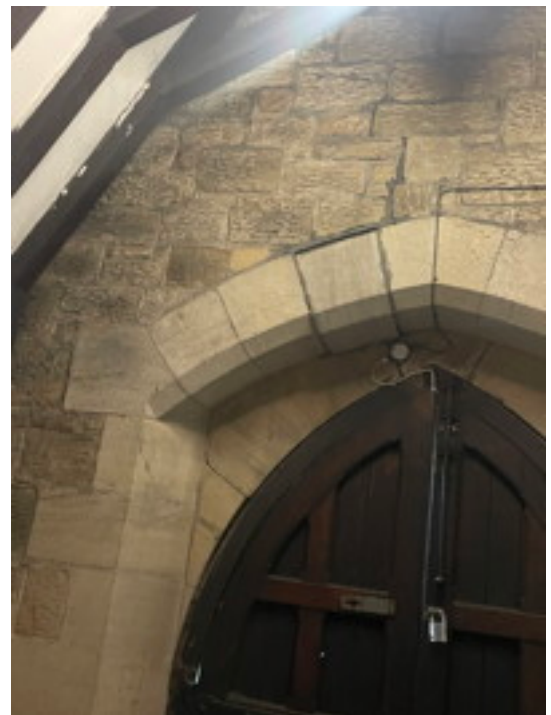
**Dropped Stone to South Porch**

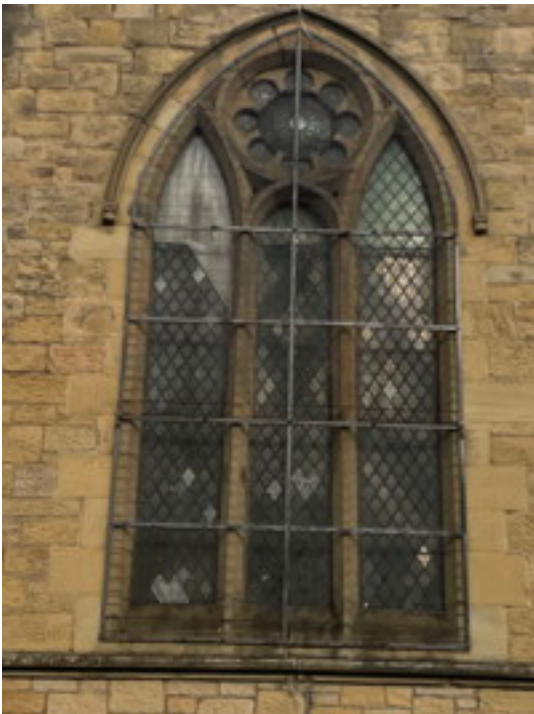
Many windows have broken panes, some of substantial size, generally caused by vandalism. Substantial missing glazing to organ chamber LHS replaced with polycarbonate and also to Vestry. The polycarbonate protection has come to the end of its life and is now brittle and would provide little or no protection if attacked. Exterior metal grills require redecoration and some require refitting. South porch doors, vestry and west doors require decoration. Metal bar across top of west end window appears to serve no purpose and should be removed.

**Organ Chamber Missing Glazing**

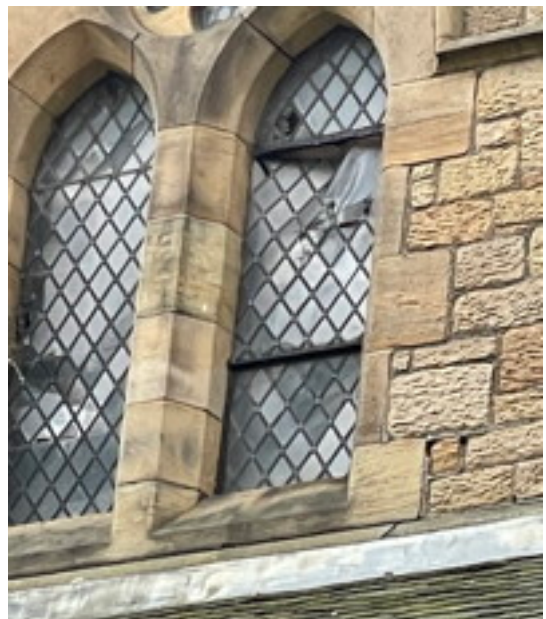
**Typical Vandalised North  
Elevation Clerestory Window**

Repairs of north clerestory windows and polycarbonate protection for north clerestory as Iona Art Glass Quote. Cost Band 3– £10,000 - £30,000.

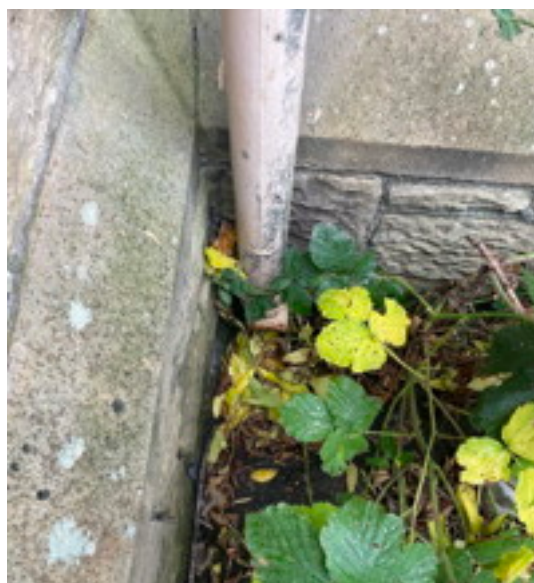
**Typical Gully blocked with vegetation**

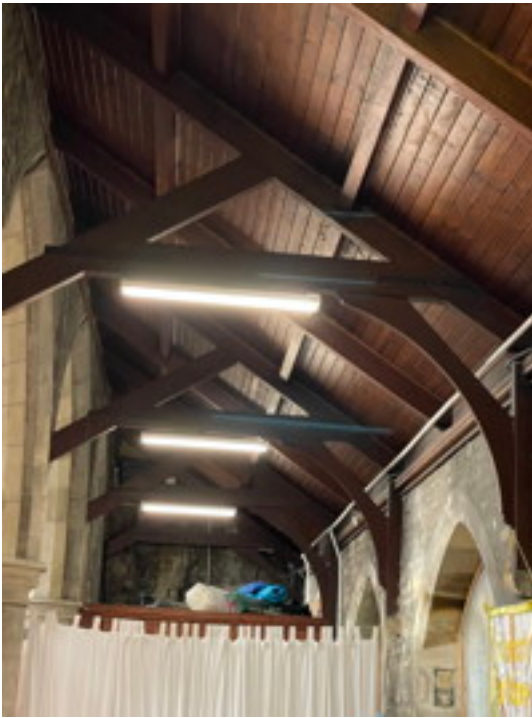
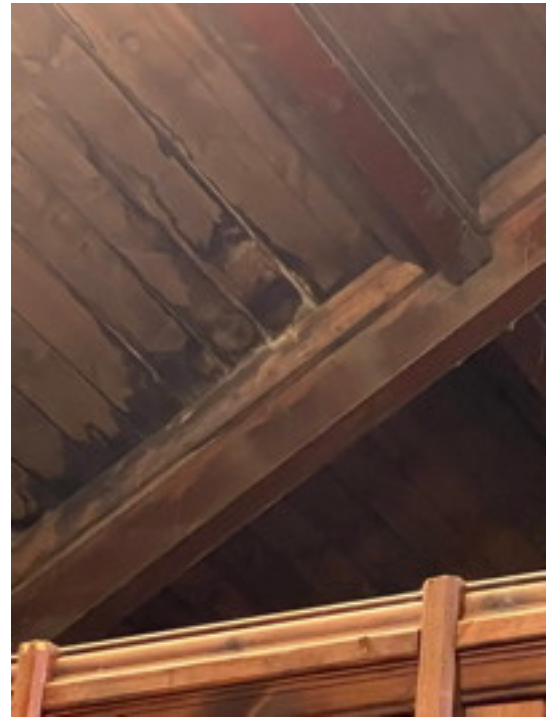
Generally no visible defects to roof timbers when viewed from ground level to nave and north aisle. There is some staining to the north aisle above the kitchen ceiling which corresponds to the damaged parapet caused by the subsidence. There are two areas to the south aisle which correspond to missing slates above showing signs of rot.

**South Aisle Ceiling**

Arrange a timber survey with a reputable timber preservation company to establish whether the timbers are suffering from wet rot (to be expected) or dry rot (to be dreaded). Cost Band 1– £0.00-£1,999.

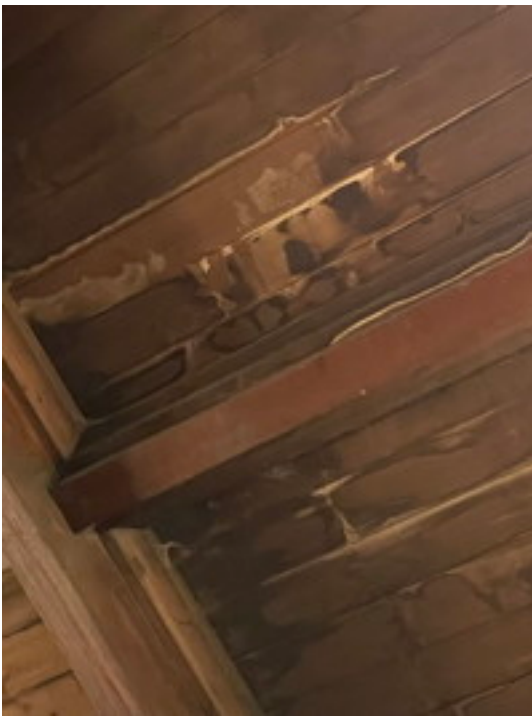
**Staining to South Aisle Ceiling**

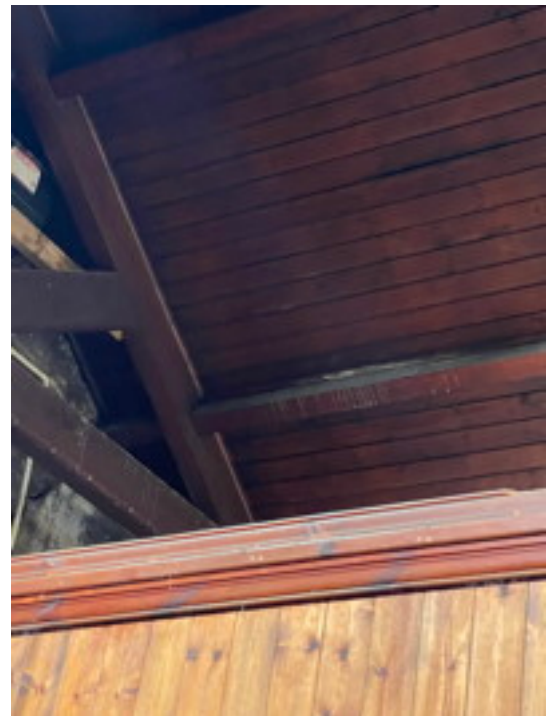
**Staining Over Kitchen Ceiling**

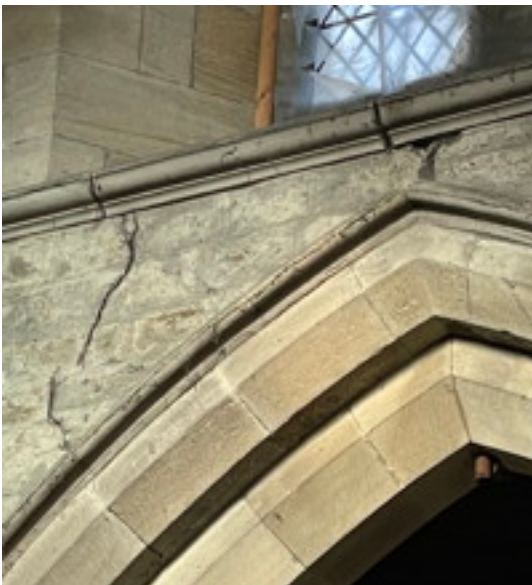
**Nave Cracking to West End**

There is some structural movement to west end north side associated with the recent subsidence. There is cracking to the chancel associated with the 1990s subsidence.

Complete investigation of ground conditions below subsided north west corner and prepare design to underpin. Carry out remedial work as already advised by stonemason to include dismantling north west corner to safe and structurally sound level and rebuilding with helical bar for strength in some of the stepped joints. Costs included above.

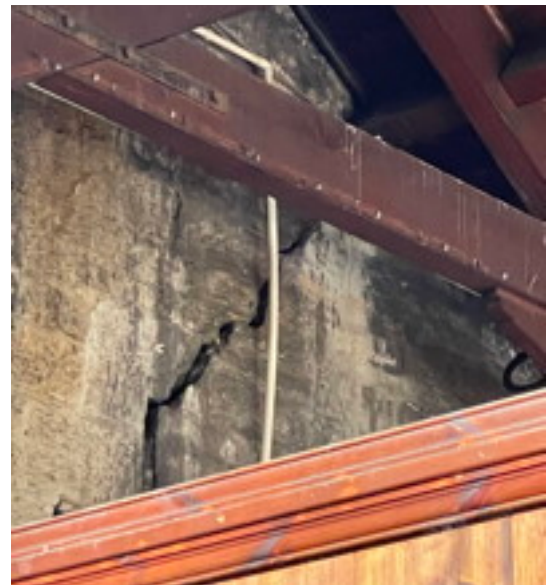
**West Wall Cracking Over Kitchen**

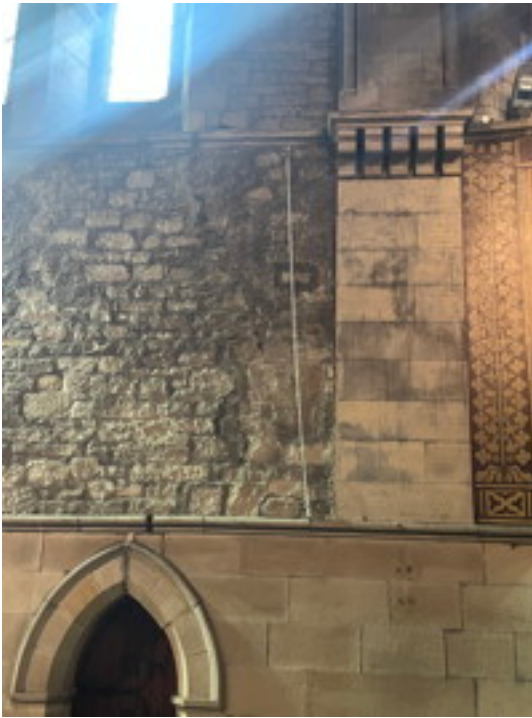
**Cracking to Chancel North Elevation**

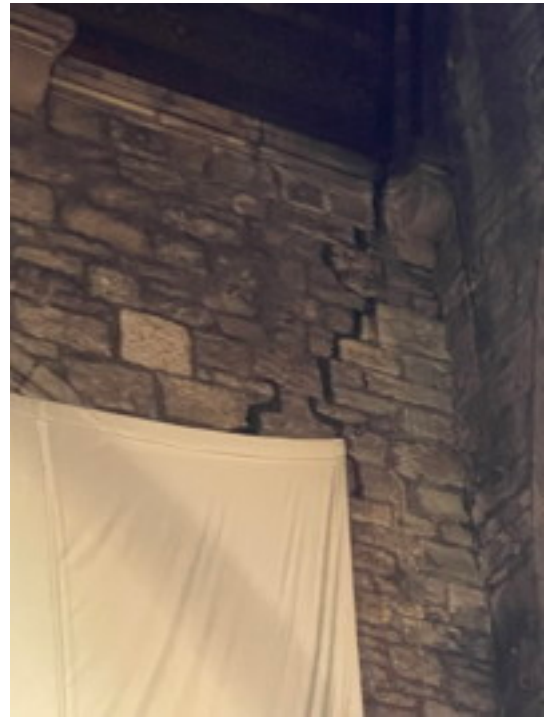
**Cracking to Chancel South Elevation**

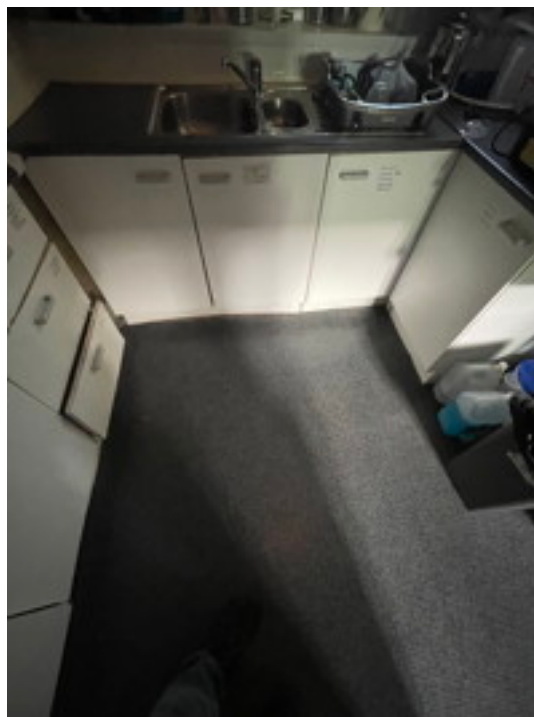
**Kitchen Looking West**

The floor has sunk and the kitchen units moved due to the subsidence. Water is penetrating the roof, again due to the subsidence, and has left a large area of mineral wool insulation exposed where the plasterboard ceiling has come down. The units are not fit for purpose, given that the church caters for about 80 people for lunch on a weekly basis. The lighting is inadequate.

Complete investigation of ground conditions below subsided north west corner and prepare design to underpin. Carry out remedial work as already advised by stonemason to include dismantling north west corner to safe and structurally sound level, then rebuilding with helical bar for strength in some of the stepped joints. All costed above.

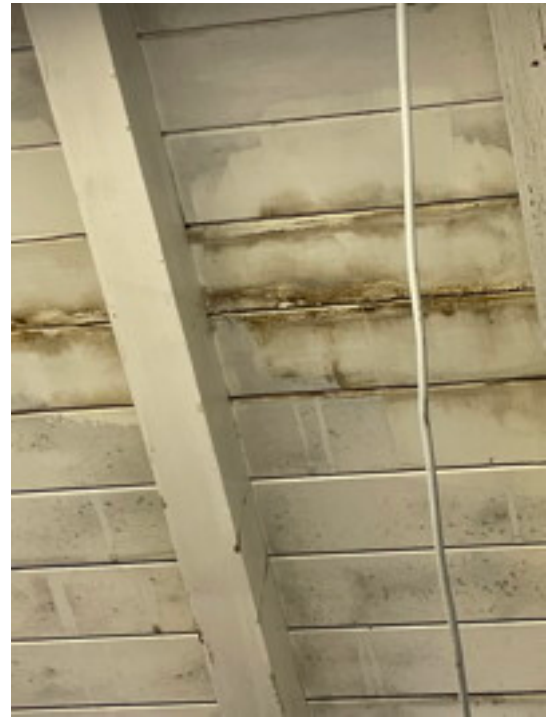
**Vestry Store Ceiling**

The vestry store is all generally in fair condition accept for the ceiling which shows signs of rot. The priest in charge reported that the joist ends had been replaced some years ago and the roof repaired following water penetration. Unless there is still water penetration due to the very low pitch, approx 14 degrees, causing wet rot, there is real possibility of dry rot which like a moisture content of around 20%

Arrange a timber survey with a reputable timber preservation company to establish whether the timbers are suffering from wet rot or dry rot. Cost Band 1– £0.00-£1,999.

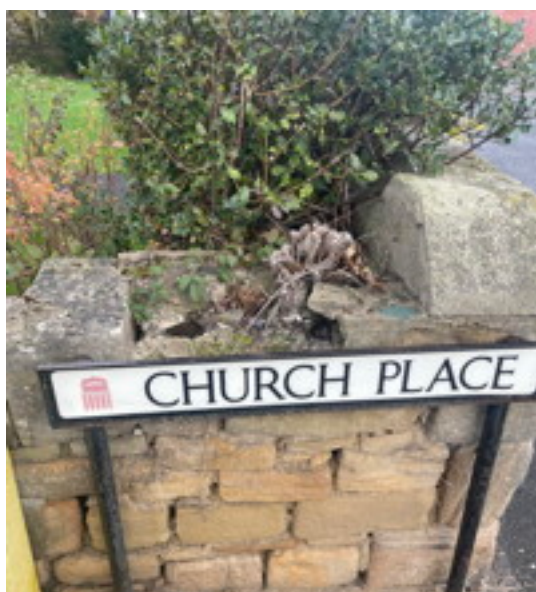
**Tree Damage South East Corner**

The walls are generally in satisfactory condition with some major exceptions. A very large section of wall has collapsed along the southern boundary following a tree falling. Neither the council or the insurers will accept responsibility. A considerable amount of the stone has been removed. To the eastern elevation, a section of wall has started to collapse due to tree growth within the wall. Similar tree growth has occurred at the south east corner.

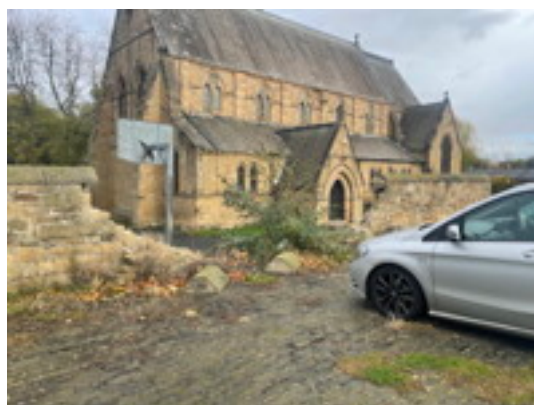
**Collapsed South Boundary Wall**
