Diocese of Durham
St Mary, Gainford

Ecclesiastical Jurisdiction and Care of Churches Measure 2018

Quinquennial Report
On the architect's inspection of

31st January 2023

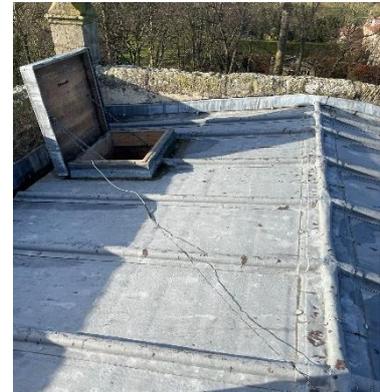
Figure 1- Tower roof and hatch

6.1 **The tower:** Lead roof, roll top and 9 bays, with a box gutter on both the N & S sides. There is a good fall to each gutter and the lead appears to be in satisfactory condition.

6.1.1 The access hatch is also lead covered and heavy to lift, there is also no stay so if the hatch closes it would be incredibly difficult to open. It would be wise to either replace the covering or install a hydraulic mechanism to assist the opening function. There are signs of woodworm in the hatch cover and surrounding timbers.

6.1.3 At the eastern end by the flagpole the pointing to the leadwork in mastic is coming away.

6.1.4 The south-east pinnacle ball top is heavily weathered, and the previous QI reported a crack, this should be investigated and replaced if necessary. Interestingly, the replacement top for the weathervane on the opposite side is in timber.

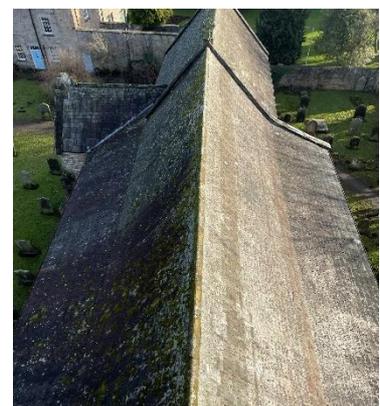
Figure 2- North Face of Nave Roof

6.5 **Nave and aisles** steeply pitched nave and lower pitched aisles in diminishing Westmorland slates. The weak point will always be at the point where the slope changes over the aisles, there is some internal staining, but appears to be no current leaks. To the north slope there are three cracked tiles towards the west and the tiles adjacent to the west abutment look uneven. To the south the ridge bedding is coming away in multiple locations. There are five areas where slates are missing or broken and one large slate in the middle is loose. The south aisle has three slates missing or slipped at the aisle junction about mid-way.

6.5.1 To the south the area of slating at the junction of the nave crossing and aisle has had multiple repairs in the

past, evidenced by tinges. The internals at this location should be closely monitored for any leaks. To the western water tables there were repairs noted in 2015 and 2017 to the 'southwestern end and the tower', where there was a great deal of damp internally previously – see item 14.3.

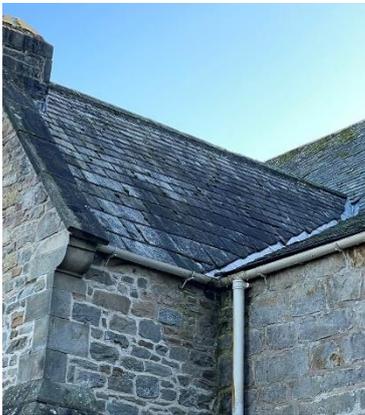
Figure 3- Gutter to west organ loft

7.1 **Chancel:** The gutter to the north drains onto the organ loft roof, the gutter is rusted at the end and meets a valley. As noted in the last inspection a running outlet with directional shoe would be better in this instance. An additional downpipe to the east would be a further improvement.

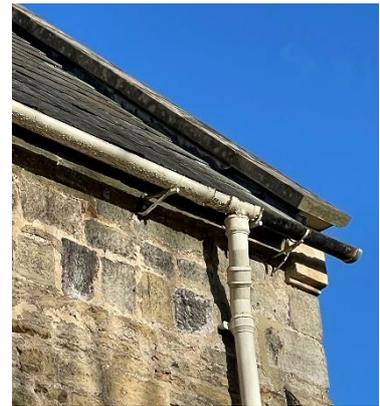
Figure 5- Gutter to South Chancel

7.8 **South Chancel:** Possible backfall to the gutter towards the aisle. Replacement gutter at the East end requires decoration and the end cap making plumb. Downpipe is okay but has had quite a bit of debris in it in the past, possibly collecting at the change of angle at the plinth.

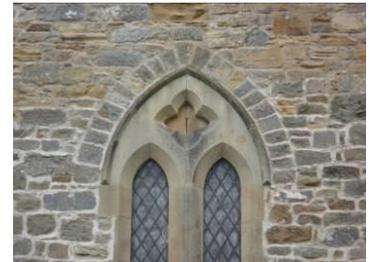
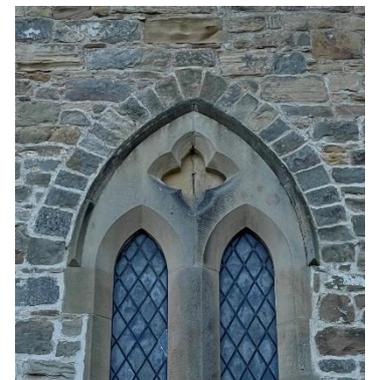
Figure 6 - crack in lancet in 2014 (top) and 2023 (bottom) item 8.3.2

8.3.2 **North Elevation:** Chimney flaunching looks poor, capping needs to be checked from above. There is a water trap at the head of the water tabling. Some erosion to the stonework above the window, this area also requires re-pointing. Walling generally sound, as is the lancet, apart from one minor crack in the quatrefoil window. The crack appears to have progressed very slightly from the previous inspection report but looks to be due to weathering rather than additional movement, this should be monitored closely.

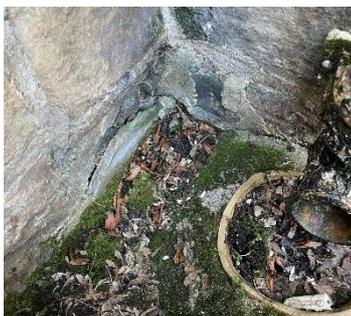
Figure 7 – east elevation stone as item 8.3.3

8.3.3 **East Elevation:** Okay apart from some open joints on the buttress and at plinth. One stone at corner with aisle has delaminated and this is now directing water into the structure.

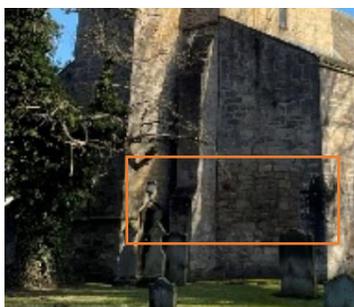
Figure 9 –porch standing stone

- 5.2 The walling is generally sound, although there are some areas of repointing required. The celtic stones to the porch and embedded near the entrance are degrading due to the rising damp and are at risk of any remaining decoration being lost.

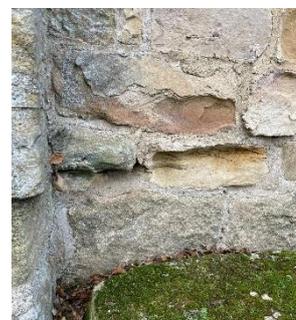
Figure 10 – S.W aisle stone

8.7 **South Aisle, Western end:** Eight weathered stones at the base of the wall but generally not currently requiring attention, one needs monitoring to determine point of replacement. The buttress has a metal piece in it that will rust over time and break the stone. The buttress against the porch has its foundations on show. There is dead ivy on this elevation which should be removed.

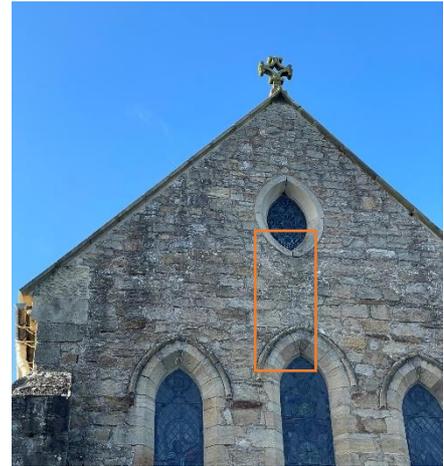
Figure 11 – East lancet cracking

8.10 **Chancel:** Poorly executed mortar pointing over various stages, some now beginning to weather. However, it is generally sound. A suggestion of cracking on the Easternmost lancet head but not problematic. The Western lancet has open joints on the hoodmould and it can be seen that there has been movement in the lead. Both windows are unprotected. New stones to the door jamb are settling in nicely. The buttress is okay apart from a couple of open joints.

- 8.11.1 South water table has been renewed recently. The broken stone below the kneeler has not been dressed well and doesn't match the opposite profile.
- 8.11.2 Walling is generally in good condition; however, the structural issues discussed at item 13.1 are visible to a lesser extent - The central lancet has a crack running through the stone up to the vesica window. There is no crack below it but there is a buttress there, suggesting that this has been strengthened in the past. The left-hand lancet has a crack running vertically and a crack in the cill. The lancet on the right-hand side looks okay. Above the vesica, a crack continues to run up, although not far, to the apex. There has been slight movement of the northern kneeler in the past. This all suggests the wall head is spreading here.

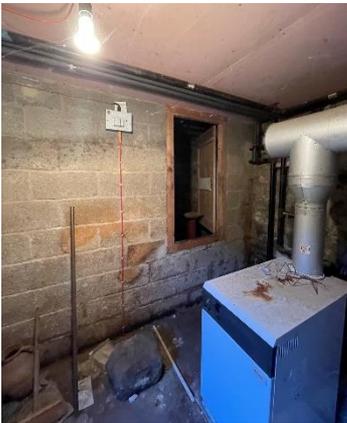
Figure 12 – boiler room

- 8.12.1 Situated at the West end of the church on the North side. The steps down to it are covered in moss and leaves. The stonework is slightly eroded around the enclosure. The boiler room door is a simple boarded door with rusting iron hinges, but reasonably serviceable.

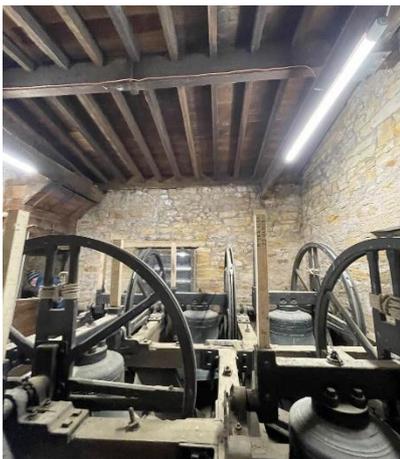
Figure 14 – Belfry from SW corner

- 9.3.1 Some minor delamination of stonework and occasional open joints, particularly at high level in the South-East corner. The roof structure appears sound and no evidence of water coming from the parapet gutters, there is some historic staining to the underside but no current damp patches.

9.3.2 There is a build-up of dust/ sand from stone erosion around the perimeter. Although the area appears to have been tidied of some loose debris, there are still old clappers that should be removed. The timber bell frame rests on the floor and supports six bells. There are some bird markings, although these appear to be historic. The mesh to the louvres appears ok, but wildlife can get in through the rainwater hopper inlets as below.

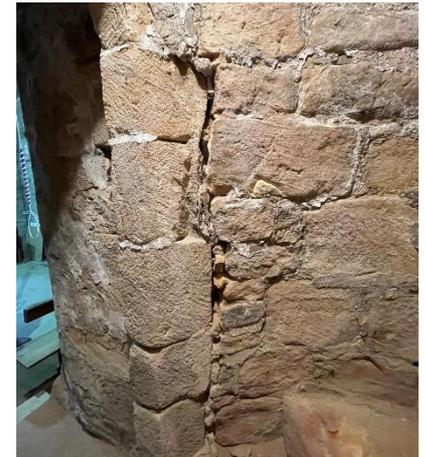
Figure 15 – jamb of ringing chamber

- 9.4.1 At the entrance to the ringing chamber on the right-hand side of the door jamb, there is a wide crack. It has been patched in the past and mortar is continuously lost from the infill. Above it, there is a further hole in the stonework and this is next to the cable. To the left of the arch, the same applies. There are some large areas of stonework jointing that need infilling.

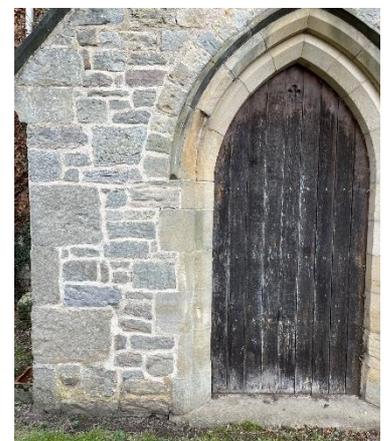
Figure 16 – south porch door

10.6 **Doors** are generally in good condition, the sealed door to the south porch requires decoration, as does the northern porch and priest door externally.

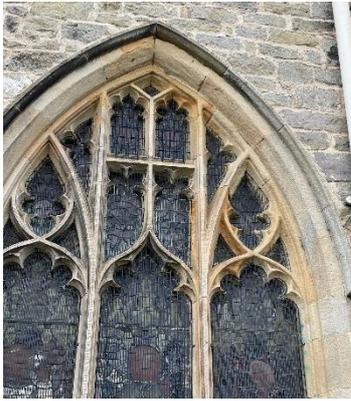
Figure 17 – southeast aisle tracery

10.5 **Southeast Aisle:** The tracery to the window closest to the south porch has some erosion, to be monitored for further degradation, though no action required in this quinquennium.

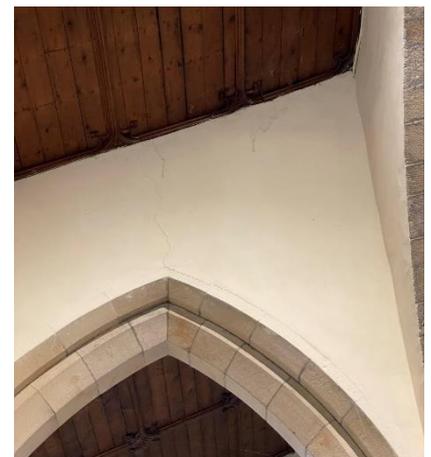
Figure 20- Crack to southern aisle arch

13.3 The arch to the tower crossing looks to have been poorly cement pointed in the past at the apex. The southern arch looking from the nave side has a hairline crack emanating from the apex, which was not noted in the last inspection therefore should be monitored closely for any progression. Both the North and South arcades to the tower look okay.

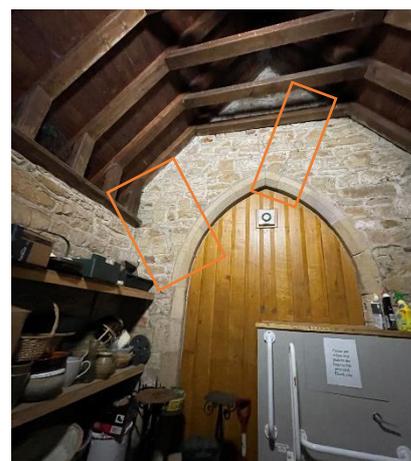
Figure 21- Crack to south porch

13.8 There are cracks as both porches pull away from the church, these show no change from available records.

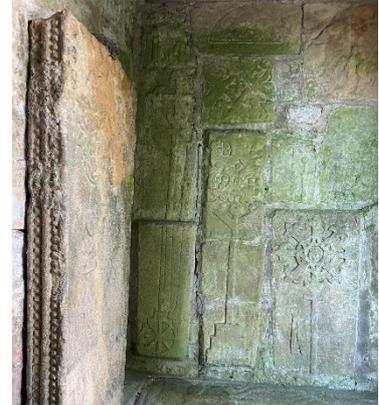
Figure 22- North porch walls

14.8 **North Porch:** The walls have some slight open joints at the doorway to the church. There is a lot of damp coming up and all the walls are green. some large historic cracks reside. Cracking internally to the west wall is currently 3-5mm in width. The area is walled in grave covers which are pleasant but will deteriorate if attacked by damp. The large slab to the right-hand side of the doorway will also continue to degenerate whenever it is attached to a damp wall, and this has progressed since the last inspection (with birds nest also on top). On the northern side of the church, damp will always be an issue in an open porch such as this, but regular clearing of moss on the roof and maintaining gutters will aid and allow a better feature of these attractive artefacts.

14.9 The rising damp is a concern, especially to the western wall. Ideally, a strategy should be devised and implemented to both improve the ground drainage externally, improve air flow to these walls and regularly inspect this area. Initially, I would look to investigate if the gullies connect to a wider drainage system. The churchwarden has informed me that what the previous inspector suspected was a timber floor is concrete screeded with DPM, which is beneficial as the damp conditions would have made any timbers very vulnerable to damp, however the floor can therefore not breathe over a large area, which is likely causing the damp to rise higher up the western wall.

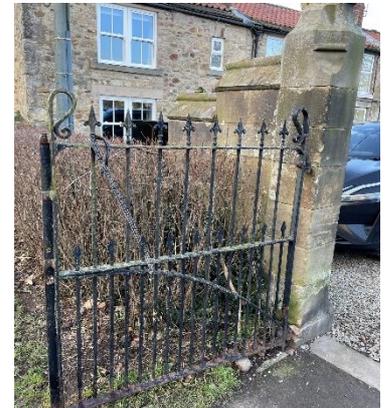
Figure 24- entrance gate

27.2 The Northern boundary has a large entrance gateway with gates which are in servicable condition. The bottom hinge is broken in the gatepost and these need a better fixing arrangement. The passage gate is jammed against the post, and also requires some routine maintenance.
