**QUINQUENNIAL INSPECTION REPORT
OF
ST. EDMUND'S CHAPEL, HIGH STREET, GATESHEAD, NE8 1EP**

QUINQUENNIAL INSPECTION AND REPORT

DATE OCTOBER 2020

David Beaumont BA (Hons) Grad Dip, RIBA, AABC

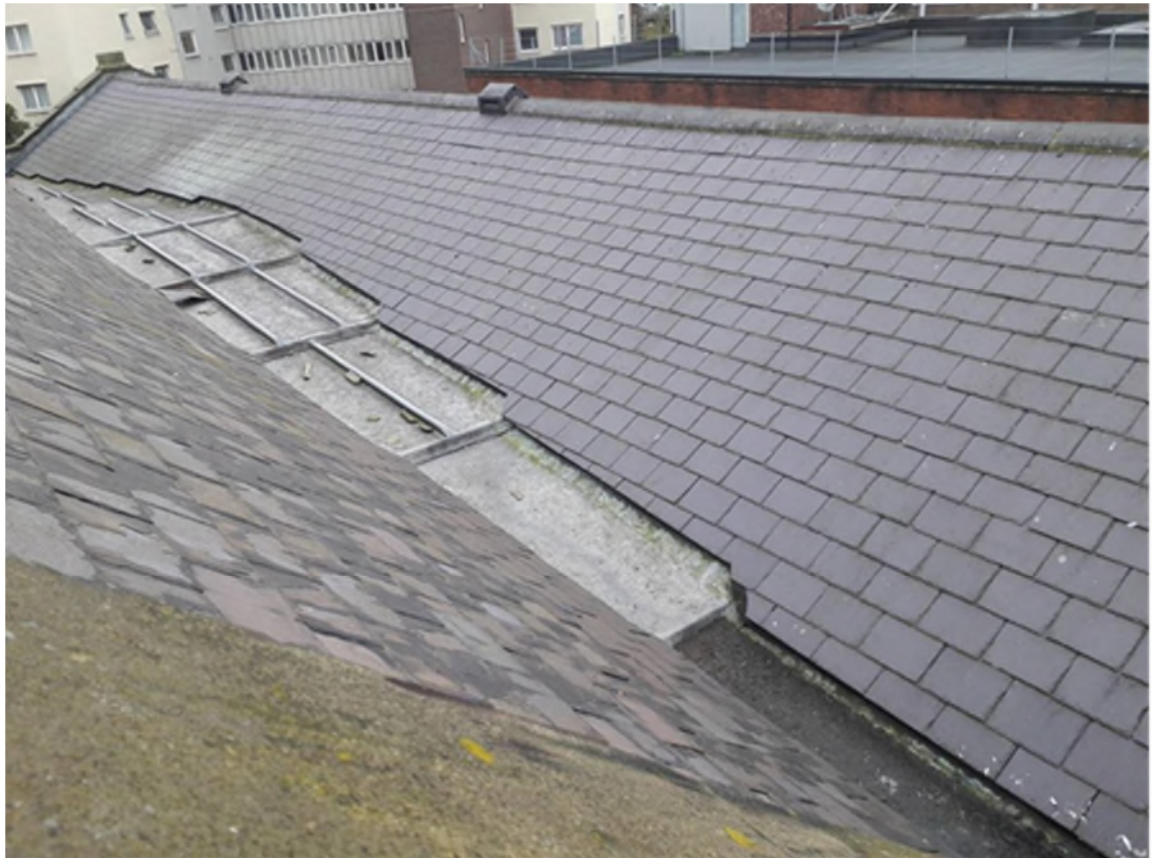
The Trinity roof that adjoins the shared box gutter is in poor condition and the ridge bedding is breaking down, the slating is cracked and slipping and these are coming into the box gutter and are effecting the performance of it.

The shared box gutter outlets have and still are a constant source of water ingress spoiling the plaster and decoration of the gables. There is damp penetration at both ends internally and externally and the roof and gutter inspections that have been carried out during the last QI on three occasions have all revealed that the chutes at each exit are blocking as a consequence of pigeons, their mess, those that choose to expire and come to rest to block up the box gutter outlets which is joined by the detritus of Trinity's roof failing slating.

View towards Edmund. Note bits in the gutter

The exit of the box gutters is narrow and choked by the masonry arrangement and it would be wise to have these completely opened out to reduce these problems.

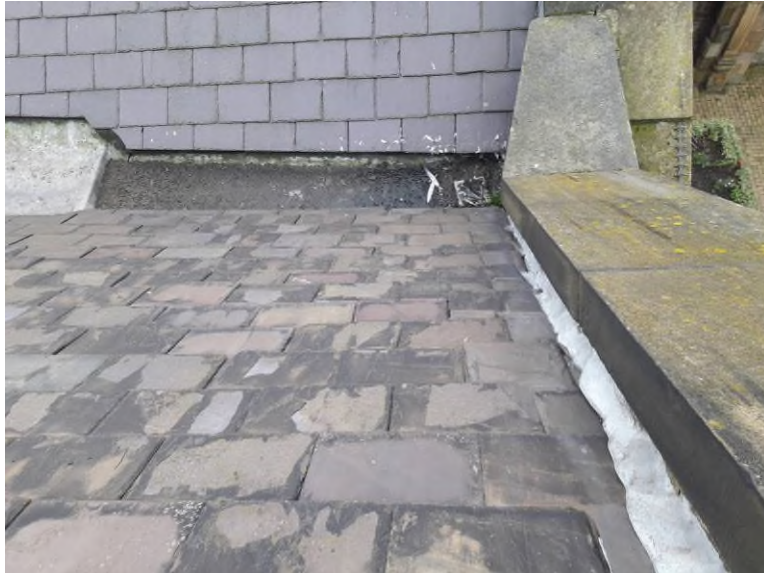
The outlets frequently block. There was water coming inside during the inspection from the east end.

It was repaired the following day.

It was a blocked east outlet. Again. Caused by detritus from Trinity's poor roof and the products and bodies of pigeons. The outlets had lead covers with holes which formed a dam and these have been removed to let the wind and rain assist their passage. There must have been 80 pigeons on Trinity roof at the QI.

Recommendation: consider redesigning the outlet of the box gutter. Inspect the south parapet gutter when next attending to roofing repairs. Refix E downpipe.

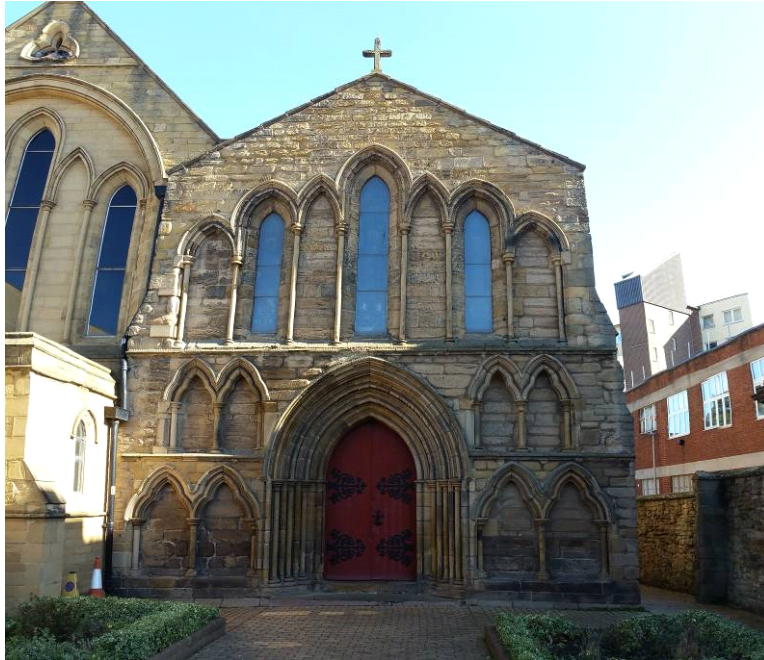
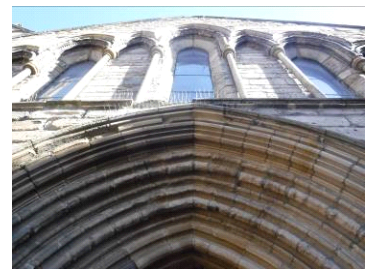
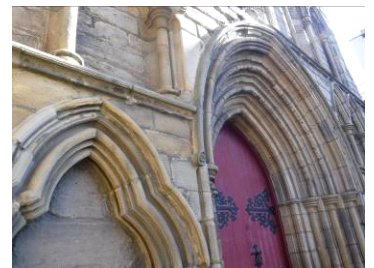
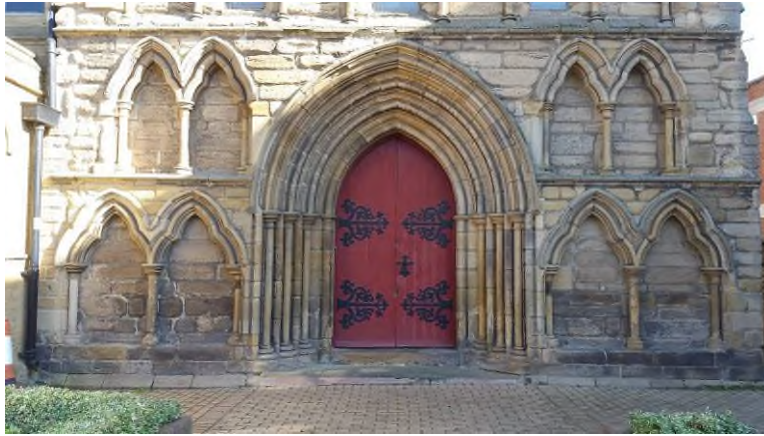
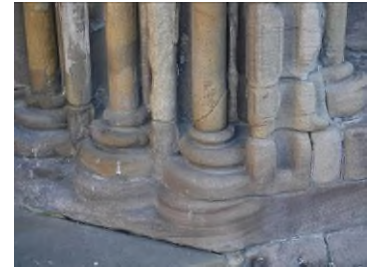
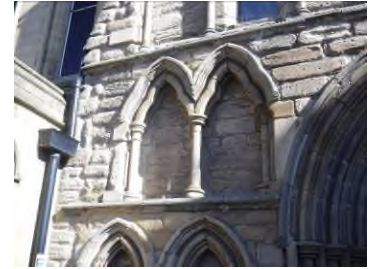
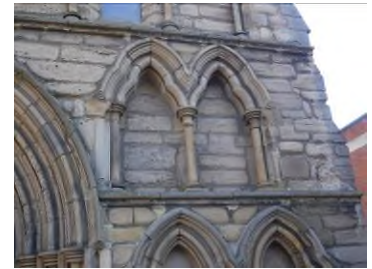
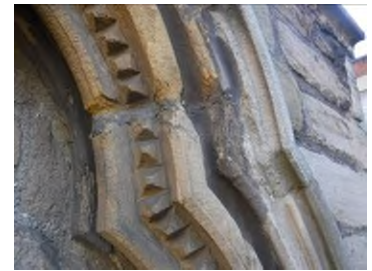
B West side –

There doesn't really seem to be much change from the 2013 QI.

The observations made by the 2015 report by Classical Masonry are still relevant.

There is shaling hood moulding to the N most lower tier and to the door orders. The upper level hood moulds have been repaired in the past and they seem ok as do their interior arches. The shafts look ok though they are wasting away at their feet at the upper level. At mid-level all ok. At bottom level the n most has got a crack in it.

Within the doorway, N most nook shaft has cracked at the bottom, its neighbour is wasting away and a good kick would probably break that. The door within it is sound though the decoration is breaking up a bit.

The W wall is topped with a rebated water table with pigeon spikes. As it crosses Trinity to the N there is no flashing and open joints in Trinity wall. Consolidation of the Trinity pointing and avoid flashing (as it doesn't fit the coursing well) is probably the best solution.

Polycarbonate covering seems fair. The arches have pigeon spikes on, there is a bit of spiking missing at the middle stage above the door head.

Recommendation: make a photogrammetry survey of the façade, consider conservation repair methods, and restore missing bird spikes. Advise Trinity of pointing requirement at watertable.

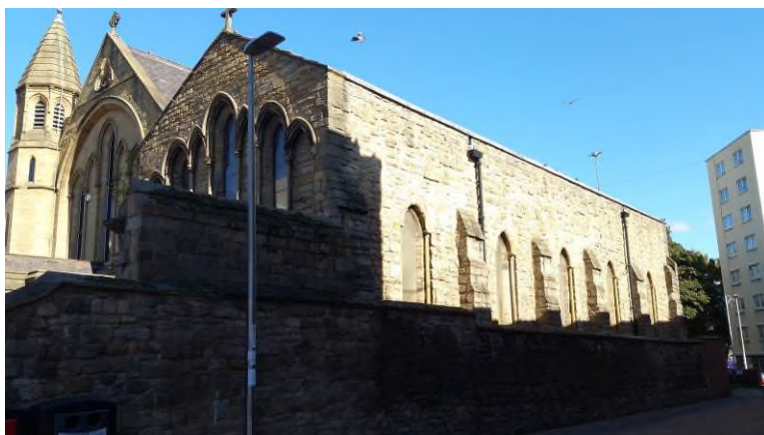
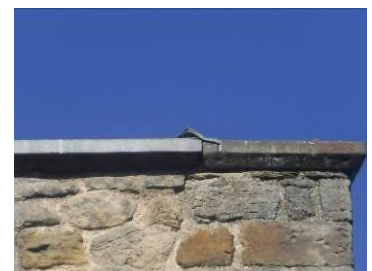
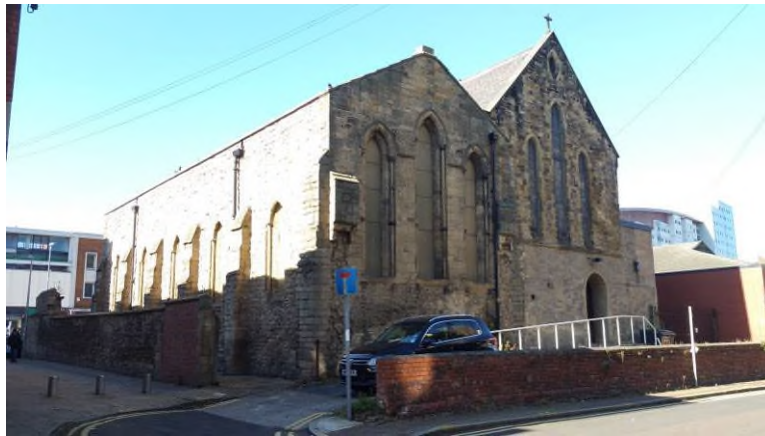
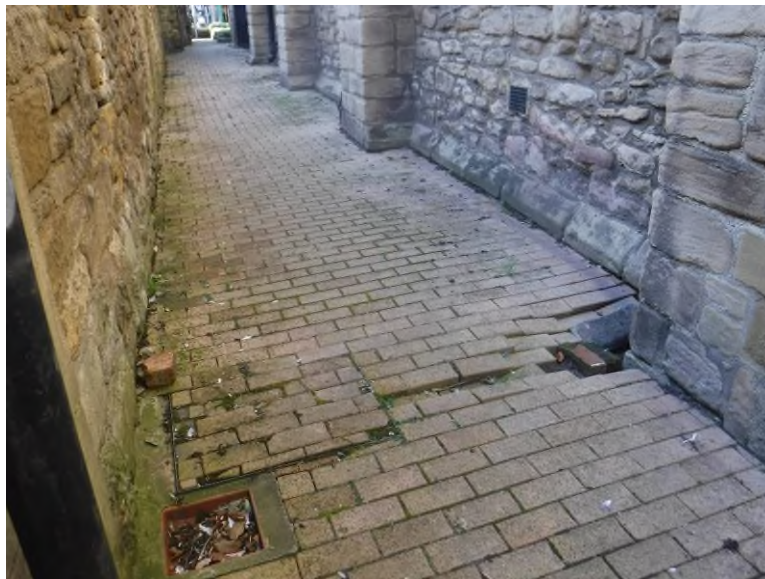
- **North side**

The wall is topped off by a lead covered coping, that all seems ok. The sandstone walling itself is worn but all of the pointing is ok, as are the buttresses.

At the lower parts of the walls are metal air grates these must be the floor ventilators, but they are only on one side so it can't really run all the way through and it seems to stop at the E end where the floor is solid at the altar. There was a lower chamber, infilled in the 1980's.

Recommendation: none

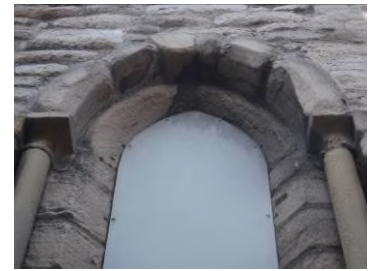
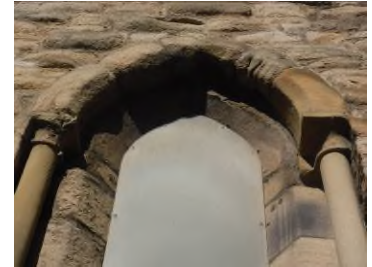
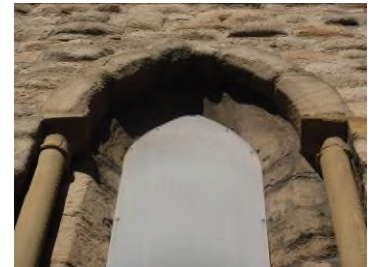
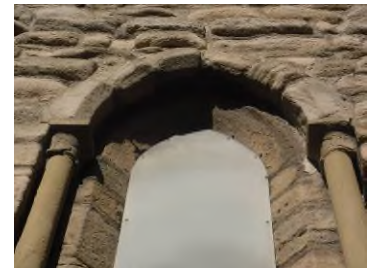
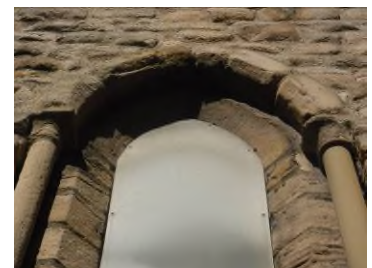
Comments on the window openings from W to E:

- 1) Crack to the W capital and erosion to the right.
- 2) The same as no. 1 but reversed and looking frail.
- 3) E capital friable.
- 4) E capital friable.
- 5) Both capitals friable.

The shafts seem generally ok, it's the capitals that seem to have the most wear and they are breaking up a bit, there have been

some repairs to the windows in the past. It's not needed yet, maybe 10-15 years' time.

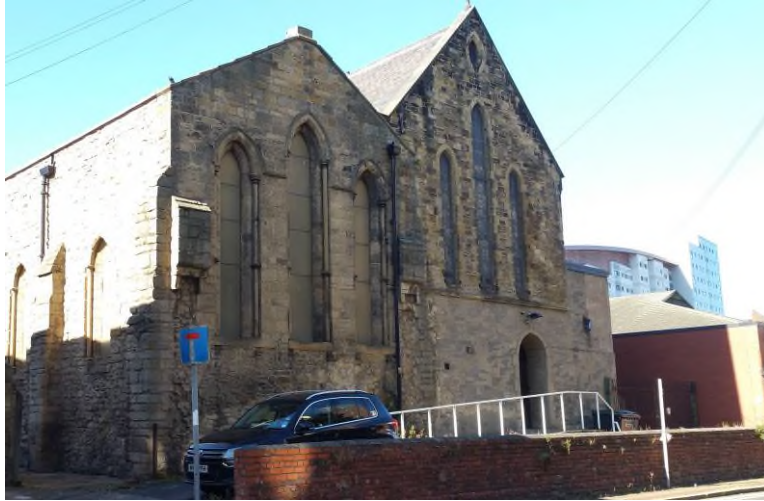
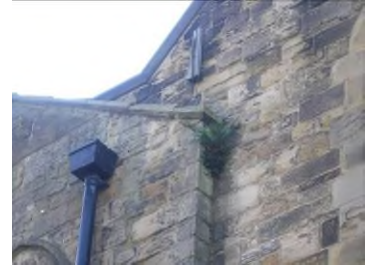
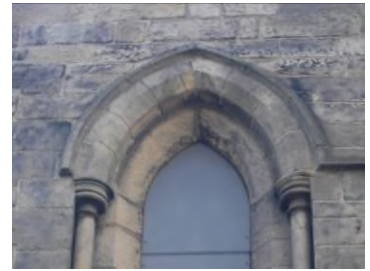
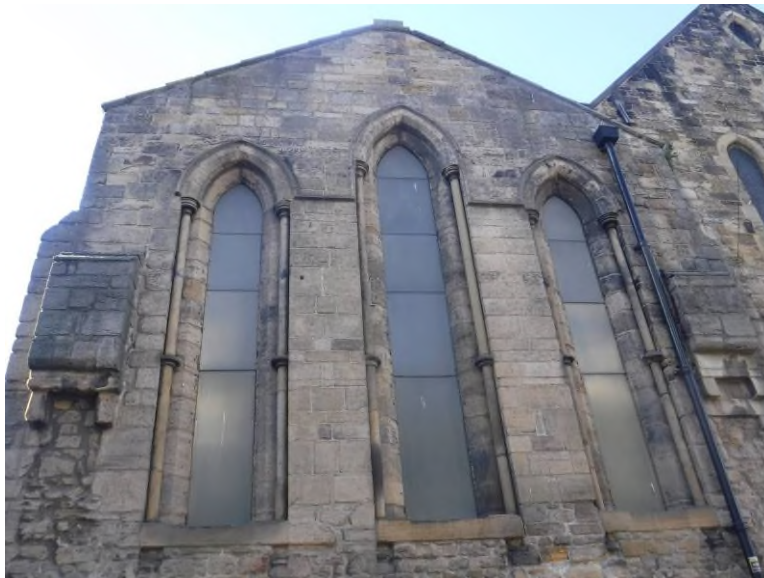
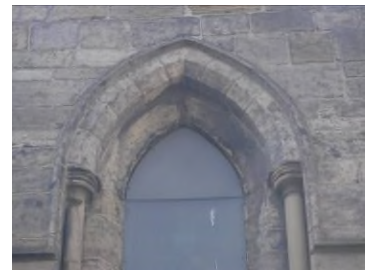
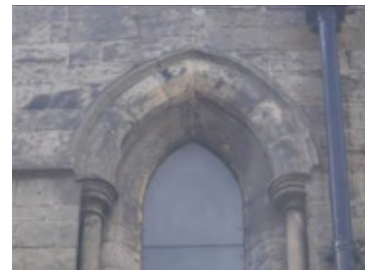
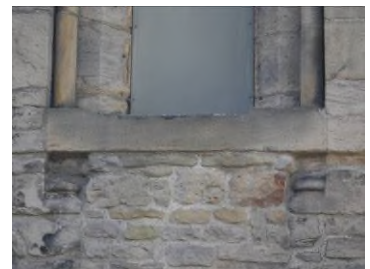
- **East side**

Rebated water table as the W side, slight factors to some of the rebates but its ok. No bird spikes here.

Walling is all ashlar at the upper levels and there is also a hanging partial buttress. It looks as if the cills of the windows have been raised in the past as the bases of the shafts are in the walling.

Below the cills the walling is random and there used to be two doorways or window openings which have now been filled in. The masonry is all in fair condition. The external ground rises a little and there is a ramp formed for Trinity access.

Three single lancet windows, the chamfered reveals are ok and much less weathered than they are on the N, the capitals to the nookshafts are in better condition as are the collars midway down apart from the middle window, N side and the N window N side, and there is also a crack to the shaft here.

The shafts are weathered and two have been replaced in the recent past and others in the distant past and they look as if they will manage for now. The shafts do not sit on their bases which have been terminated by a heavy cill running through to raise the cills of the windows, probably to suit an internal reordering.

Recommendation: none

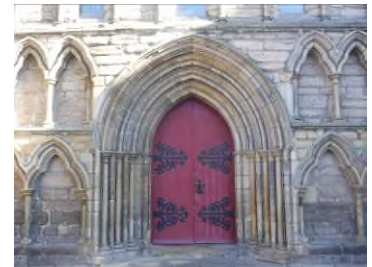
C Pair of heavily boarded doors at the entrance, decoration breaking down, and iron hinges rusting a bit, latch is ok.

Recommendation: overhaul door and redecorate.

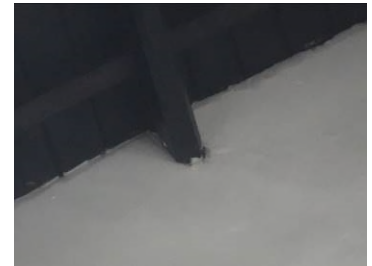
- Curved roof trusses with extended struts down to stone corbels and these support purlins and flat rafters. There is a slight bit of pull-out of the purlins at the E end and might there be a touch of that also on the W? I can't imagine that this is active.

Recommendation: none

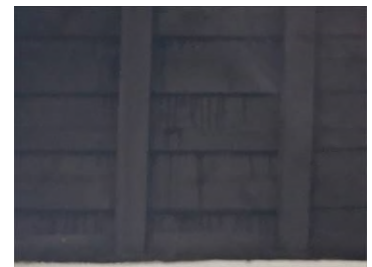
- D The nave ceiling is boarded and there are evidence of some water staining halfway up the slope on the W end at the N face (the box gutter was leaking at the inspection). The shrinkage of the boards is revealing a white lining suggesting there may be insulation or possibly that is the roofing felt on top of this boarding. The boarding itself is probably sarking boards.

Within the vestry it is flat plaster ceilings, it has got some cracking and the joints are taped over with masking tape.

Recommendation: update vestry ceiling decoration

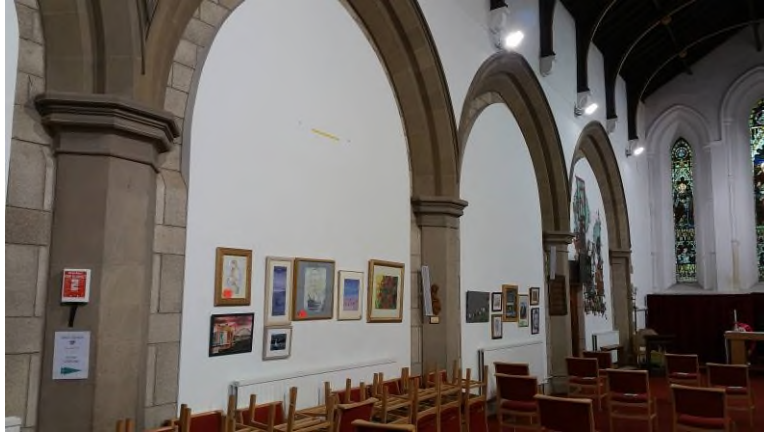
Four arcade arches blocked in as part of the division of Trinity Centre to the N. The arches structurally have no defects to them. They are in ashlar masonry with some slight damp at the bottom of the bases (vestry is the worst) but nothing concerning. Their infill is fair faced blockwork and there is some slight cracking to the arches of approximately 2mm and this is probably just material shrinkage and the use of cement which is not flexible enough, the worst of them is at the E end. Sound does transmit from Trinity. Is there a fire risk here?

Recommendation: Find the records of the construction work to establish what the details of the infill are. Assess if there is a risk from activities in Trinity.

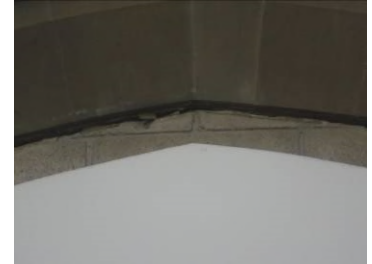
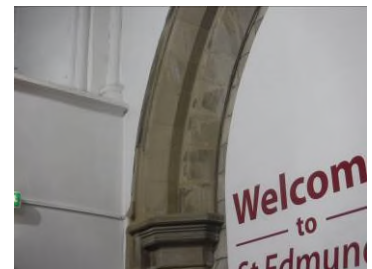
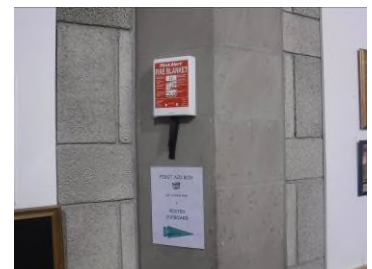
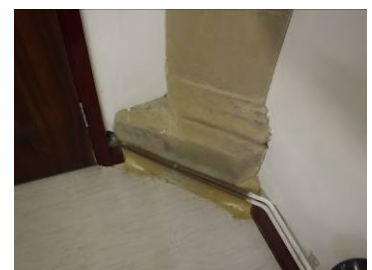
D The whole of the interior apart from the arcades is plastered and painted.

There has been water ingress at the W effecting both the last arcade arch wall above it and the W gable corner directly where the hopper head is.

There is quite recent decoration failure at the E end where there is also a panel of plaster that looks to be coming away below the purlin (*confirmed as actually coming away in August 2021*). The decoration throughout is a bit tired now, there is some yellowing coming through on the nook shafts at the E end and slight yellowing at the base of the shafts on the S side and the church has plans in place for redecorating the interior.

Recommendation: carry out redecoration

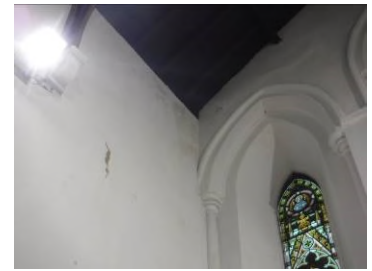
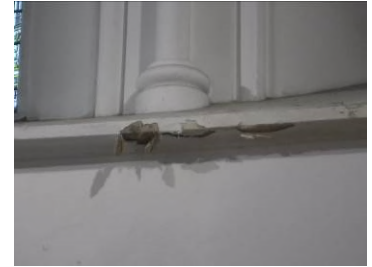
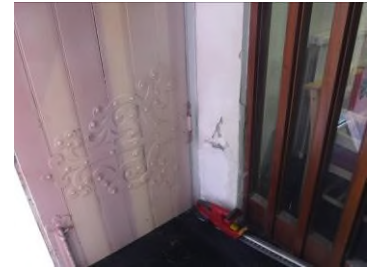
The vestry works in 2015 are all reasonably up-to-date.

Door reveal plaster patch coming away.

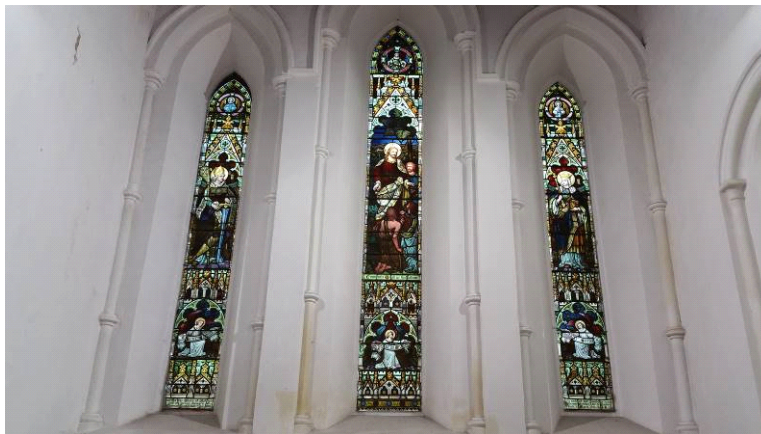
D East side –

E gable formed of three single lancet window with pictorial glazing, supported by saddle bars they are slightly rusty but seem to be in fair condition and the glass on all three lights looks to be ok, slightly cobwebby at the top in some instance.

Recommendation: carry out a further assessment of the glazing repair needs, repair rusted ventilators to provide fresh air. Remove cobwebs and clean glass.

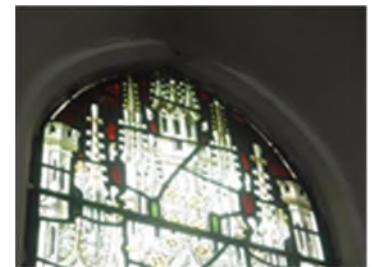
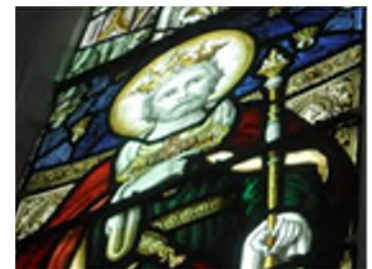
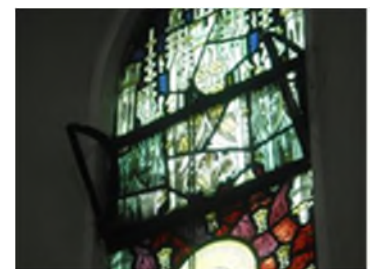
S side – Where there are five lights, working from E to W:

- 1) Lancet pictorial St. Aiden ok.
- 2) Lancet pictorial St. Hilda, buckling a bit at the arch, below that a ventilator which doesn't look openable and there is some cracked glass within that, there is also some cracking to the glass of St. Hilda on her robe.
- 3) Lancet pictorial, St. Oswald, bowing to the fourth panel that contains the head quite significant actually, glass is by Atkinson Brothers, Newcastle.

- 4) Venerable Bede lancet pictorial has a ventilator that looks rusted up and not used, slight buckling at the arch, ok.
- 5) Lancet pictorial St. Cuthbert, his head looks to be buckling slightly and there is paint marks right up at the apex.

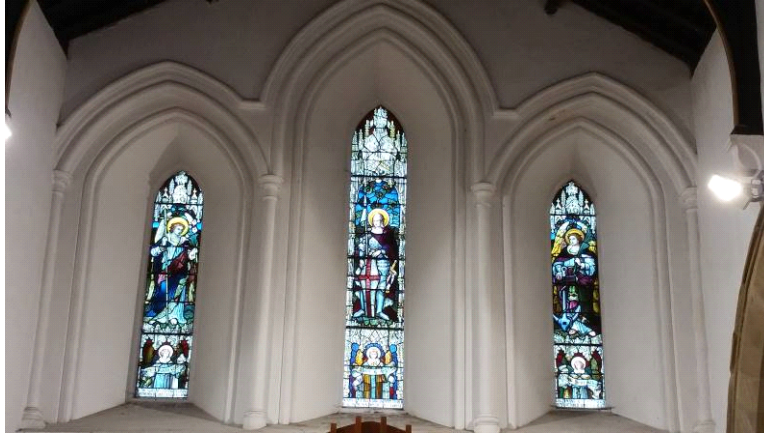
West end

There are three lancet lights, working from left to right:

- 1) Pictorial, Faith a bit of cobweb at the top.
- 2) St. George, looks ok.
- 3) Pictorial Hope, a bit dusty all of this glass is in memory of Stanley Dawson, Sim Tucker, Lieutenant 6th Battalion, fell in action October 1917. The glass all looks ok.

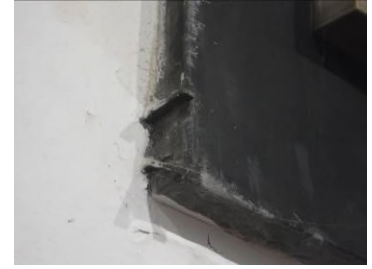
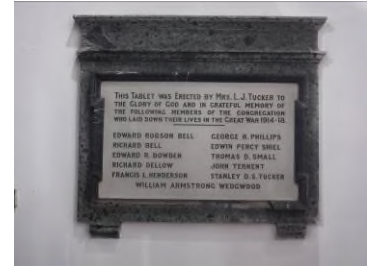
Early Victorian monument to Colonel Robert Ellison, in marble with black tablet by GG Adams SC London, it has been cleaned in circa 1980, the tablet has been secured at the bottom with floor brads that are rusting, it would be worthwhile just checking that for its stability.

WWI tablet in grey granite celebrating the congregation members who died, the bottom part of the shouldered frame surround has broken away and there is a couple of chips to the cornice.

Recommendation: check monument fixings

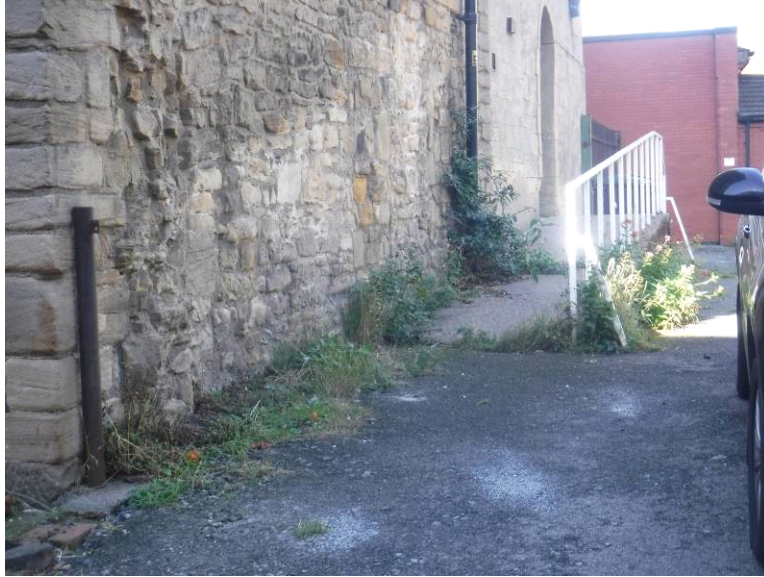
W side- is a rough area of tarmacking, concrete and weeds which provides a little car parking for the church. It has little visual amenity and could be considered to be replanned to make the church more attractive and welcoming.

Recommendation: weed the paving and repair, consider updating.

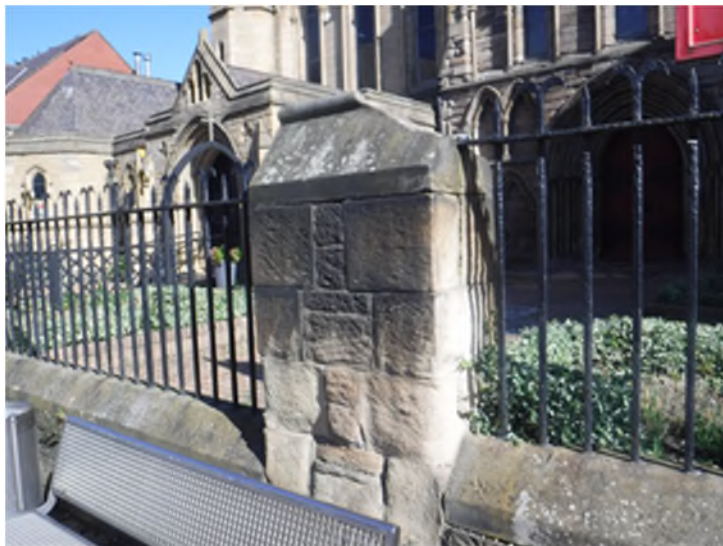
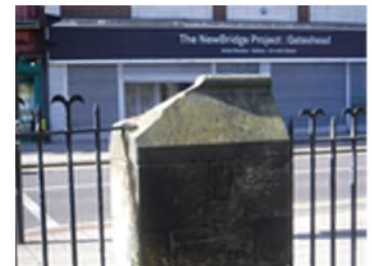
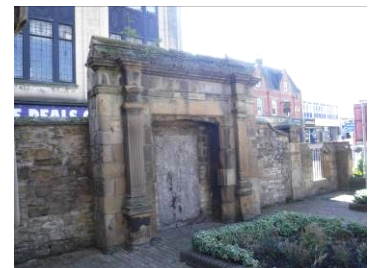
West

The boundary is to the High Street and this has a low wall with intermediate stone buttresses with iron railings within it, this was the subject of the report by Classic Masonry and it needs a few repairs, see the report for the repairs.

Recommendation: W- repair railings and stone wall, remove plants from gateway

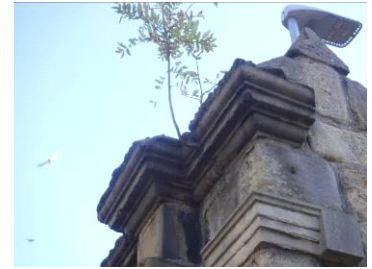
Within the SW corner is a relocated gateway. It has plants growing out the top which will break the top in time. Looks a bit down at heel but it will do, Is it the church's responsibility to maintain it?

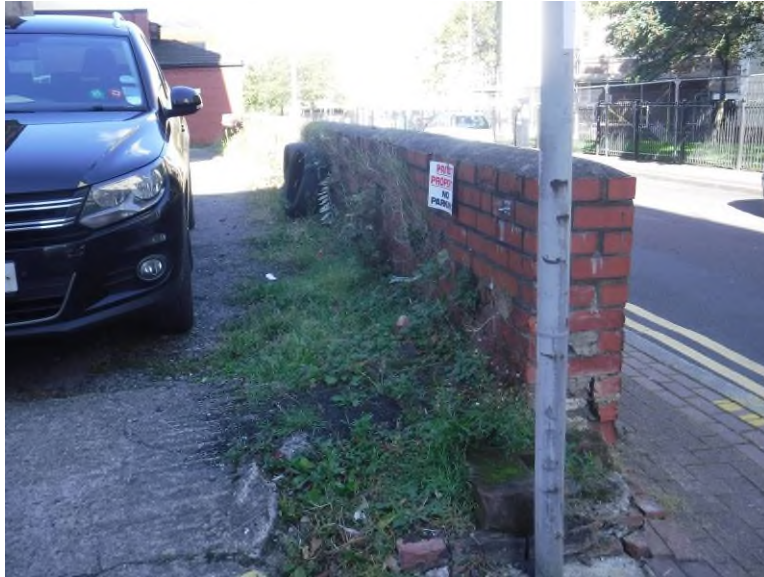
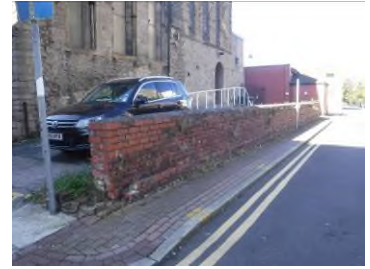
C **East**

Engineering brick with cement coping with lots of plants growing inside it.

E- remove weeds and assess condition.

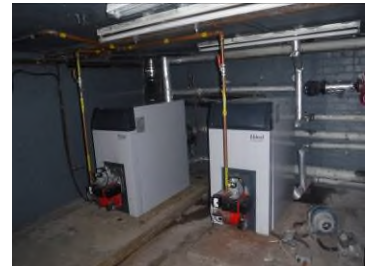
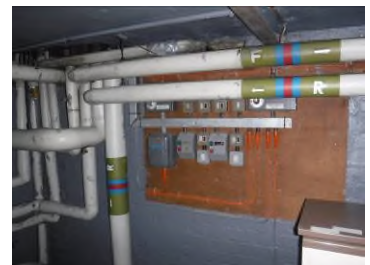
B **Ceiling** – Concrete shuttered ceiling repainted and in good condition, it has two steel beams with a bit of rust on them but they are ok.

Walls – The walls are brick and black and have recently been repainted and they are in good condition.

Floors –These are concrete, slight evidence of damp around the back of the boiler, it is probably the boiler leaking rather than damp coming up out of the ground, I am not so sure but generally the floor is dry.

Room contains two Ideal Falcon GTS boilers with Nuway burners and Grundfos pumps. The room also has a couple of old cabinets but it is actually in very good condition. There is also some garden tools in the corner. The door just slightly catches but it is satisfactory, there is also a metal gate in front of that and that is ok and the general enclosure of that lobby is alright. There are steps down to the boiler room and they are ok as are the

retaining stonework walls though there is a little bit of planting growing in the open joints.

Recommendation: investigate water on floor, remove plants at stair.
